REPORT NUMBER: 221-MGA-2007-001

**SAFETY COMPLIANCE TESTING FOR
FMVSS NO. 221
SCHOOL BUS BODY JOINT STRENGTH**

**THOMAS BUILT BUSES INC.
2007 THOMAS SAF-T-LINER C2
NHTSA NO.: C70900**

**PREPARED BY:
MGA RESEARCH CORPORATION
5000 WARREN ROAD
BURLINGTON, WI 53105**

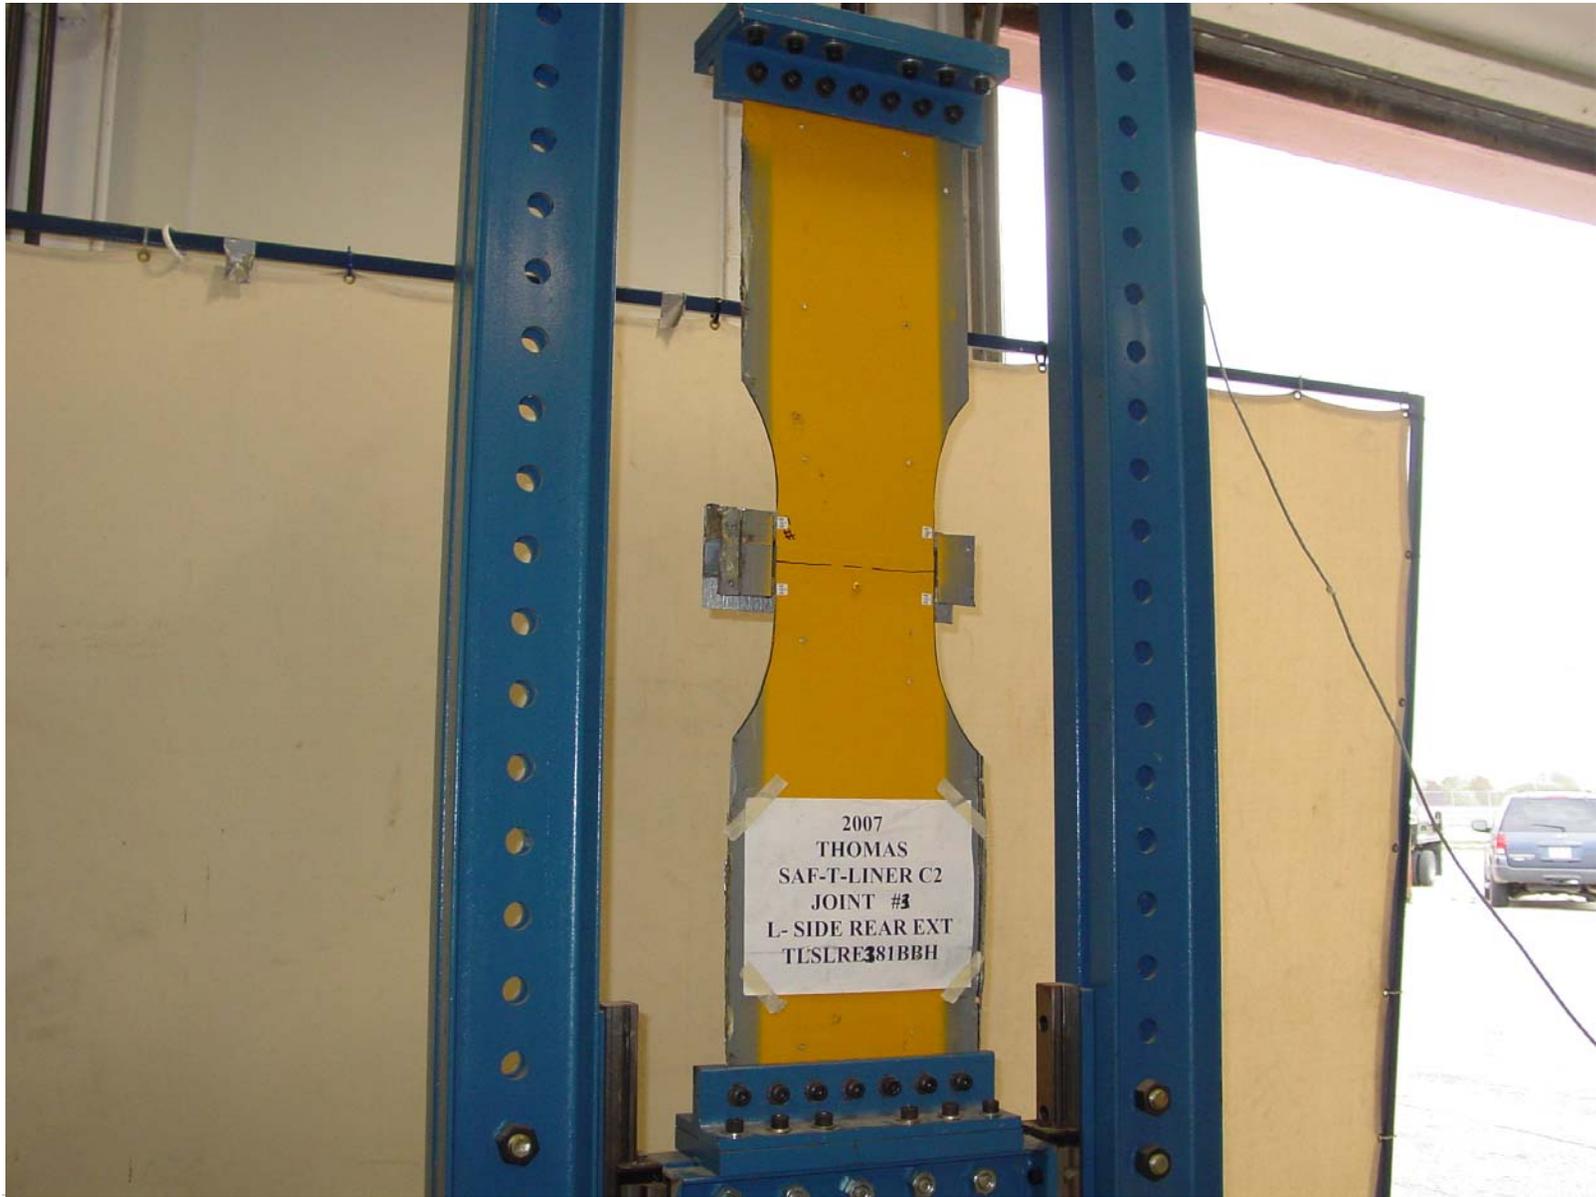
Post-Test of Joint #3

Weaker Member	Stronger Member
Material	Galvanized, CS, ASTM, A653	N/A
Tensile Strength (MPa)	310.3	N/A
Gage/Thickness (mm)	20 / 0.912	N/A
Fastener Holes (No./Diameter – mm.)	1 / 4.70	N/A
Net Area (Sq. mm.)	181.0	N/A
Material Strength (N)	56159.4	N/A
60% of Material Strength (N)	33695.6	N/A
Maximum Load From Tensile Test of Joint (N)	63416.8	N/A
PASS/FAIL	PASS	N/A

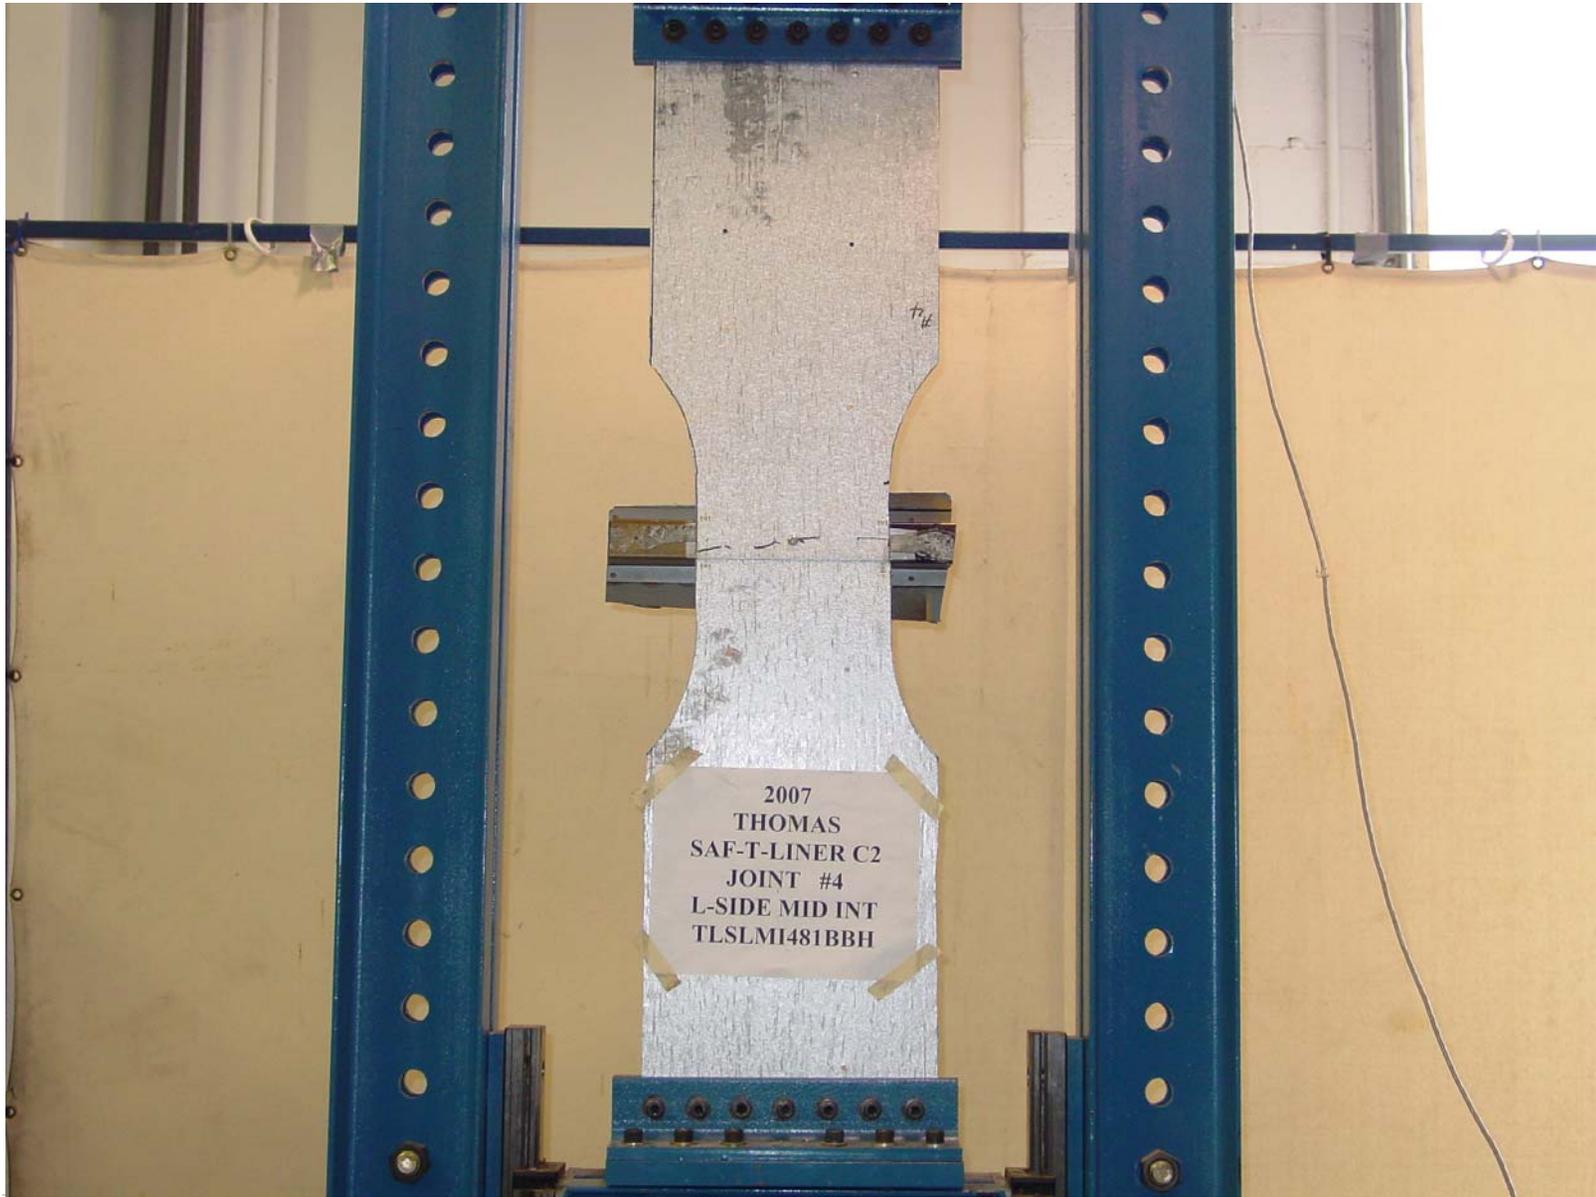
Pre-Test of Joint #4

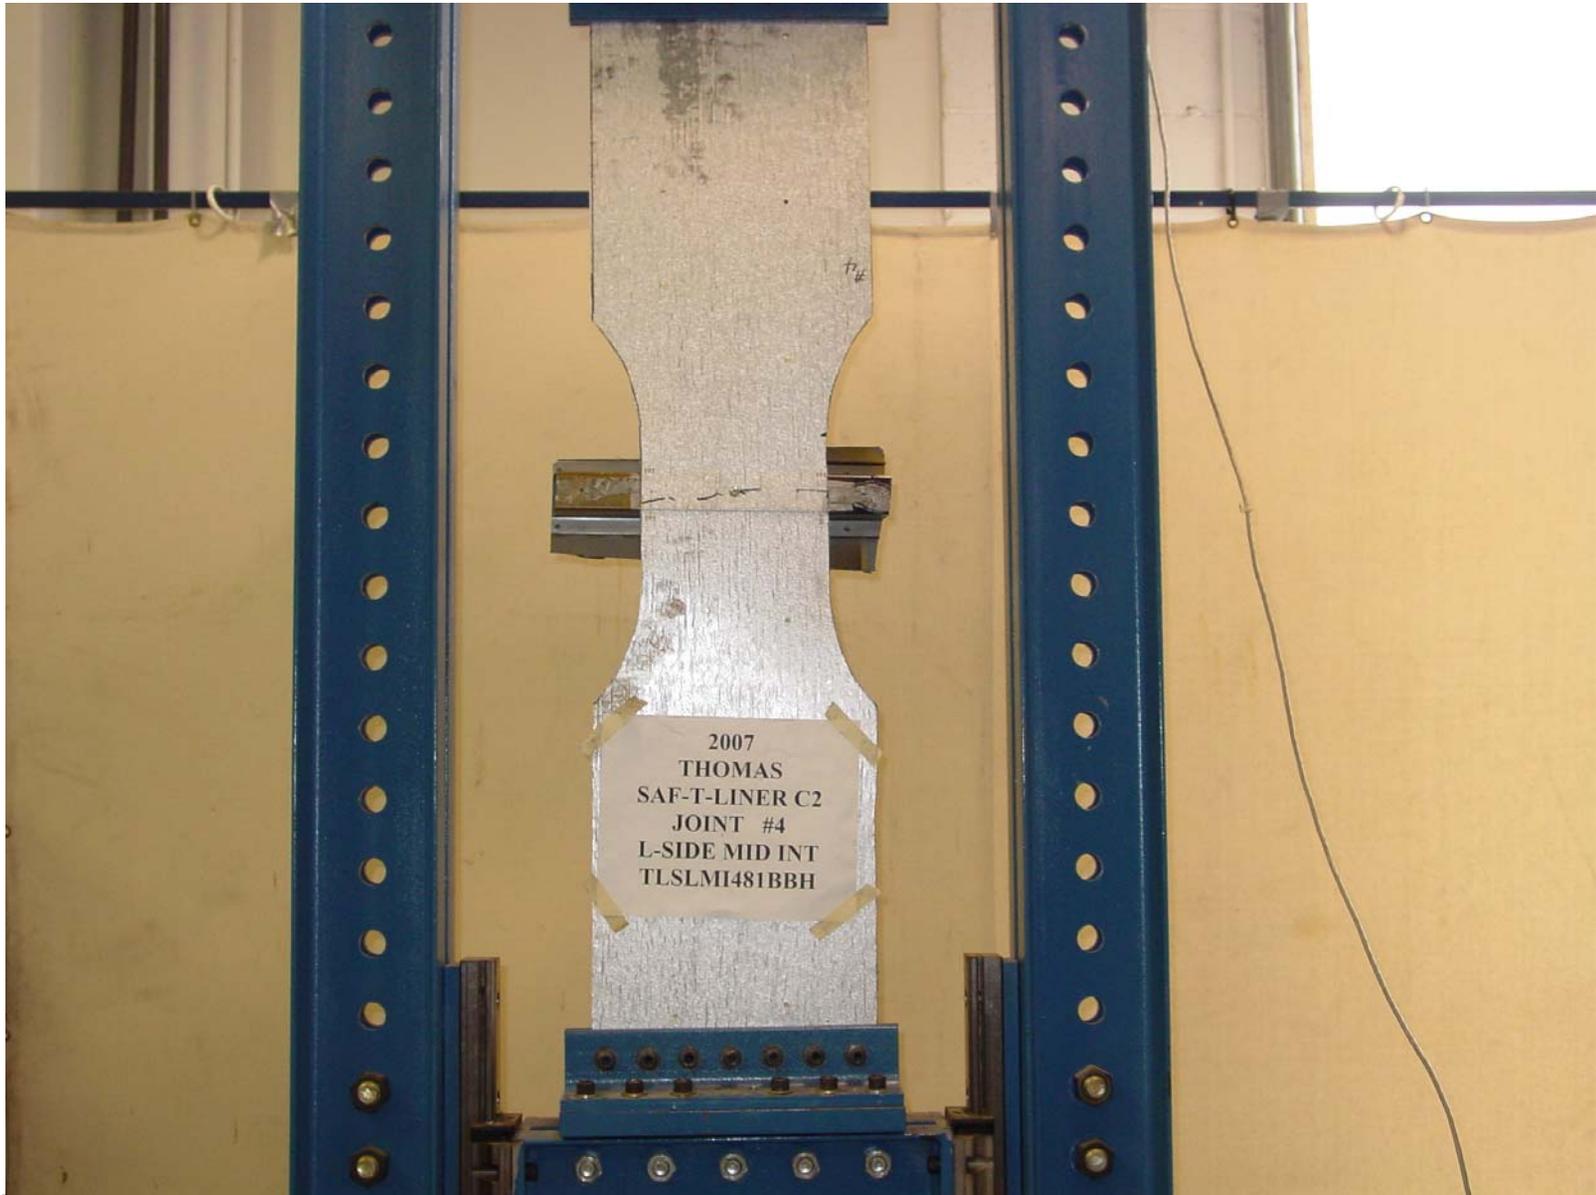
Post-Test of Joint #4

Weaker Member	Stronger Member
Material	Embossed Galvalume, ASTM, A792	N/A
Tensile Strength (MPa)	310.3	N/A
Gage/Thickness (mm)	24 / 0.589	N/A
Fastener Holes (No./Diameter – mm.)	1 / 3.99	N/A
Net Area (Sq. mm.)	117.4	N/A
Material Strength (N)	36422.4	N/A
60% of Material Strength (N)	21853.5	N/A
Maximum Load From Tensile Test of Joint (N)	45409.7	N/A
PASS/FAIL	PASS	N/A

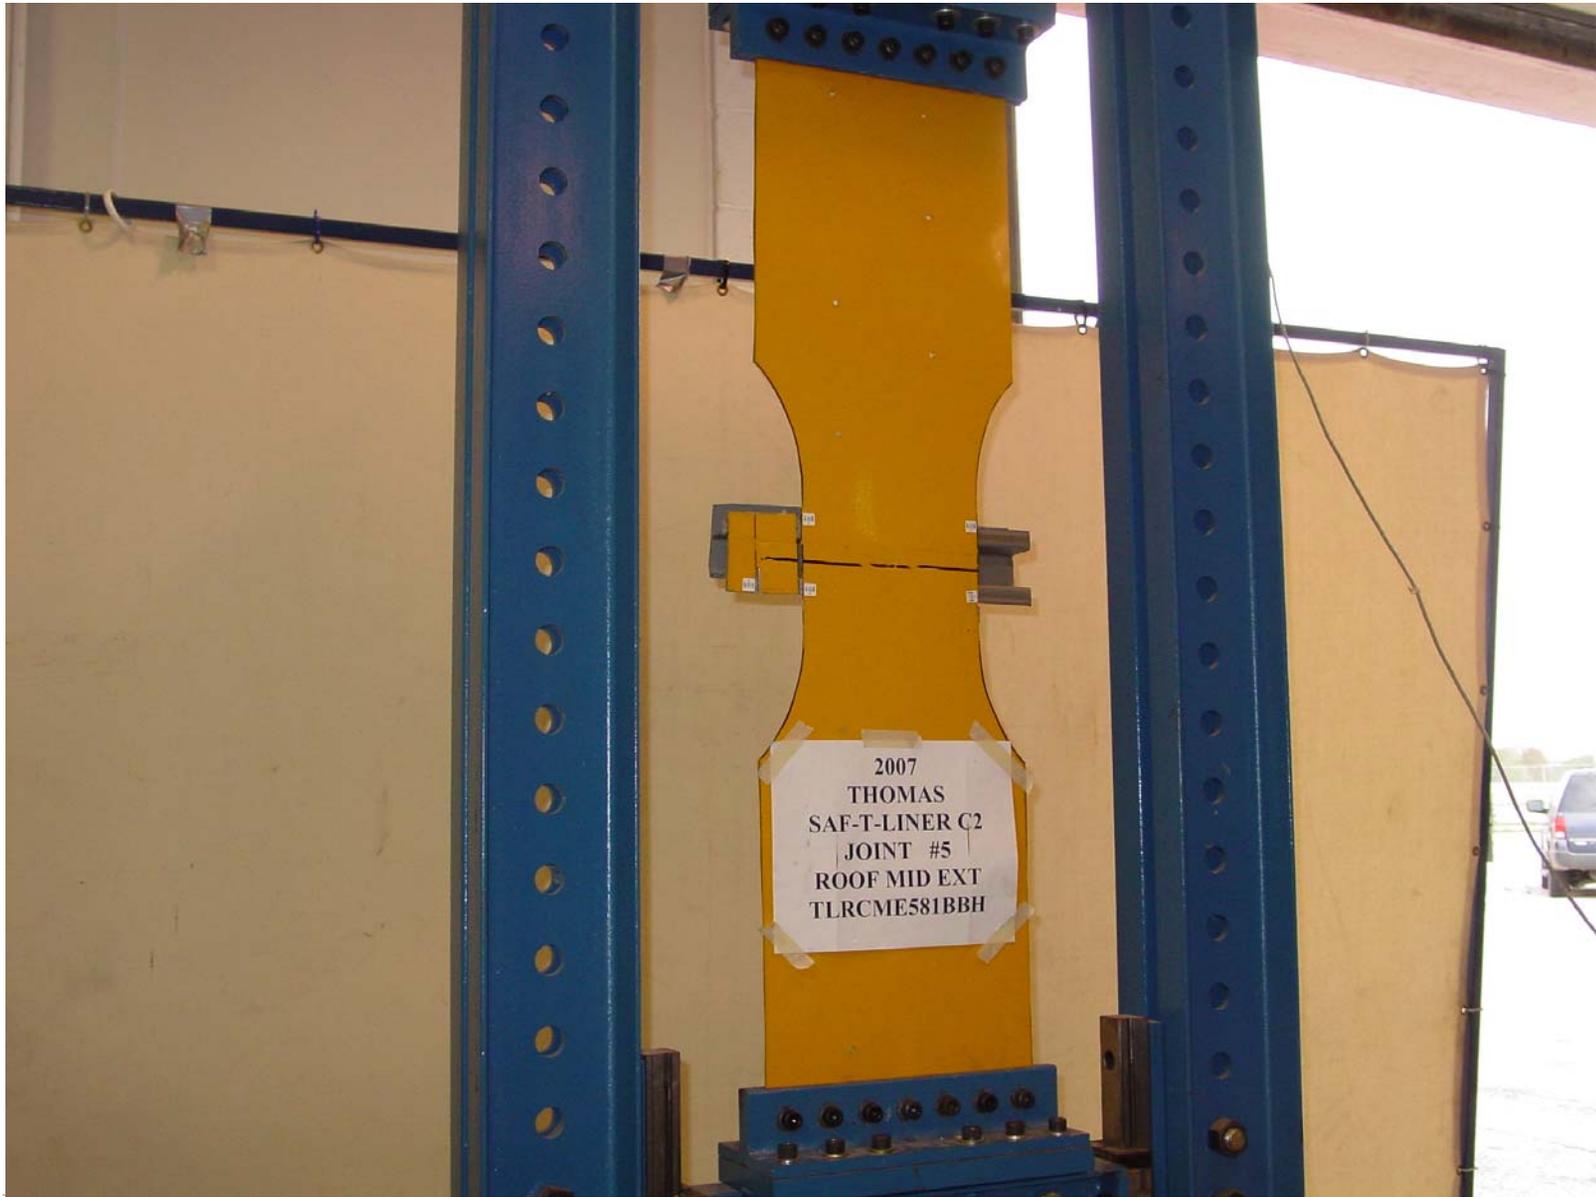
Pre-Test of Joint #5

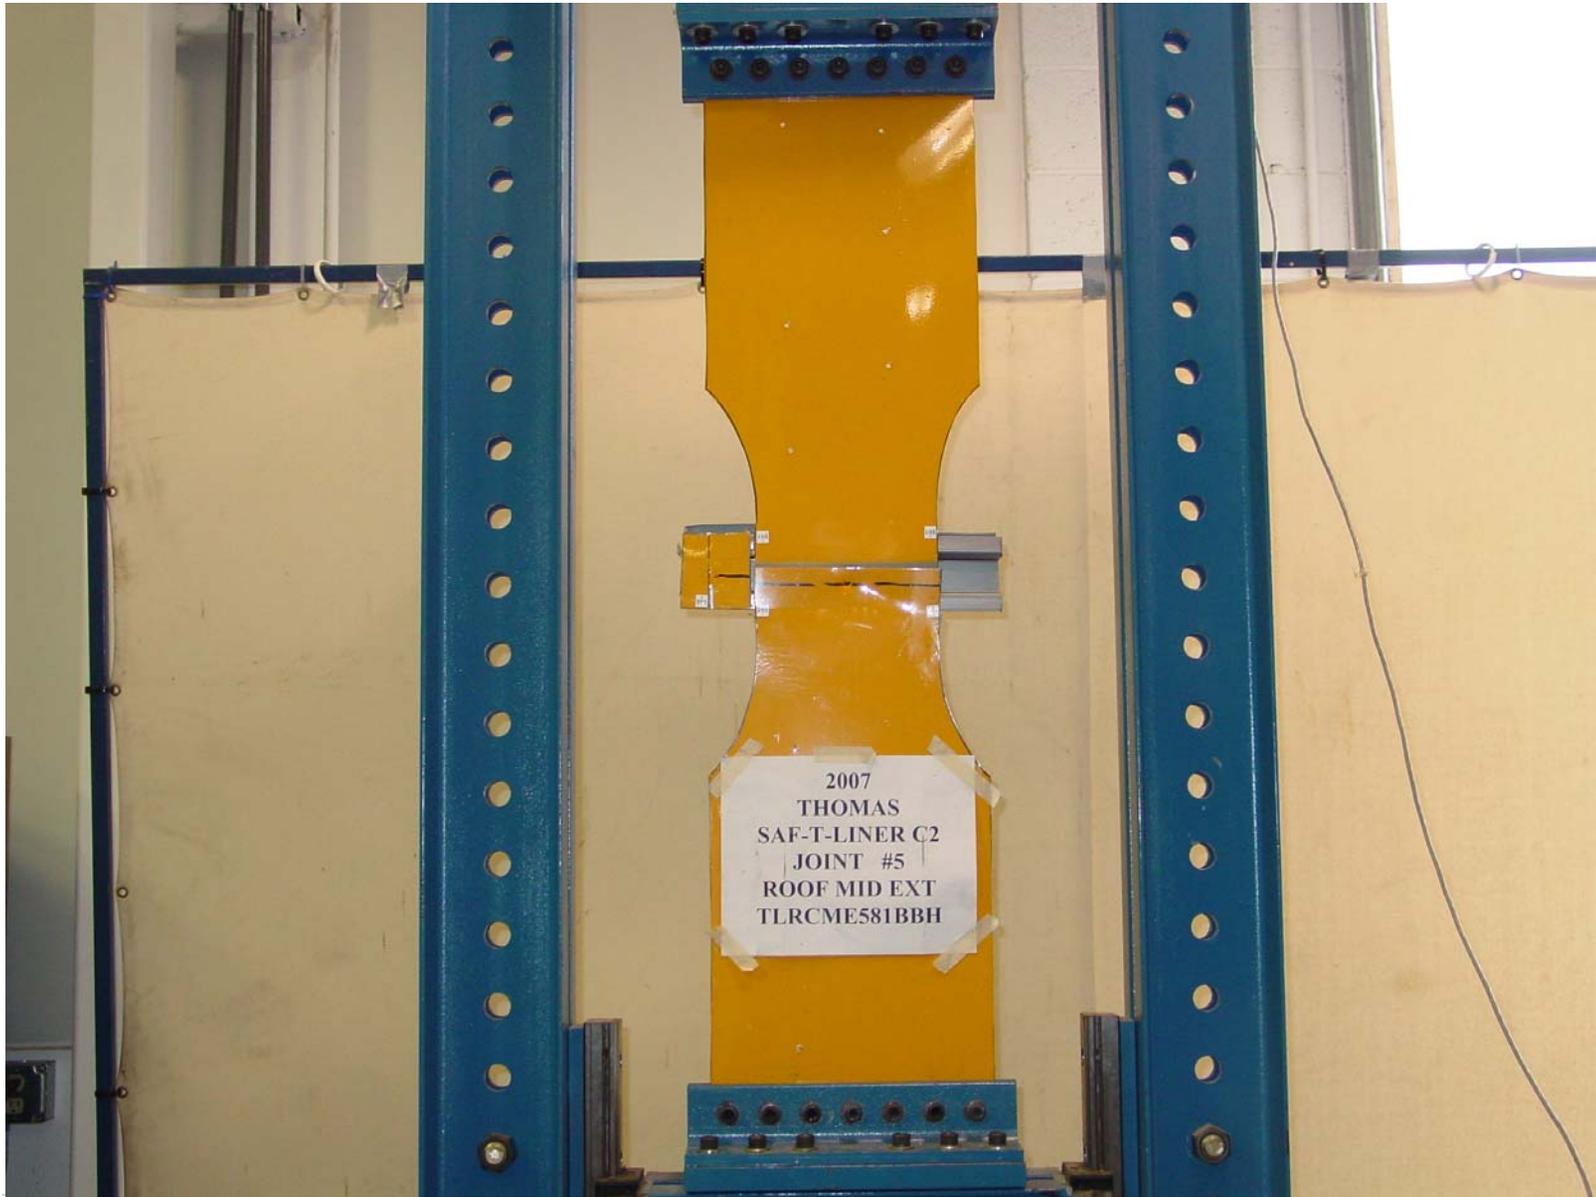
Post-Test of Joint #5

Weaker Member	Stronger Member
Material	Galvanized, CS, ASTM, A653	N/A
Tensile Strength (MPa)	310.3	N/A
Gage/Thickness (mm)	20 / 0.912	N/A
Fastener Holes (No./Diameter – mm.)	1 / 5.13	N/A
Net Area (Sq. mm.)	180.6	N/A
Material Strength (N)	56037.2	N/A
60% of Material Strength (N)	33622.3	N/A
Maximum Load From Tensile Test of Joint (N)	68527.8	N/A
PASS/FAIL	PASS	N/A

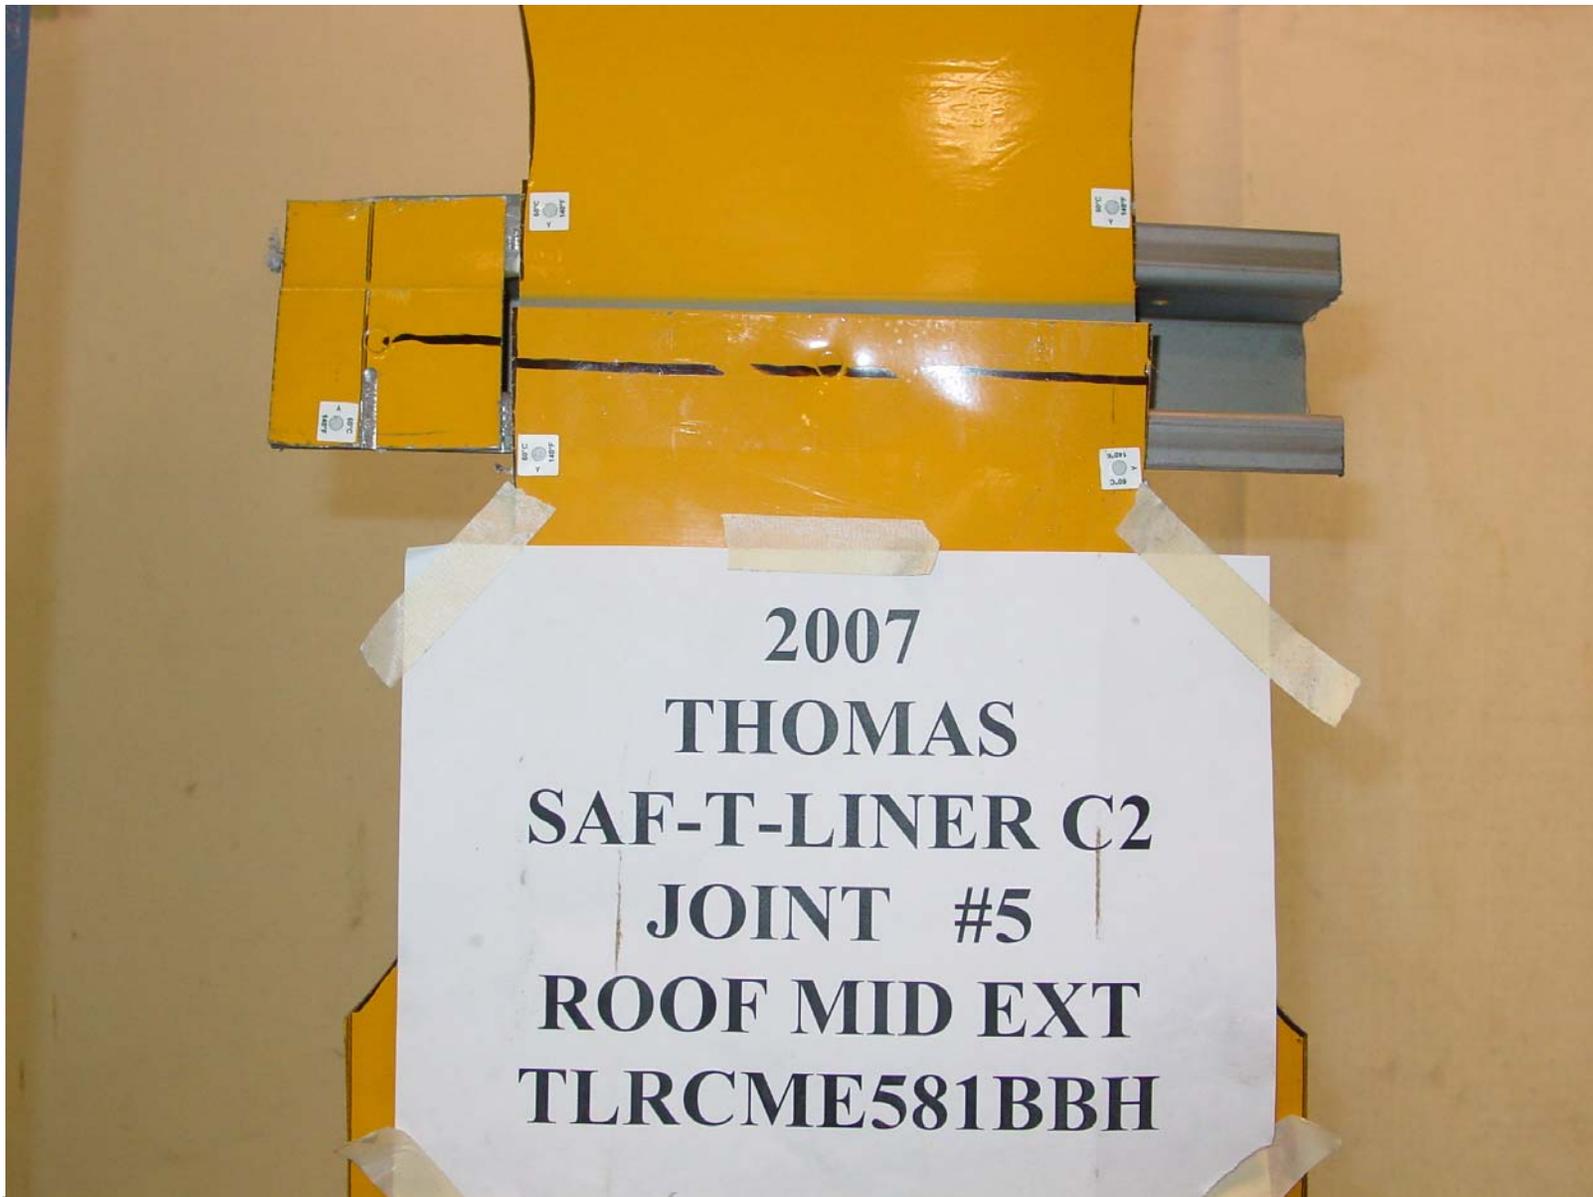
Post-Test of Joint #5 view 2

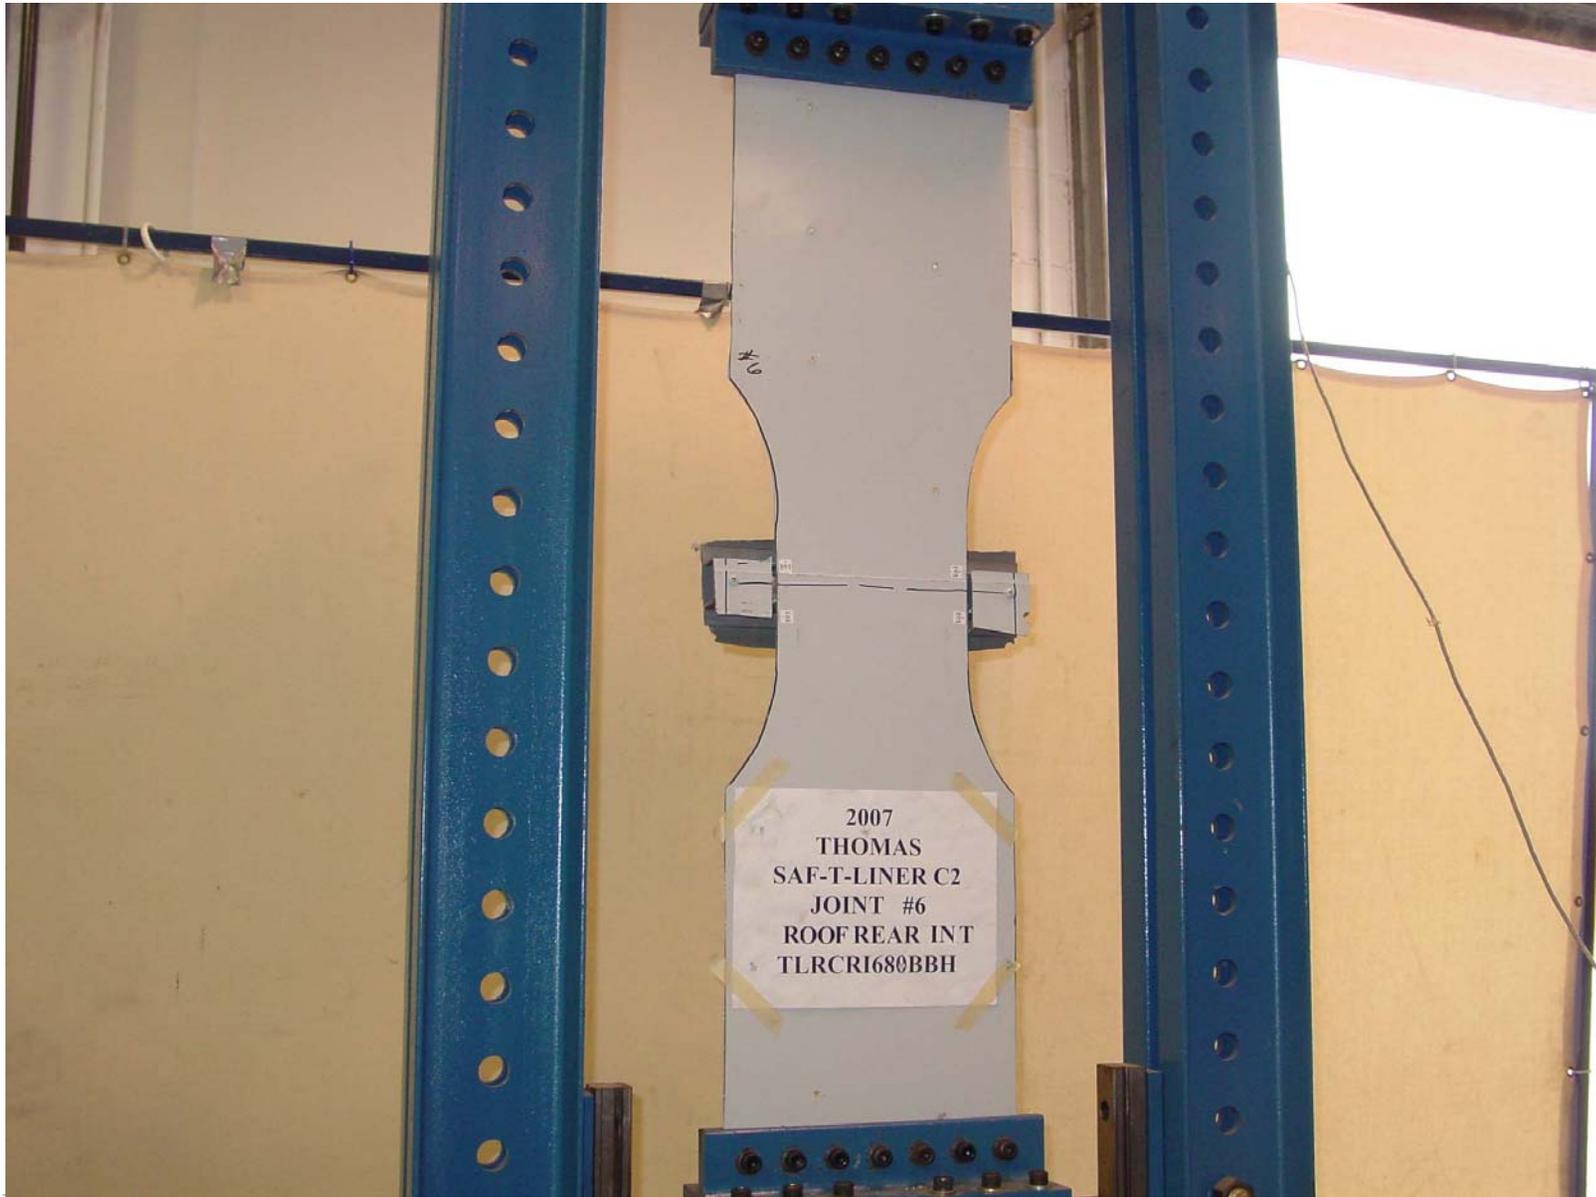
Pre-Test of Joint #6

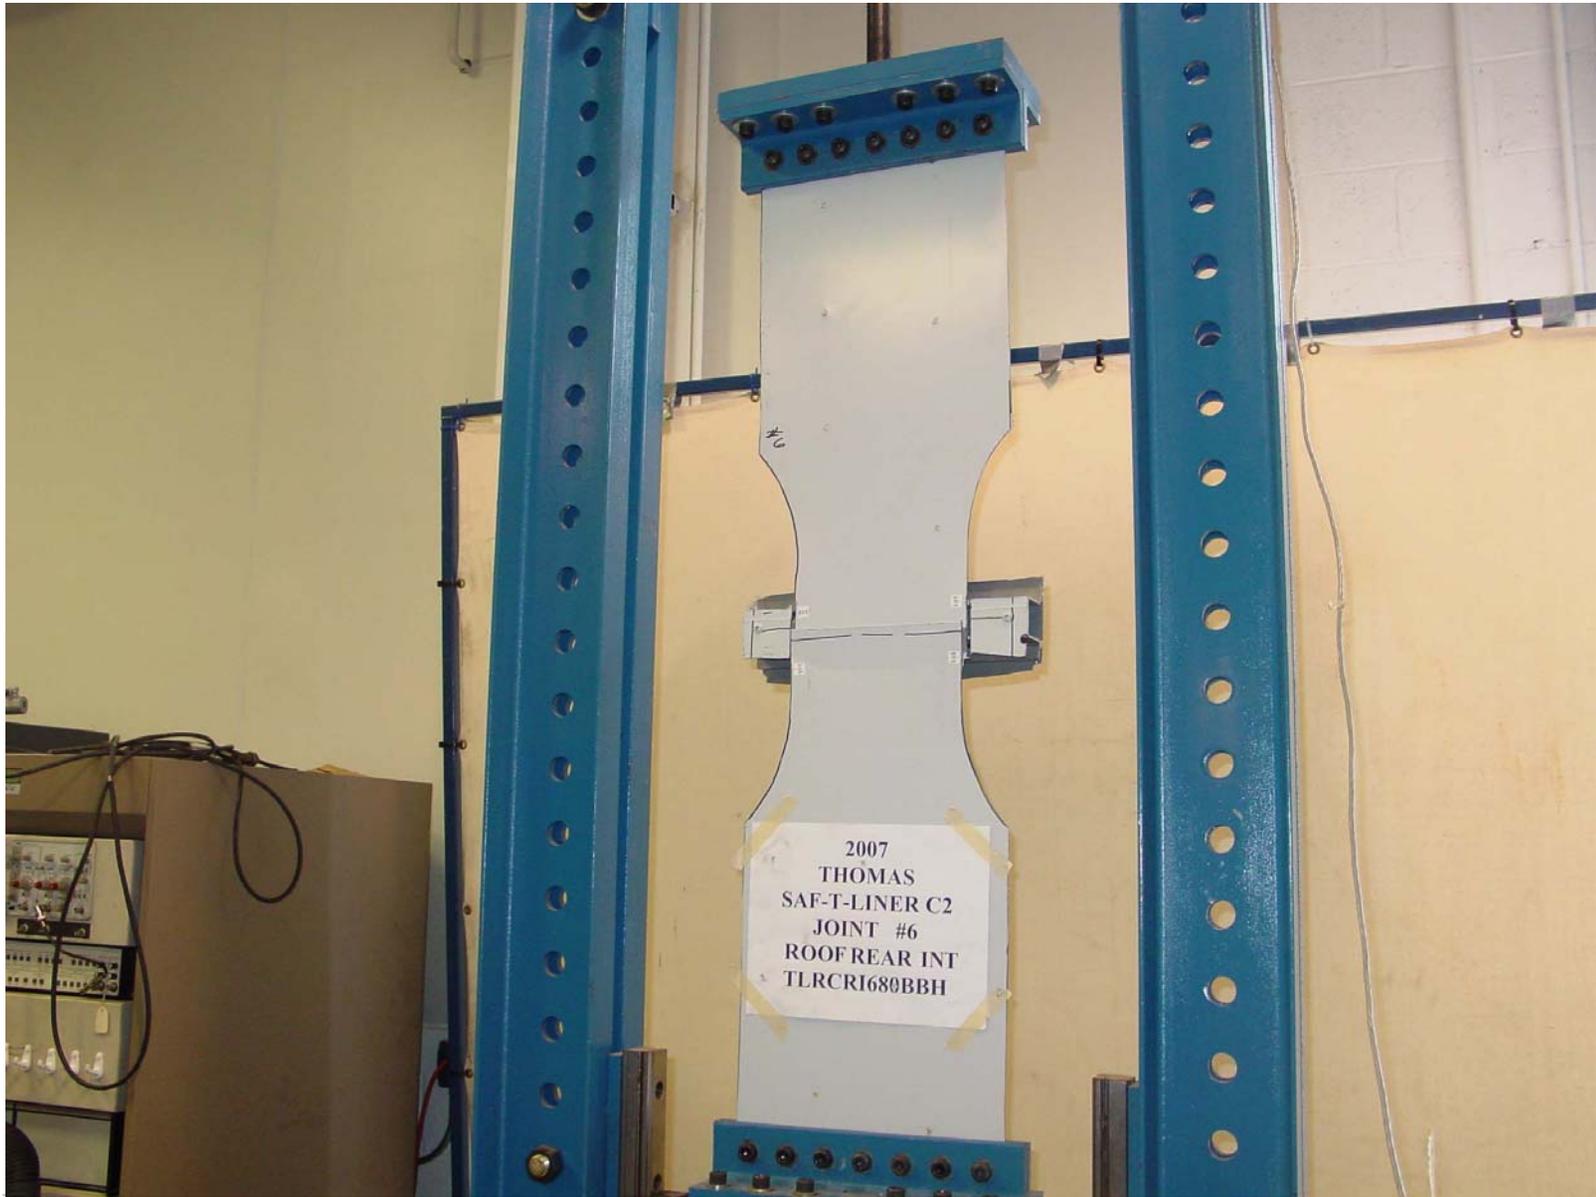
Post-Test of Joint #6

Weaker Member	Stronger Member
Material	Galvanized, SS, ASTM, A653	N/A
Tensile Strength (MPa)	310.3	N/A
Gage/Thickness (mm)	22 / 0.0253	N/A
Fastener Holes (No./Diameter – mm.)	0 / 0	N/A
Net Area (Sq. mm.)	130.6	N/A
Material Strength (N)	40514.4	N/A
60% of Material Strength (N)	24308.6	N/A
Maximum Load From Tensile Test of Joint (N)	60562.3	N/A
PASS/FAIL	PASS	N/A

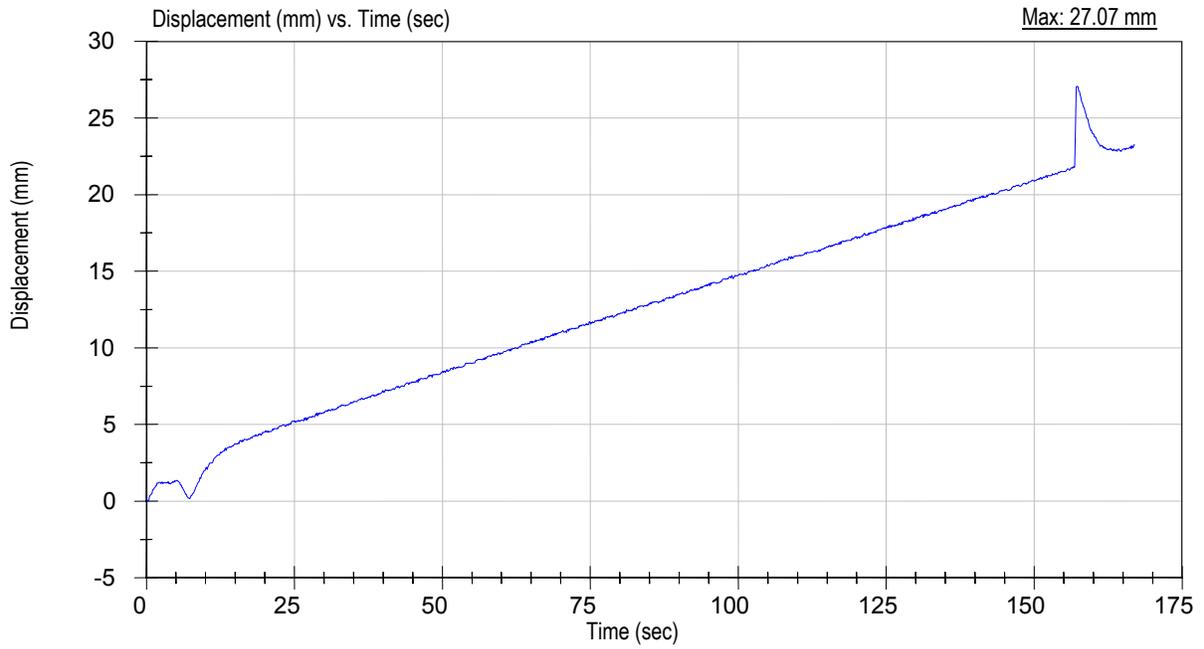
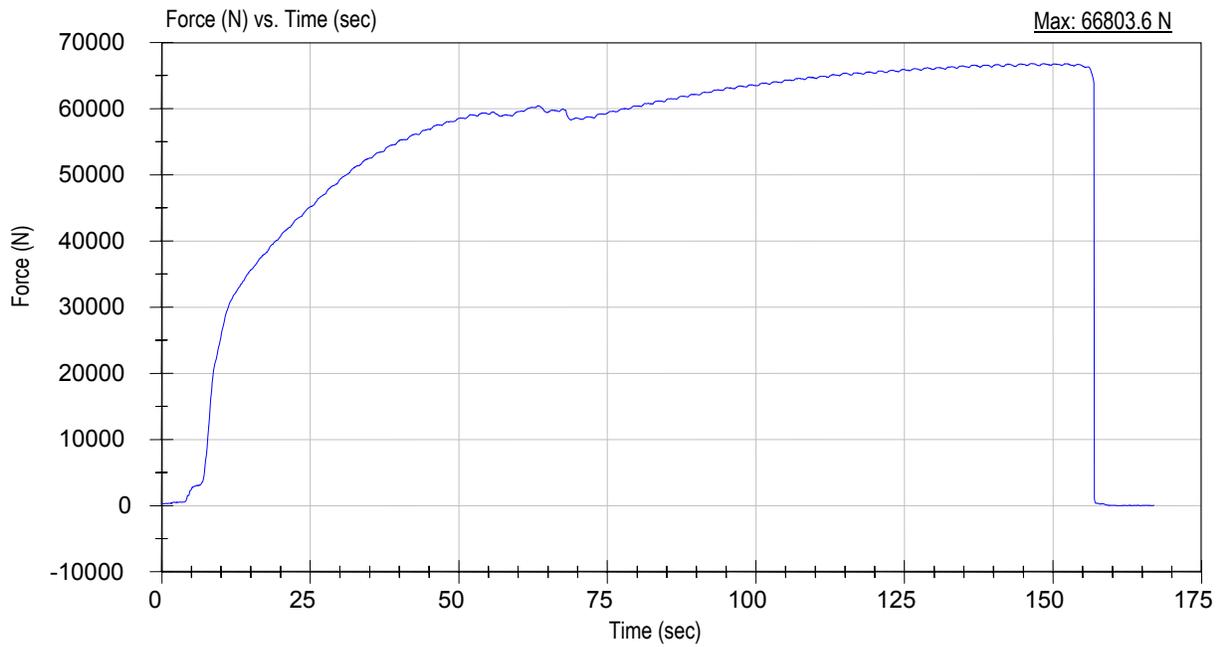
Test Desc: FMVSS 221 (Required Load: 33622.3 N)
Sample: 1- Right Side Mid Exterior

The rate of load application was ¼ inch per minute. The force and displacement were recorded and displacement vs. time was plotted to monitor the displacement rate.

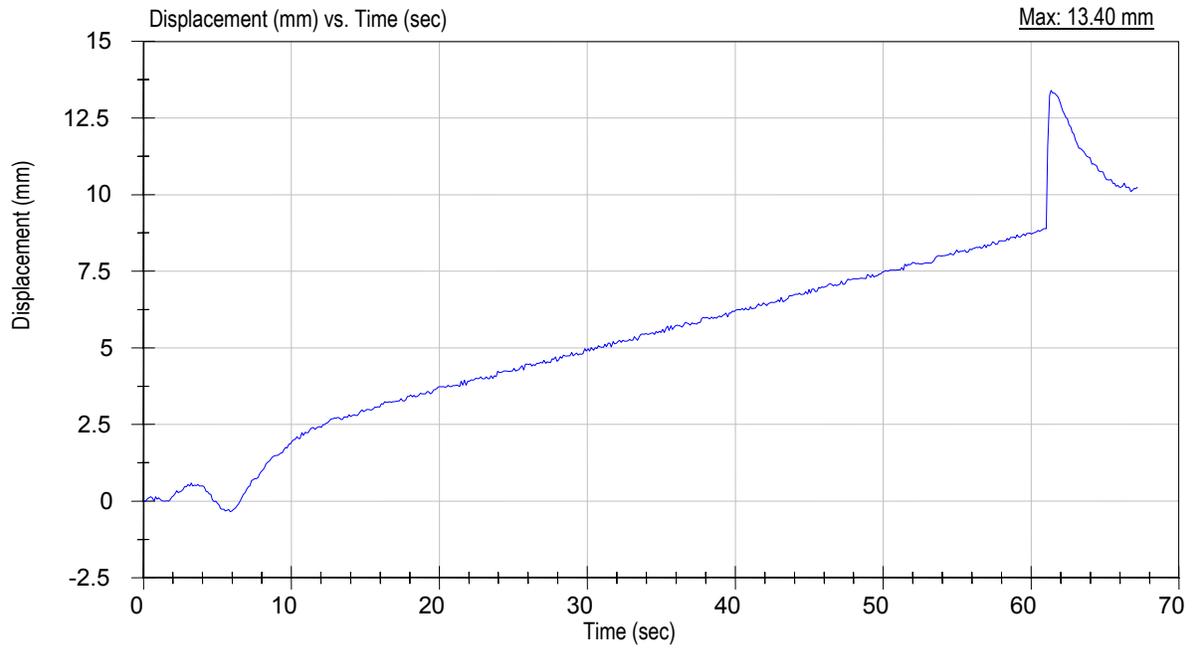
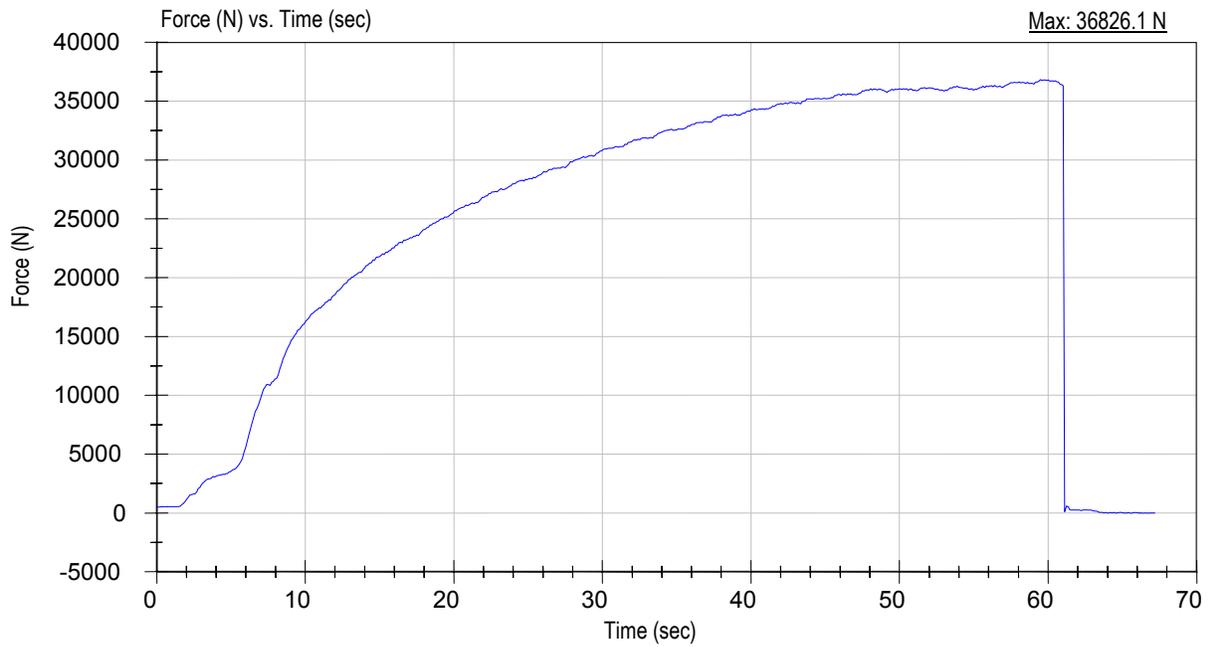
Test Desc: FMVSS 221 (Required Load: 21853.5 N)
Sample: 2 -Left Side Front Interior

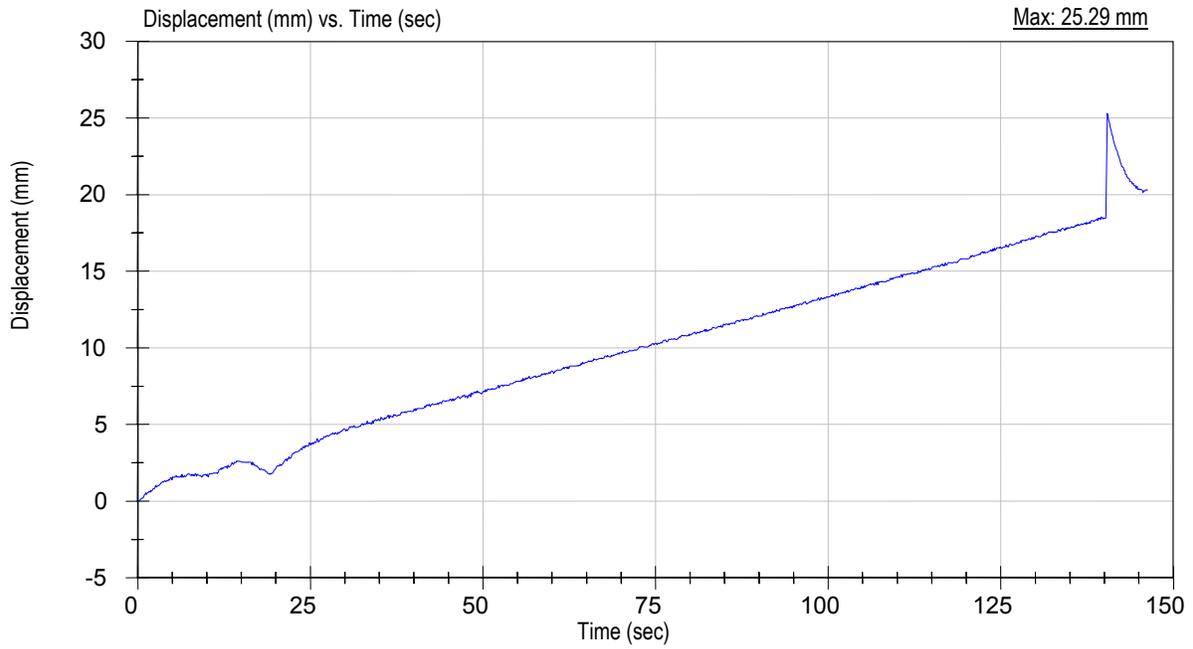
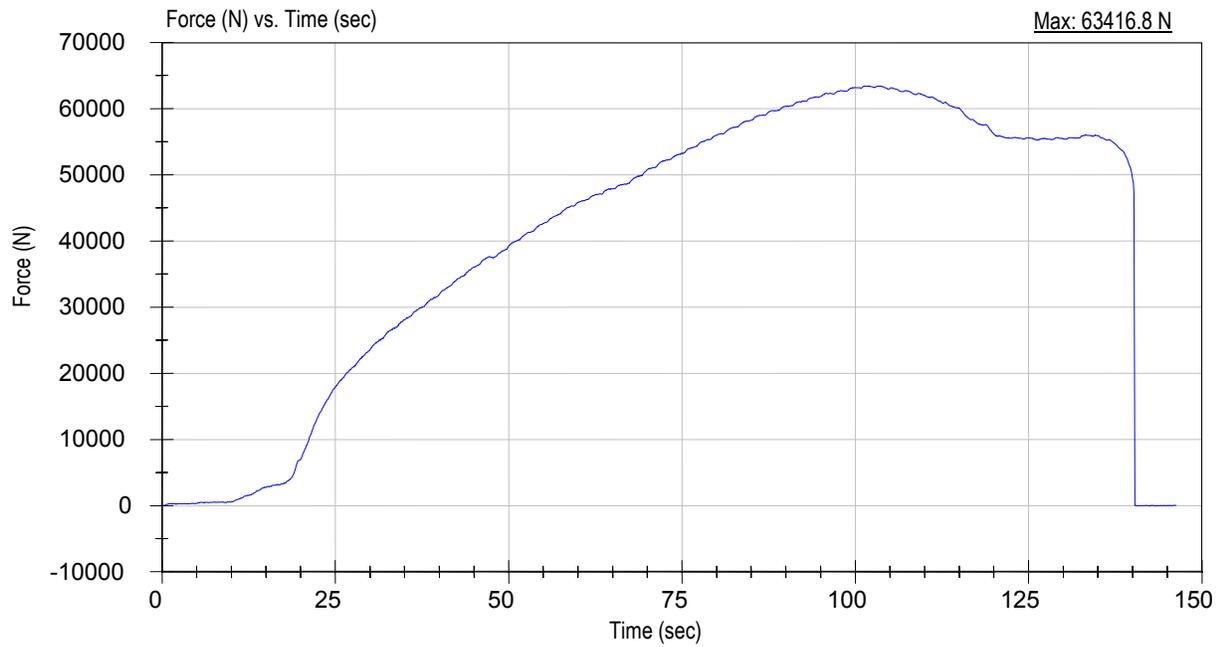
Test Desc: FMVSS 221 (Required Load: 33695.6 N)
Sample: 3- Left Side Rear Exterior

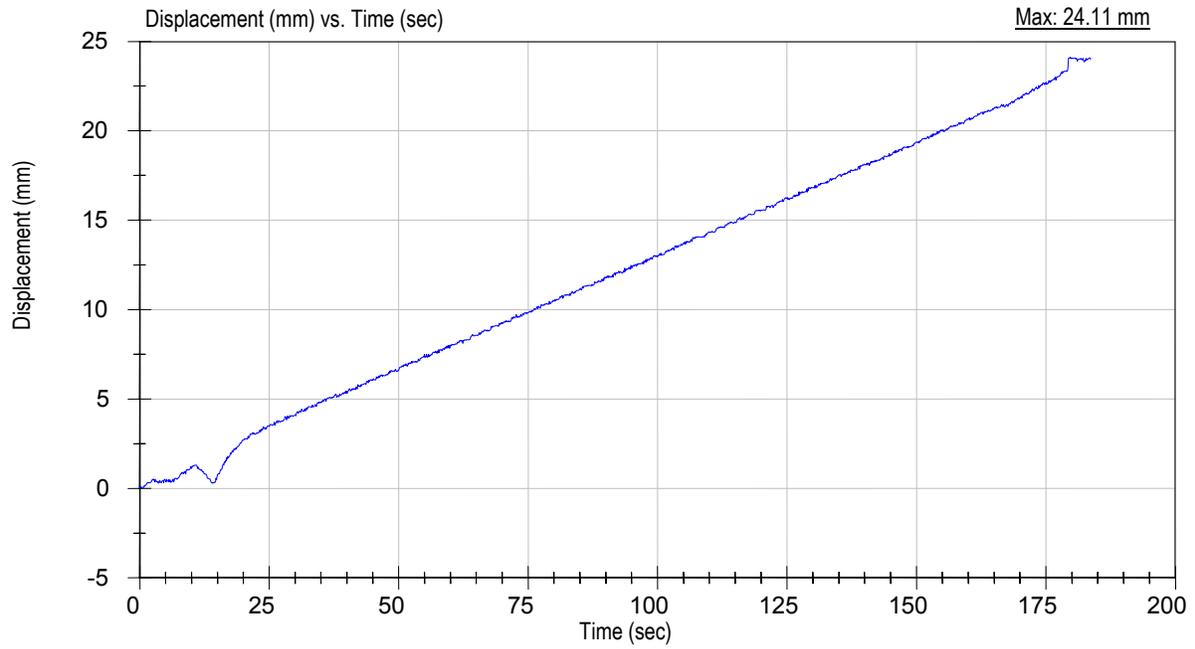
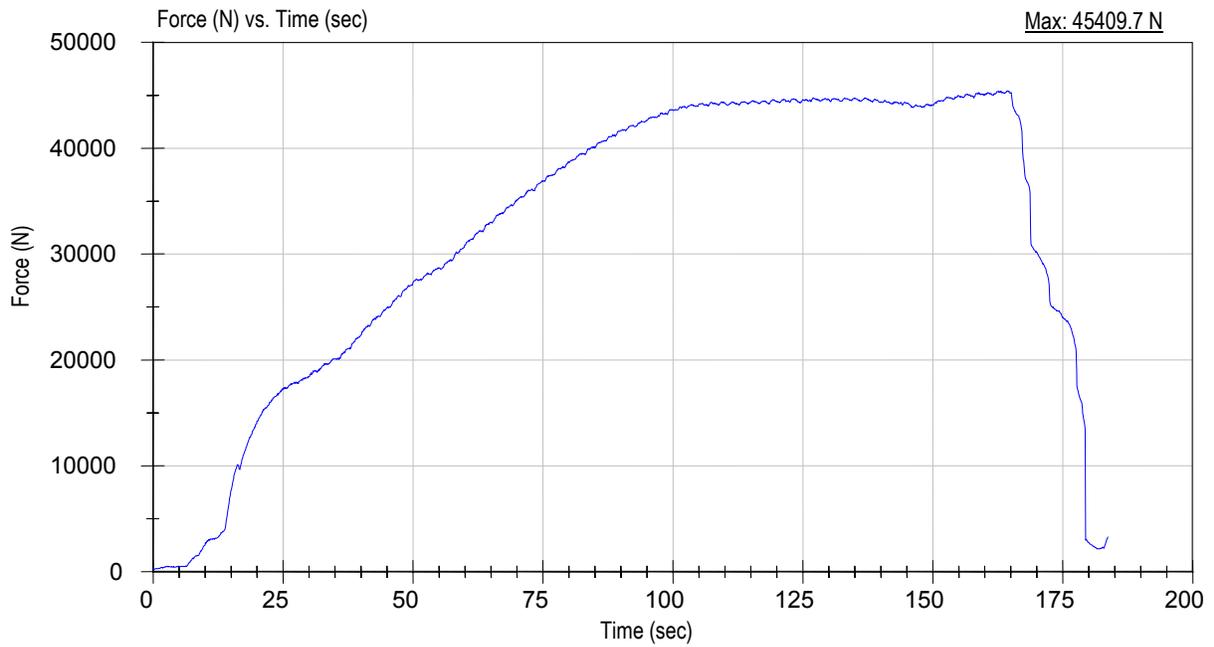
Test Desc: FMVSS 221 (Required Load: 21853.5 N)
Sample: 4 - Left Side Mid Interior
