REPORT NUMBER: 221-MGA-2007-001

**SAFETY COMPLIANCE TESTING FOR
FMVSS NO. 221
SCHOOL BUS BODY JOINT STRENGTH**

**THOMAS BUILT BUSES INC.
2007 THOMAS SAF-T-LINER C2
NHTSA NO.: C70900**

**PREPARED BY:
MGA RESEARCH CORPORATION
5000 WARREN ROAD
BURLINGTON, WI 53105**

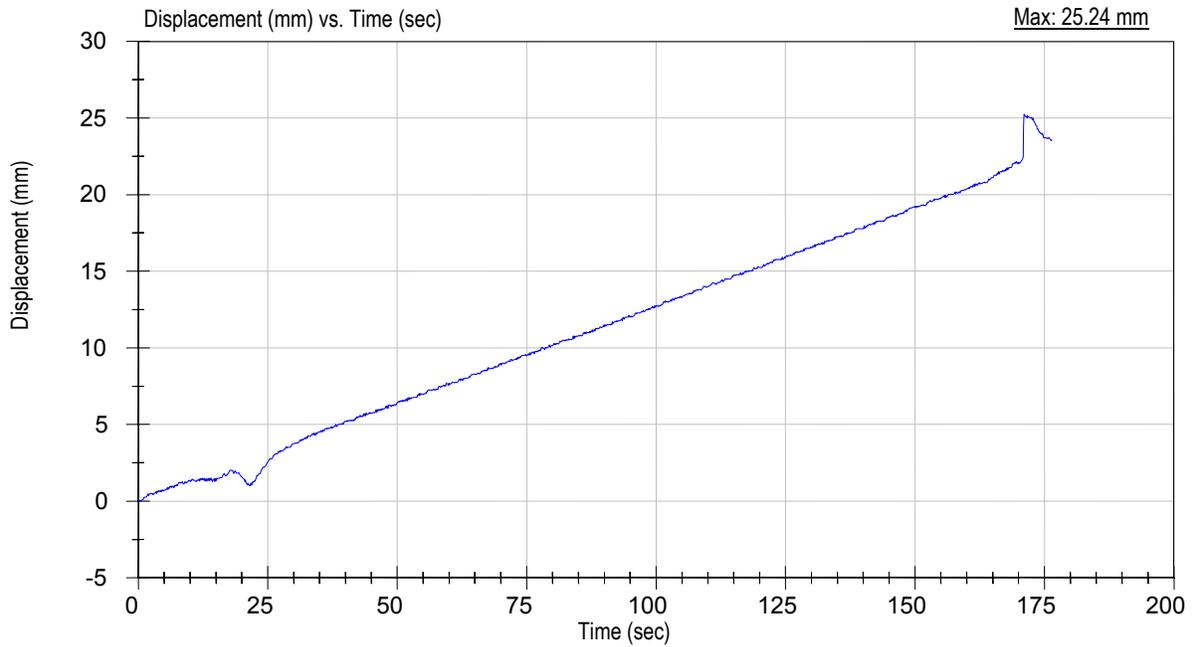
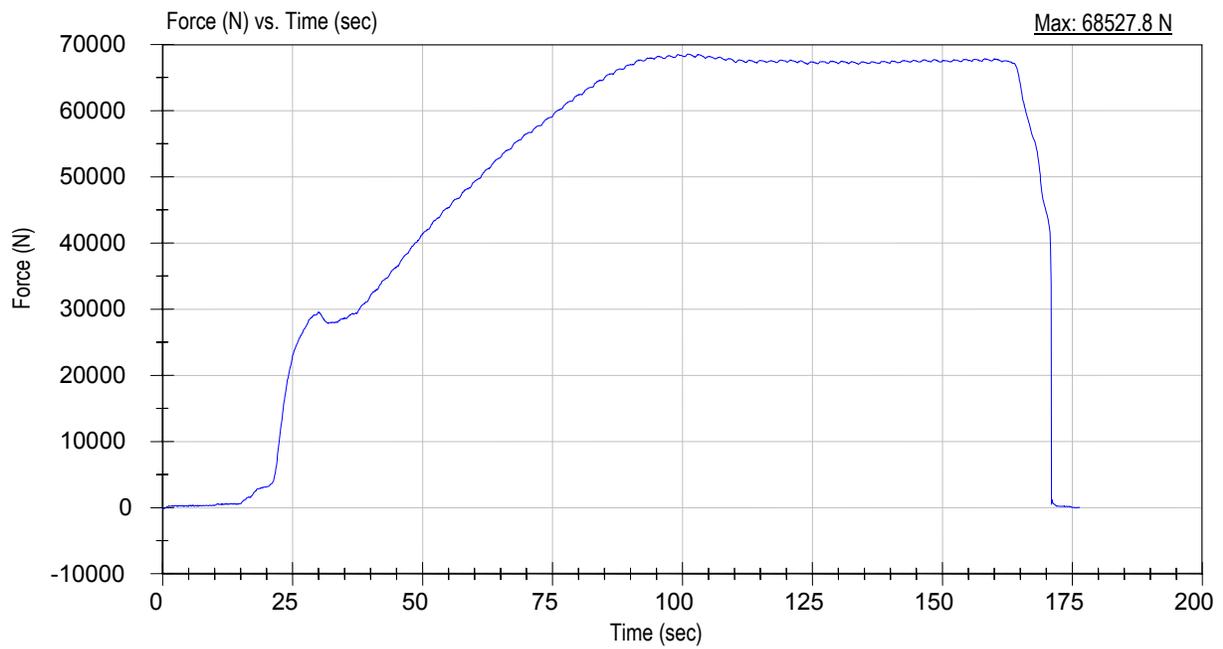
Test Desc: FMVSS 221 (Required Load: 33622.3 N)
Sample: 5 - Roof Mid Exterior

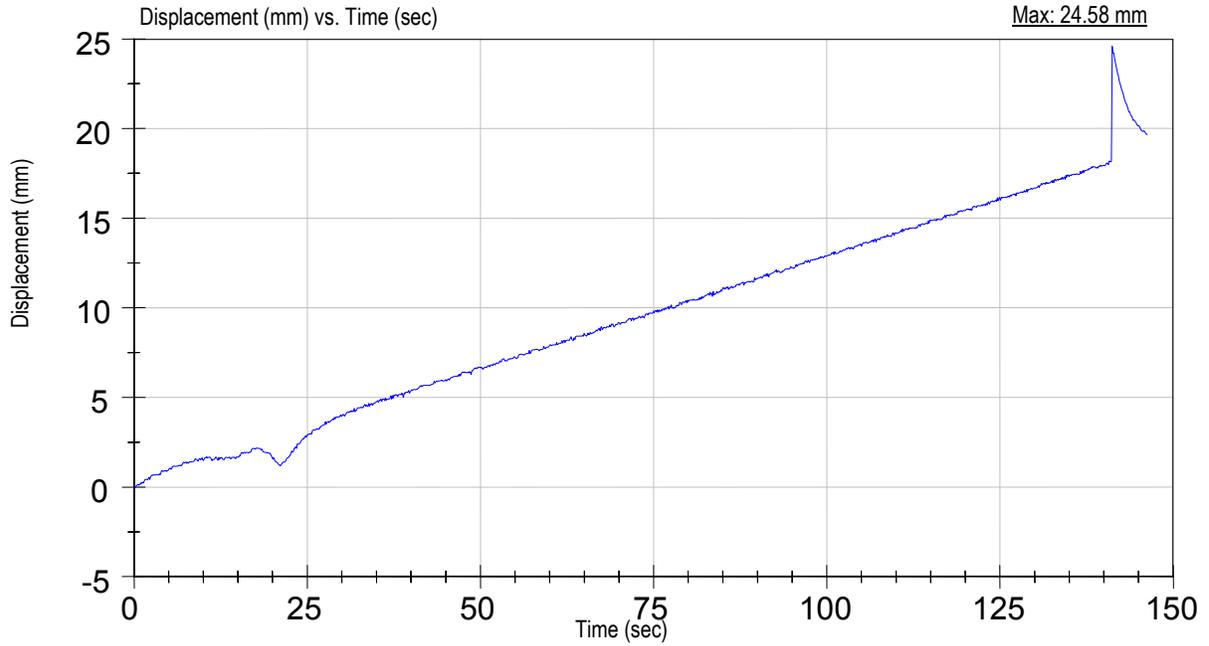
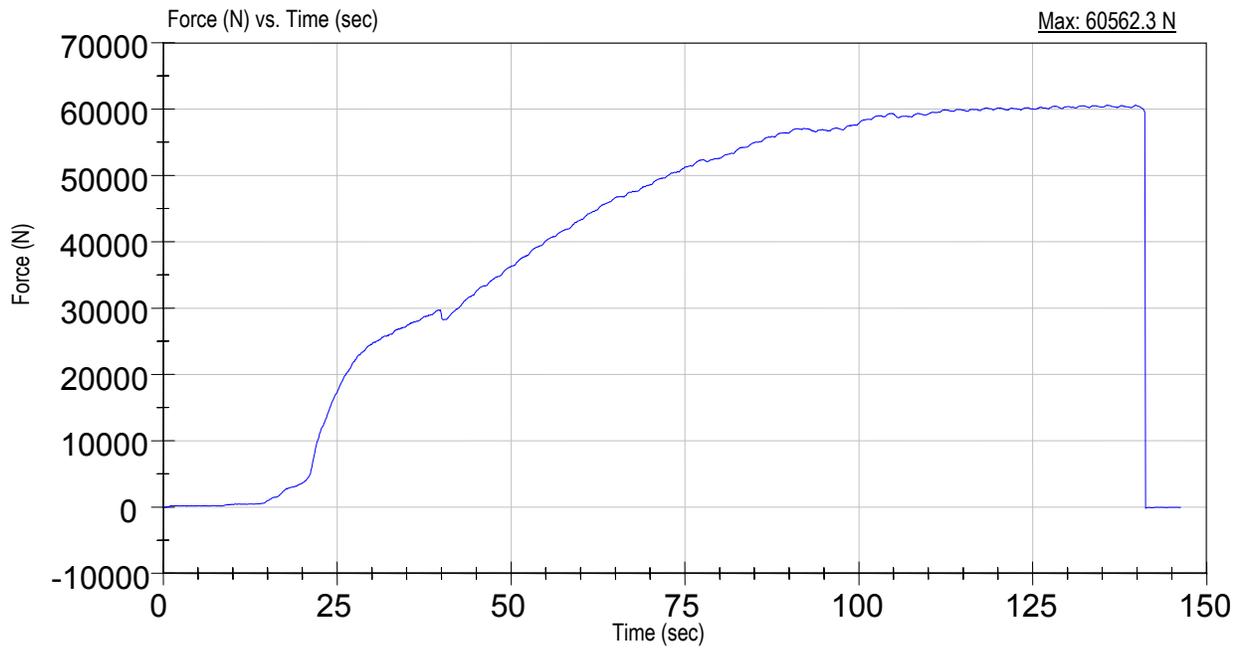
Test Desc: FMVSS 221 (Required Load: 24308.6 N)
Sample: 6 – Roof Rear Interior

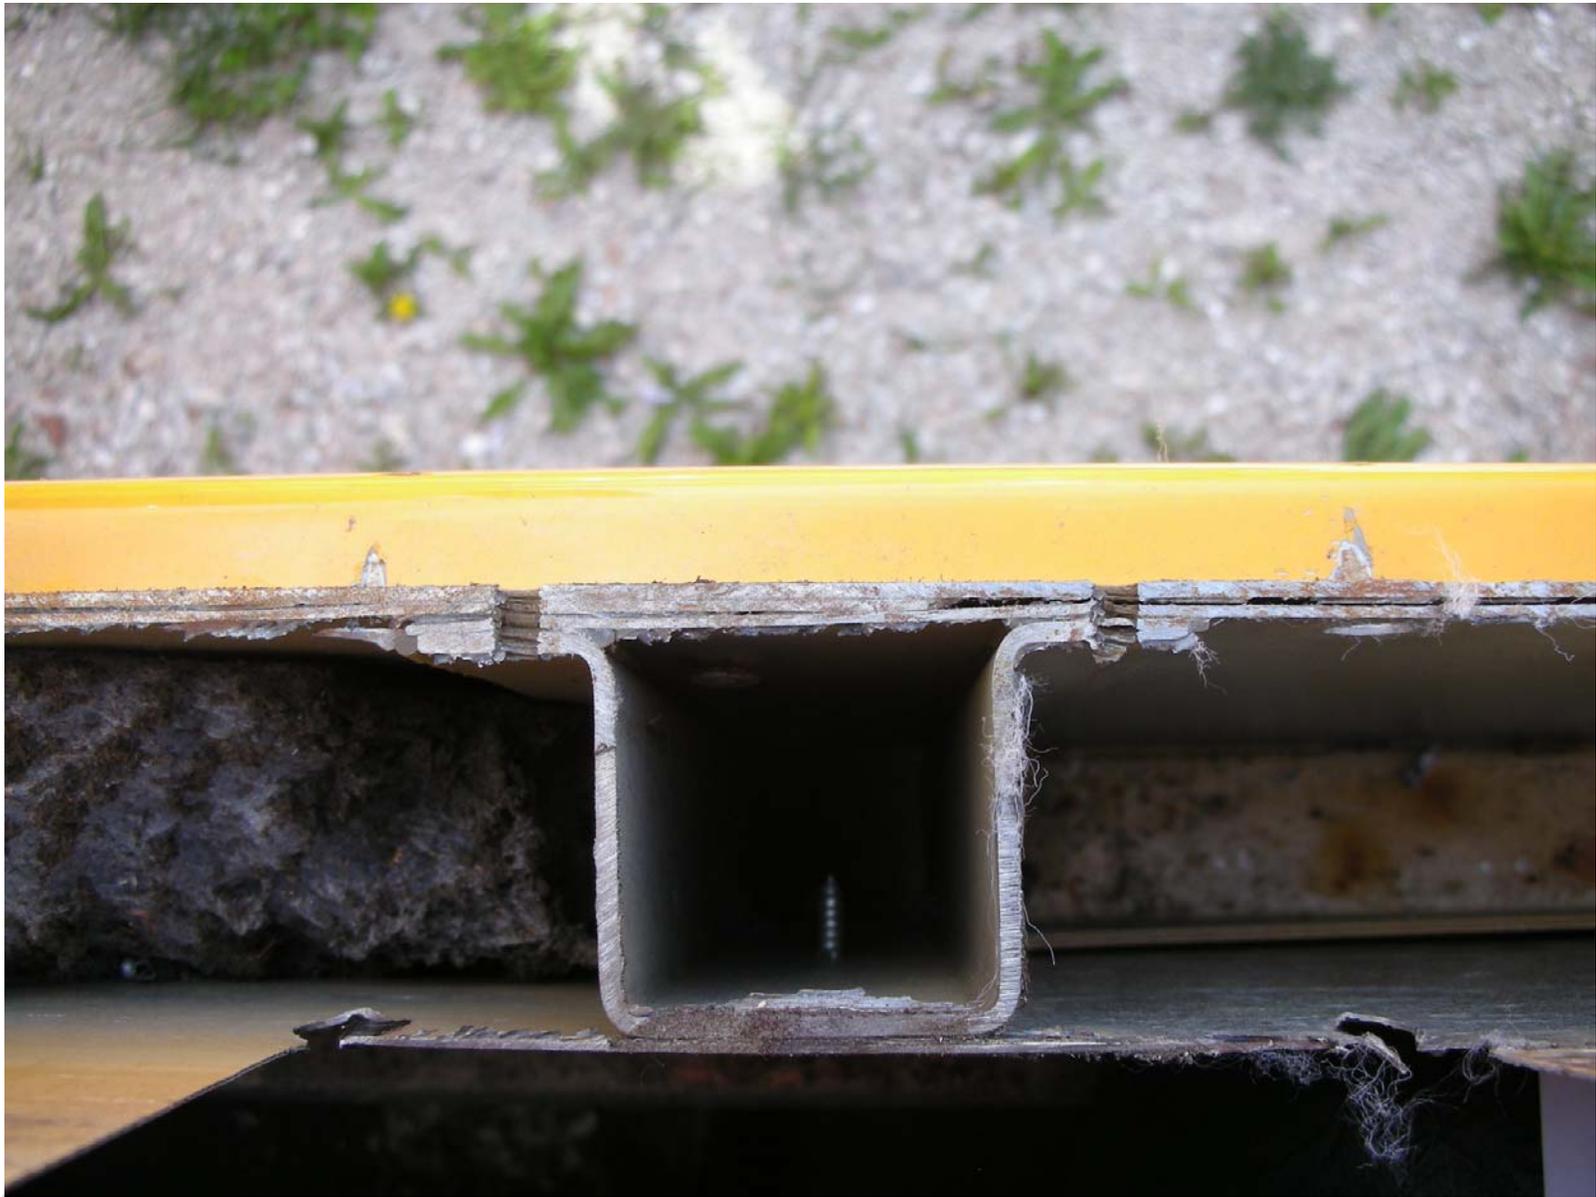
View of Joint #1

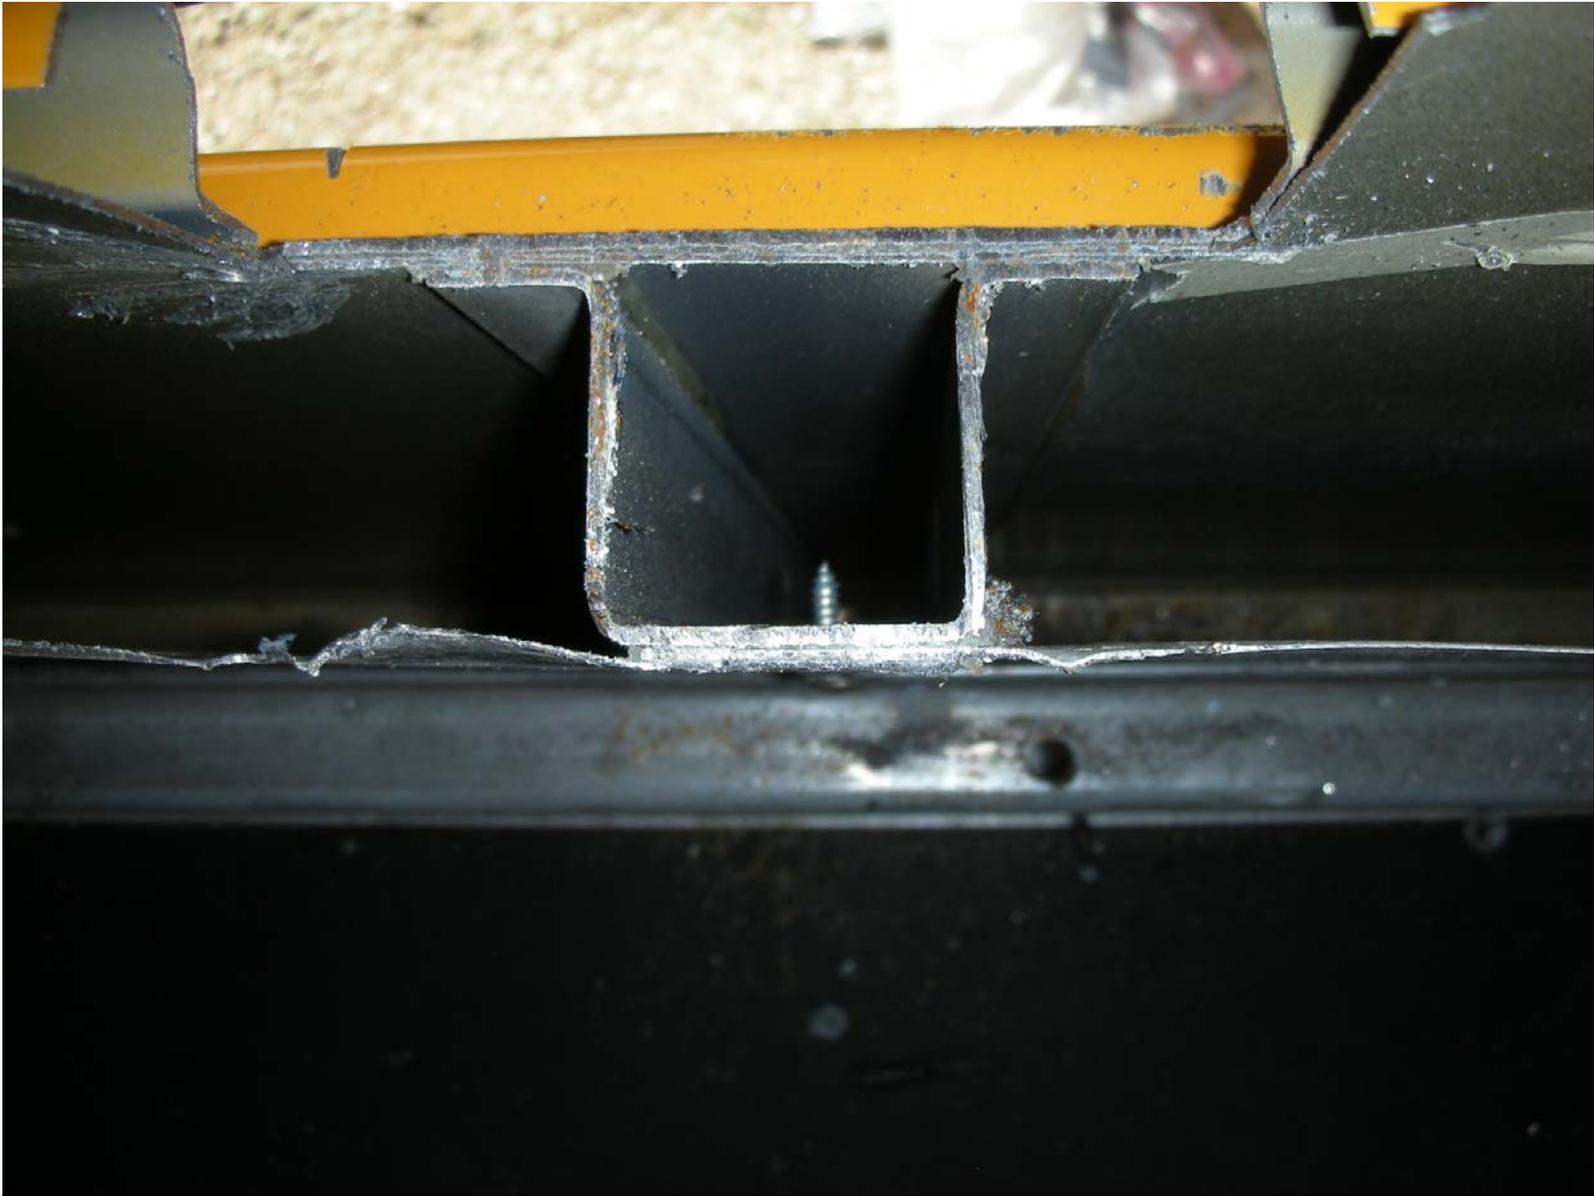
View of Joint #2

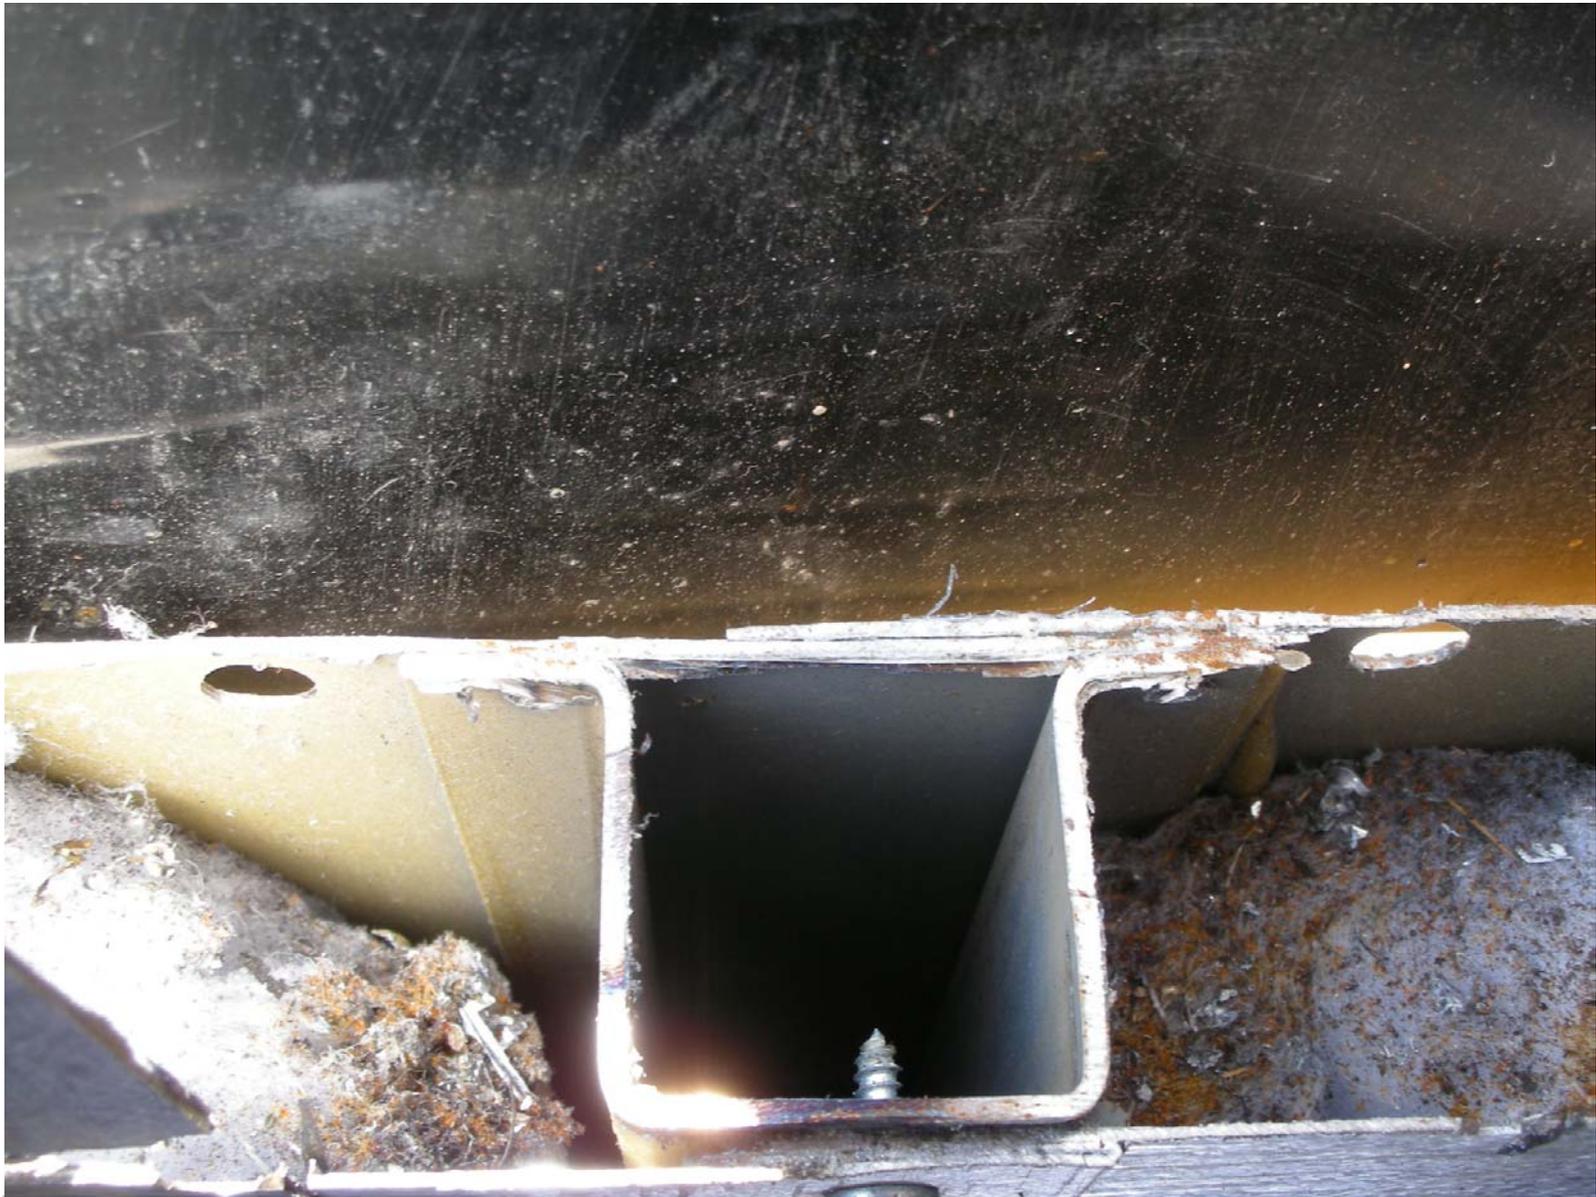
View of Joint #3

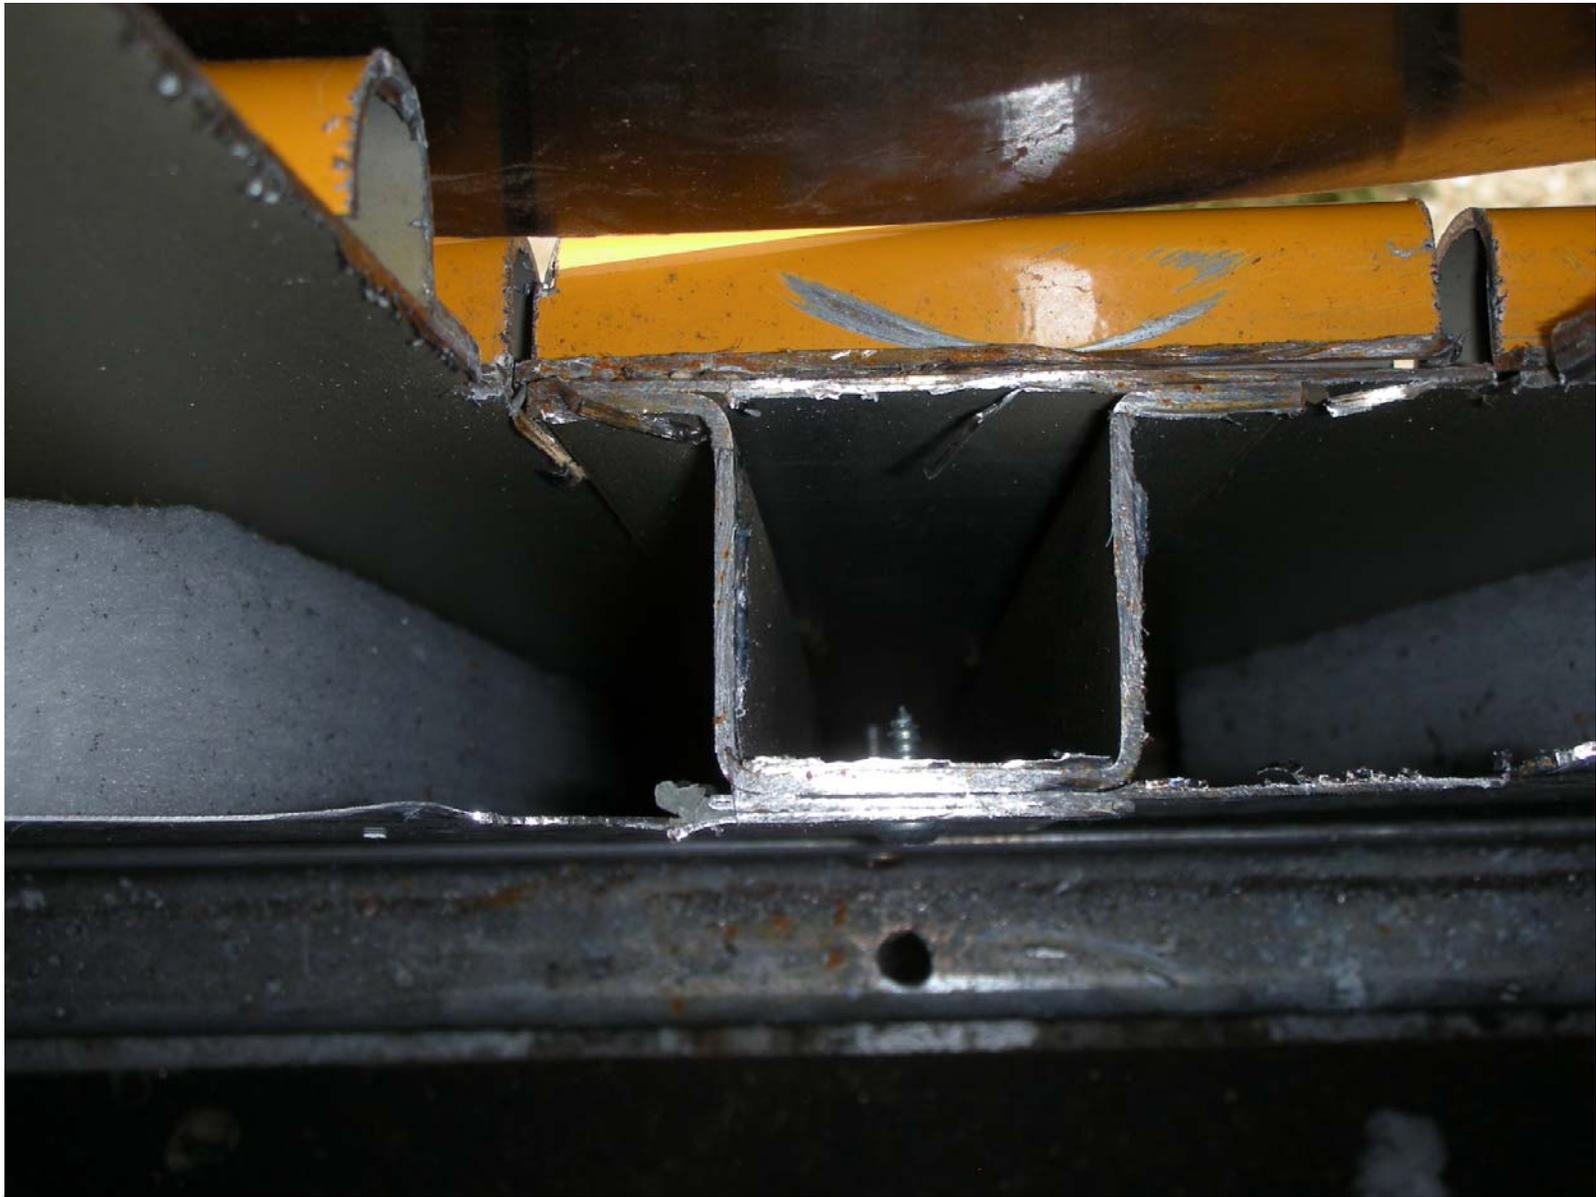
View of Joint #4

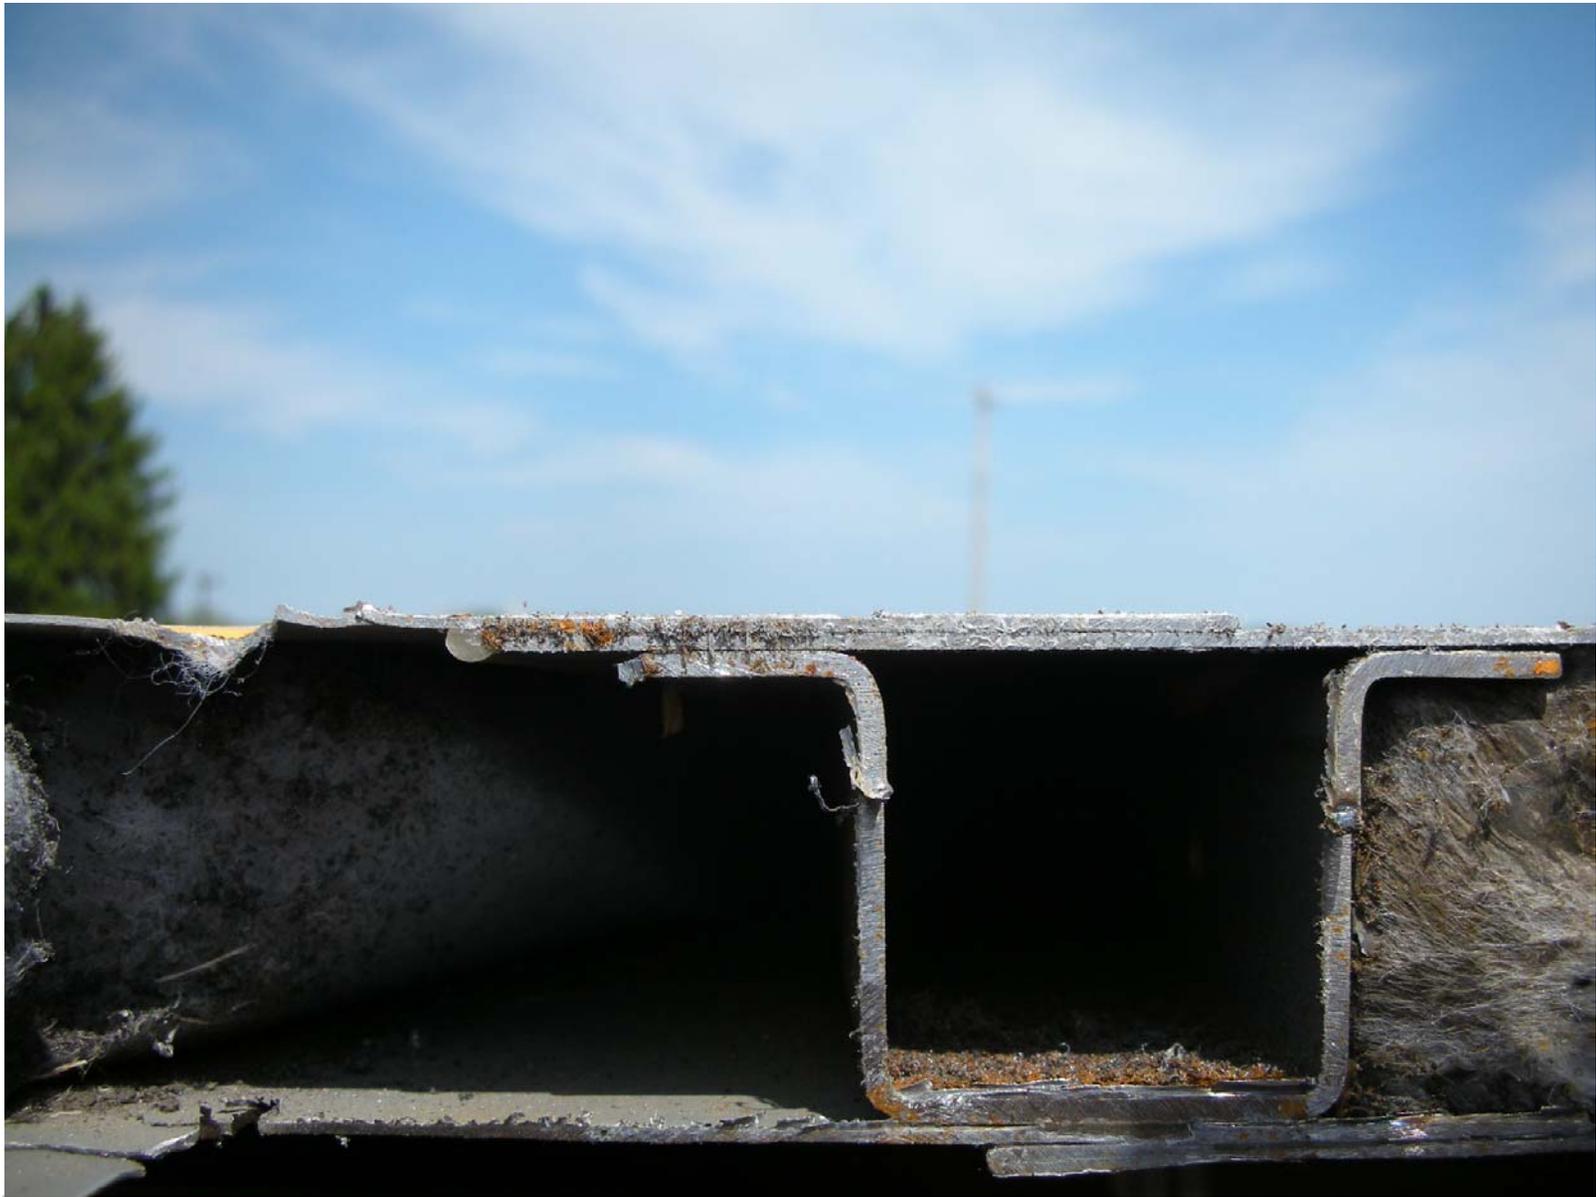
View of Joint #5

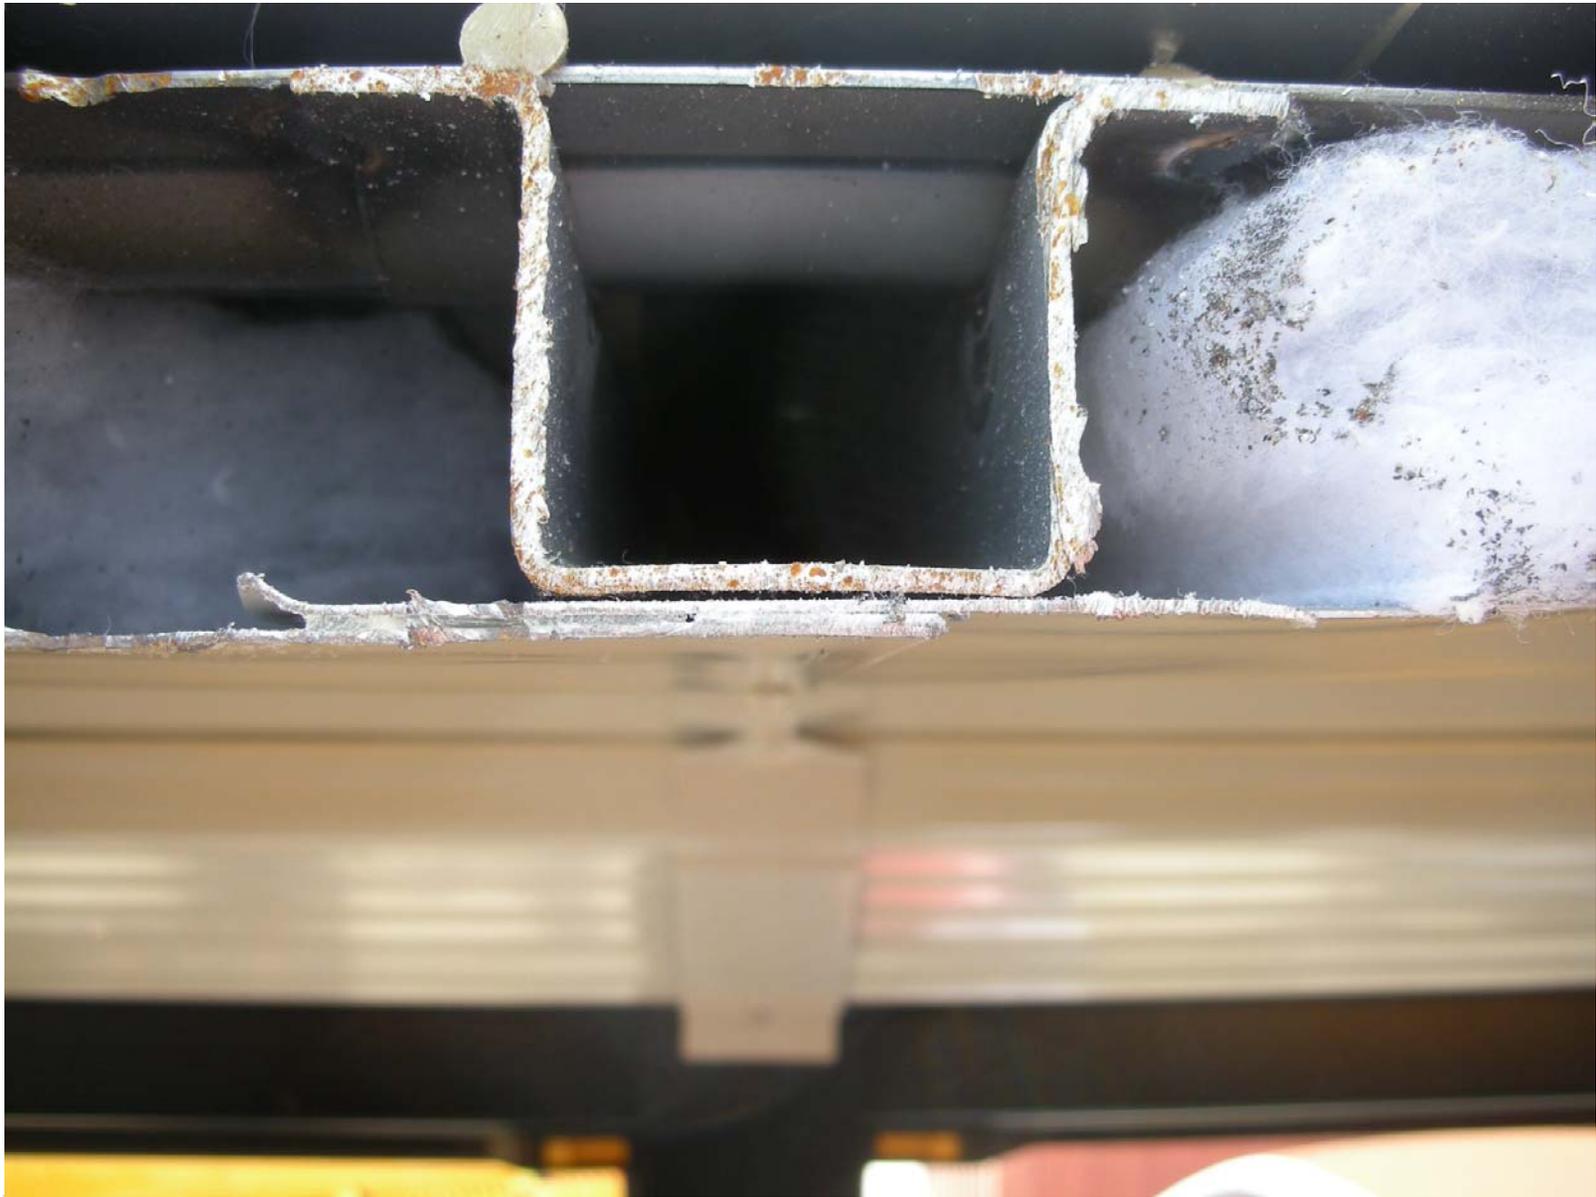
View of Joint #6
