REPORT NUMBER 110-STF-07-003

**SAFETY COMPLIANCE TESTING FOR
FMVSS NO. 110
TIRE SELECTION AND RIMS**

**GENERAL MOTORS CORPORATION
2007 CHEVROLET COLORADO
PICKUP TRUCK
NHTSA NO. C70106**

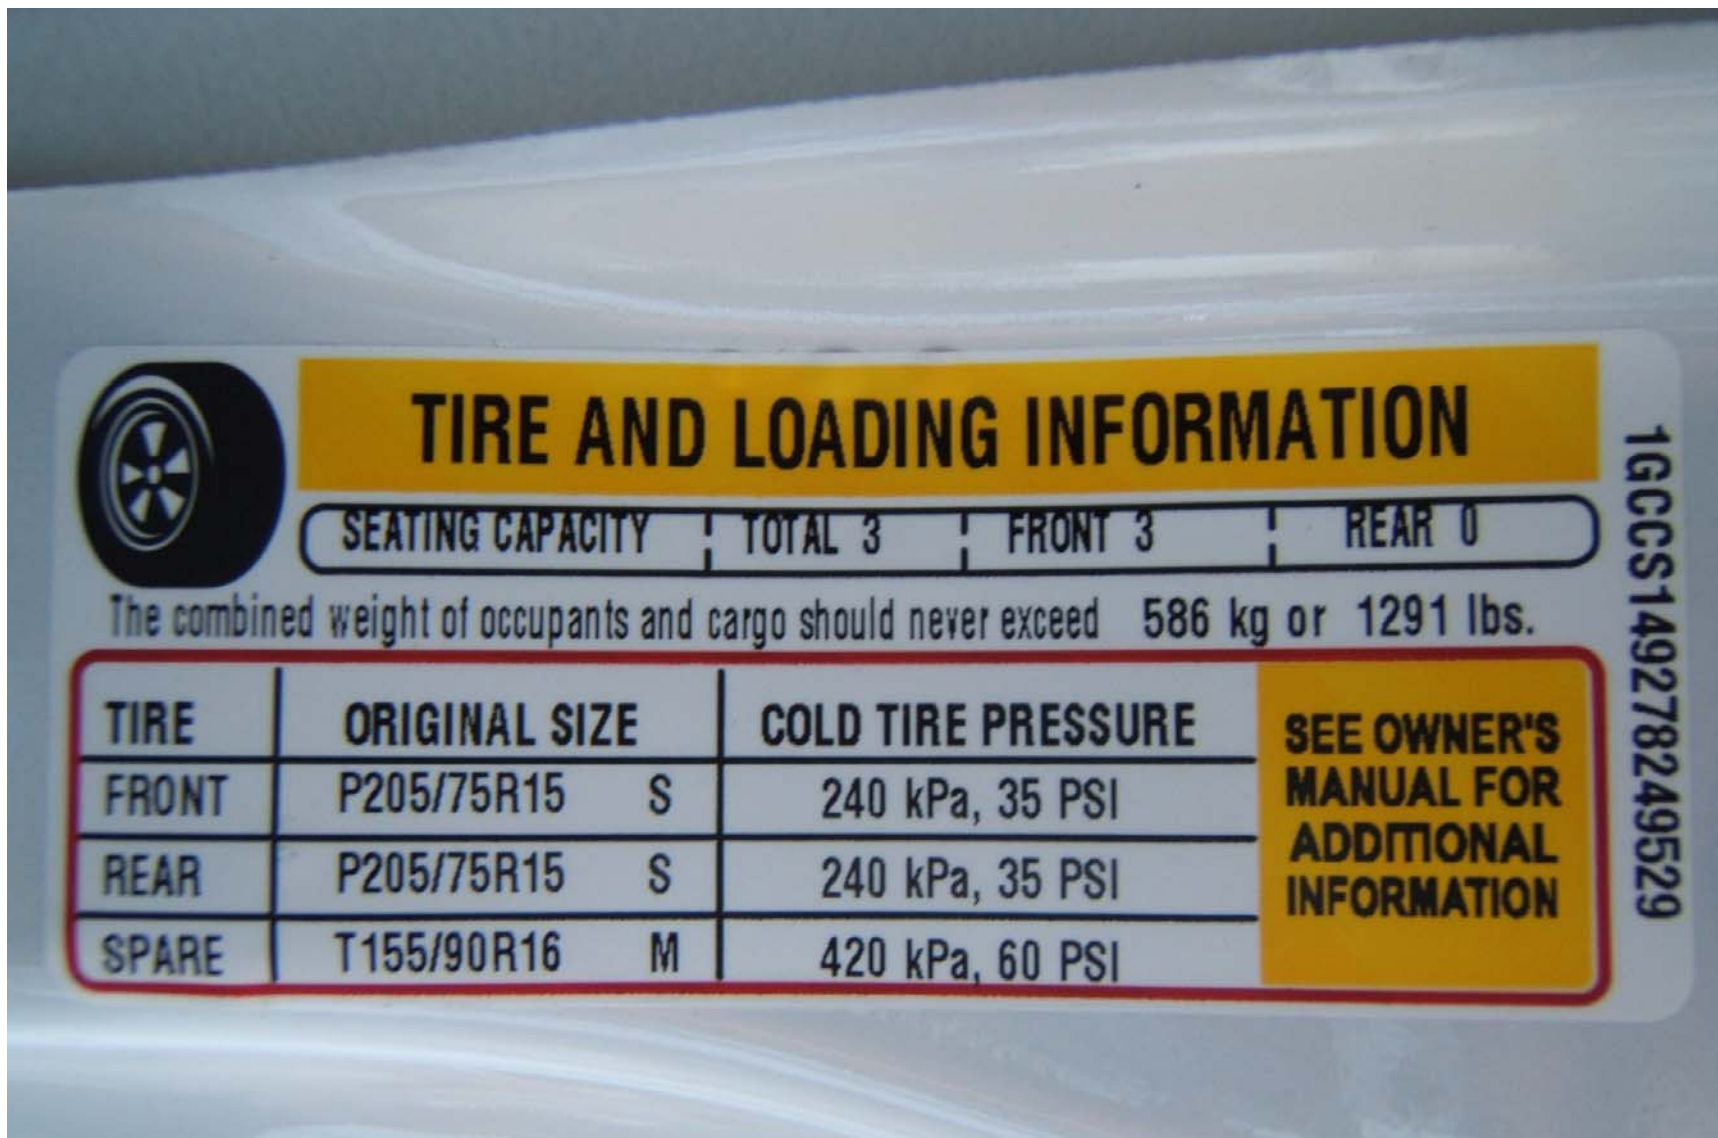
Vehicle Placard has the exact color and format as specified in the above Figure 1 and text is in English language. (X) YES () NO

FIGURE 5.4
 VEHICLE PLACARD

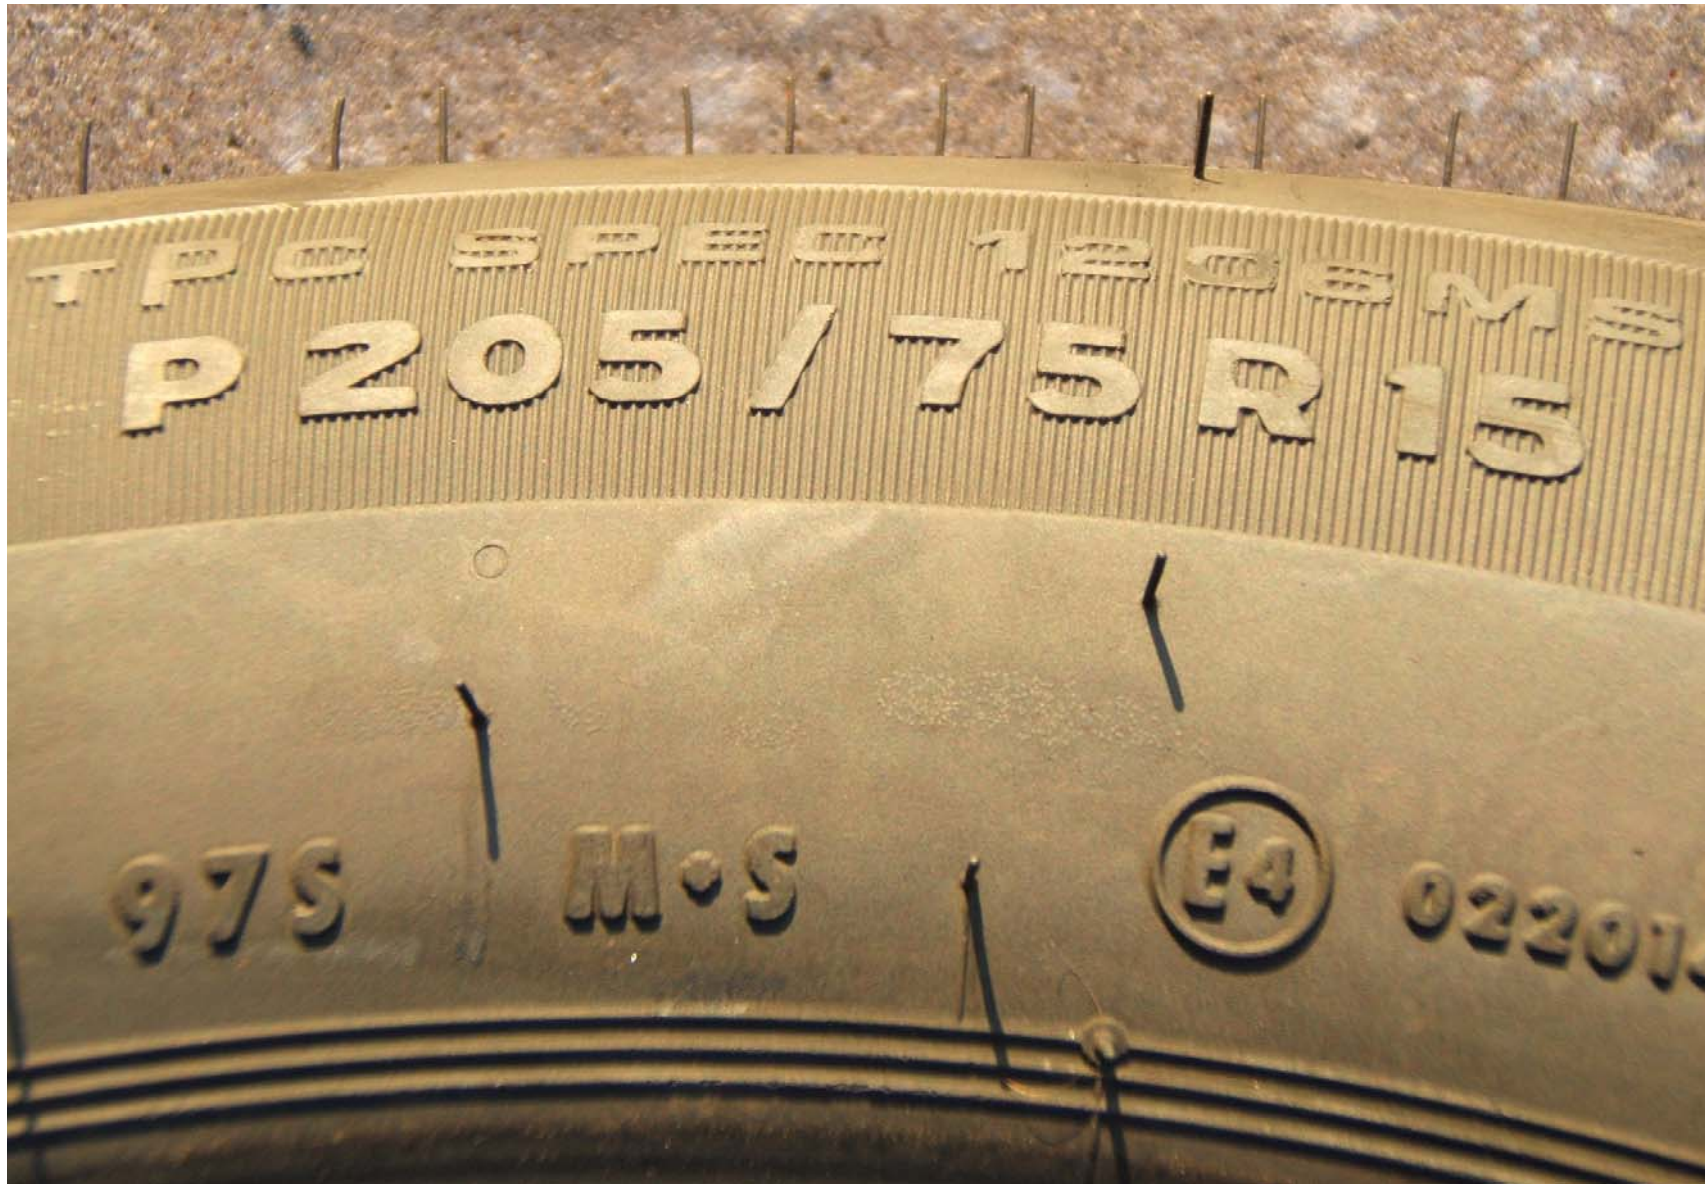
FIGURE 5.7
TIRE SHOWING SIZE, LOAD INDEX, AND SPEED SYMBOL

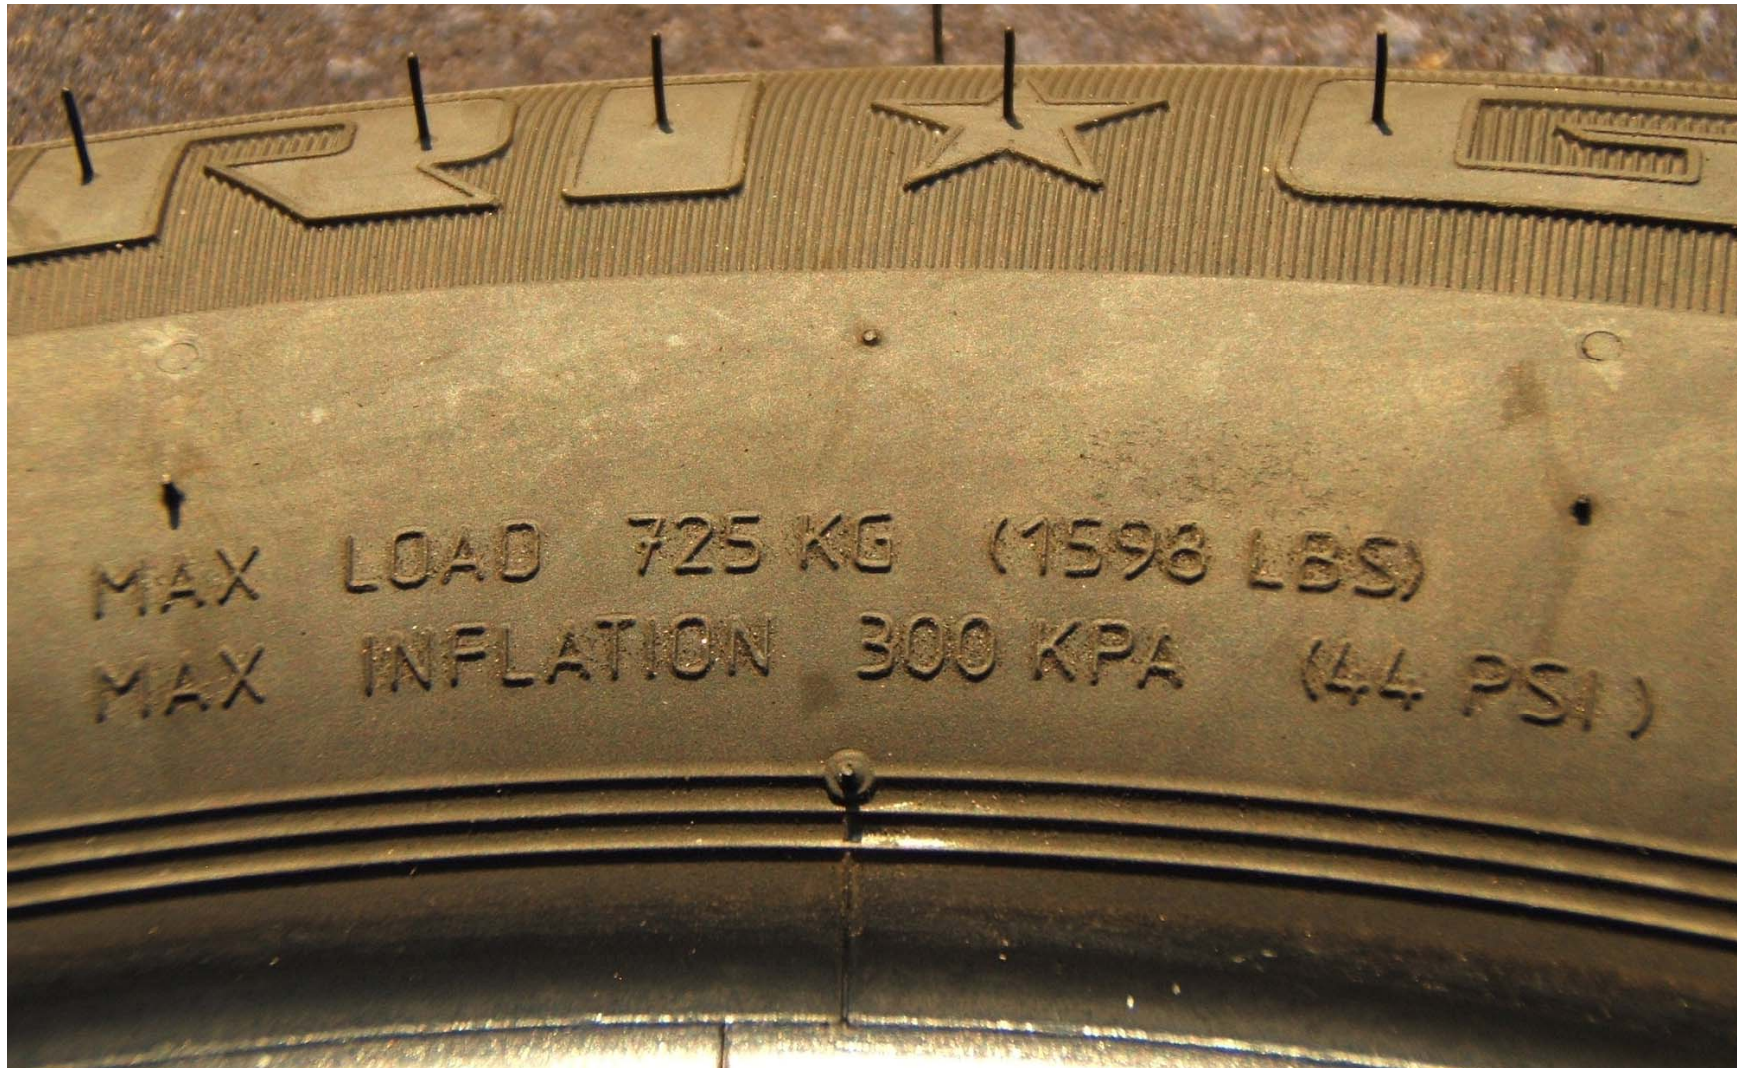
FIGURE 5.8
TIRE SHOWING MAX LOAD RATING AND MAX INFLATION PRESSURE

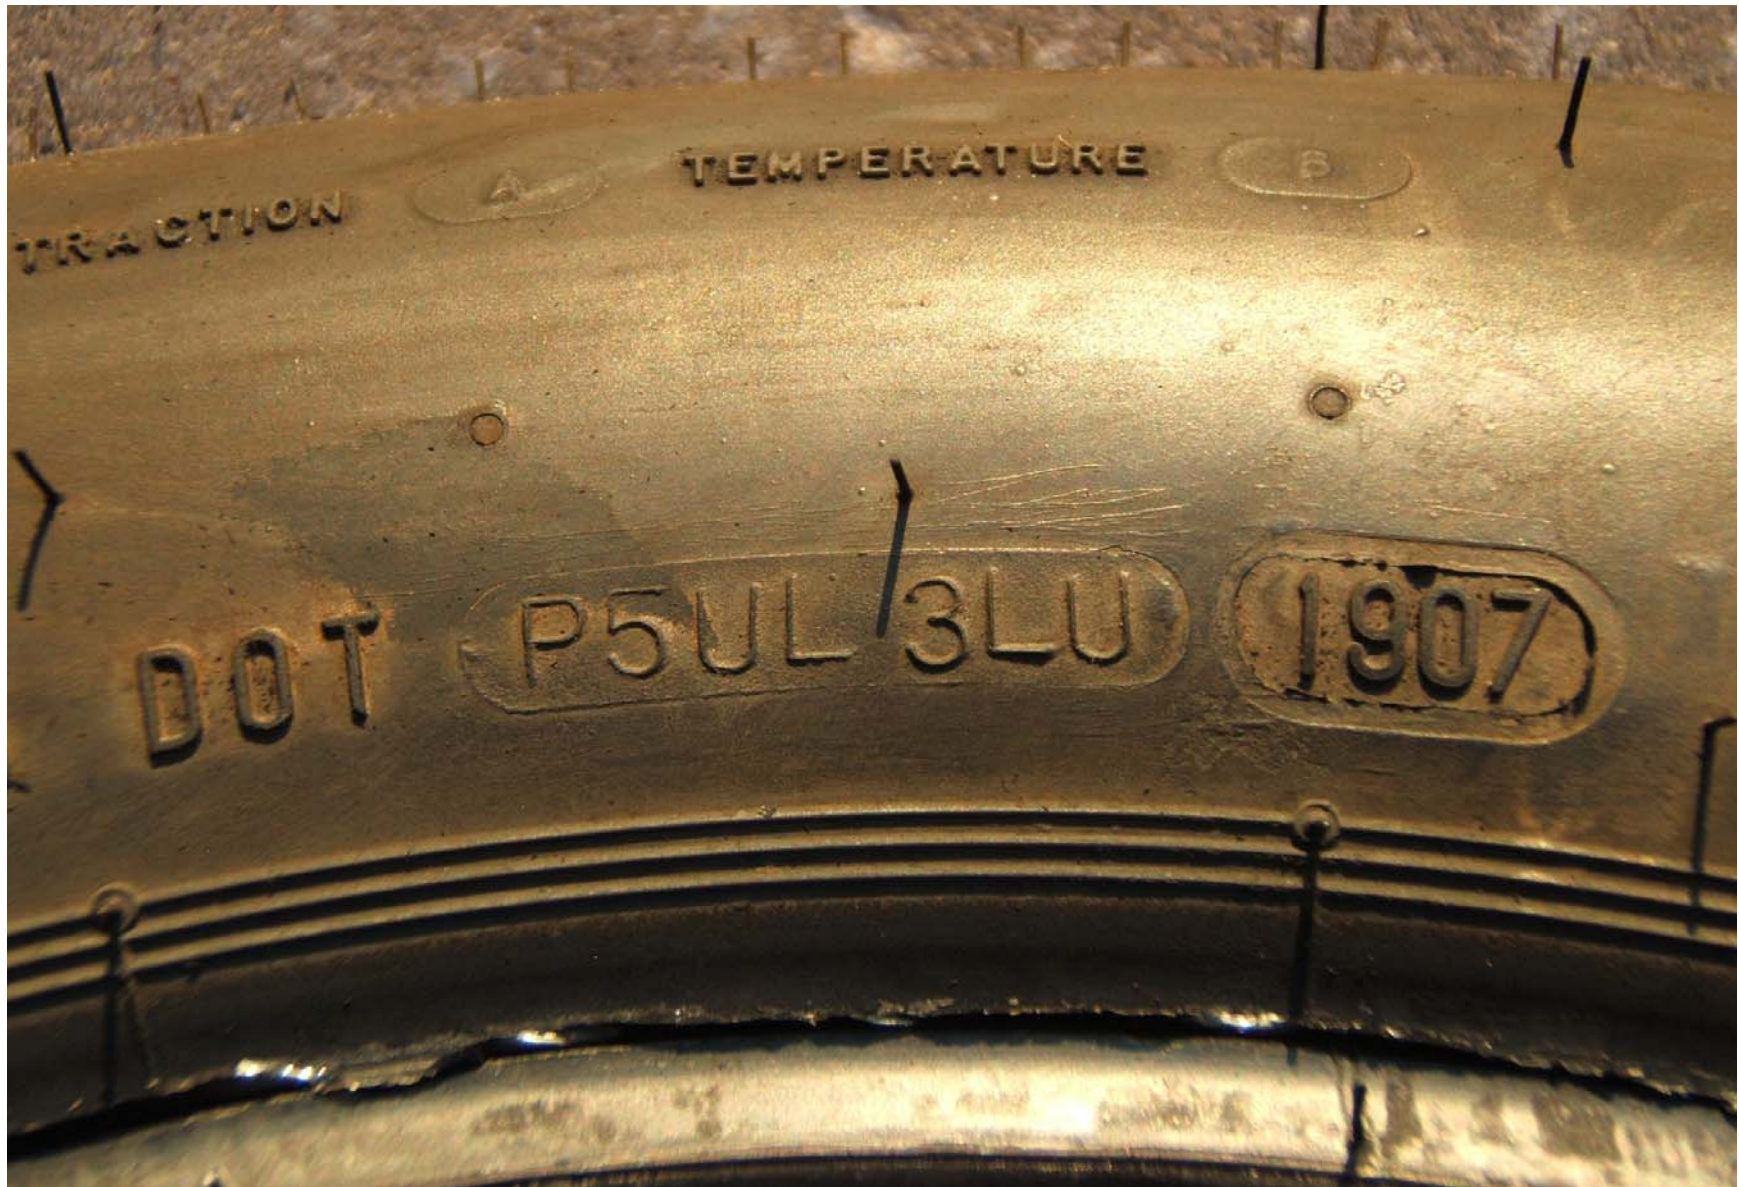
Serial Number: Right Front P5UL3LU1907 Left Front P5UL3LU1807
Right Rear P5UL3LU1807 Left Rear P5UL3LU1907
Spare WBV0H500207

FIGURE 5.10
TIRE SHOWING SERIAL NUMBER

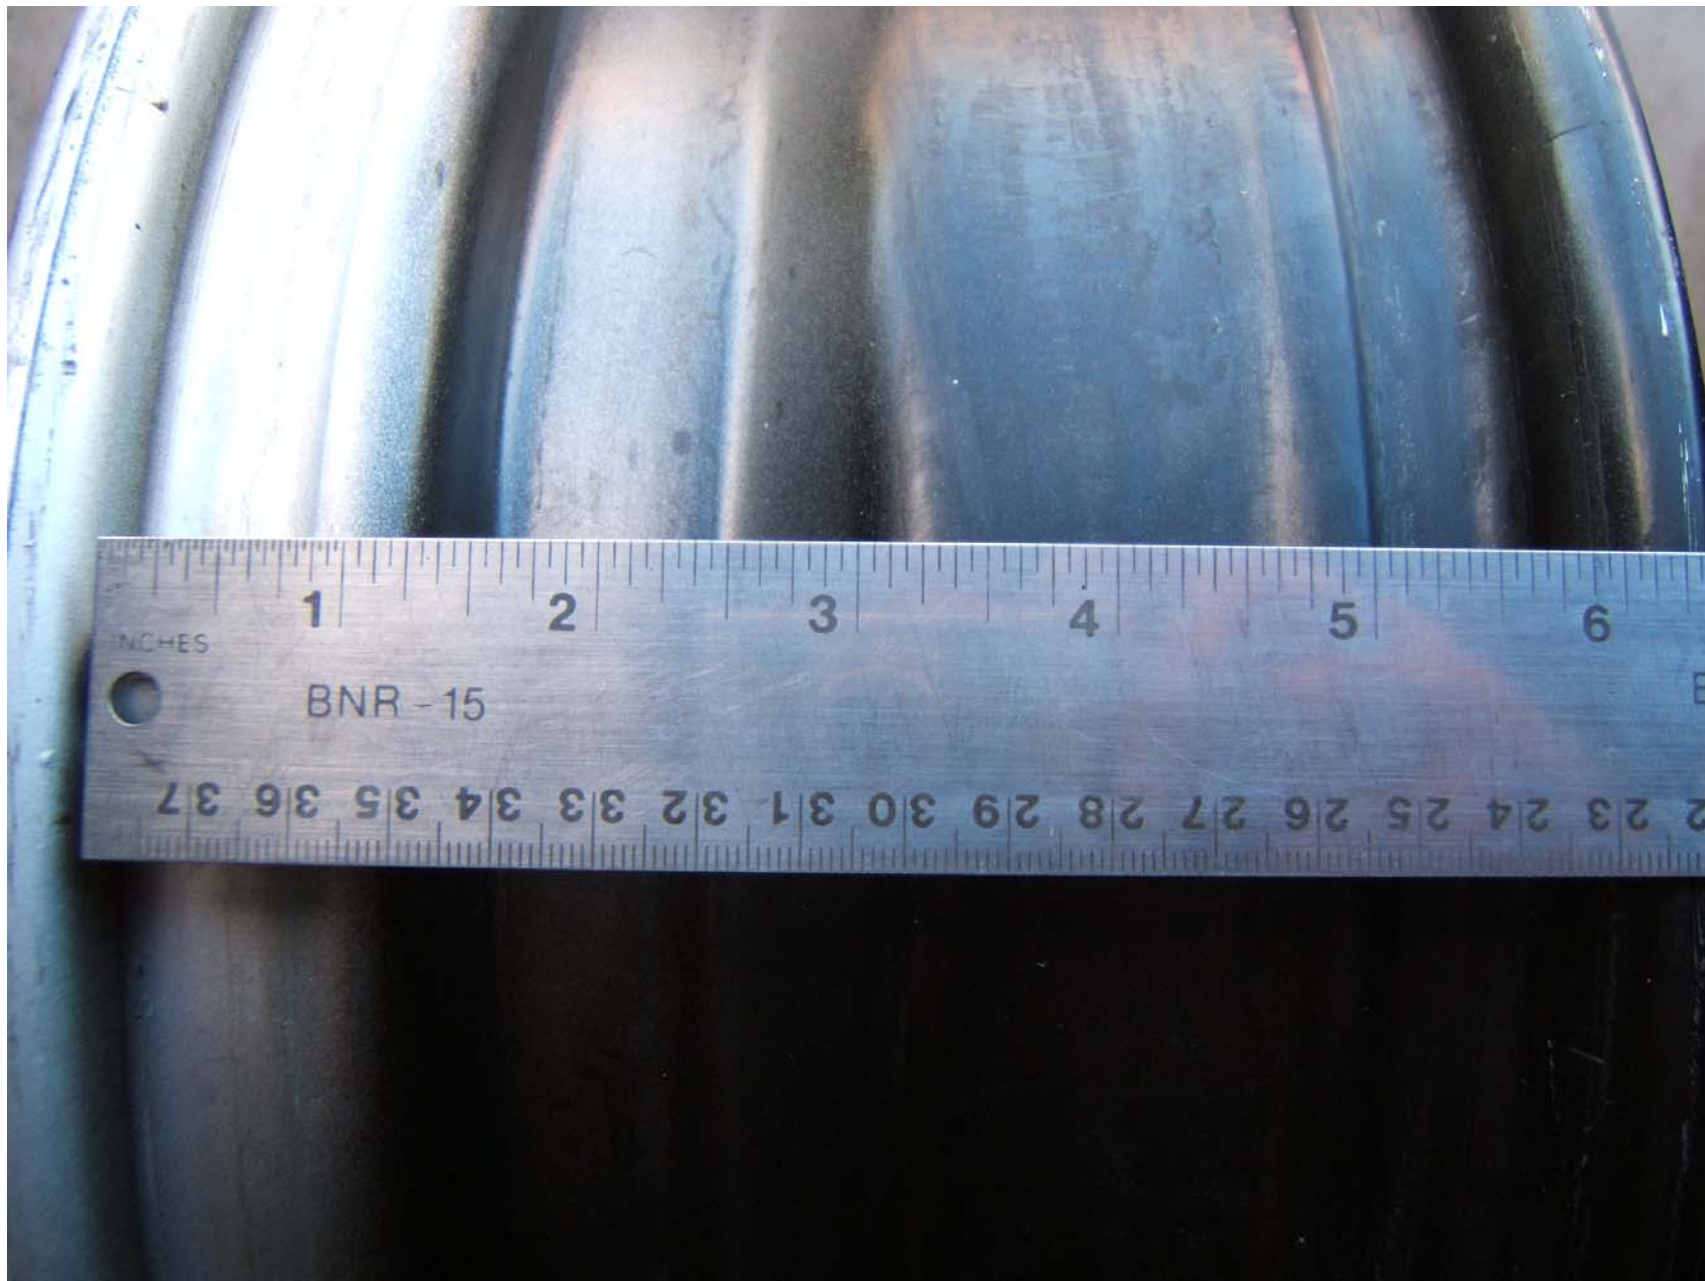
Rim Measurements	RIGHT FRONT	LEFT REAR (If different)
Rim width	15.2 cm (6.0 in)	
Rim diameter	38.1 cm (15 in)	
Rim measurements same as rim markings?	Yes

FIGURE 5.11
RIM CONTOUR FOR FULL WIDTH OF CROSS SECTION

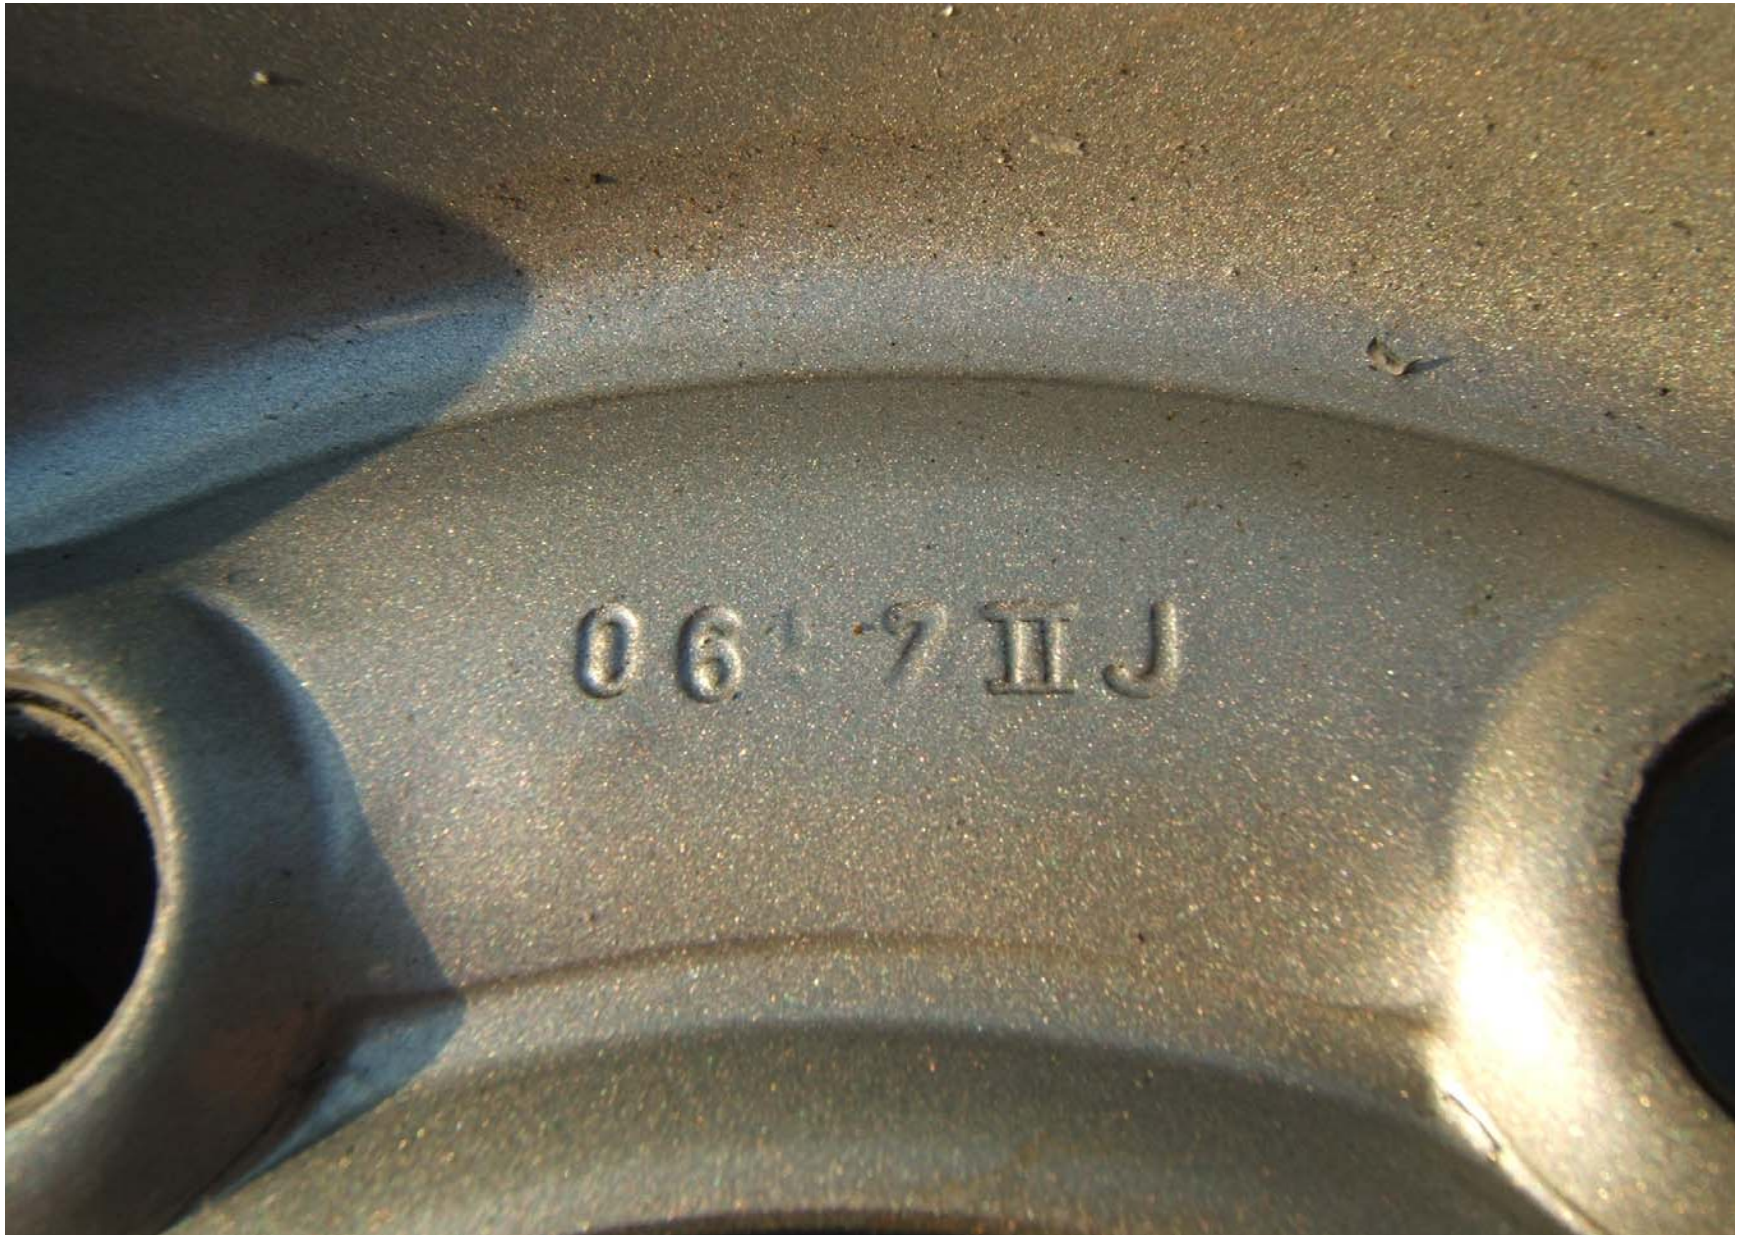
REMARKS: Date-of-manufacture format does not meet the requirement of FMVSS 120, S5.2(e). Per the COTR, "065" stands for day of the year, "7" stands for 2007, and "II" stands for second shift. S5.2 specifies month, day and year or the month and year of manufacture, expressed either numerically or by use of a symbol.

FIGURE 5.12
RIM SHOWING MANUFACTURE DATE

TEST FAILURE DESCRIPTION: Rim date-of-manufacture format does not indicate rim information as required by FMVSS 120, S5.2, and verified by FMVSS 110/120 testing. See photograph of rim, Figure 5.12 in report 110-STF-07-003.

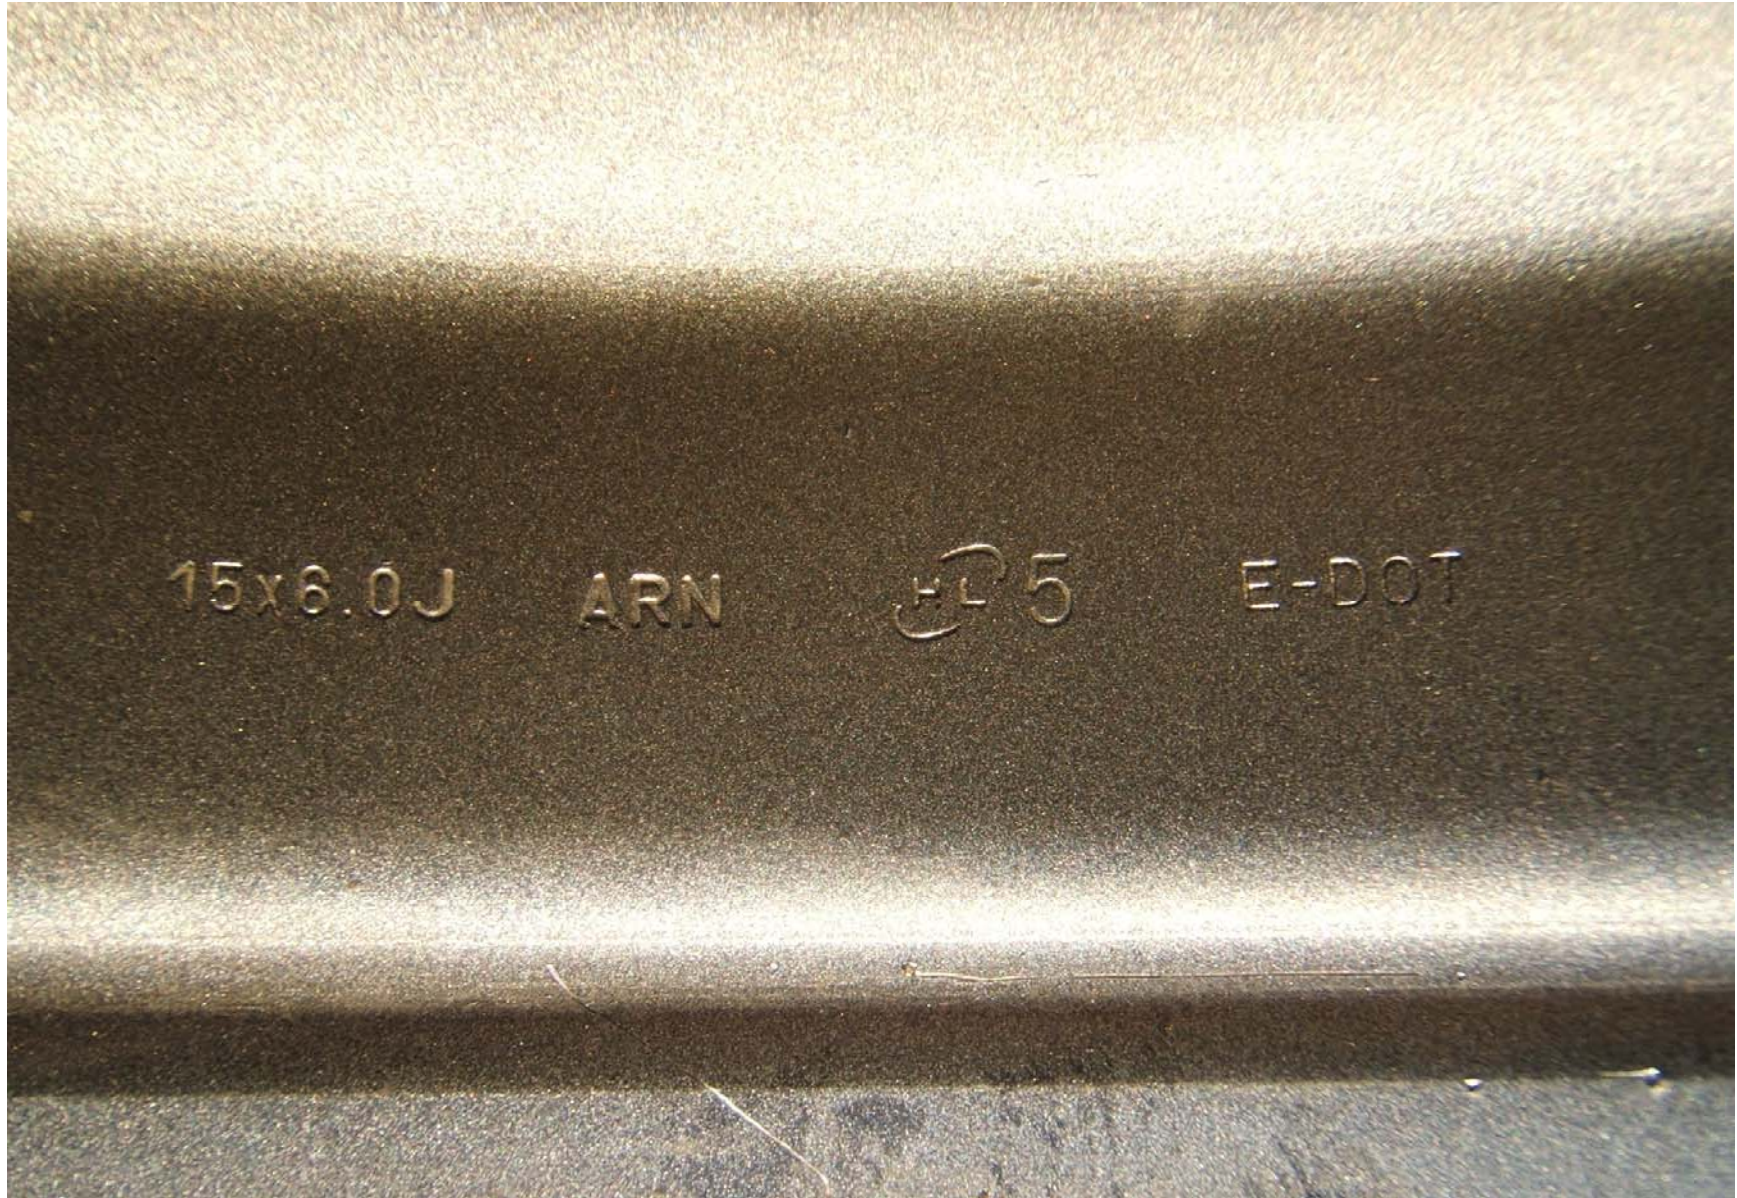
FIGURE 5.13
RIM SHOWING SIZE, MANUFACTURER SYMBOL,
REFERENCE SOURCE, AND DOT SYMBOL

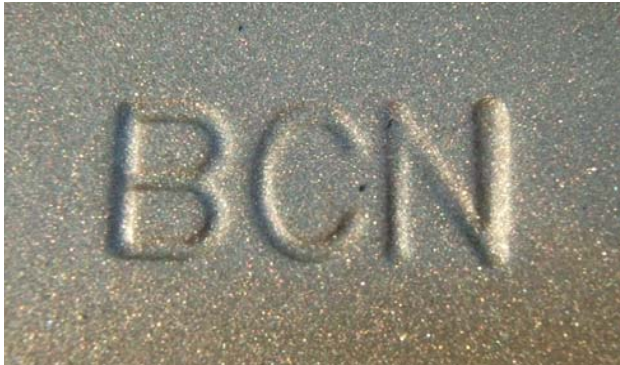
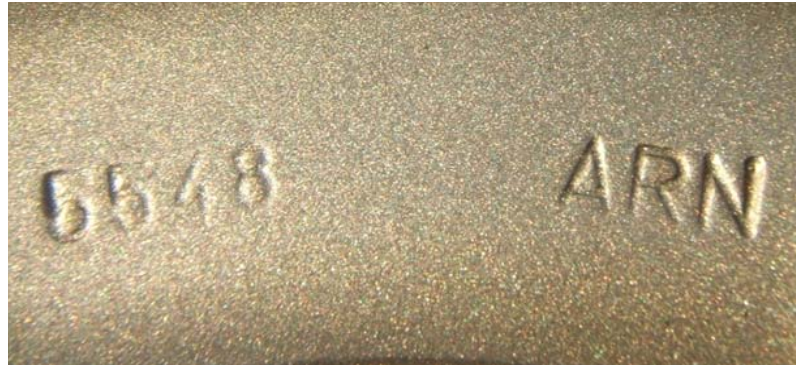
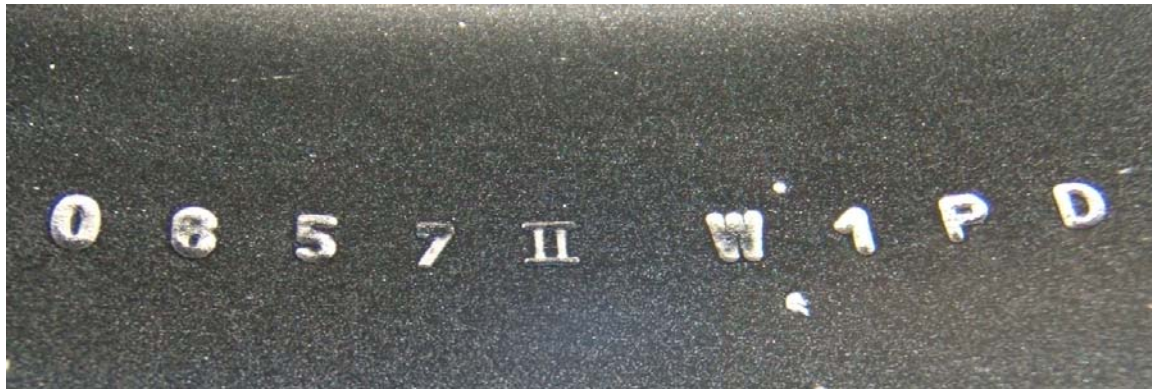
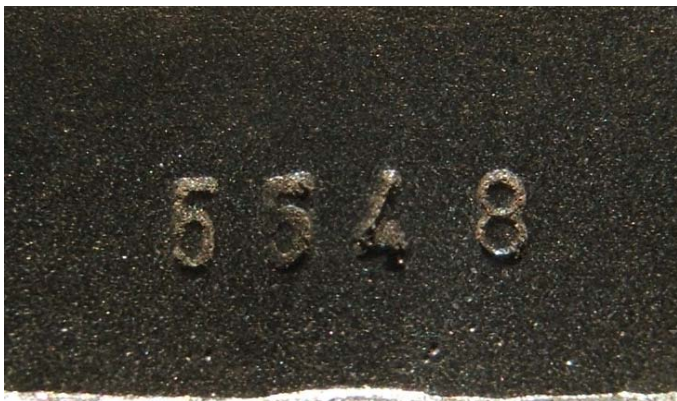
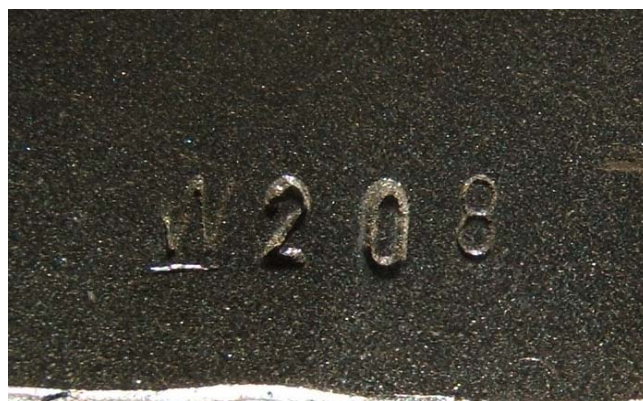
Rim Markings	RIGHT FRONT	LEFT REAR (if different)
A. Source of published dimensions (letter designation)	E	
B. Rim Size	15x6.0J	
C. Does rim contain DOT symbol? (Yes/No)	Yes	
D. Manufacturer's name, symbol or trademark (copy format)

E. Date of manufacture or symbol (copy format)	0657II	
Do items A-C appear on weather side of rim (Yes/No)	Yes	
Letter height (not less than 3 mm)	4 mm	
Lettering (impressed or embossed)	Impressed	
Are all rim markings legible? (Yes/No)	Yes	
Do all markings comply with requirements (Yes/No)	No - see remarks

FIGURE 5.15
RIM MARKINGS

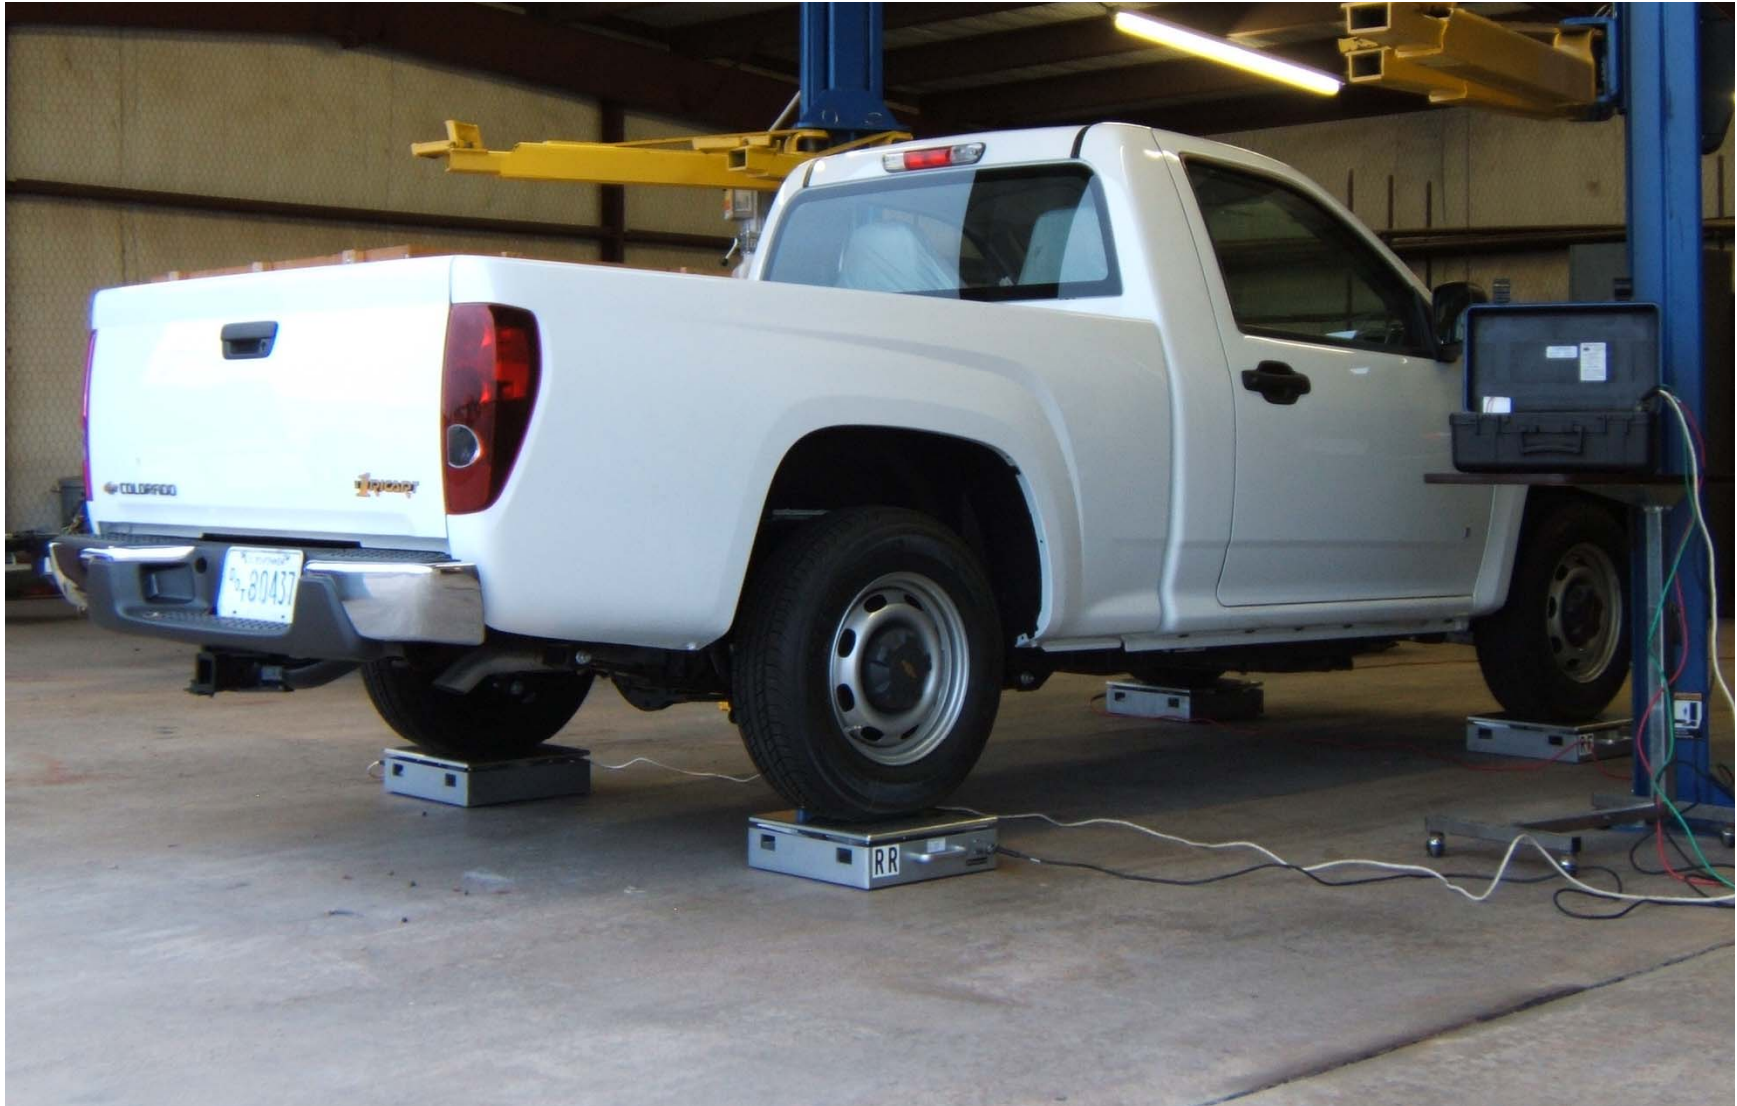
ITEM	Tire or Vehicle Rating*	Unloaded Vehicle Weight		Vehicle Weight with Full Occupant Load		Vehicle Maximum Weight with Occupants and Cargo	
		Measured	Over-load	Measured	Over-load	Measured	Over-load
Left Front Tire	659 kg (1,453 lbs)	444.1 kg (979 lbs)	no	499.9 kg (1,102 lbs)	no	487.2 kg (1,074 lbs)	no
Right Front Tire	659 kg (1,453 lbs)	416.4 kg (918 lbs)	no	470.8 kg (1,038 lbs)	no	459.5 kg (1,013 lbs)	no
Front Axle (GAWR)	1149 kg (2,533 lbs)	860.5 kg (1,897 lbs)	no	970.7 kg (2,140 lbs)	no	946.7 kg (2,087 lbs)	no
Left Rear Tire	659 kg (1,453 lbs)	352.9 kg (778 lbs)	no	399.2 kg (880 lbs)	no	603.3 kg (1,330 lbs)	no
Right Rear Tire	659 kg (1,453 lbs)	332.0 kg (732 lbs)	no	379.2 kg (836.0 lbs)	no	580.6 kg (1,280 lbs)	no
Rear Axle (GAWR)	1,314 kg (2,896 lbs)	684.9 kg (1,510 lbs)	no	778.4 kg (1,716 lbs)	no	1,183.9 kg (2,610 lbs)	no
Total Vehicle (GVWR)	2,200 kg (4,850 lbs)	1,545.4 kg (3,407 lbs)	no	1,749.1 kg (3,856 lbs)	no	2,130.5 kg (4,697 lbs)	no

FIGURE 5.18
VEHICLE ON WEIGHT SCALES
