REPORT NUMBER: 201UI-CAL-07-04

**SAFETY COMPLIANCE TESTING FOR FMVSS 201  
OCCUPANT PROTECTION IN INTERIOR IMPACT  
UPPER INTERIOR HEAD IMPACT PROTECTION**

**NISSAN MOTOR COMPANY  
2007 NISSAN VERSA**

NHTSA NUMBER: C75203

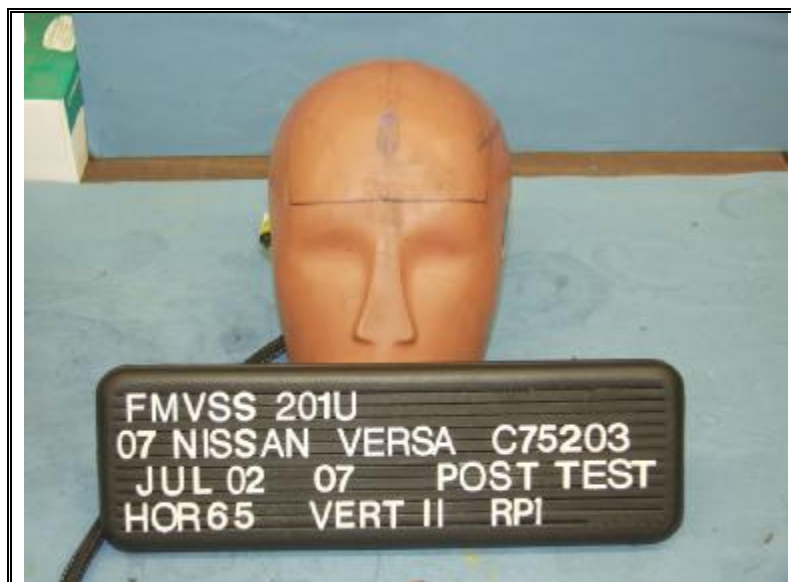
POST-IMPACT RP1 HEADFORM

Free Motion HIC	943.1
HIC(d)	877.9
Impact Velocity (kph)	23.57
HIC T1 (msec)	6.9
HIC T2 (msec)	11.6

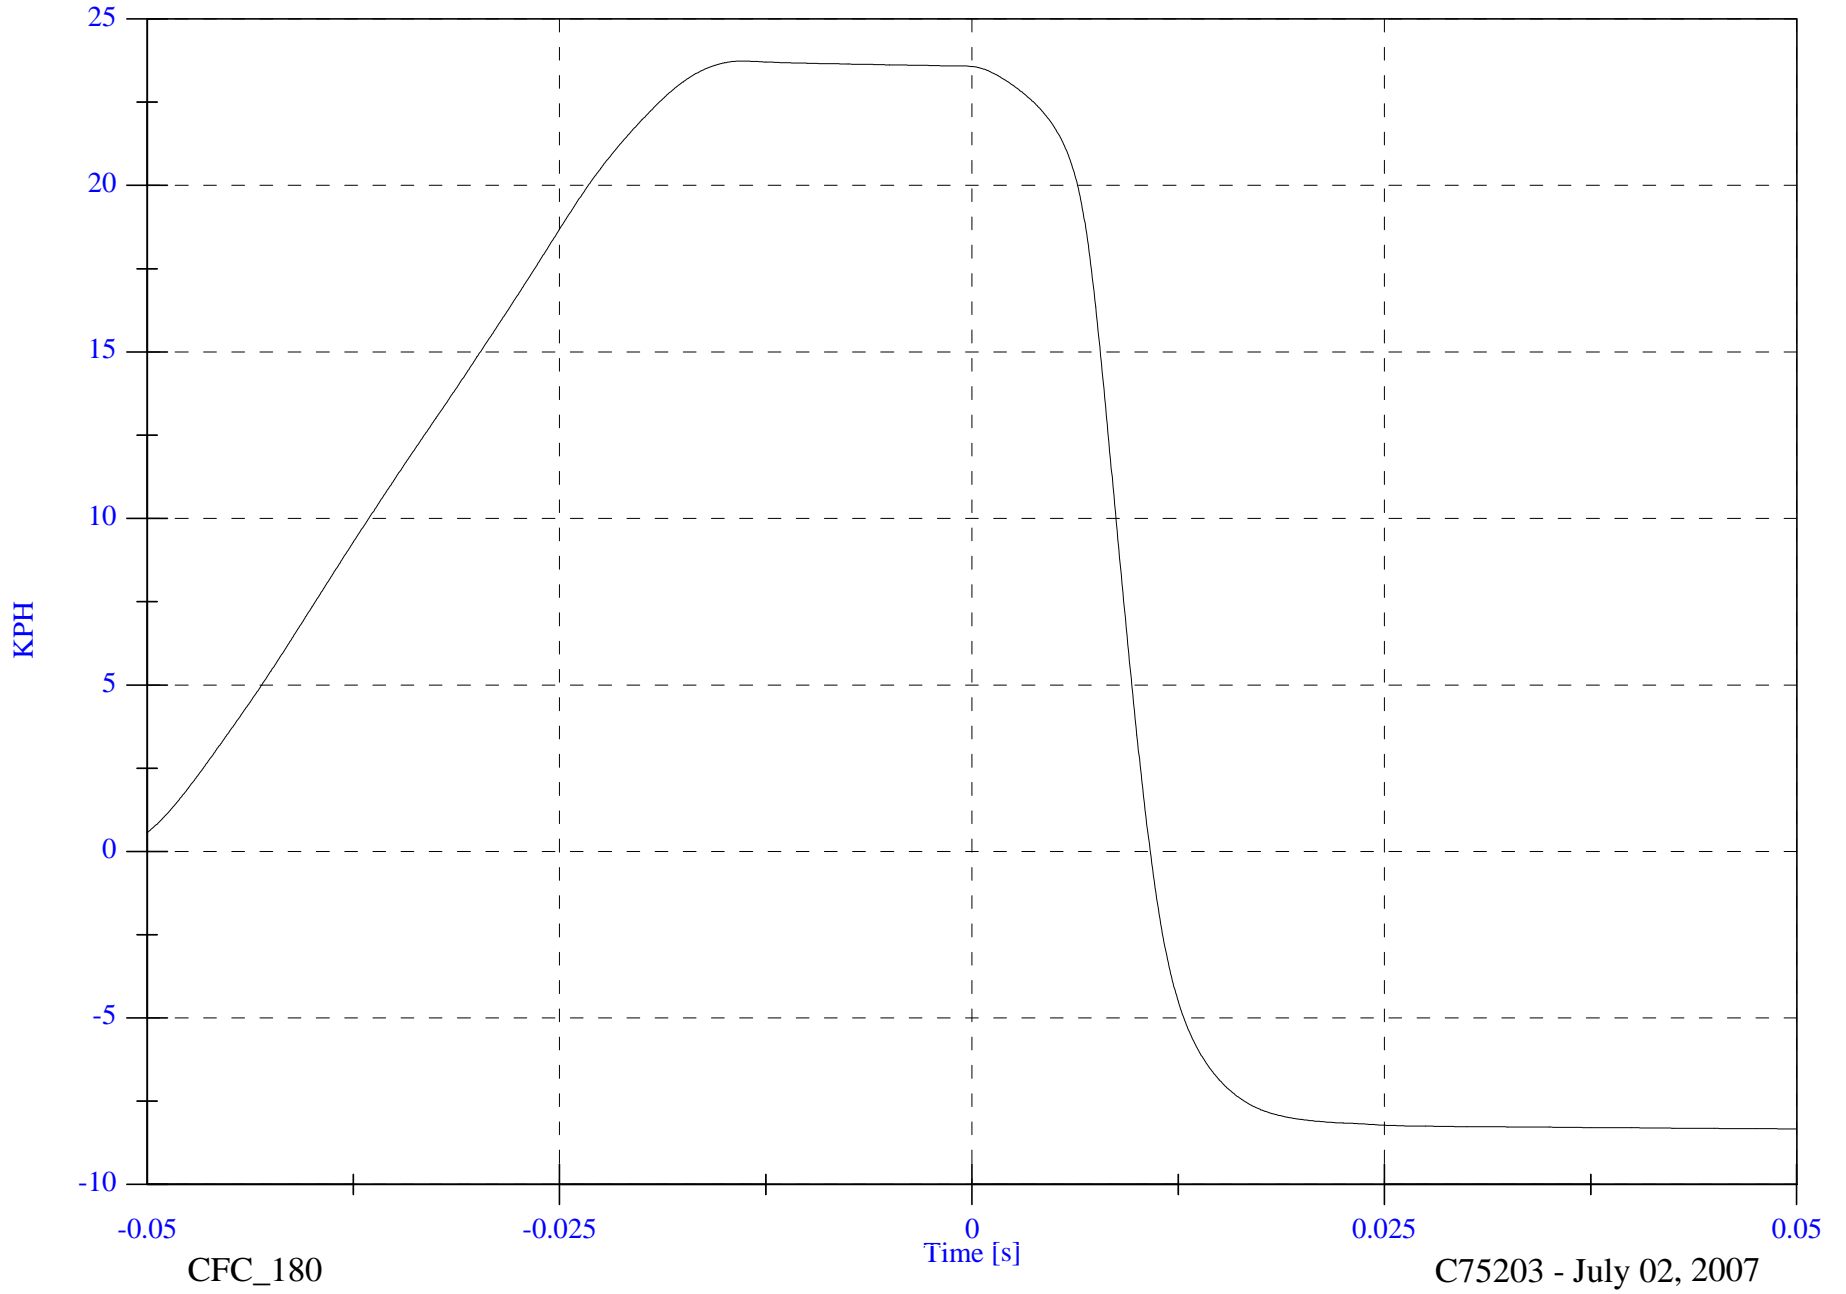
C75203 PASSENGER SIDE RP1 IMPACT PLOT #5

Max: 23.7 [KPH] at -0.014 [s]

Min: -8.3 [KPH] at 0.050 [s]

### Headform Velocity

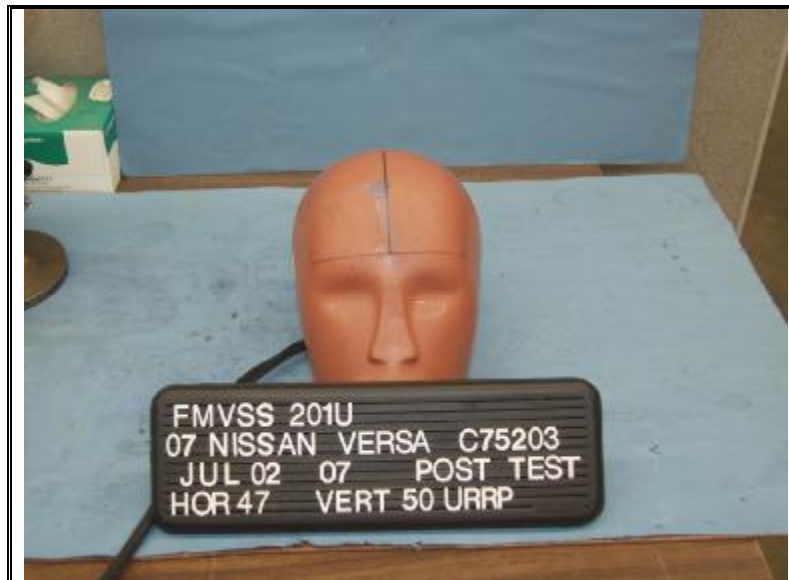
POST-IMPACT URRP HEADFORM

Free Motion HIC	386.6
HIC(d)	458.0
Impact Velocity (kph)	23.6
HIC T1 (msec)	8.8
HIC T2 (msec)	15.5

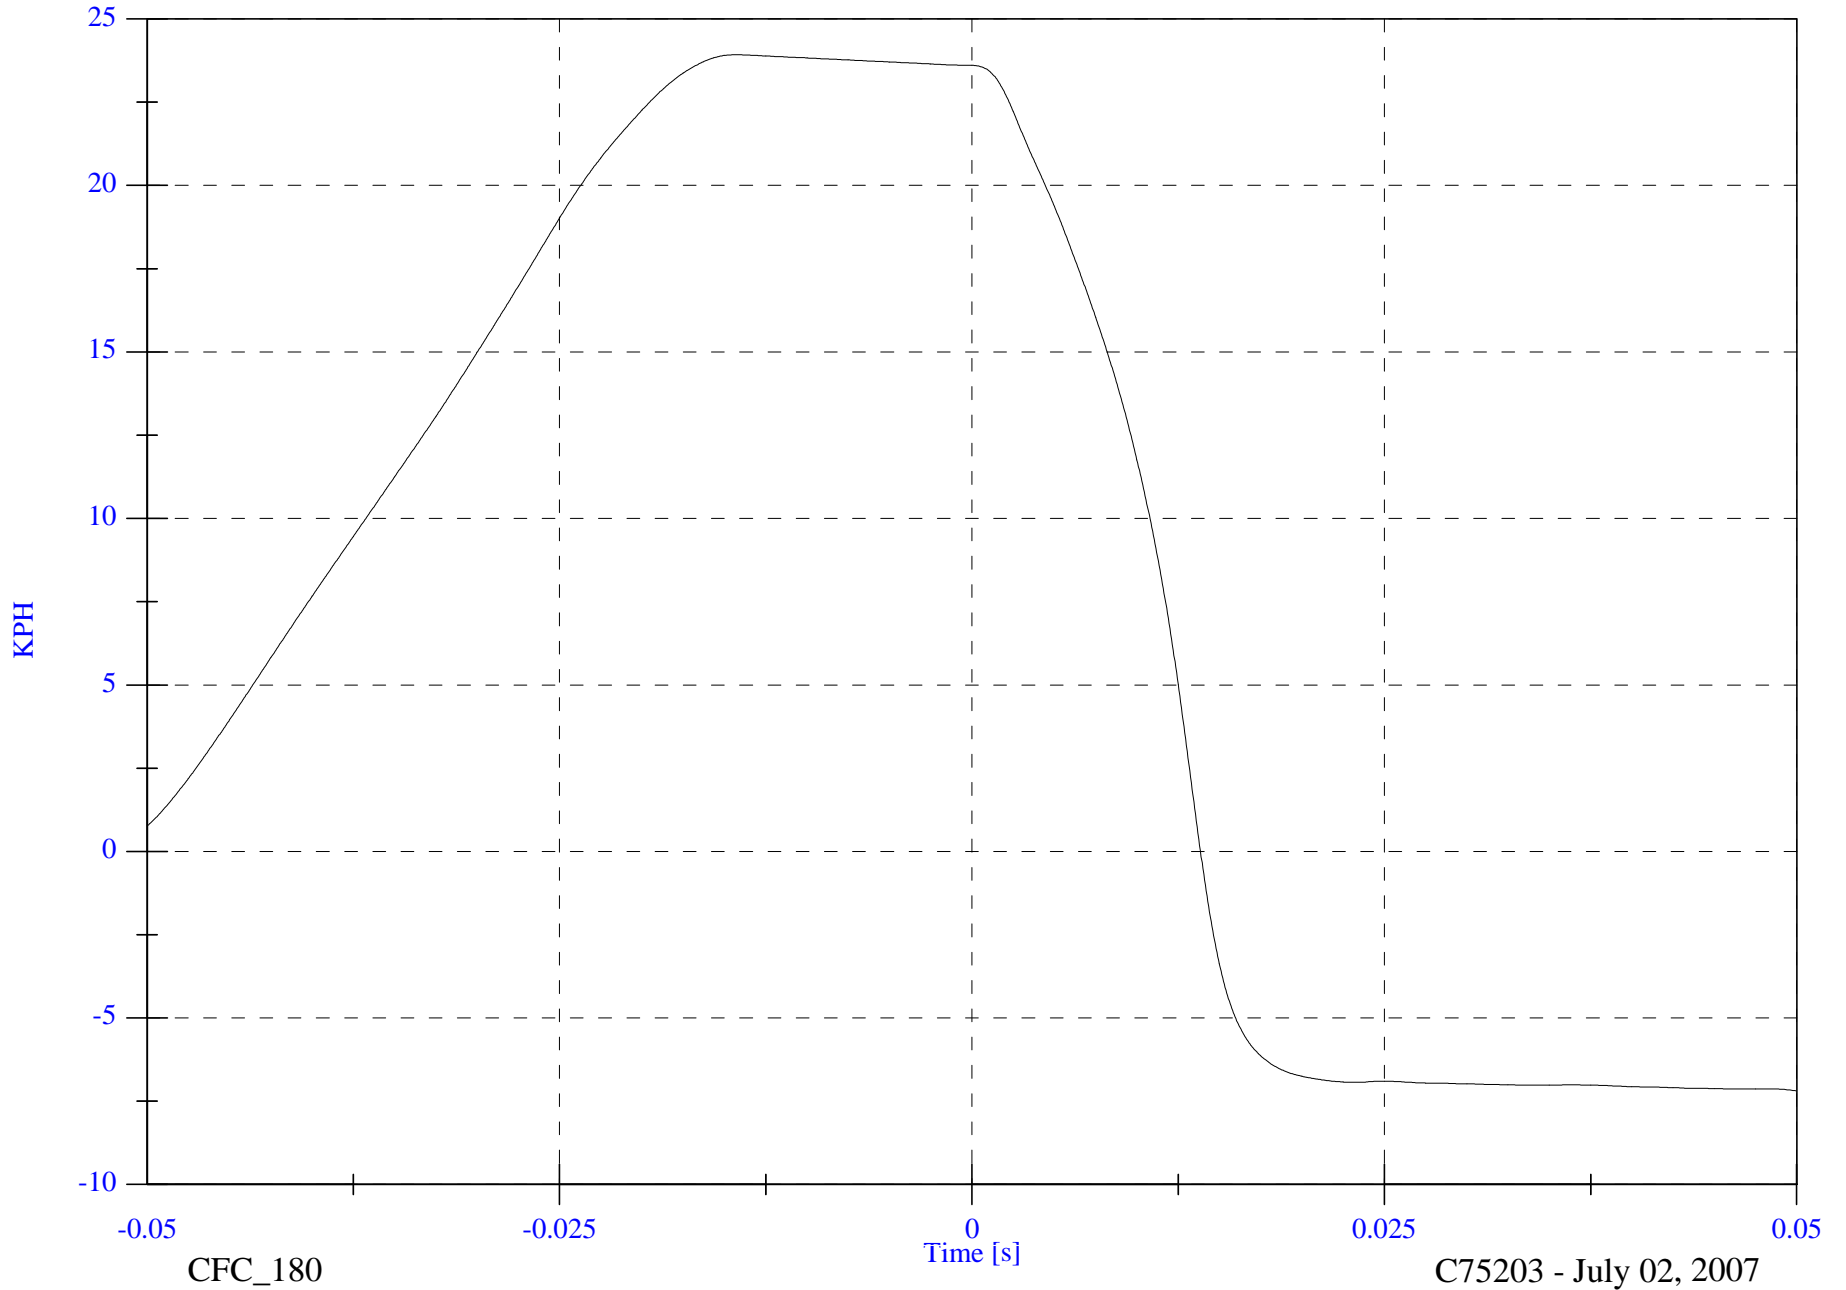
C75203 PASSENGER SIDE URRP IMPACT PLOT #5

Min: -7.2 [KPH] at 0.050 [s]

### Headform Velocity

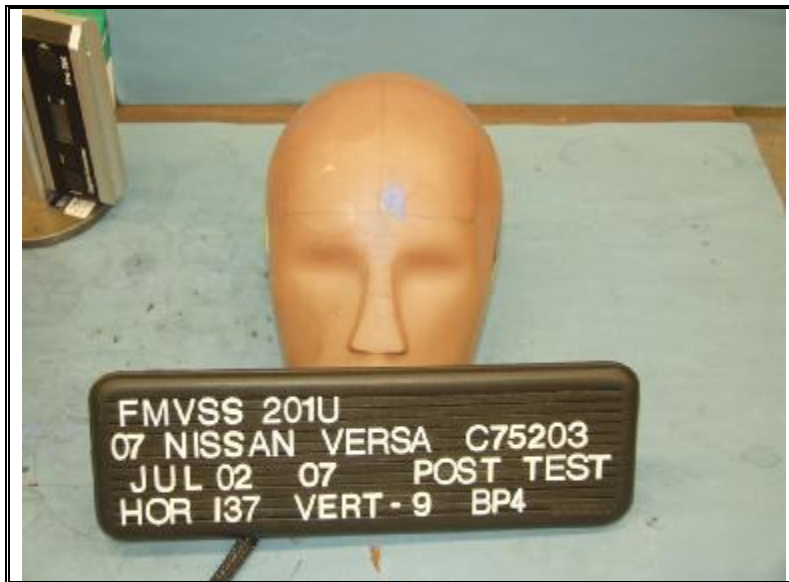
POST-IMPACT BP4 HEADFORM

Free Motion HIC	560.3
HIC(d)	589.1
Impact Velocity (kph)	23.67
HIC T1 (msec)	2.3
HIC T2 (msec)	12.7

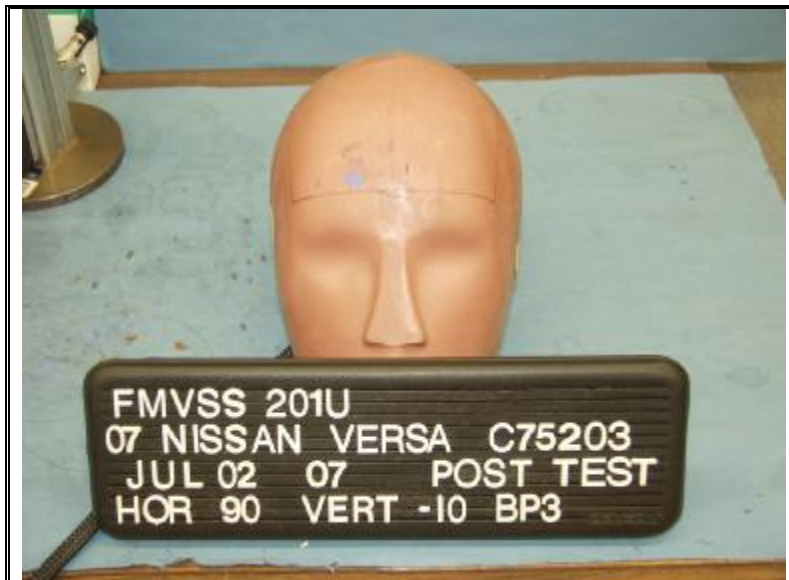
POST-IMPACT BP3 HEADFORM

Free Motion HIC	629.0
HIC(d)	640.9
Impact Velocity (kph)	23.62
HIC T1 (msec)	1.8
HIC T2 (msec)	9.0

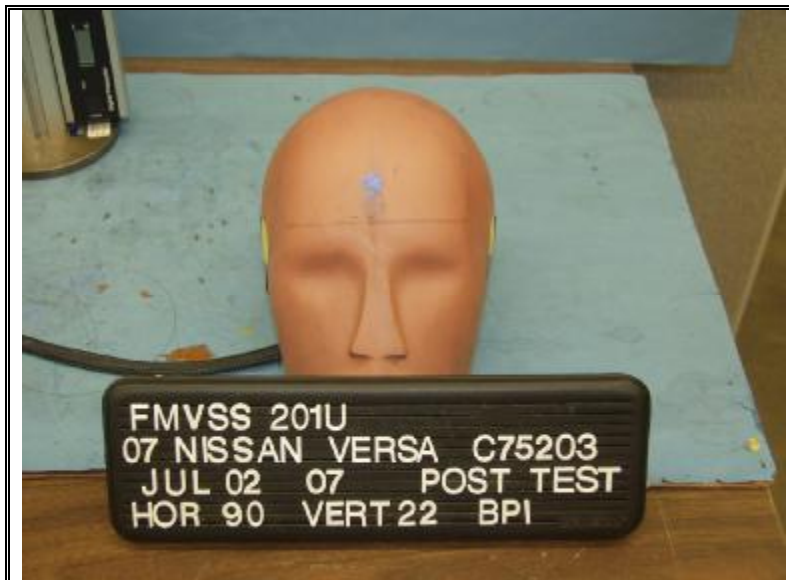
POST-IMPACT BP1 HEADFORM

Free Motion HIC	462.3
HIC(d)	515.2
Impact Velocity (kph)	18.58
HIC T1 (msec)	5.6
HIC T2 (msec)	11.8

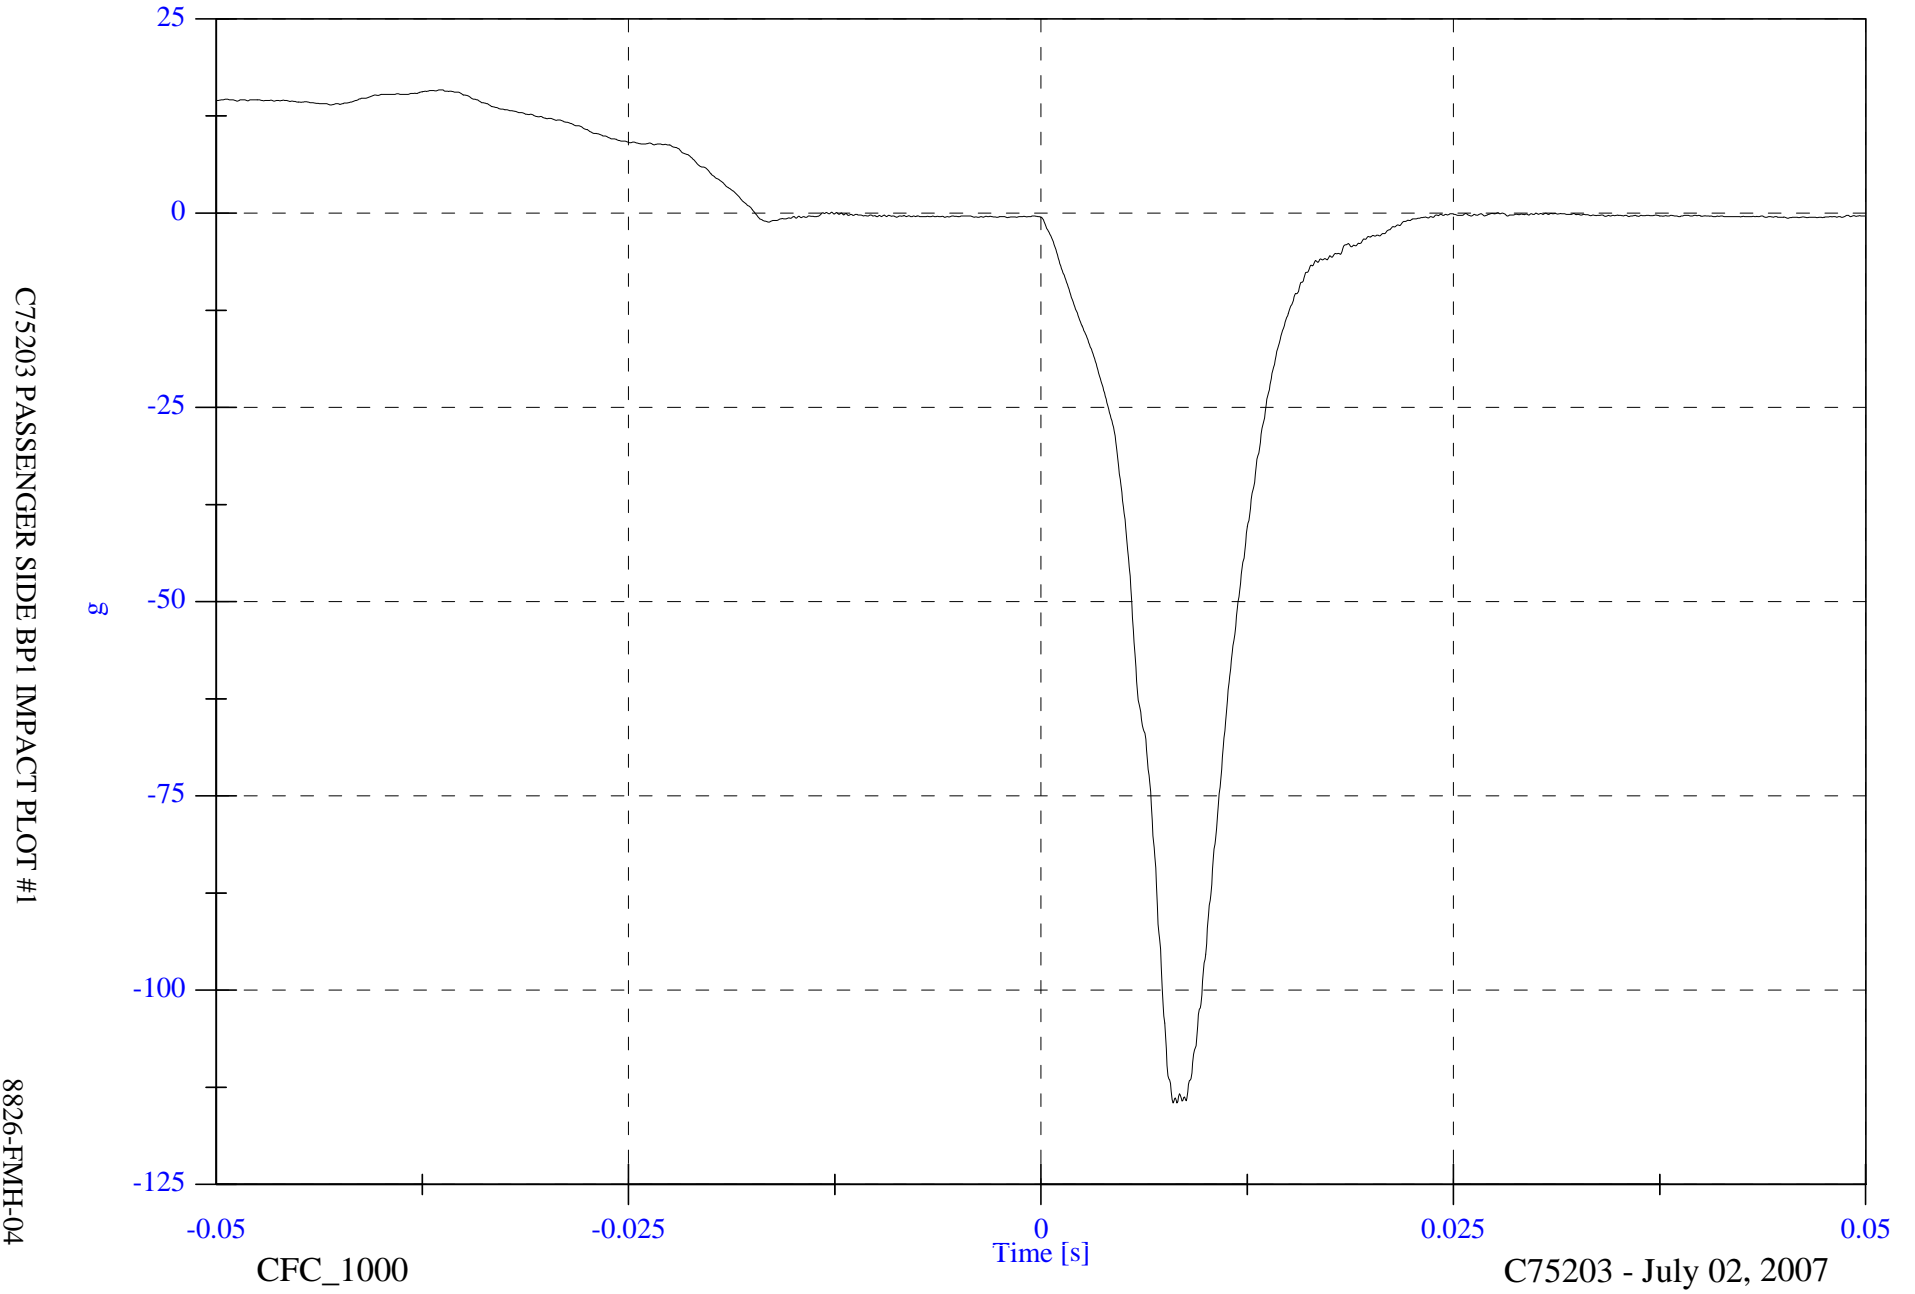
C75203 PASSENGER SIDE BP1 IMPACT PLOT #1

### Headform X Acceleration

Min: -114.5 [g] at 0.008 [s]

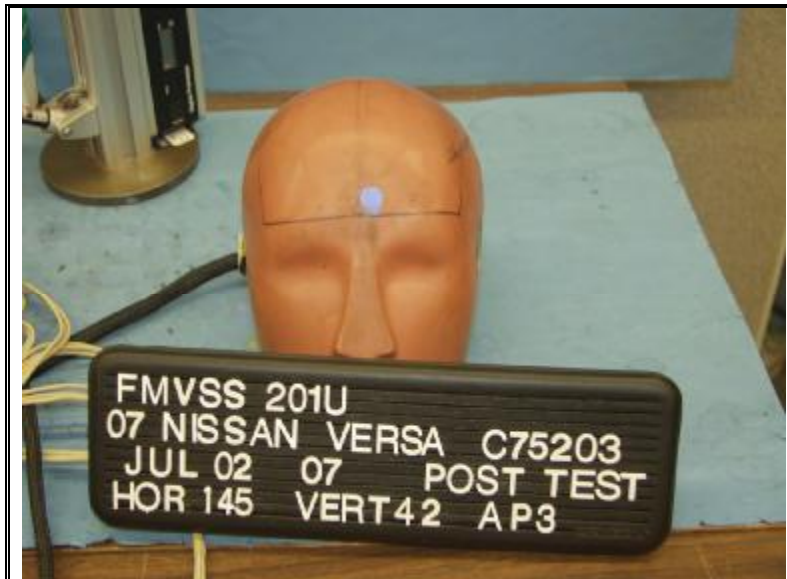
POST-IMPACT AP3 HEADFORM

Free Motion HIC	619.0
HIC(d)	633.4
Impact Velocity (kph)	18.75
HIC T1 (msec)	2.1
HIC T2 (msec)	7.1

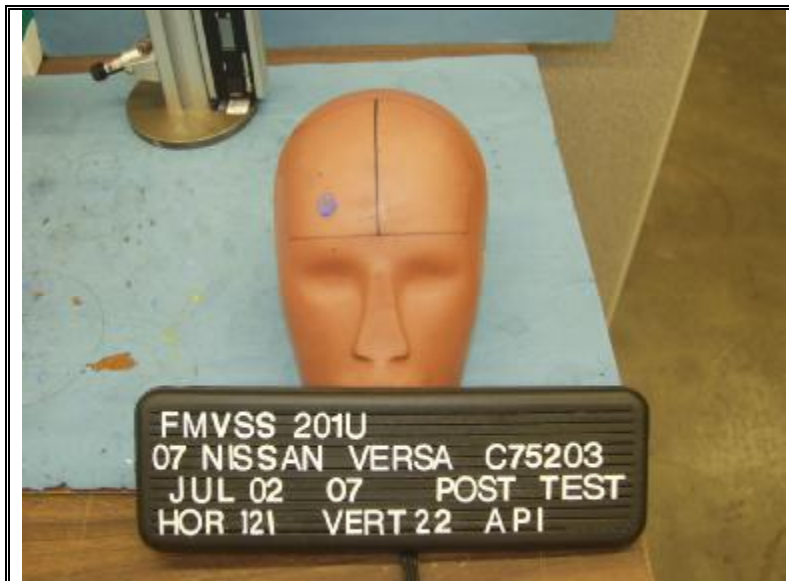
POST-IMPACT AP1 HEADFORM

Free Motion HIC	220.5
HIC(d)	332.8
Impact Velocity (kph)	18.52
HIC T1 (msec)	3.7
HIC T2 (msec)	11.1

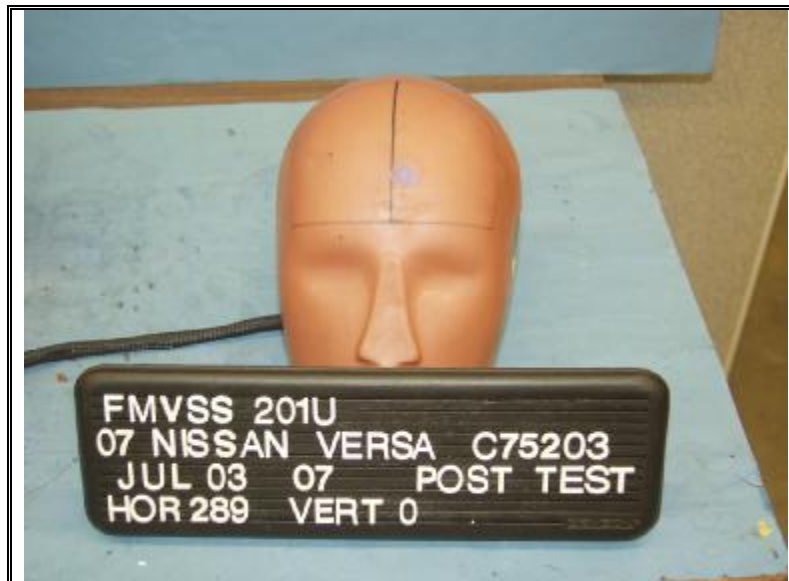
POST-IMPACT RP2 HEADFORM

Free Motion HIC	720.2
HIC(d)	709.8
Impact Velocity (kph)	23.49
HIC T1 (msec)	3.9
HIC T2 (msec)	9.0

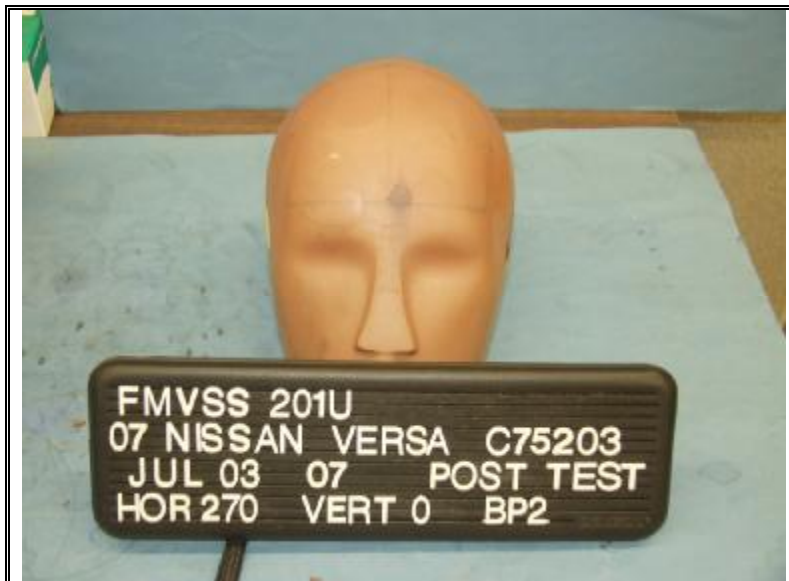
POST-IMPACT BP2 HEADFORM

Free Motion HIC	718.7
HIC(d)	708.6
Impact Velocity (kph)	23.56
HIC T1 (msec)	1.4
HIC T2 (msec)	9.6

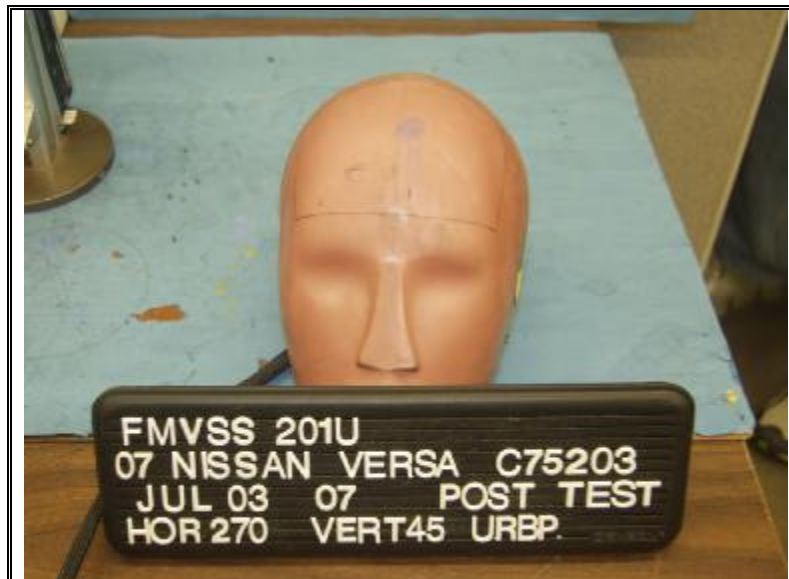
POST-IMPACT URBP HEADFORM

Free Motion HIC	797.1
HIC(d)	767.8
Impact Velocity (kph)	23.83
HIC T1 (msec)	2.3
HIC T2 (msec)	10.2

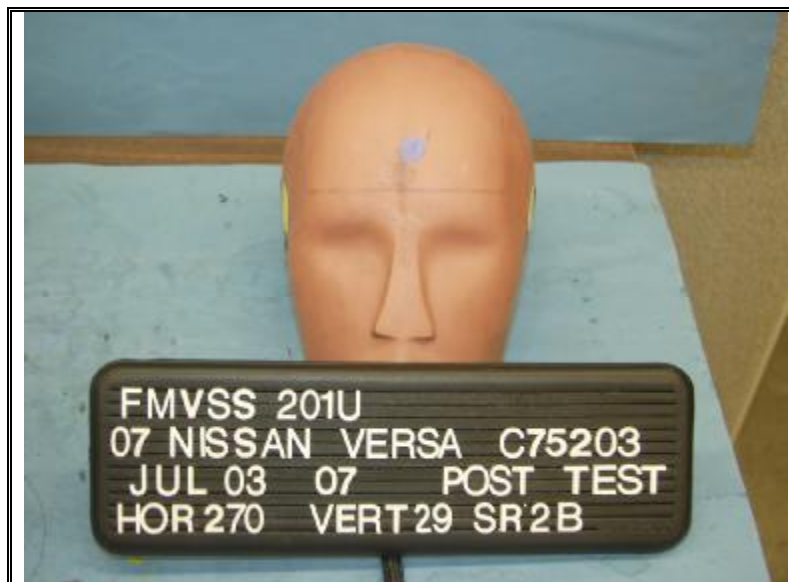
POST-IMPACT SR2BHEADFORM

Free Motion HIC	144.7
HIC(d)	275.6
Impact Velocity (kph)	18.5
HIC T1 (msec)	3.6
HIC T2 (msec)	19.6

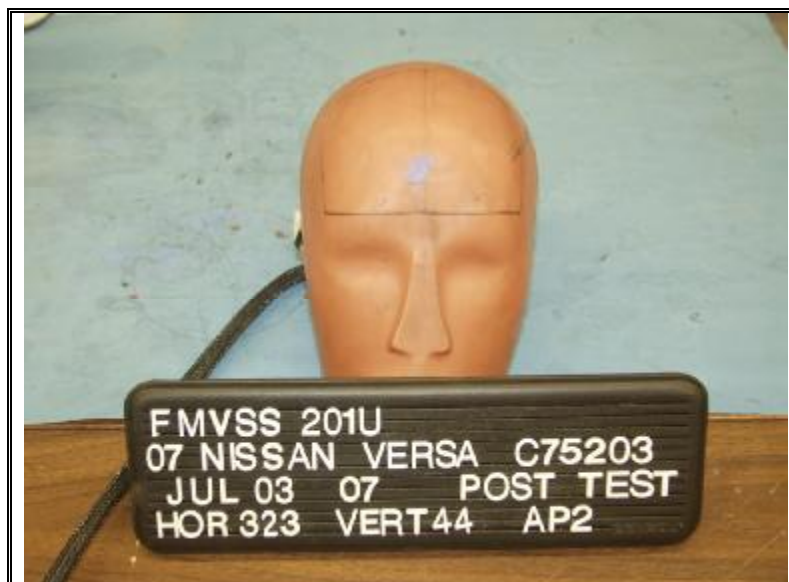
POST-IMPACT AP2 HEADFORM

Free Motion HIC	290.6
HIC(d)	385.7
Impact Velocity (kph)	18.68
HIC T1 (msec)	2.2
HIC T2 (msec)	11.8
