REPORT NUMBER: 201UI-CAL-07-07

**SAFETY COMPLIANCE TESTING FOR FMVSS 201
OCCUPANT PROTECTION IN INTERIOR IMPACT
UPPER INTERIOR HEAD IMPACT PROTECTION**

**General Motors Corporation
2007 Pontiac Torrent**

NHTSA NUMBER: C70108

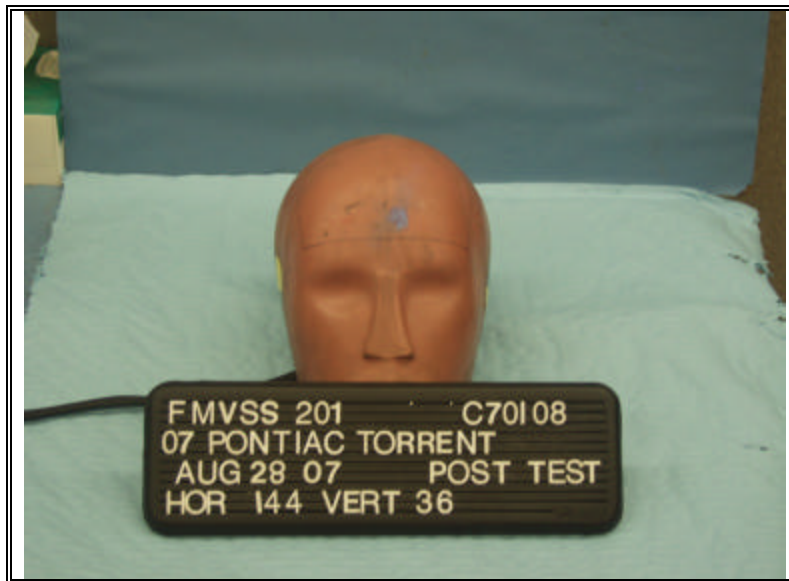
POST-IMPACT AP3 HEADFORM

Test Number:	01
Test Date:	08/28/07
Target Location:	A-PILLAR
Target Code:	AP3
Horizontal Impact Angle:	144°
Vertical Impact Angle:	36°
Ambient Temperature:	22.3 C°
Relative Humidity:	53.2
Time of Impact:	10:45
Headform Number:	0805

Impact Point Description (from lower midpoint on midsagittal line)			
On Centerline	6	mm right	x mm left
On Centerline	15	mm up

Free Motion HIC	596.6
HIC(d)	616.5
Impact Velocity (kph)	23.35
HIC T1 (msec)	1.5
HIC T2 (msec)	11.5

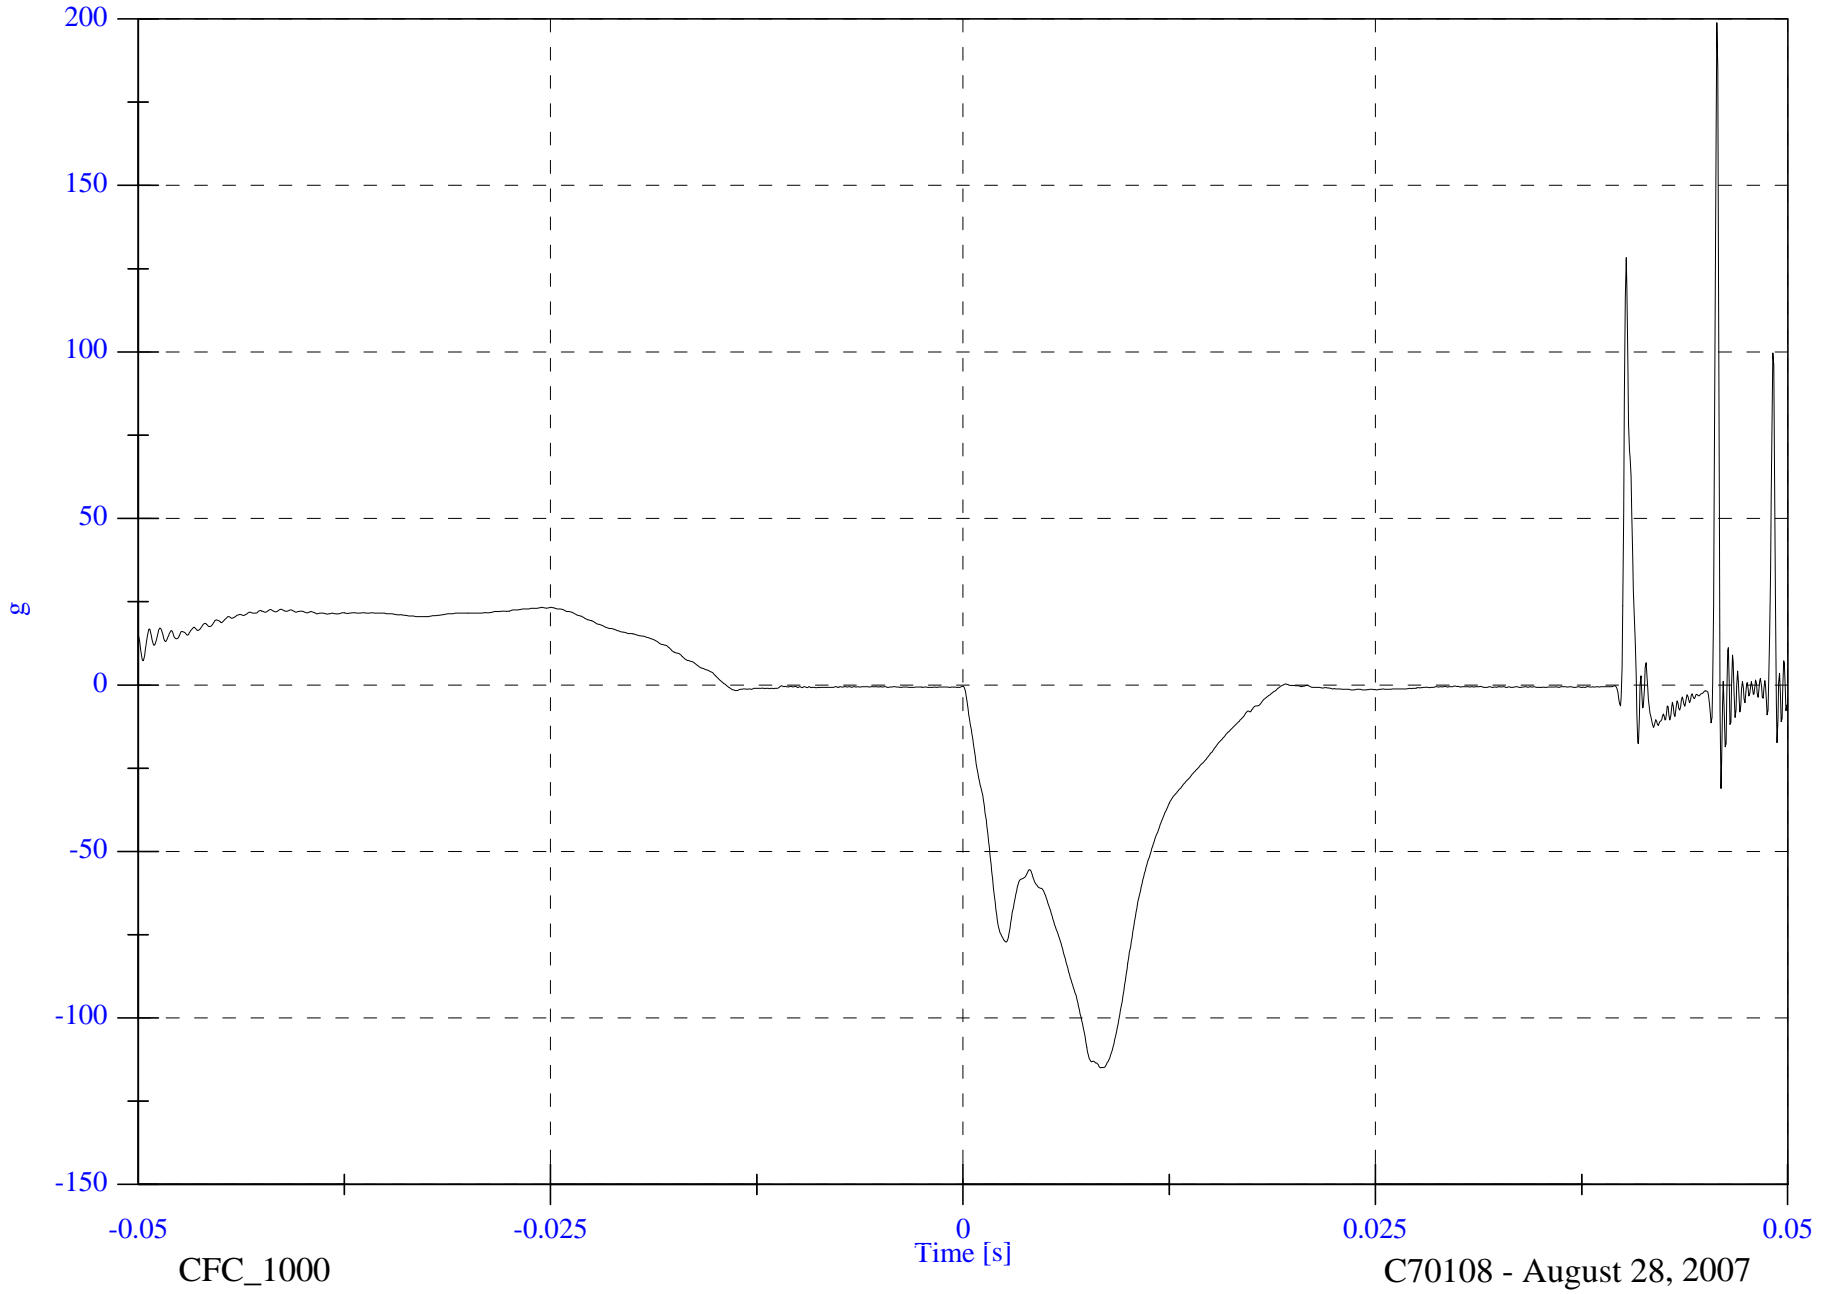
C70108 PASSENGER SIDE AP3 IMPACT PLOT #1

Headform X Acceleration

Max: 198.8 [g] at 0.046 [s]

Min: -115.0 [g] at 0.008 [s]

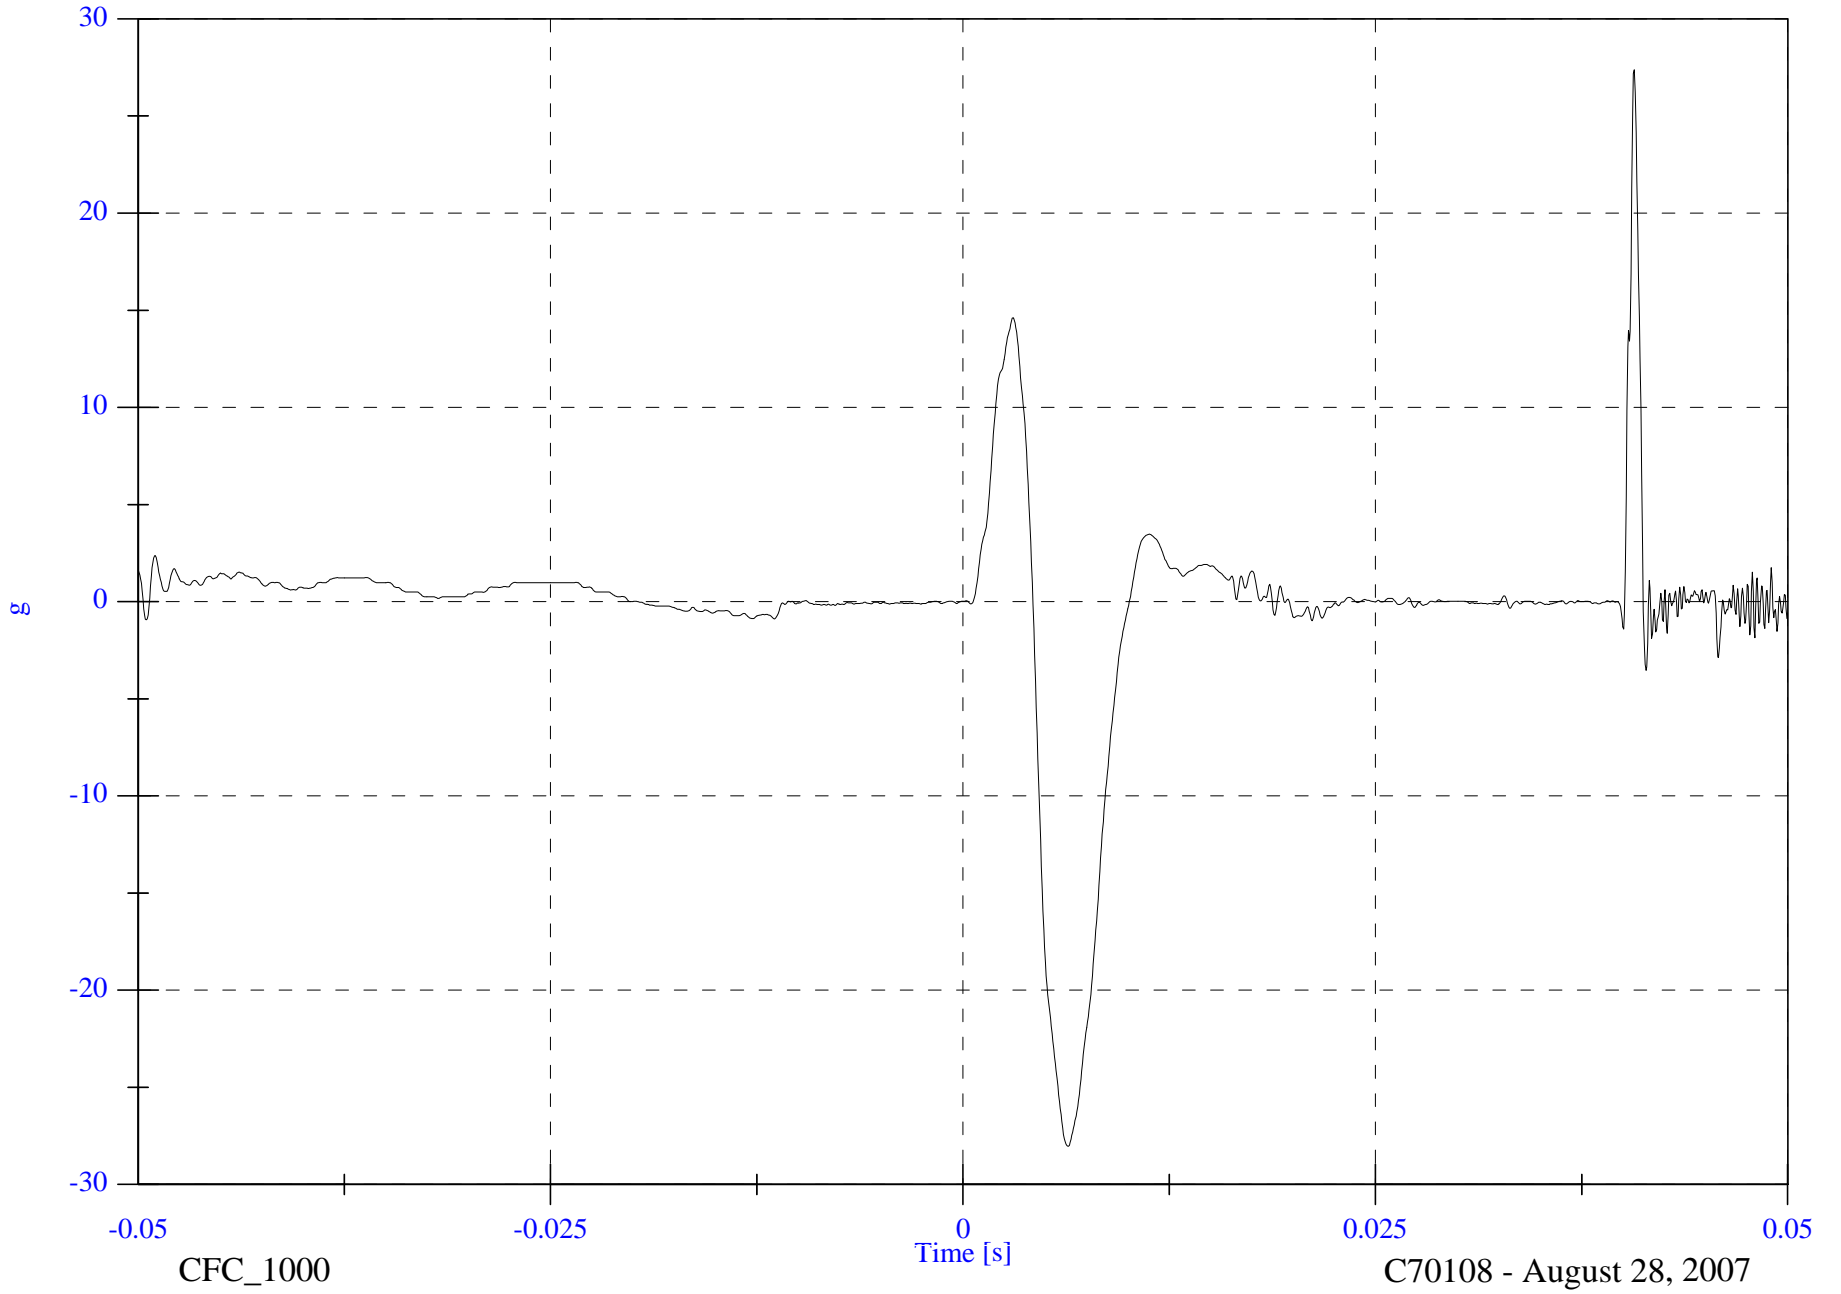
C70108 PASSENGER SIDE AP3 IMPACT PLOT #2

Headform Y Acceleration

Max: 27.4 [g] at 0.041 [s]

Min: -28.0 [g] at 0.006 [s]

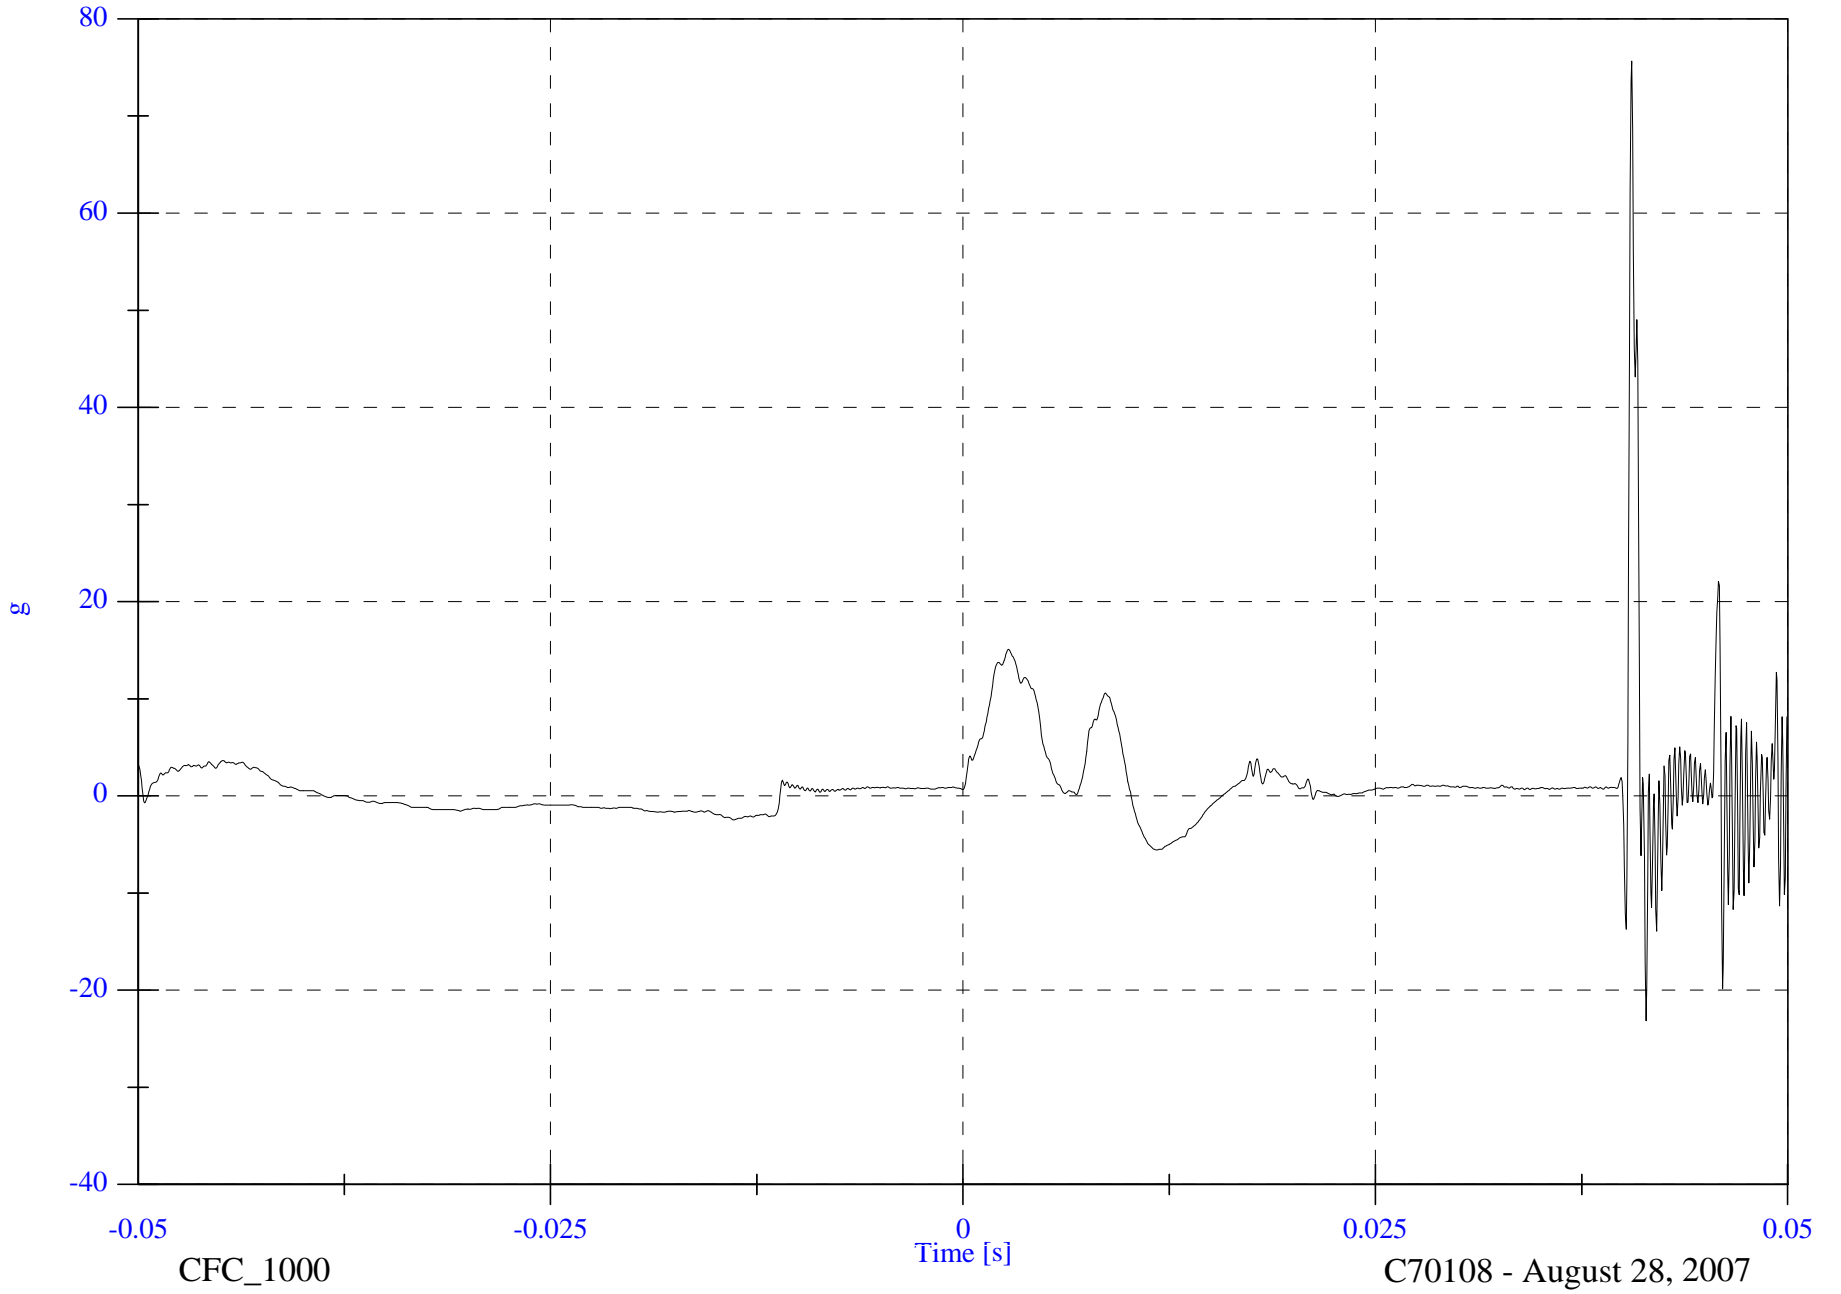
C70108 PASSENGER SIDE AP3 IMPACT PLOT #3

Headform Z Acceleration

Max: 75.7 [g] at 0.041 [s]

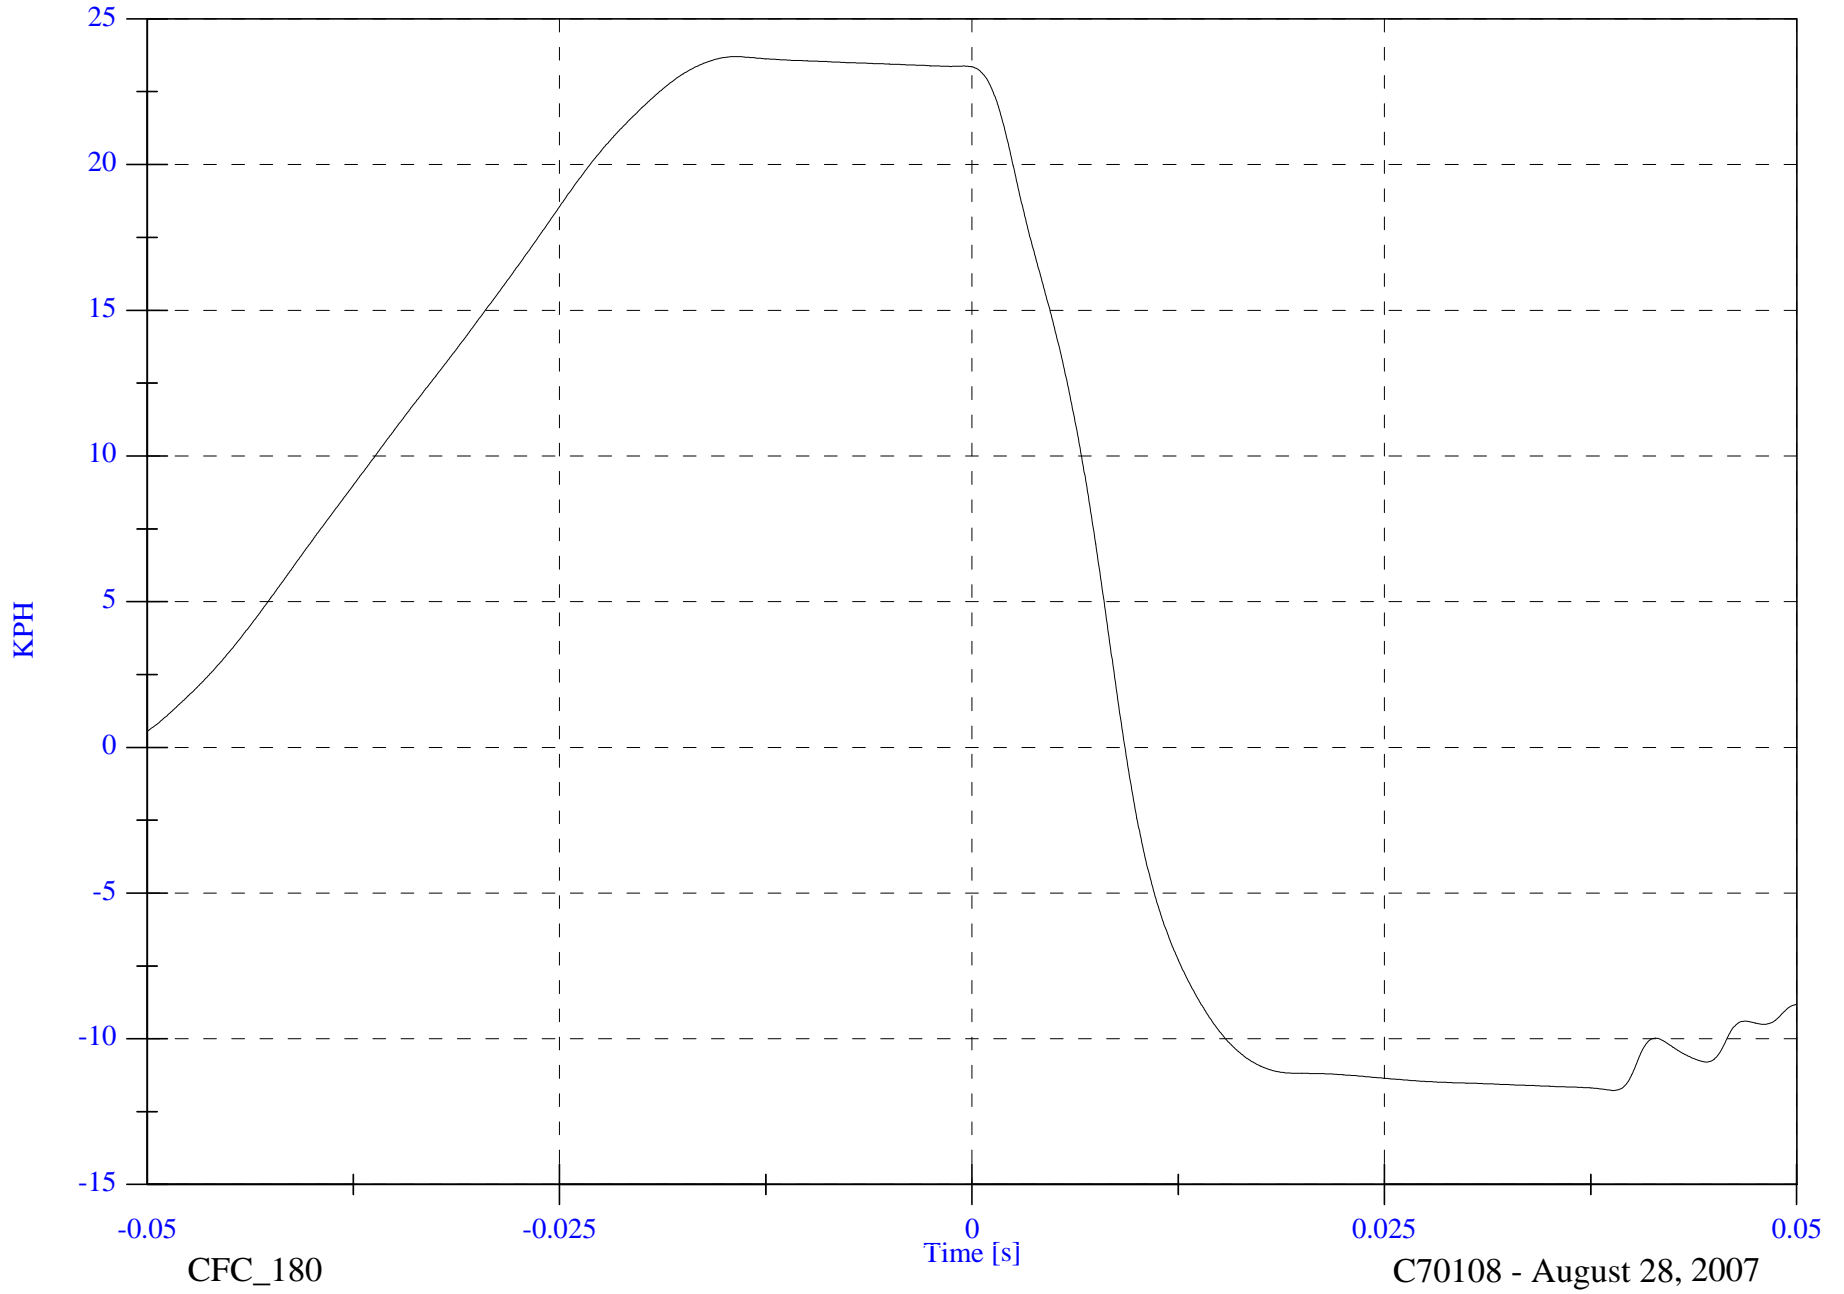
C70108 PASSENGER SIDE AP3 IMPACT PLOT #5

Max: 23.7 [KPH] at -0.014 [s]

Min: -11.8 [KPH] at 0.039 [s]

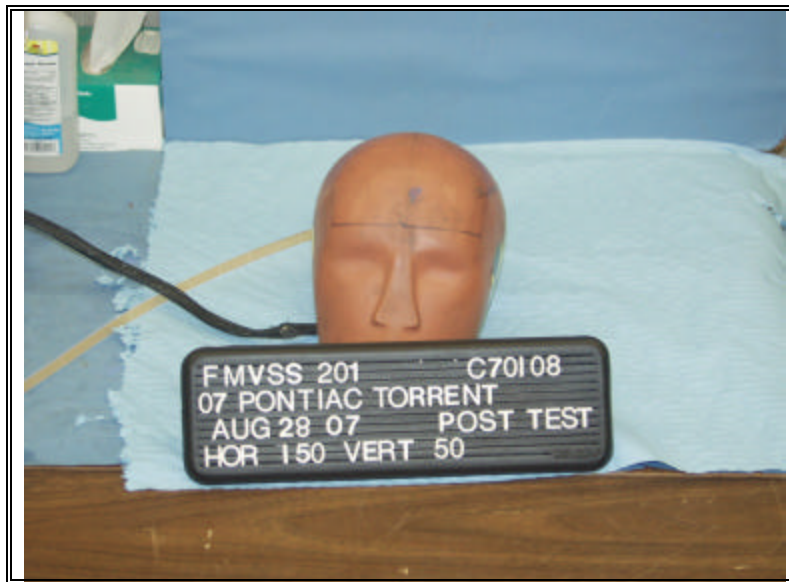
POST-IMPACT AP1 PASS HEADFORM

* Passenger side AP1 target location – X accelerometer was damaged during the free-flight resulting in no velocity, FMH HIC, or HIC(d)

Test Number:	02
Test Date:	08/28/07
Target Location:	A-PILLAR
Target Code:	AP1 PASS
Horizontal Impact Angle:	150°
Vertical Impact Angle:	50°
Ambient Temperature:	21.1 C°
Relative Humidity:	47.4
Time of Impact:	11:15
Headform Number:	0062

Free Motion HIC	*
HIC(d)	*
Impact Velocity (kph)	*
HIC T1 (msec)	*
HIC T2 (msec)	*

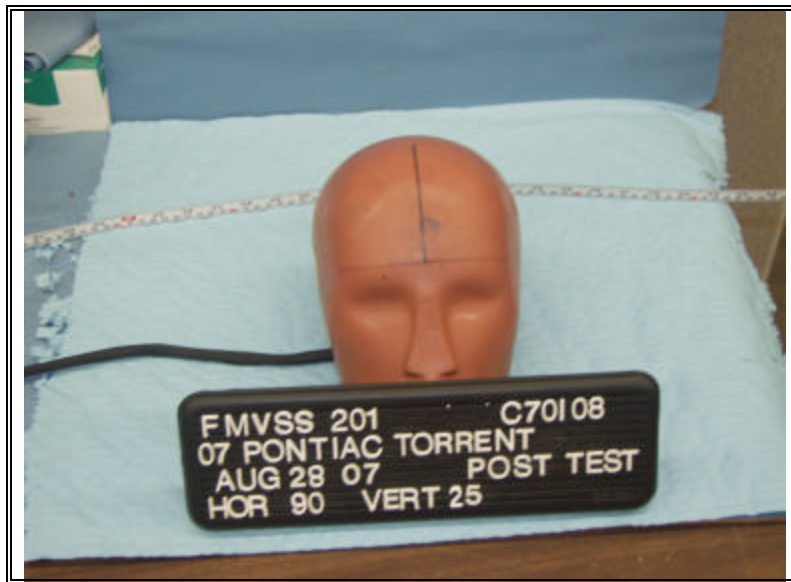
POST-IMPACT SR2B HEADFORM

Test Number:	03
Test Date:	08/28/07
Target Location:	SIDE RAIL
Target Code:	SR2B
Horizontal Impact Angle:	90°
Vertical Impact Angle:	25°
Ambient Temperature:	20.6 C°
Relative Humidity:	47.1
Time of Impact:	12:45
Headform Number:	0355

Impact Point Description (from lower midpoint on midsagittal line)			
On Centerline	2	mm right	x mm left
On Centerline	22		mm up

Free Motion HIC	363.3
HIC(d)	440.5
Impact Velocity (kph)	23.61
HIC T1 (msec)	14.5
HIC T2 (msec)	19.0

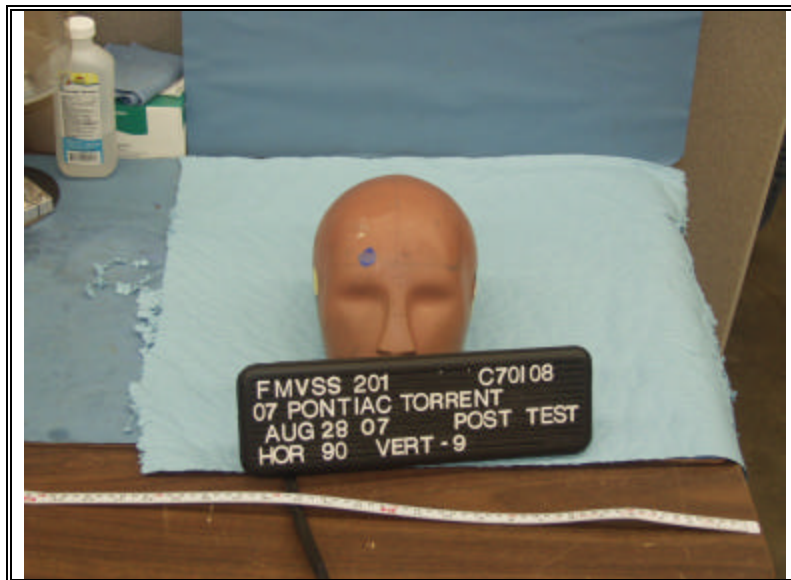
POST-IMPACT BP3 HEADFORM

Test Number:	04
Test Date:	08/28/07
Target Location:	B-PILLAR
Target Code:	BP3
Horizontal Impact Angle:	90°
Vertical Impact Angle:	-9°
Ambient Temperature:	20.6 C°
Relative Humidity:	47.6
Time of Impact:	13:15
Headform Number:	0642

Impact Point Description (from lower midpoint on midsagittal line)			
On Centerline	5	<input checked="" type="checkbox"/> mm right	<input type="checkbox"/> mm left
On Centerline	25	mm up

Free Motion HIC	730.6
HIC(d)	717.6
Impact Velocity (kph)	23.82
HIC T1 (msec)	4.6
HIC T2 (msec)	9.8

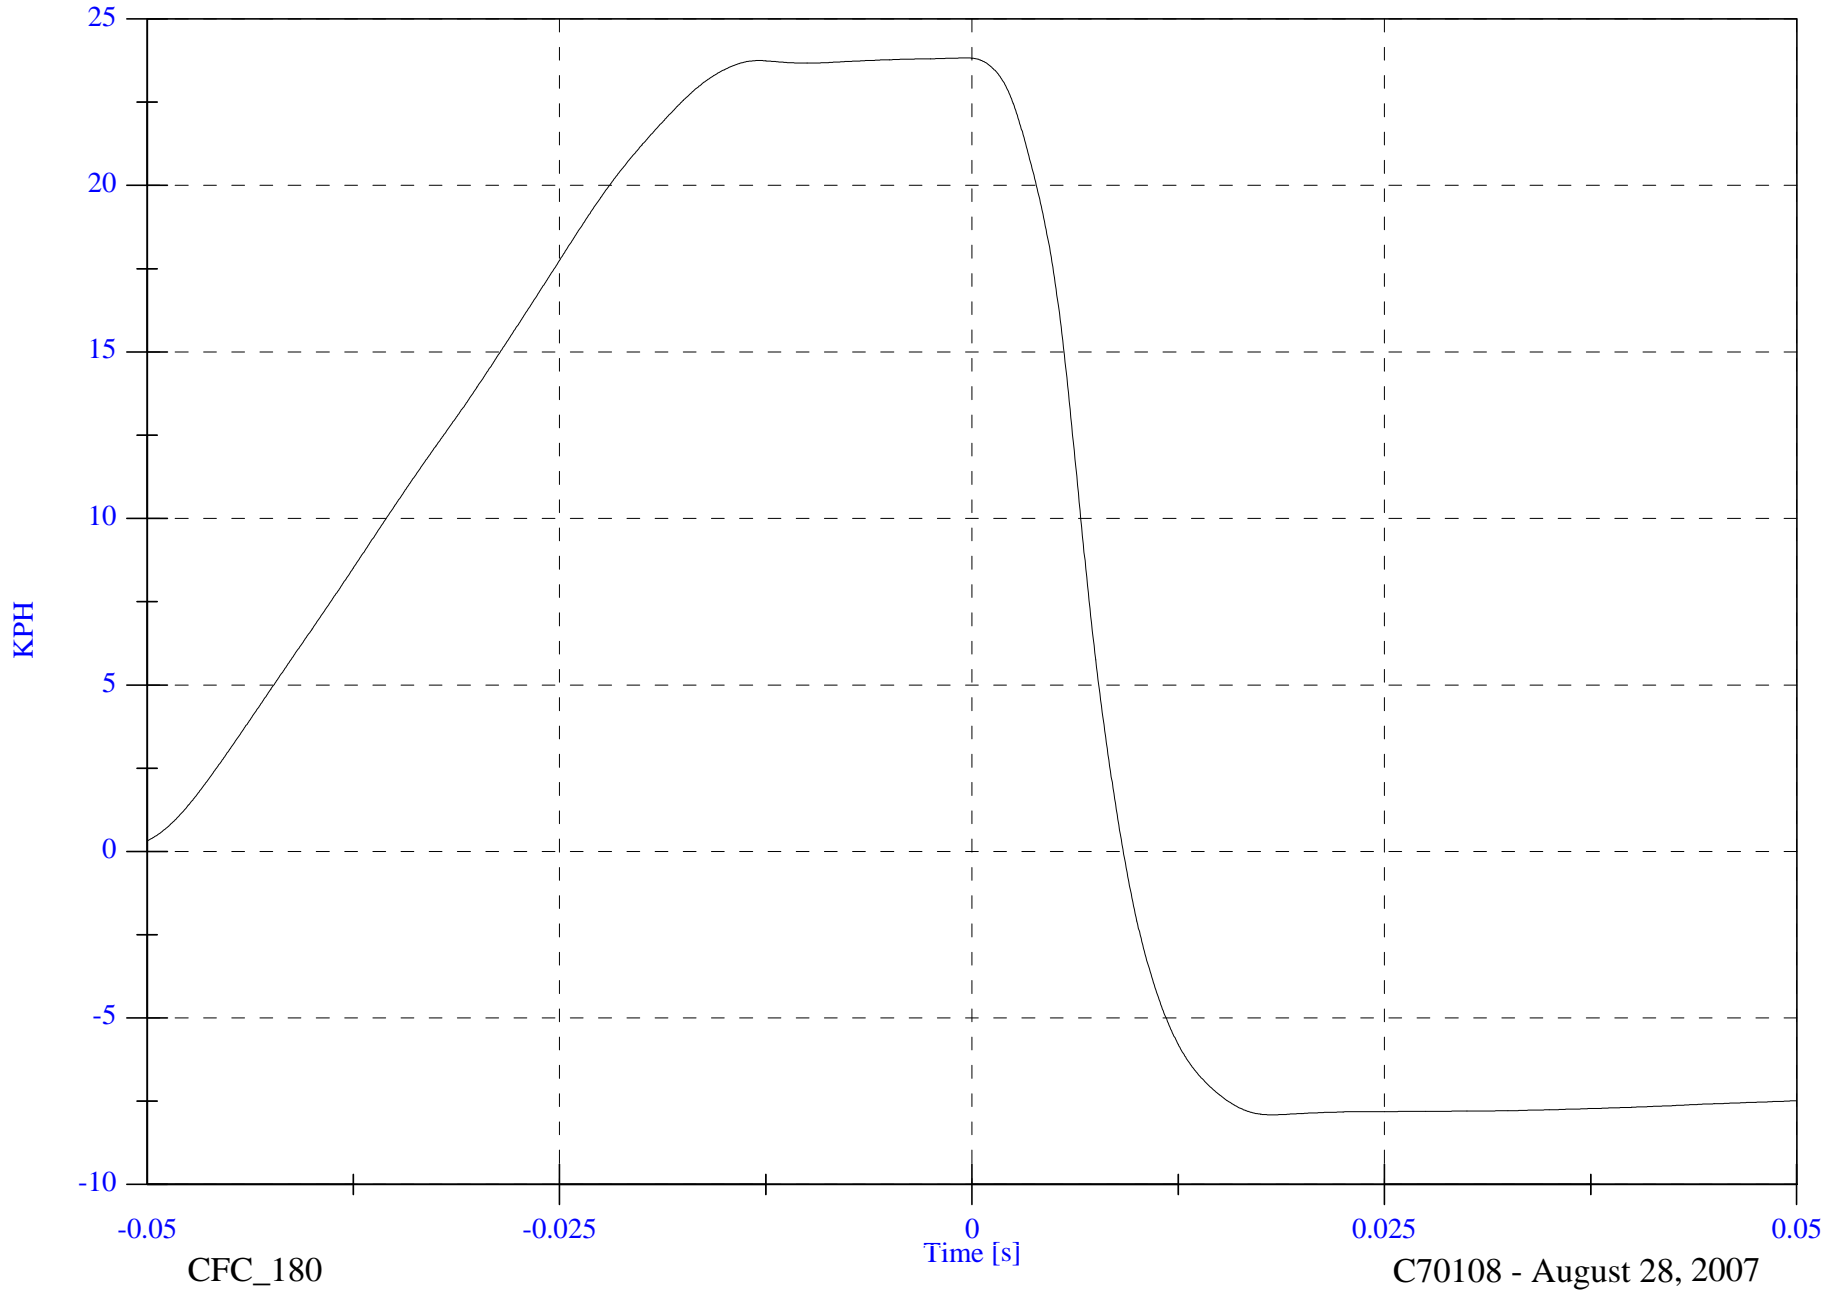
C70108 PASSENGER SIDE BP3 IMPACT PLOT #5

Min: -7.9 [KPH] at 0.018 [s]

Headform Velocity

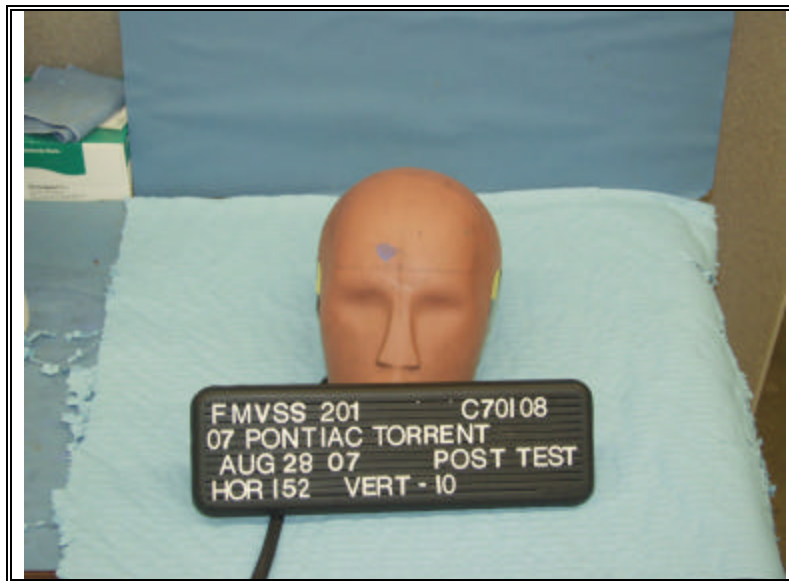
POST-IMPACT BP4 HEADFORM

Test Number:	05
Test Date:	08/28/07
Target Location:	B-PILLAR
Target Code:	BP4
Horizontal Impact Angle:	152°
Vertical Impact Angle:	-10°
Ambient Temperature:	20.7 C°
Relative Humidity:	49
Time of Impact:	14:00
Headform Number:	1255

Impact Point Description (from lower midpoint on midsagittal line)					
On Centerline	13	x	mm right		mm left
On Centerline	13				mm up

Free Motion HIC	589.9
HIC(d)	611.4
Impact Velocity (kph)	23.53
HIC T1 (msec)	2.2
HIC T2 (msec)	10.4

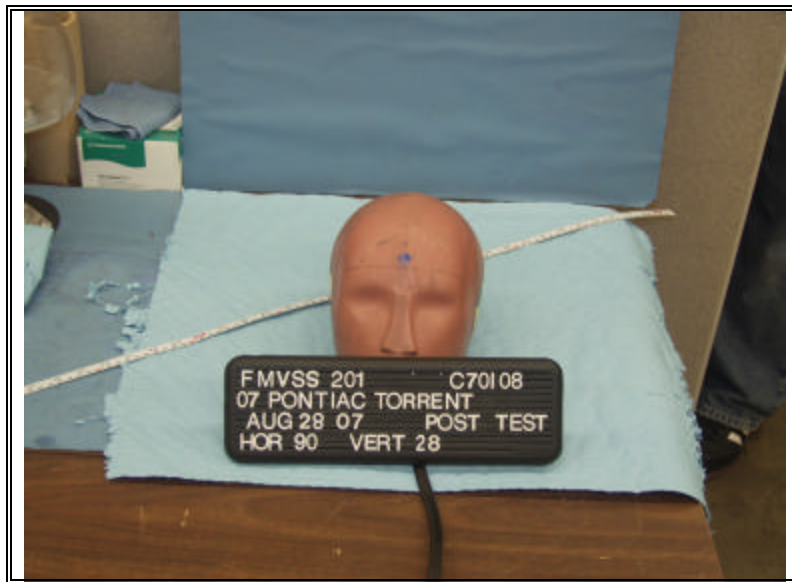
POST-IMPACT BP1 HEADFORM

Test Number:	06
Test Date:	08/28/07
Target Location:	B-PILLAR
Target Code:	BP1
Horizontal Impact Angle:	90°
Vertical Impact Angle:	28°
Ambient Temperature:	20.7 C°
Relative Humidity:	50.1
Time of Impact:	14:30
Headform Number:	0805

Impact Point Description (from lower midpoint on midsagittal line)			
On Centerline	0	<input type="checkbox"/>	mm right <input type="checkbox"/> mm left
On Centerline	8		mm up

Free Motion HIC	580.9
HIC(d)	604.7
Impact Velocity (kph)	23.67
HIC T1 (msec)	6.2
HIC T2 (msec)	13.8

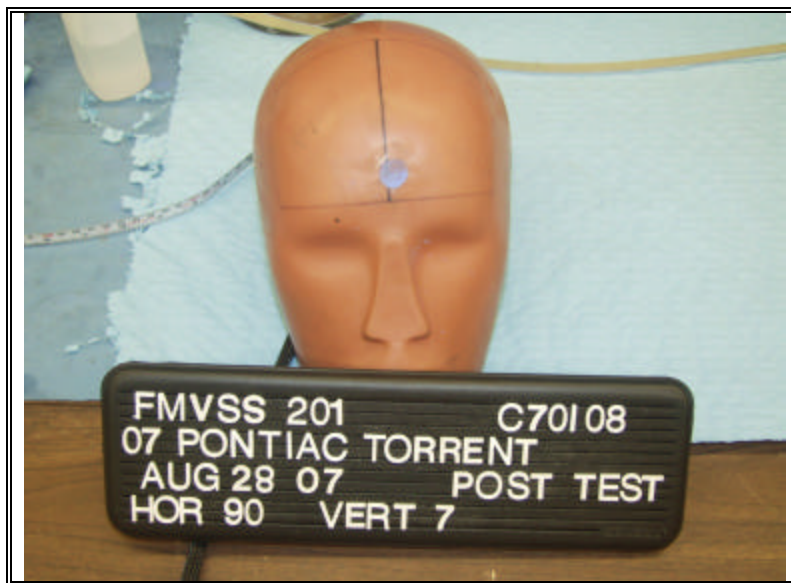
POST-IMPACT OP1 HEADFORM

Test Number:	07
Test Date:	08/28/07
Target Location:	OTHER PILLAR
Target Code:	OP1
Horizontal Impact Angle:	90°
Vertical Impact Angle:	7°
Ambient Temperature:	20.6 C°
Relative Humidity:	50.9
Time of Impact:	15:50
Headform Number:	0355

Impact Point Description (from lower midpoint on midsagittal line)			
On Centerline	3	mm right	x mm left
On Centerline	14	mm up

Free Motion HIC	478.6
HIC(d)	527.5
Impact Velocity (kph)	23.66
HIC T1 (msec)	1.0
HIC T2 (msec)	11.0

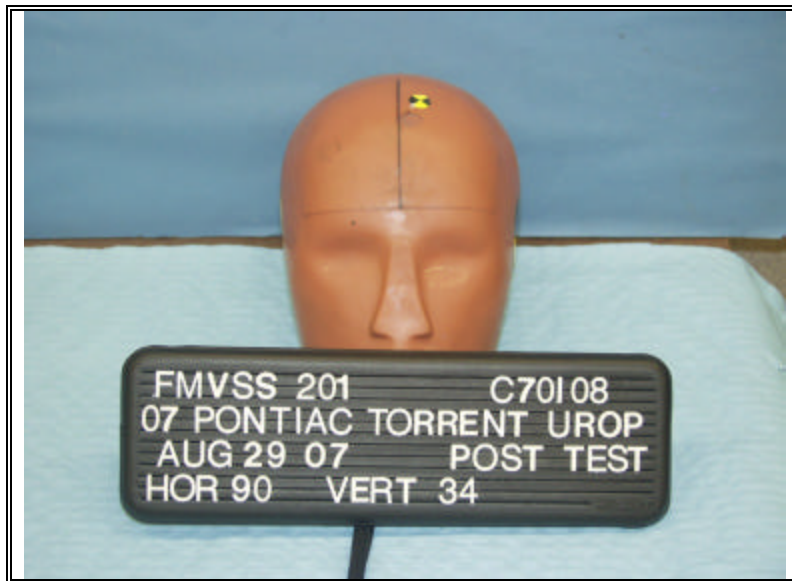
POST-IMPACT UROP HEADFORM

Test Number:	08
Test Date:	08/29/07
Target Location:	UPPER ROOF
Target Code:	UROP
Horizontal Impact Angle:	90°
Vertical Impact Angle:	34°
Ambient Temperature:	20.8 C°
Relative Humidity:	45
Time of Impact:	8:45
Headform Number:	0355

Impact Point Description (from lower midpoint on midsagittal line)			
On Centerline	7	mm right	x mm left
On Centerline	53		mm up

Free Motion HIC	188.3
HIC(d)	308.5
Impact Velocity (kph)	23.55
HIC T1 (msec)	4.2
HIC T2 (msec)	28.4

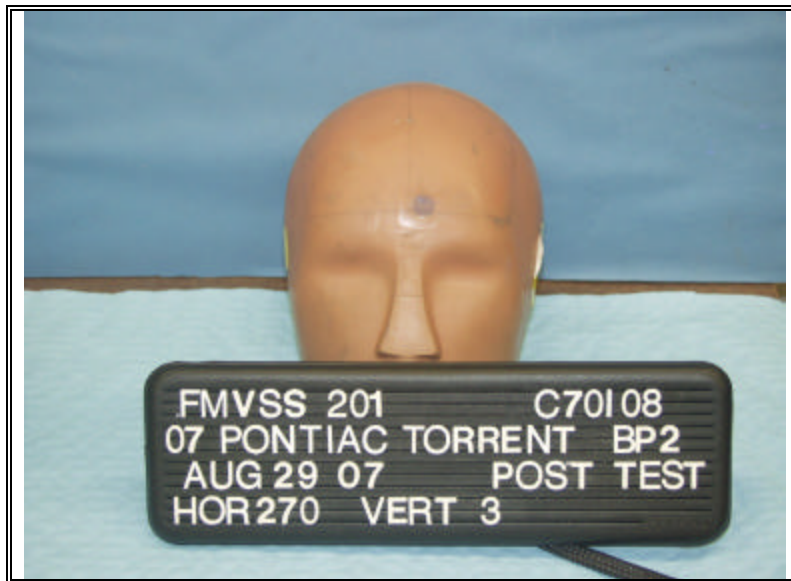
POST-IMPACT BP2 HEADFORM

Test Number:	09
Test Date:	08/29/07
Target Location:	B-PILLAR
Target Code:	BP2
Horizontal Impact Angle:	270°
Vertical Impact Angle:	3°
Ambient Temperature:	21.8 C°
Relative Humidity:	59.2
Time of Impact:	10:00
Headform Number:	0642

Impact Point Description (from lower midpoint on midsagittal line)			
On Centerline	6	mm right	x mm left
On Centerline	4	mm up

Free Motion HIC	762.4
HIC(d)	789.9
Impact Velocity (kph)	23.58
HIC T1 (msec)	1.9
HIC T2 (msec)	7.7

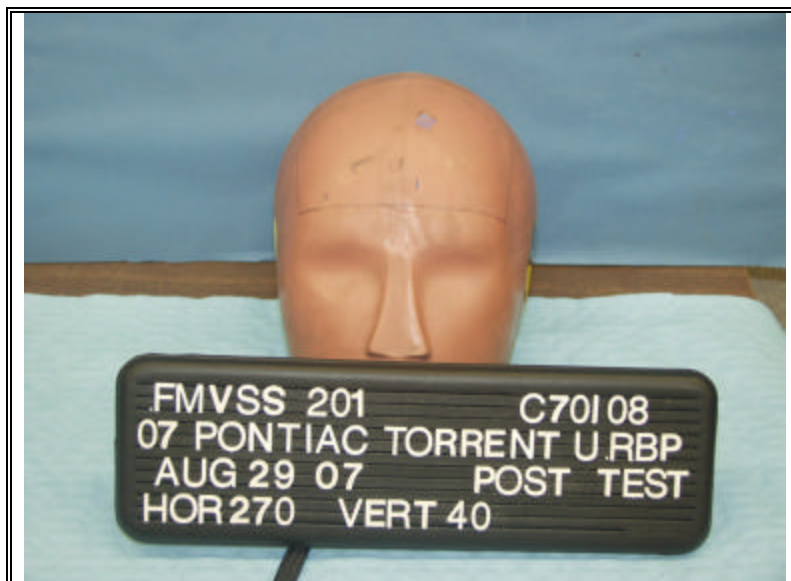
POST-IMPACT URBP HEADFORM

Test Number:	10
Test Date:	08/29/07
Target Location:	UPPER ROOF
Target Code:	URBP
Horizontal Impact Angle:	270°
Vertical Impact Angle:	40°
Ambient Temperature:	21.3 C°
Relative Humidity:	56.7
Time of Impact:	10:25
Headform Number:	0805

Impact Point Description (from lower midpoint on midsagittal line)			
On Centerline	9	mm right	x mm left
On Centerline	49	mm up

Free Motion HIC	272.8
HIC(d)	372.2
Impact Velocity (kph)	23.5
HIC T1 (msec)	4.3
HIC T2 (msec)	16.1

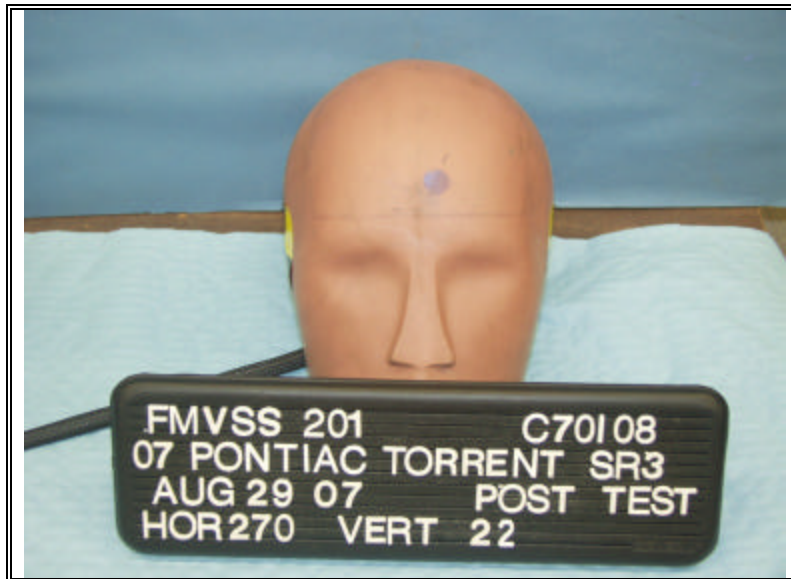
POST-IMPACT SR3HEADFORM

Test Number:	11
Test Date:	08/29/07
Target Location:	SIDE RAIL
Target Code:	SR3
Horizontal Impact Angle:	270°
Vertical Impact Angle:	22°
Ambient Temperature:	21.3 C°
Relative Humidity:	56.3
Time of Impact:	10:55
Headform Number:	1255

Impact Point Description (from lower midpoint on midsagittal line)			
On Centerline	8	mm right	x mm left
On Centerline	16	mm up

Free Motion HIC	425.9
HIC(d)	487.7
Impact Velocity (kph)	23.71
HIC T1 (msec)	16.0
HIC T2 (msec)	19.5

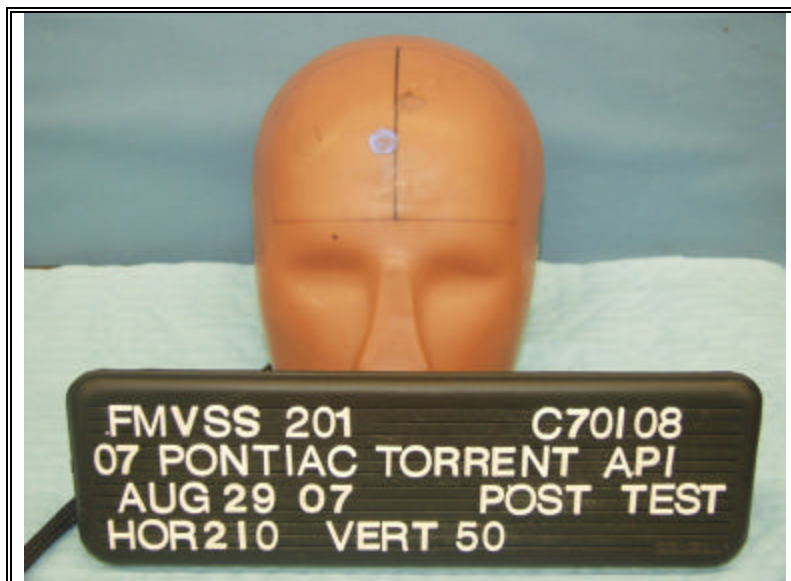
POST-IMPACT API DRIV HEADFORM

The selected impact areas on the test vehicle appeared to comply with the performance requirements of FMVSS 201 with the exception of the Driver Side AP1 location.

Test Number:	12
Test Date:	08/29/07
Target Location:	A-PILLAR
Target Code:	API DRIV
Horizontal Impact Angle:	210°
Vertical Impact Angle:	50°
Ambient Temperature:	22.6 C°
Relative Humidity:	57.8
Time of Impact:	13:49
Headform Number:	0355

Impact Point Description (from lower midpoint on midsagittal line)			
On Centerline	4	<input checked="" type="checkbox"/> mm right	<input type="checkbox"/> mm left
On Centerline	34	mm up

Free Motion HIC	1179.2
HIC(d)	1056.2
Impact Velocity (kph)	23.42
HIC T1 (msec)	3.1
HIC T2 (msec)	7.4

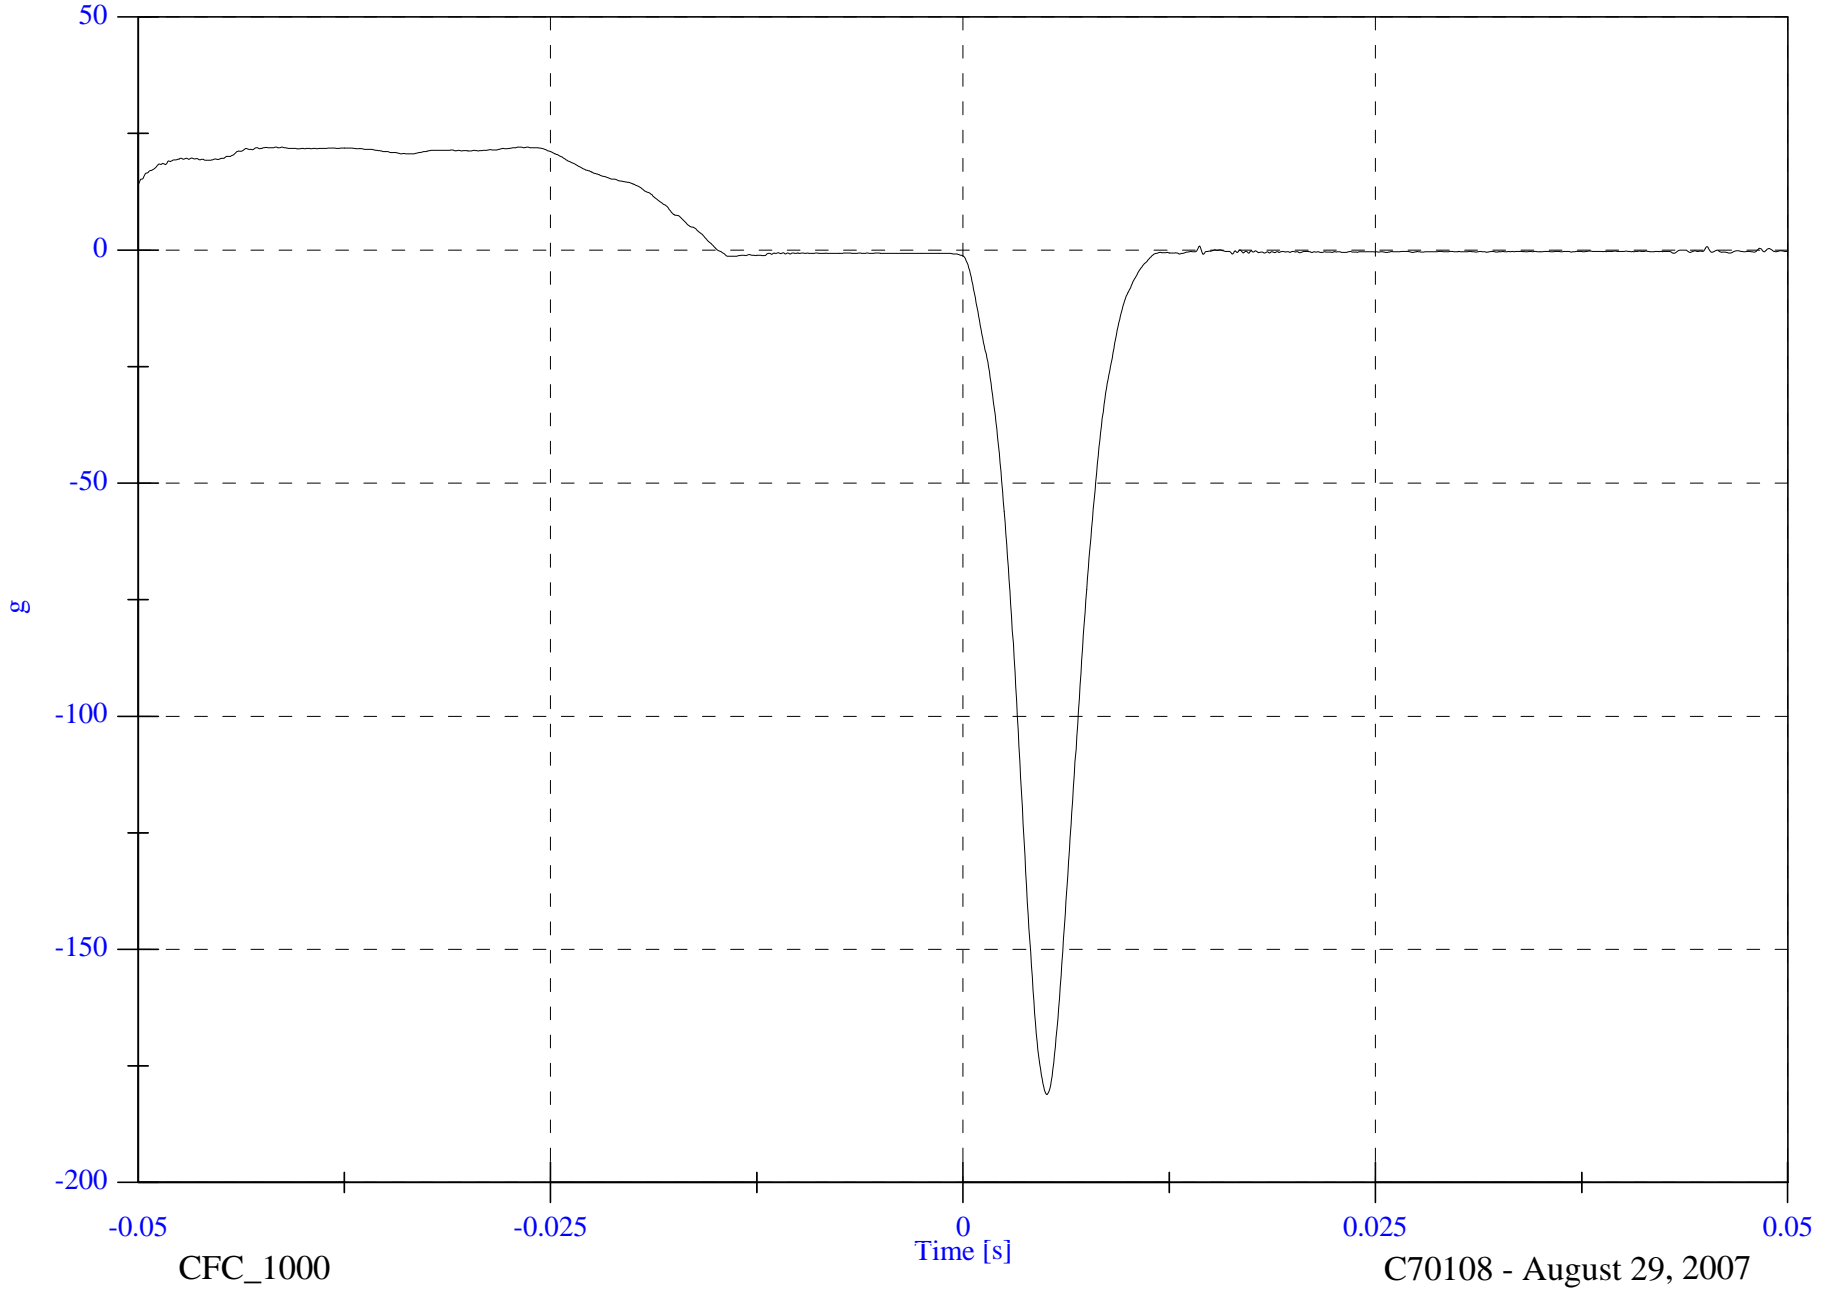
C70108 DRIVER SIDE AP1 IMPACT PLOT #1

Min: -181.1 [g] at 0.005 [s]
