REPORT NUMBER: 201UI-CAL-07-07

**SAFETY COMPLIANCE TESTING FOR FMVSS 201
OCCUPANT PROTECTION IN INTERIOR IMPACT
UPPER INTERIOR HEAD IMPACT PROTECTION**

**General Motors Corporation
2007 Pontiac Torrent**

NHTSA NUMBER: C70108

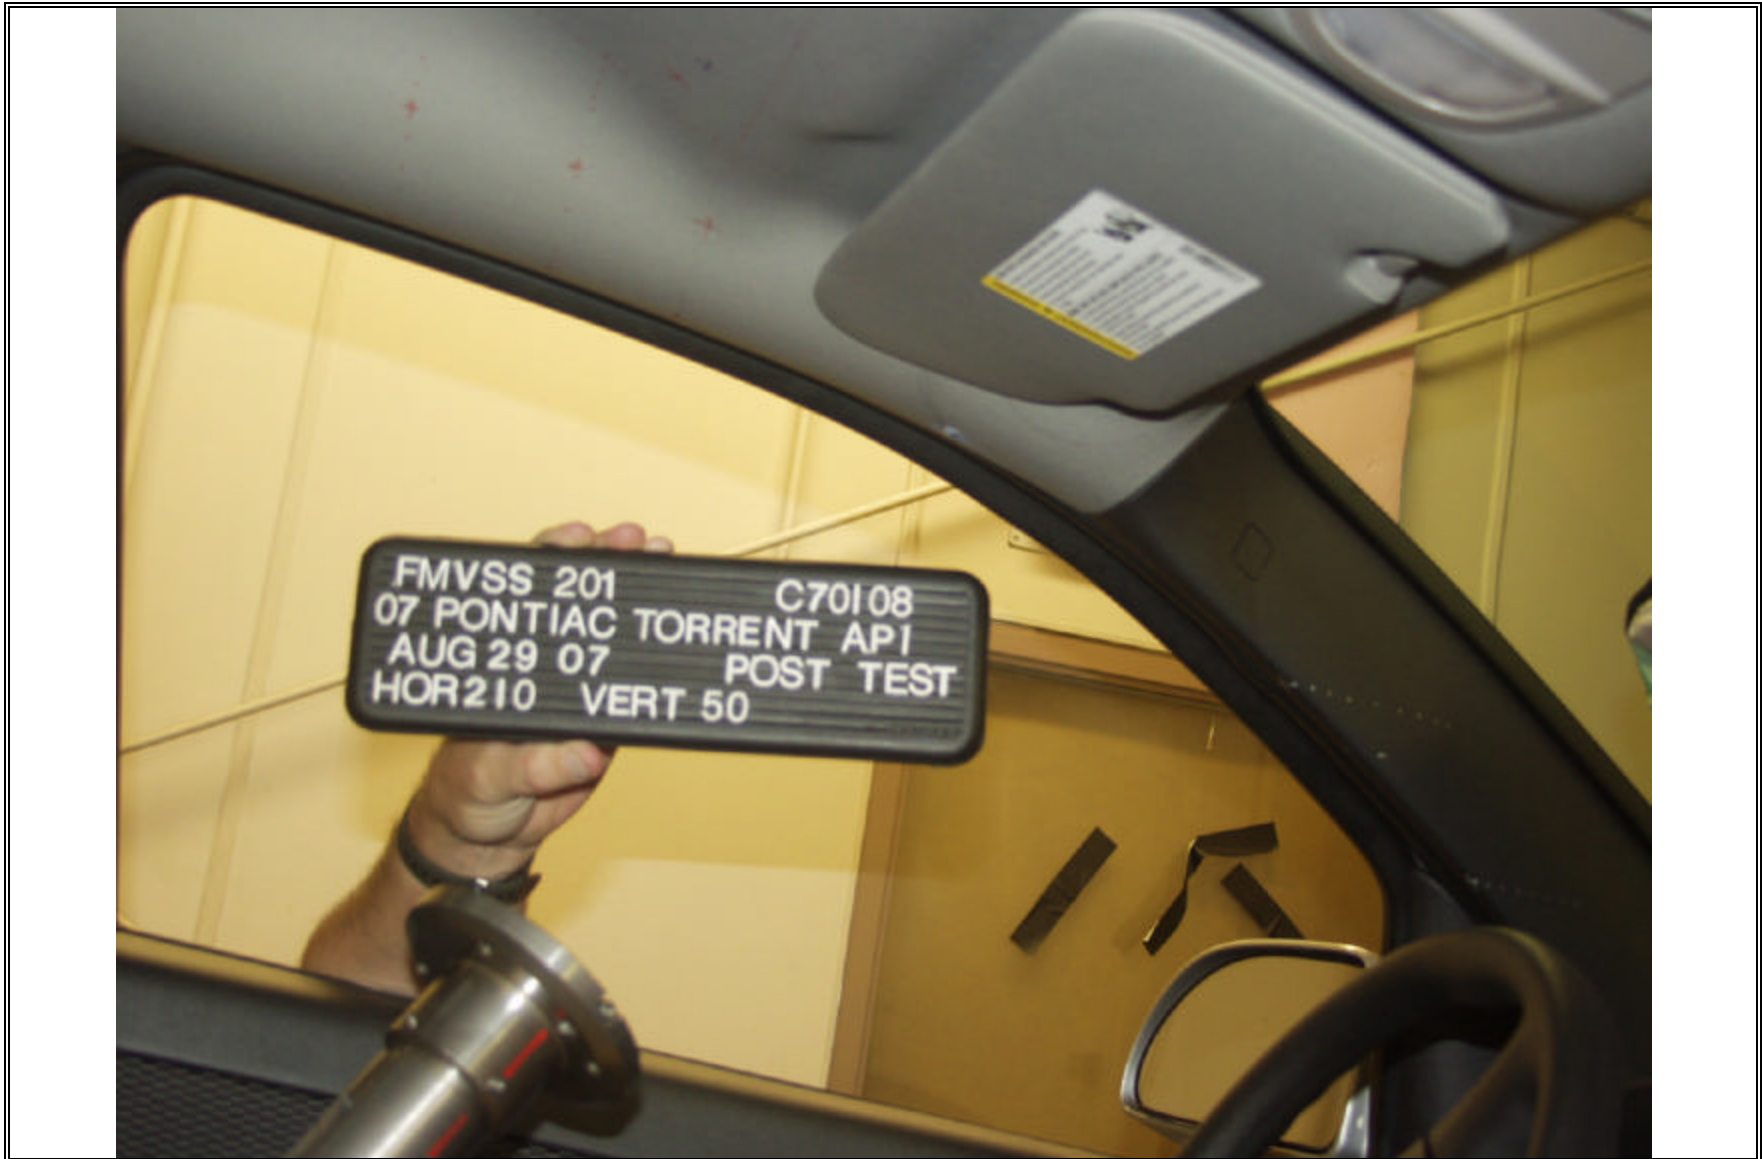
POST-IMPACT AP1 DRIV

Test Number:	12
Test Date:	08/29/07
Target Location:	A-PILLAR
Target Code:	API DRIV
Horizontal Impact Angle:	210°
Vertical Impact Angle:	50°
Ambient Temperature:	22.6 C°
Relative Humidity:	57.8
Time of Impact:	13:49
Headform Number:	0355

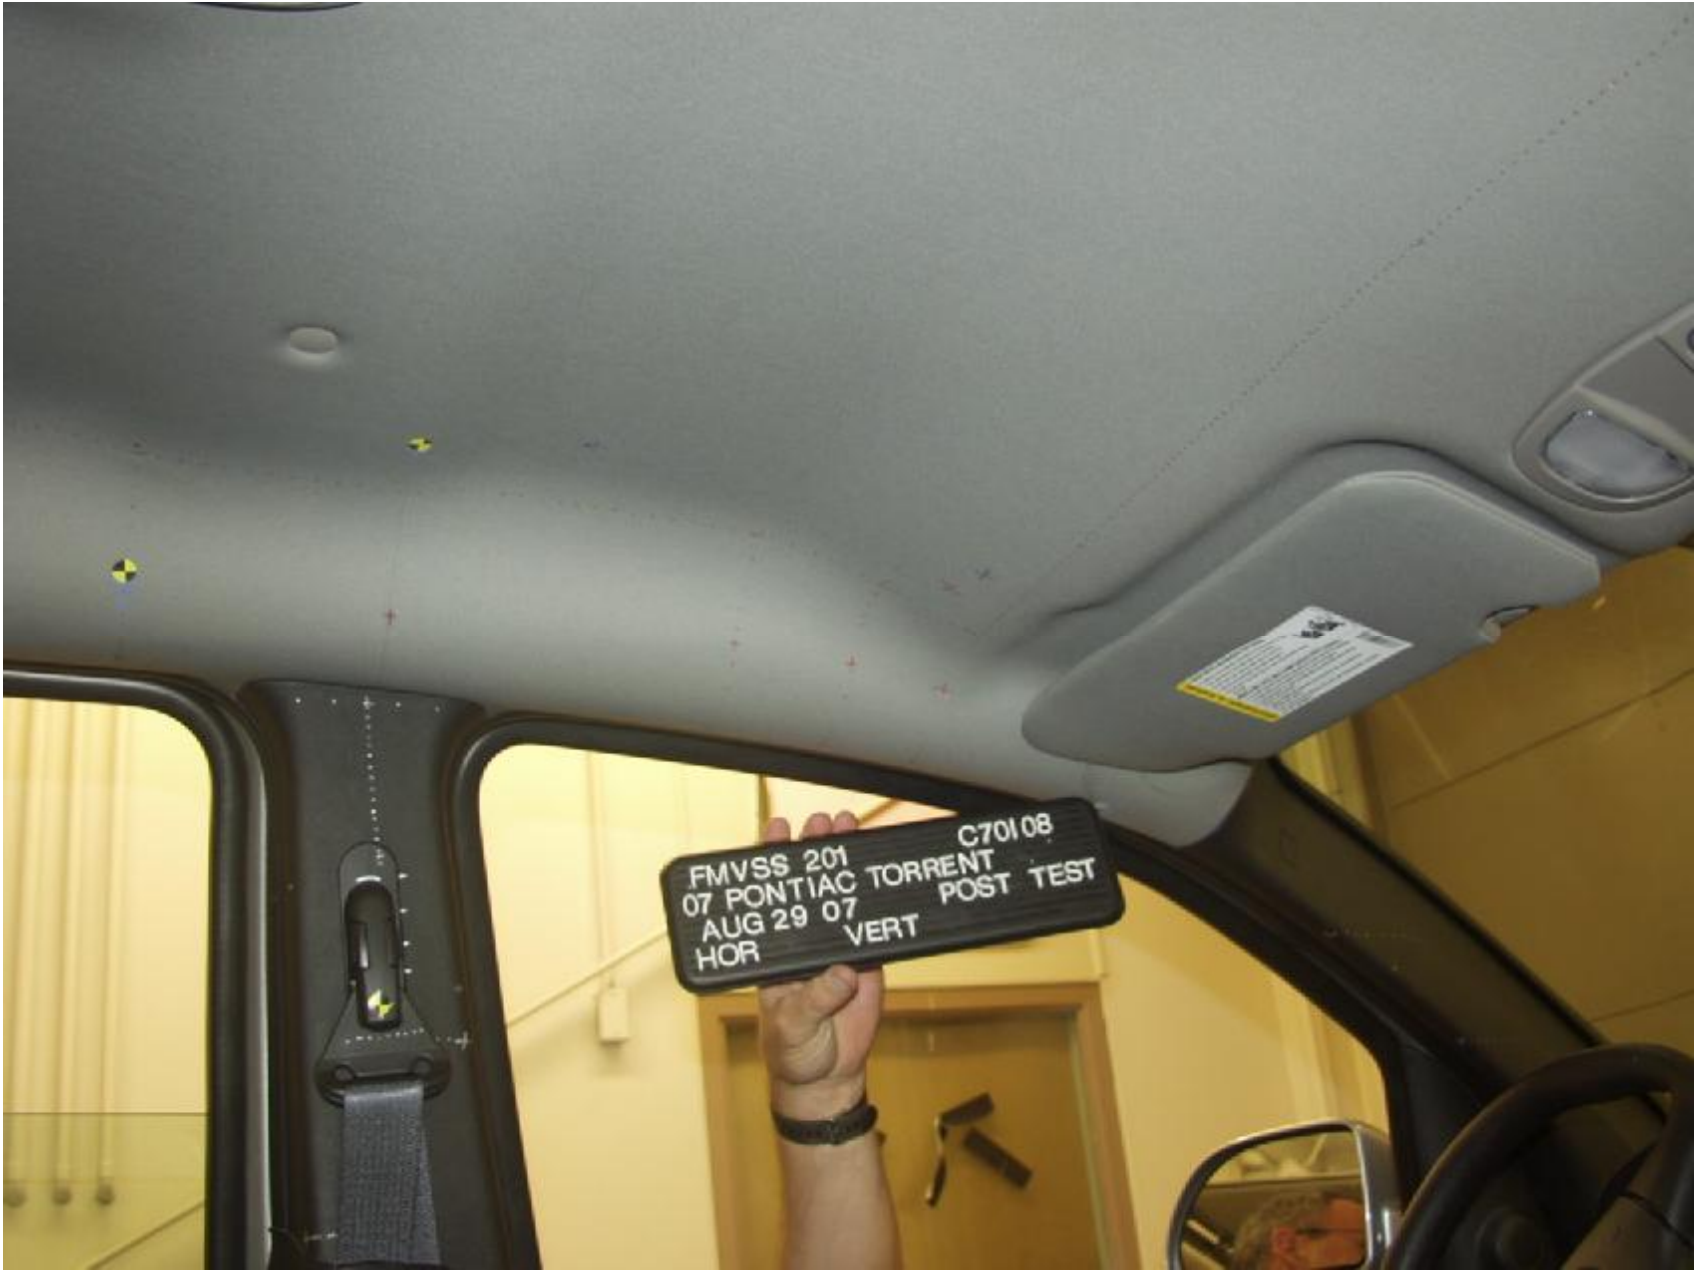
Figure A-21 : POST-TEST DRIVER SIDE SIDE RAIL

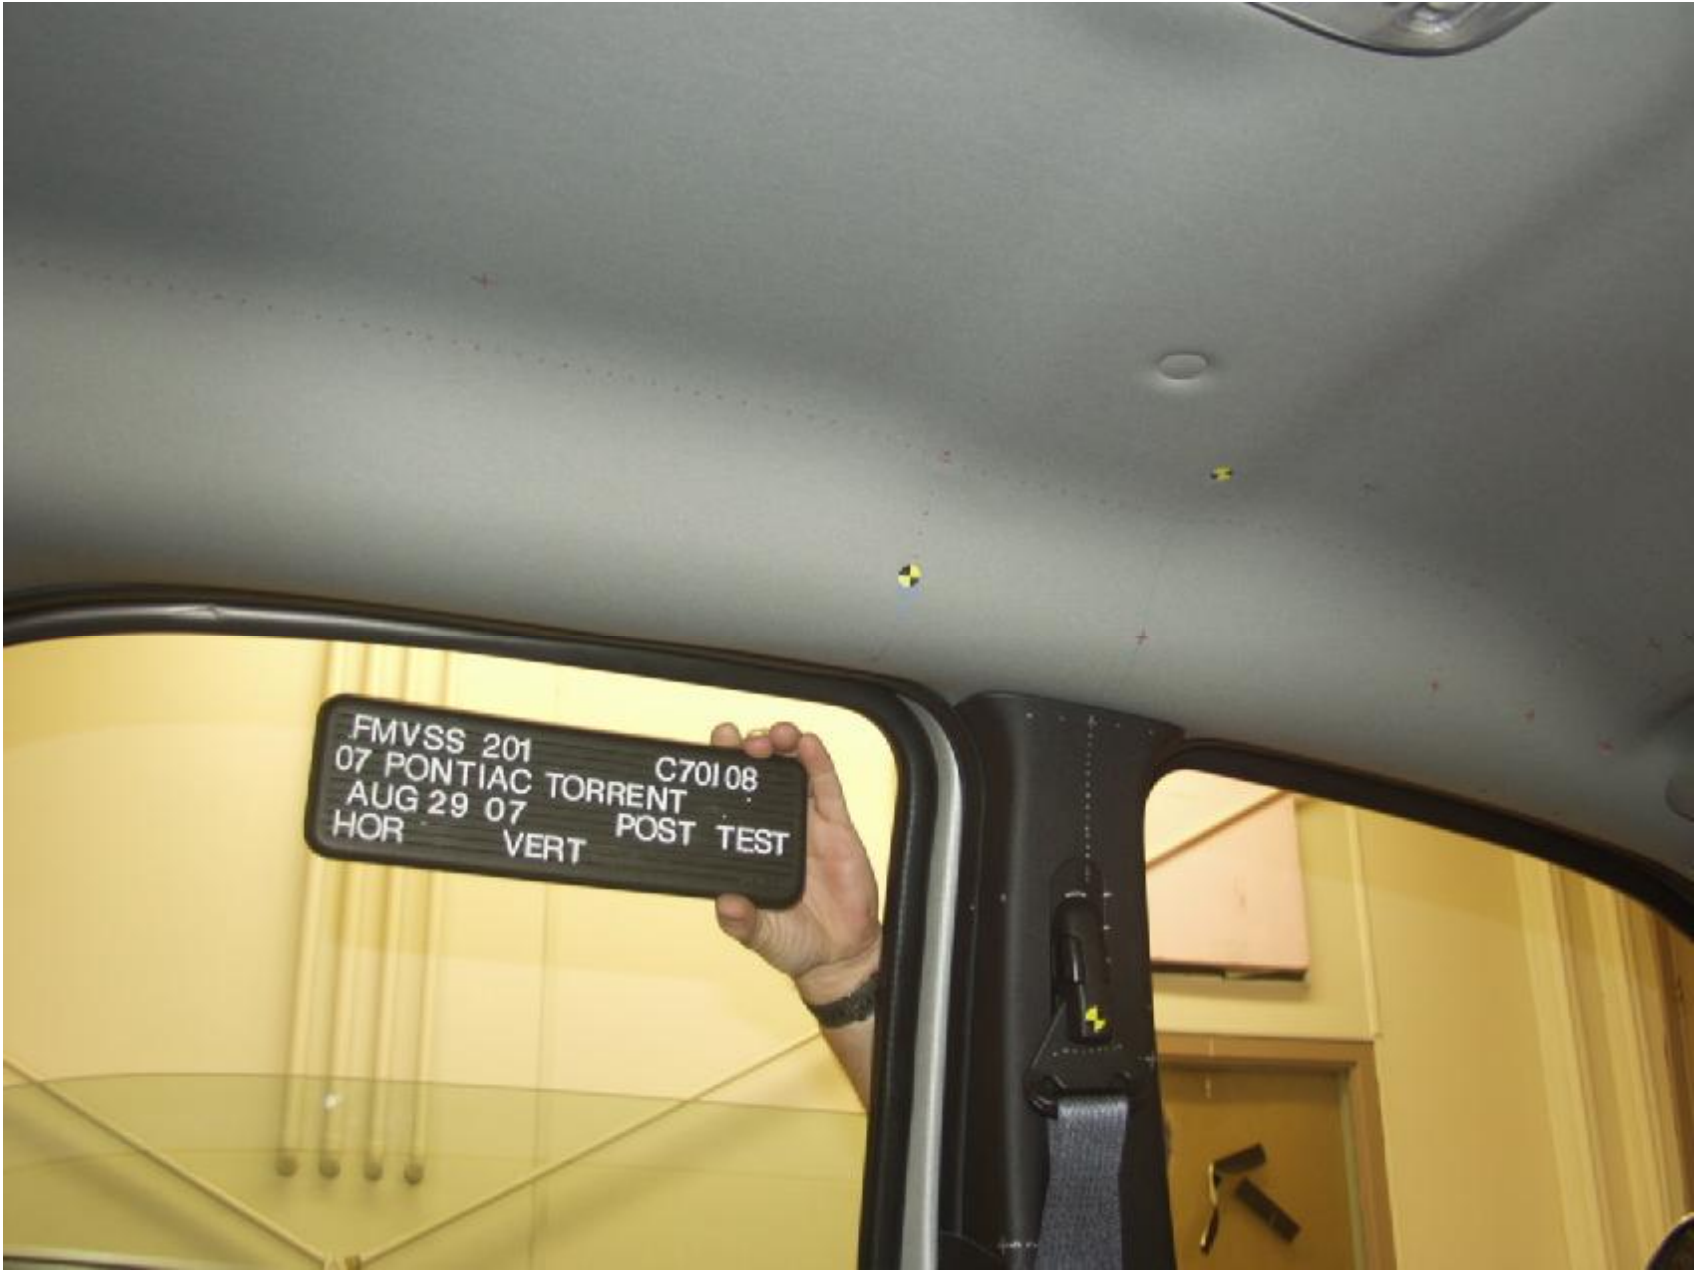
Figure A-22 : POST-TEST DRIVER SIDE B-PILLAR

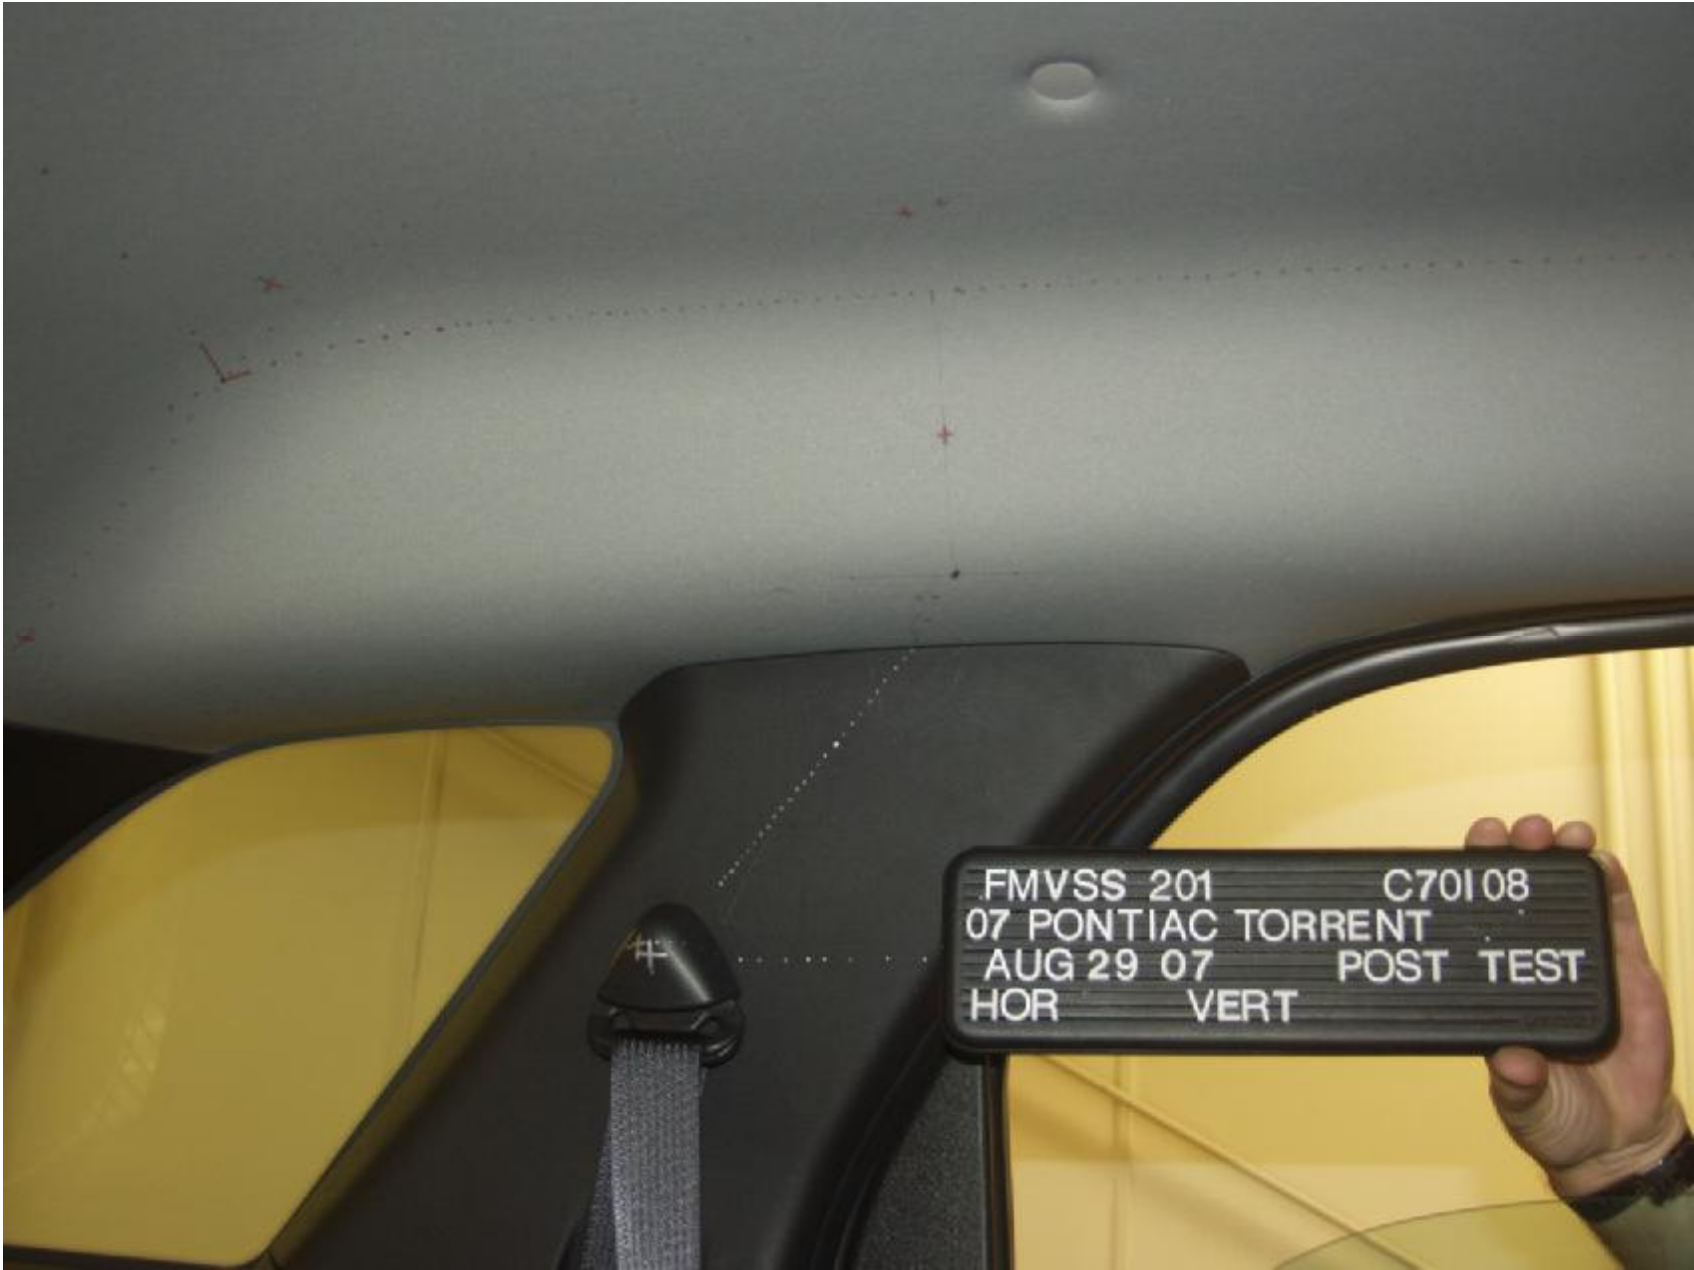
Figure A-23 : POST-TEST DRIVER SIDE OTHER PILLAR

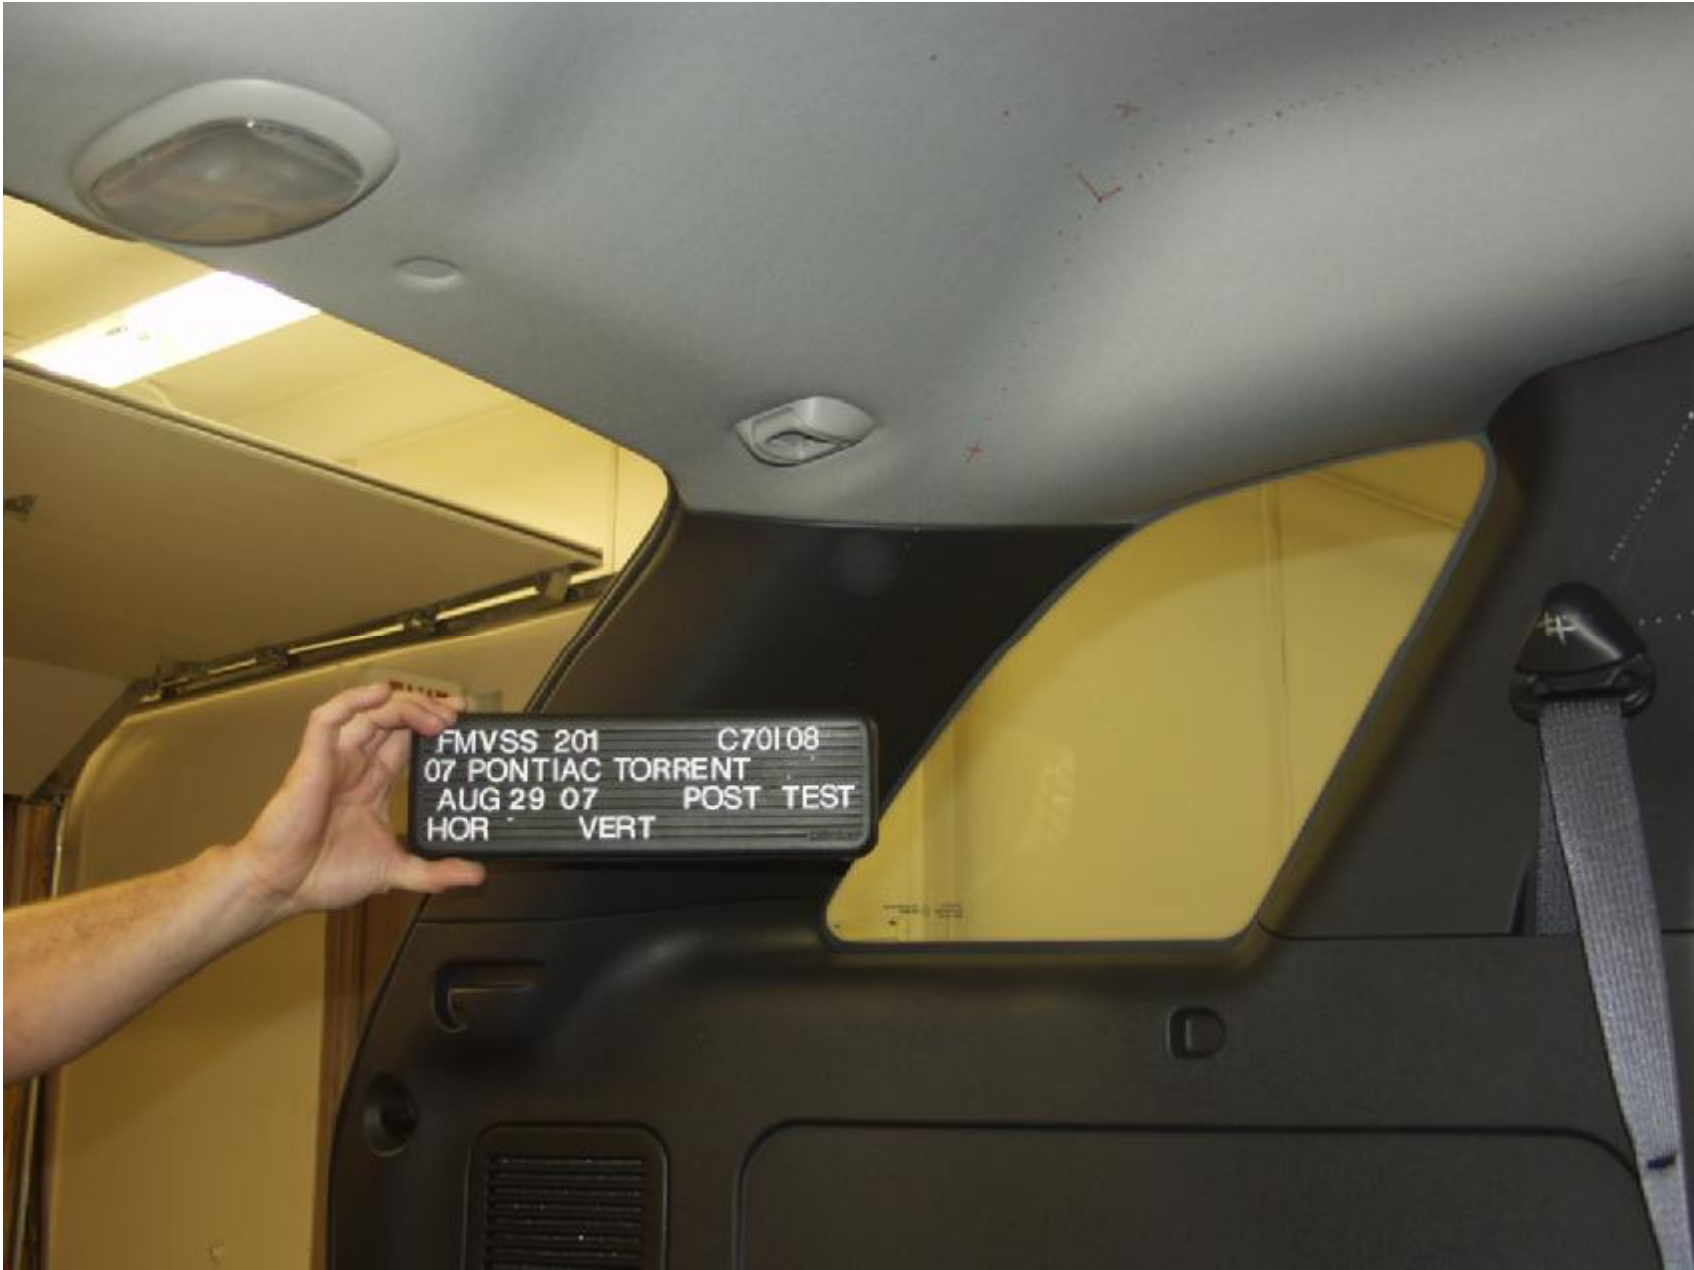
Figure A-24 : POST-TEST DRIVER SIDE REAR PILLAR

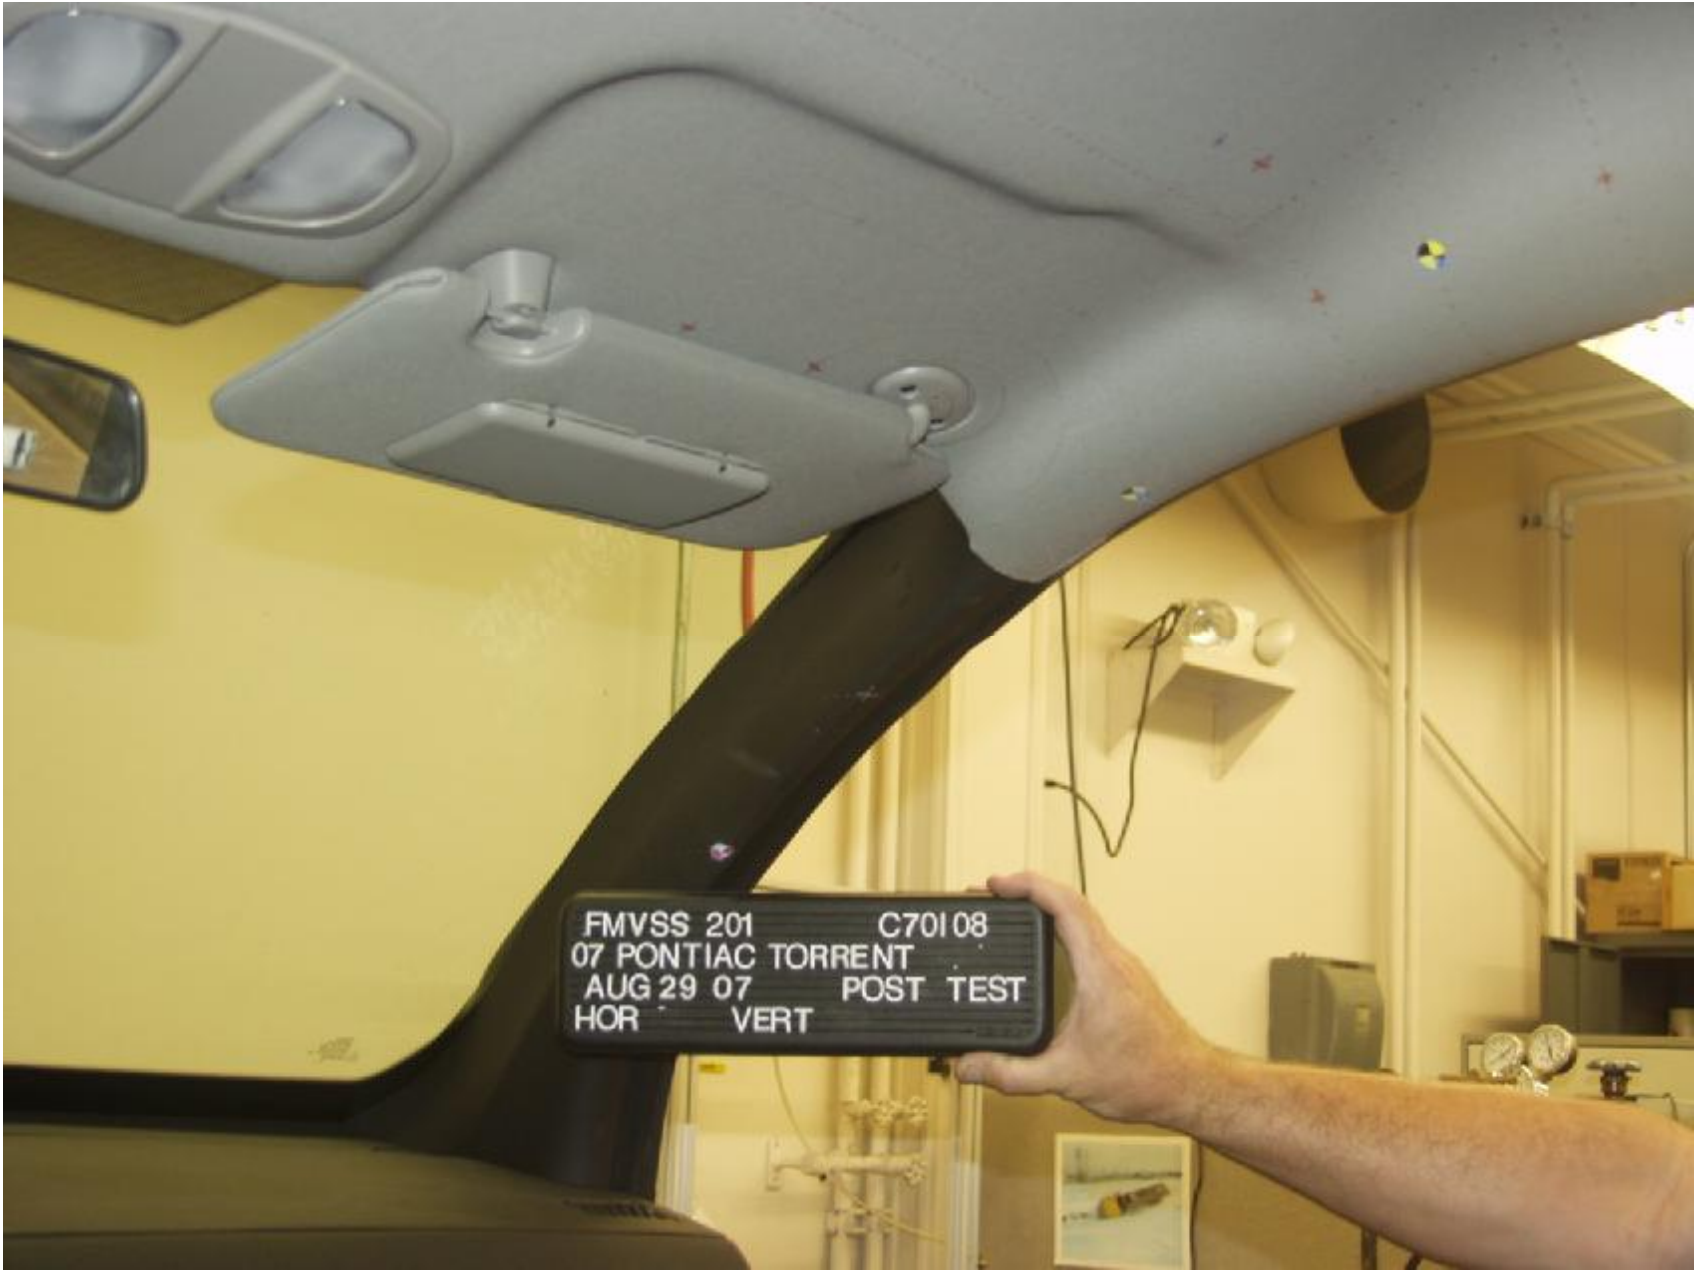
Figure A-25 : POST-TEST PASSENGER SIDE A-PILLAR

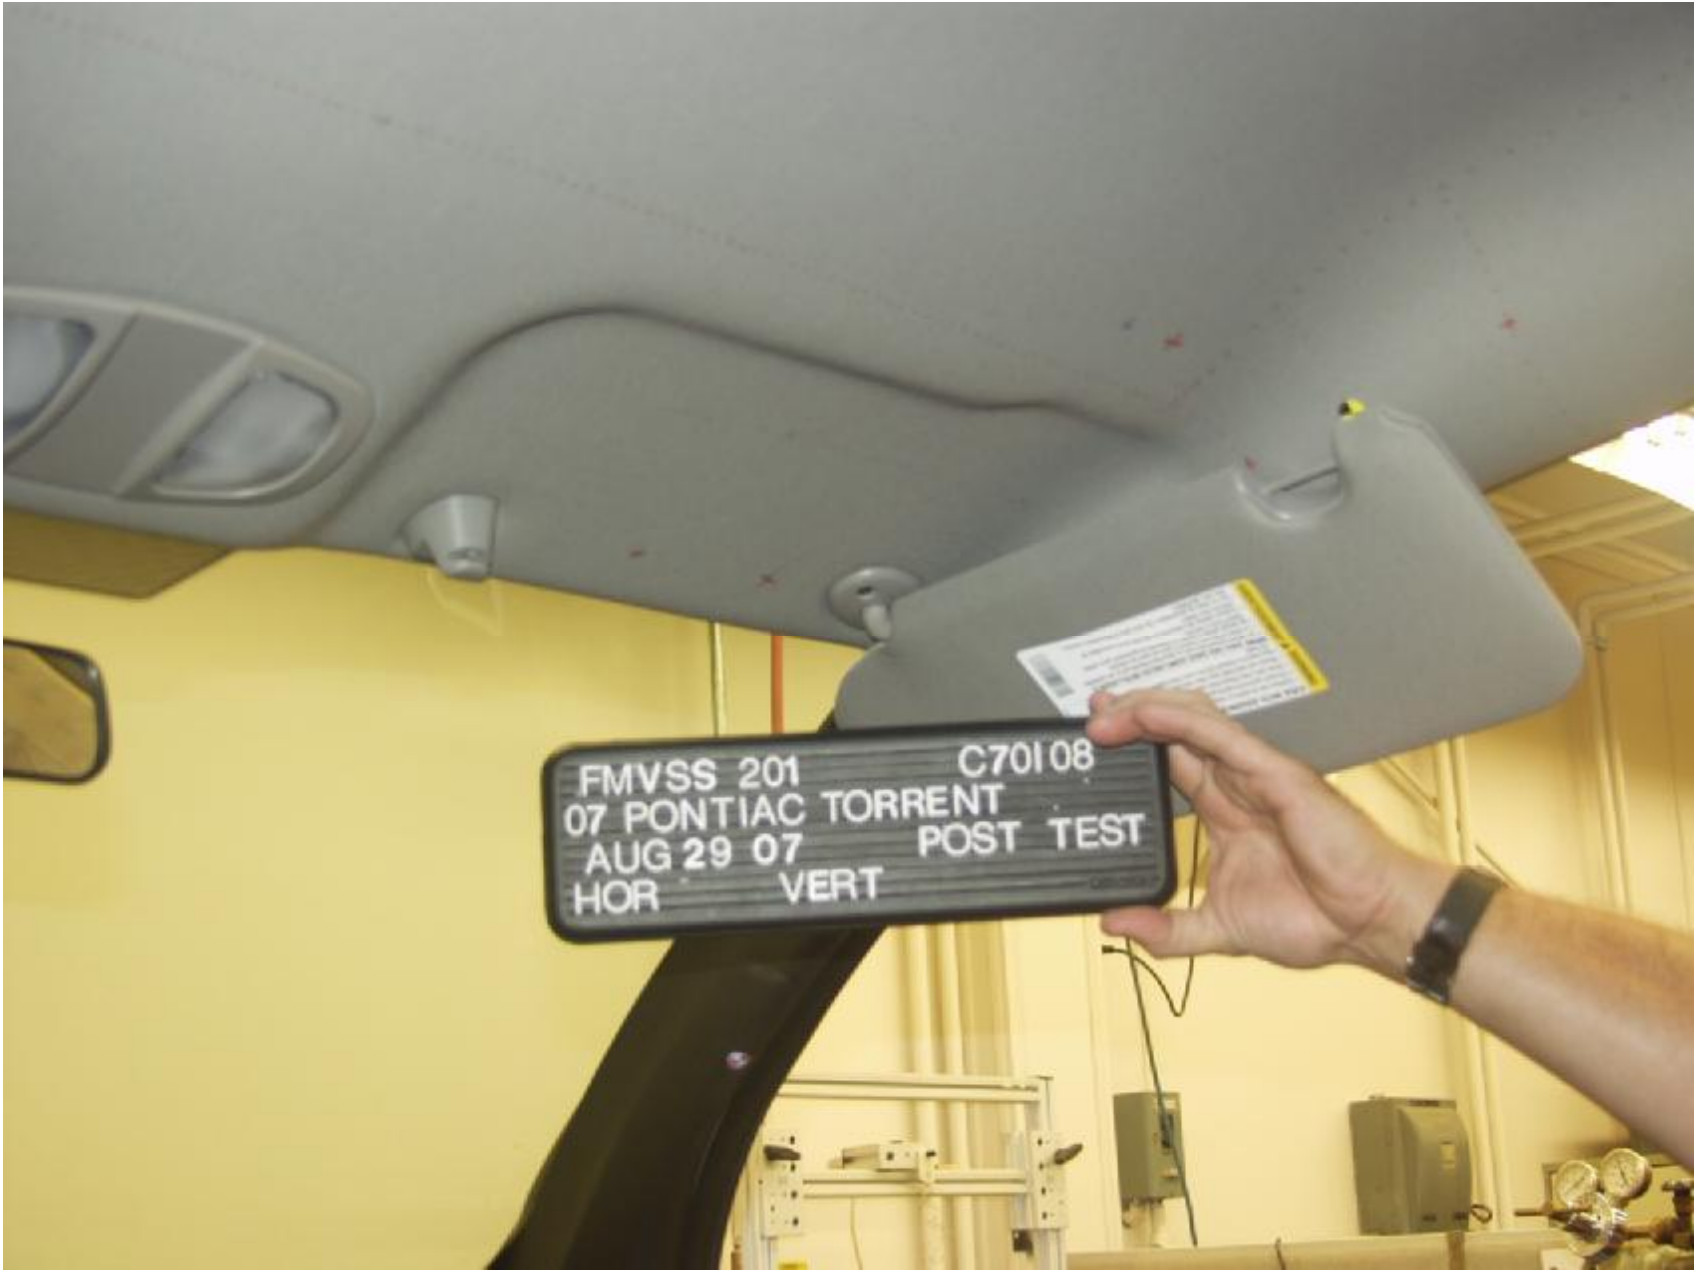
Figure A-26 : POST-TEST PASSENGER SIDE FRONT HEADER

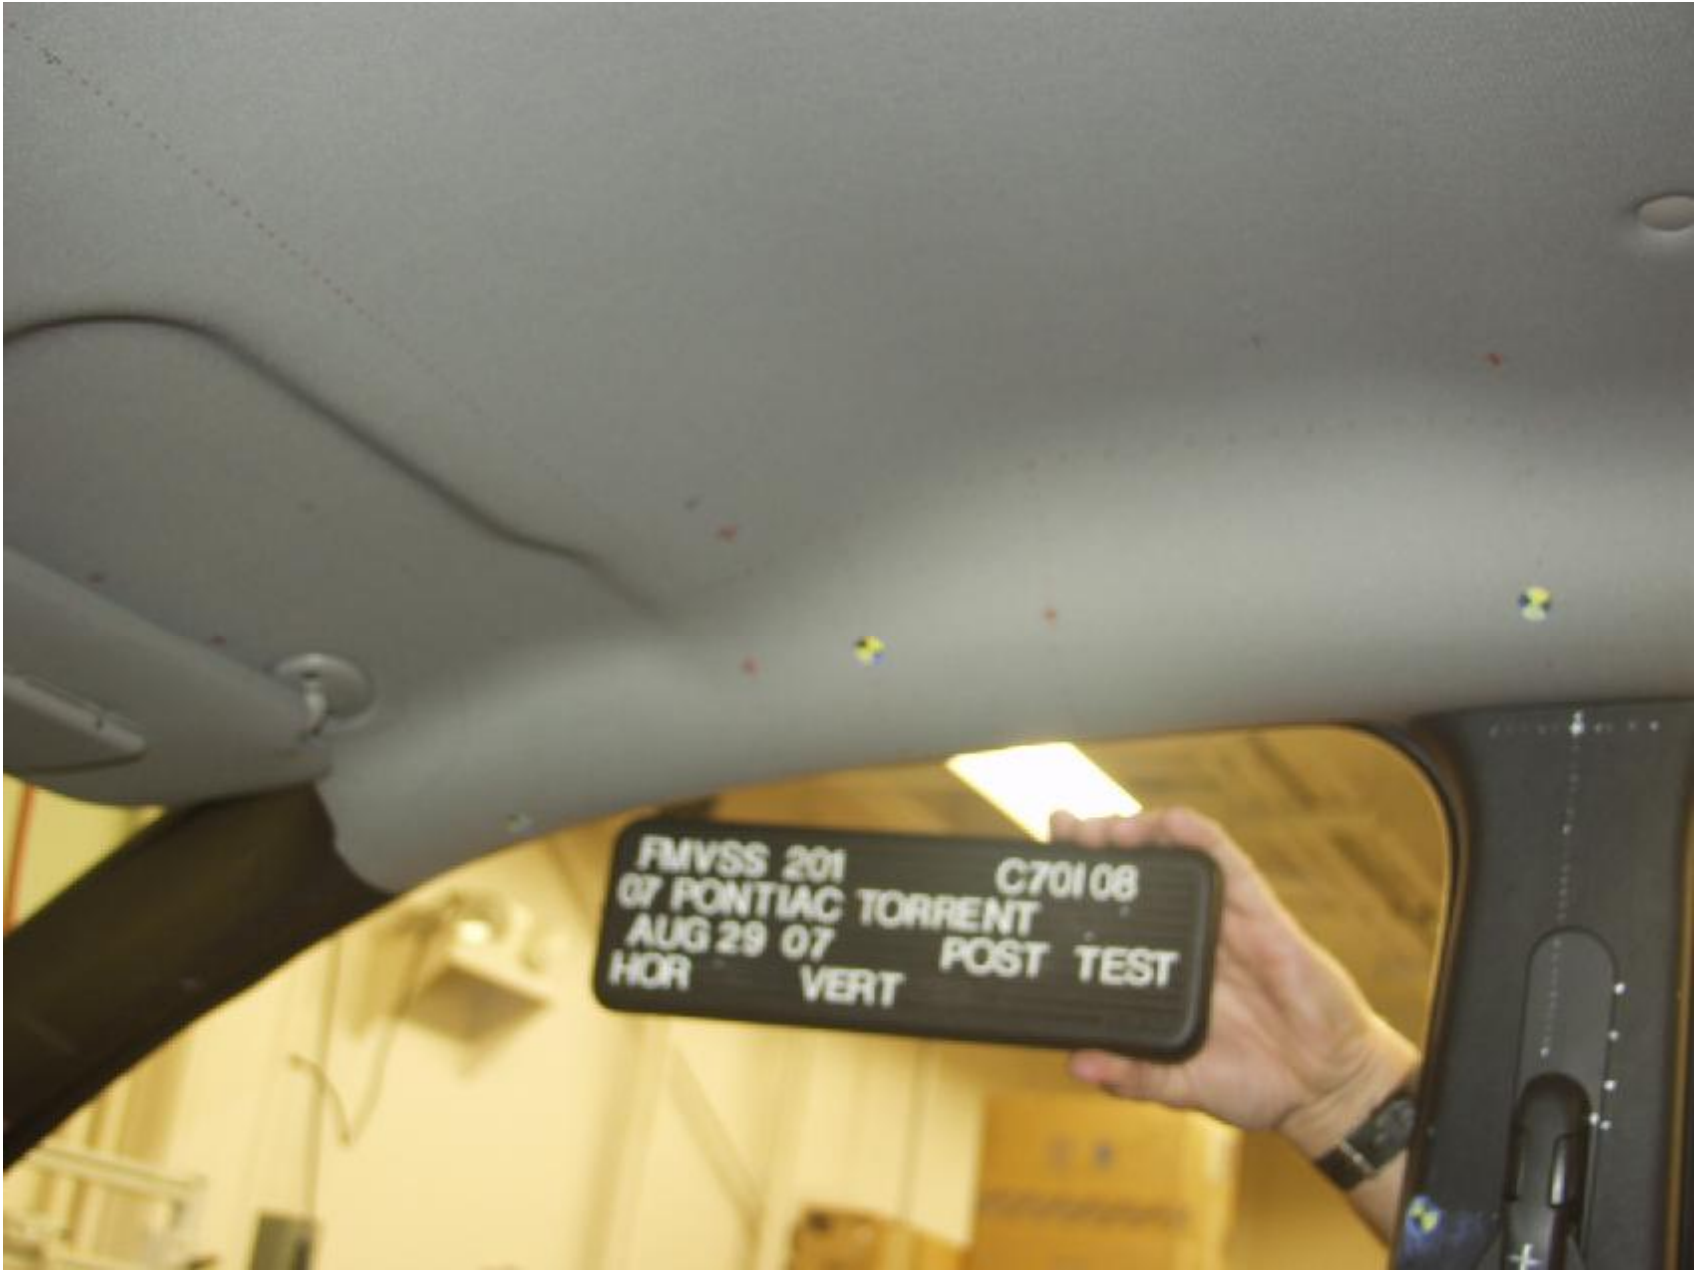
Figure A-27 : POST-TEST PASSENGER SIDE SIDE RAIL

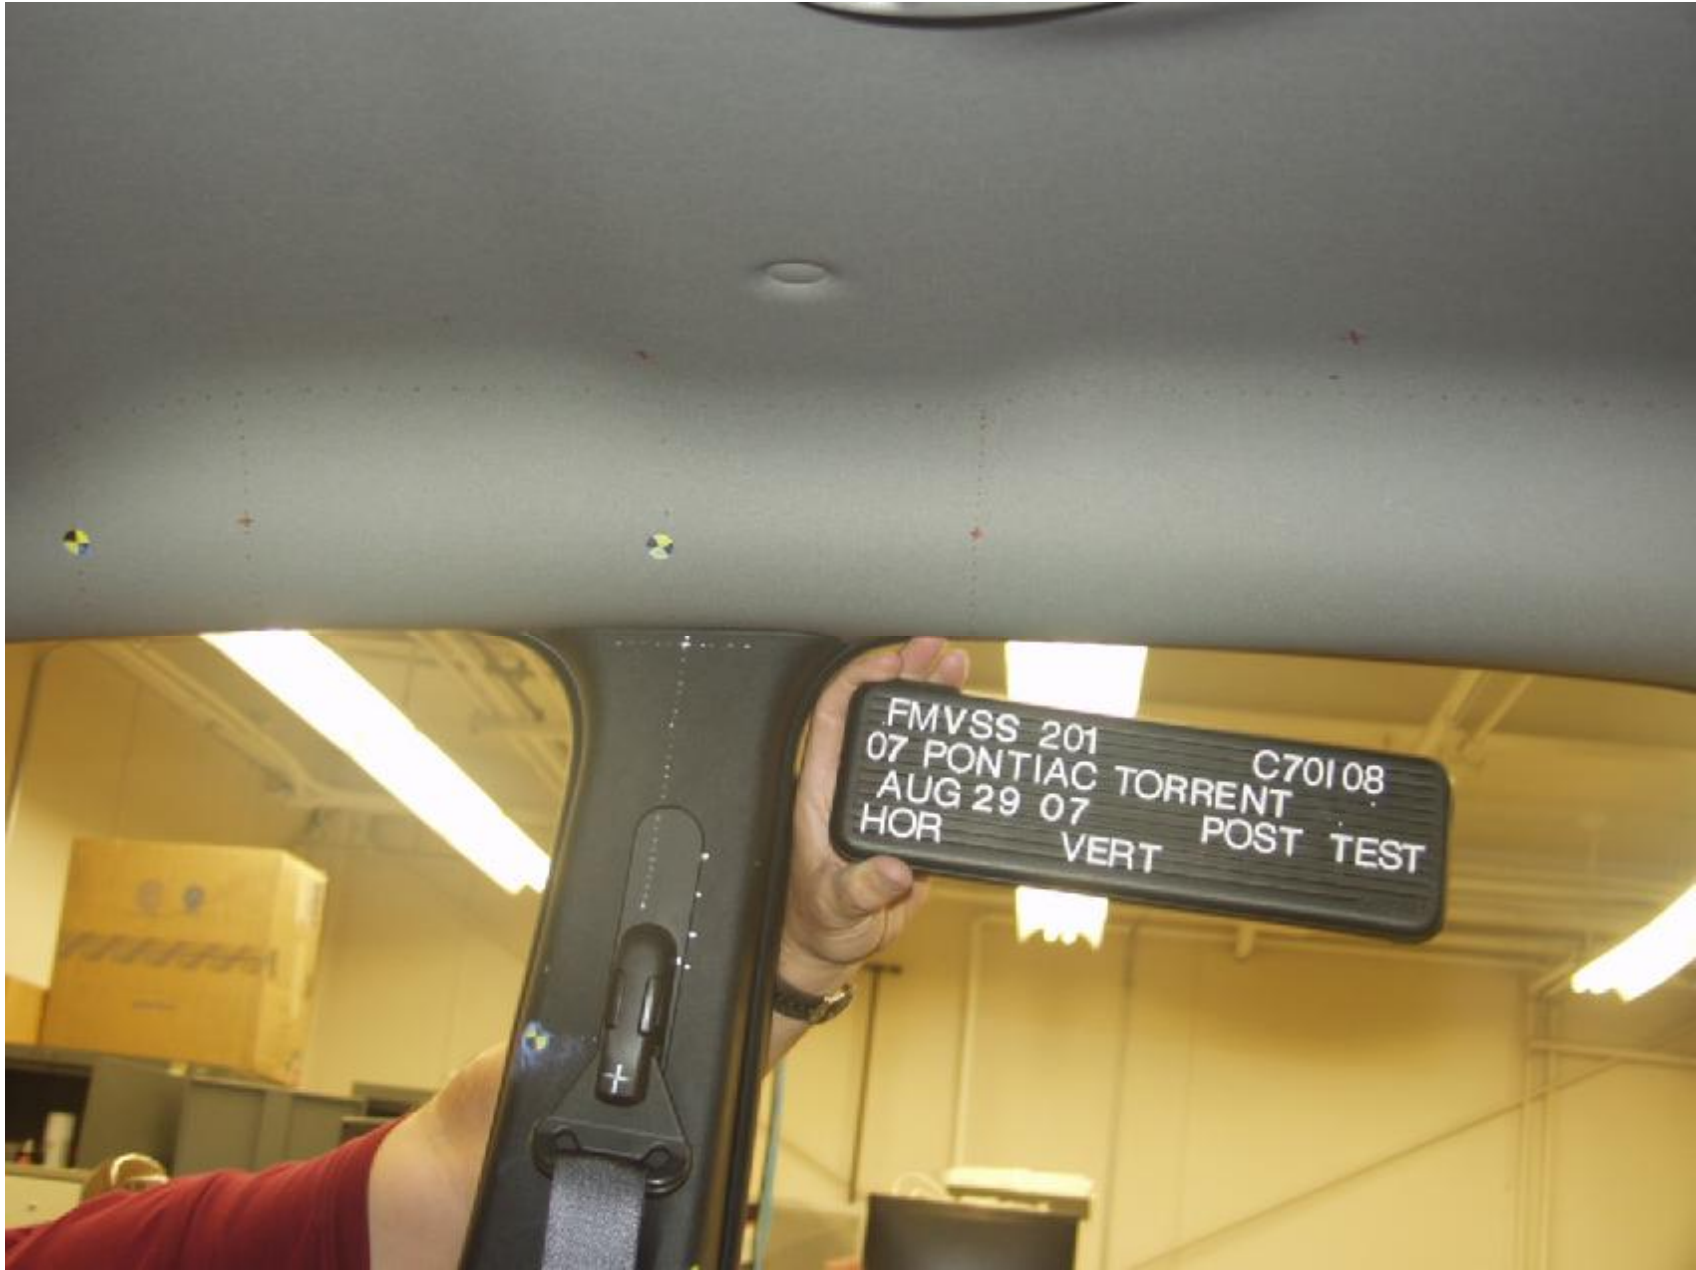
Figure A-28 : POST-TEST PASSENGER SIDE B-PILLAR

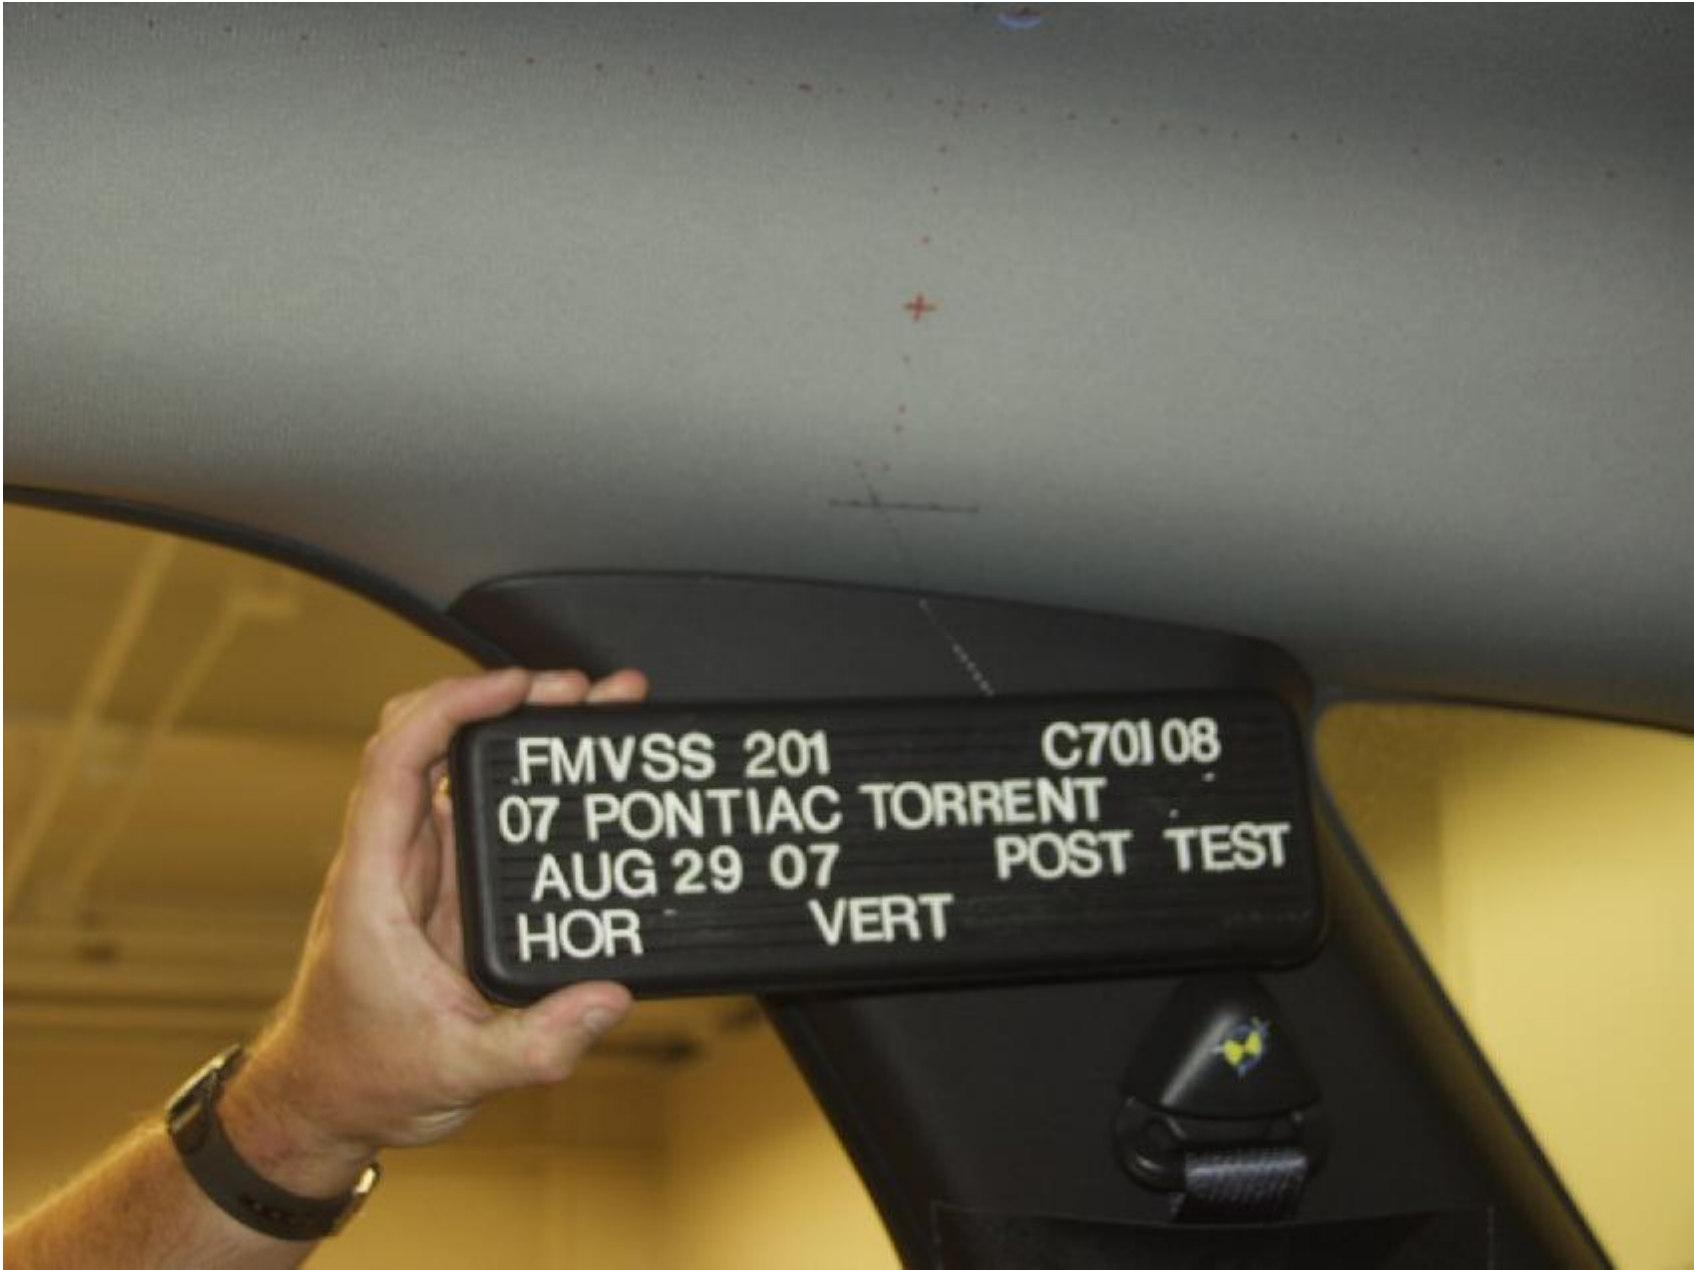
Figure A-29 : POST-TEST PASSENGER SIDE OTHER PILLAR
