REPORT NUMBER: 201UI-CAL-07-07

**SAFETY COMPLIANCE TESTING FOR FMVSS 201
OCCUPANT PROTECTION IN INTERIOR IMPACT
UPPER INTERIOR HEAD IMPACT PROTECTION**

**General Motors Corporation
2007 Pontiac Torrent**

NHTSA NUMBER: C70108

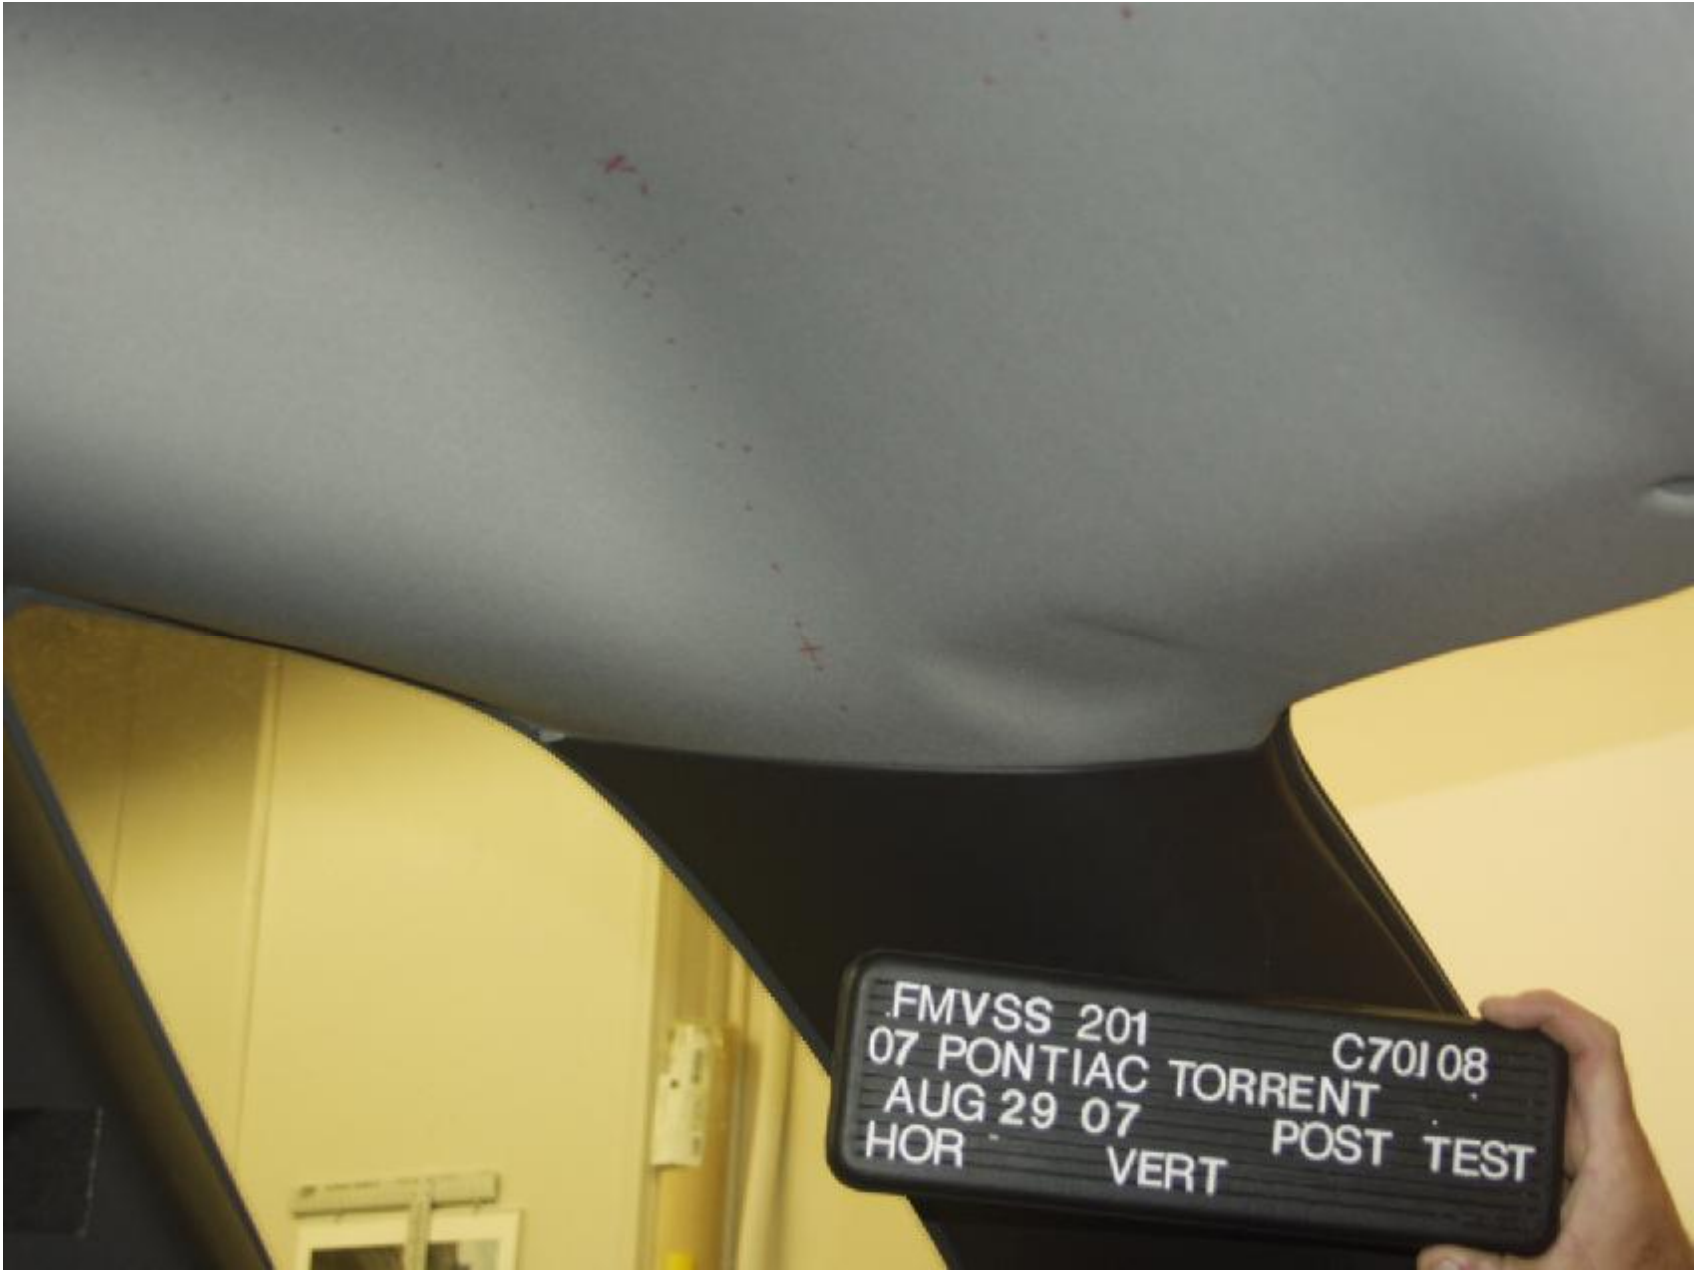
Figure A-30 : POST-TEST PASSENGER SIDE REAR PILLAR

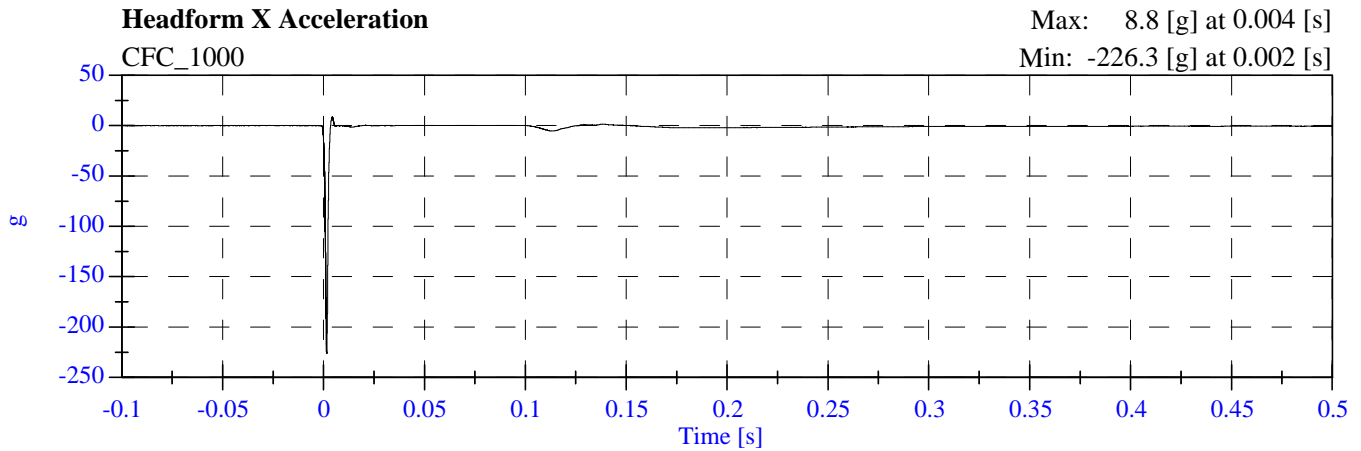
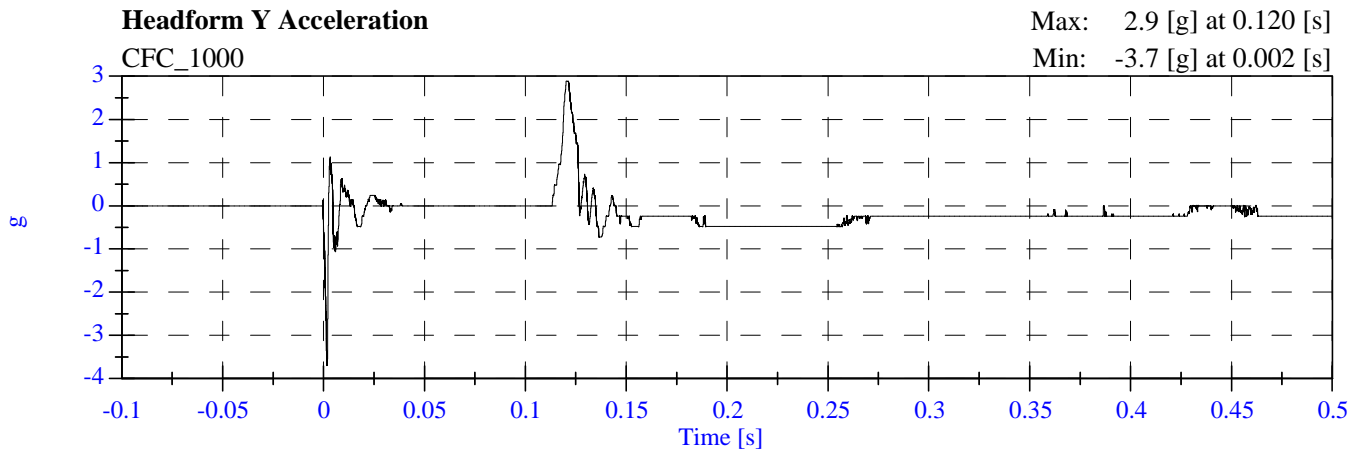
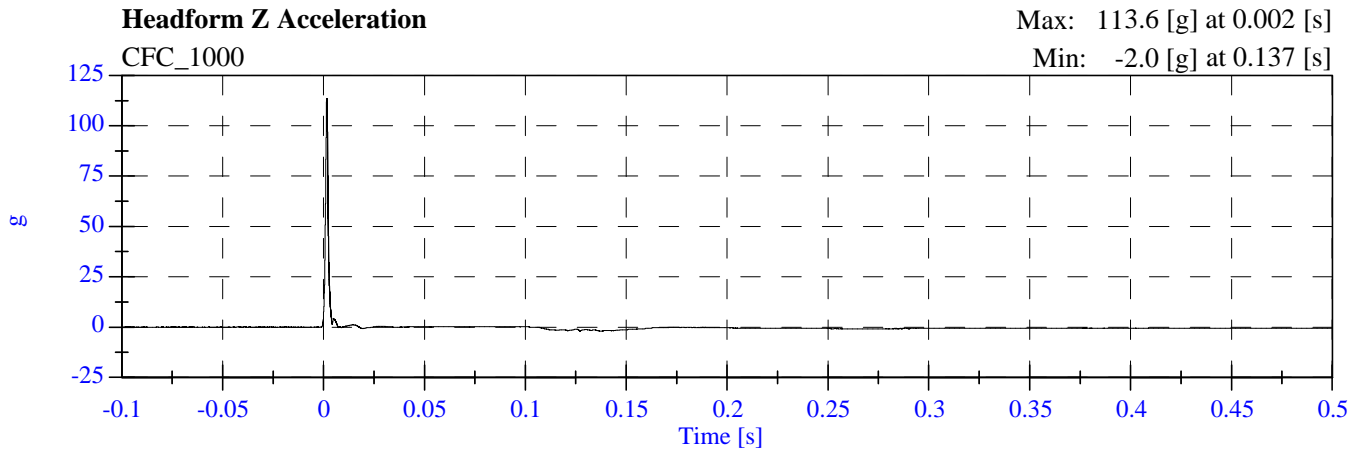
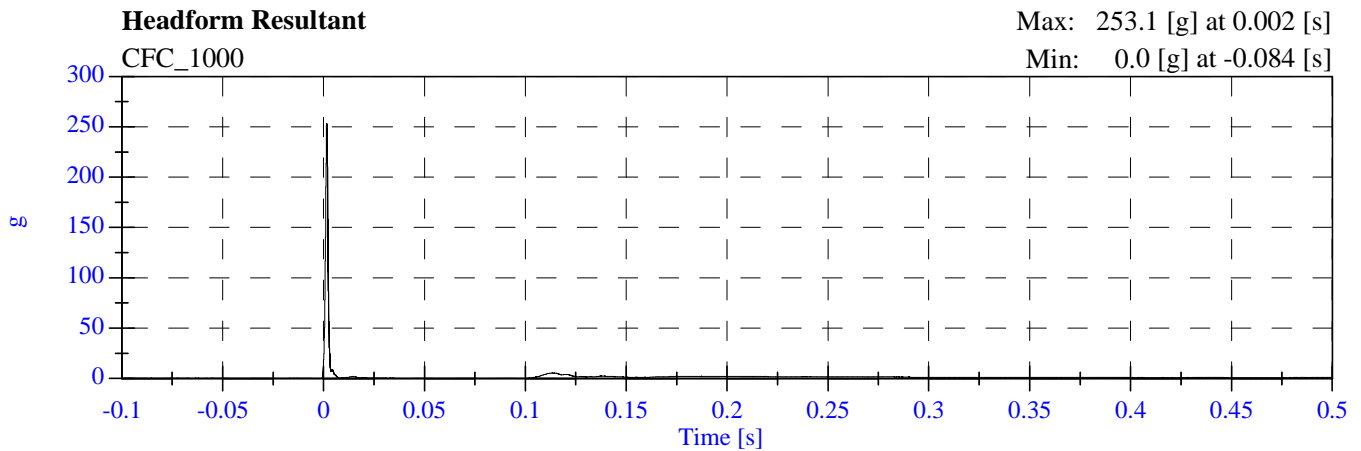
FMVSS 201U - Headform 1255 Calibration Post-Test C70108 - August 30, 2007
