REPORT NUMBER: 201UI-CAL-07-08

**SAFETY COMPLIANCE TESTING FOR FMVSS 201  
OCCUPANT PROTECTION IN INTERIOR IMPACT  
UPPER INTERIOR HEAD IMPACT PROTECTION**

**Ford Motor Company  
2007 Ford Edge**

NHTSA NUMBER: C70204

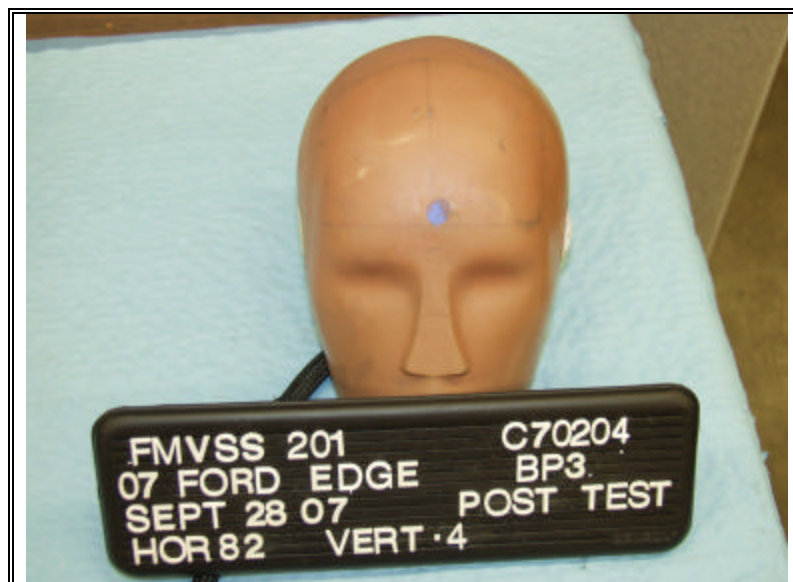
POST-IMPACT BP3 HEADFORM

Test Number:	4
Test Date:	09/28/07
Target Location:	B Pillar
Target Code:	BP3
Horizontal Impact Angle:	82°
Vertical Impact Angle:	(4)°
Ambient Temperature:	22.0°C
Relative Humidity:	58%
Time of Impact:	14:48
Headform Number:	642

Impact Point Description (from lower midpoint on midsagittal line)			
On Centerline	3	<input type="checkbox"/>	mm right <input checked="" type="checkbox"/> mm left
On Centerline	5		mm up

Free Motion HIC	587.9
HIC(d)	609.9
Impact Velocity (kph)	23.6
HIC T1 (msec)	2.7
HIC T2 (msec)	10.8

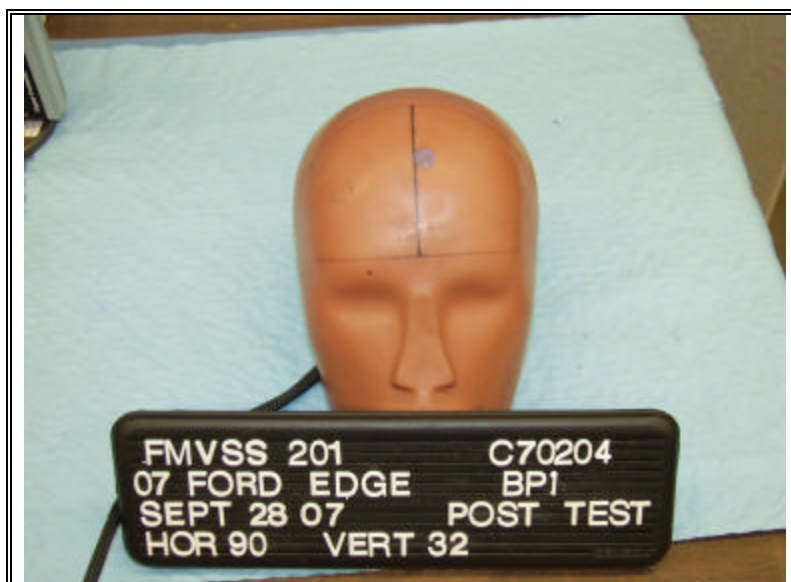
POST-IMPACT BP1 HEADFORM

Test Number:	5
Test Date:	09/28/07
Target Location:	B Pillar
Target Code:	BP1
Horizontal Impact Angle:	90°
Vertical Impact Angle:	32°
Ambient Temperature:	22.0°C
Relative Humidity:	55%
Time of Impact:	15:18
Headform Number:	355

Impact Point Description (from lower midpoint on midsagittal line)					
On Centerline	2	<input checked="" type="checkbox"/>	mm right	<input type="checkbox"/>	mm left
On Centerline	53				mm up

Free Motion HIC	289.3
HIC(d)	384.7
Impact Velocity (kph)	18.34
HIC T1 (msec)	5.8
HIC T2 (msec)	15.9

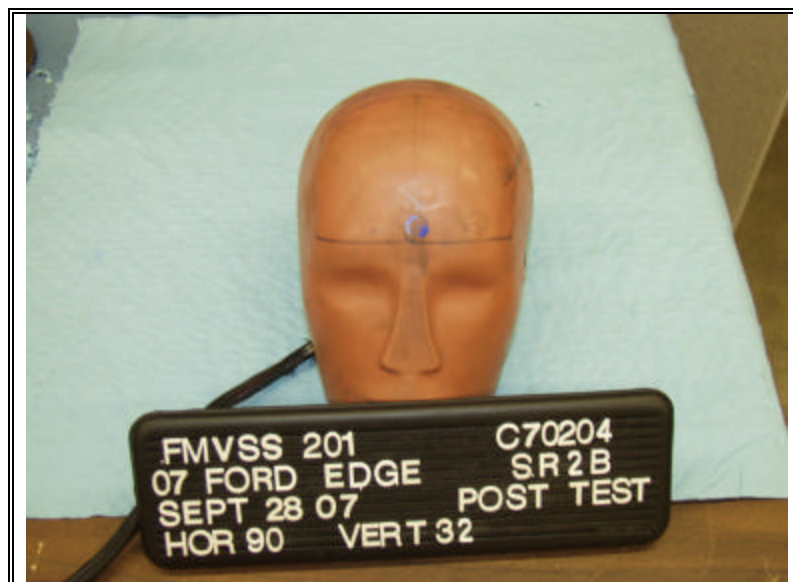
POST-IMPACT SR2B HEADFORM

Test Number:	6
Test Date:	09/28/07
Target Location:	Side Rail
Target Code:	SR2B
Horizontal Impact Angle:	90°
Vertical Impact Angle:	32°
Ambient Temperature:	22.0°C
Relative Humidity:	58%
Time of Impact:	15:43
Headform Number:	62

Impact Point Description (from lower midpoint on midsagittal line)			
On Centerline	2	<input type="checkbox"/>	mm right <input checked="" type="checkbox"/> mm left
On Centerline	6		mm up

Free Motion HIC	223.5
HIC(d)	335
Impact Velocity (kph)	18.45
HIC T1 (msec)	5.0
HIC T2 (msec)	15.8

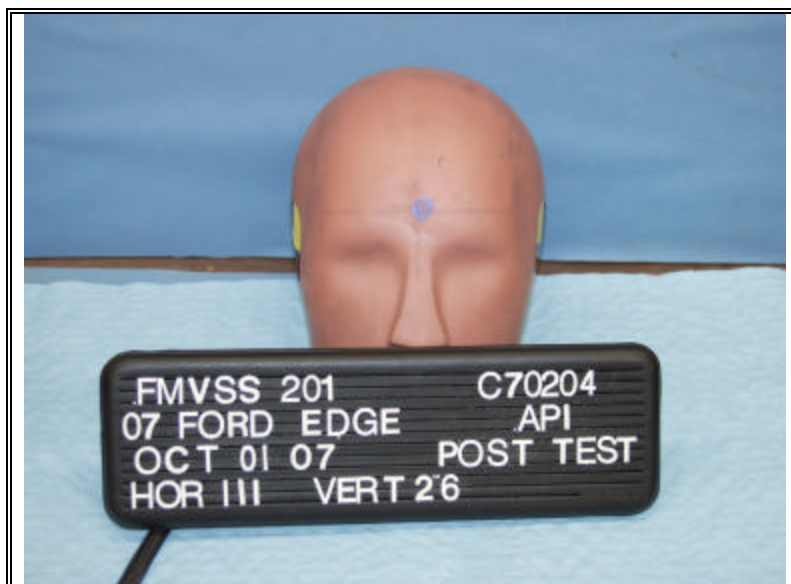
POST-IMPACT AP1 HEADFORM

Test Number:	8
Test Date:	10/01/07
Target Location:	A Pillar
Target Code:	AP1
Horizontal Impact Angle:	111°
Vertical Impact Angle:	26°
Ambient Temperature:	21.0°C
Relative Humidity:	47%
Time of Impact:	9:56
Headform Number:	1255

Impact Point Description (from lower midpoint on midsagittal line)			
On Centerline	4	<input type="checkbox"/>	mm right <input checked="" type="checkbox"/> mm left
On Centerline	2		mm up

Free Motion HIC	299.6
HIC(d)	392.4
Impact Velocity (kph)	18.5
HIC T1 (msec)	7.2
HIC T2 (msec)	11.9

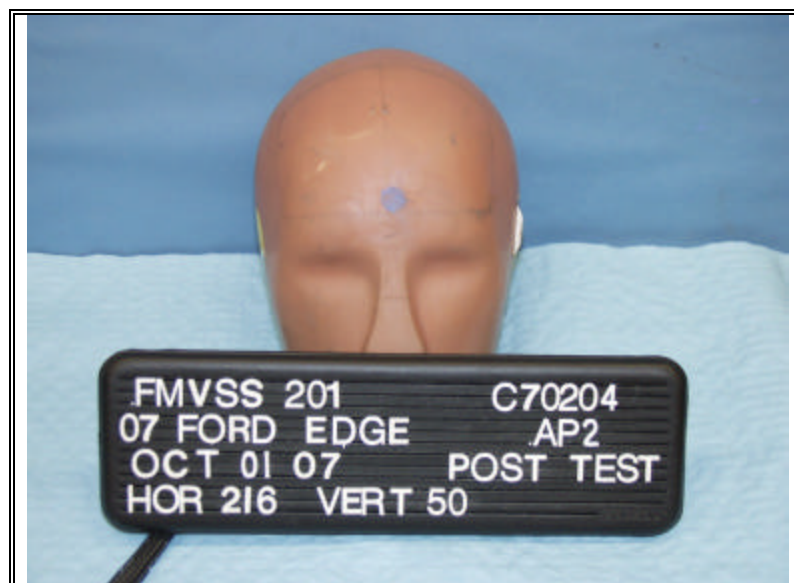
POST-IMPACT AP2 HEADFORM

Test Number:	9
Test Date:	10/01/07
Target Location:	A Pillar
Target Code:	AP2
Horizontal Impact Angle:	216°
Vertical Impact Angle:	50°
Ambient Temperature:	21°C
Relative Humidity:	51%
Time of Impact:	11:44
Headform Number:	642

Impact Point Description (from lower midpoint on midsagittal line)				
On Centerline	2	<input type="checkbox"/>	mm right	<input checked="" type="checkbox"/> mm left
On Centerline	7			mm up

Free Motion HIC	311.7
HIC(d)	401.6
Impact Velocity (kph)	18.54
HIC T1 (msec)	2.4
HIC T2 (msec)	11.5

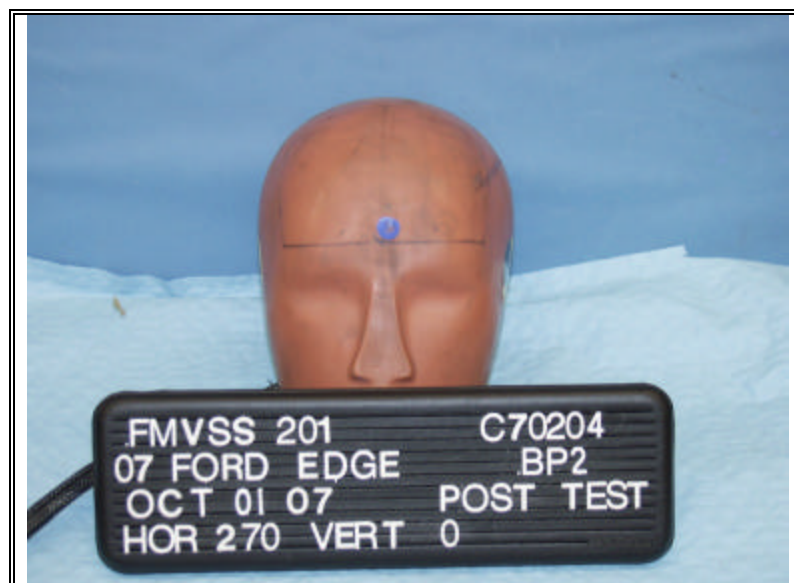
POST-IMPACT BP2 HEADFORM

Test Number:	10
Test Date:	10/01/07
Target Location:	B Pillar
Target Code:	BP2
Horizontal Impact Angle:	270°
Vertical Impact Angle:	0°
Ambient Temperature:	21°C
Relative Humidity:	46
Time of Impact:	13:39
Headform Number:	62

Impact Point Description (from lower midpoint on midsagittal line)					
On Centerline	3	<input type="checkbox"/>	mm right	<input checked="" type="checkbox"/>	mm left
On Centerline	7				mm up

Free Motion HIC	559.8
HIC(d)	588.8
Impact Velocity (kph)	23.5
HIC T1 (msec)	3.1
HIC T2 (msec)	8.6
