REPORT NUMBER: 201UI-CAL-08-03

**SAFETY COMPLIANCE TESTING FOR FMVSS 201
OCCUPANT PROTECTION IN INTERIOR IMPACT
UPPER INTERIOR HEAD IMPACT PROTECTION**

**SAAB AUTOMOBILE AB
2008 SAAB 9-5 WAGON**

NHTSA NUMBER: C80508

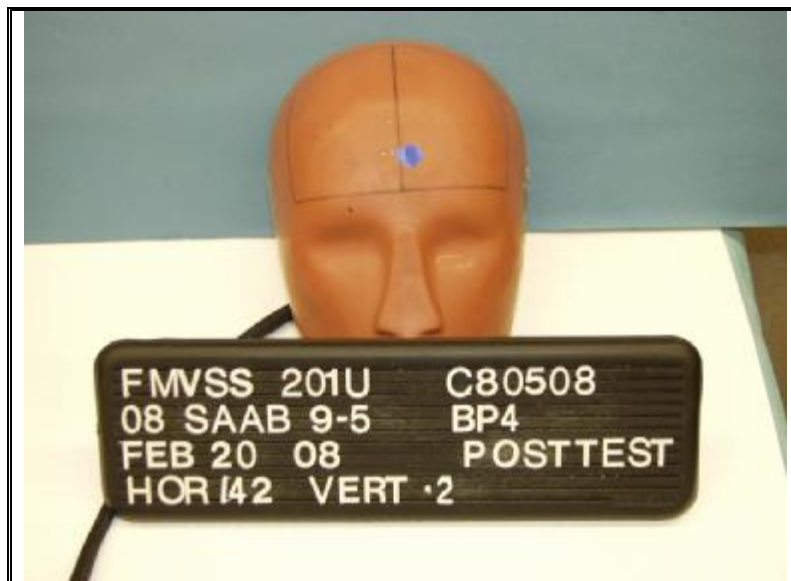
POST-IMPACT BP4 HEADFORM

Impact Point Description (from lower midpoint on midsagittal line)			
On Centerline	5	mm right	x mm left
On Centerline	16	mm up

Free Motion HIC	460.8
HIC(d)	514.0
Impact Velocity (kph)	23.65
HIC T1 (msec)	3.7
HIC T2 (msec)	11.4

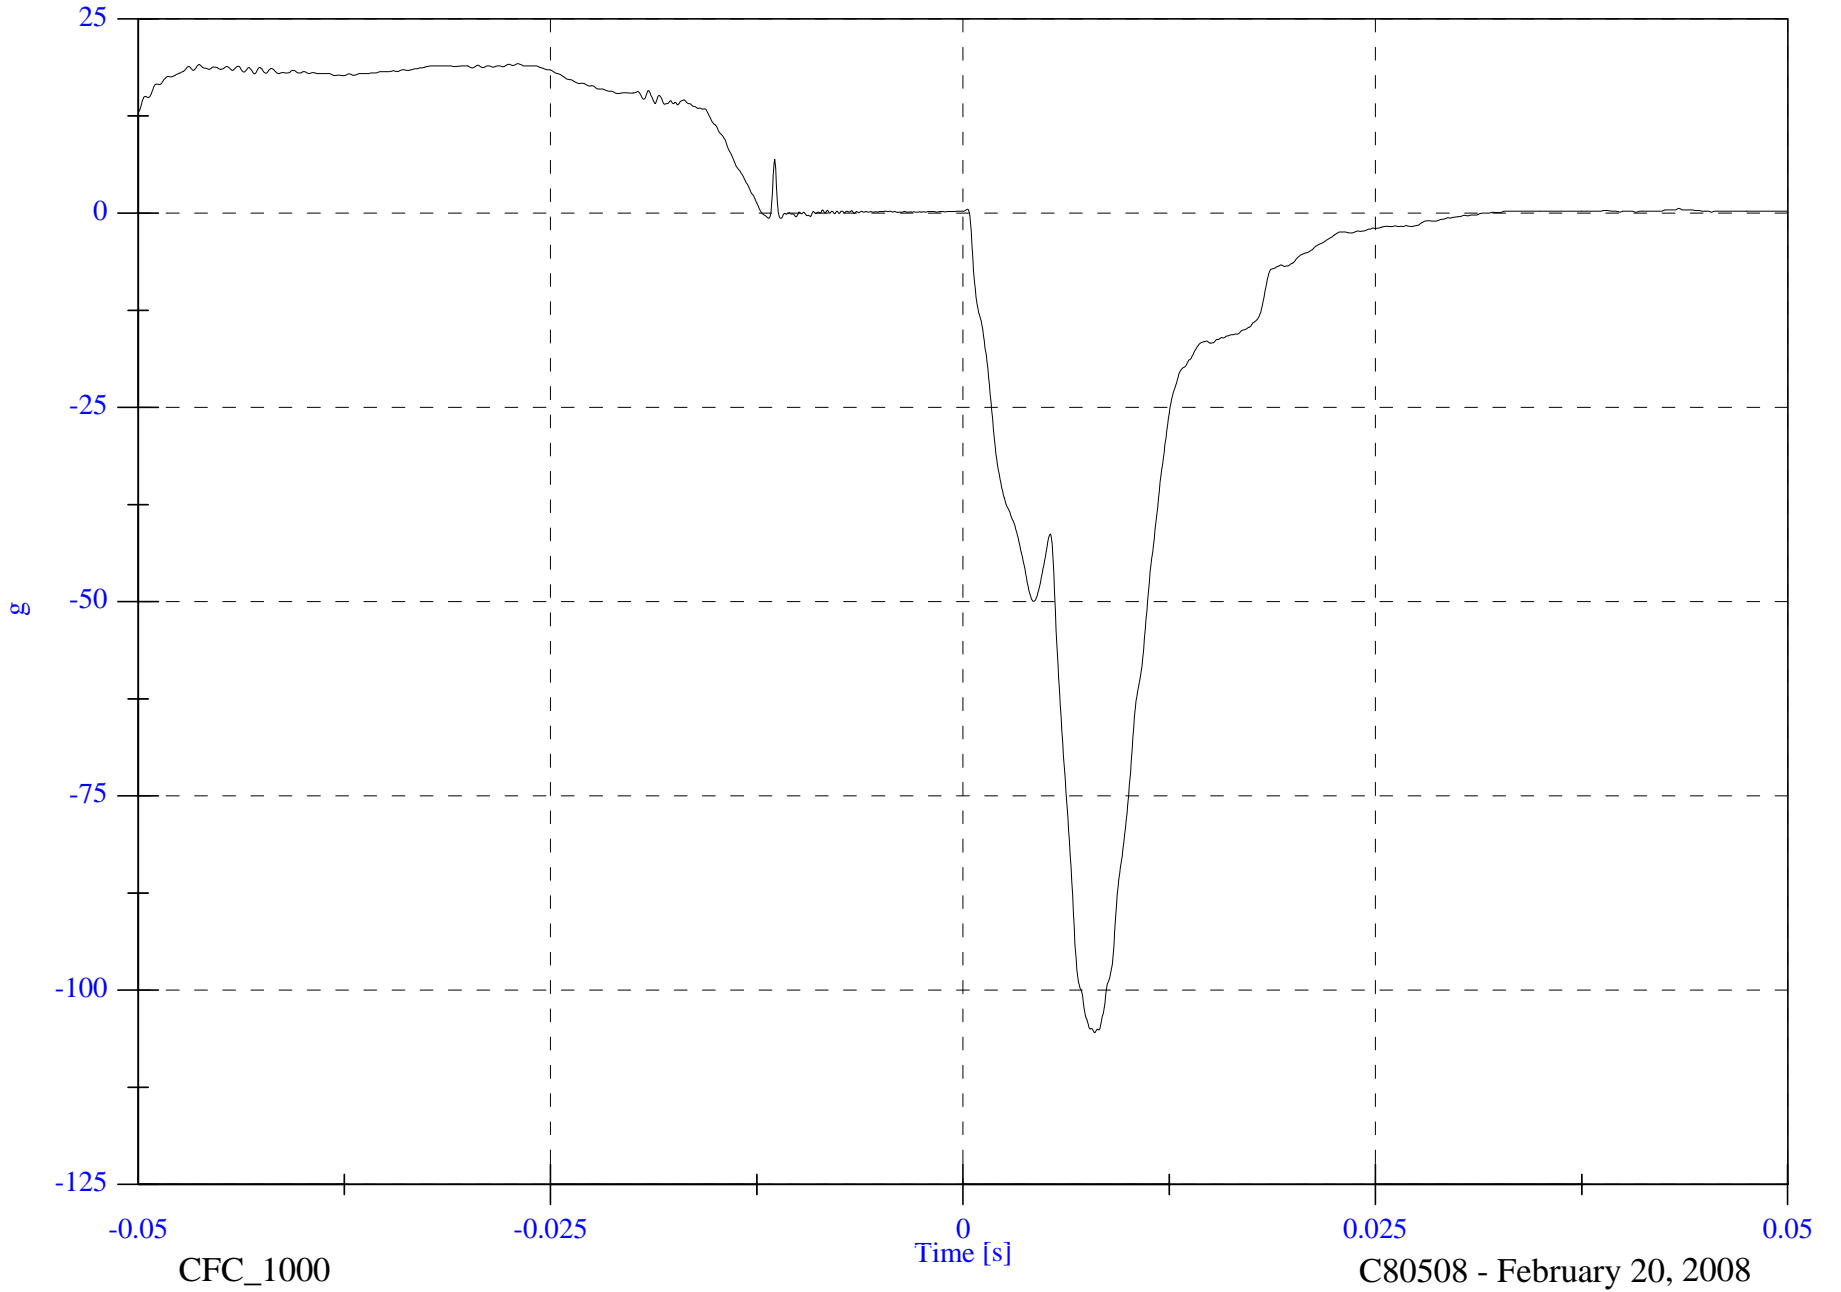
C80508 PASSENGER SIDE BP4 IMPACT PLOT #2

FMVSS 201U 2008 SAAB 9-5

Max: 19.2 [g] at -0.027 [s]

Min: -105.5 [g] at 0.008 [s]

Headform X Acceleration

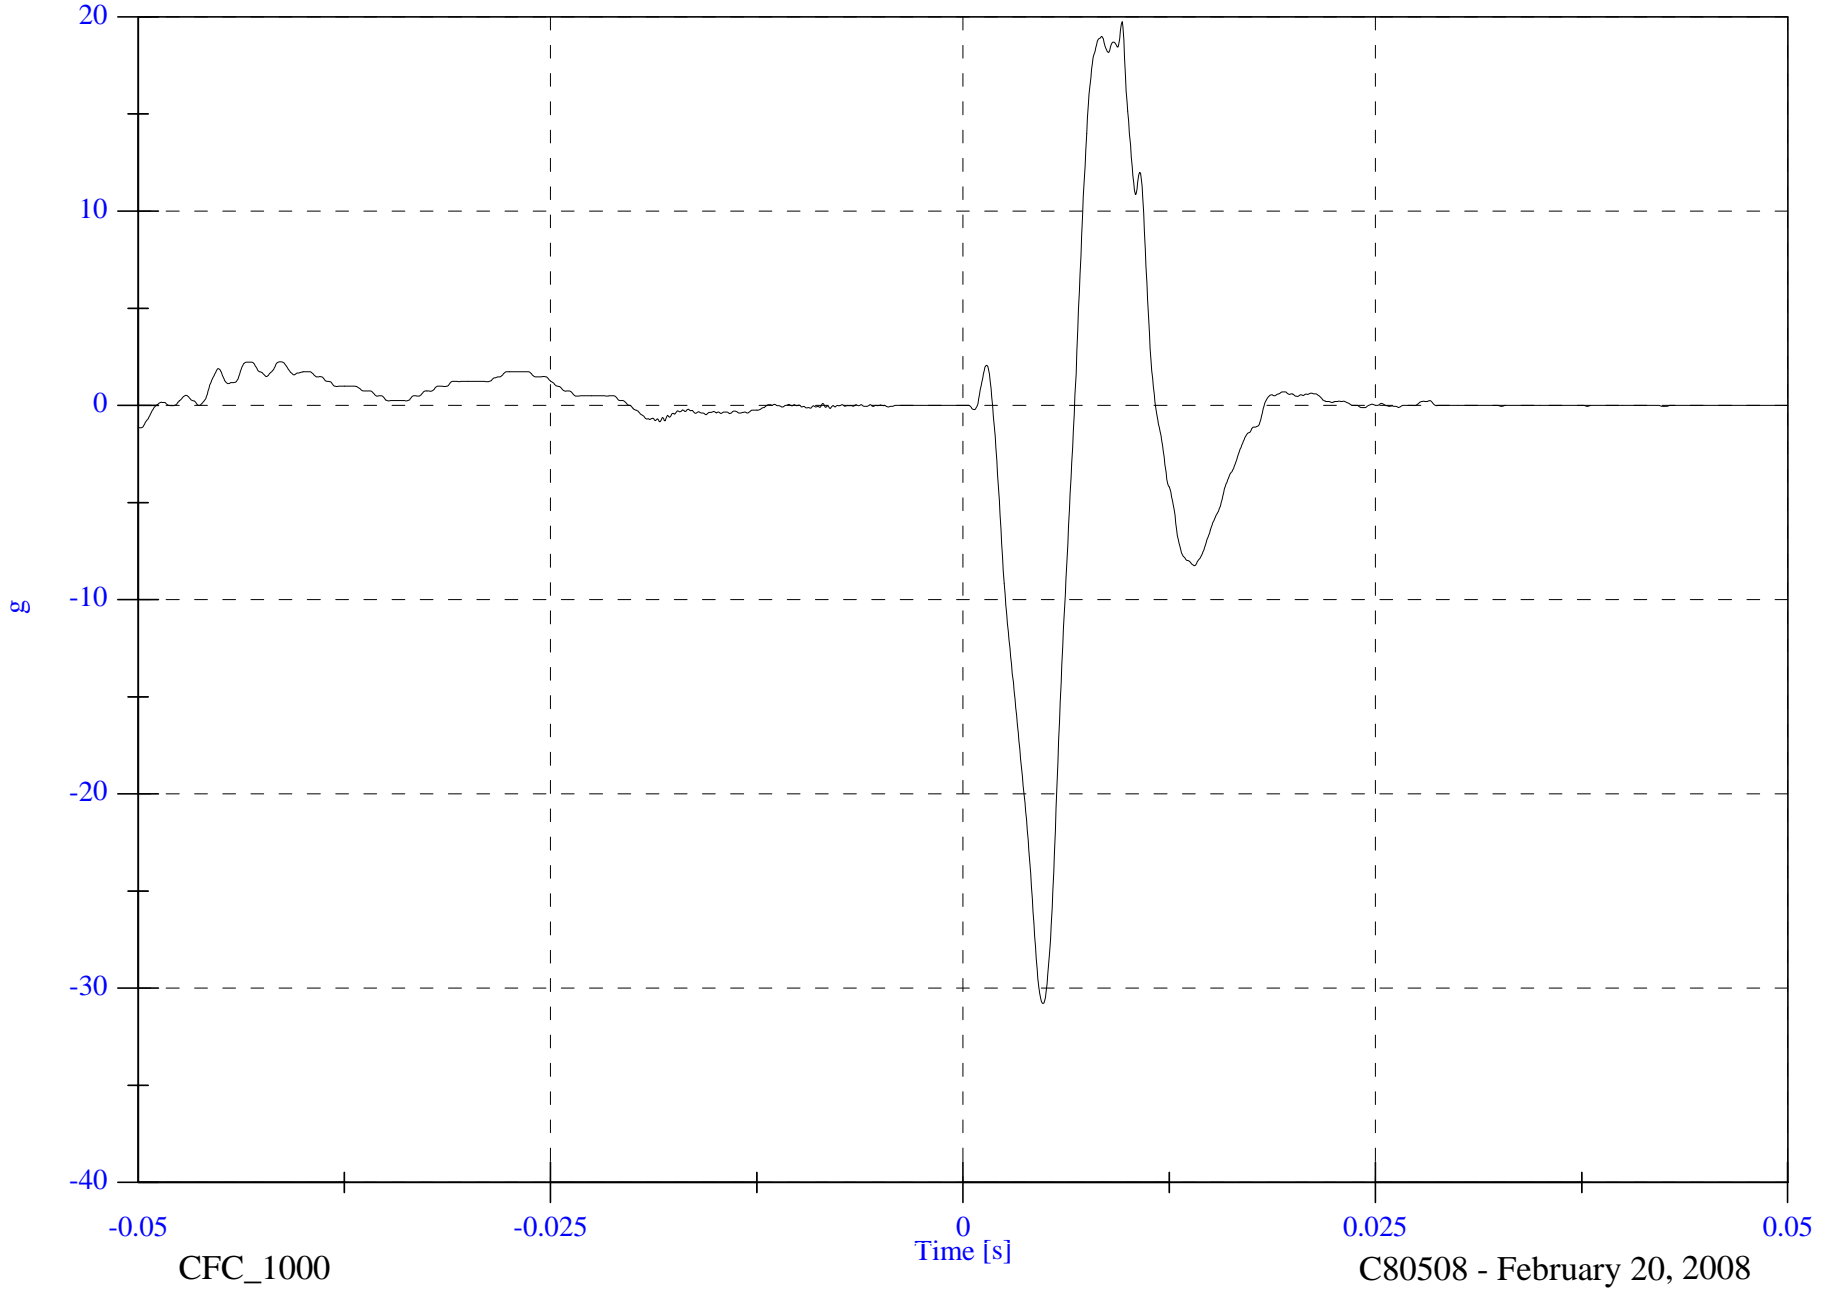
C80508 PASSENGER SIDE BP4 IMPACT PLOT #3

Headform Y Acceleration

Max: 19.7 [g] at 0.010 [s]

Min: -30.8 [g] at 0.005 [s]

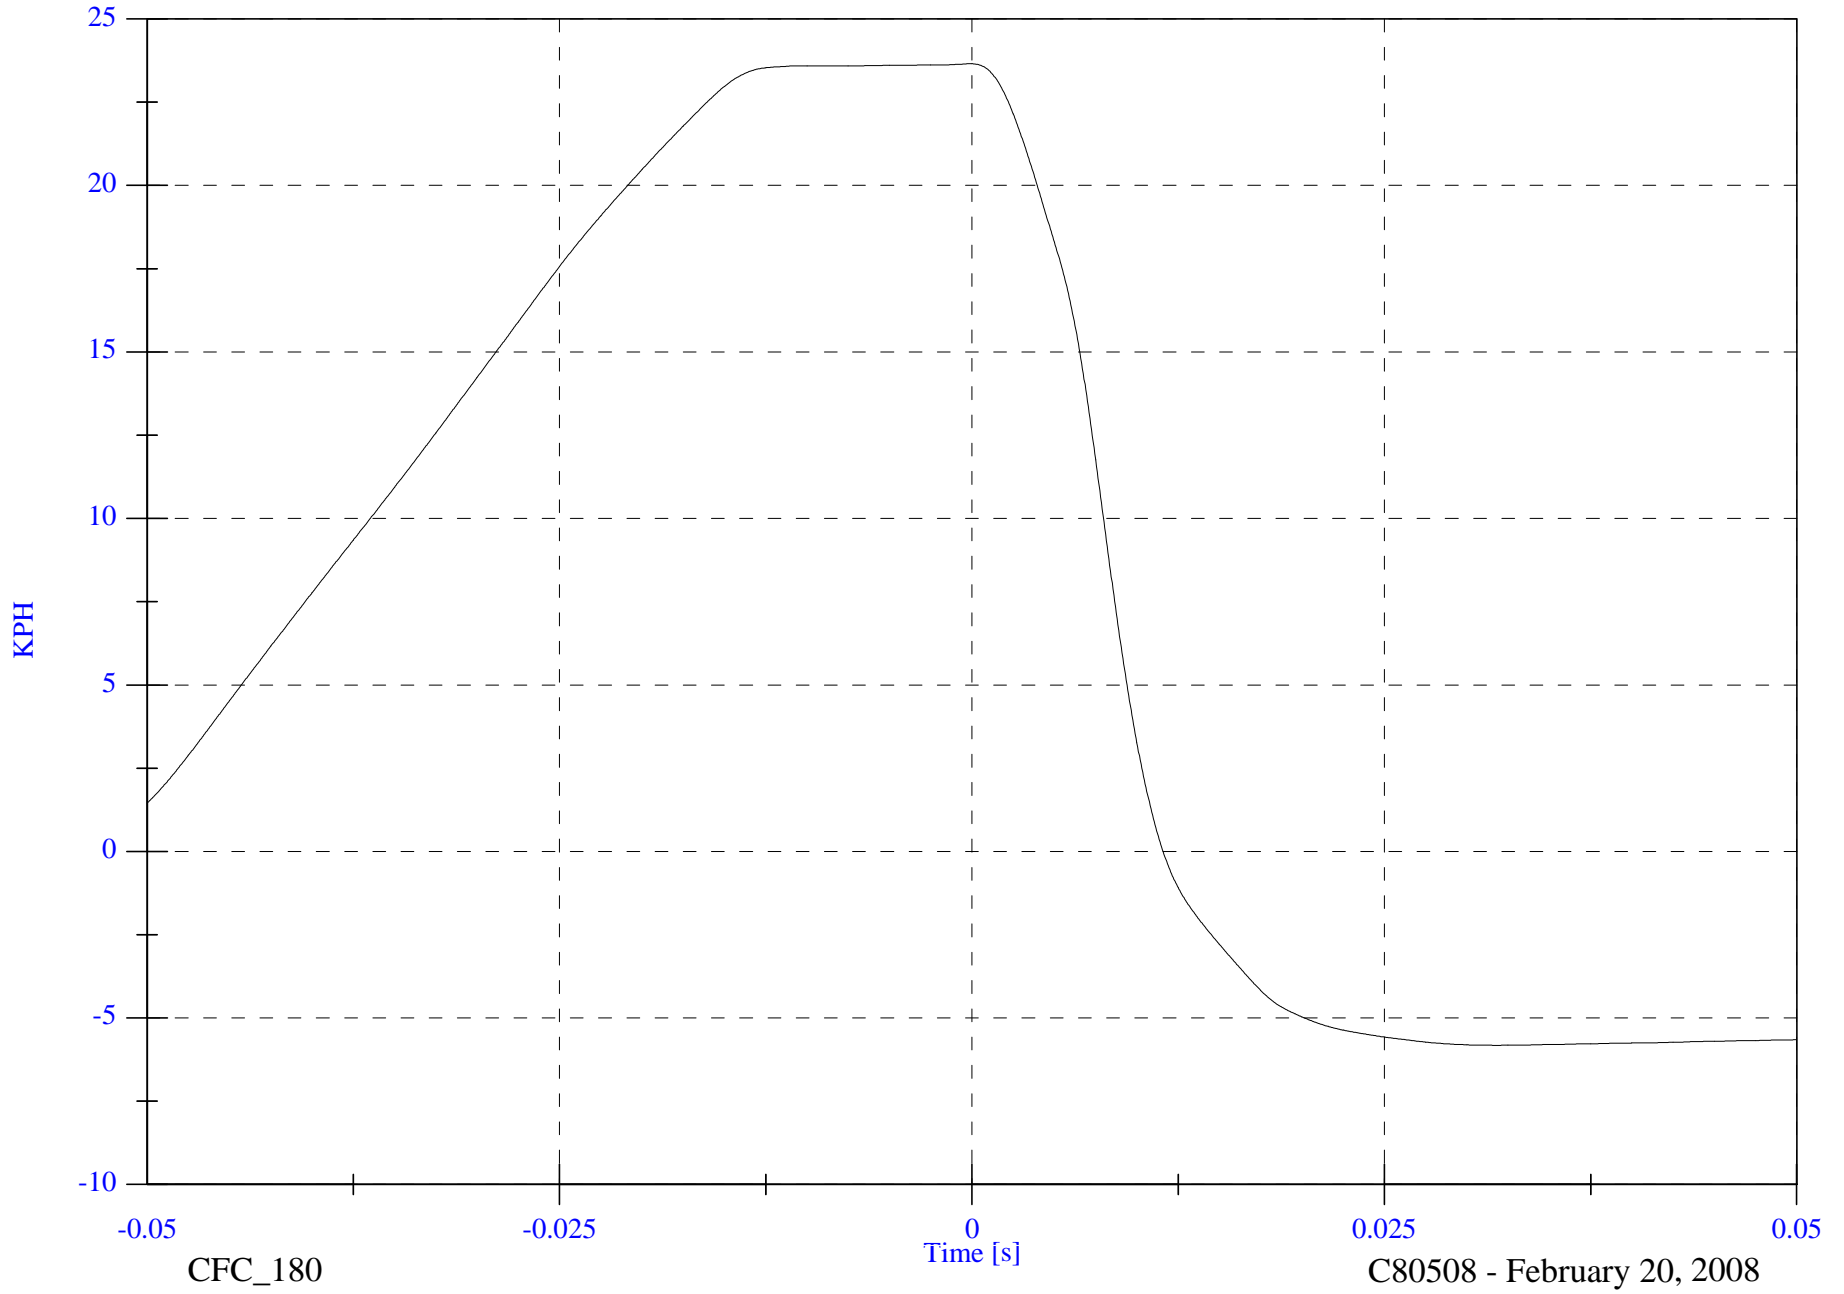
C80508 PASSENGER SIDE BP4 IMPACT PLOT #6

Max: 23.7 [KPH] at -0.000 [s]
Min: -5.8 [KPH] at 0.032 [s]

Headform Velocity

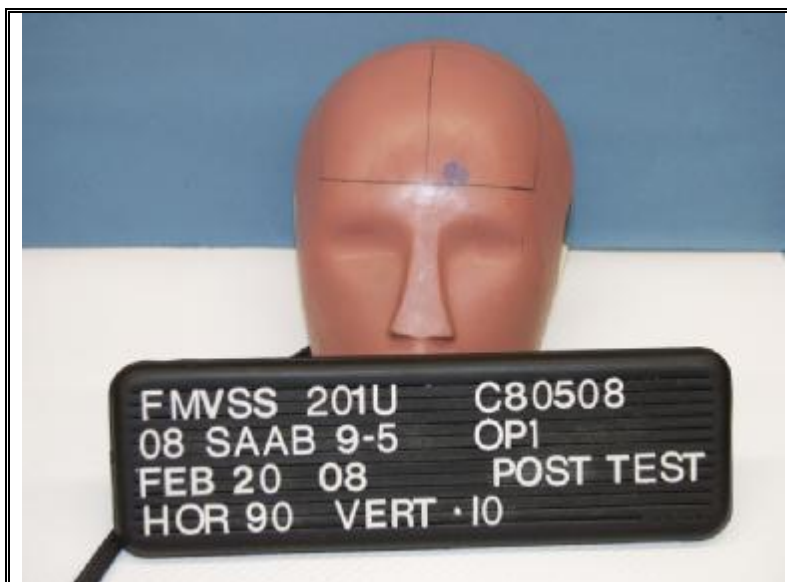
POST-IMPACT OP1 HEADFORM

Impact Point Description (from lower midpoint on midsagittal line)			
On Centerline	15	mm right	x mm left
On Centerline	5	mm up

Free Motion HIC	576.7
HIC(d)	601.5
Impact Velocity (kph)	23.56
HIC T1 (msec)	5.9
HIC T2 (msec)	13.8

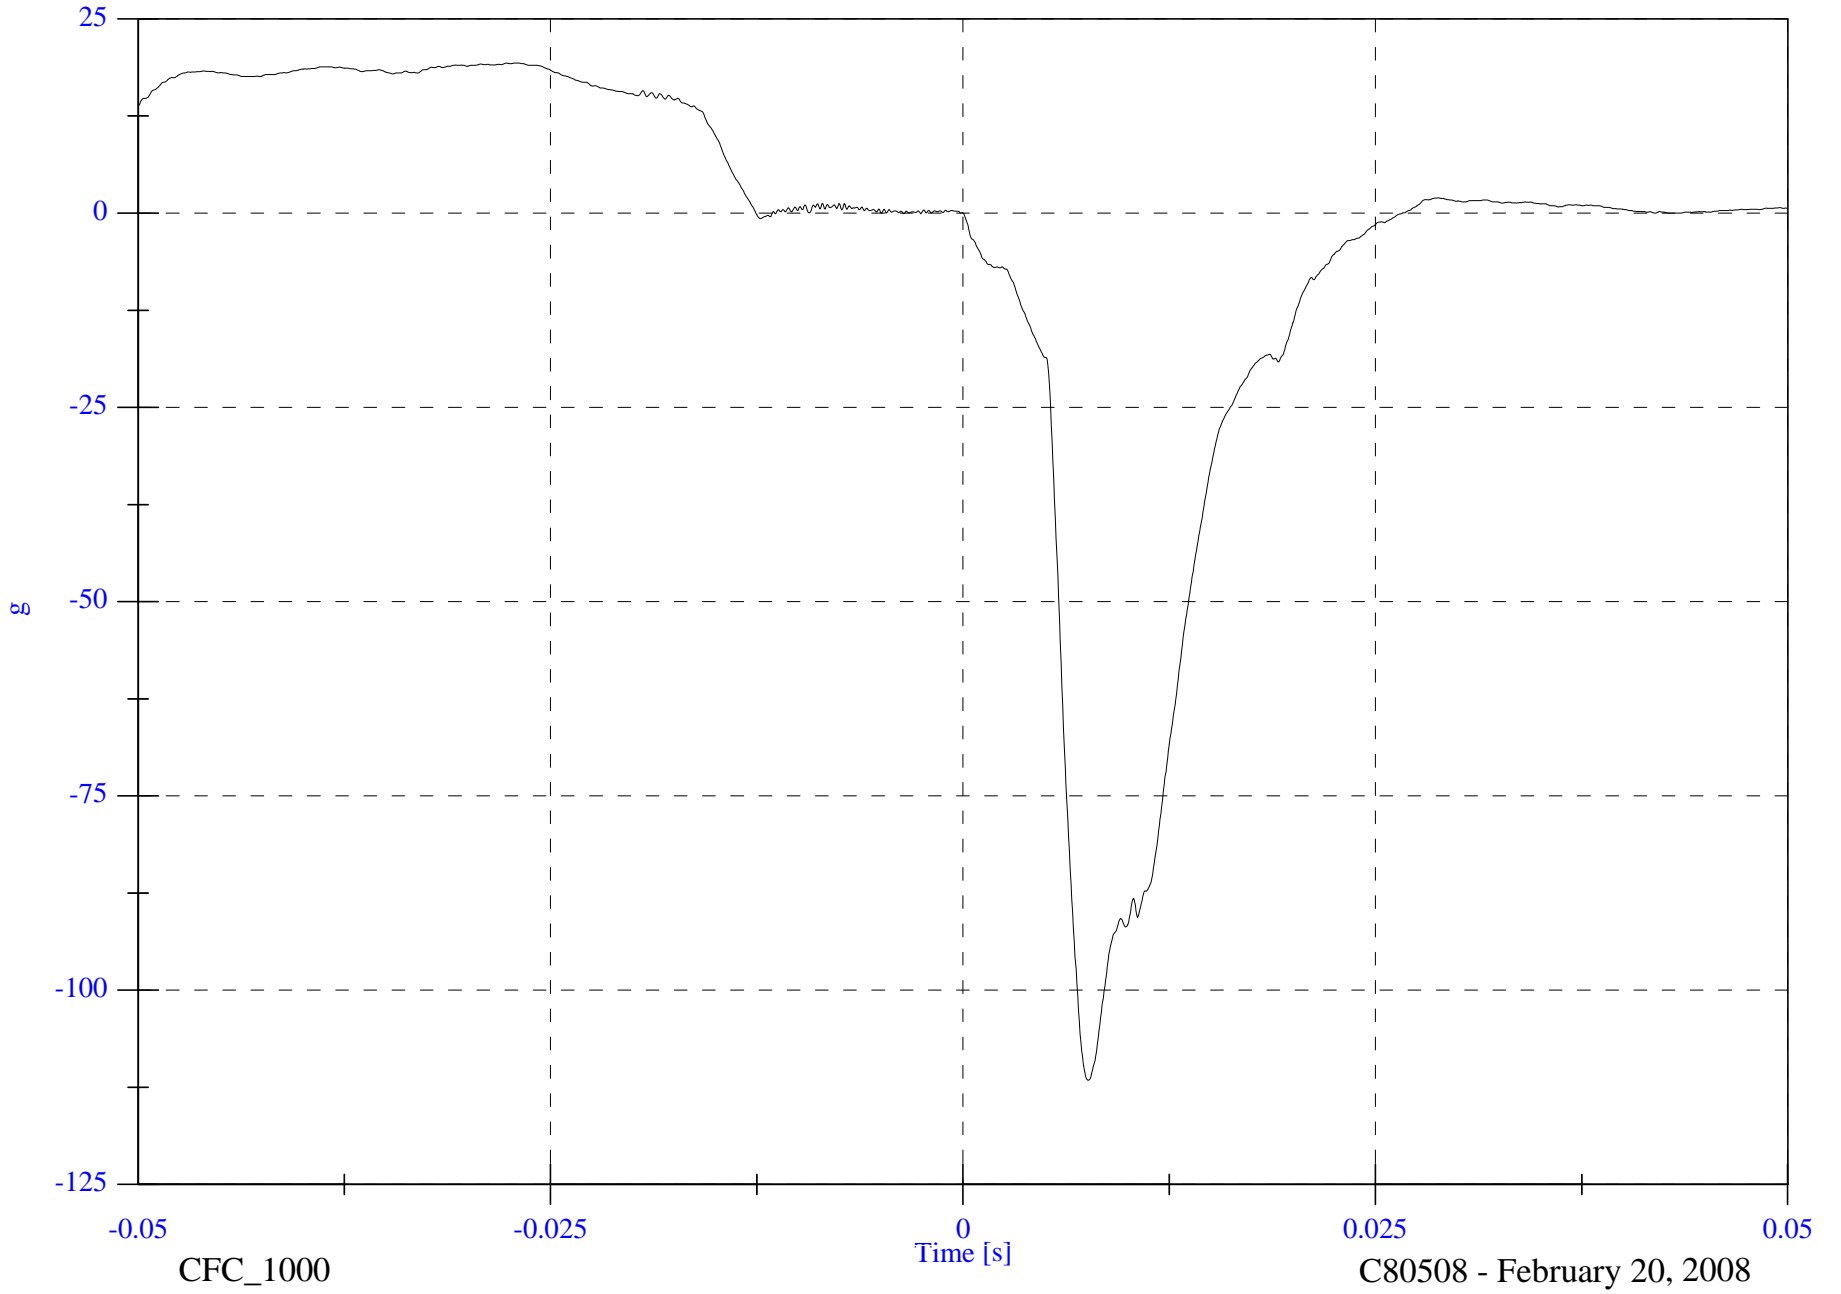
C80508 PASSENGER SIDE OP1 IMPACT PLOT #2

Max: 19.3 [g] at -0.027 [s]

Min: -111.6 [g] at 0.008 [s]

Headform X Acceleration

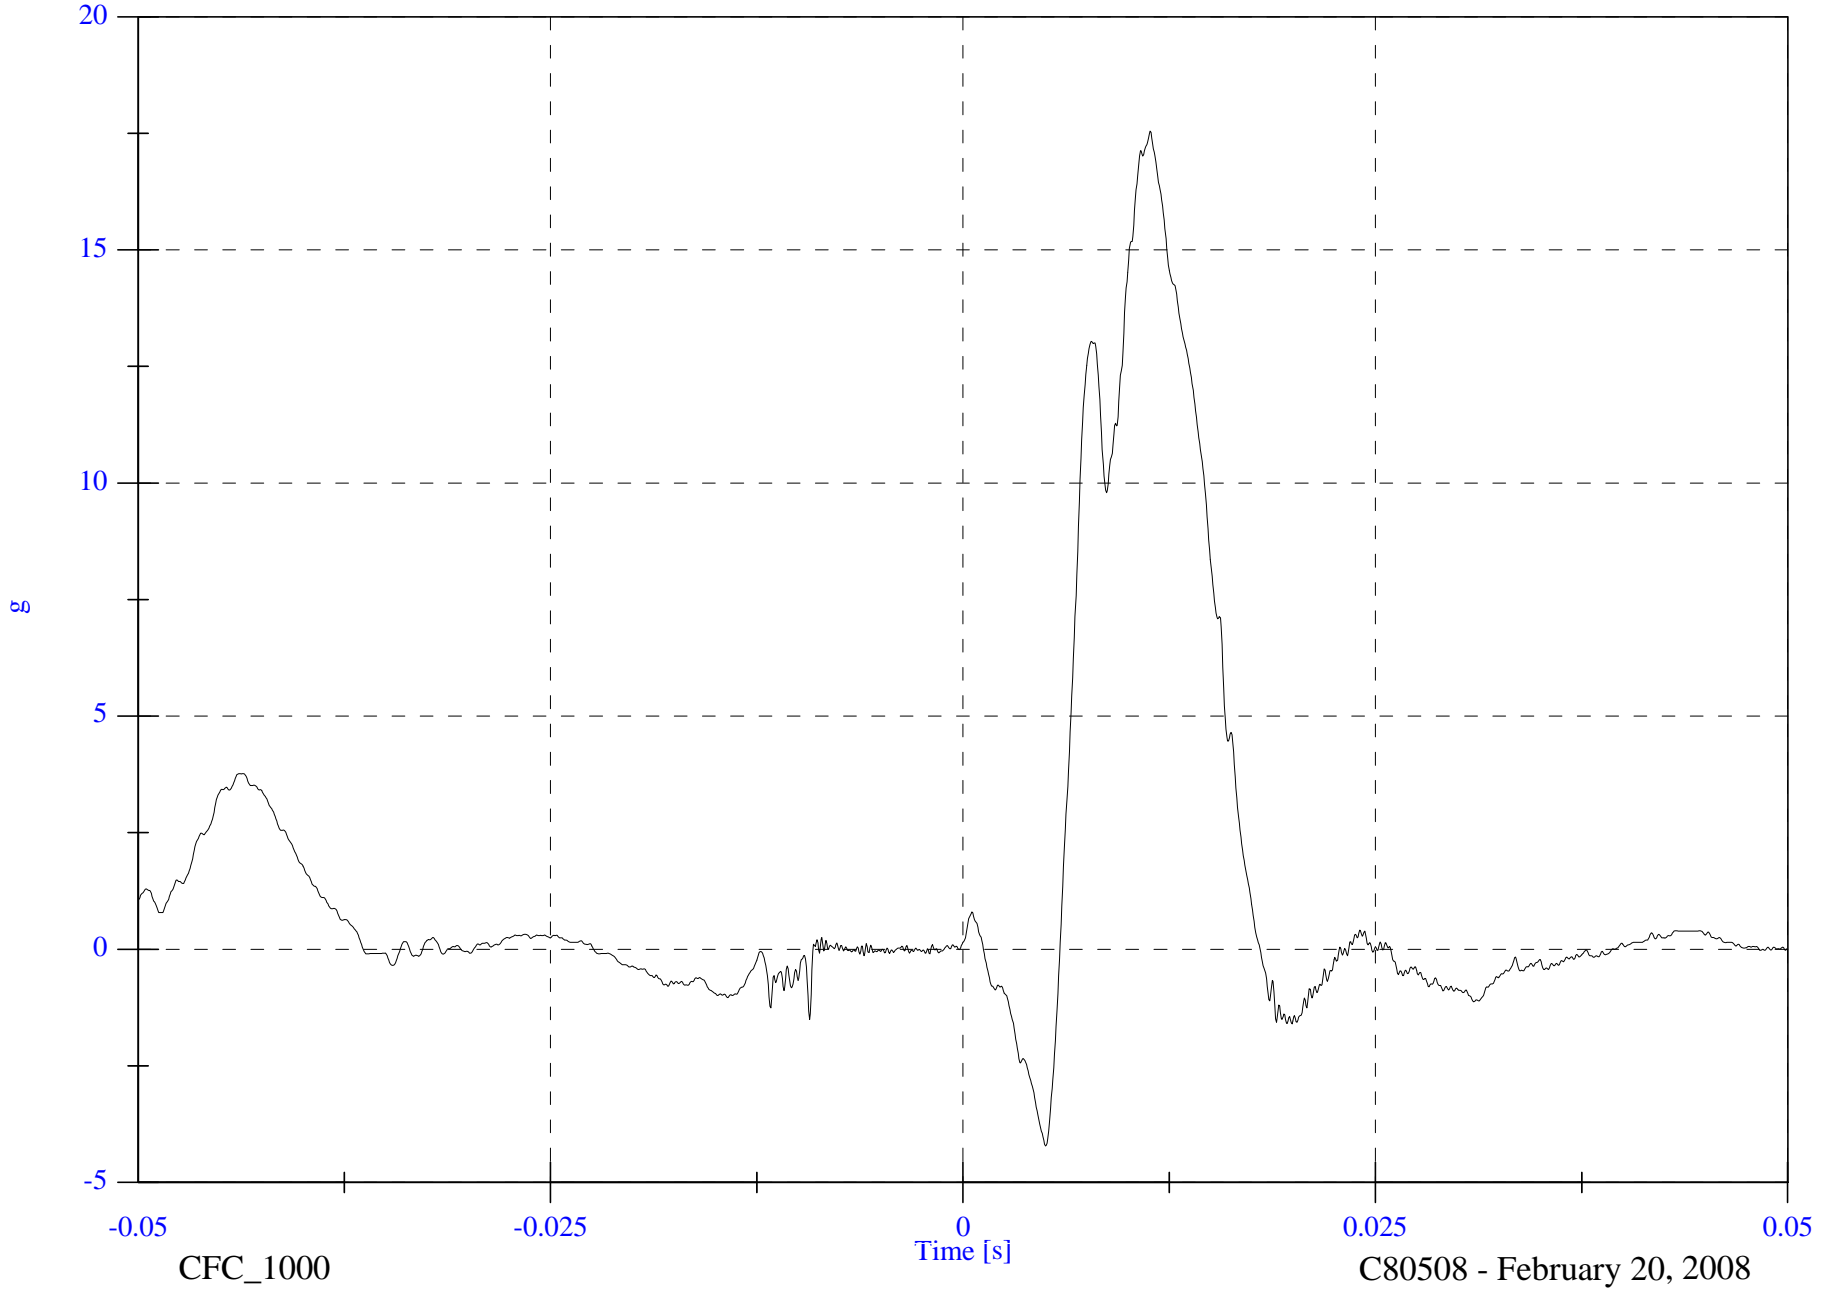
C80508 PASSENGER SIDE OP1 IMPACT PLOT #3

Headform Y Acceleration

Max: 17.6 [g] at 0.011 [s]
Min: -4.2 [g] at 0.005 [s]

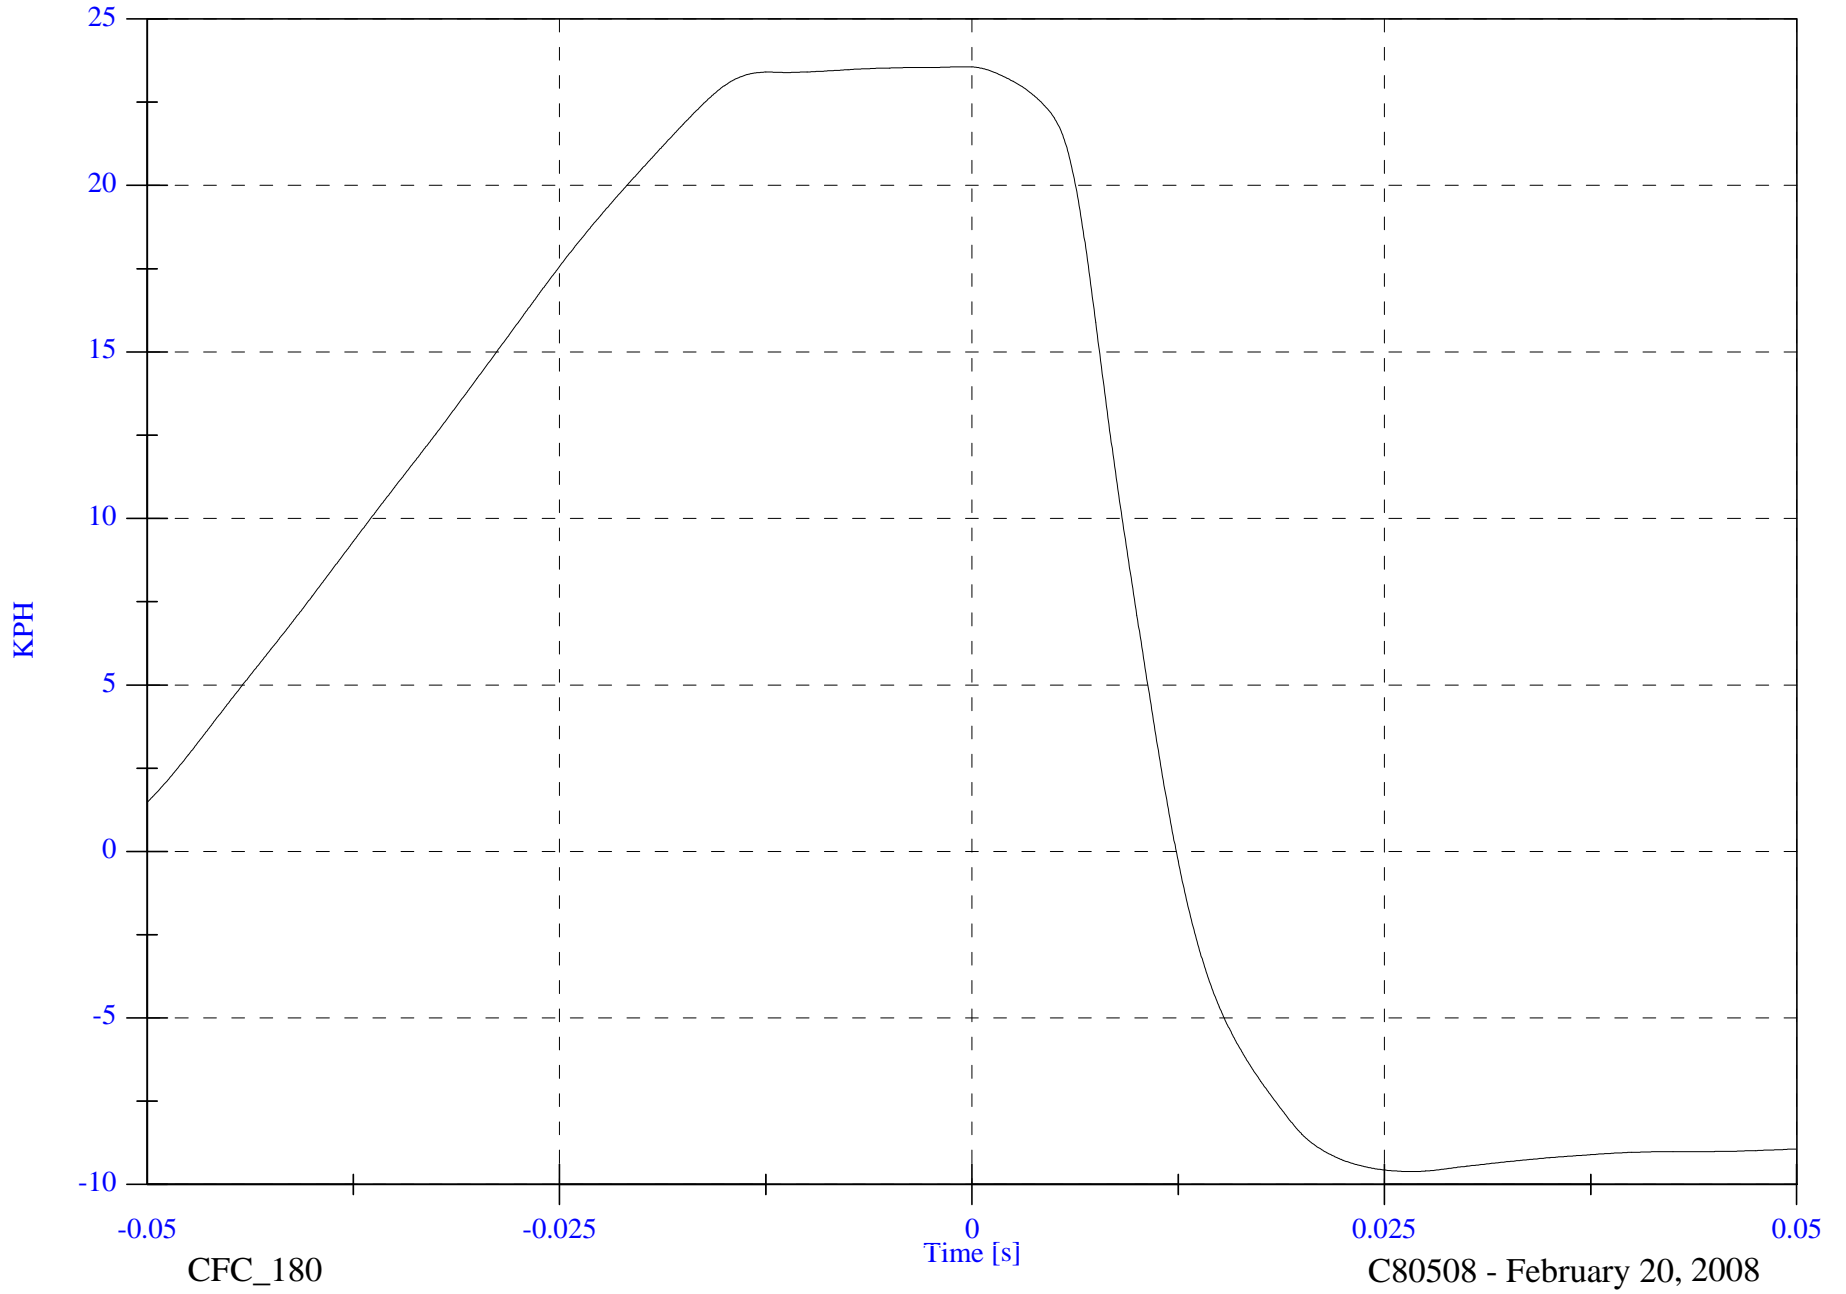
C80508 PASSENGER SIDE OP1 IMPACT PLOT #6

Headform Velocity

Max: 23.6 [KPH] at -0.000 [s]

Min: -9.6 [KPH] at 0.027 [s]

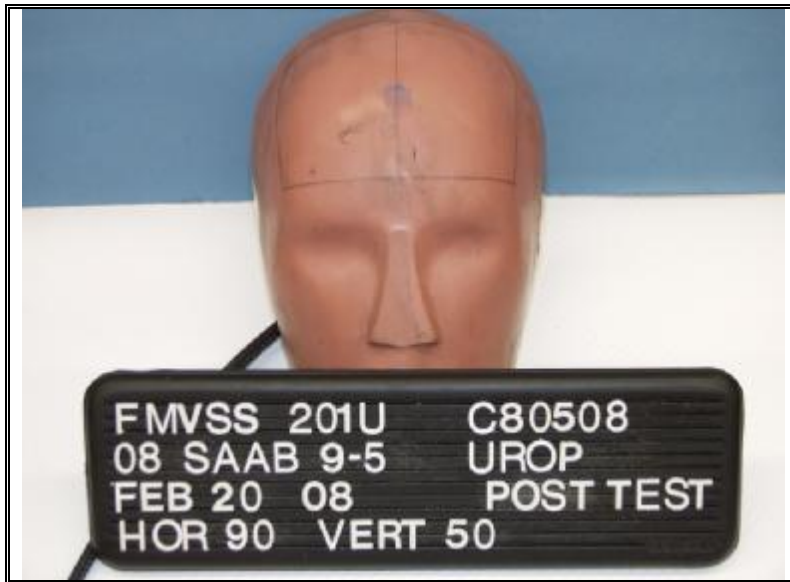
POST-IMPACT UROP HEADFORM

Impact Point Description (from lower midpoint on midsagittal line)			
On Centerline	0	<input type="checkbox"/>	mm right <input type="checkbox"/> mm left
On Centerline	40		mm up

Free Motion HIC	487.2
HIC(d)	533.9
Impact Velocity (kph)	23.88
HIC T1 (msec)	10.7
HIC T2 (msec)	15.7

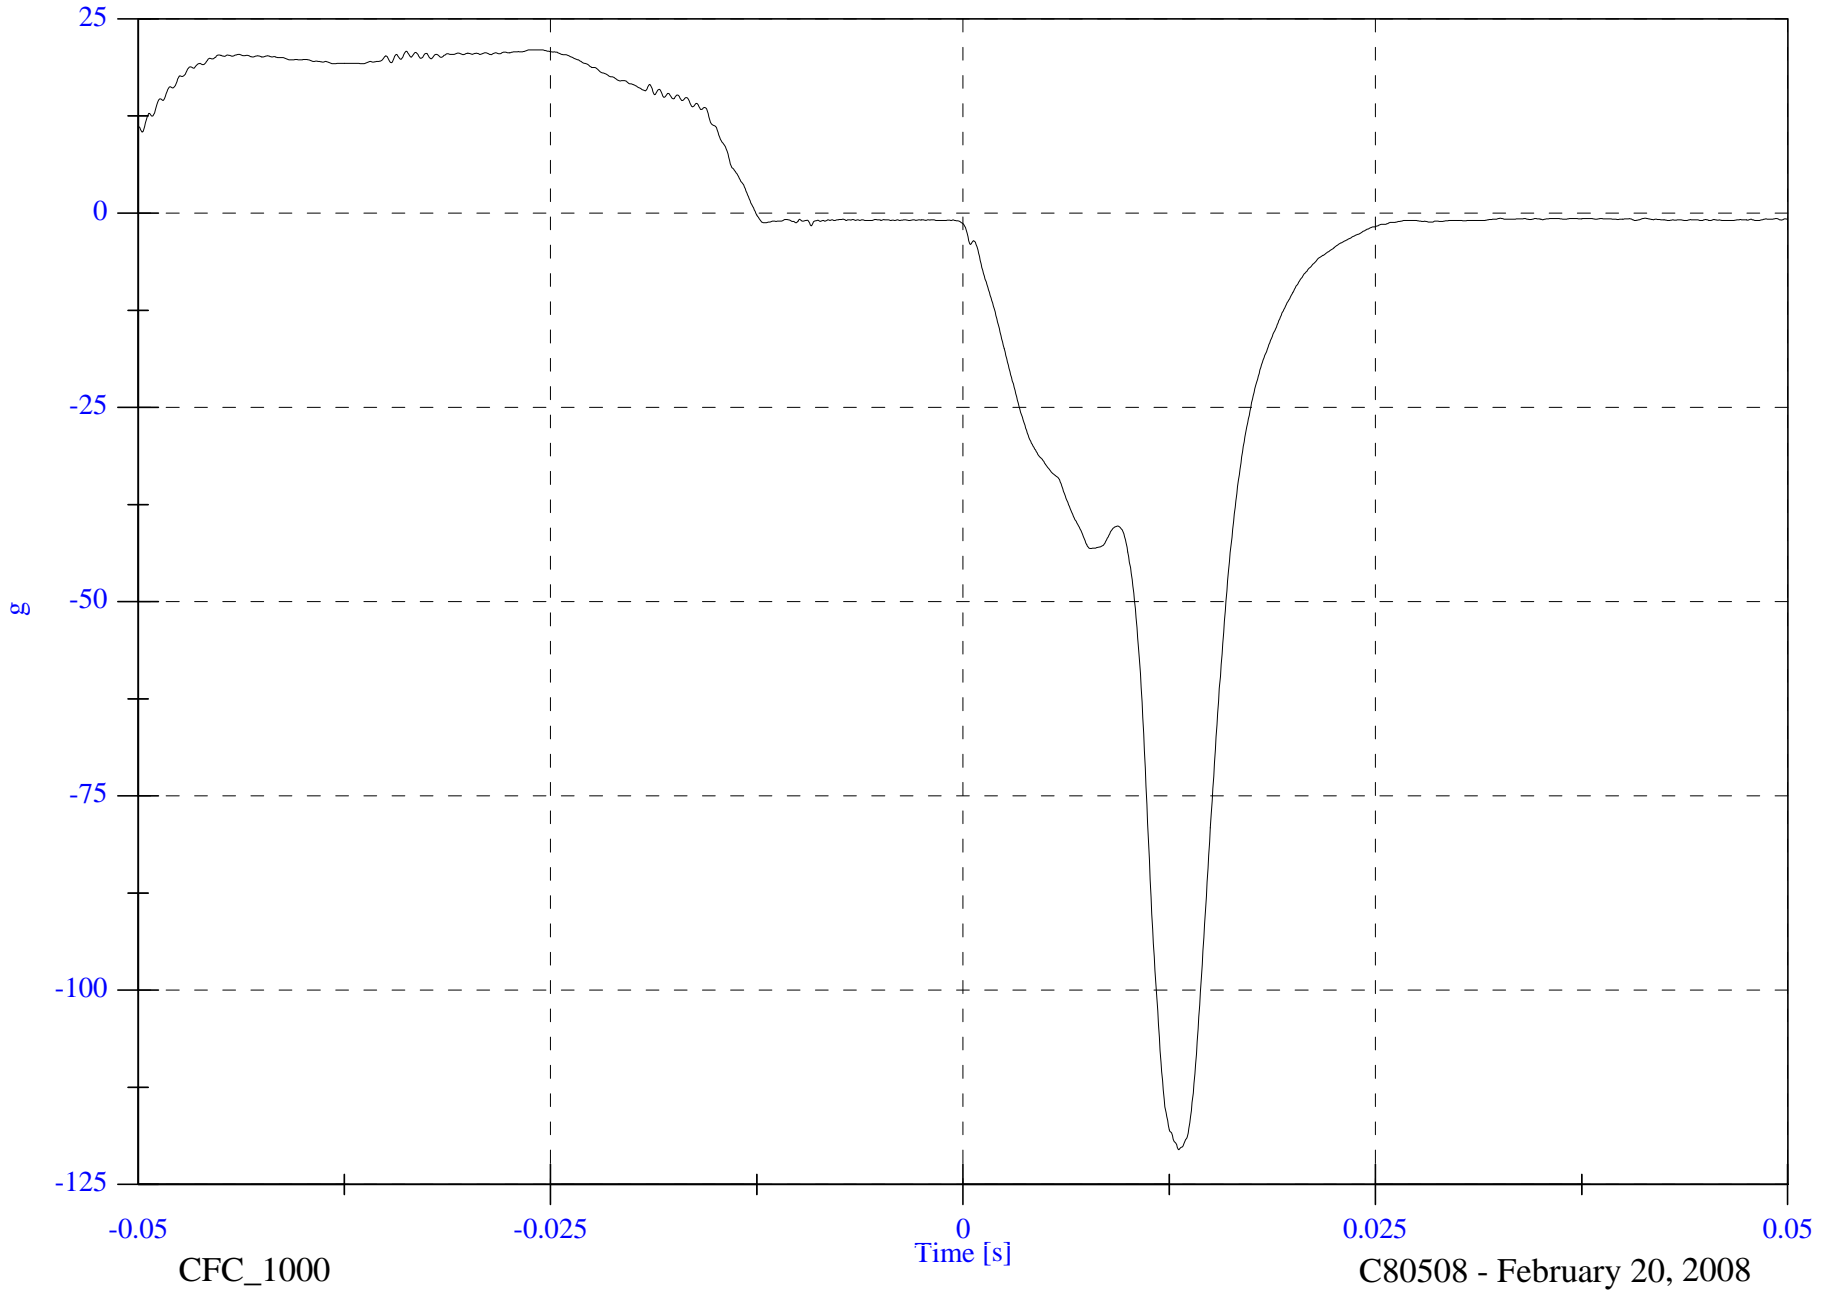
C80508 PASSENGER SIDE UROP IMPACT PLOT #4

Headform X Acceleration

Max: 21.0 [g] at -0.026 [s]

Min: -120.5 [g] at 0.013 [s]

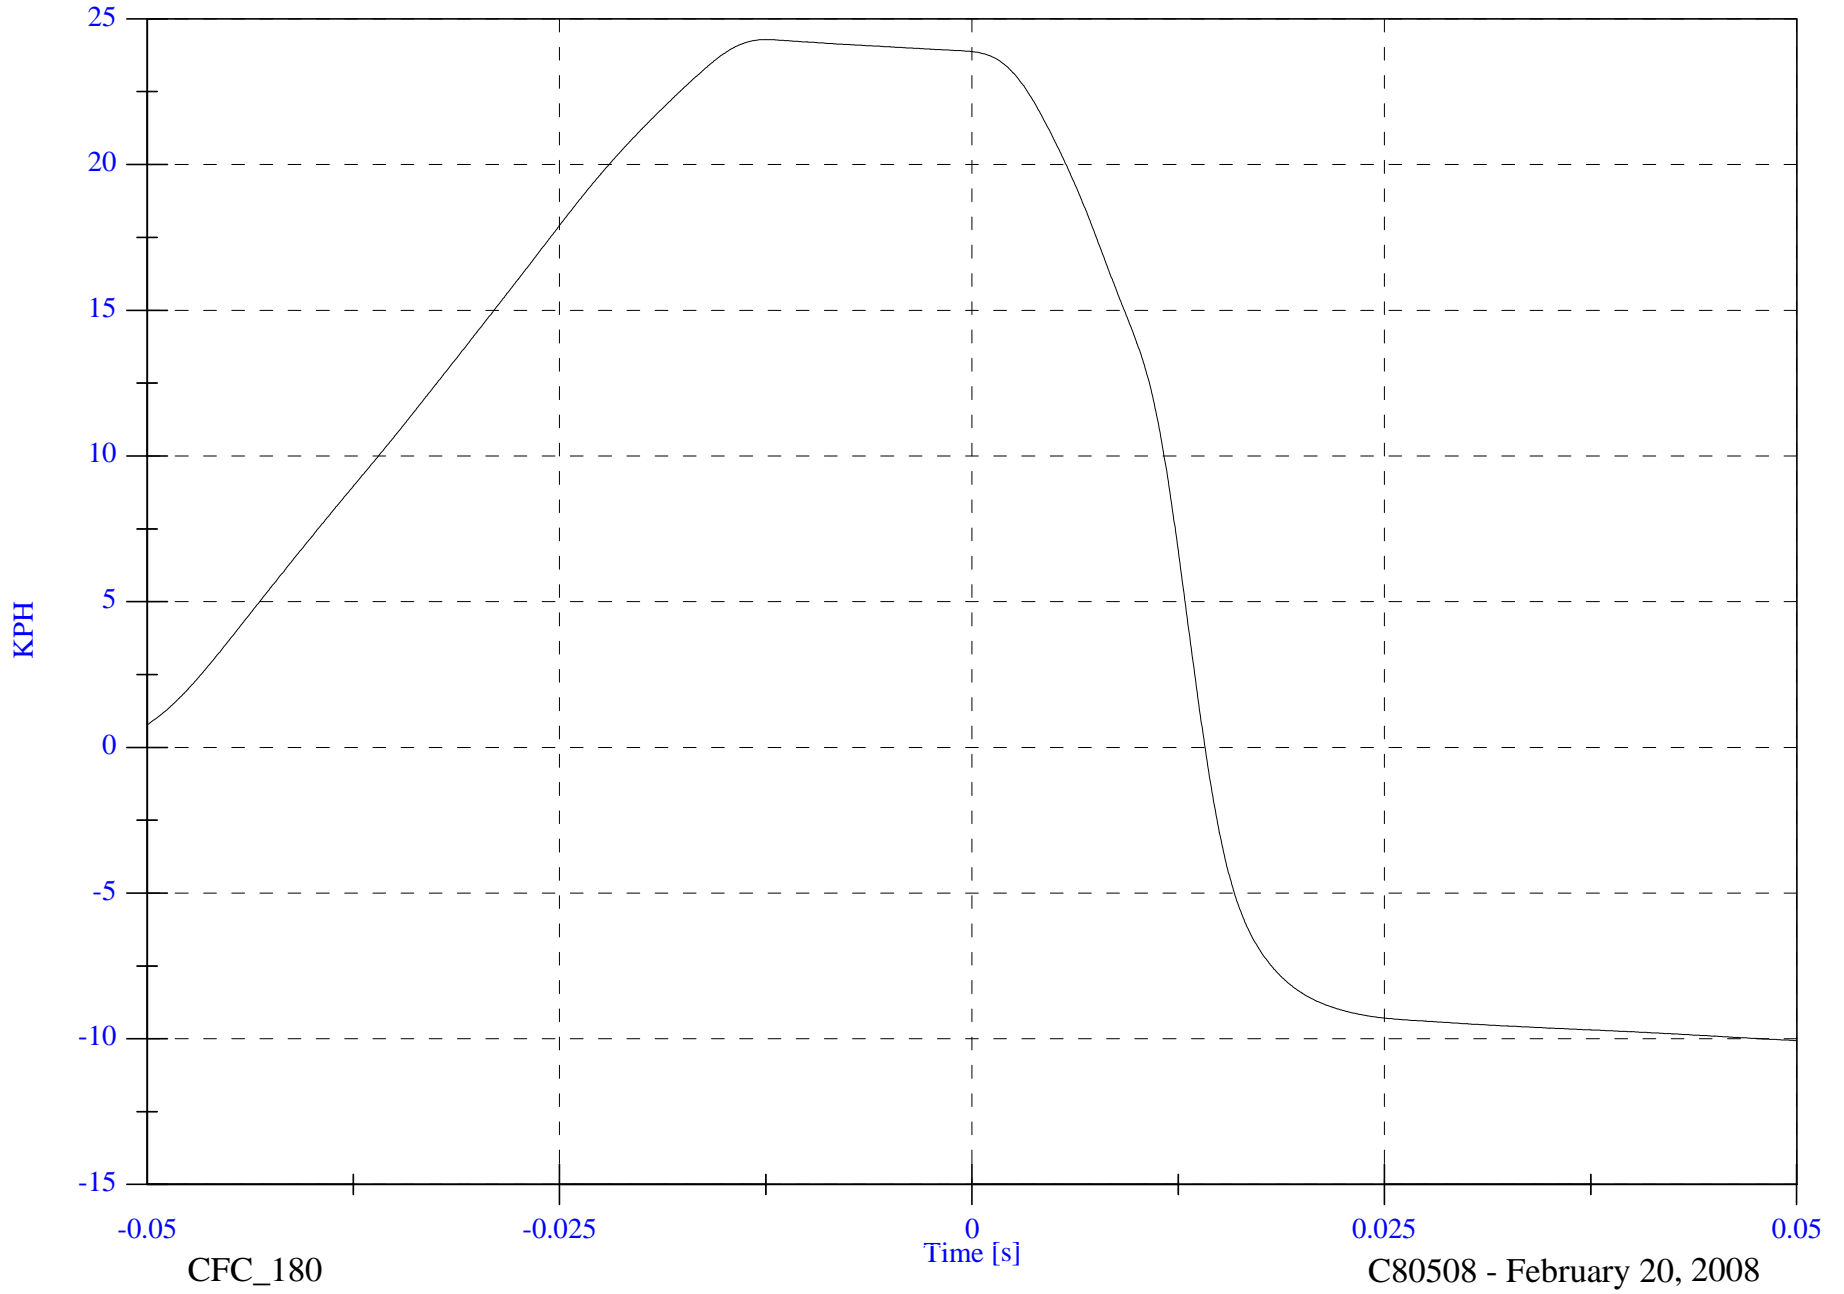
C80508 PASSENGER SIDE UROP IMPACT PLOT #8

Max: 24.3 [KPH] at -0.012 [s]
Min: -10.1 [KPH] at 0.050 [s]

Headform Velocity

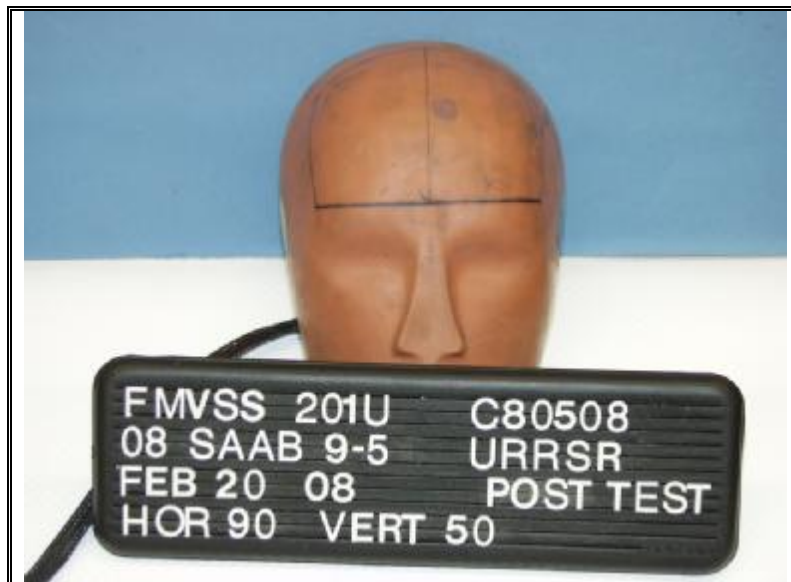
POST-IMPACT URRSR HEADFORM

Impact Point Description (from lower midpoint on midsagittal line)			
On Centerline	9	mm right	x mm left
On Centerline	47	mm up

Free Motion HIC	637.4
HIC(d)	647.3
Impact Velocity (kph)	23.8
HIC T1 (msec)	5.9
HIC T2 (msec)	14.6
