REPORT NUMBER: 201UI-CAL-08-03

**SAFETY COMPLIANCE TESTING FOR FMVSS 201
OCCUPANT PROTECTION IN INTERIOR IMPACT
UPPER INTERIOR HEAD IMPACT PROTECTION**

**SAAB AUTOMOBILE AB
2008 SAAB 9-5 WAGON**

NHTSA NUMBER: C80508

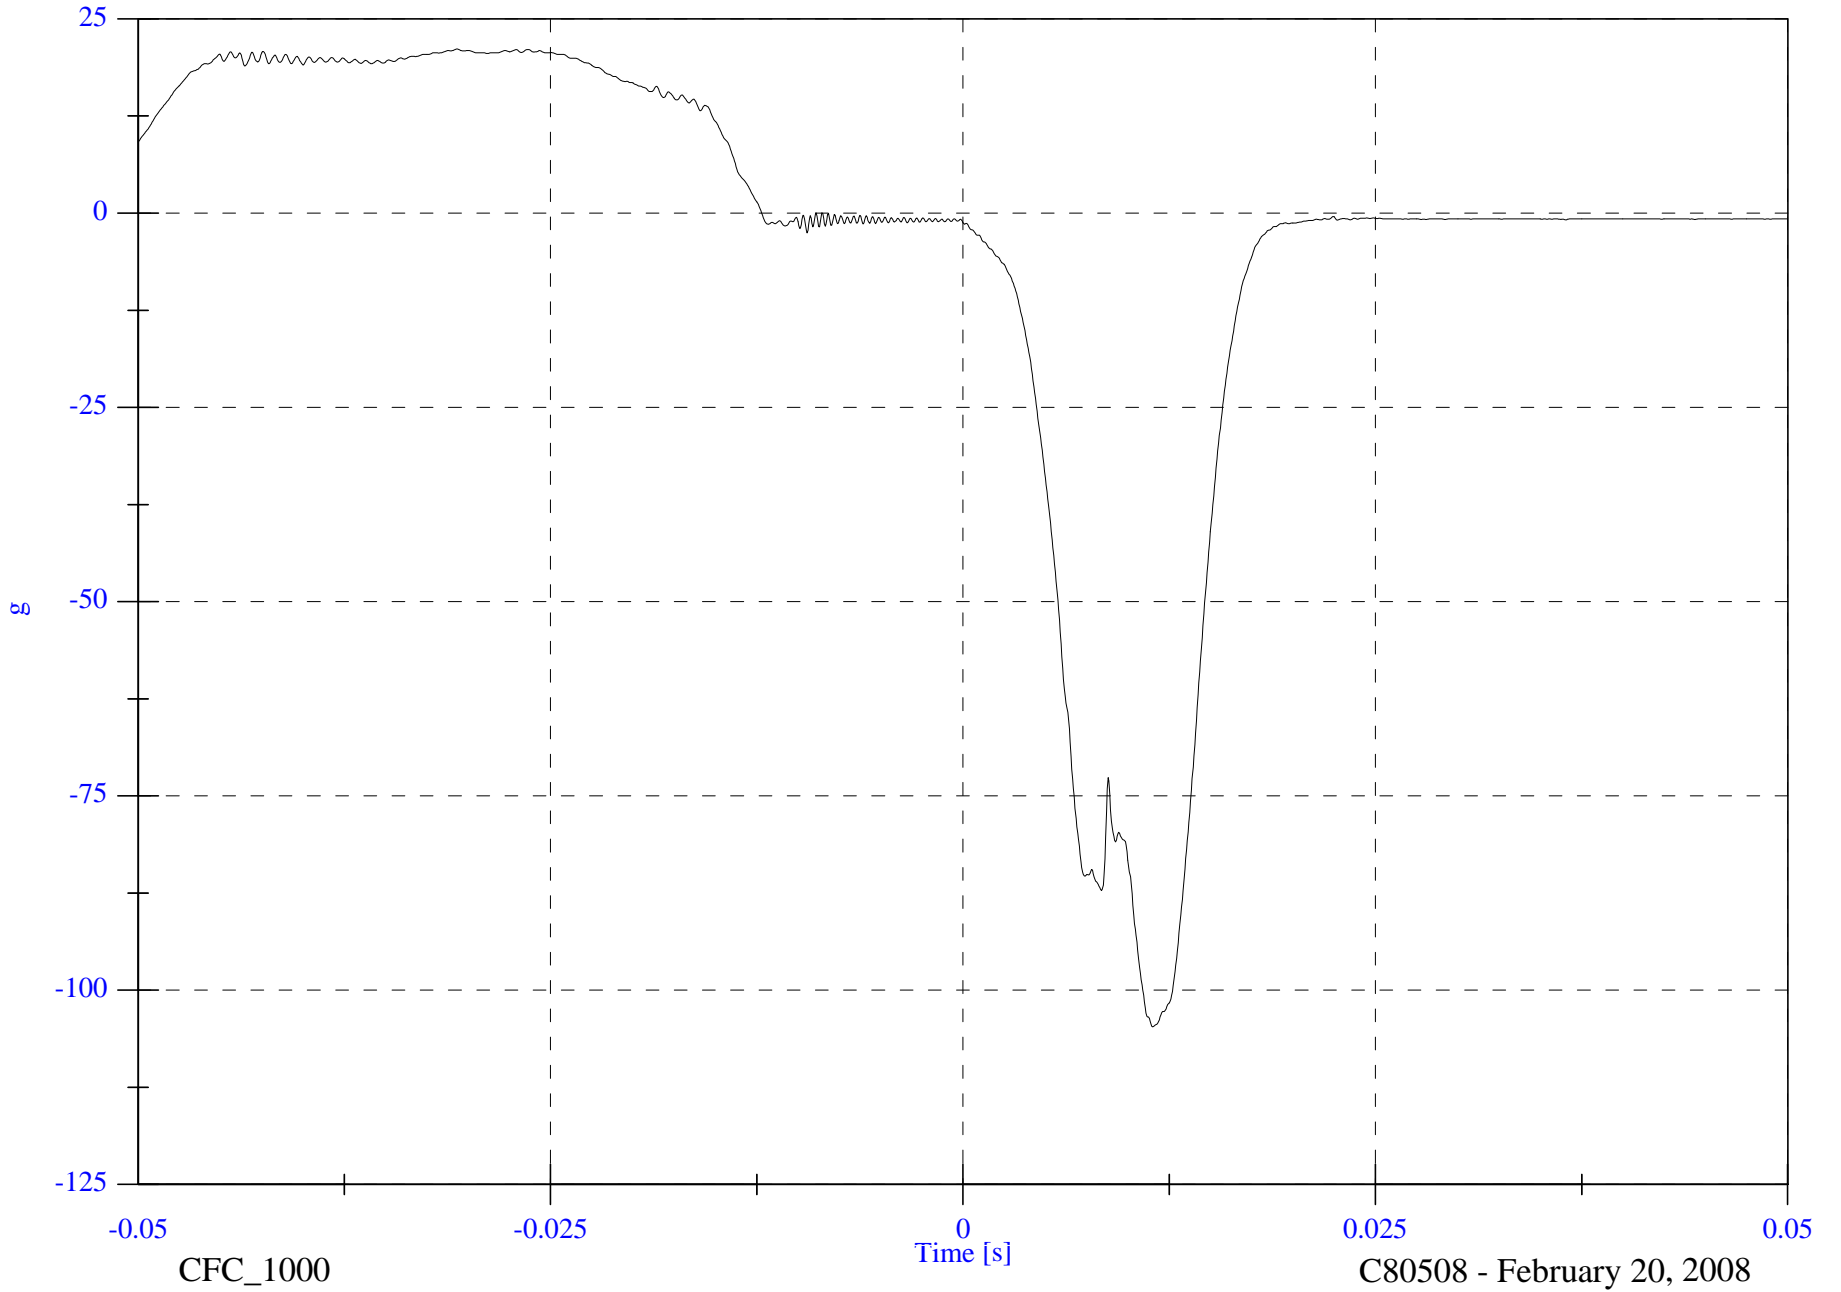
C80508 PASSENGER SIDE URRSR IMPACT PLOT #2

Max: 21.1 [g] at -0.031 [s]

Min: -104.7 [g] at 0.012 [s]

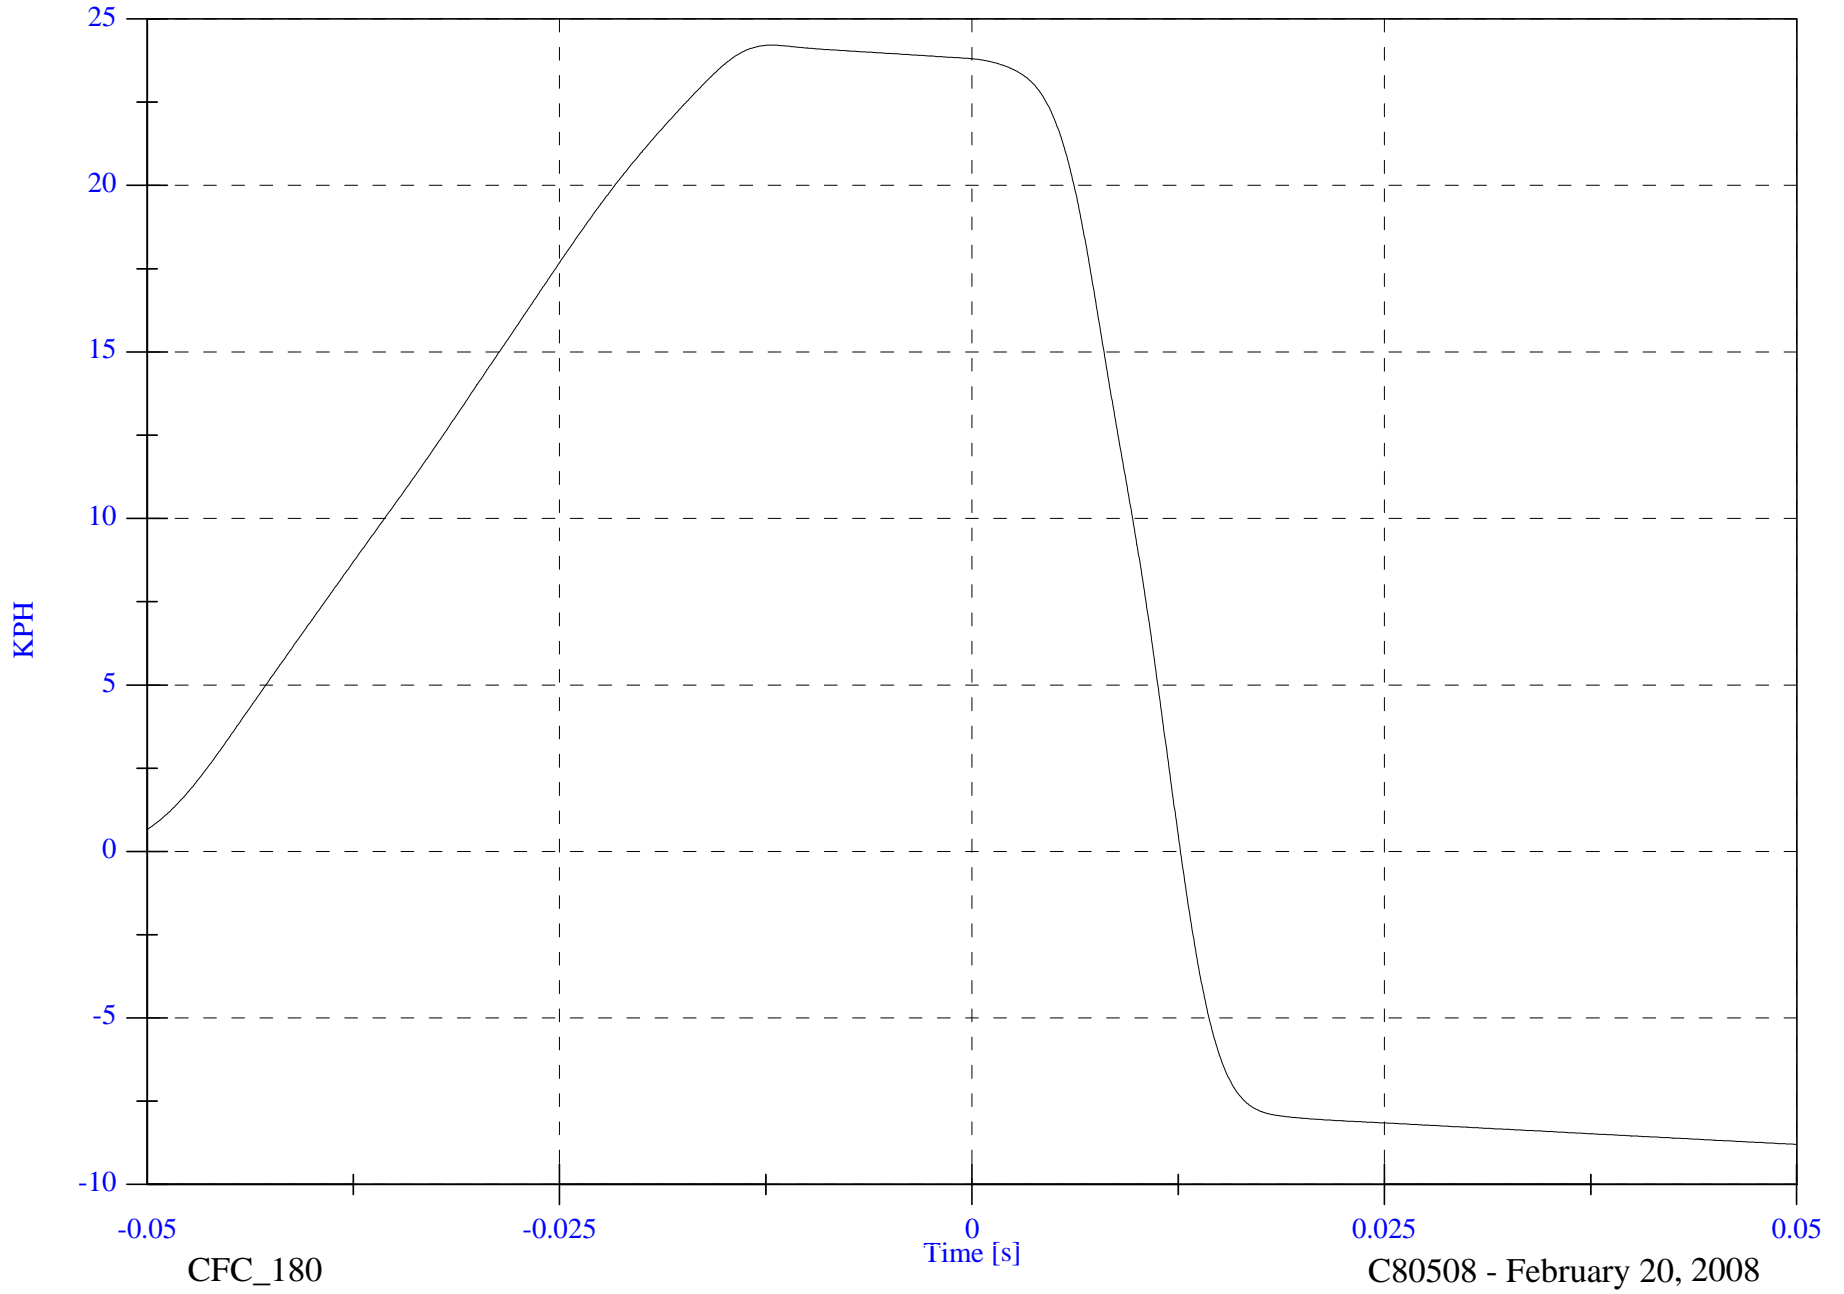
C80508 PASSENGER SIDE URRSR IMPACT PLOT #6

Max: 24.2 [KPH] at -0.012 [s]
Min: -8.8 [KPH] at 0.050 [s]

Headform Velocity

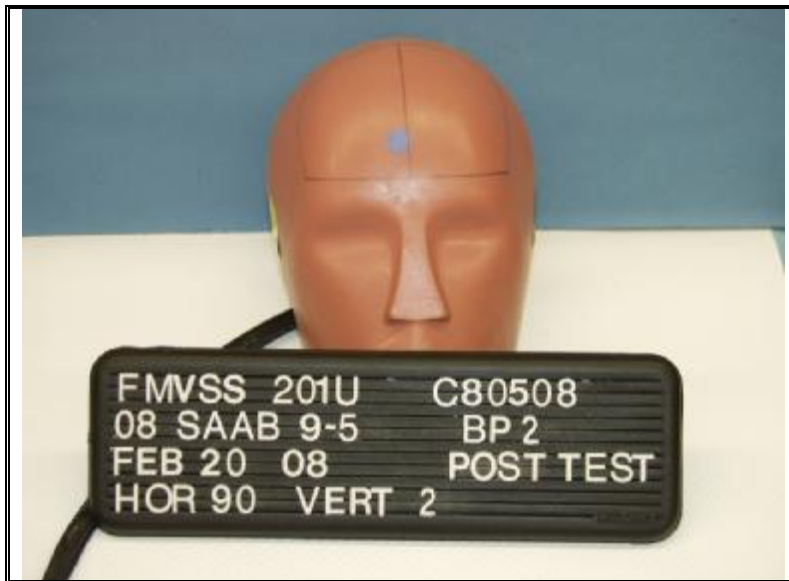
POST-IMPACT BP2 HEADFORM

Impact Point Description (from lower midpoint on midsagittal line)					
On Centerline	5	<input checked="" type="checkbox"/>	mm right	<input type="checkbox"/>	mm left
On Centerline	19				mm up

Free Motion HIC	693.5
HIC(d)	689.6
Impact Velocity (kph)	23.53
HIC T1 (msec)	3.8
HIC T2 (msec)	10.6

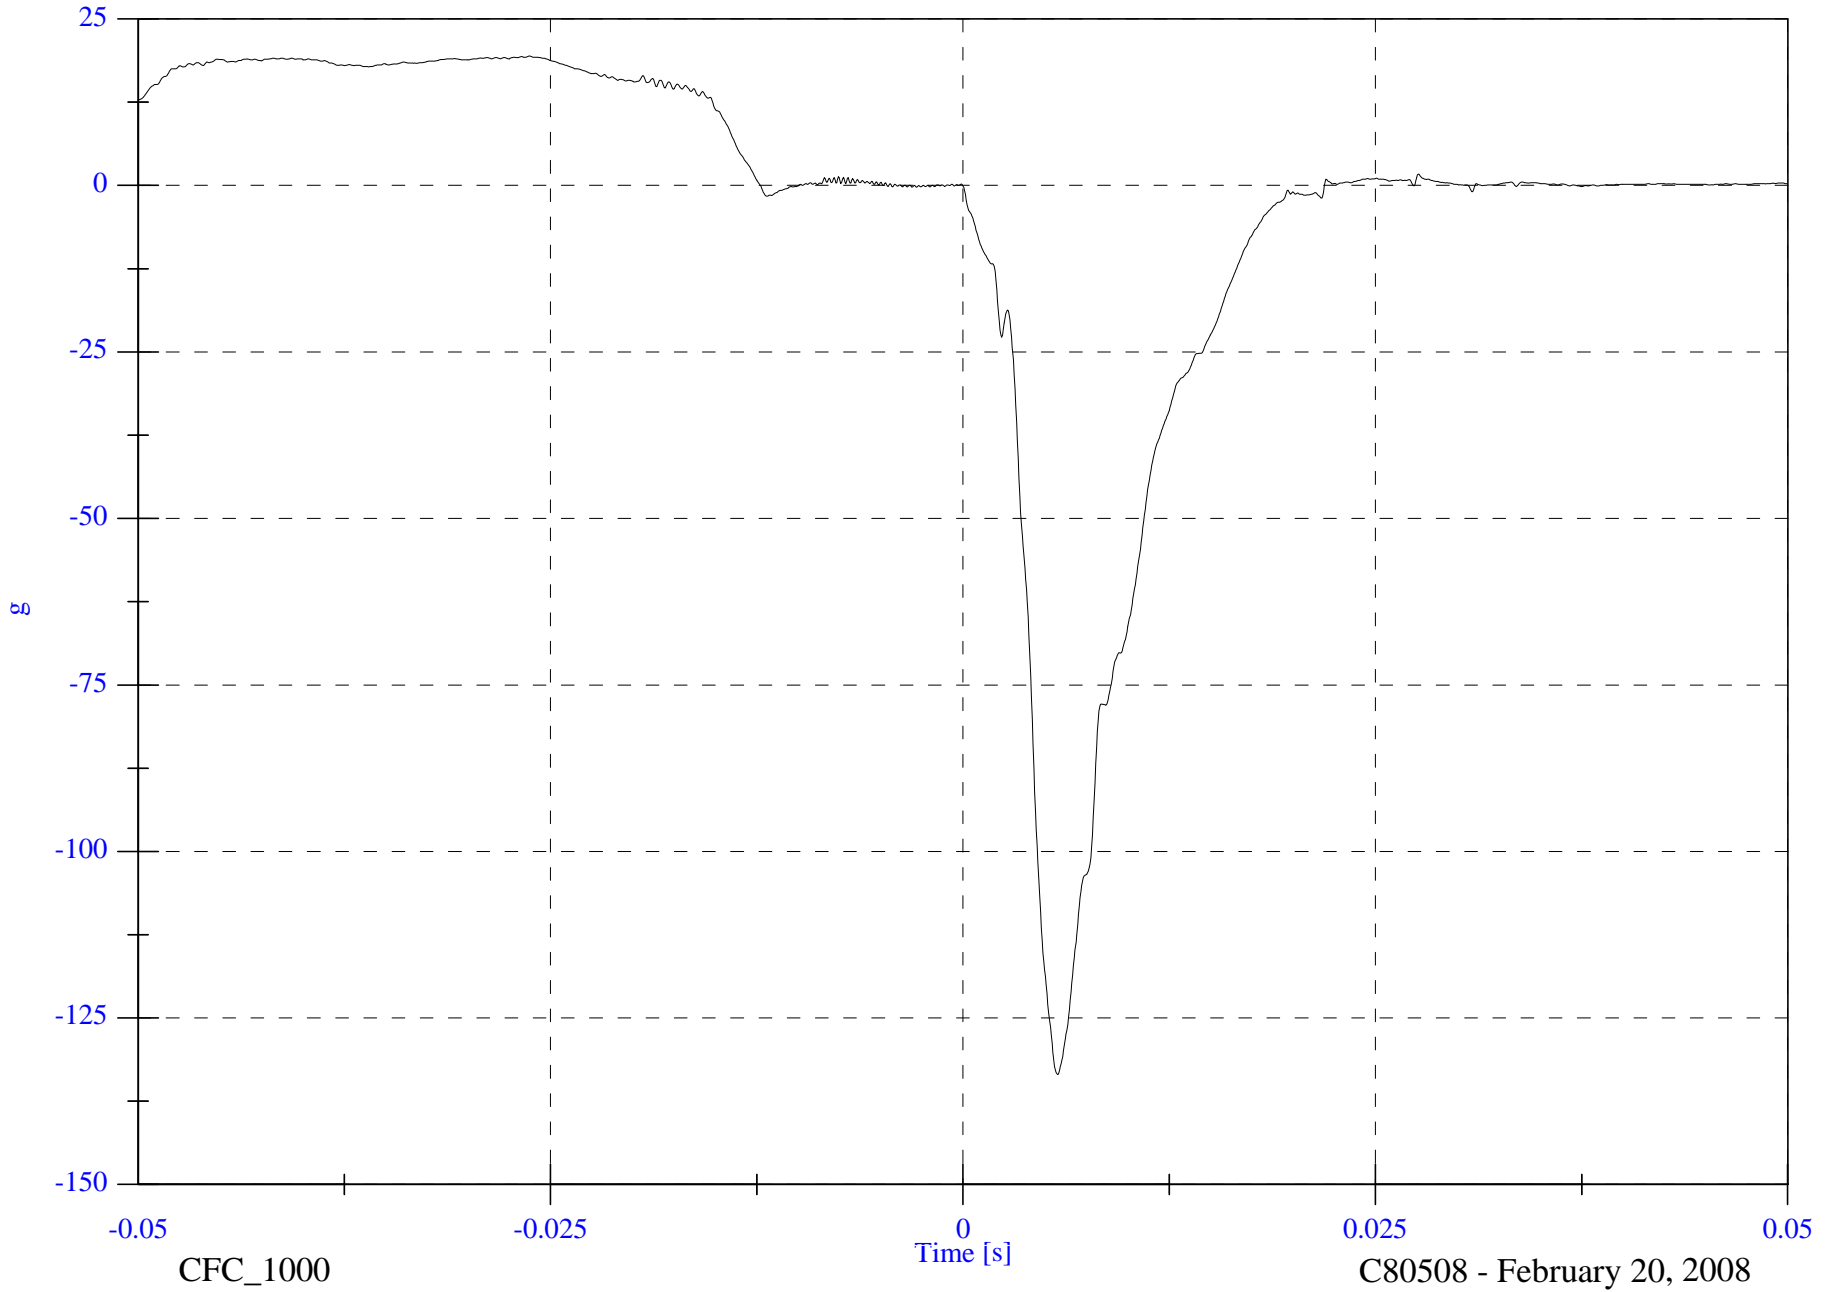
C80508 PASSENGER SIDE BP2 IMPACT PLOT #2

Max: 19.4 [g] at -0.026 [s]

Min: -133.5 [g] at 0.006 [s]

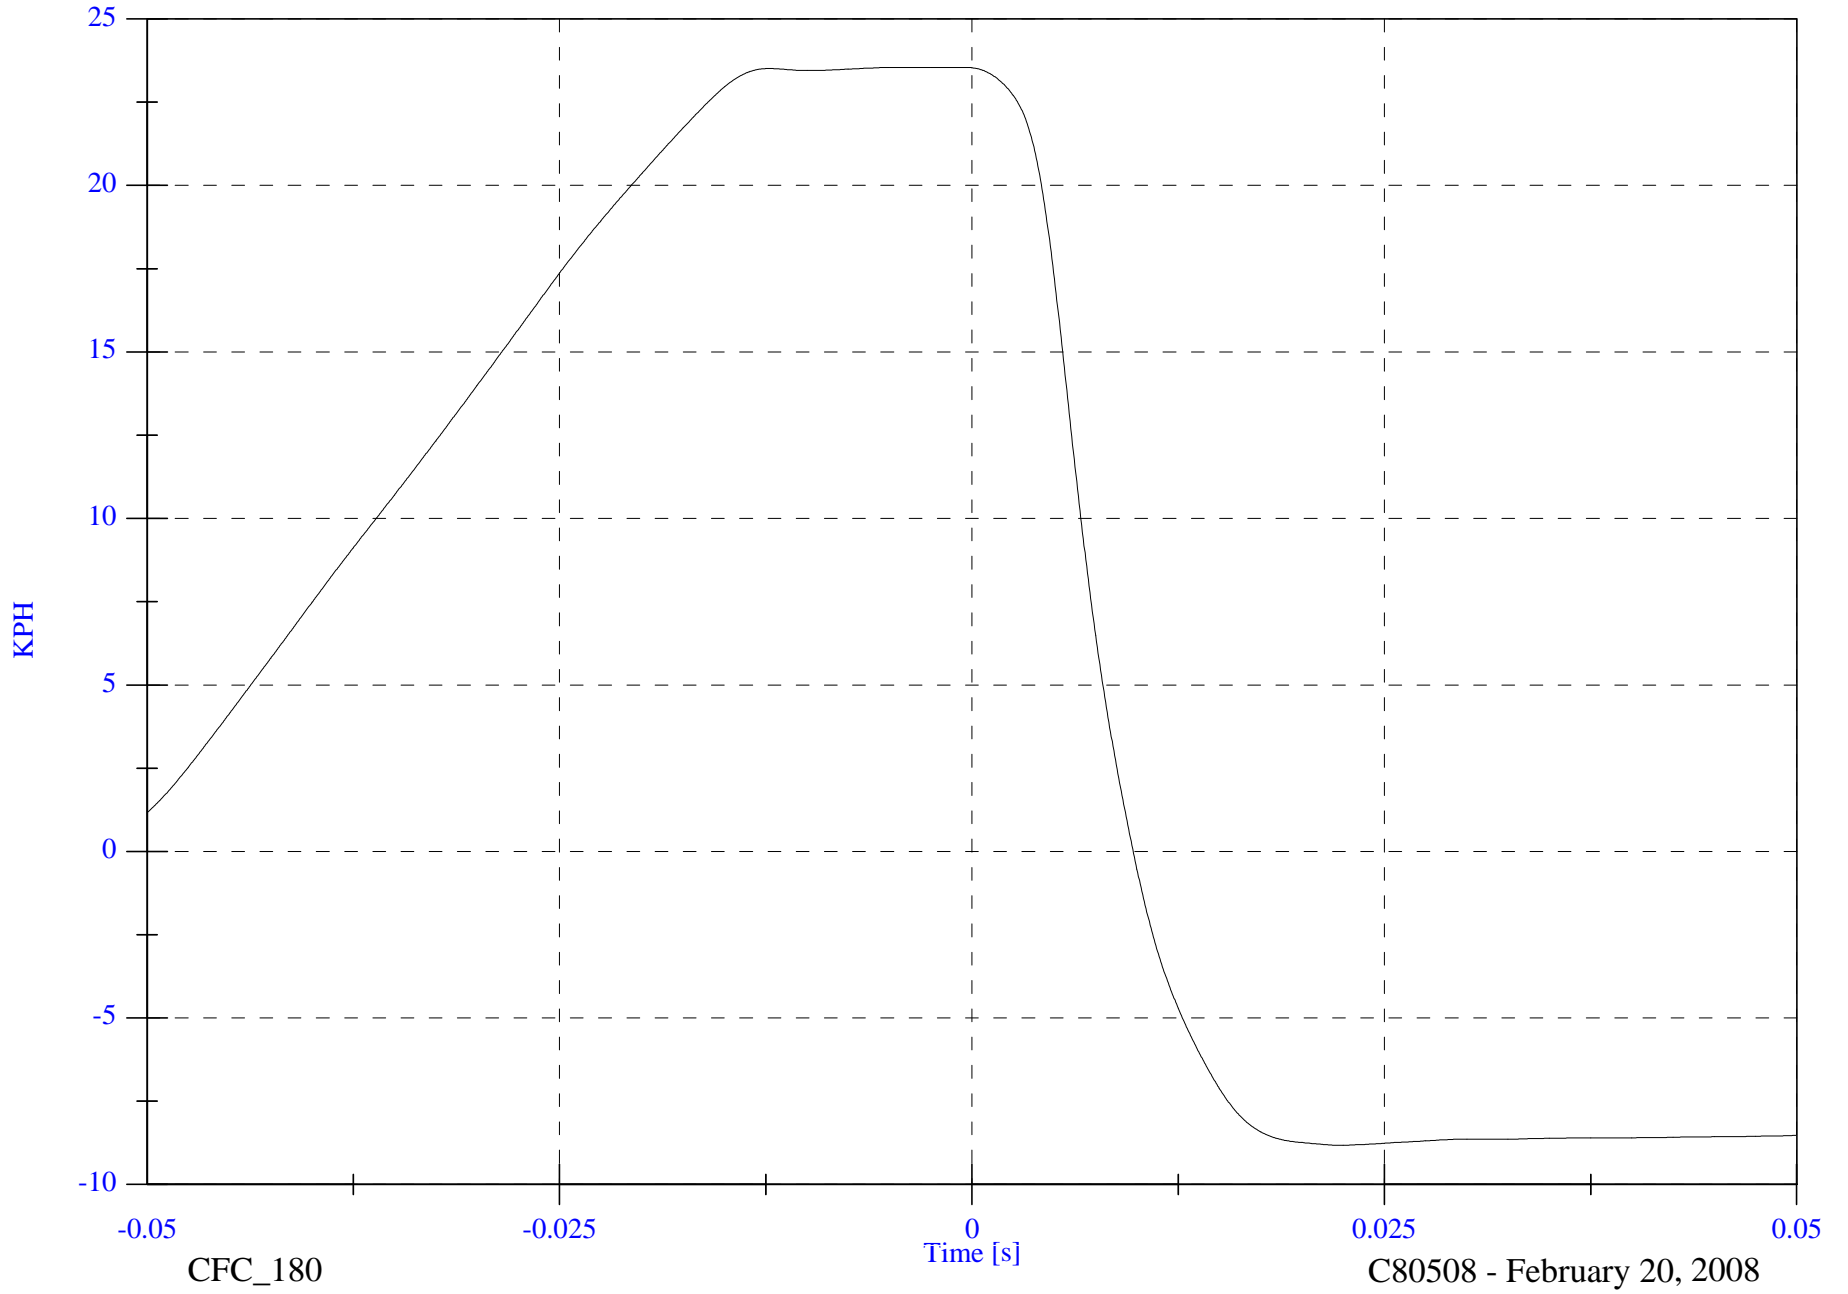
C80508 PASSENGER SIDE BP2 IMPACT PLOT #6

Min: -8.8 [KPH] at 0.022 [s]

Headform Velocity

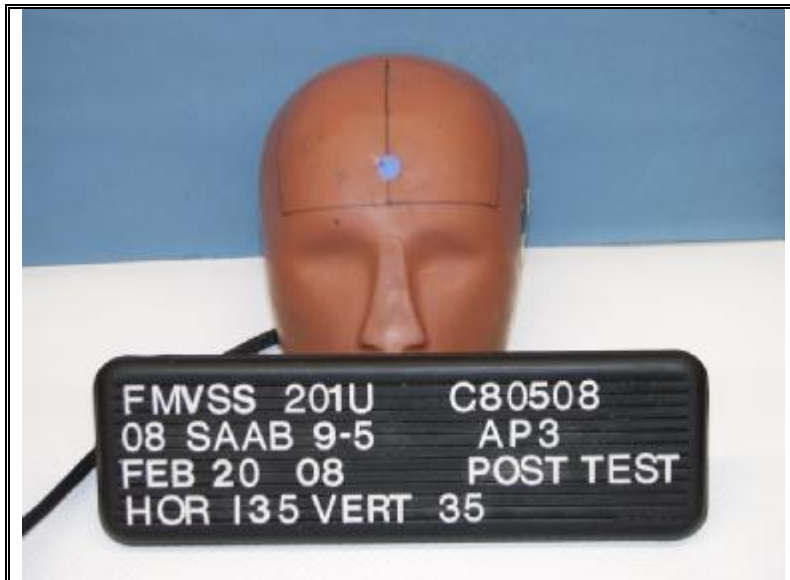
POST-IMPACT AP3 HEADFORM

Impact Point Description (from lower midpoint on midsagittal line)			
On Centerline	1	mm right	x mm left
On Centerline	16	mm up

Free Motion HIC	1779.7
HIC(d)	1509.1
Impact Velocity (kph)	23.73
HIC T1 (msec)	1.5
HIC T2 (msec)	5.1

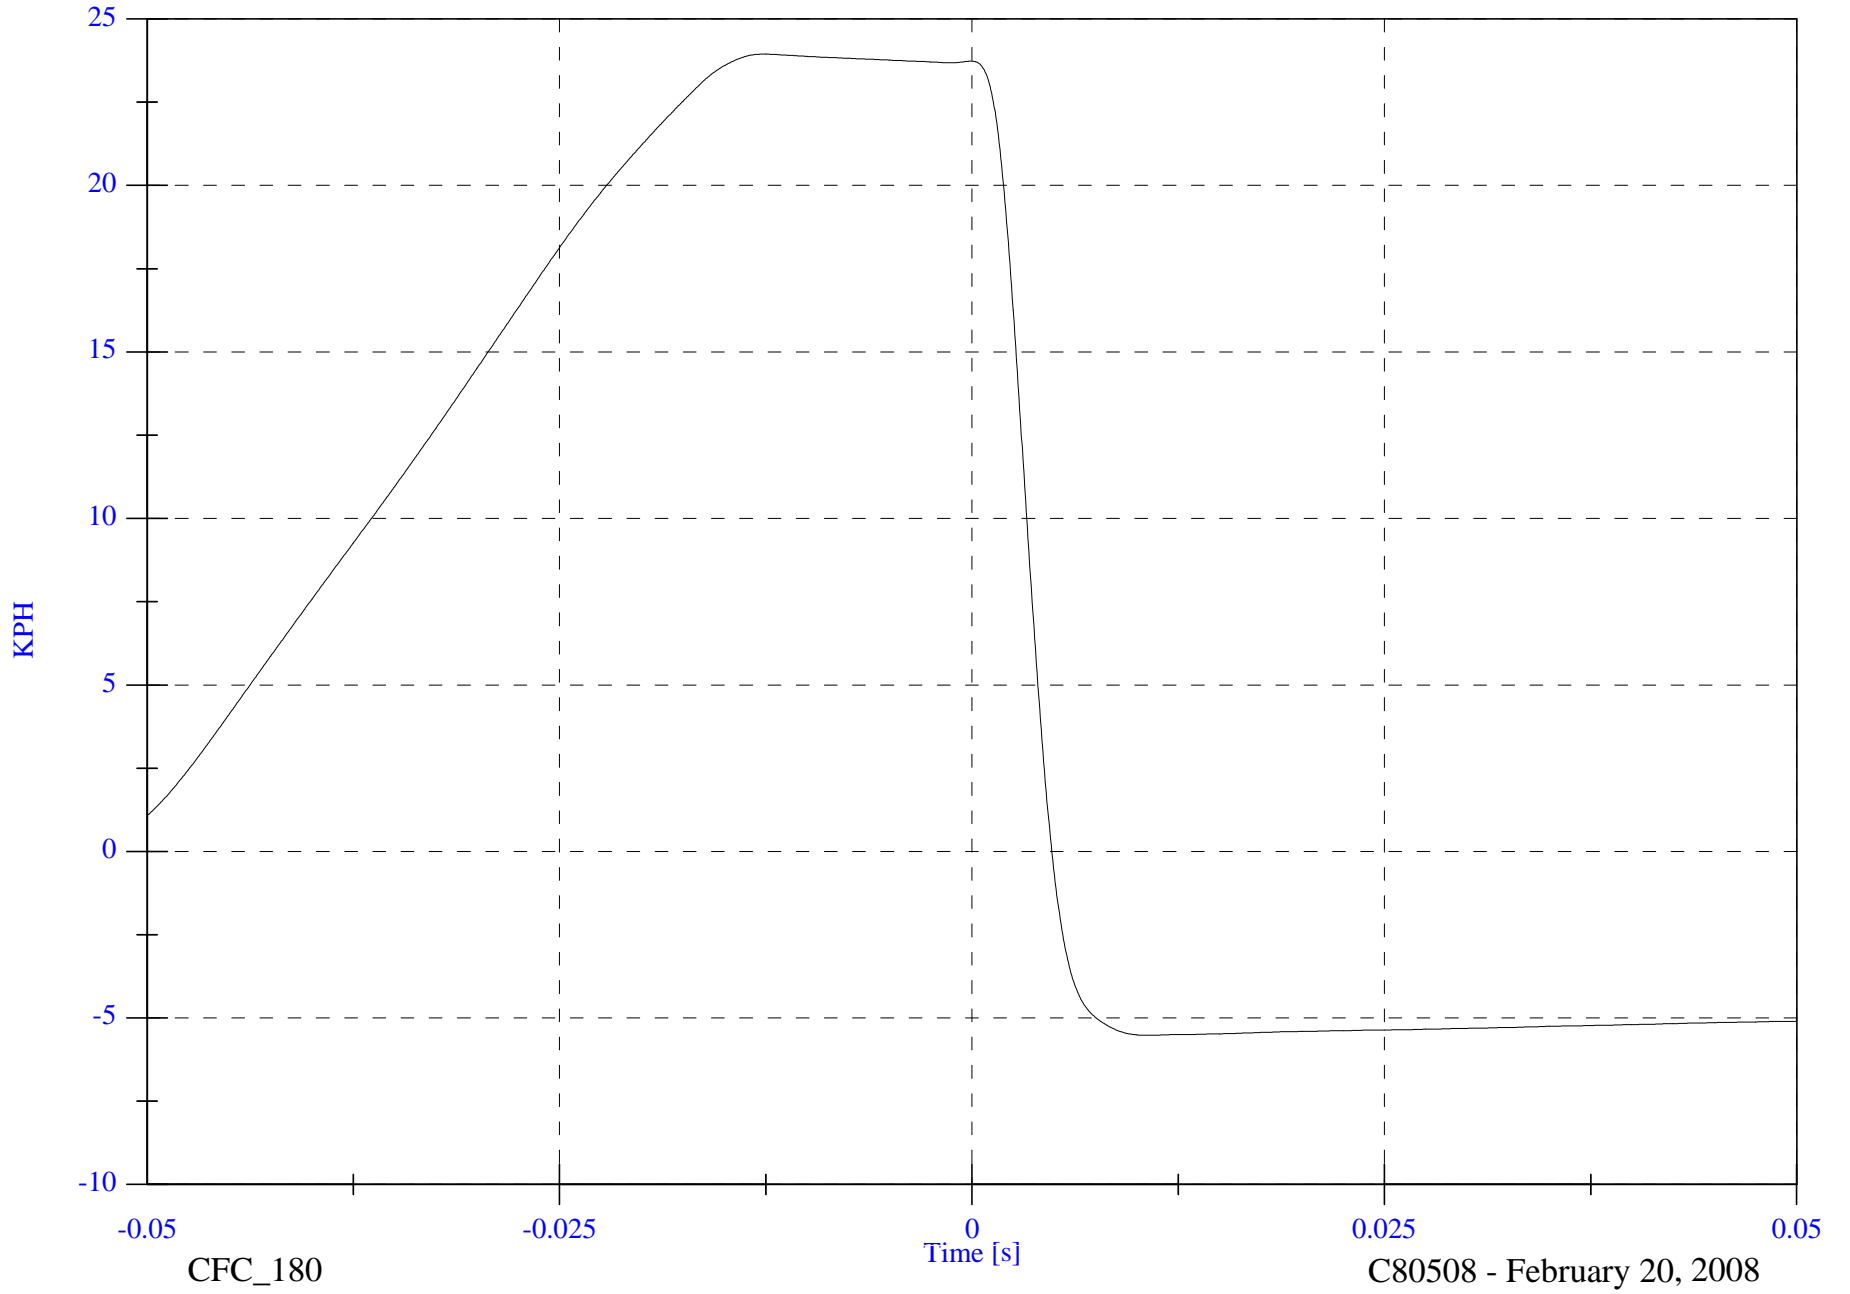
C80508 PASSENGER SIDE AP3 IMPACT PLOT #6

Max: 23.9 [KPH] at -0.013 [s]

Min: -5.5 [KPH] at 0.011 [s]

Headform Velocity

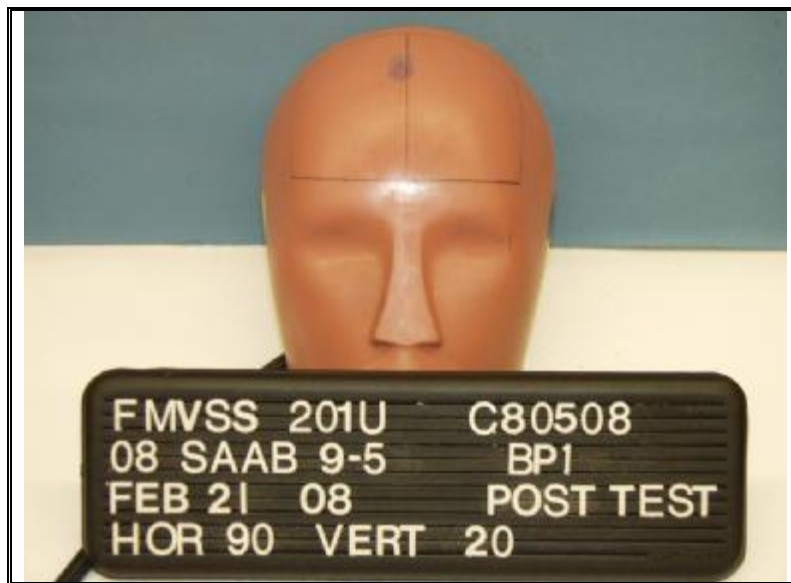
POST-IMPACT BP1 HEADFORM

Impact Point Description (from lower midpoint on midsagittal line)				
On Centerline	3	x	mm right	mm left
On Centerline	59		mm up

Free Motion HIC	482.9
HIC(d)	530.7
Impact Velocity (kph)	23.59
HIC T1 (msec)	4.1
HIC T2 (msec)	14.7

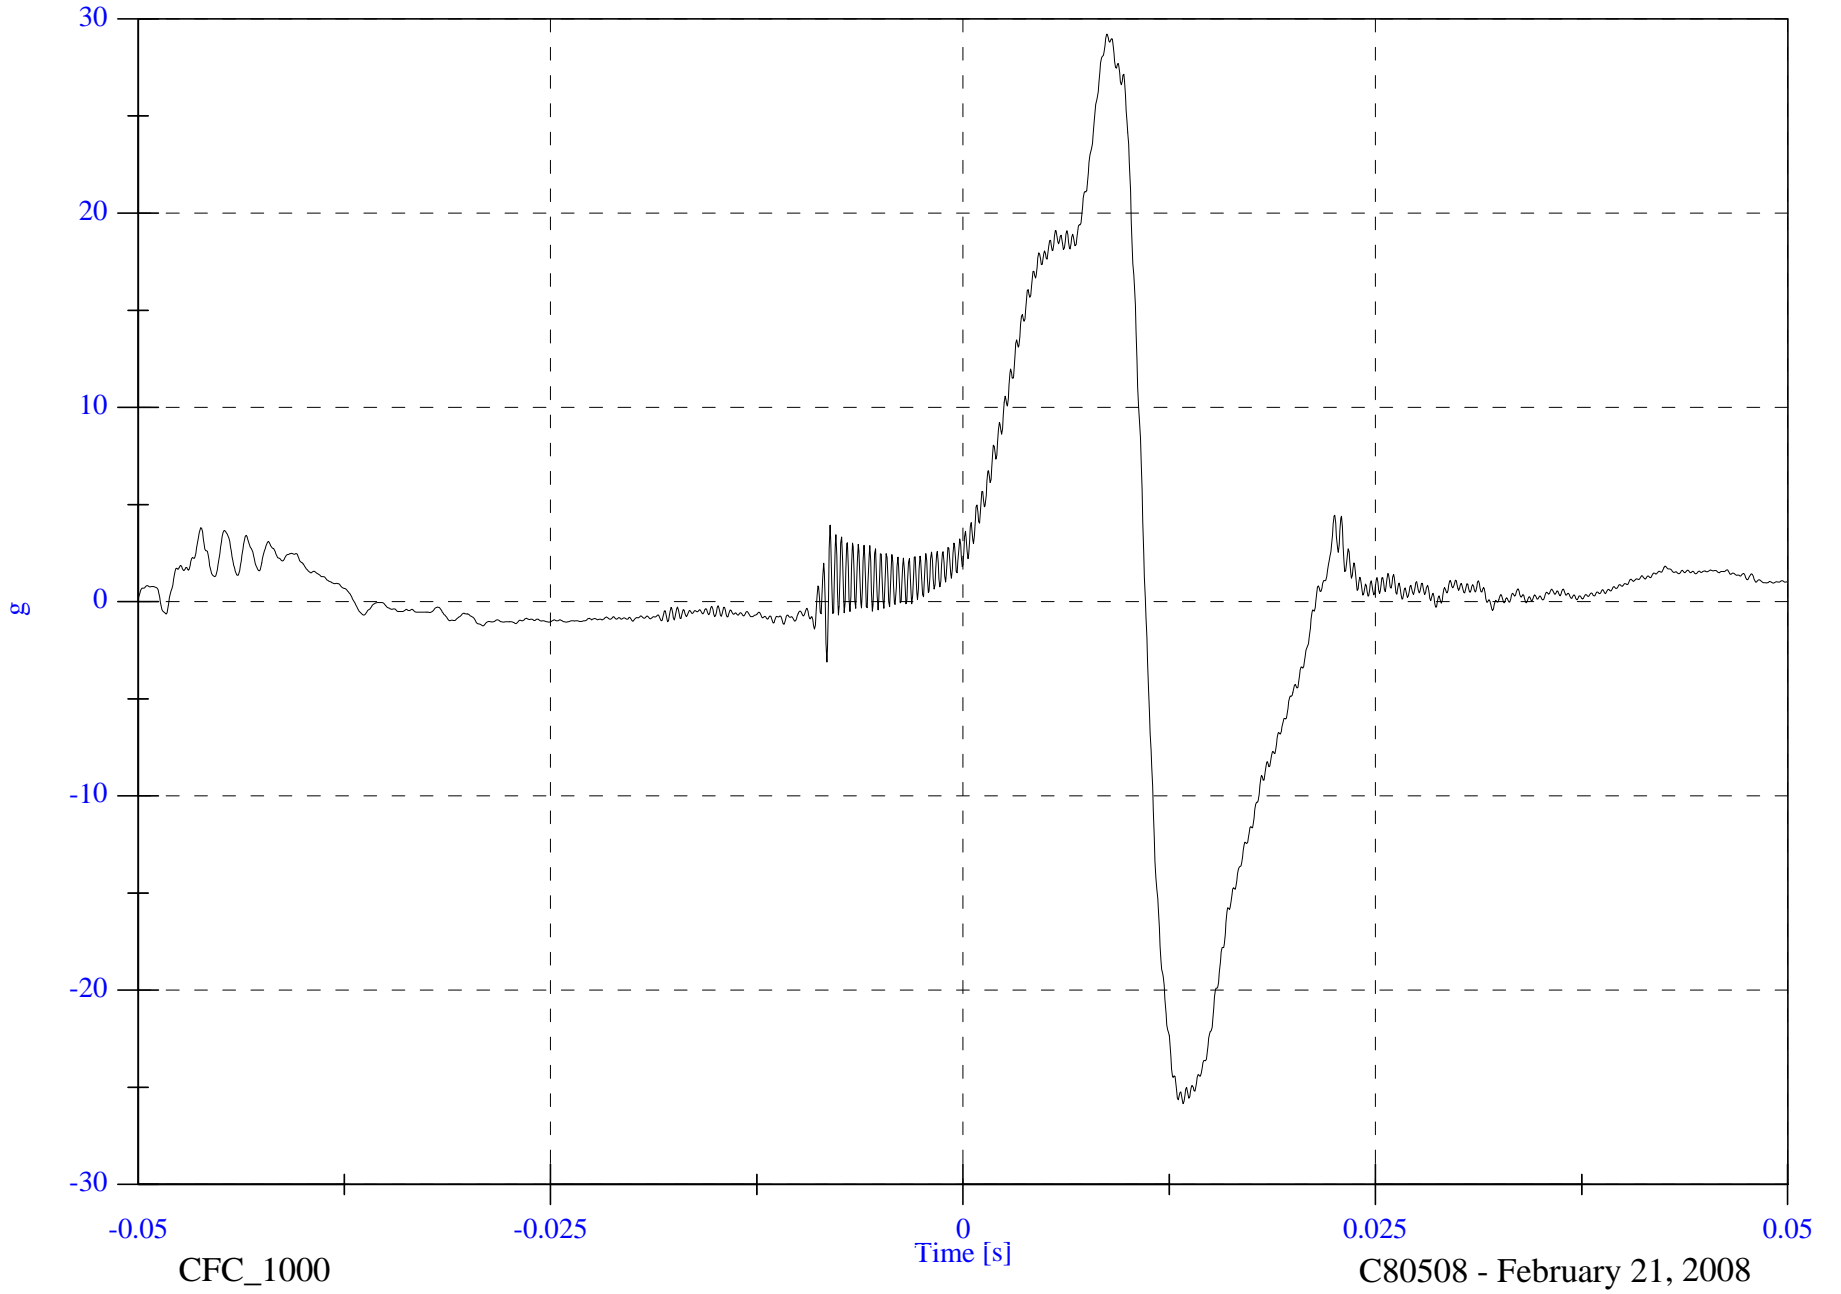
C80508 DRIVER SIDE BP1 IMPACT PLOT #4

Headform Z Acceleration

Max: 29.2 [g] at 0.009 [s]
Min: -25.8 [g] at 0.013 [s]

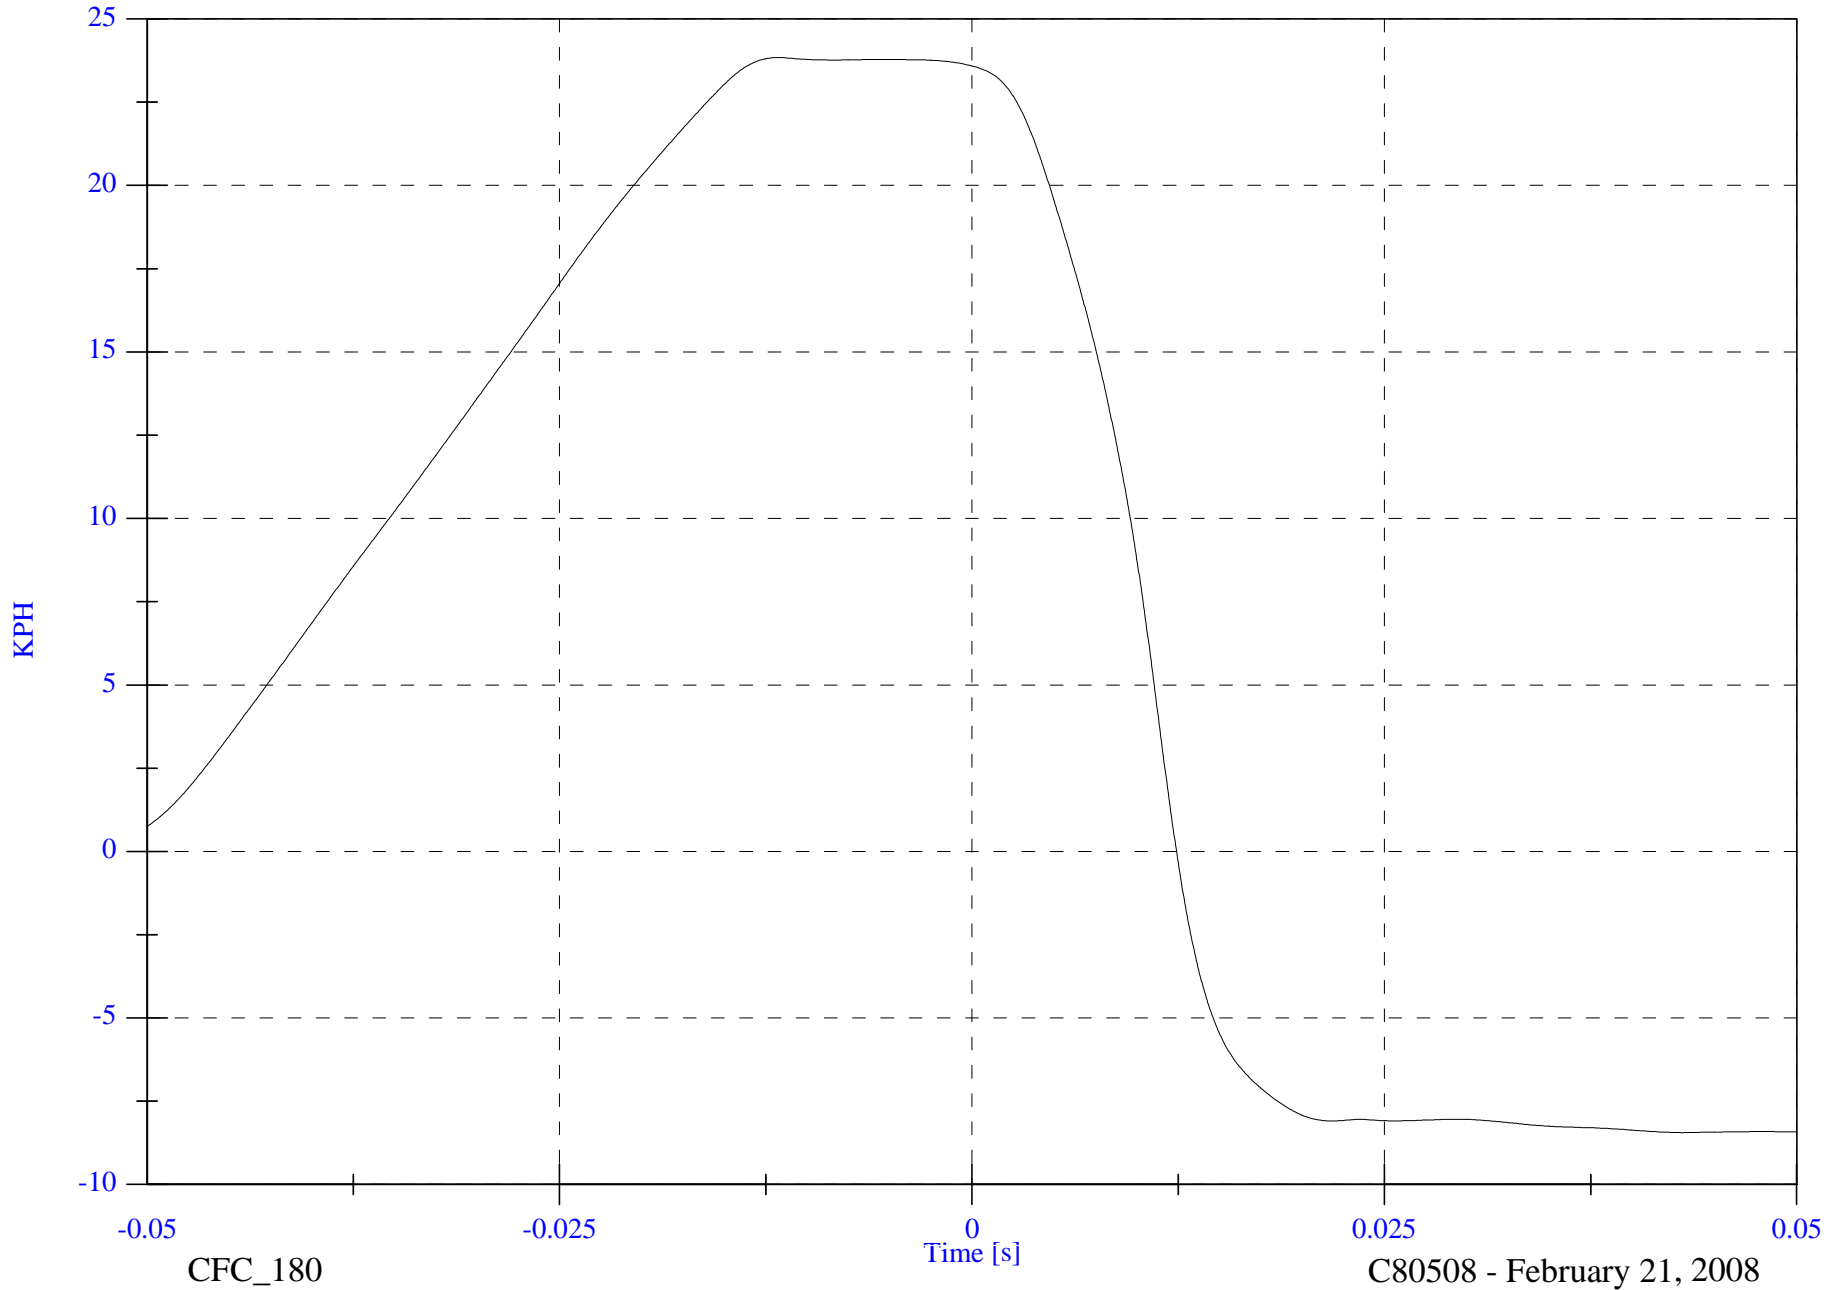
C80508 DRIVER SIDE BP1 IMPACT PLOT #6

Min: -8.4 [KPH] at 0.043 [s]

Headform Velocity

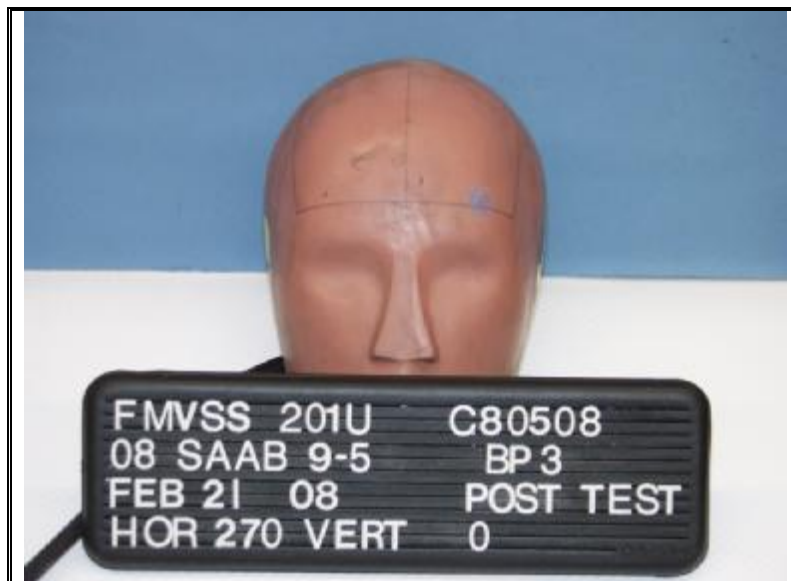
POST-IMPACT BP3 HEADFORM

Impact Point Description (from lower midpoint on midsagittal line)			
On Centerline	40	mm right	x mm left
On Centerline	4	mm up

Free Motion HIC	551.4
HIC(d)	582.4
Impact Velocity (kph)	23.8
HIC T1 (msec)	3.6
HIC T2 (msec)	11.7

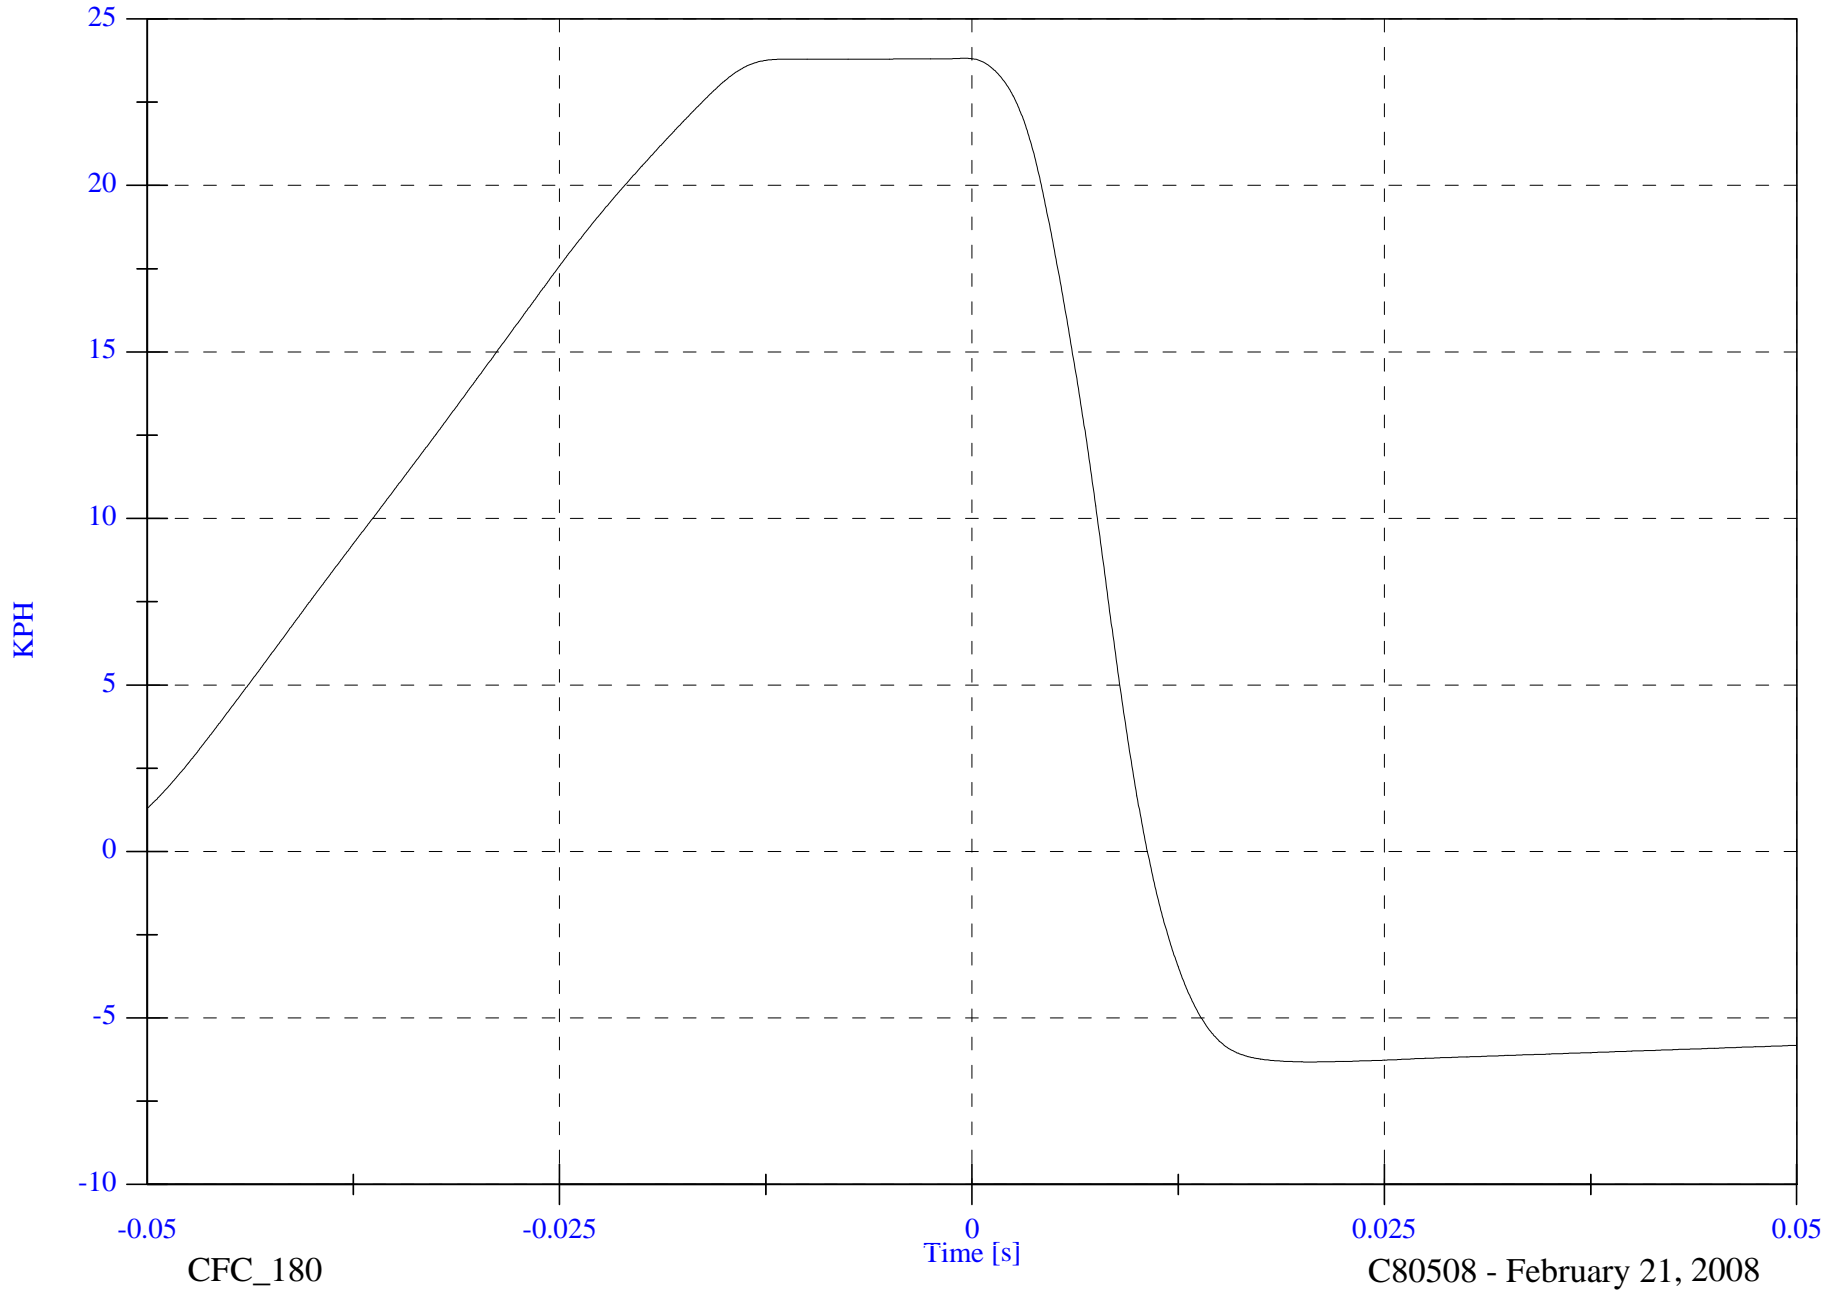
C80508 DRIVER SIDE BP3 IMPACT PLOT #6

Min: -6.3 [KPH] at 0.020 [s]

Headform Velocity

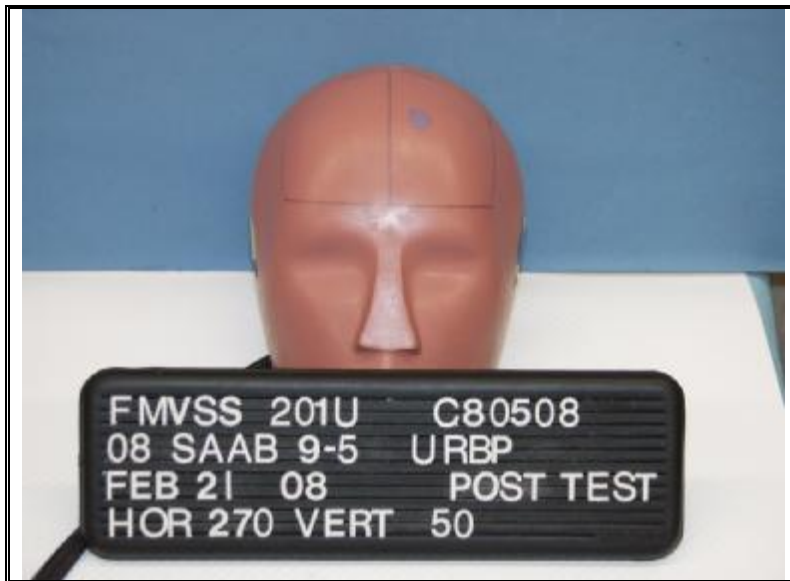
POST-IMPACT URBP HEADFORM

Impact Point Description (from lower midpoint on midsagittal line)			
On Centerline	10	mm right	x mm left
On Centerline	50	mm up

Free Motion HIC	176.1
HIC(d)	299.3
Impact Velocity (kph)	23.73
HIC T1 (msec)	2.0
HIC T2 (msec)	21.7
