REPORT NUMBER: 201UI-CAL-08-03

**SAFETY COMPLIANCE TESTING FOR FMVSS 201
OCCUPANT PROTECTION IN INTERIOR IMPACT
UPPER INTERIOR HEAD IMPACT PROTECTION**

**SAAB AUTOMOBILE AB
2008 SAAB 9-5 WAGON**

NHTSA NUMBER: C80508

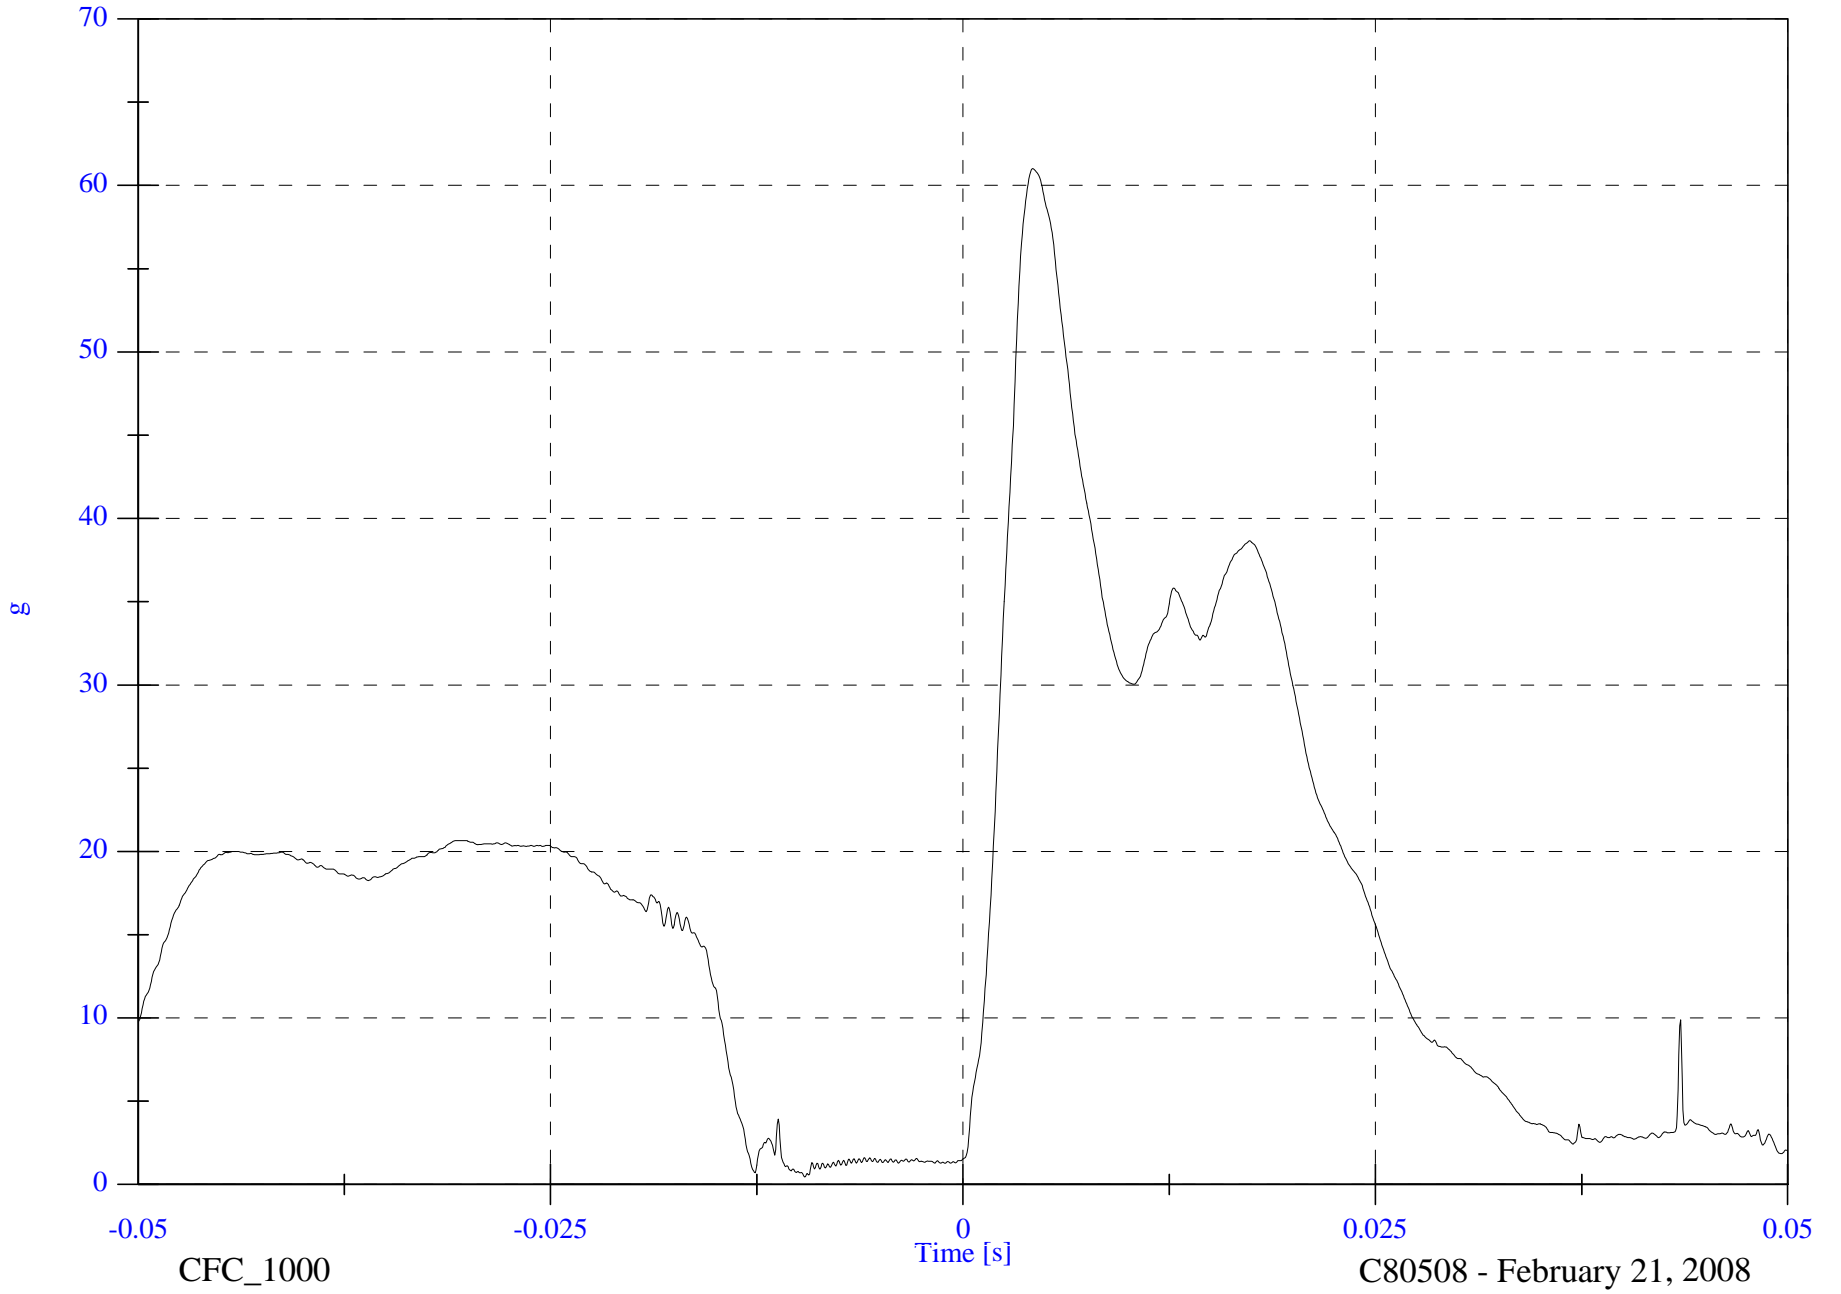
C80508 DRIVER SIDE URBP IMPACT PLOT #5

Headform Resultant

Max: 61.0 [g] at 0.004 [s]
Min: 0.4 [g] at -0.010 [s]

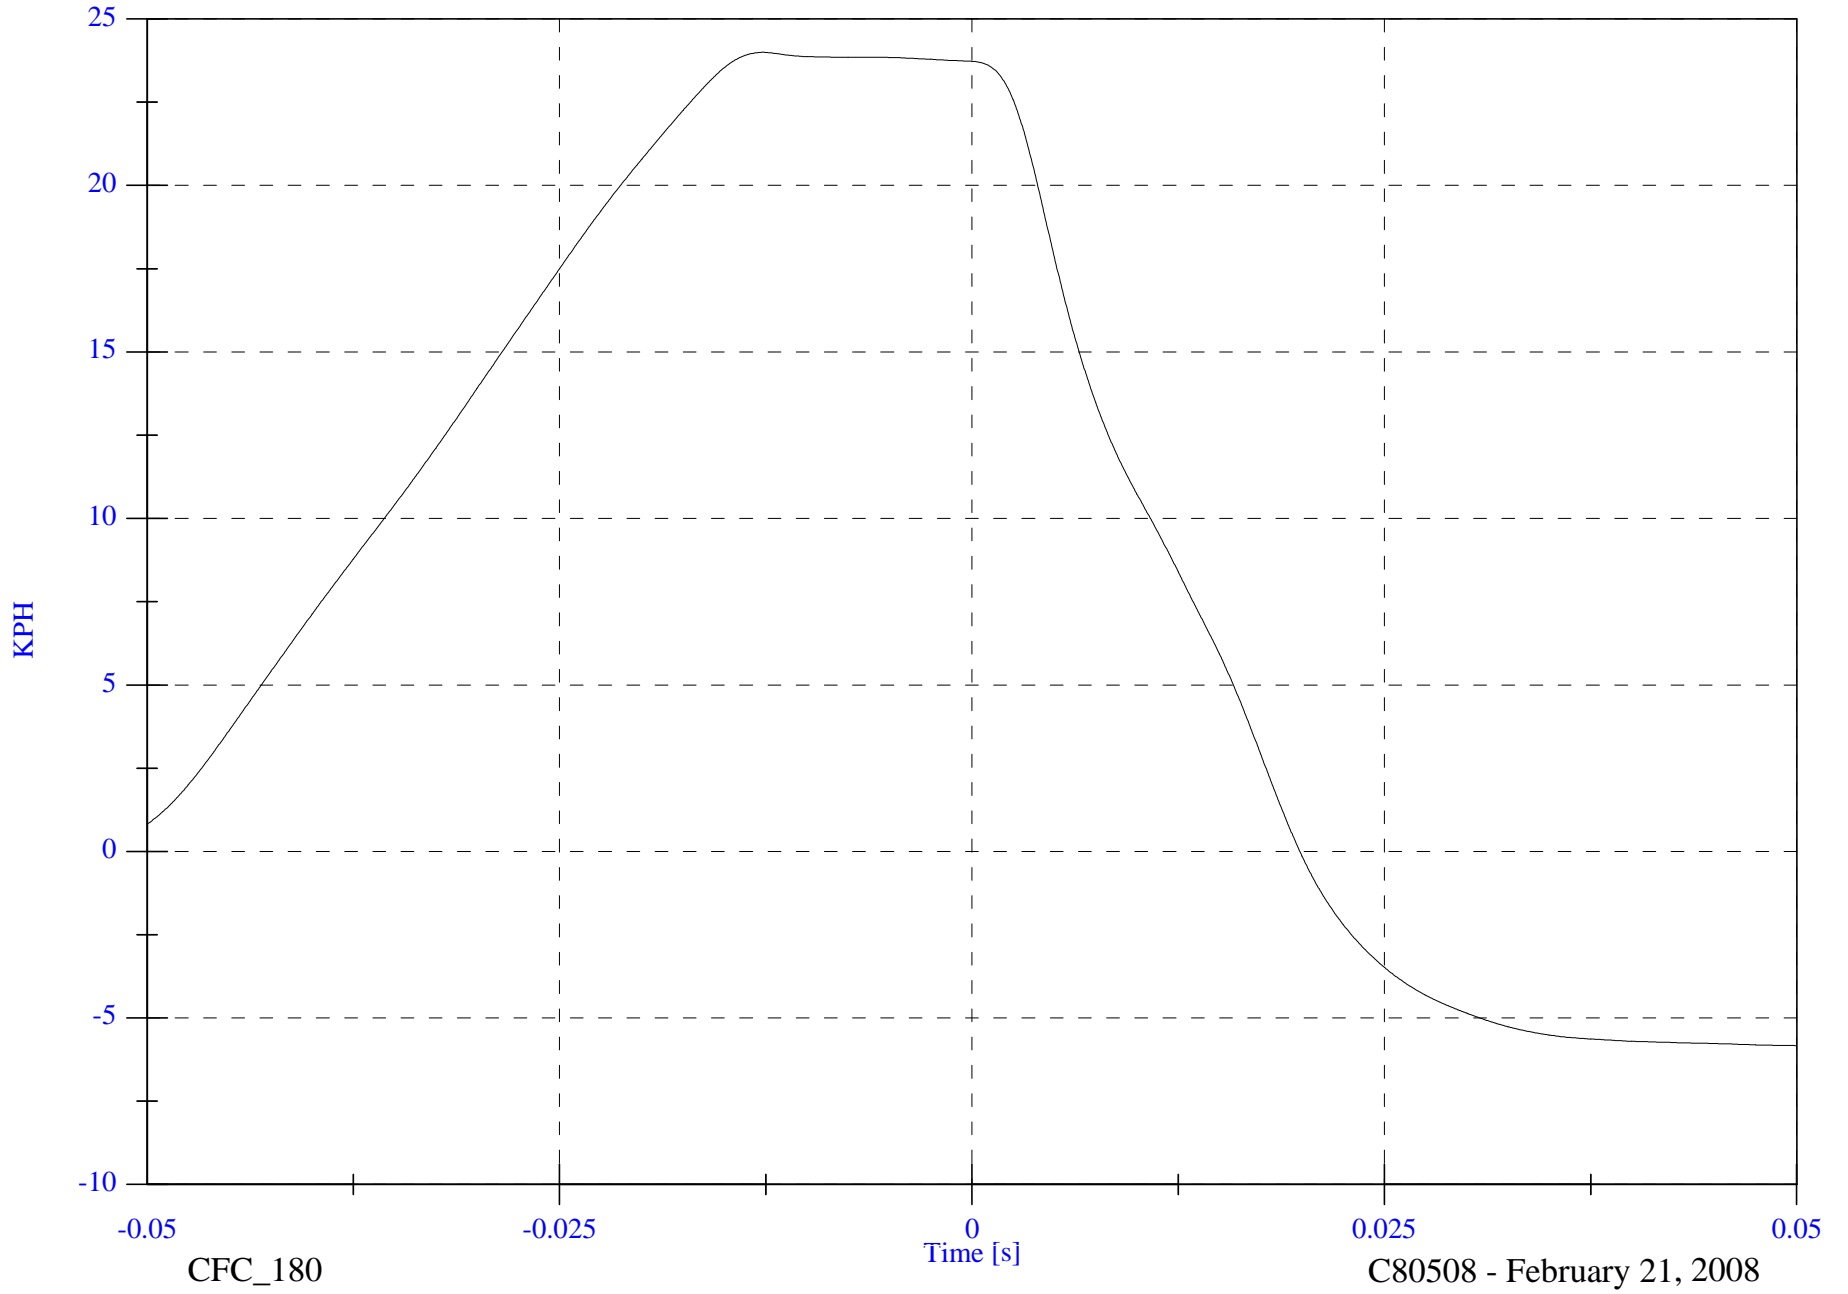
C80508 DRIVER SIDE URBP IMPACT PLOT #6

Min: -5.8 [KPH] at 0.050 [s]

Headform Velocity
