REPORT NUMBER 118-GTL-08-001

**SAFETY COMPLIANCE TESTING FOR
FMVSS NO. 118
POWER-OPERATED WINDOW, PARTITION
AND ROOF PANEL SYSTEMS**

**DAIMLERCHRYSLER AG
2008 SMART CAR FORTWO, PASSENGER CAR
NHTSA NO. C80501**

**GENERAL TESTING LABORATORIES, INC.
1623 LEEDSTOWN ROAD
COLONIAL BEACH, VIRGINIA 22443**

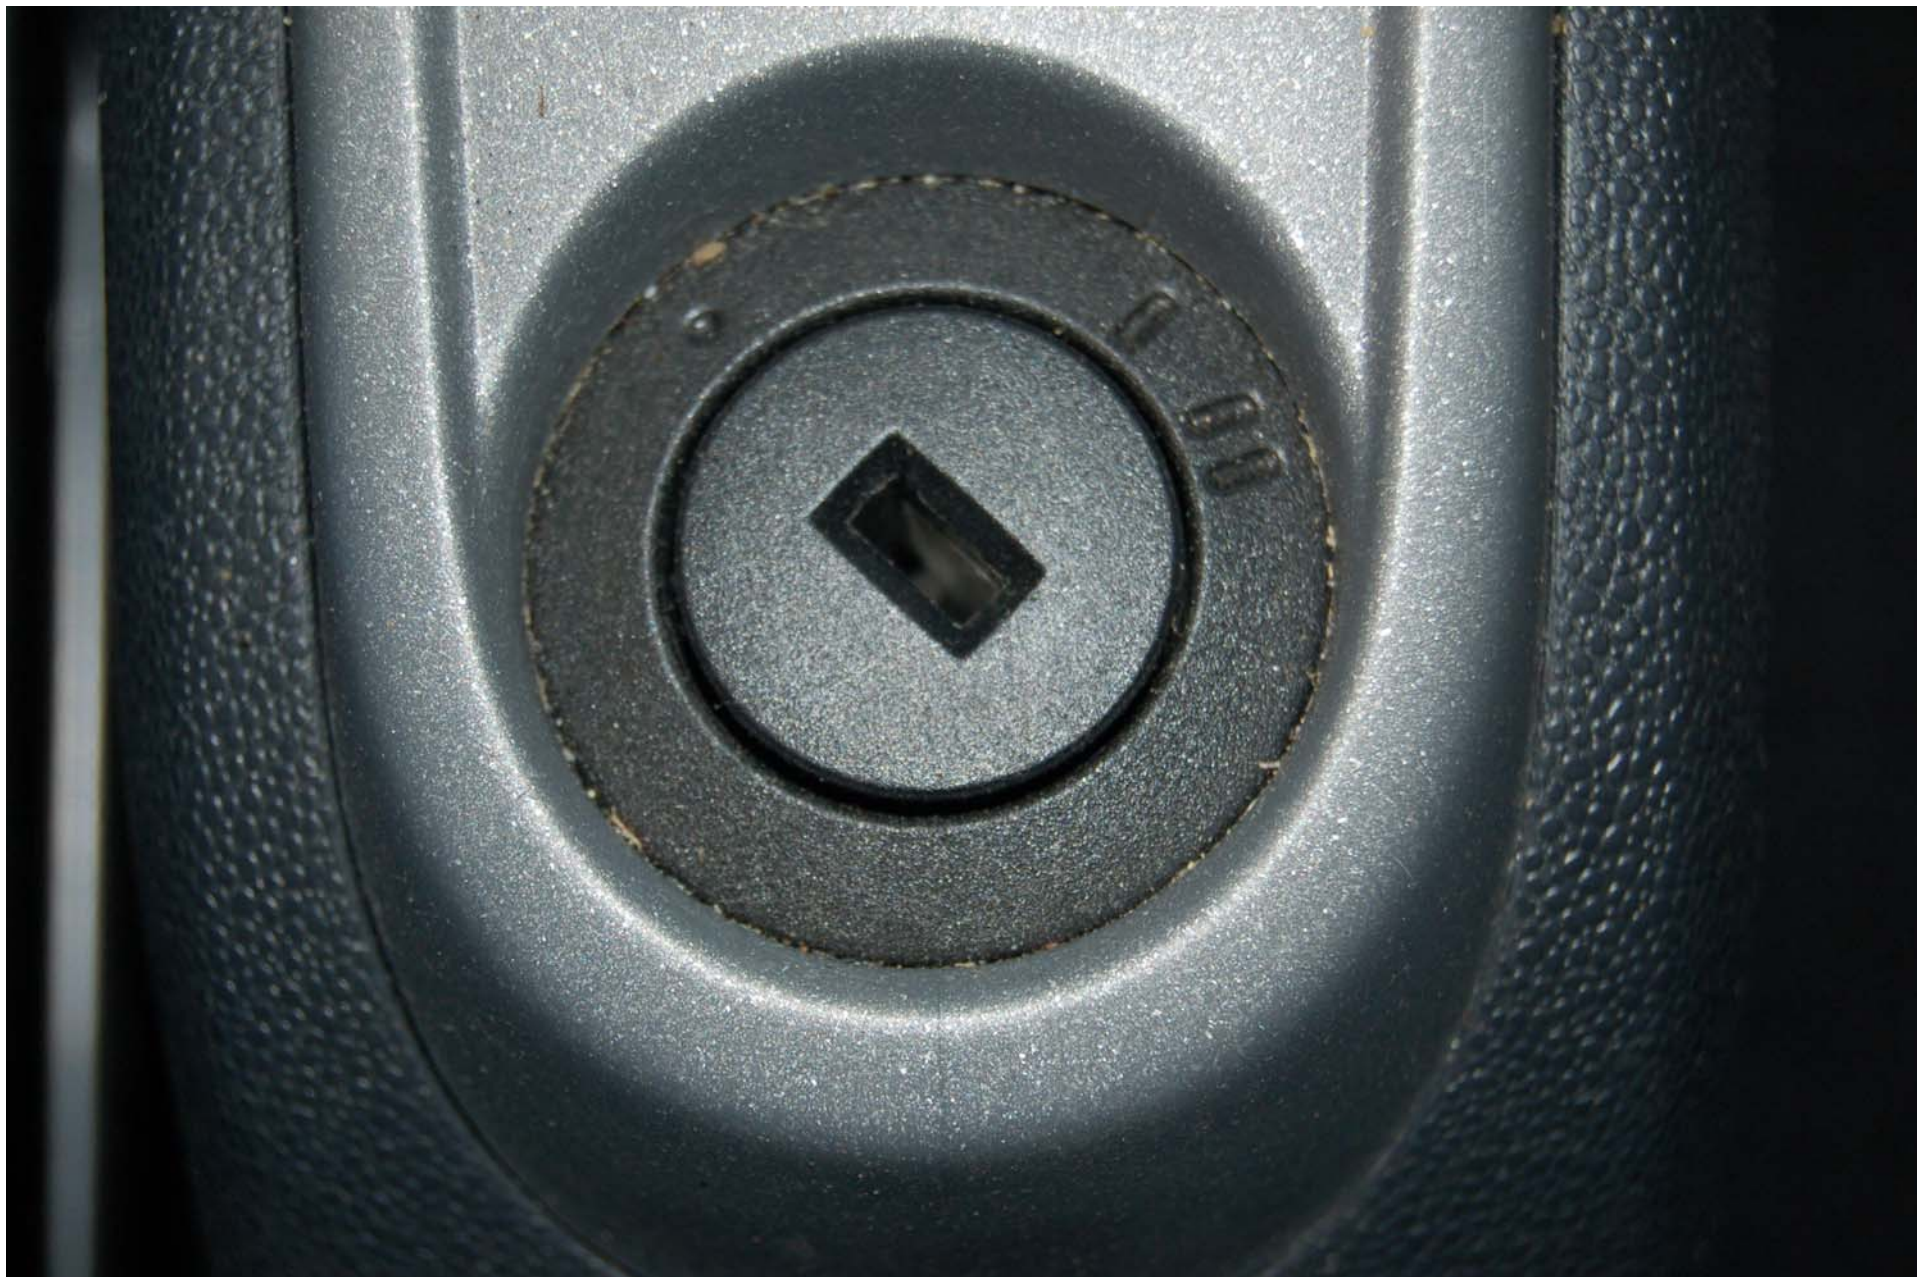
FIGURE 5.5
CLOSE-UP VIEW OF VEHICLE IGNITION SWITCH

Interior Locking System Key Positions (clockwise): REMOVE KEY, IGNITION "ON" AND ACCESSORY, START

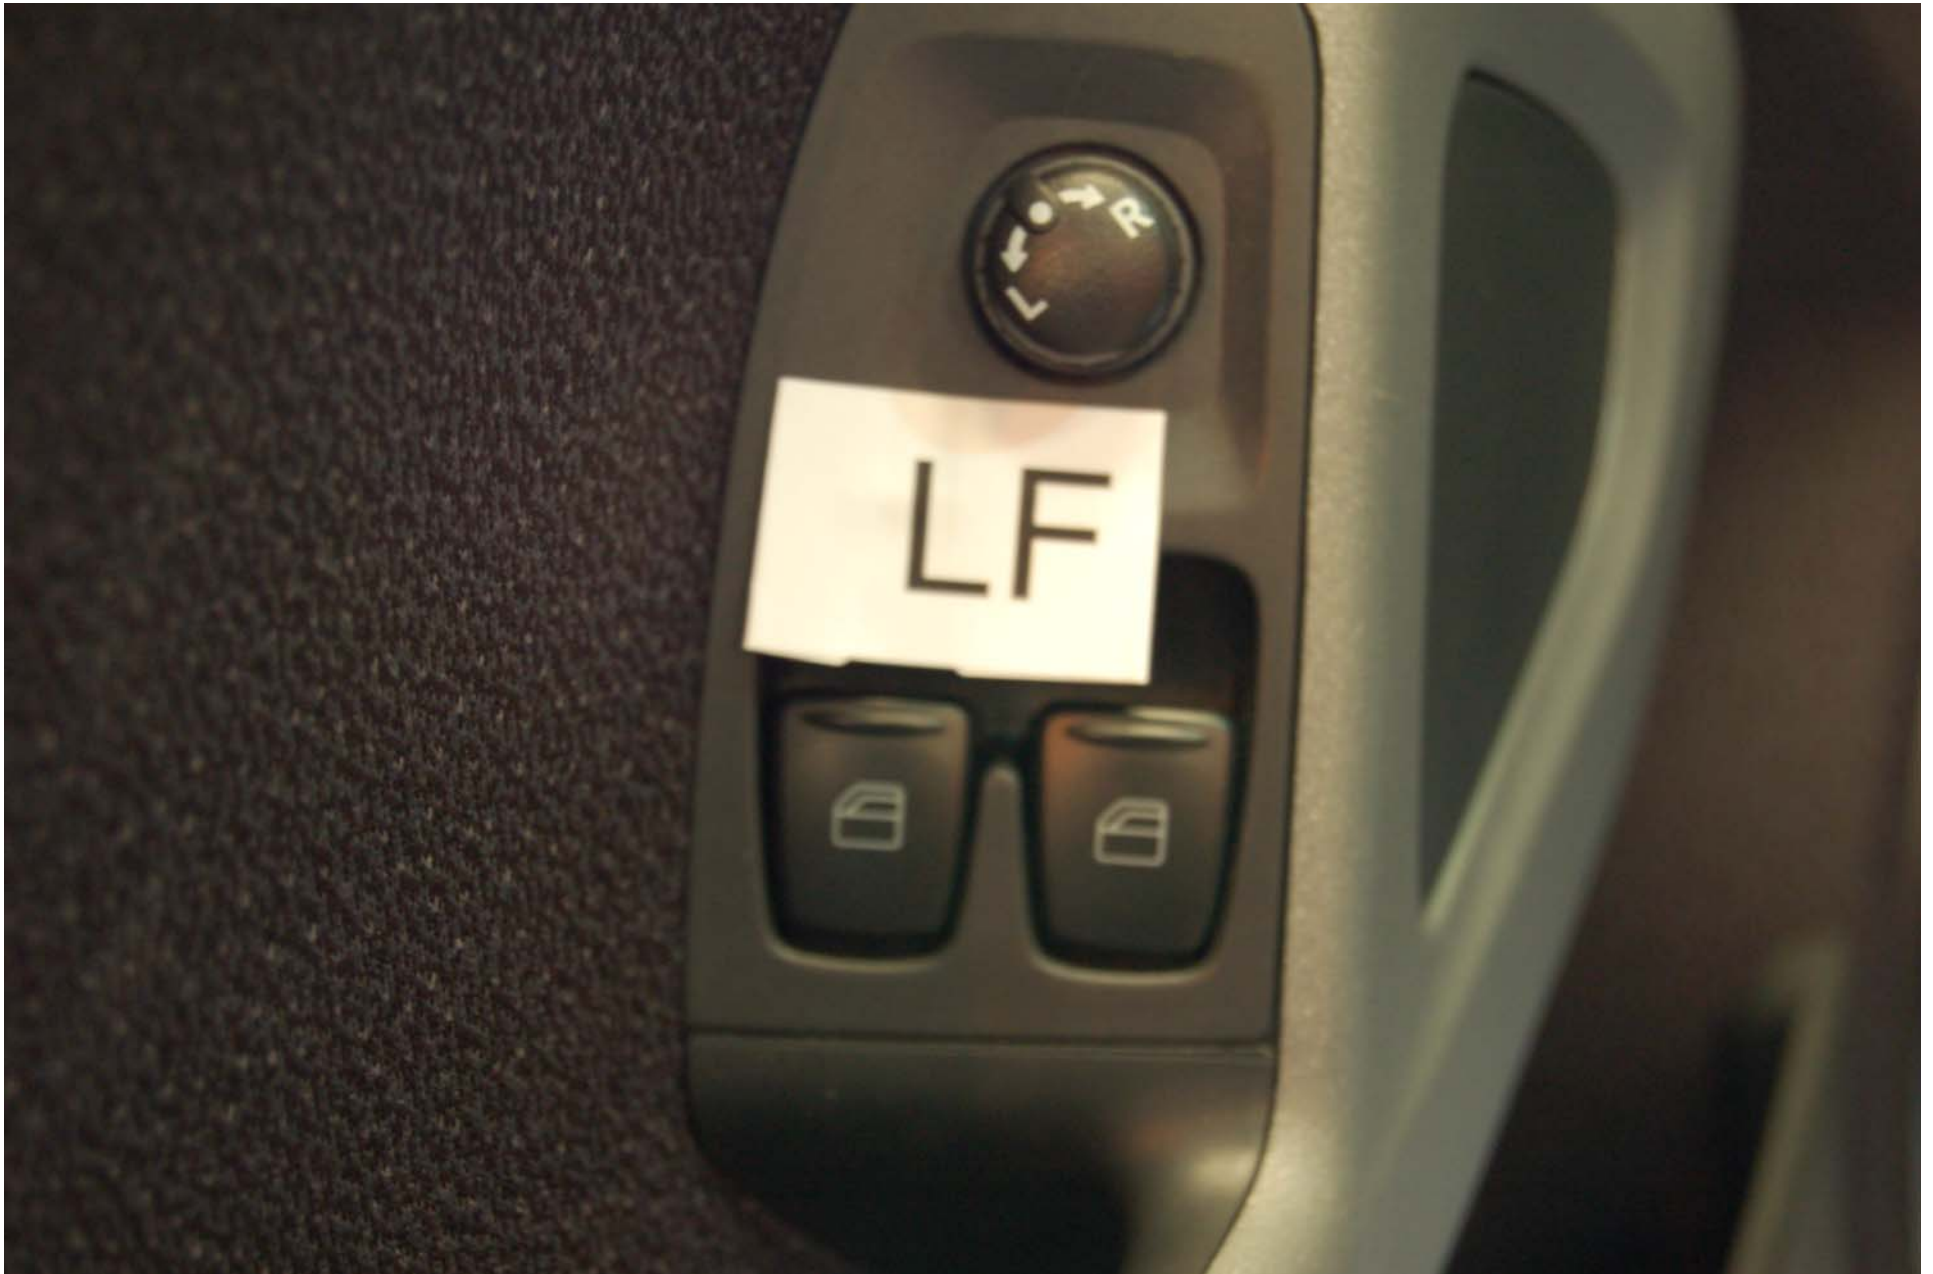
FIGURE 5.6
CLOSE-UP VIEW OF LEFT FRONT POWER WINDOW
SWITCH

Master Control Panel Pull for up/Push for downIndividual Window Pull for up/Push for down

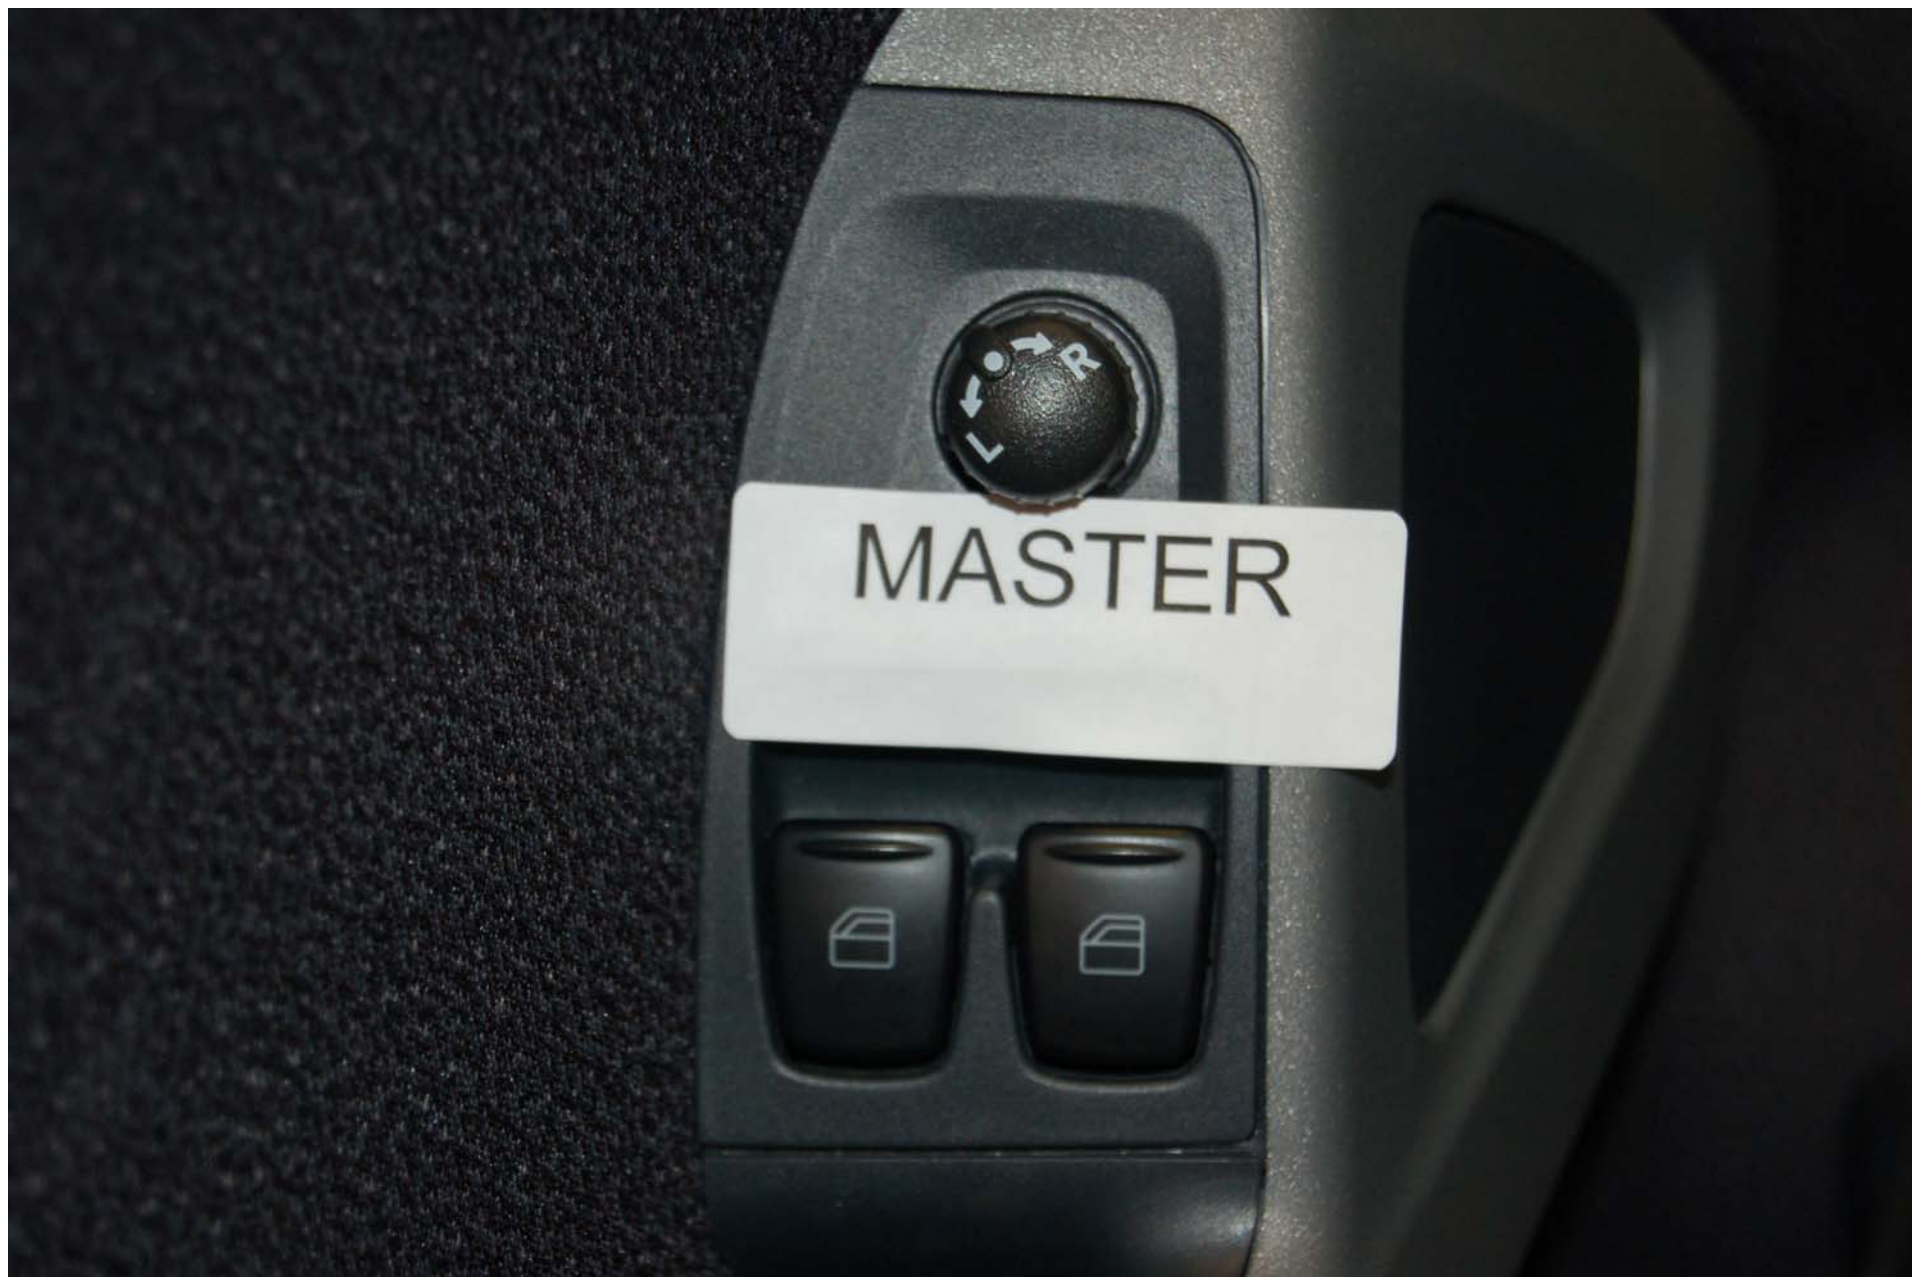
FIGURE 5.8
CLOSE-UP VIEW OF POWER WINDOW MASTER SWITCH

Master Control Panel Location: DRIVER'S DOOR PANEL
