REPORT NUMBER 138-STF-08-003

# SAFETY COMPLIANCE TESTING FOR FMVSS NO. 138 TIRE PRESSURE MONITORING SYSTEMS

VOLVO CAR CORPORATION  
2008 VOLVO XC90  
FOUR-DOOR MPV  
NHTSA NO. C85900

FINAL REPORT

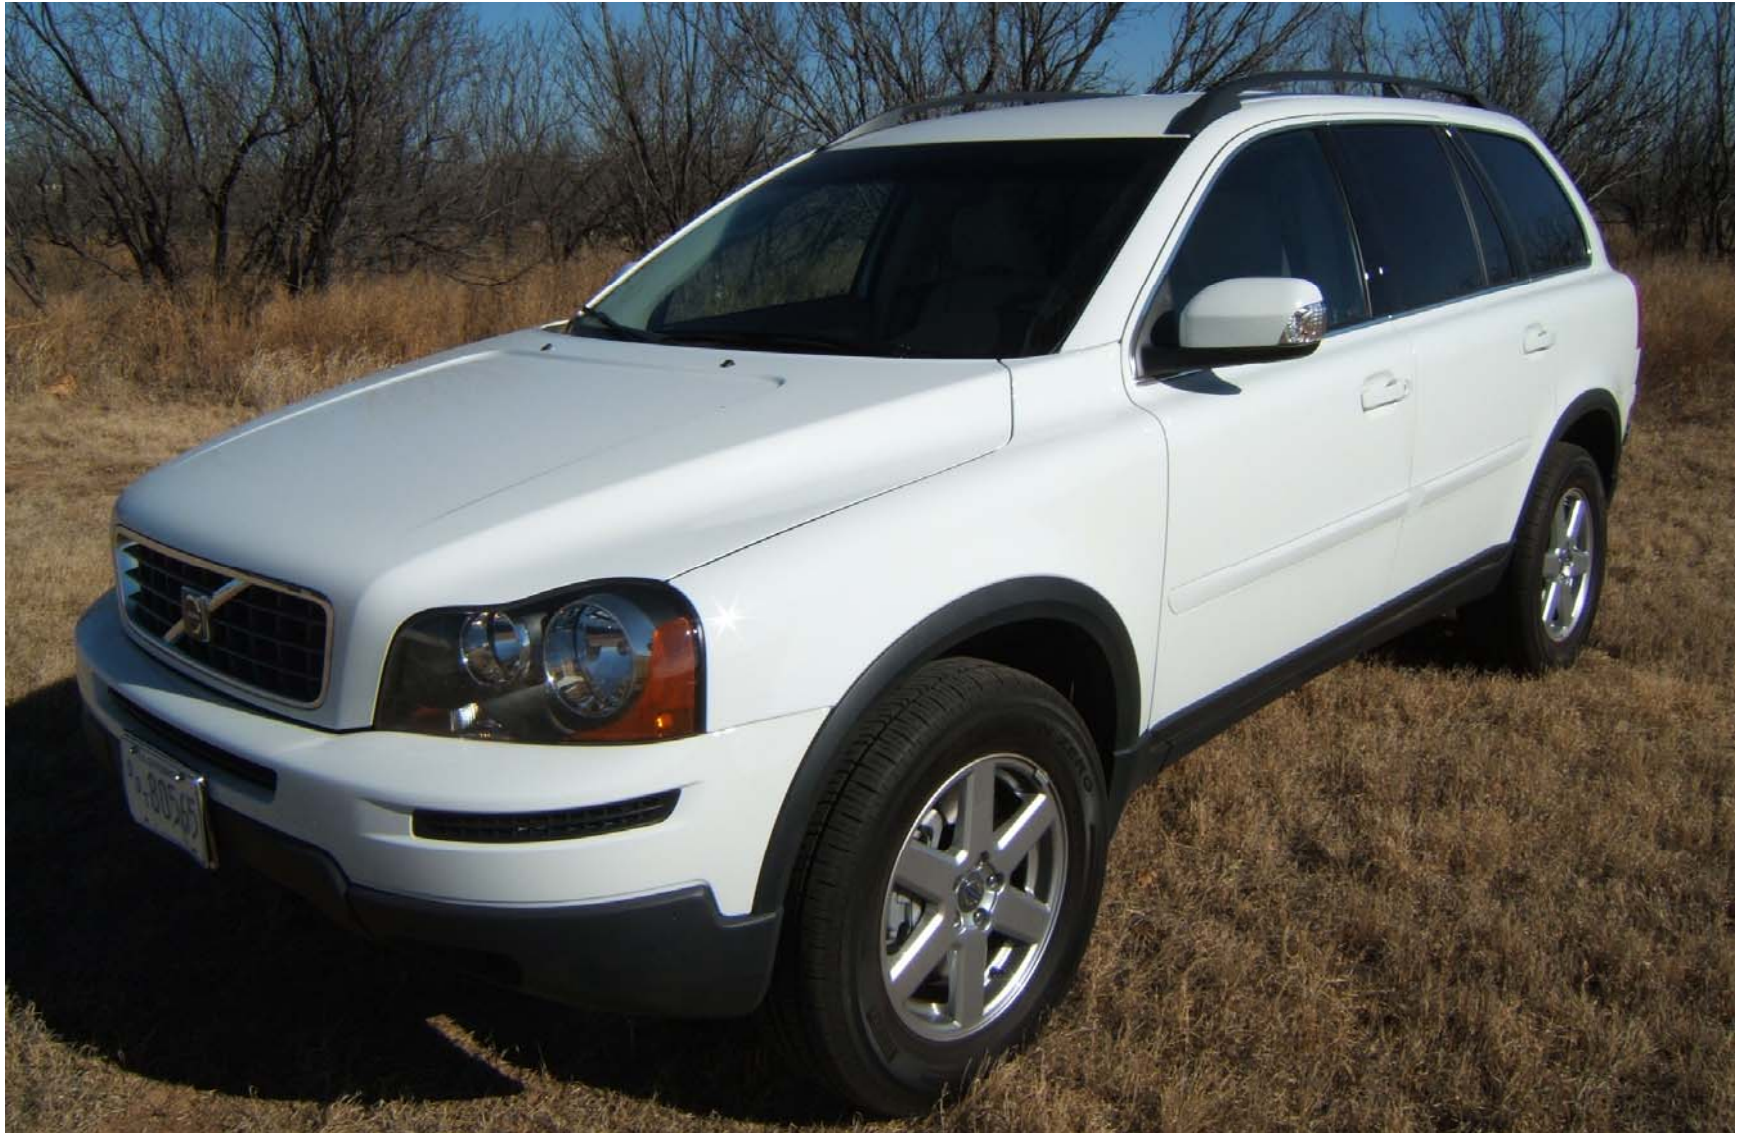
FIGURE 5.1  
 $\frac{3}{4}$  FRONTAL VIEW FROM LEFT SIDE OF VEHICLE

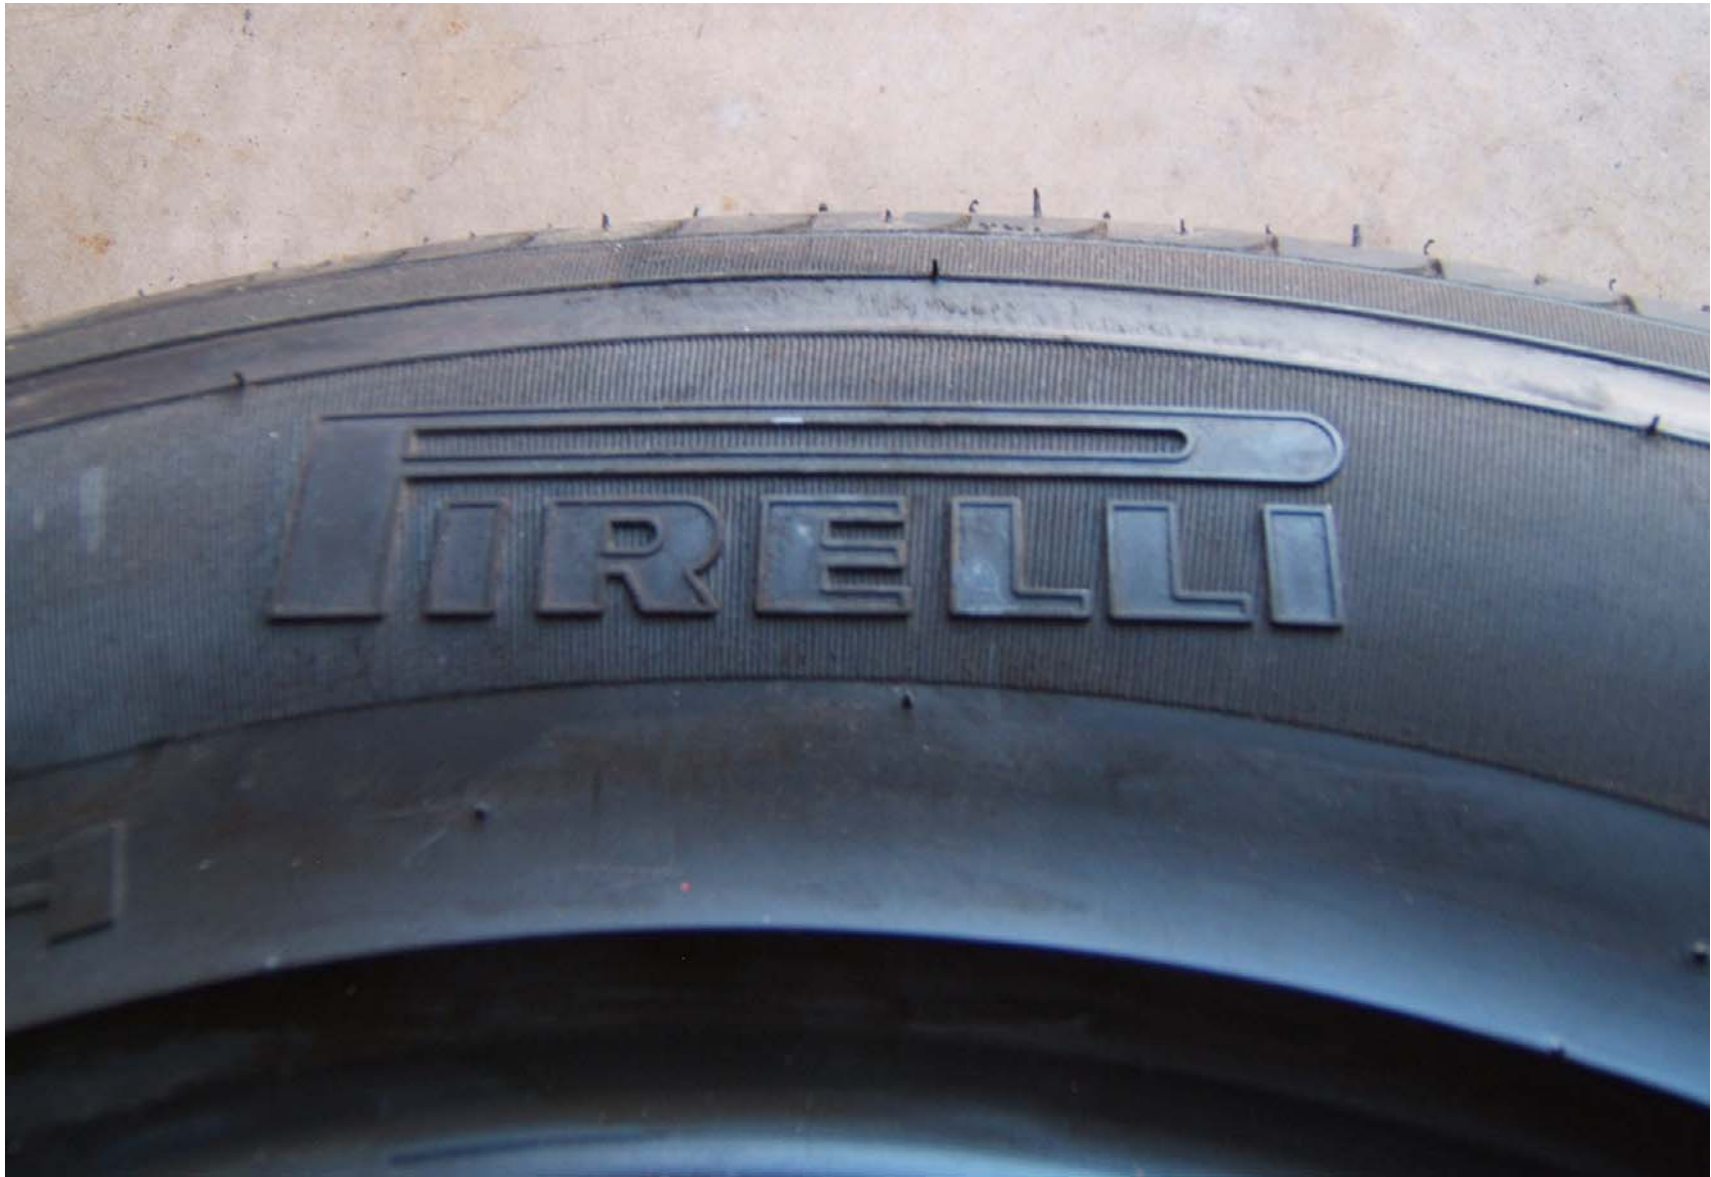
FIGURE 5.4  
TIRE SHOWING BRAND

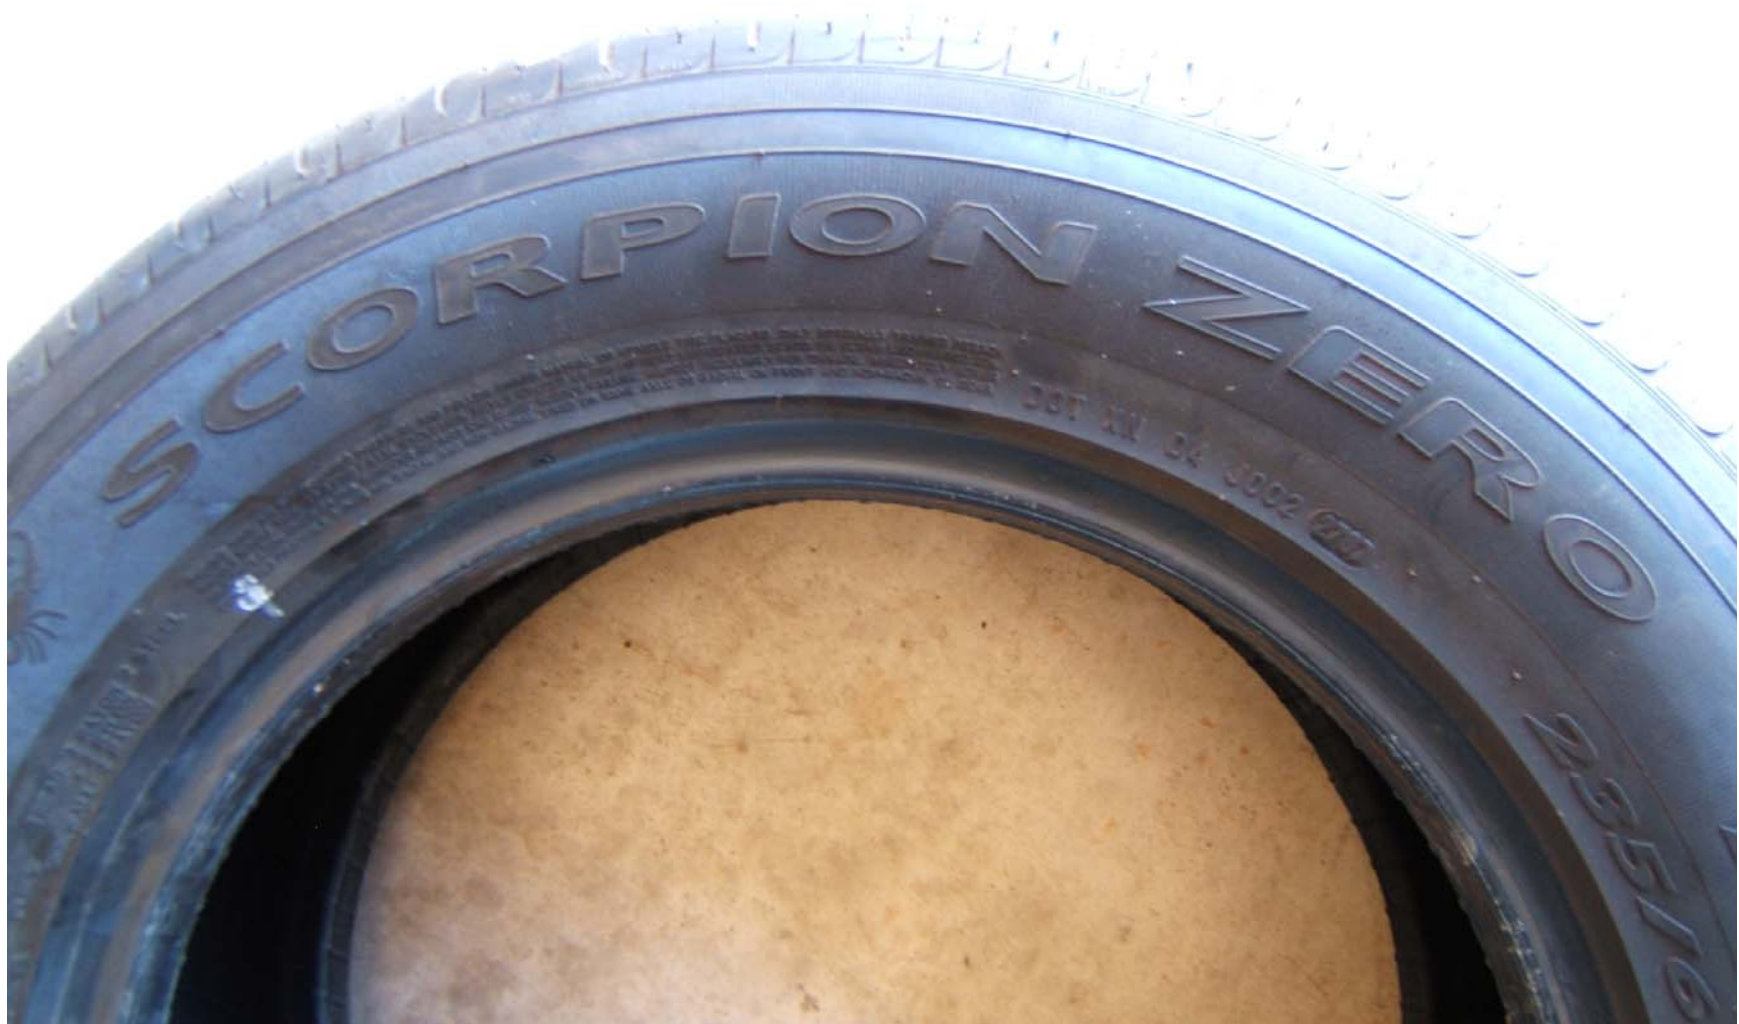
FIGURE 5.5  
TIRE SHOWING MODEL

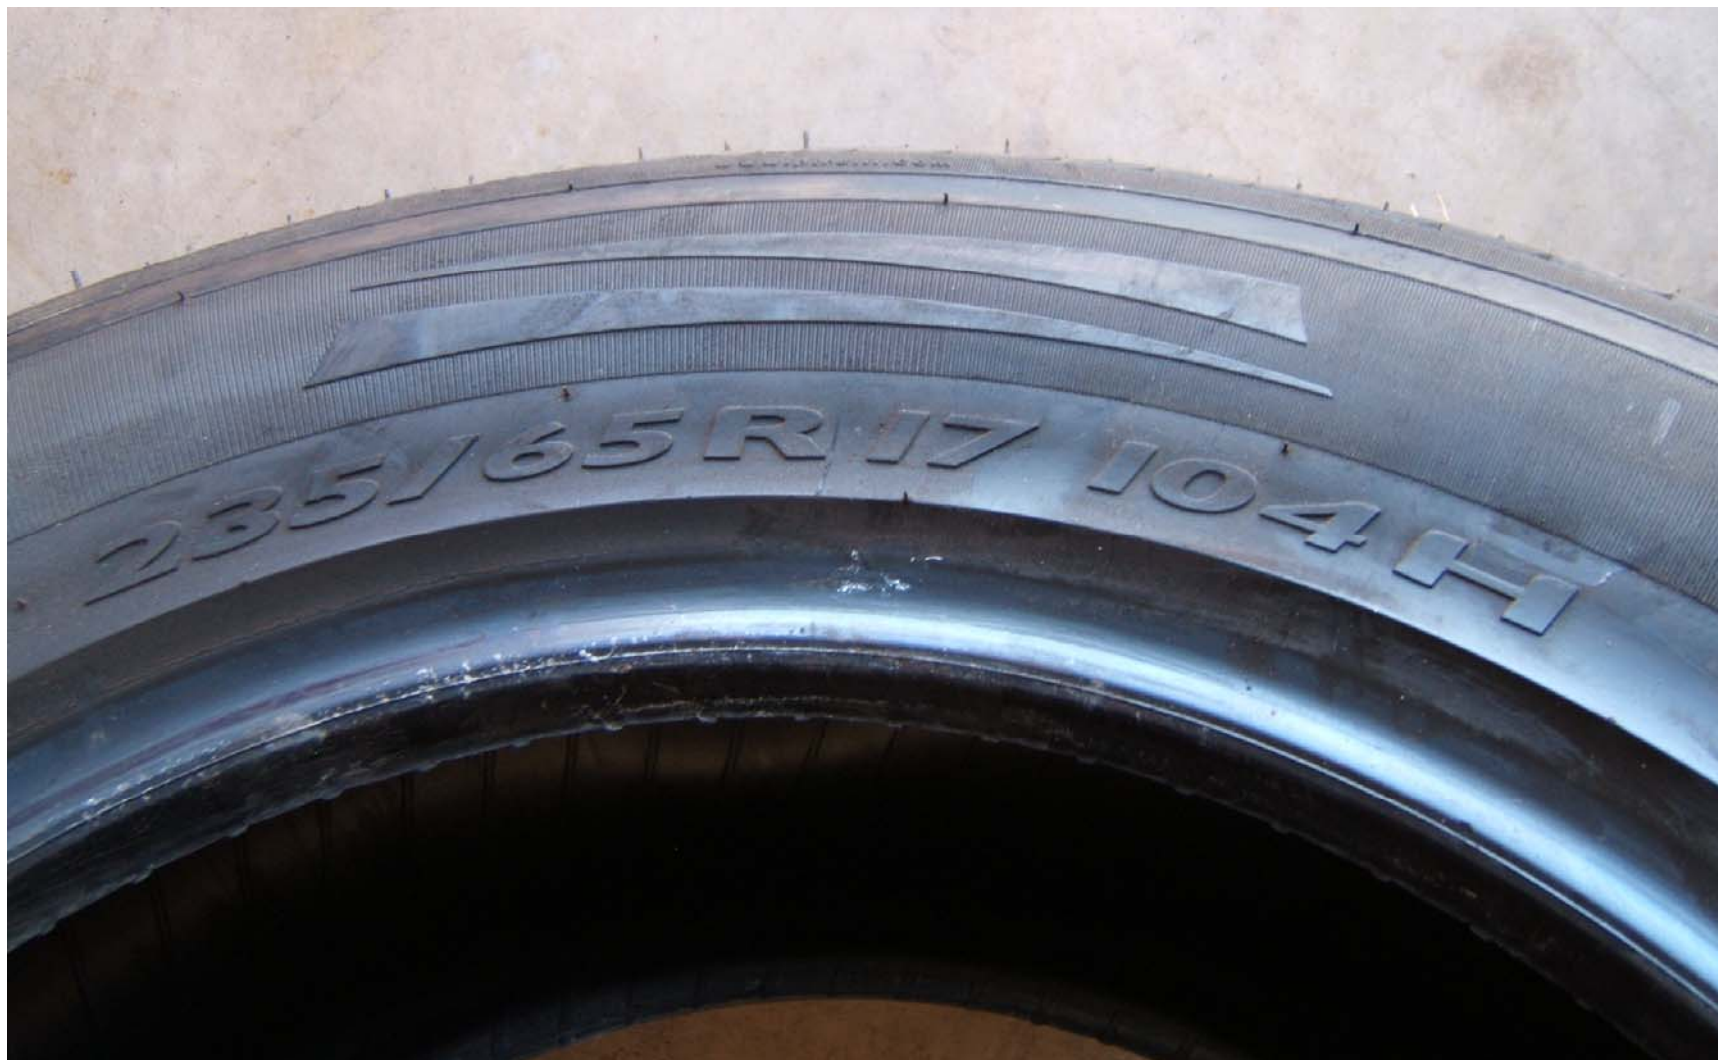
FIGURE 5.6  
TIRE SHOWING SIZE, LOAD INDEX, AND SPEED RATING

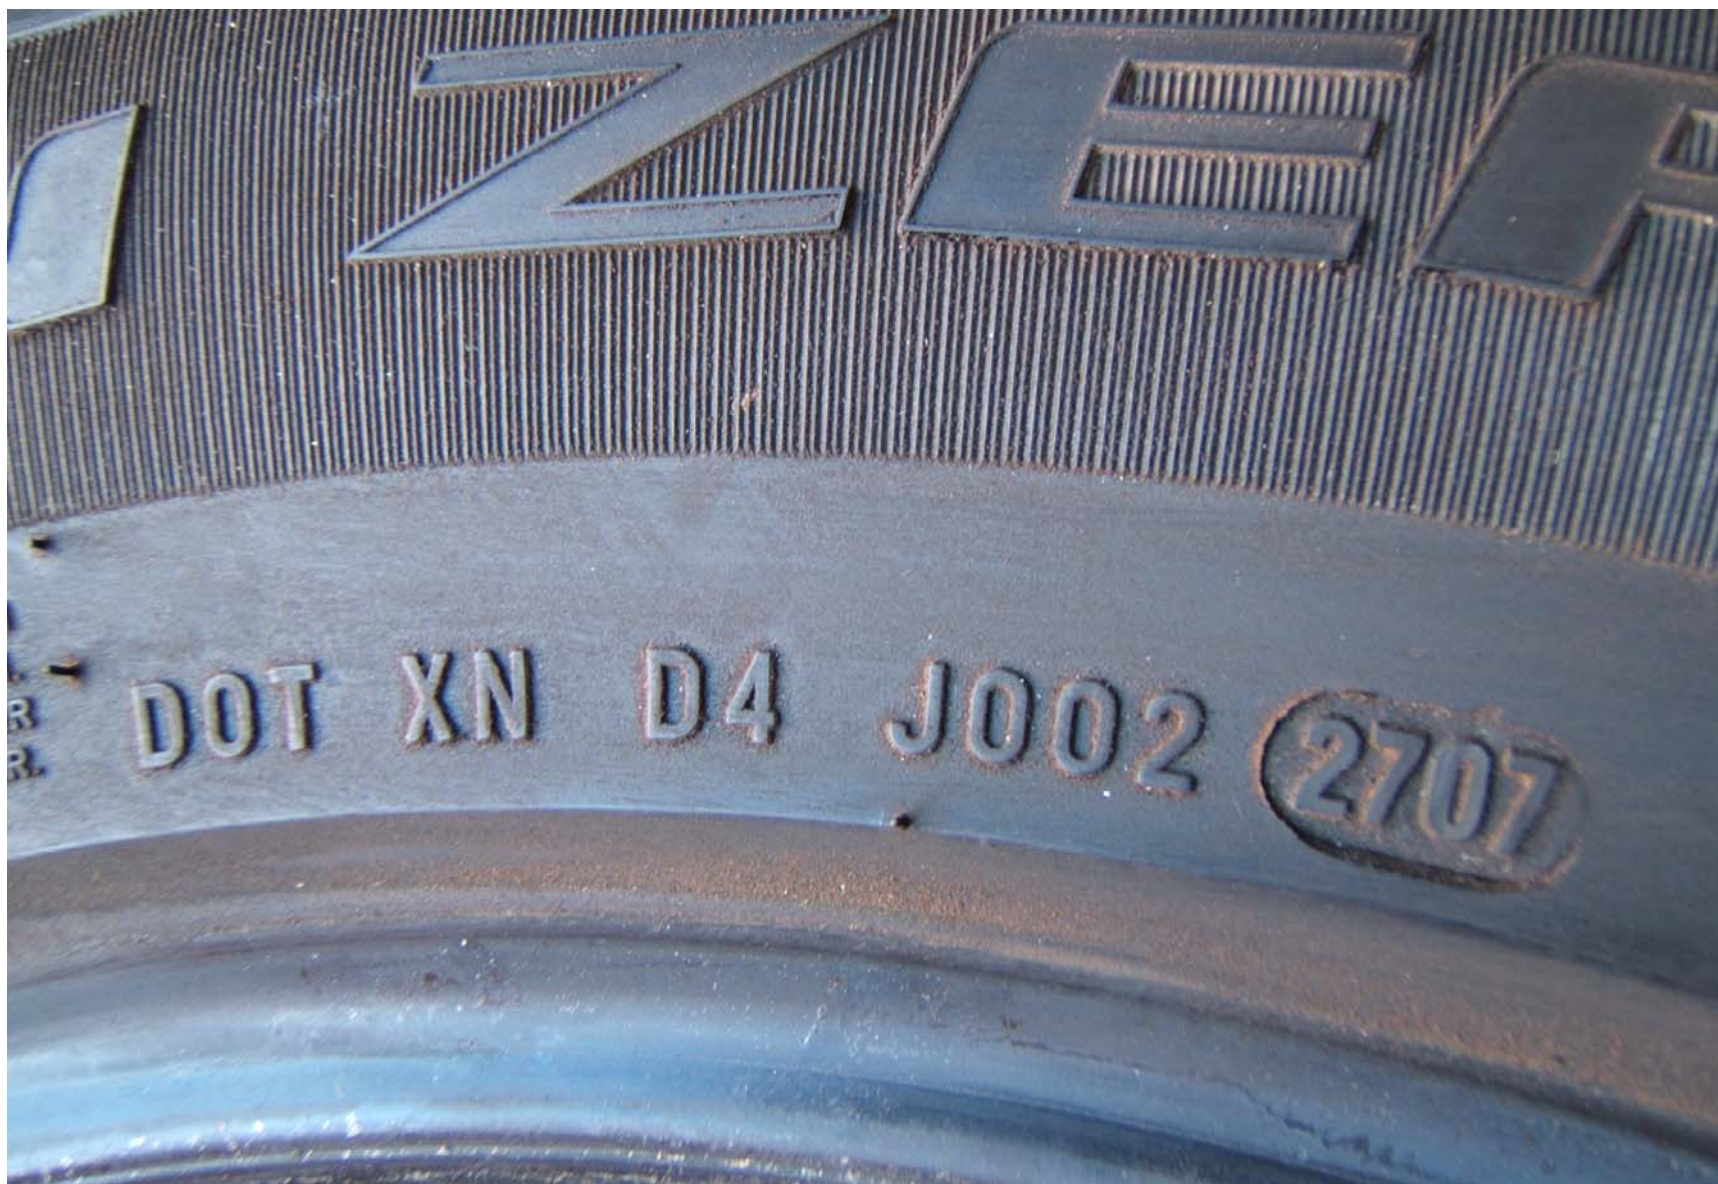
FIGURE 5.7  
TIRE SHOWING DOT SERIAL NUMBER

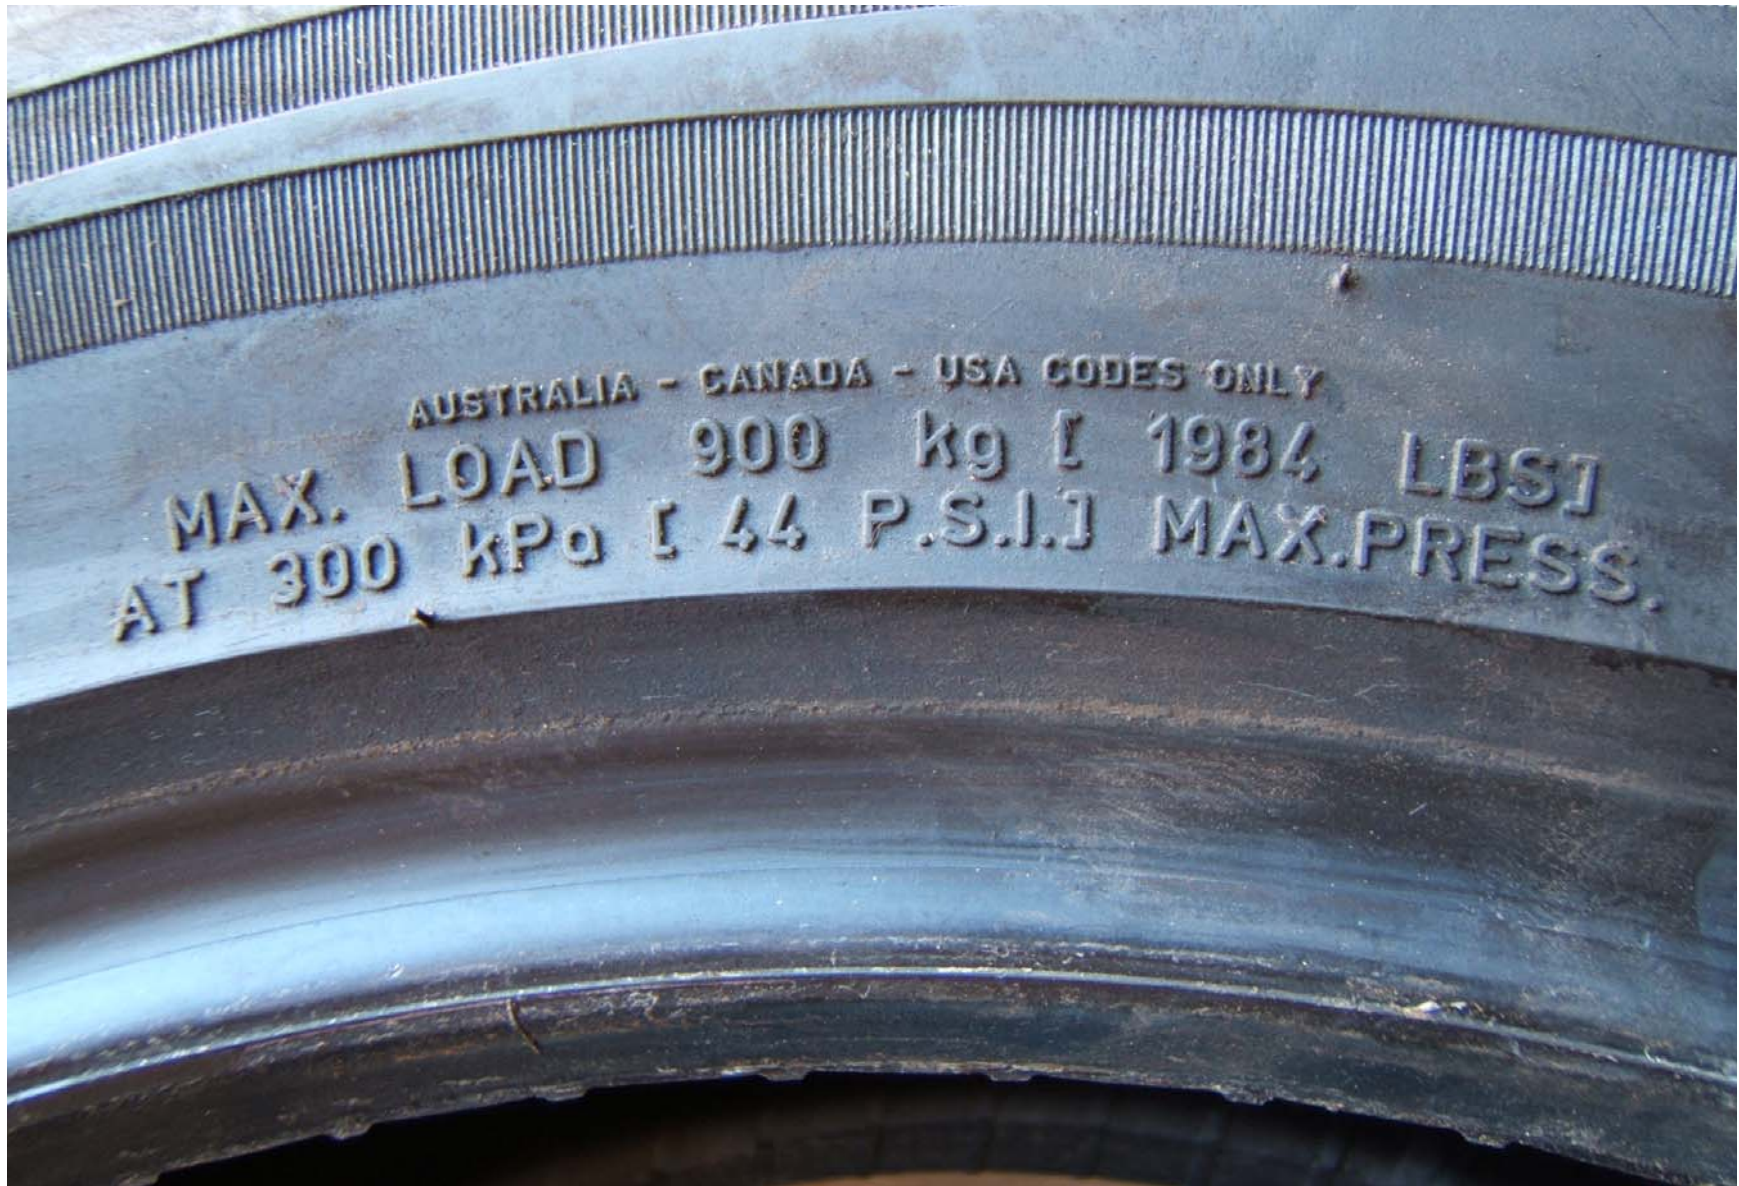
FIGURE 5.8  
TIRE SHOWING MAX LOAD RATING AND  
MAX COLD INFLATION PRESSURE

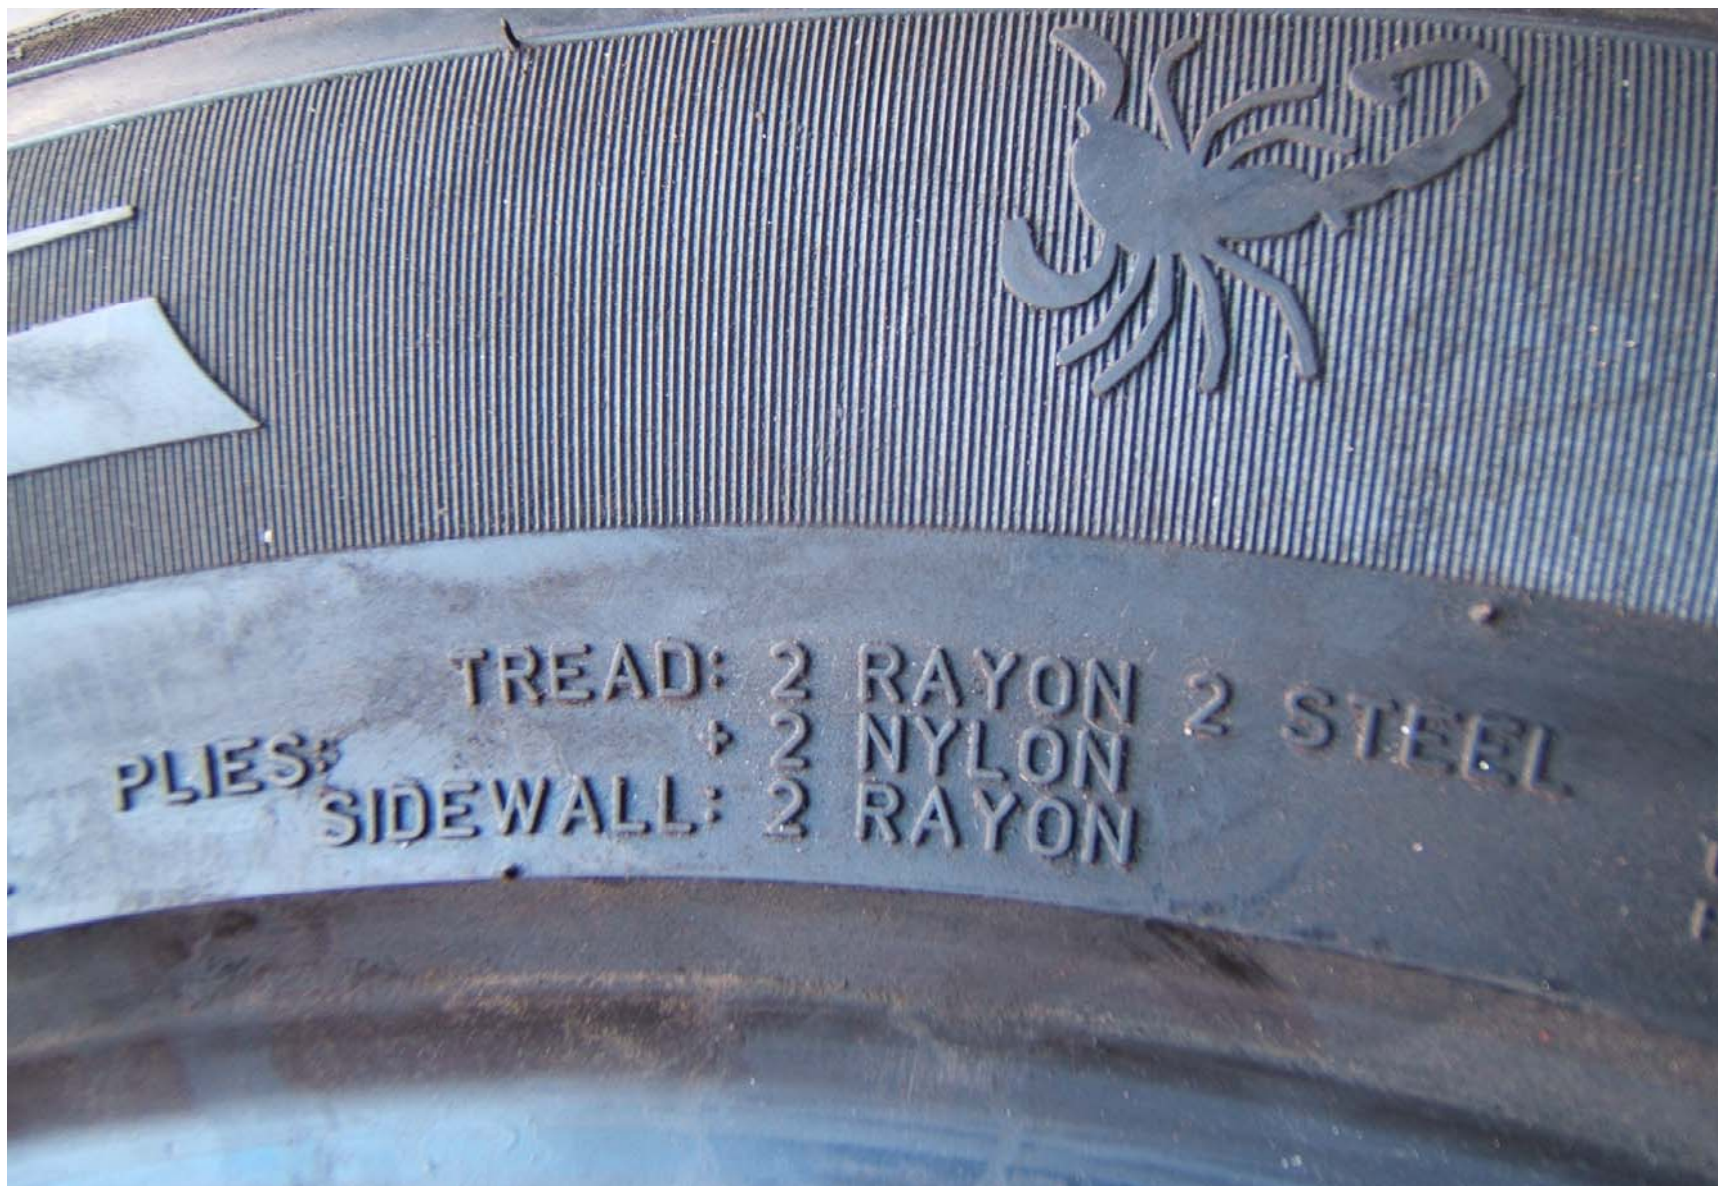
FIGURE 5.9  
TIRE SHOWING SIDEWALL / TREAD CONSTRUCTION

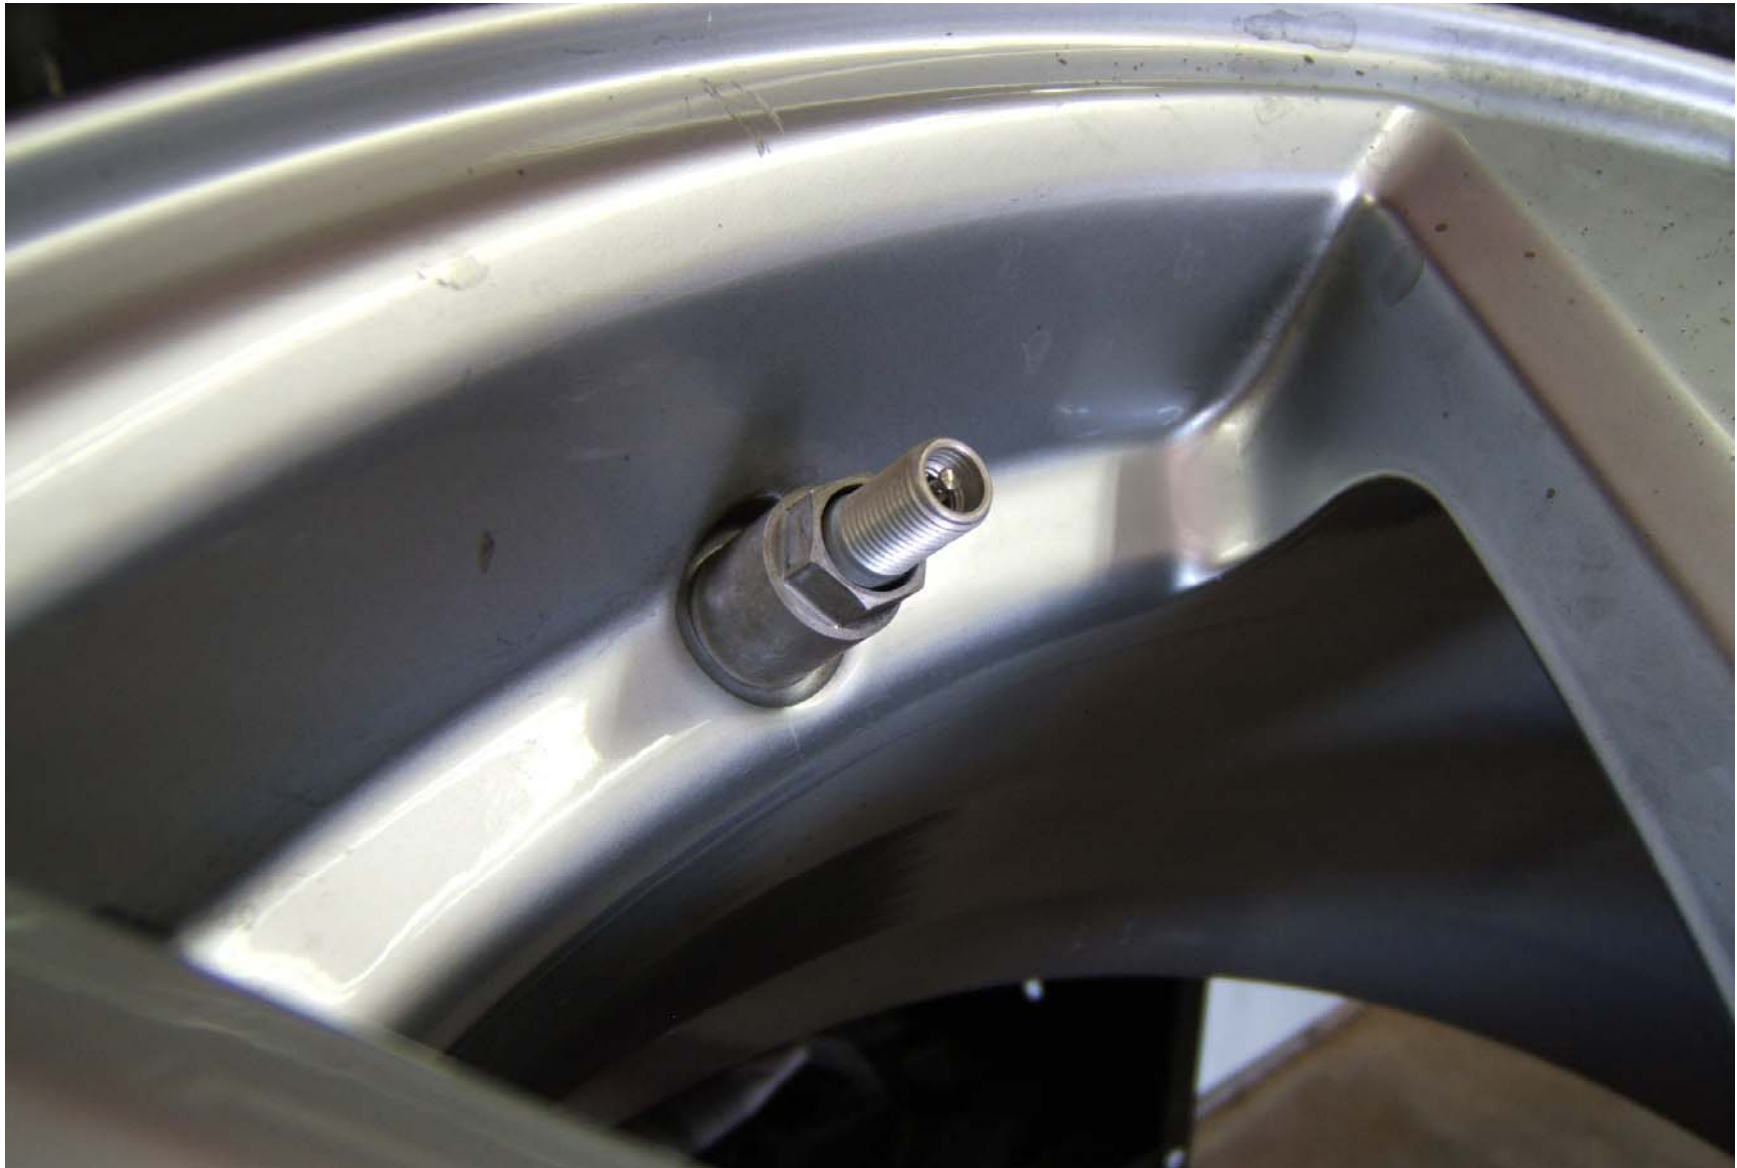
FIGURE 5.10  
RIM SHOWING VALVE STEM

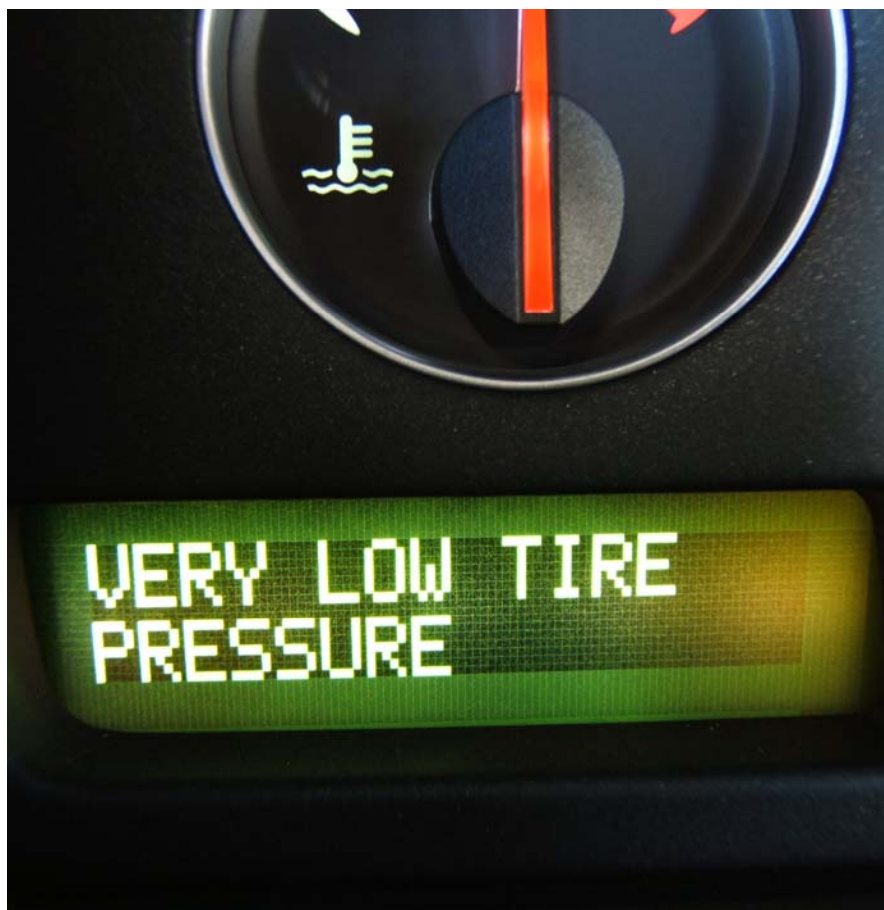
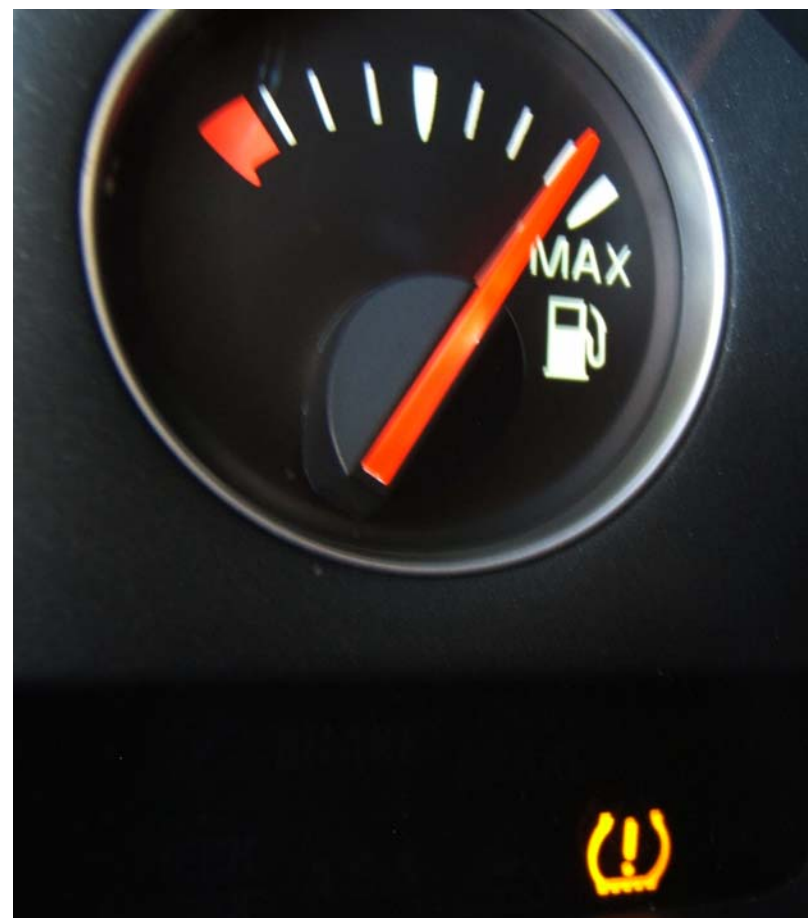
FIGURE 5.11  
INFORMATION CENTER, DISPLAYING LOW TIRE PRESSURE WARNING (ON LEFT), SHOWN  
WITH COMBINATION LOW TIRE PRESSURE WARNING / MALFUNCTION TELLTALE (ON RIGHT)

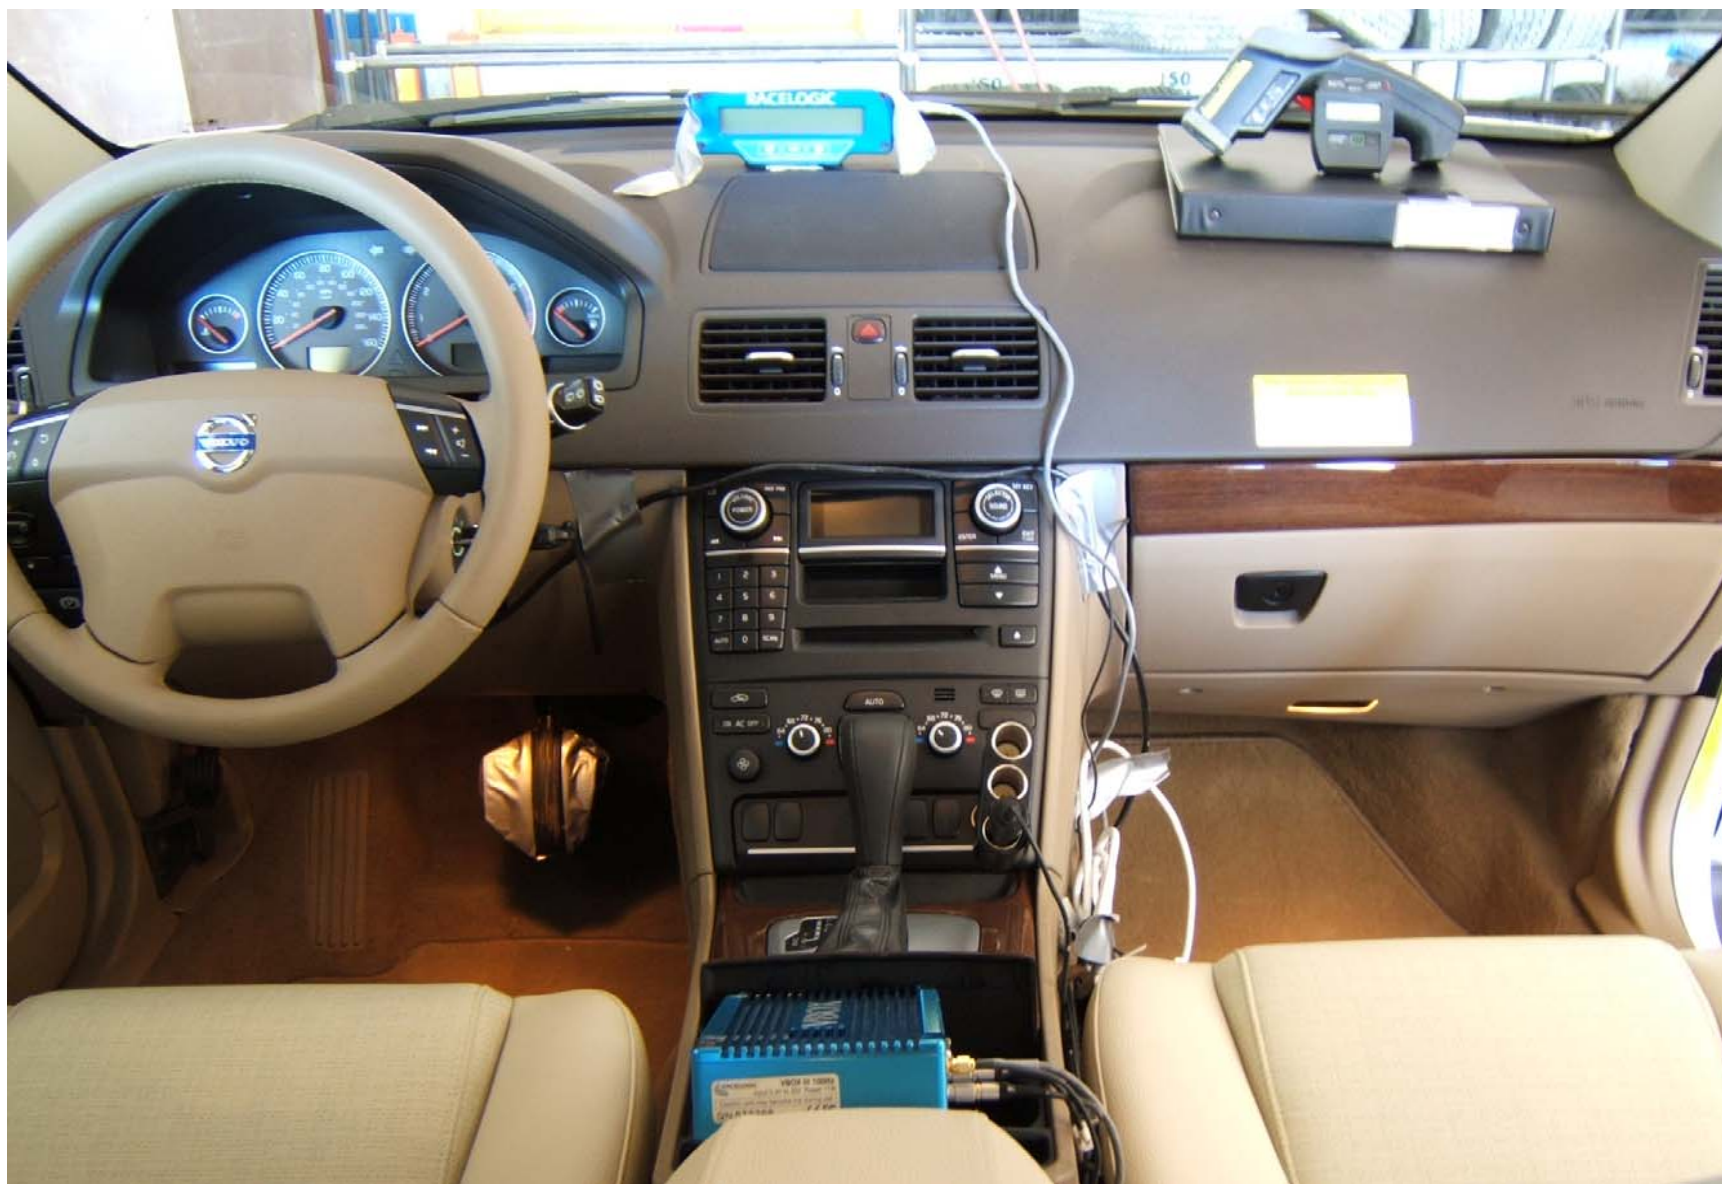
FIGURE 5.12  
TEST INSTRUMENTATION ON VEHICLE

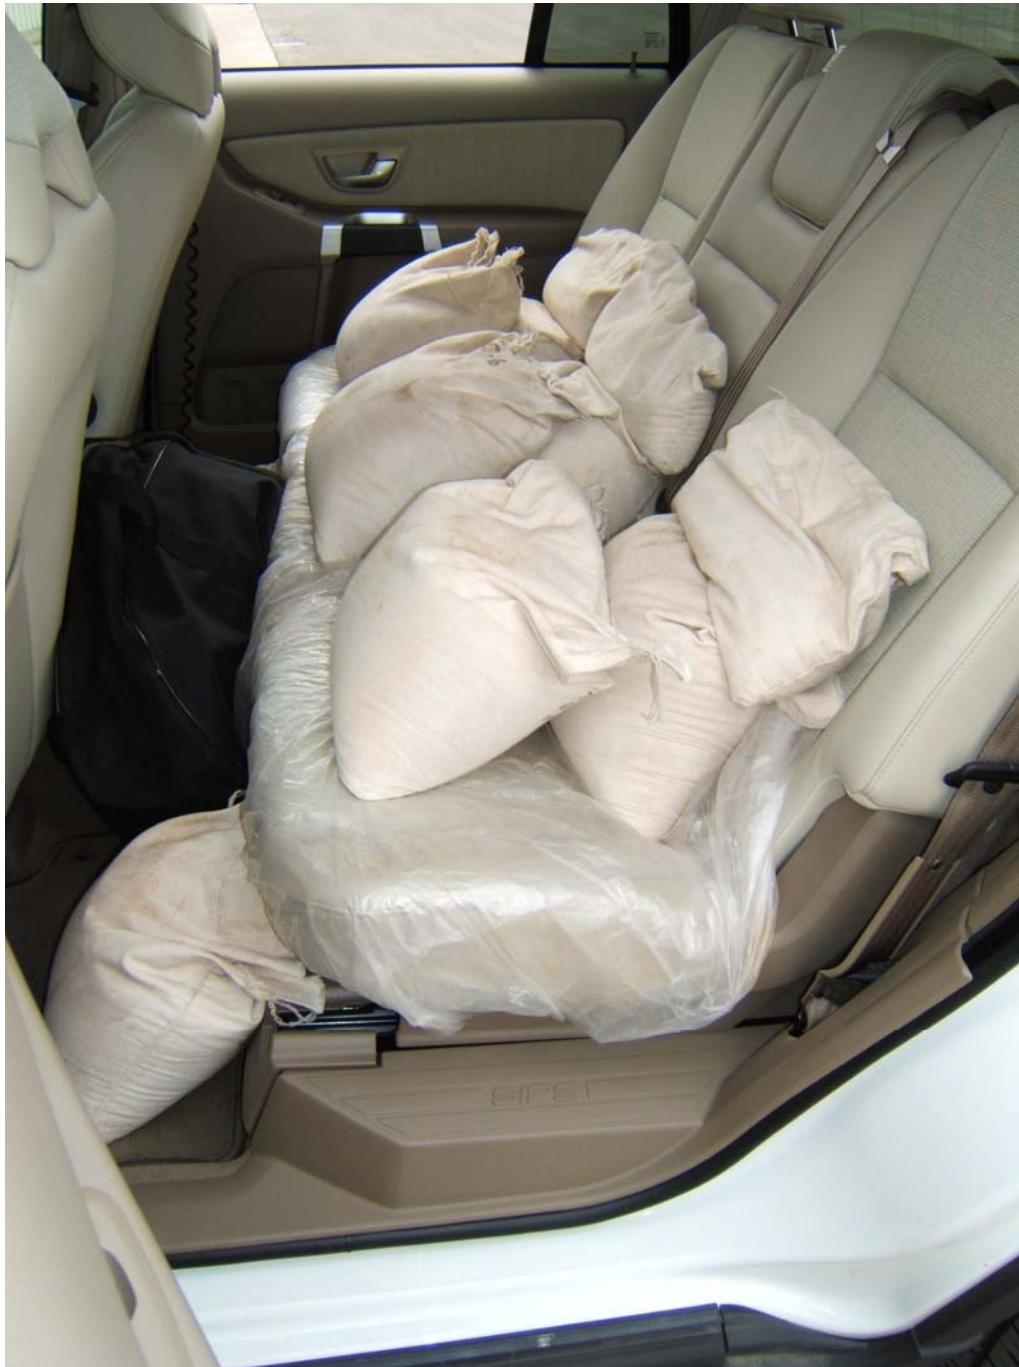
FIGURE 5.13  
VEHICLE REAR SEAT BALLAST  
FOR VCW LOAD

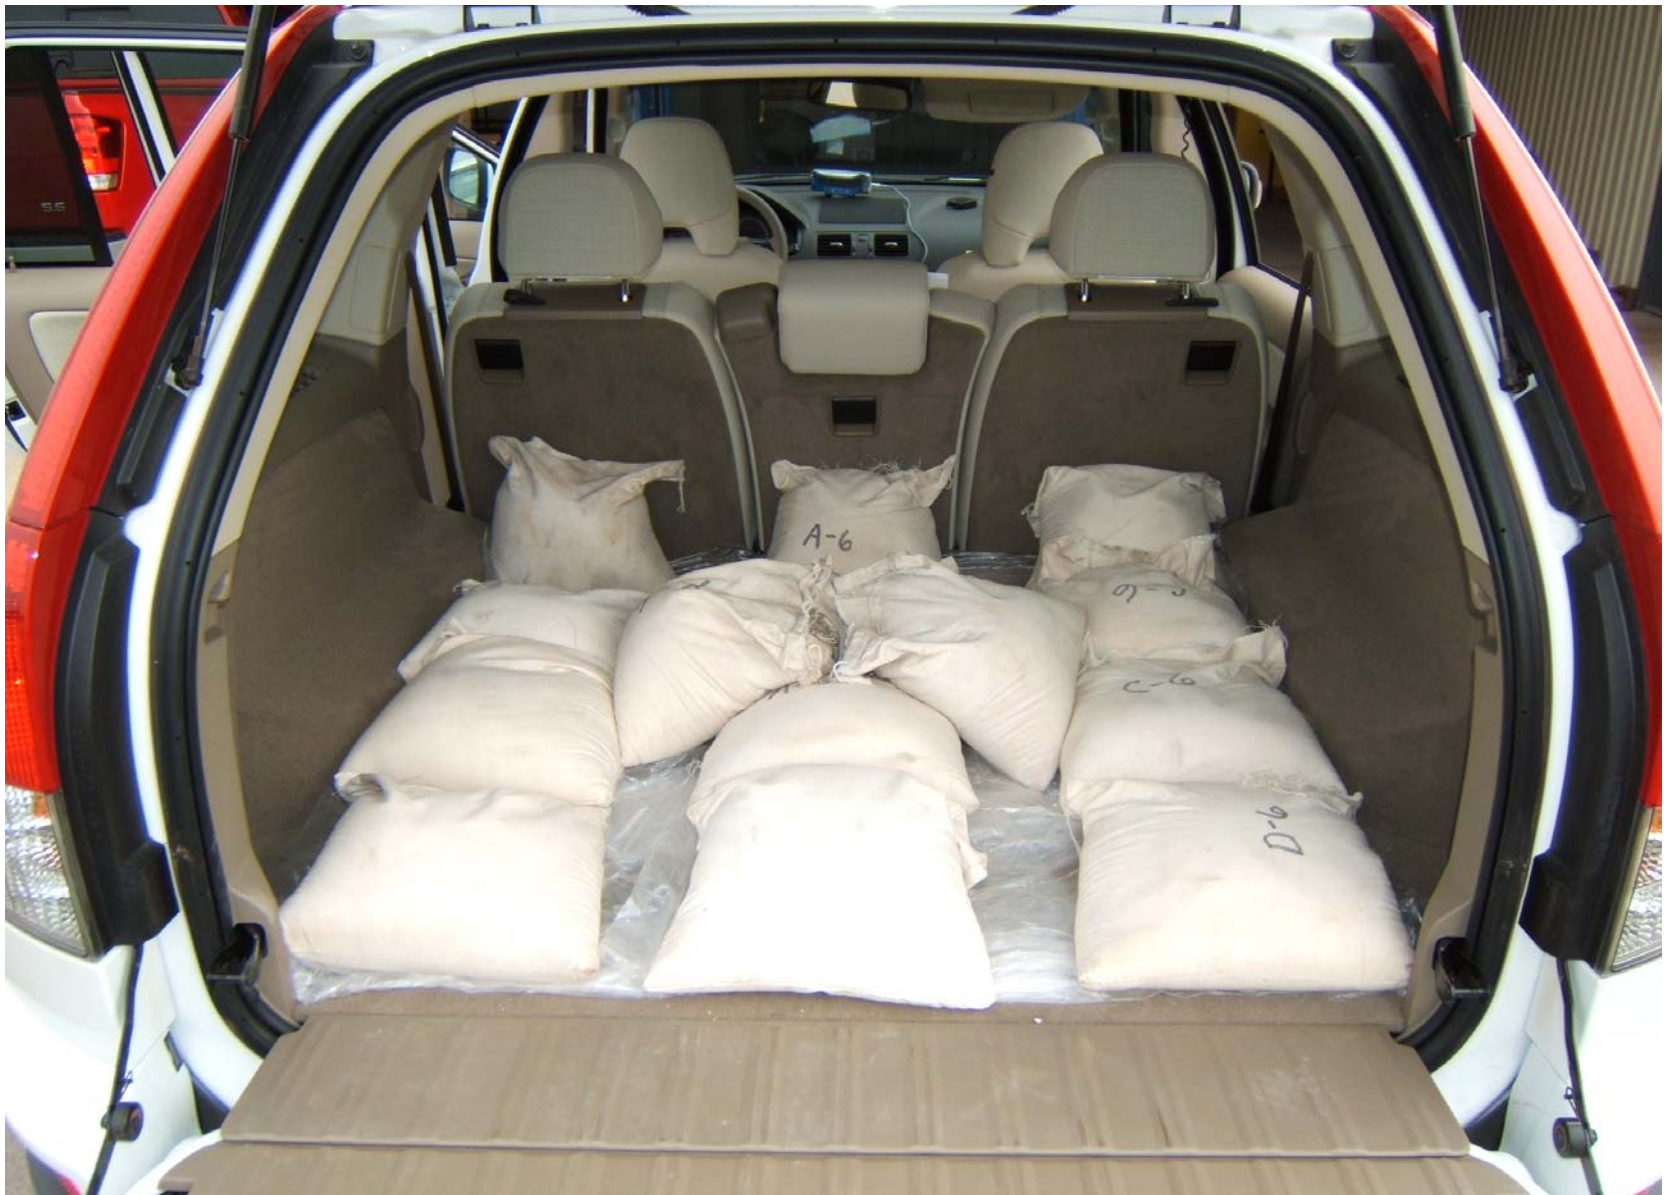
FIGURE 5.14  
REAR OF VEHICLE BALLAST  
FOR VCW LOAD
