REPORT NUMBER 138-STF-08-003

# SAFETY COMPLIANCE TESTING FOR FMVSS NO. 138 TIRE PRESSURE MONITORING SYSTEMS

VOLVO CAR CORPORATION  
2008 VOLVO XC90  
FOUR-DOOR MPV  
NHTSA NO. C85900

FINAL REPORT

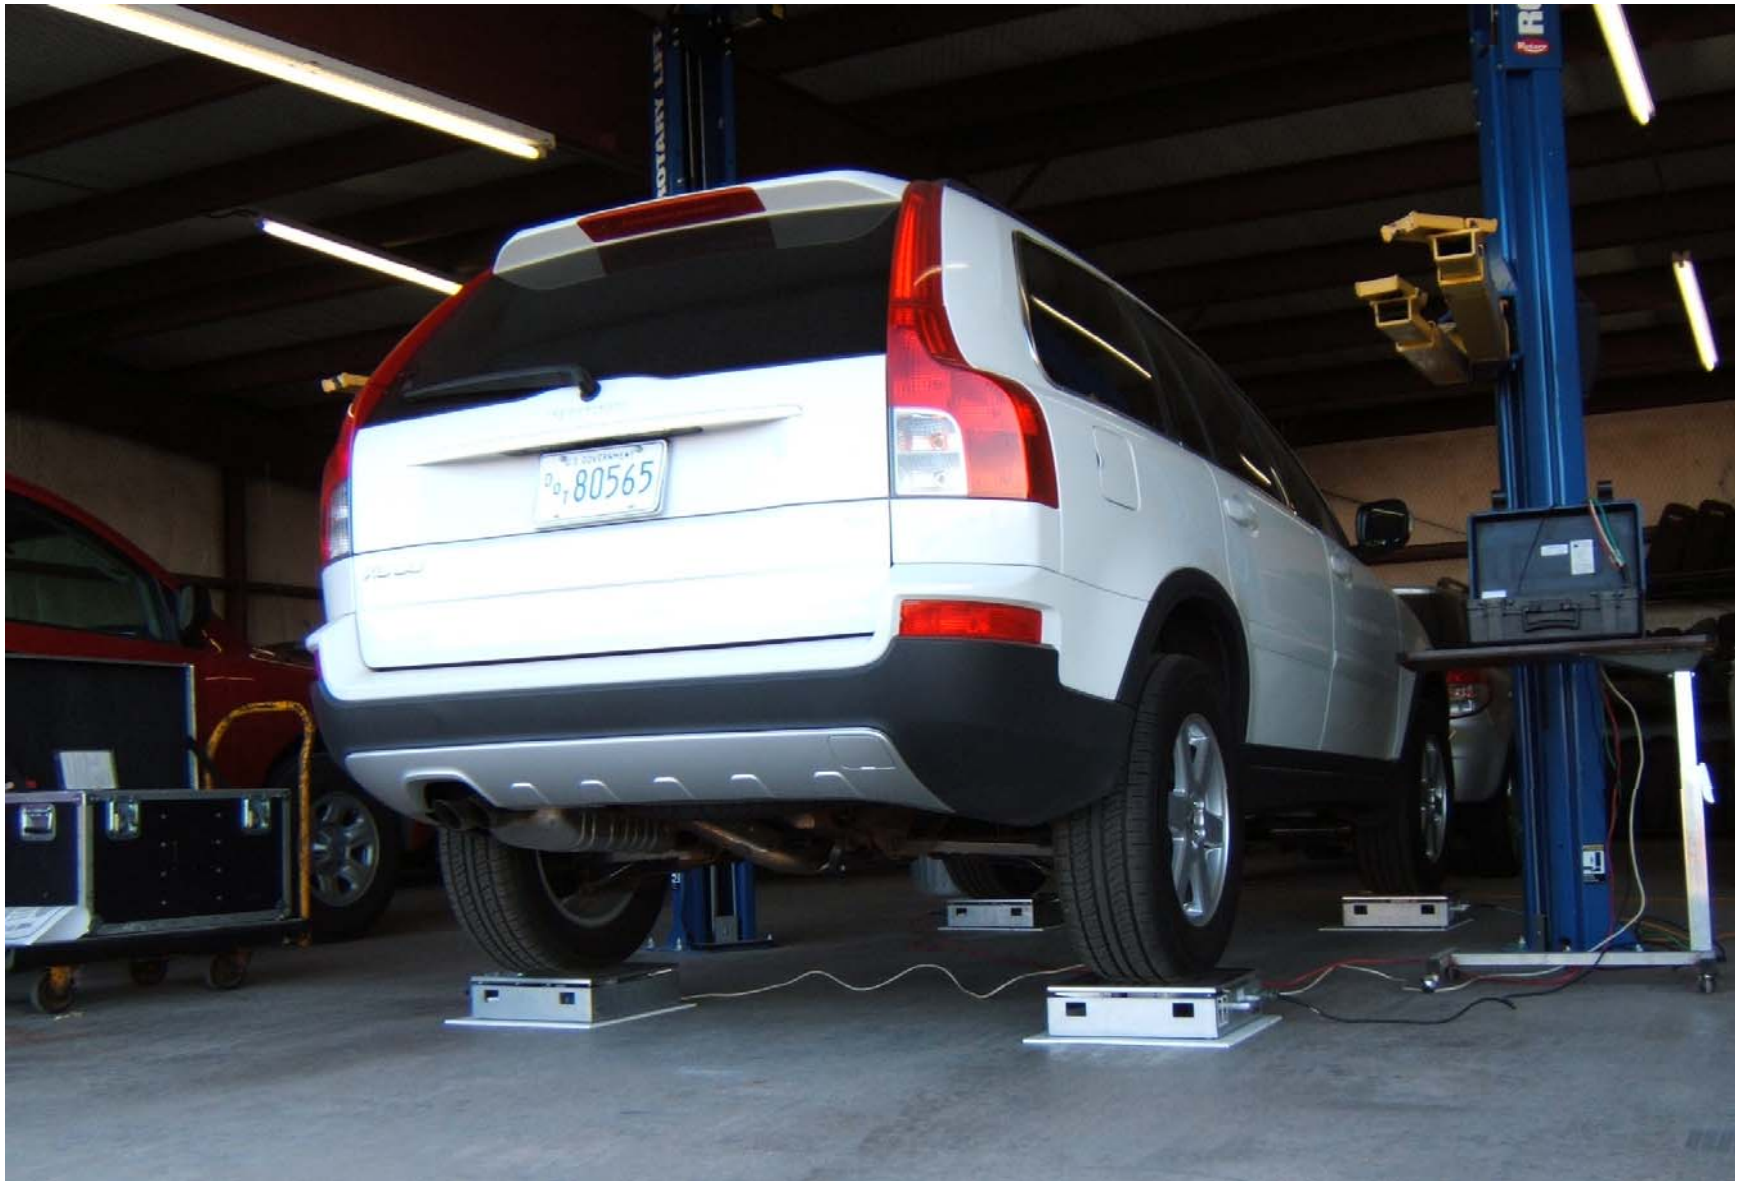
FIGURE 5.15  
VEHICLE ON WEIGHT SCALES

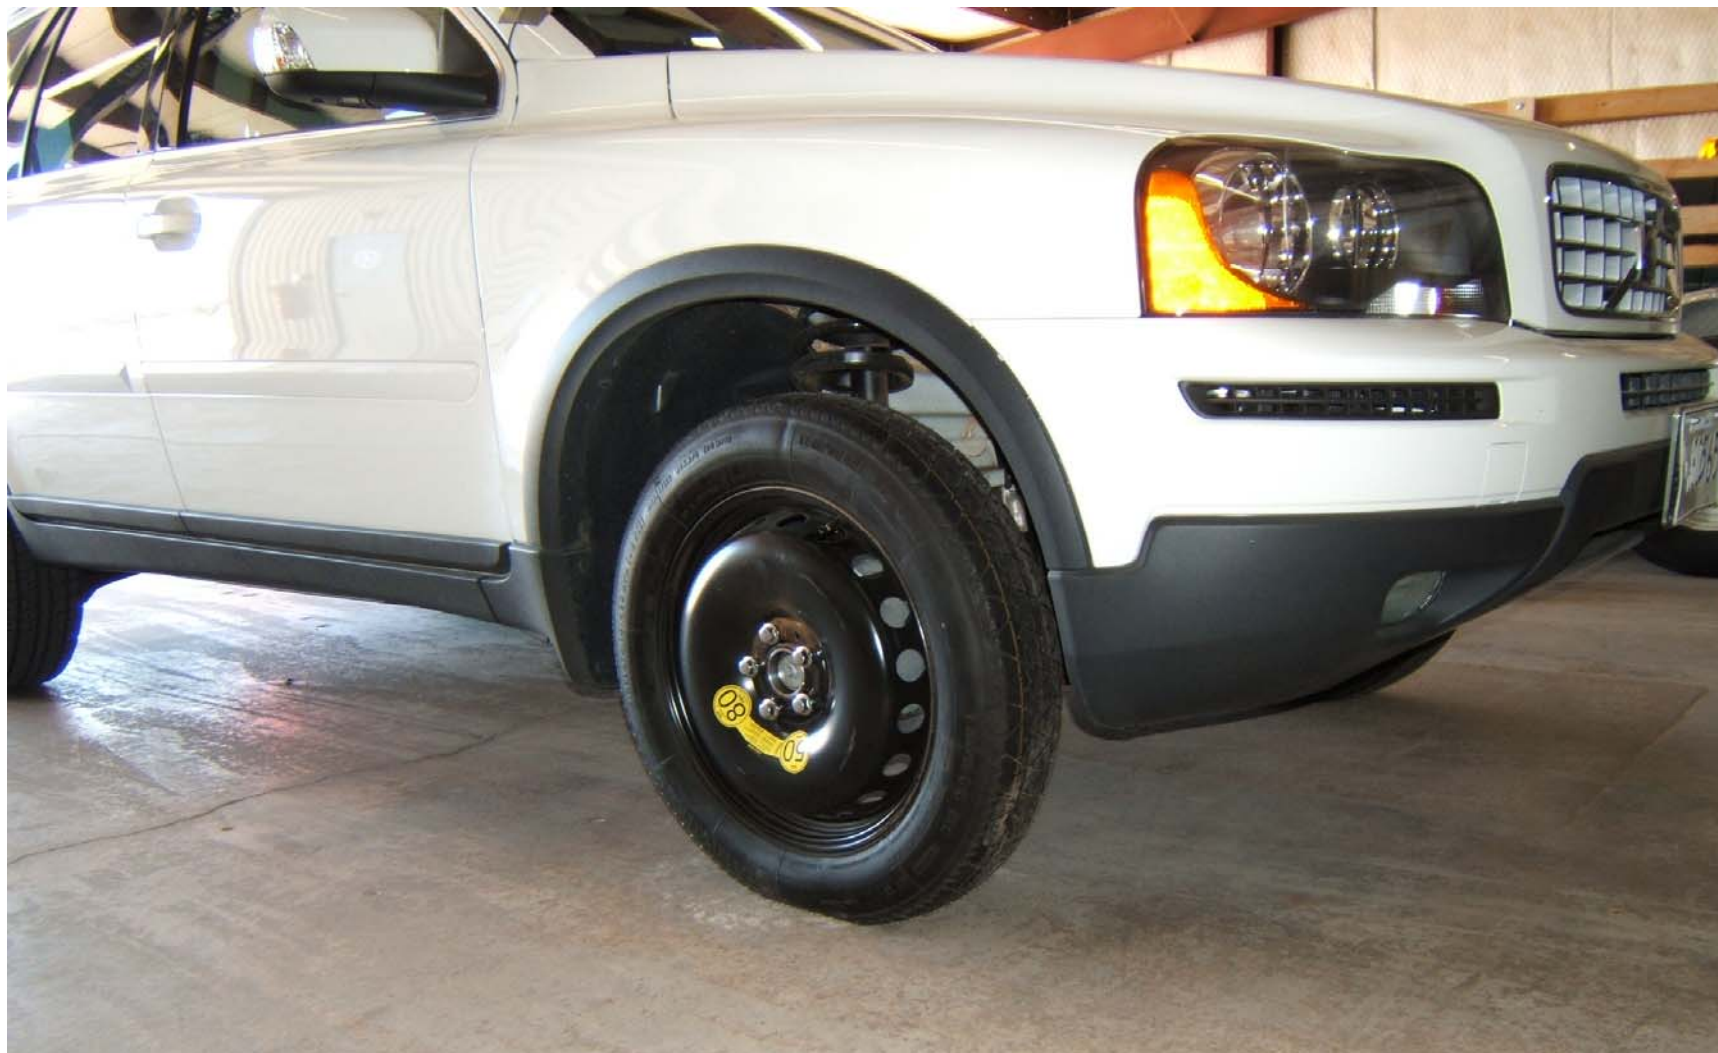
FIGURE 5.16  
SPARE INSTALLED ON RIGHT FRONT POSITION  
FOR MALFUNCTION DETECTION TEST

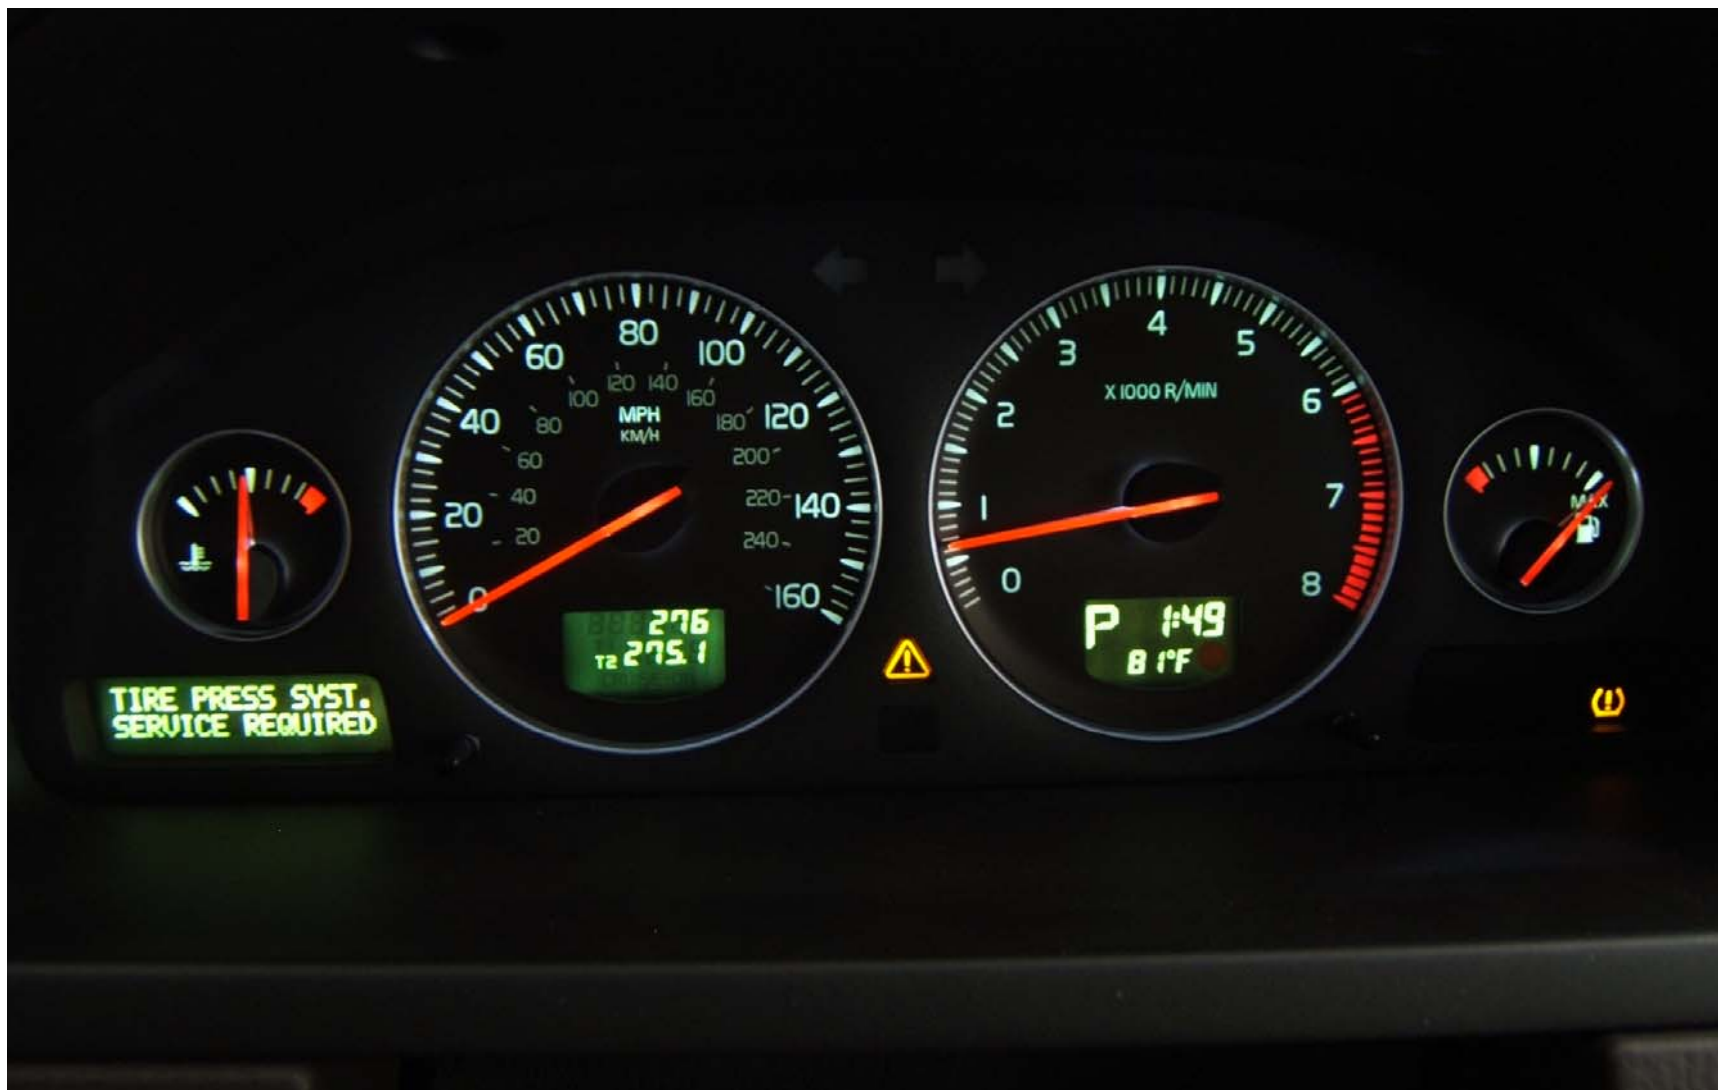
FIGURE 5.17  
INFORMATION CENTER, DISPLAYING TPMS MALFUNCTION WARNING (ON LEFT),  
AND COMBINATION LOW TIRE PRESSURE / MALFUNCTION TELLTALE (ON RIGHT)

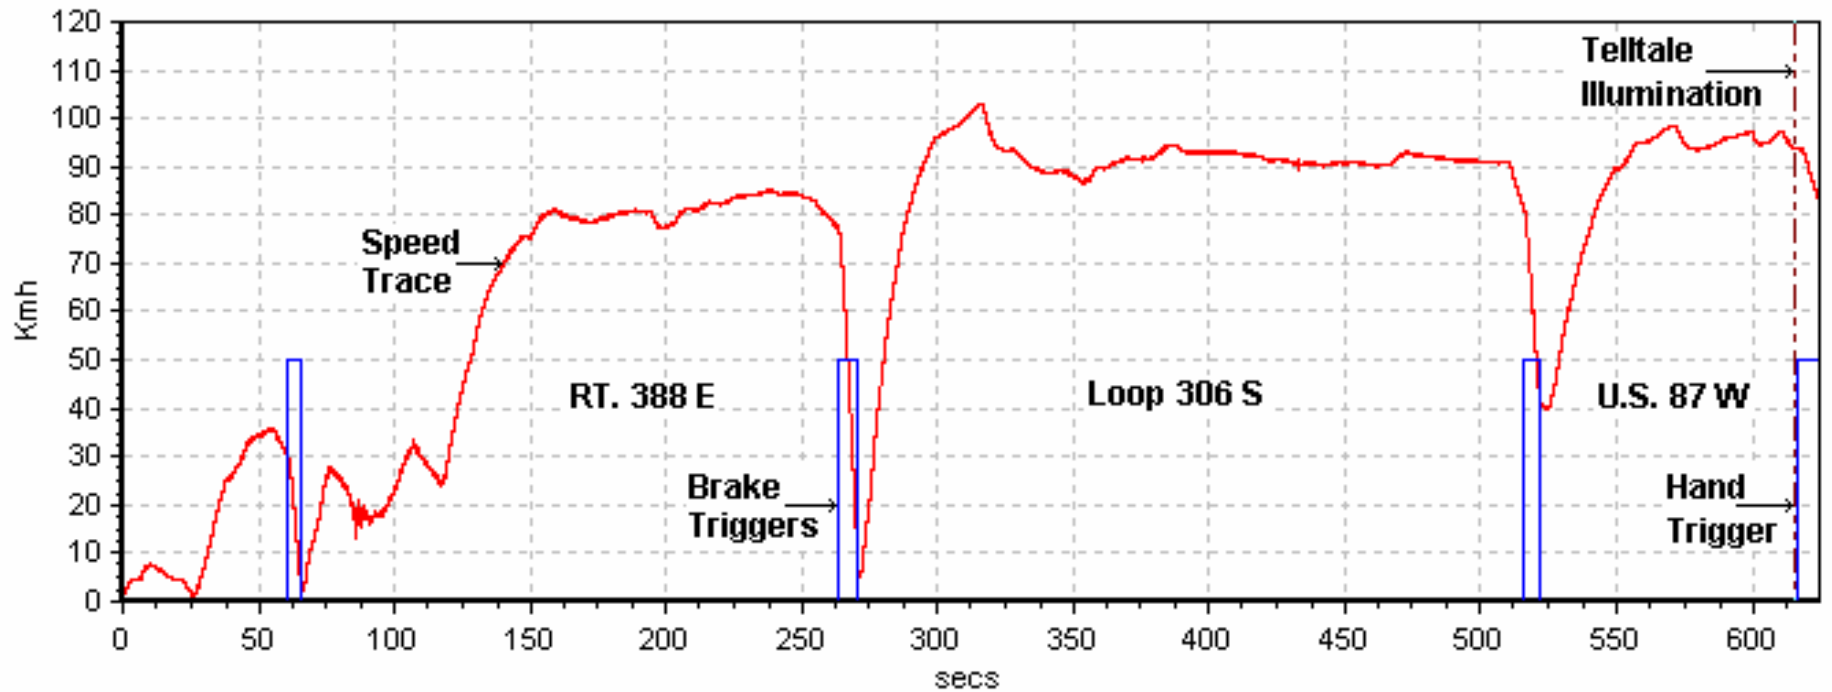
2008 Volvo XC90 (C85900) RF Illumination LLWW

Scenario B: Right Front Tire  
Test Date: 2/15/08  
Data File Time: 10:25 minutes  
Cumulative Driving Time: 7:39 minutes  
Start Point: San Angelo Test Facility Shop

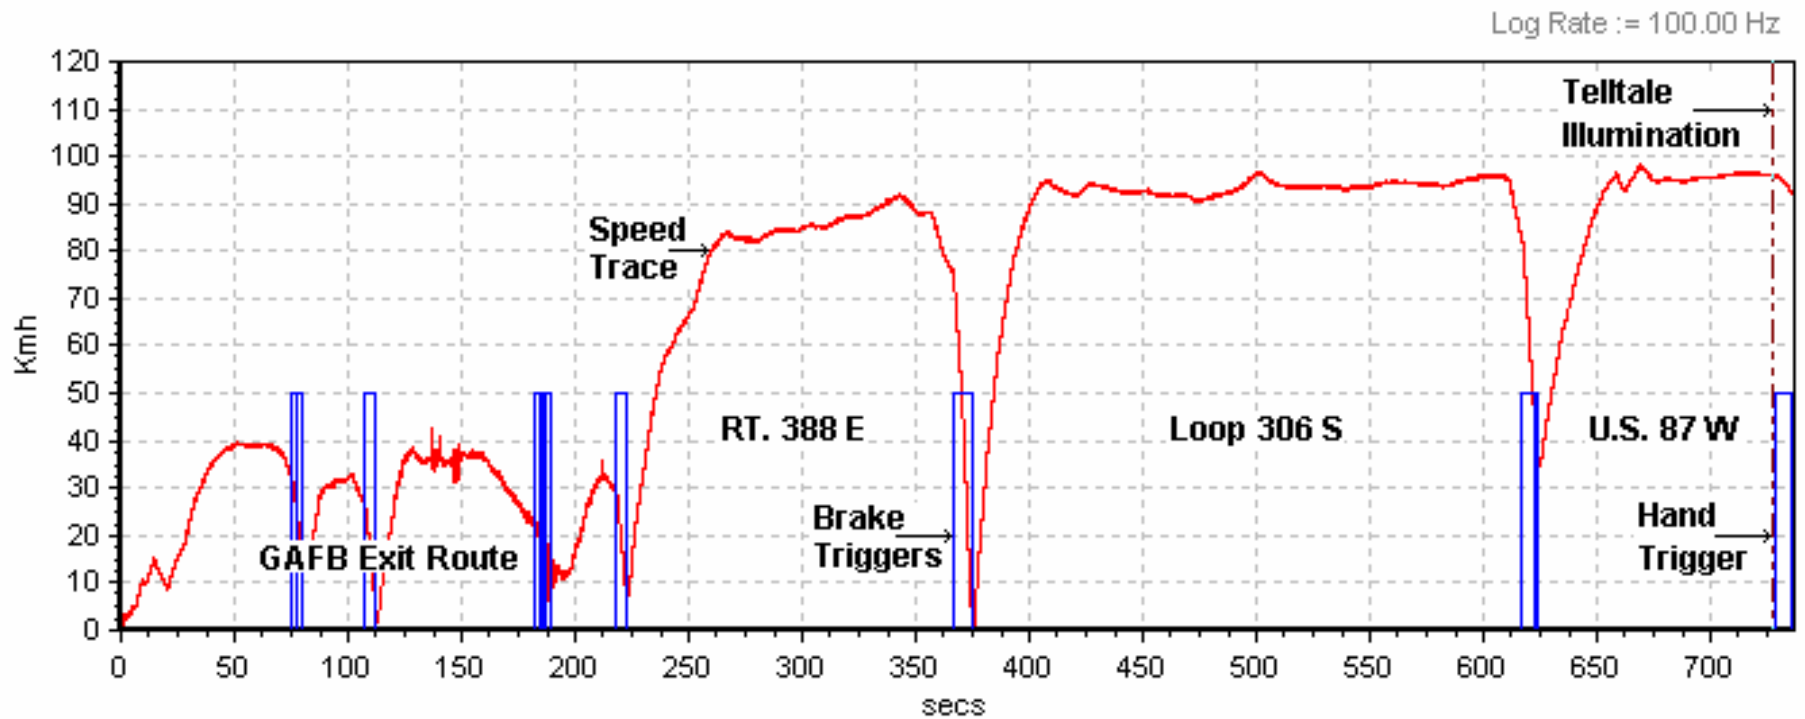
2008 Volvo XC90 (C85900) LF, RF Illumination LLVW

Scenario C: Left Front, Right Front Tires  
Test Date: 2/19/08  
Data File Time: 12:17 minutes  
Cumulative Driving Time: 7:43 minutes  
Start Point: San Angelo Test Facility Shop

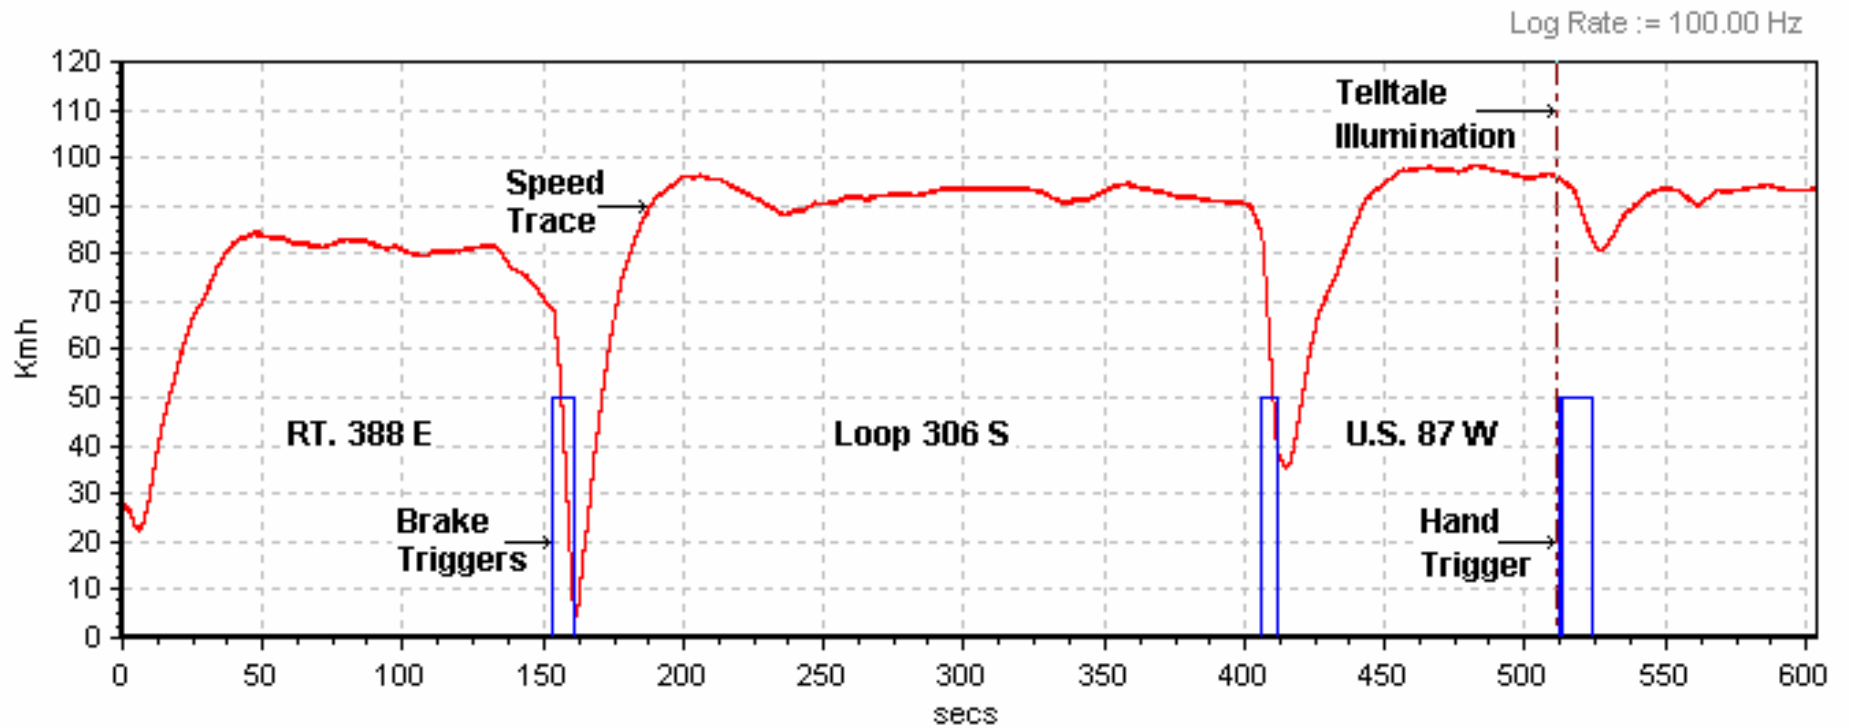
2008 Volvo XC90 (C85900) LF Illumination UWW + VCW

Scenario E: Left Front Tire  
Test Date: 2/21/08  
Data File Time: 10:04 minutes  
Cumulative Driving Time: 7:44 minutes  
Start Point: San Angelo Test Facility Shop

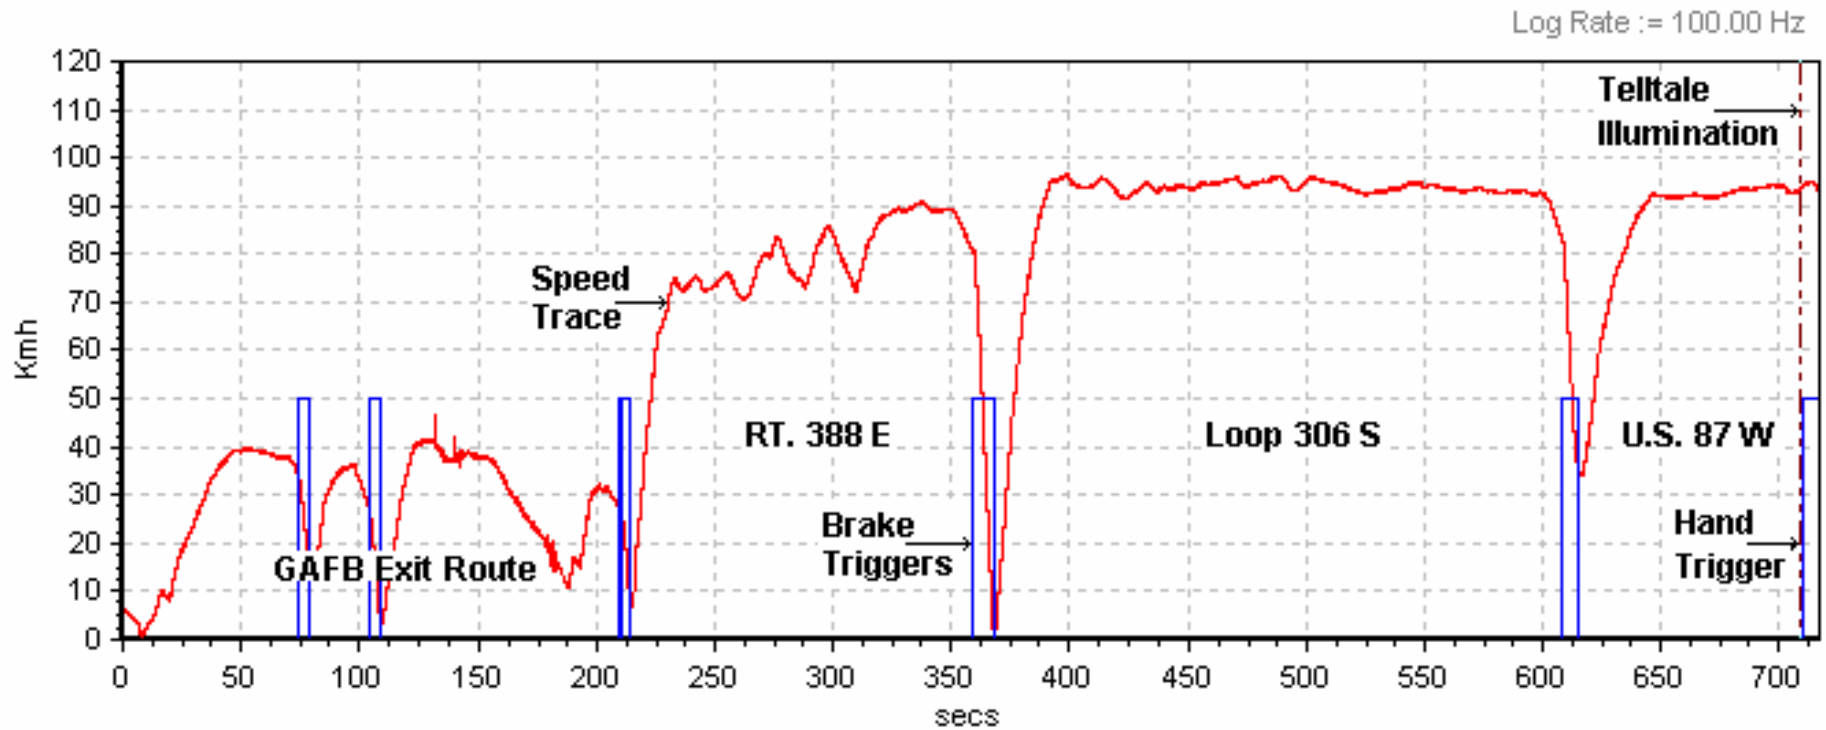
2008 Volvo XC90 (C85900) LF, LR, RR, RF Illumination UWW + VCW

Scenario H: Left Front, Left Rear, Right Rear, Right Front Tires  
Test Date: 2/26/08  
Data File Time: 11:57 minutes  
Cumulative Driving Time: 7:36 minutes  
Start Point: San Angelo Test Facility Shop

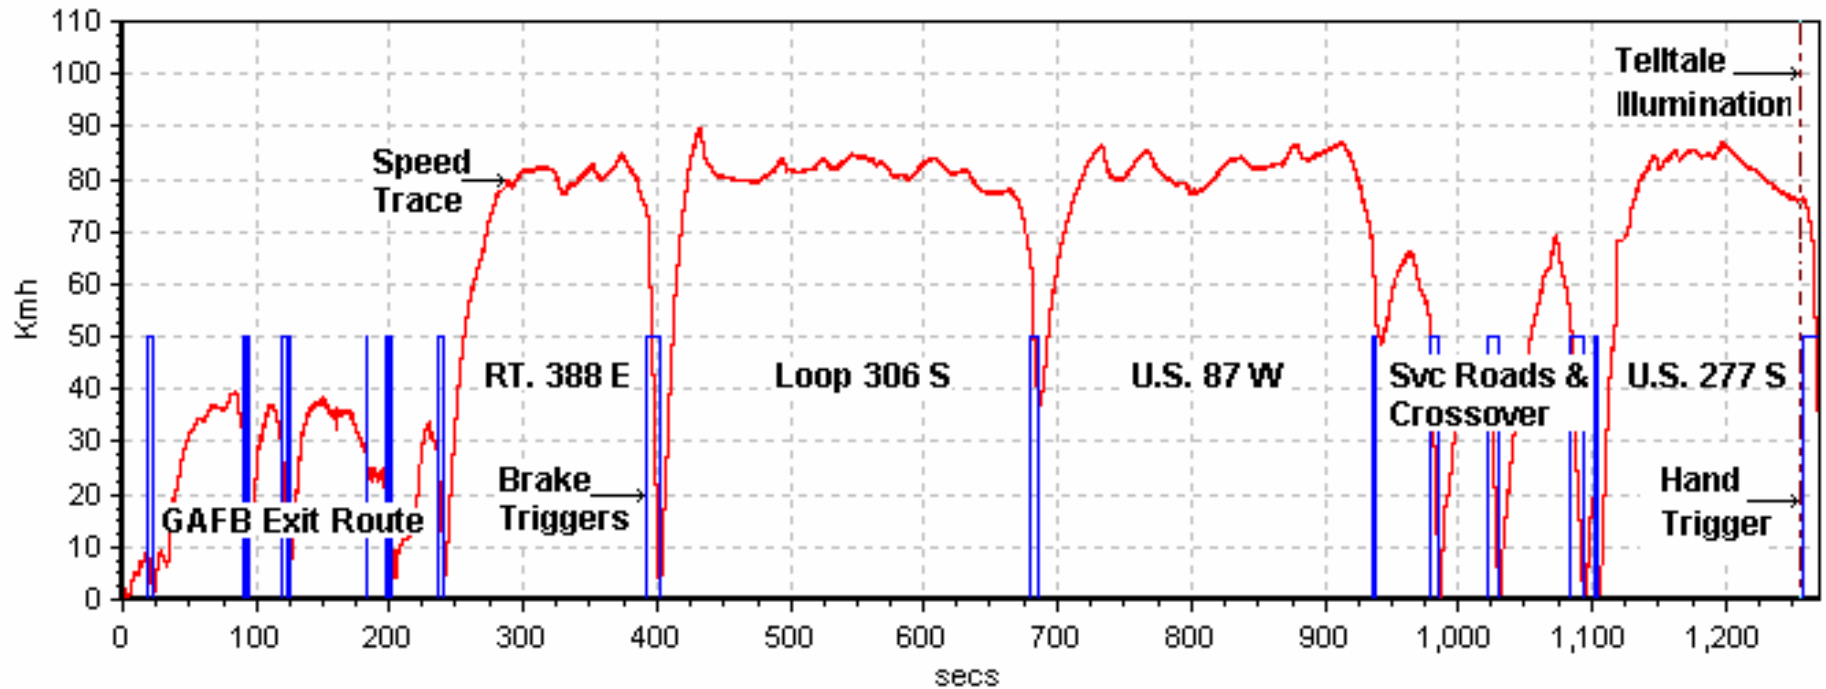
2008 Volvo XC90 (C85900) RF Spare Tire Malfunction Illumination LLVW

Scenario I: Compact Spare without Sensor Installed on Right Front Position at LLVW  
 Test Date: 2/20/08  
 Data File Time: 21:10 minutes  
 Cumulative Driving Time to Illumination: 14:14 minutes  
 Start Point: San Angelo Test Facility Shop
