REPORT NUMBER 110-STF-08-003

SAFETY COMPLIANCE TESTING FOR FMVSS NO. 110 TIRE SELECTION AND RIMS

VOLVO CAR CORPORATION
2008 VOLVO XC90
FOUR-DOOR MPV
NHTSA NO. C85900

FINAL REPORT

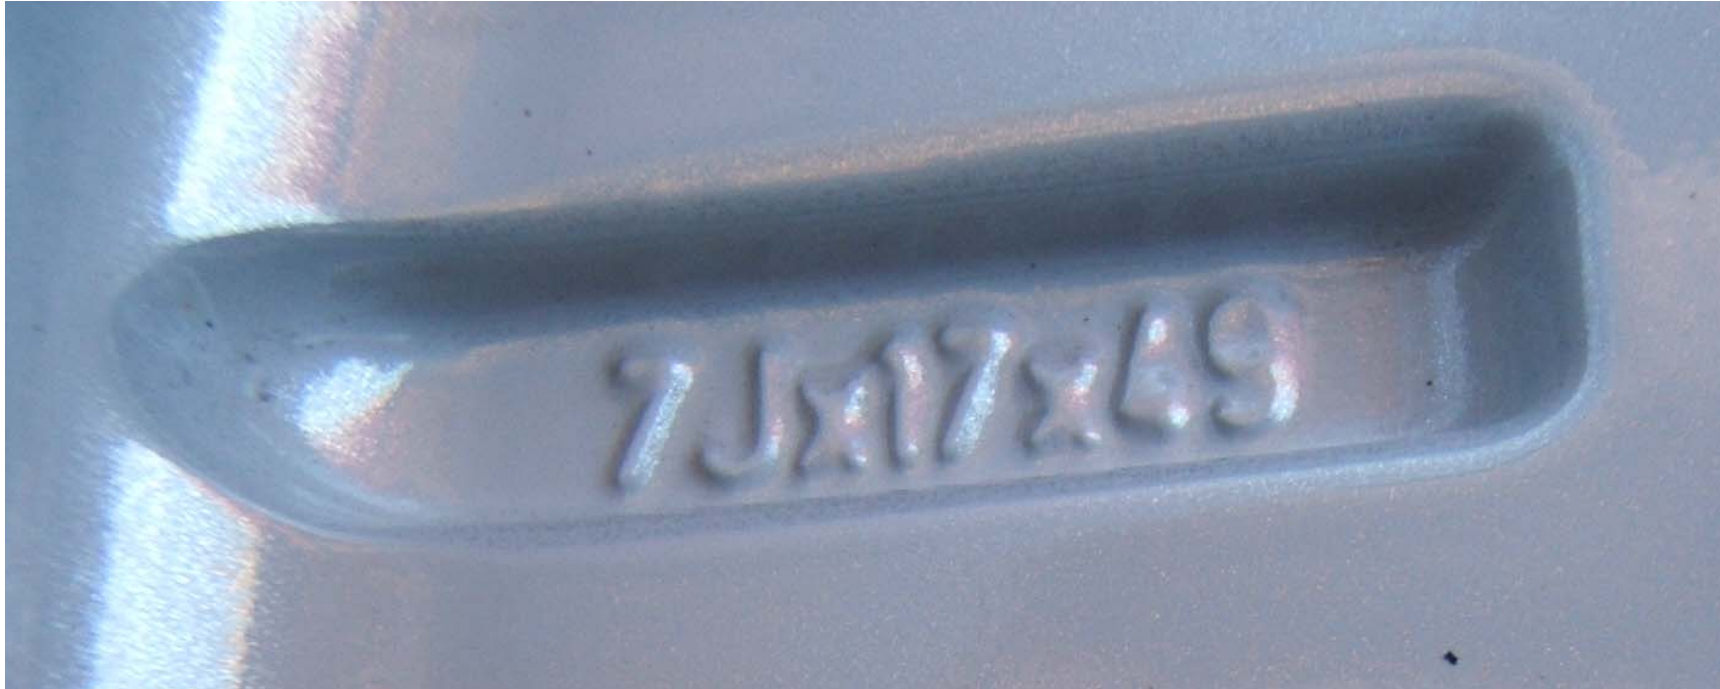
FIGURE 5.14
RIM SHOWING SIZE

Rim Markings	RIGHT FRONT	LEFT REAR (if different)
A. Source of published dimensions (letter designation)	None	
B. Rim Size Designation	7Jx17x49	
C. Does rim contain DOT symbol? (Yes/No)	No	
D. Manufacturer's name, symbol or trademark (copy format)

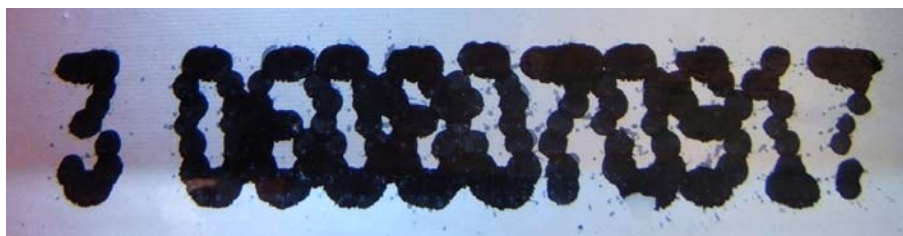
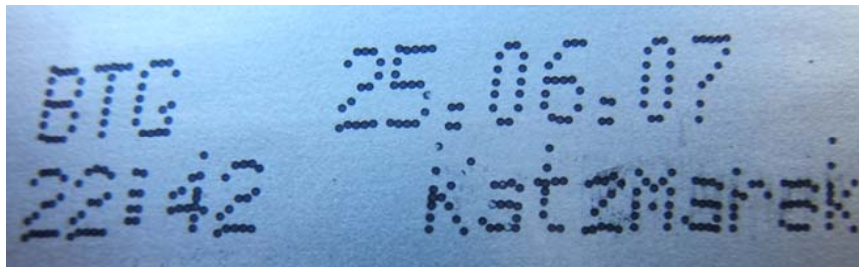
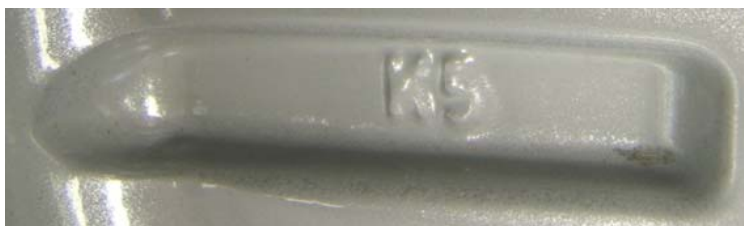
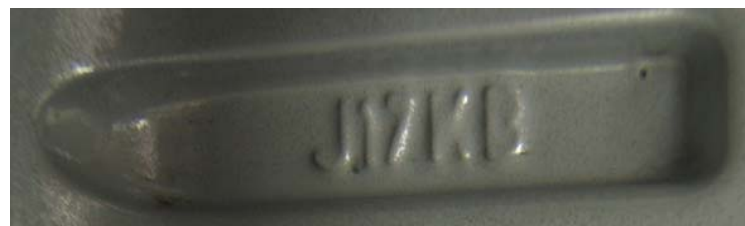
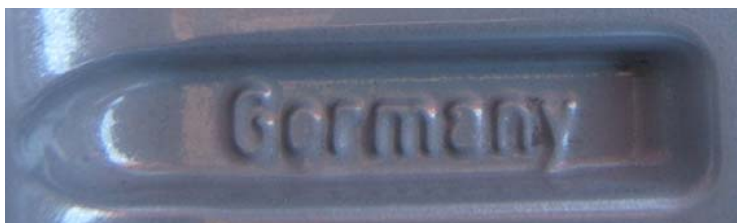
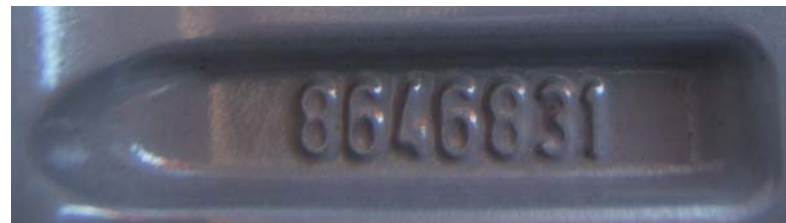
FIGURE 5.15
RIM MARKINGS

F. Letter height (not less than 3 mm)	5 mm	
G. Lettering (impressed or embossed)	Embossed	
H. Are all rim markings legible? (Yes/No)	Yes	
Do items A-C appear on weather side of rim (Yes/No)	No - B only	
Do all markings comply with requirements (Yes/No)	No

TEST FAILURE DESCRIPTION: DOT symbol required by FMVSS 110, S4.4.2(c), is not present, as verified by FMVSS 110 testing.

TEST FAILURE DESCRIPTION: The designation that indicates source of rim's published nominal dimension is not present. This is a violation of FMVSS S110, S4.4.2(a) verified by FMVSS 110/120 testing.

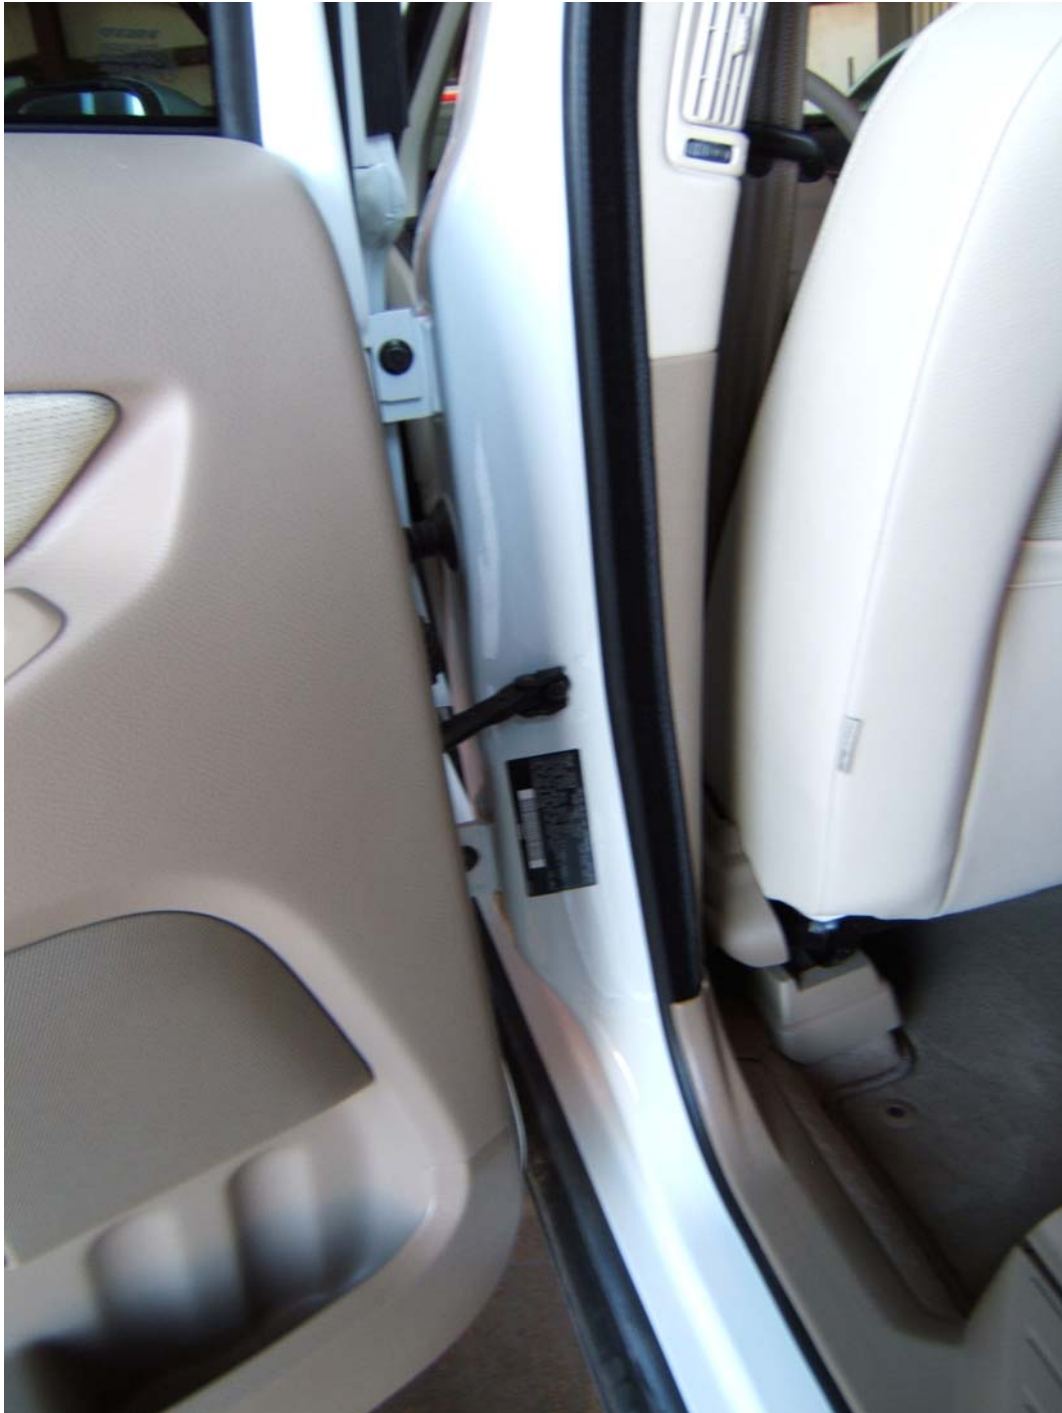
FIGURE 5.21
CERTIFICATION LABEL SHOWN ON
BACK OF DRIVER'S SIDE B PILLAR

REMARKS: Certification label is attached on rear of B pillar, not on front closest to driver seating position. Rim size labeled on certification label is incorrectly formatted.

TEST FAILURE DESCRIPTION: As verified by FMVSS 110 testing, the vehicle certification label is not affixed to the front of the driver's side of the B-pillar as required by FMVSS 567.4(c).
