REPORT NUMBER 138-STF-08-004

SAFETY COMPLIANCE TESTING FOR FMVSS NO. 138 TIRE PRESSURE MONITORING SYSTEMS

TOYOTA MOTOR CORPORATION
2008 SCION XD
FIVE-DOOR PASSENGER CAR
NHTSA NO. C85107

FINAL REPORT

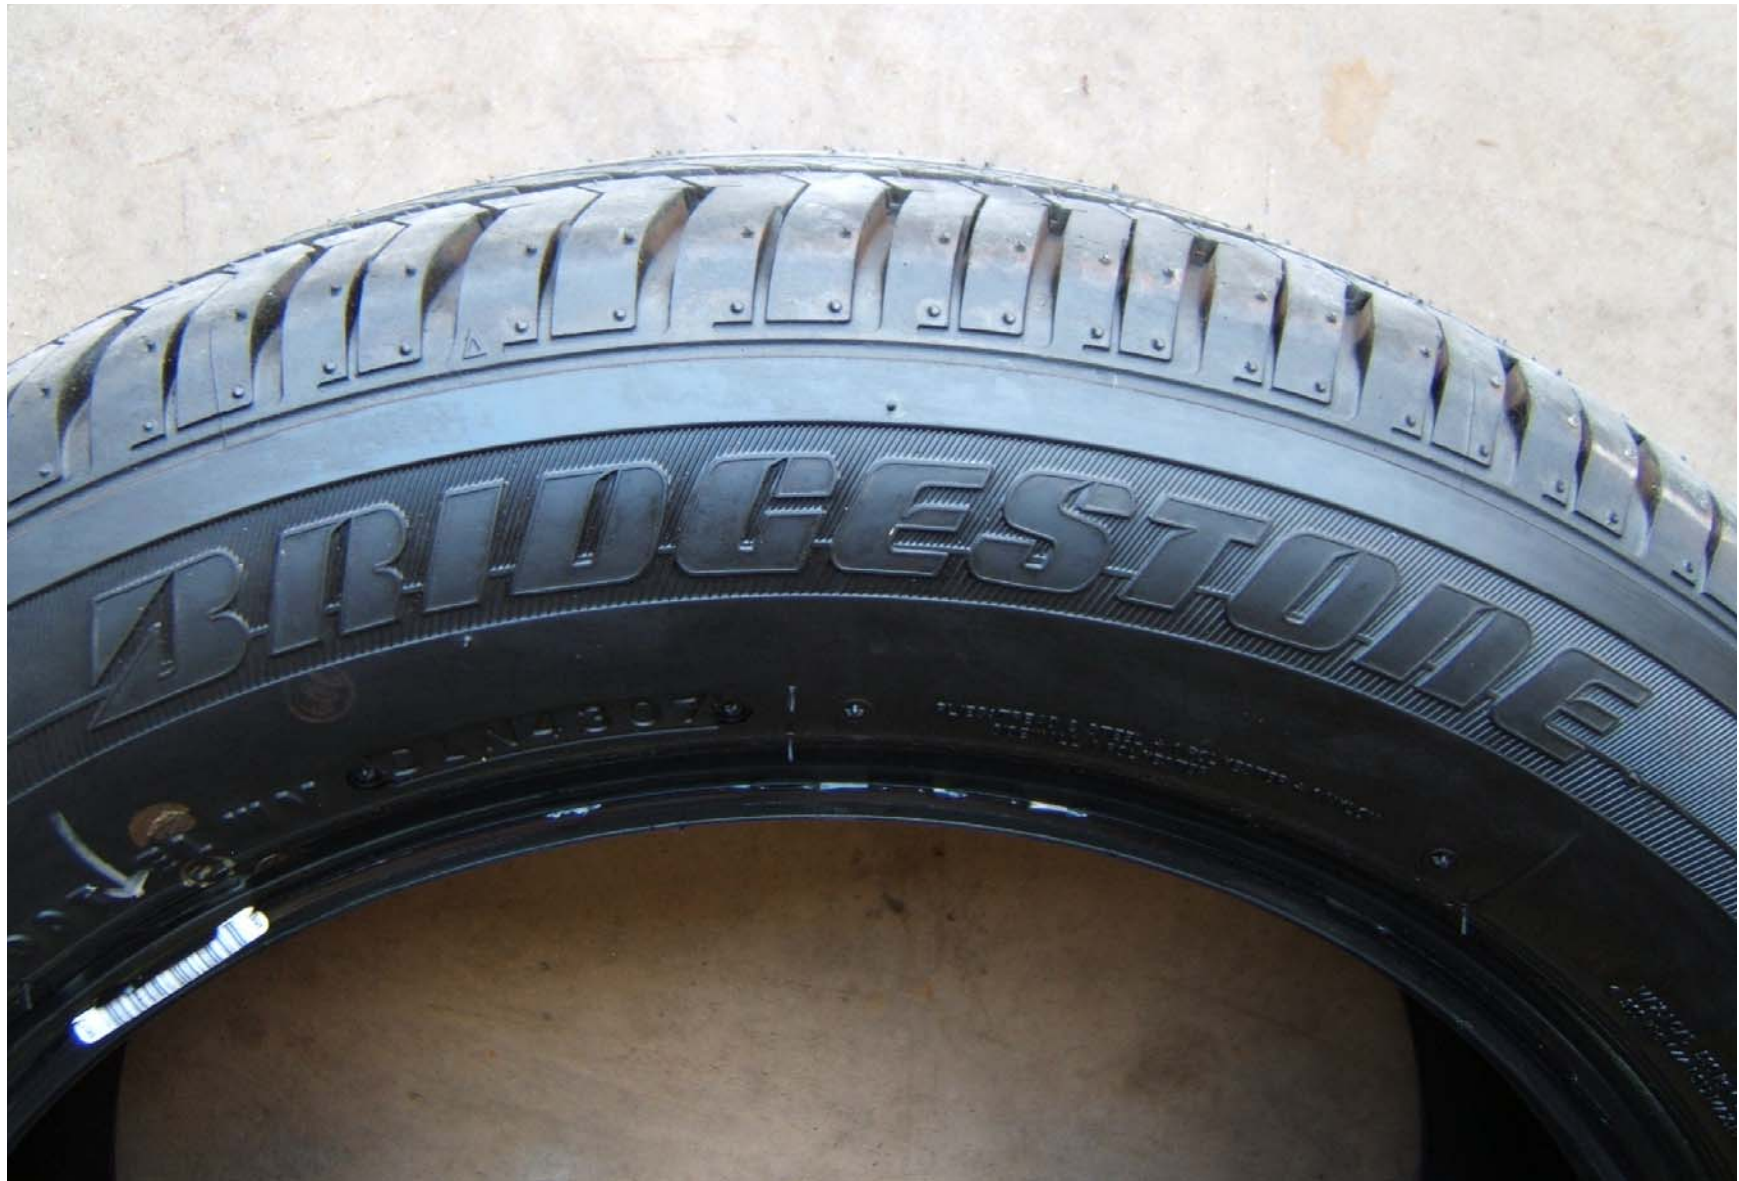
FIGURE 5.4
TIRE SHOWING BRAND

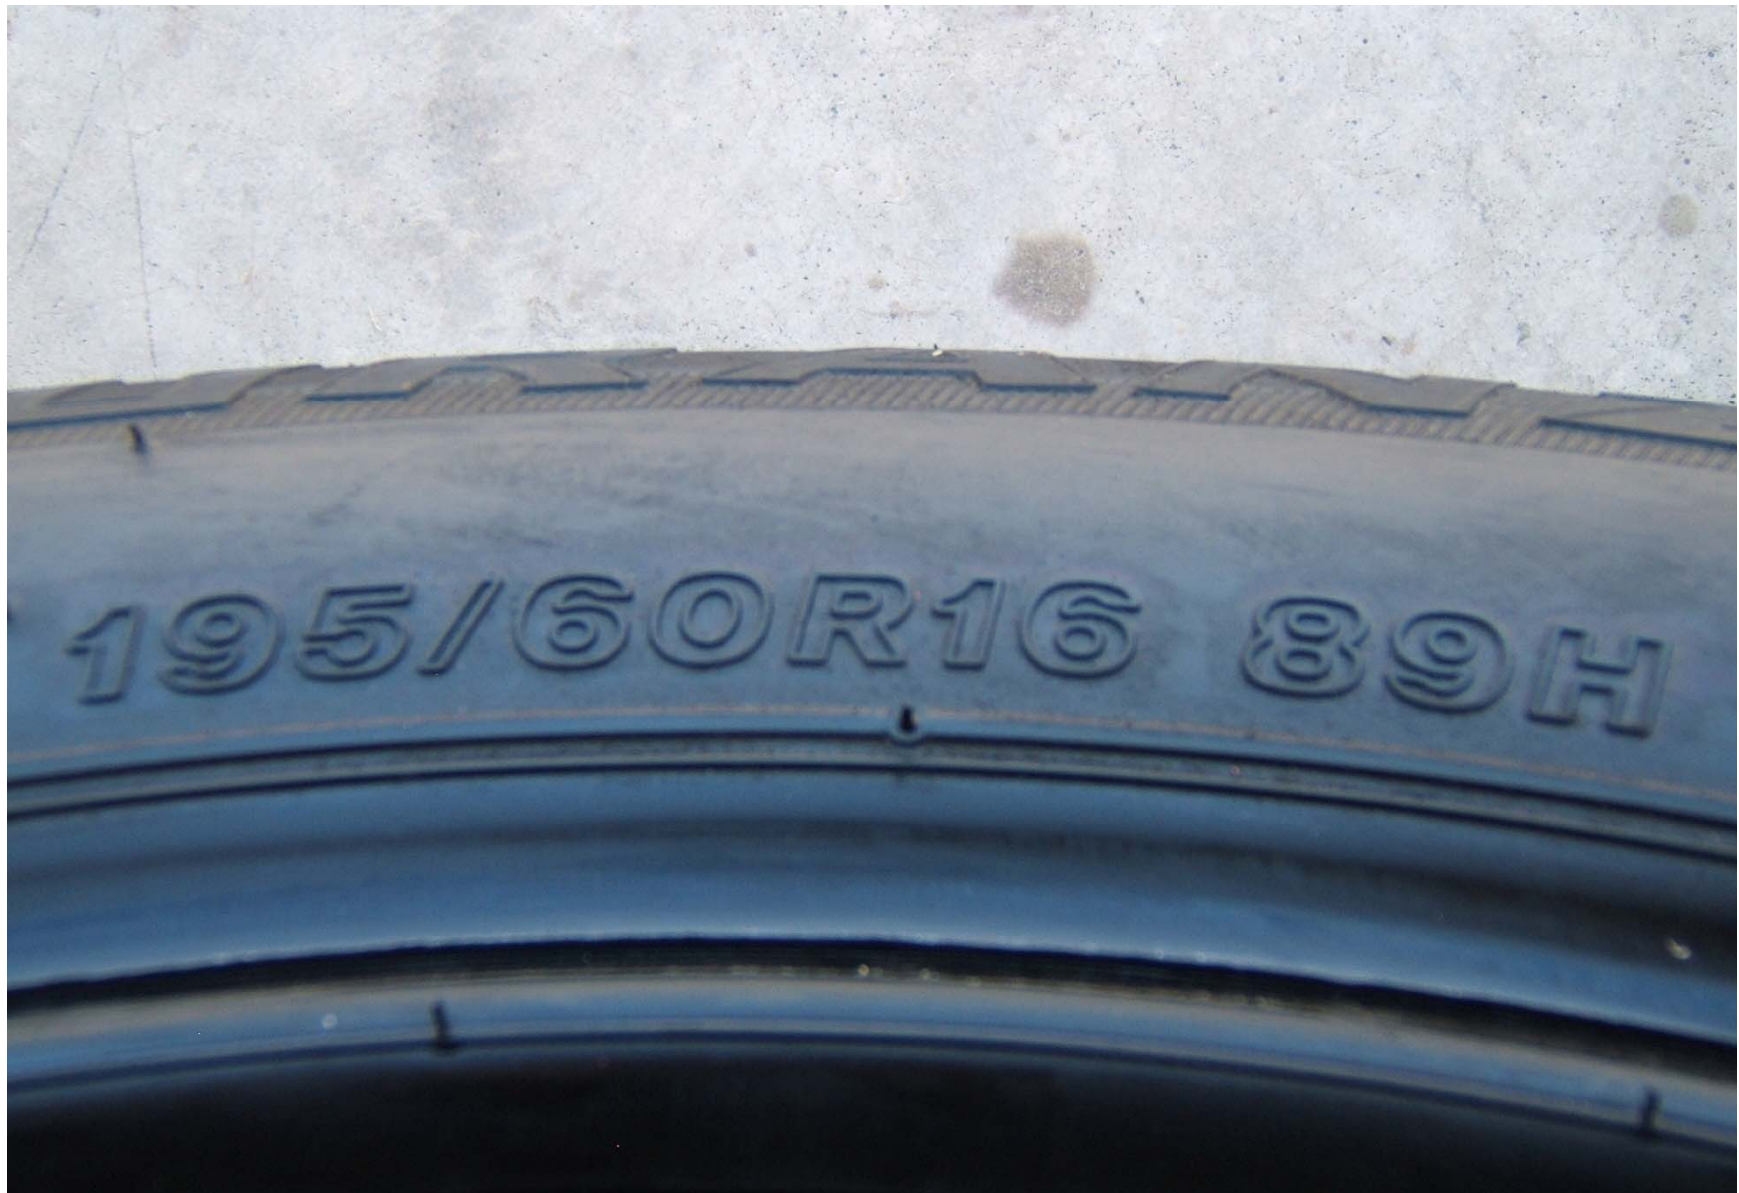
FIGURE 5.6
TIRE SHOWING SIZE, LOAD INDEX, AND SPEED RATING

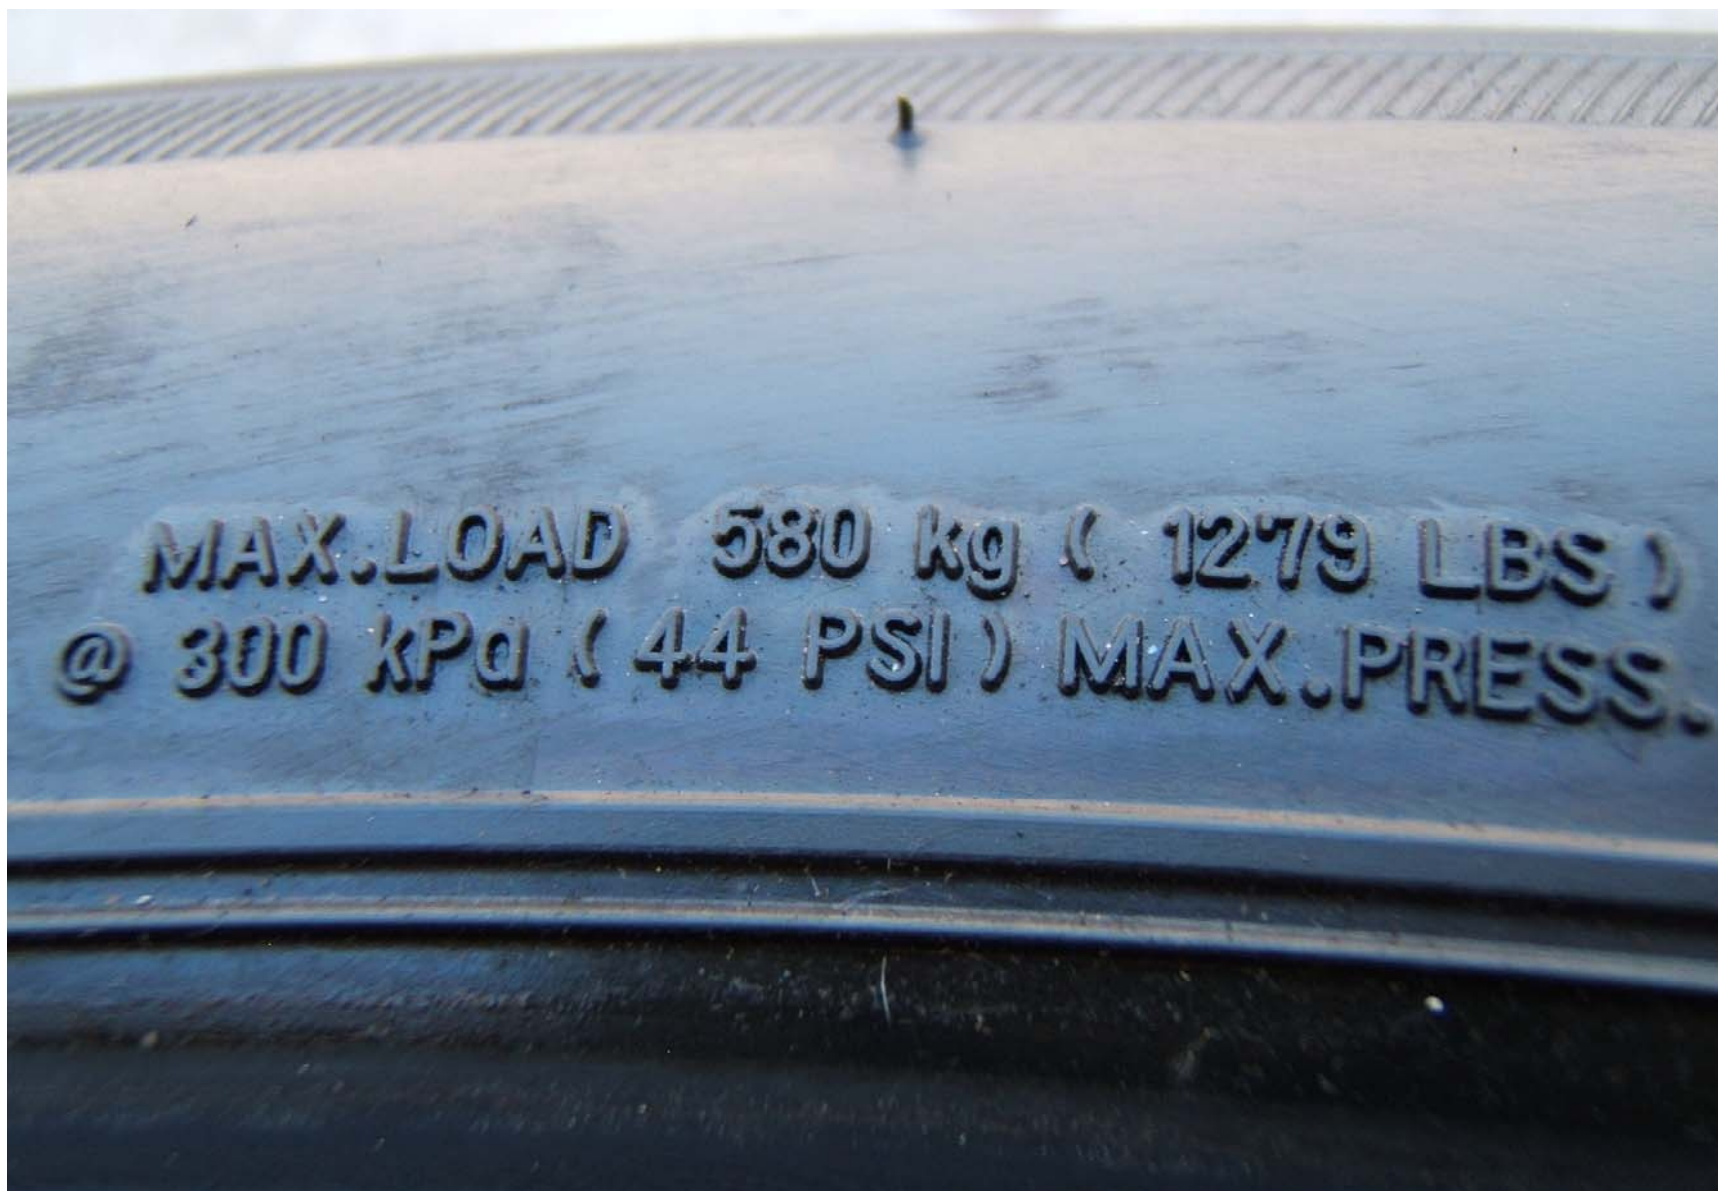
FIGURE 5.8
TIRE SHOWING MAX LOAD RATING AND
MAX COLD INFLATION PRESSURE

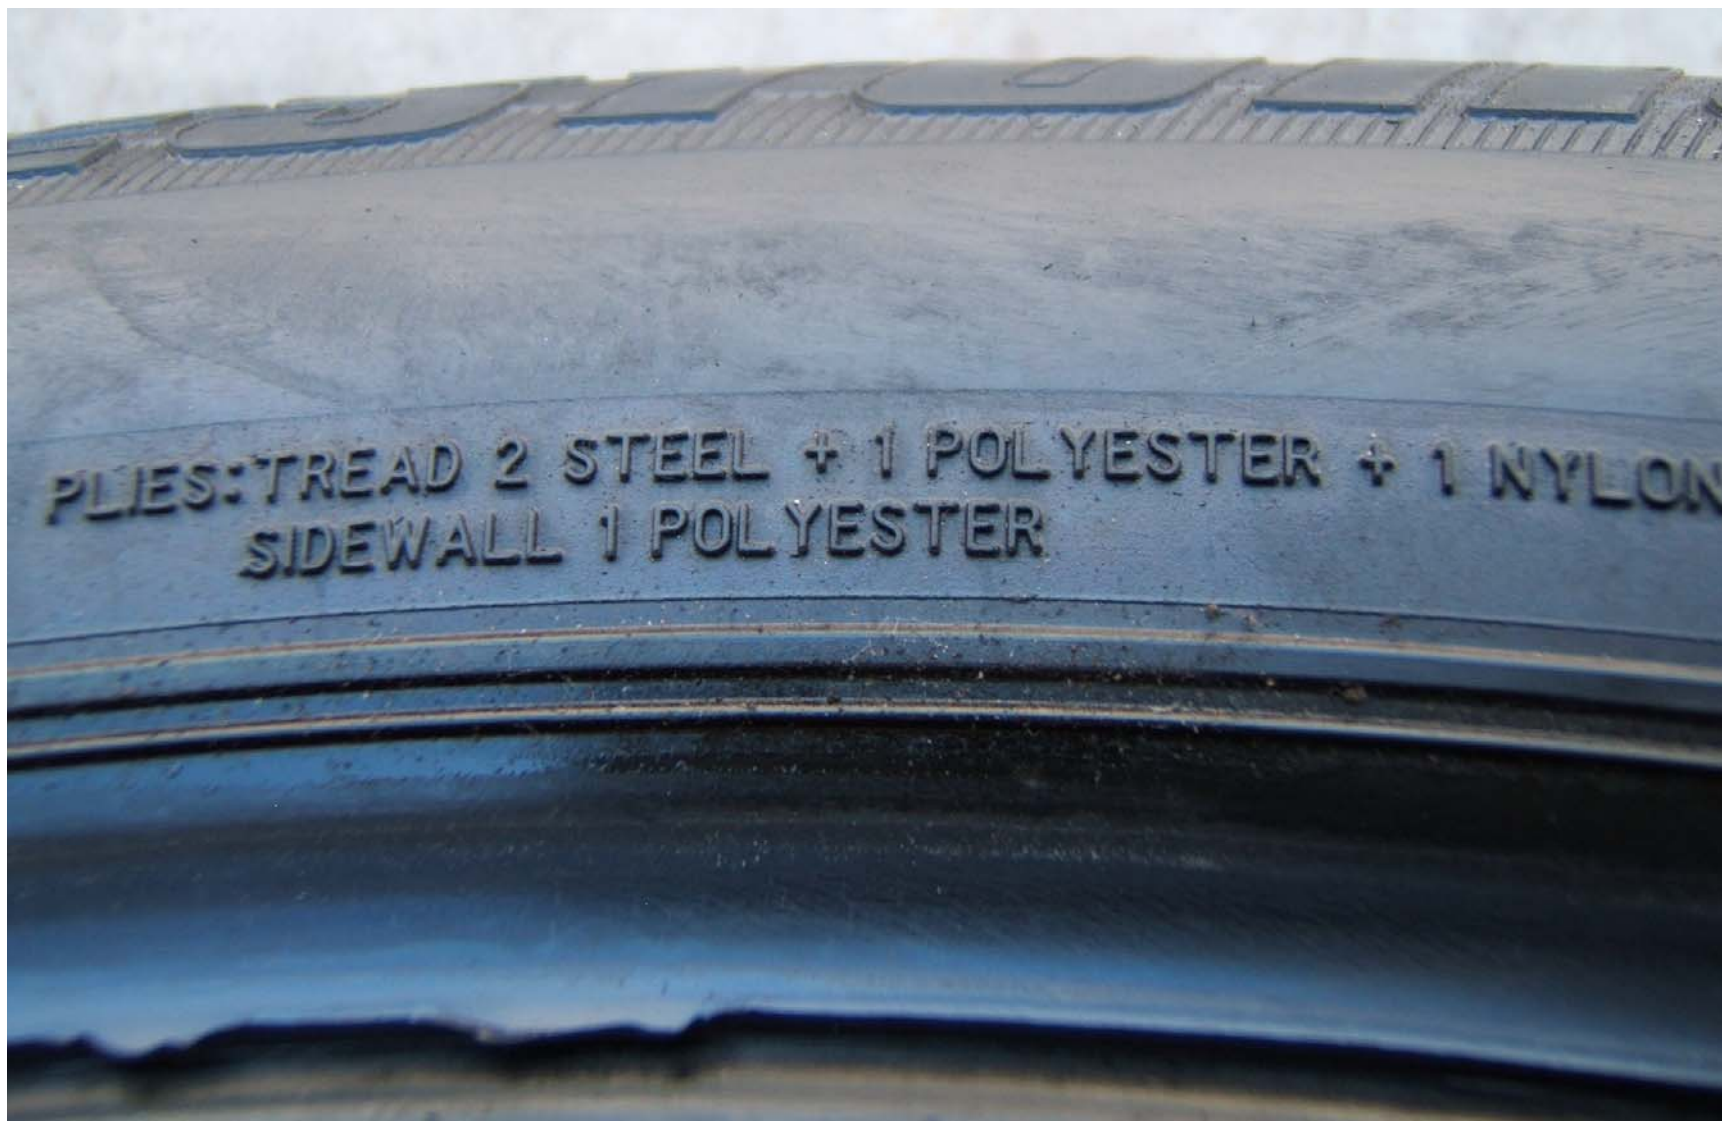
FIGURE 5.9
TIRE SHOWING SIDEWALL / TREAD CONSTRUCTION

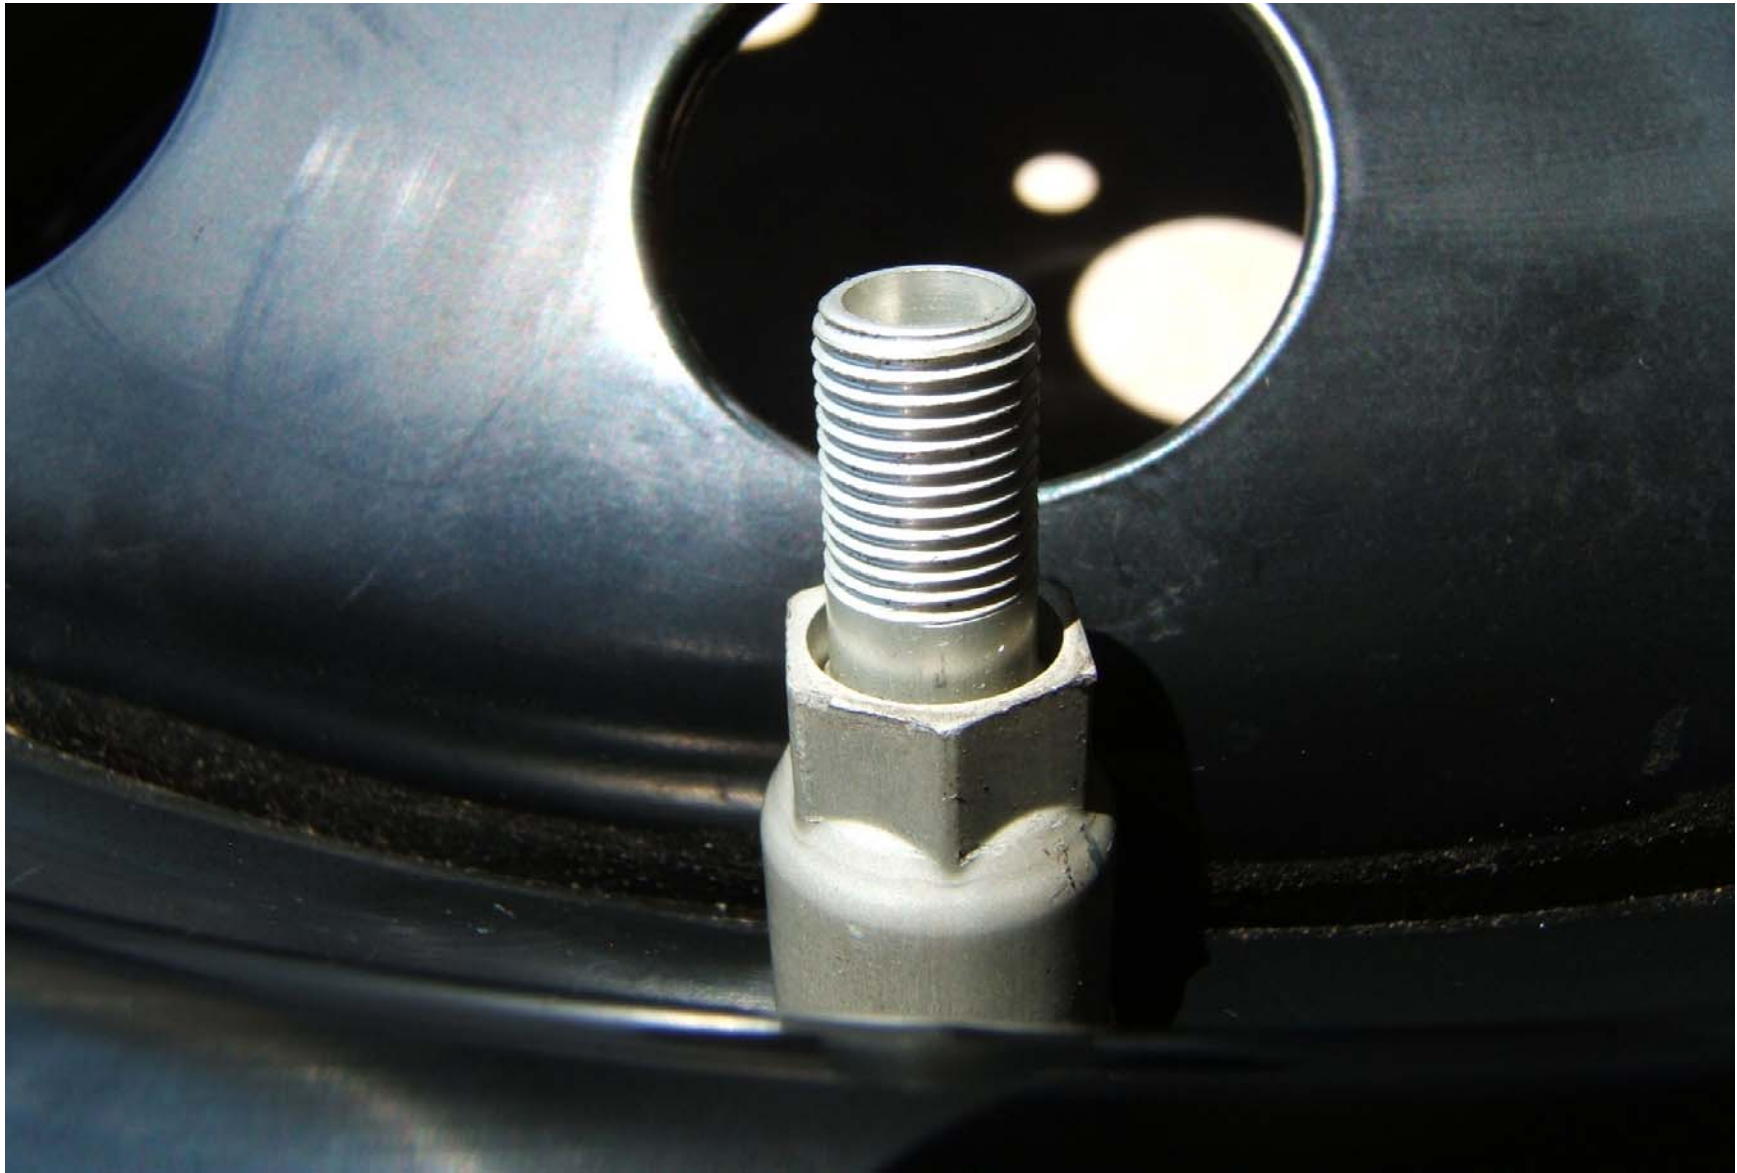
FIGURE 5.10
RIM SHOWING VALVE STEM

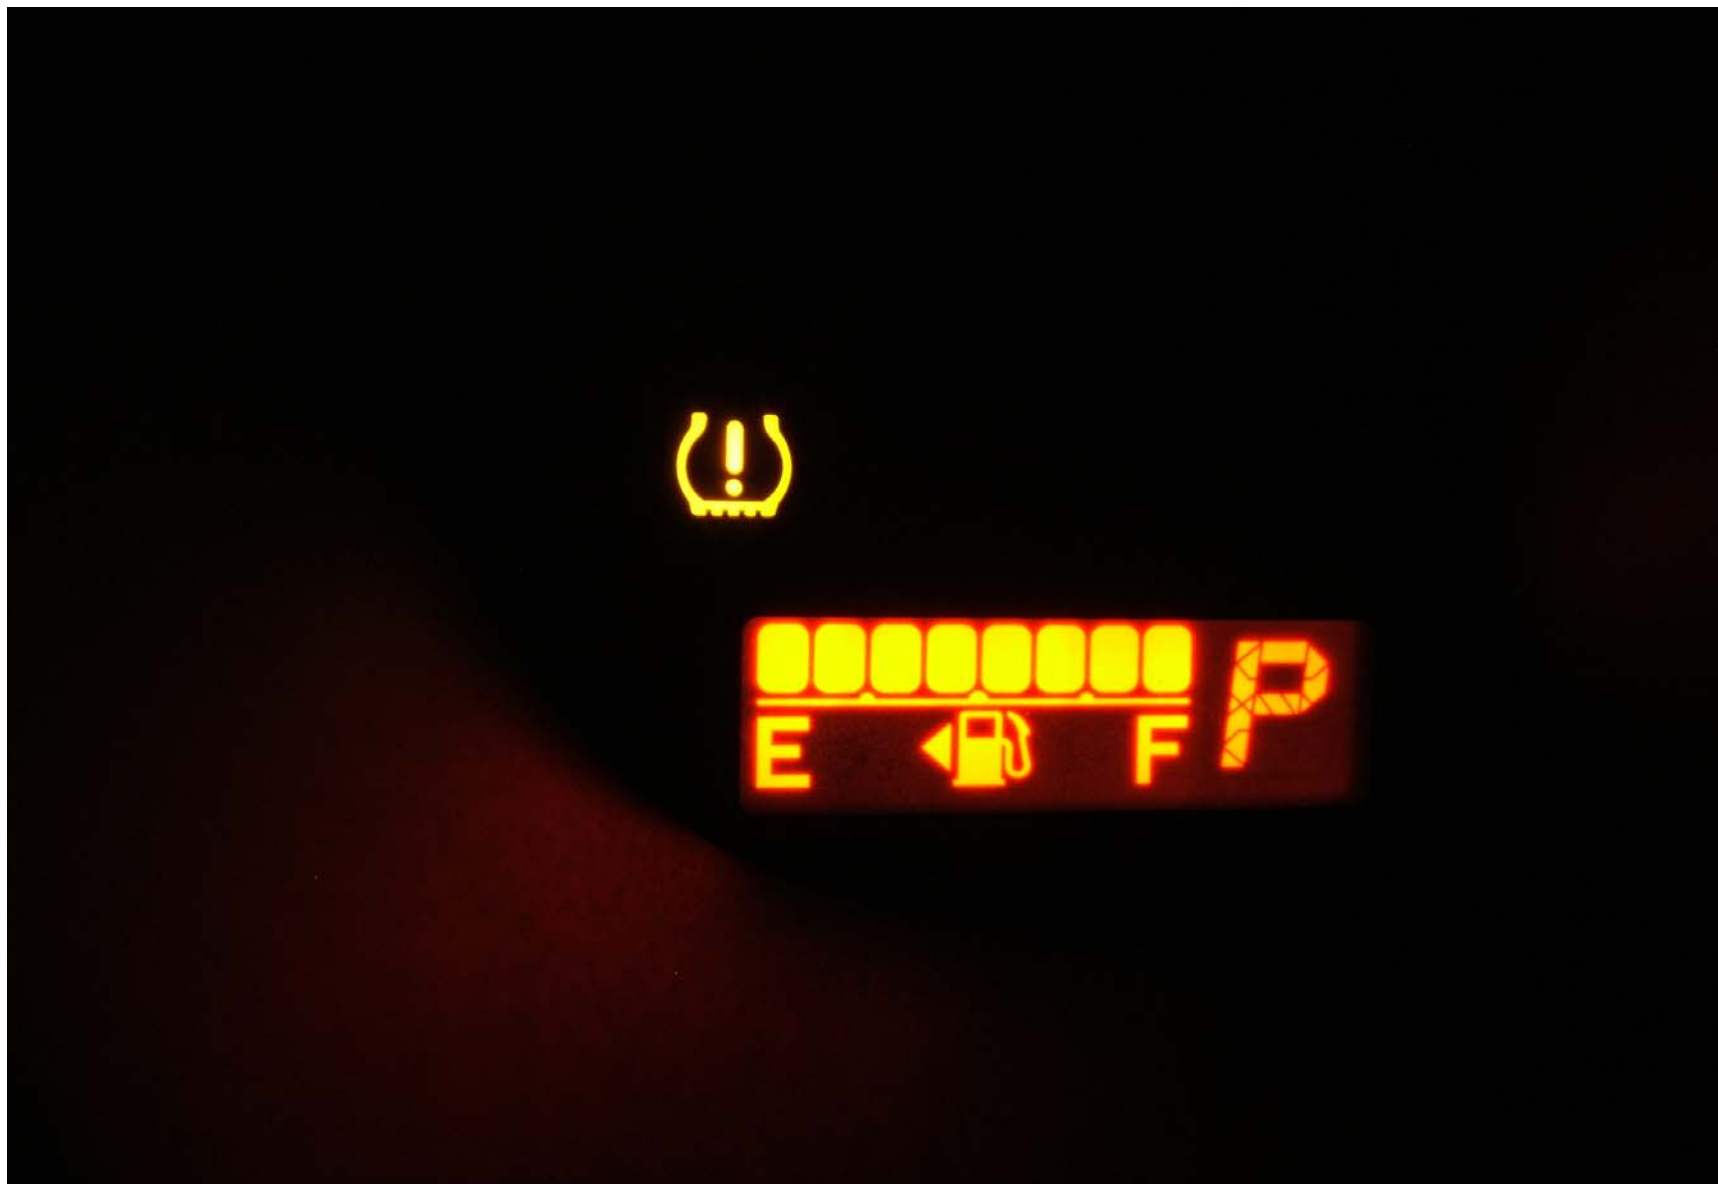
FIGURE 5.11
DISPLAY SHOWING COMBINATION LOW TIRE
PRESSURE WARNING/MALFUNCTION TELLTALE

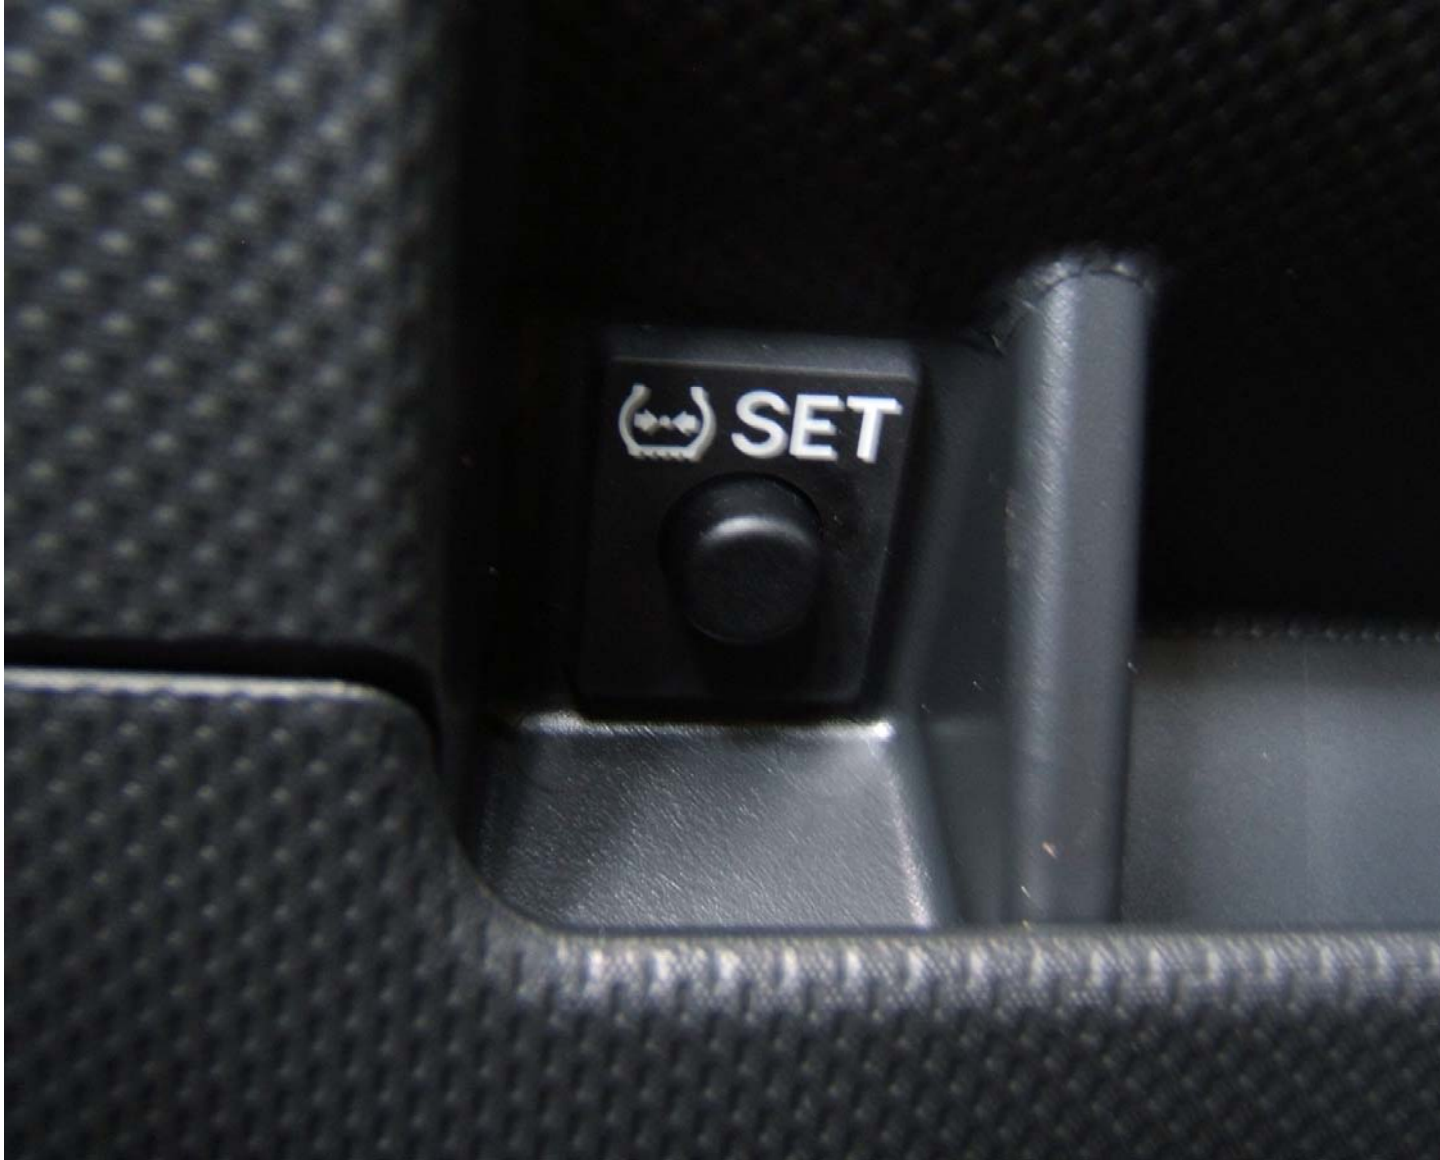
FIGURE 5.12
RESET BUTTON

The Scion was equipped with a reset button that stores the cold tire inflation pressure used with the TPMS system. Initially the manufacture-recommended preset cold tire inflation pressure is stored. During this test, the reset button did not require activation because the factory set tire air pressure for TPMS was not required to be changed.

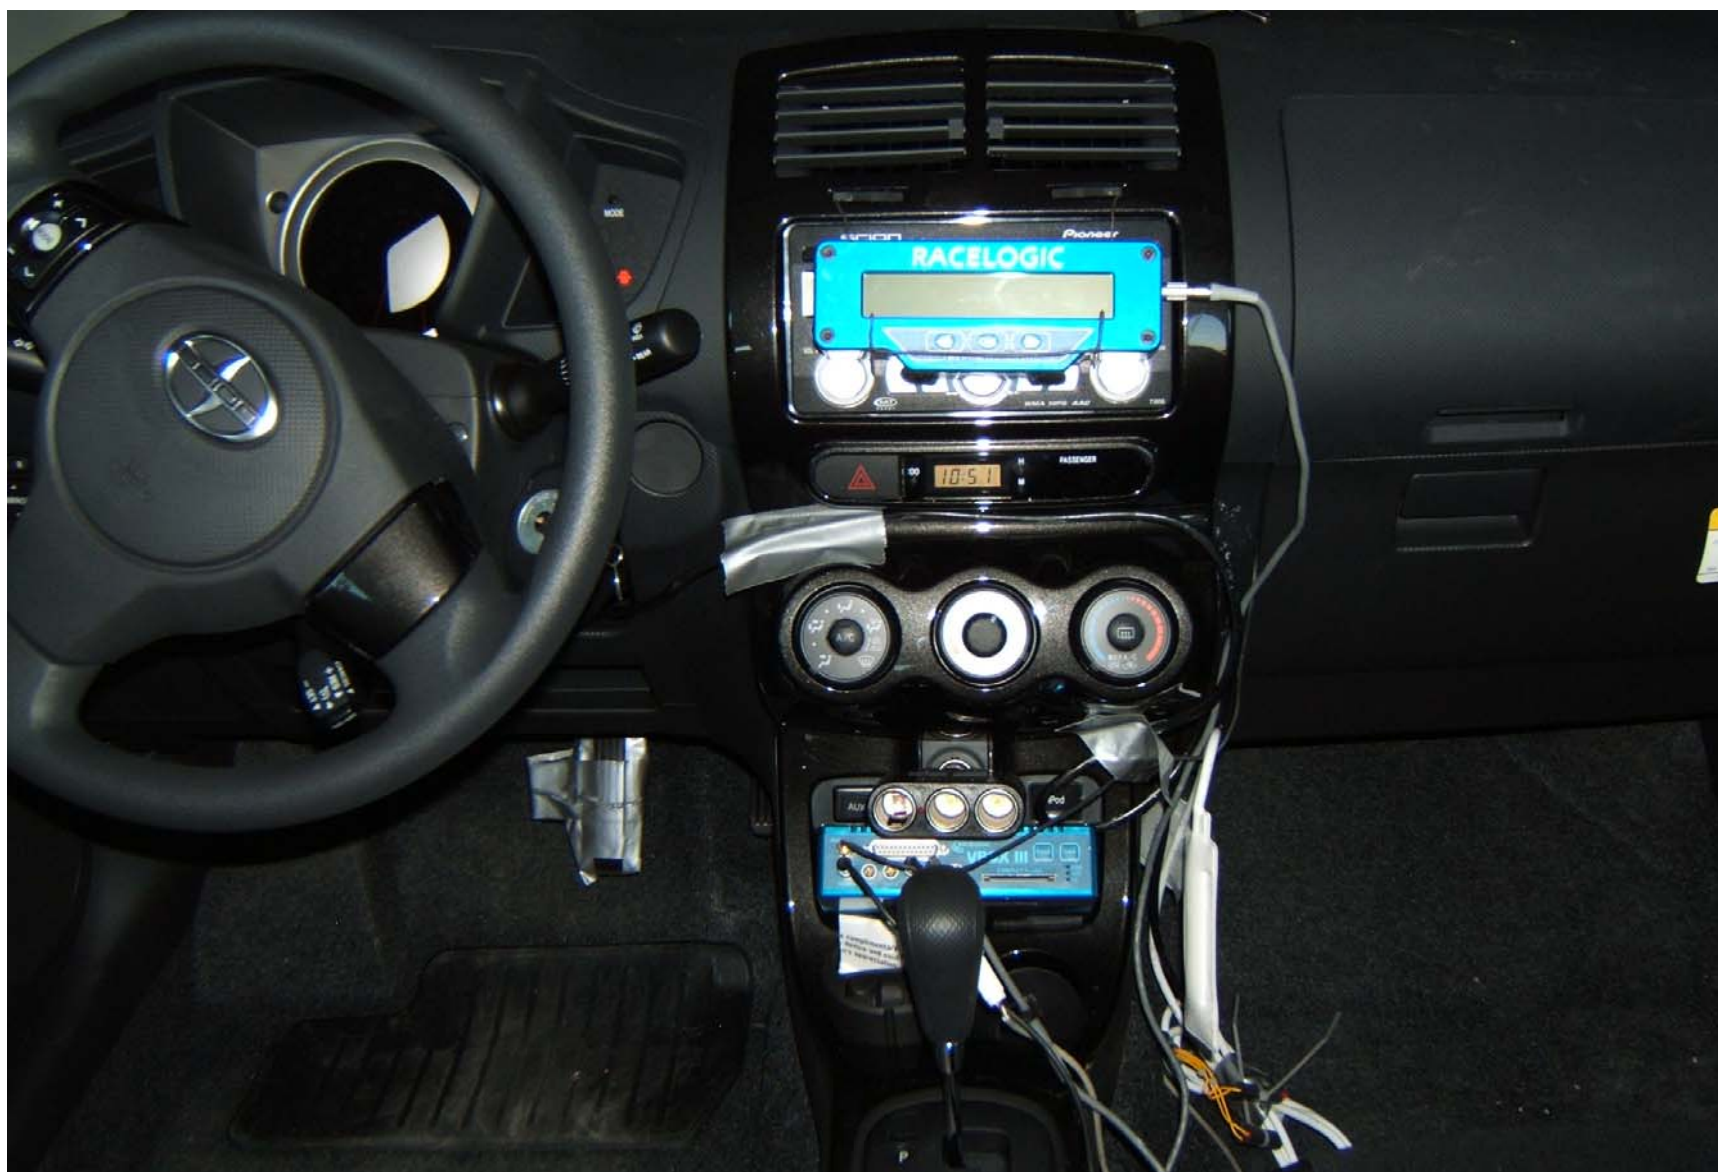
FIGURE 5.13
TEST INSTRUMENTATION ON VEHICLE

The vehicle was instrumented with a Racelogic VBOX III 100 Hz GPS Data Logger and brake pedal trigger. The VBOX uses GPS to measure vehicle speed, time, and distance. Test data were recorded to a compact flash card. During the test, a stopwatch was used to determine the approximate "cumulative driving time" during each test phase. Cumulative driving time does not include time during the brake application or when the vehicle speed was below 50 km/h or above 100 km/h. Upon completion of a tire deflation scenario, graphs were generated by VBOX software showing vehicle speed versus time during the test procedures. The graphs furnish a second-by-second analysis of each calibration and detection test phase. There was no driving time necessary for telltale illumination in the detection phases of the Scion, and no graphs were created for those phases. The cumulative driving time for each calibration phase was calculated by post processing the VBOX graph data and is reported in Section 3 (Test Data) as 'Total Driving Time'.

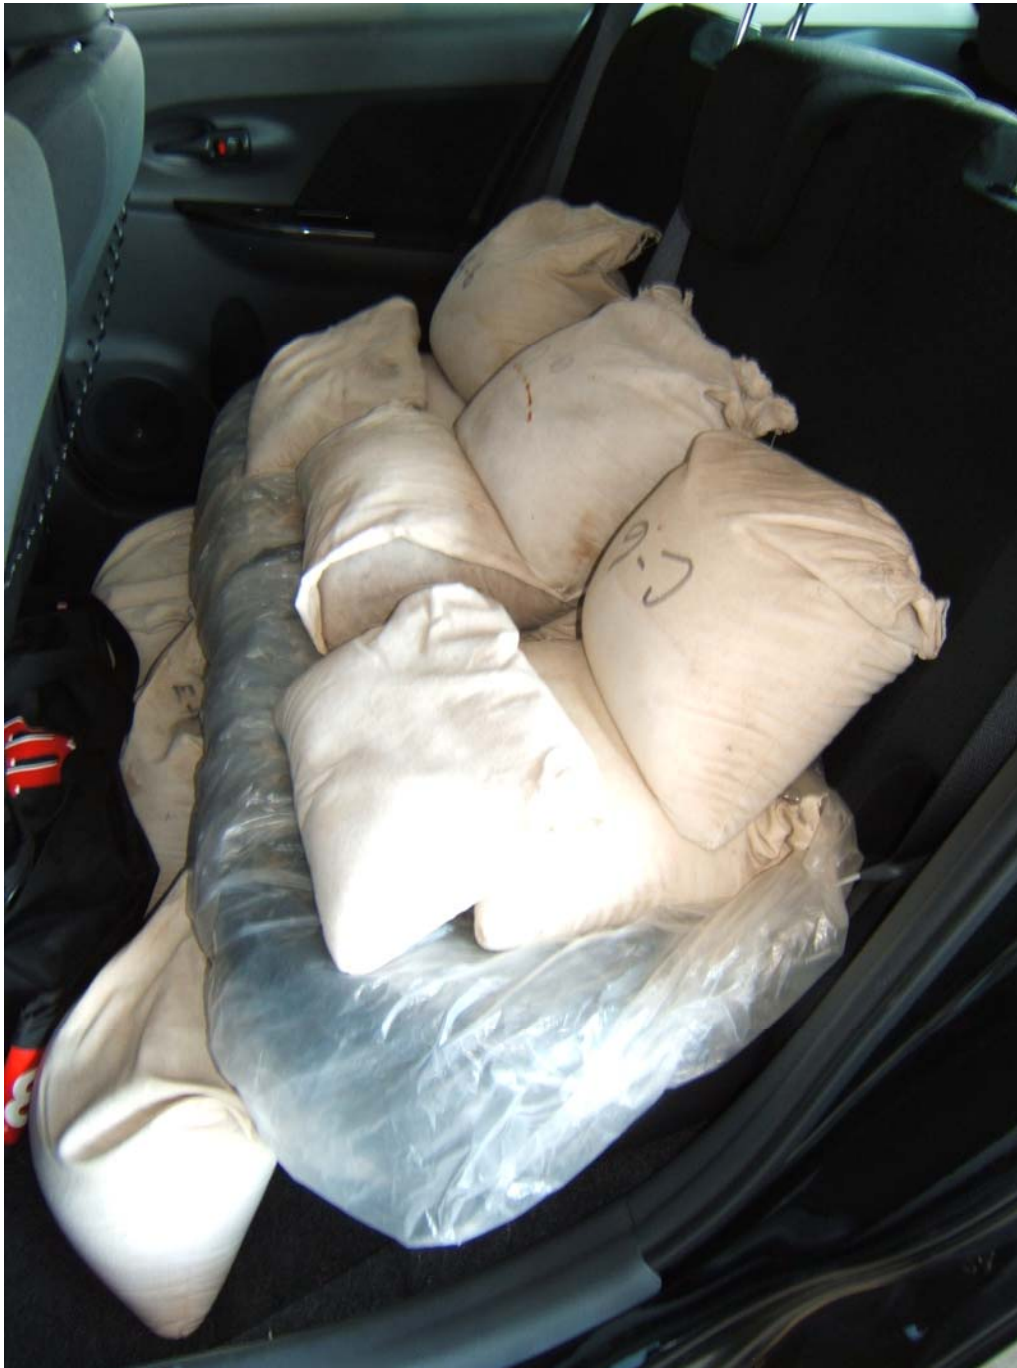
FIGURE 5.14
VEHICLE REAR SEAT BALLAST
FOR GVWR LOAD

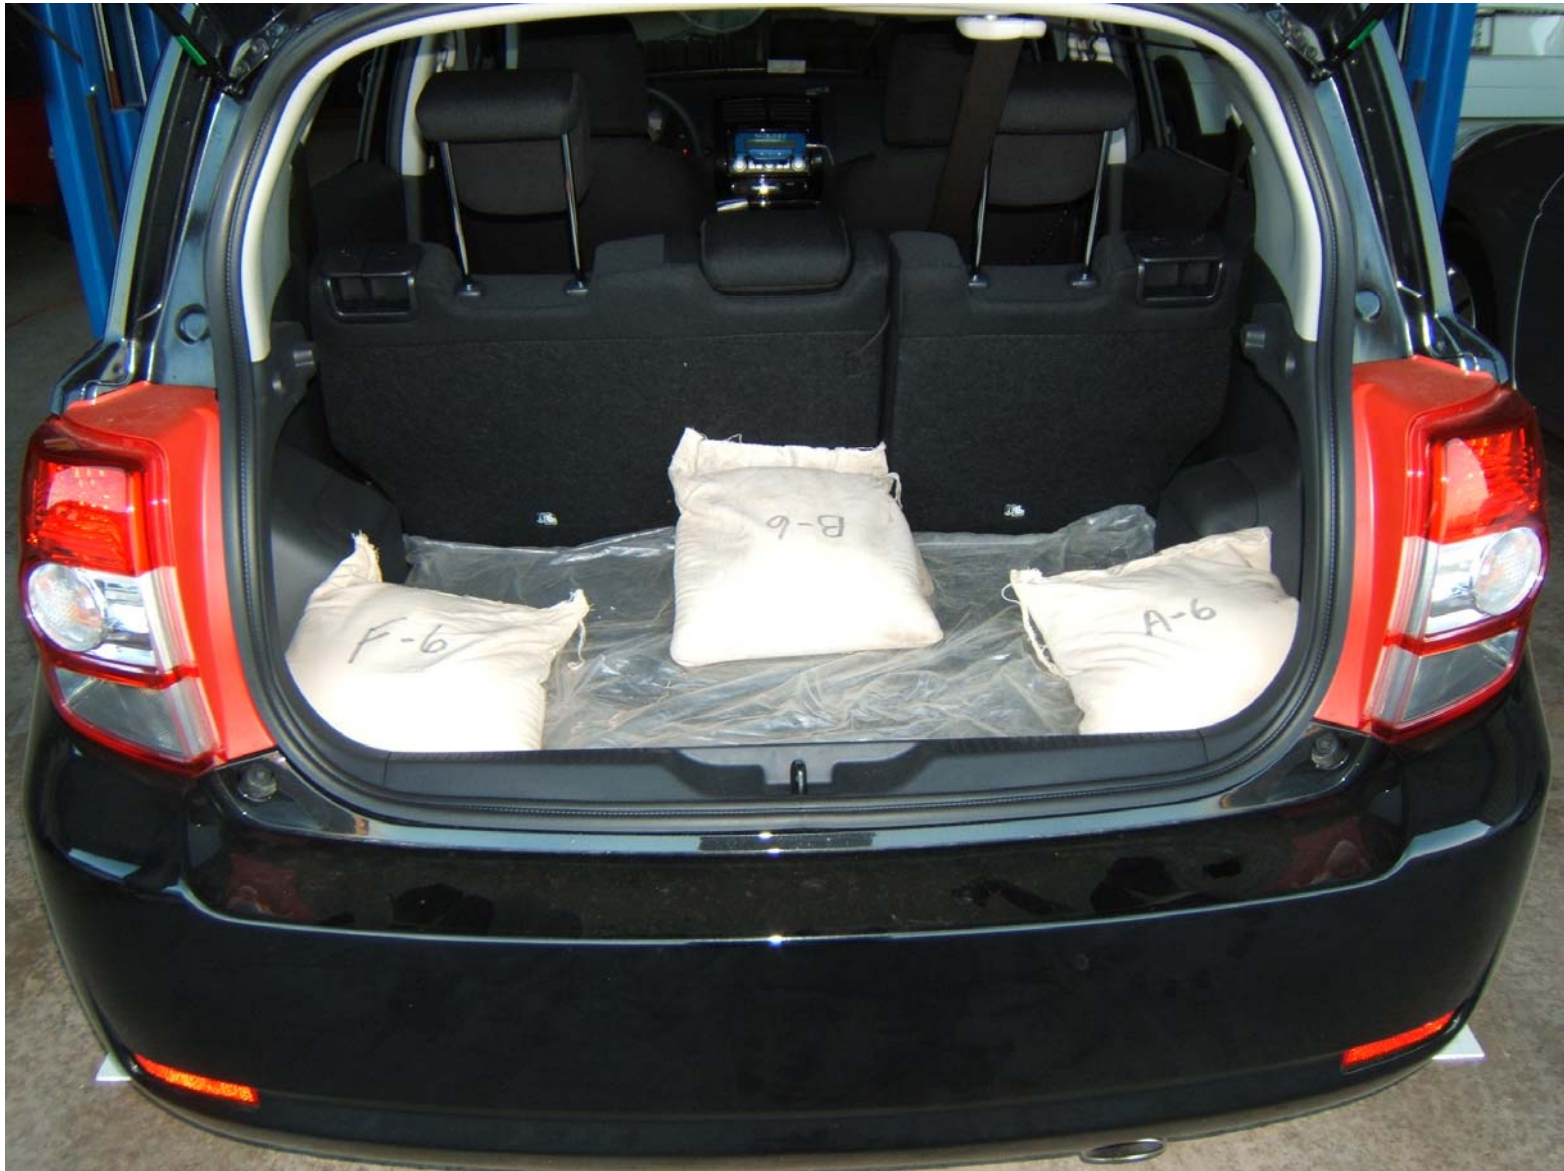
FIGURE 5.15
REAR OF VEHICLE BALLAST FOR GVWR

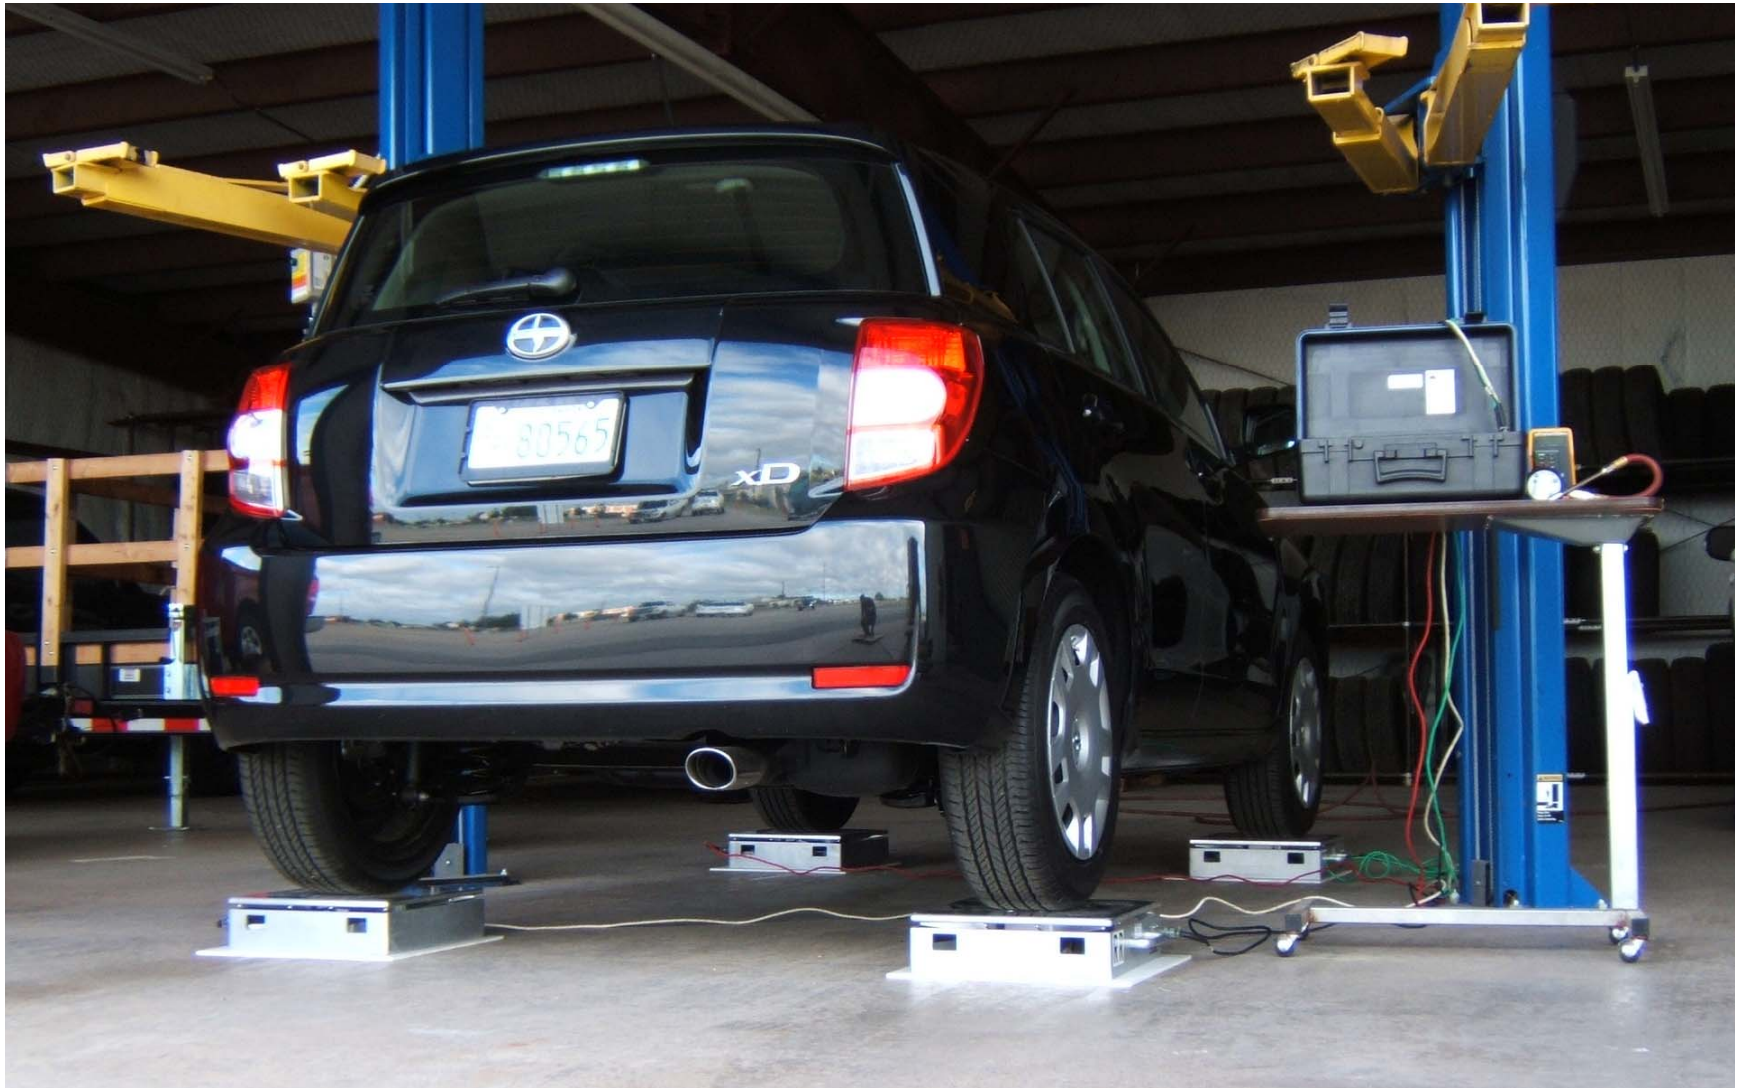
FIGURE 5.16
VEHICLE ON WEIGHT SCALES

Subsequent events included weighing the vehicle to establish the Unloaded Vehicle Weight (UVW) and the distribution of weight on the front and rear axles and each wheel position. The vehicle was loaded to its Lightly Loaded Vehicle Weight (LLVW) for four tire deflation scenarios. This LLVW included the weights of driver, one passenger, and test equipment. The vehicle was loaded to its Gross Vehicle Weight Rating (GVWR) for four additional tire deflation scenarios. The vehicle is required to be loaded to its maximum capacity without exceeding either the Vehicle Capacity Weight (VCW) or Gross Vehicle Weight Rating (GVWR). The VCW was within 2.3 kilograms of the GVWR lower limit, at which the test was run. The Gross Vehicle Weight included the weights of driver, one passenger, test equipment, ballast in the rear seat, and ballast in the internal cargo area. For determination of the telltale warning activation pressure, the recommended cold inflation pressure was identified from the vehicle placard.
