REPORT NO. 111-KAR-08-003

**SAFETY COMPLIANCE TESTING
FOR FMVSS 111**

**2008 DODGE GRAND CARAVAN SE
5-DOOR MPV**

NHTSA NO: C80305

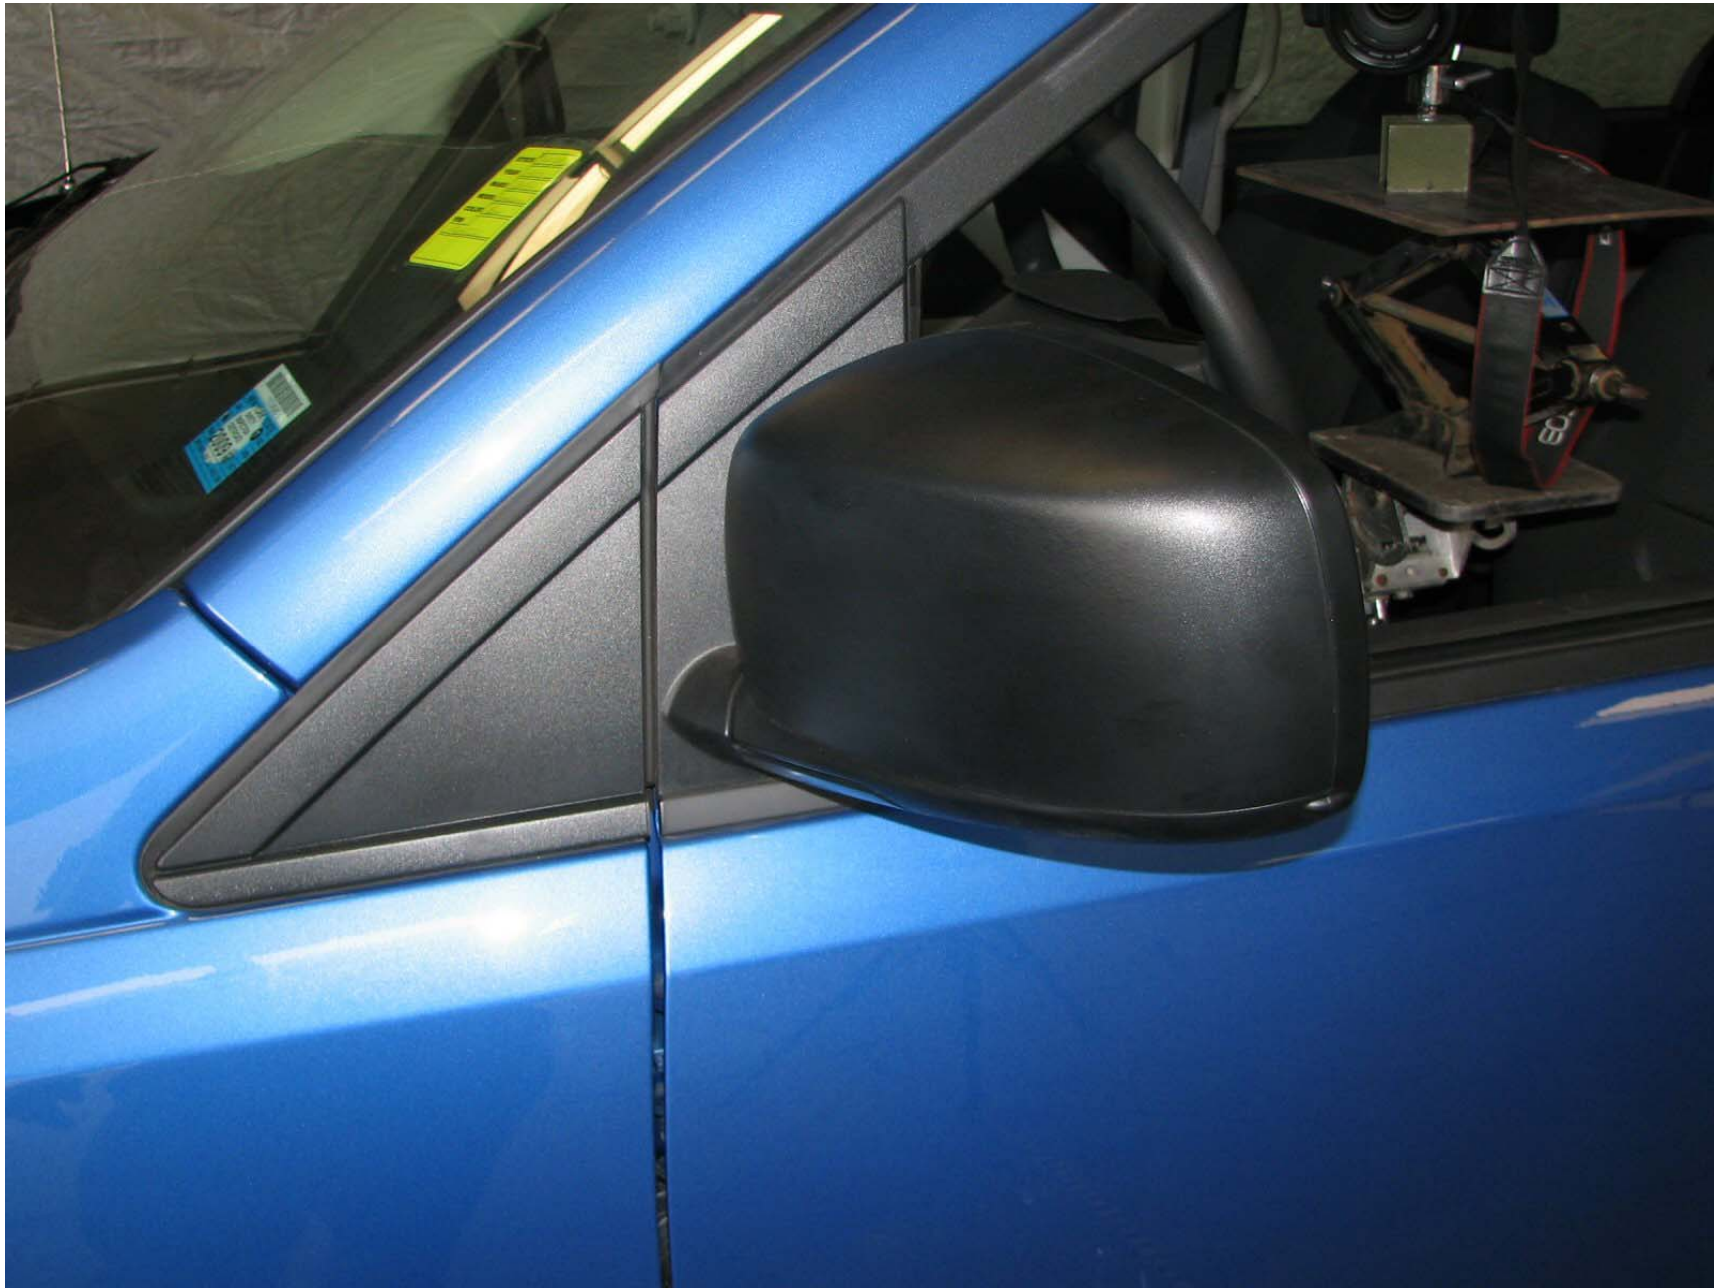
FIGURE 7: DRIVER SIDE REARVIEW MIRROR AND MOUNTING

OUTSIDE DRIVER SIDE MIRROR	PASS	FAIL	COMMENTS
STABLE SUPPORT	X		
DOES NOT PROTRUDE BEYOND VEHICLE BODY	X		
NOT OBSCURED BY UNWIPED PORTION OF WINDSHIELD	X		
ADJUSTABLE BY TILTING	X		
ADJUSTABLE FROM DRIVER SEAT	X		
FREE OF SHARP EDGES	X		
FIELD-OF-VIEW	X		Has a passenger side mirror
REFLECTANCE	X		
UNIT MAGNIFICATION	X

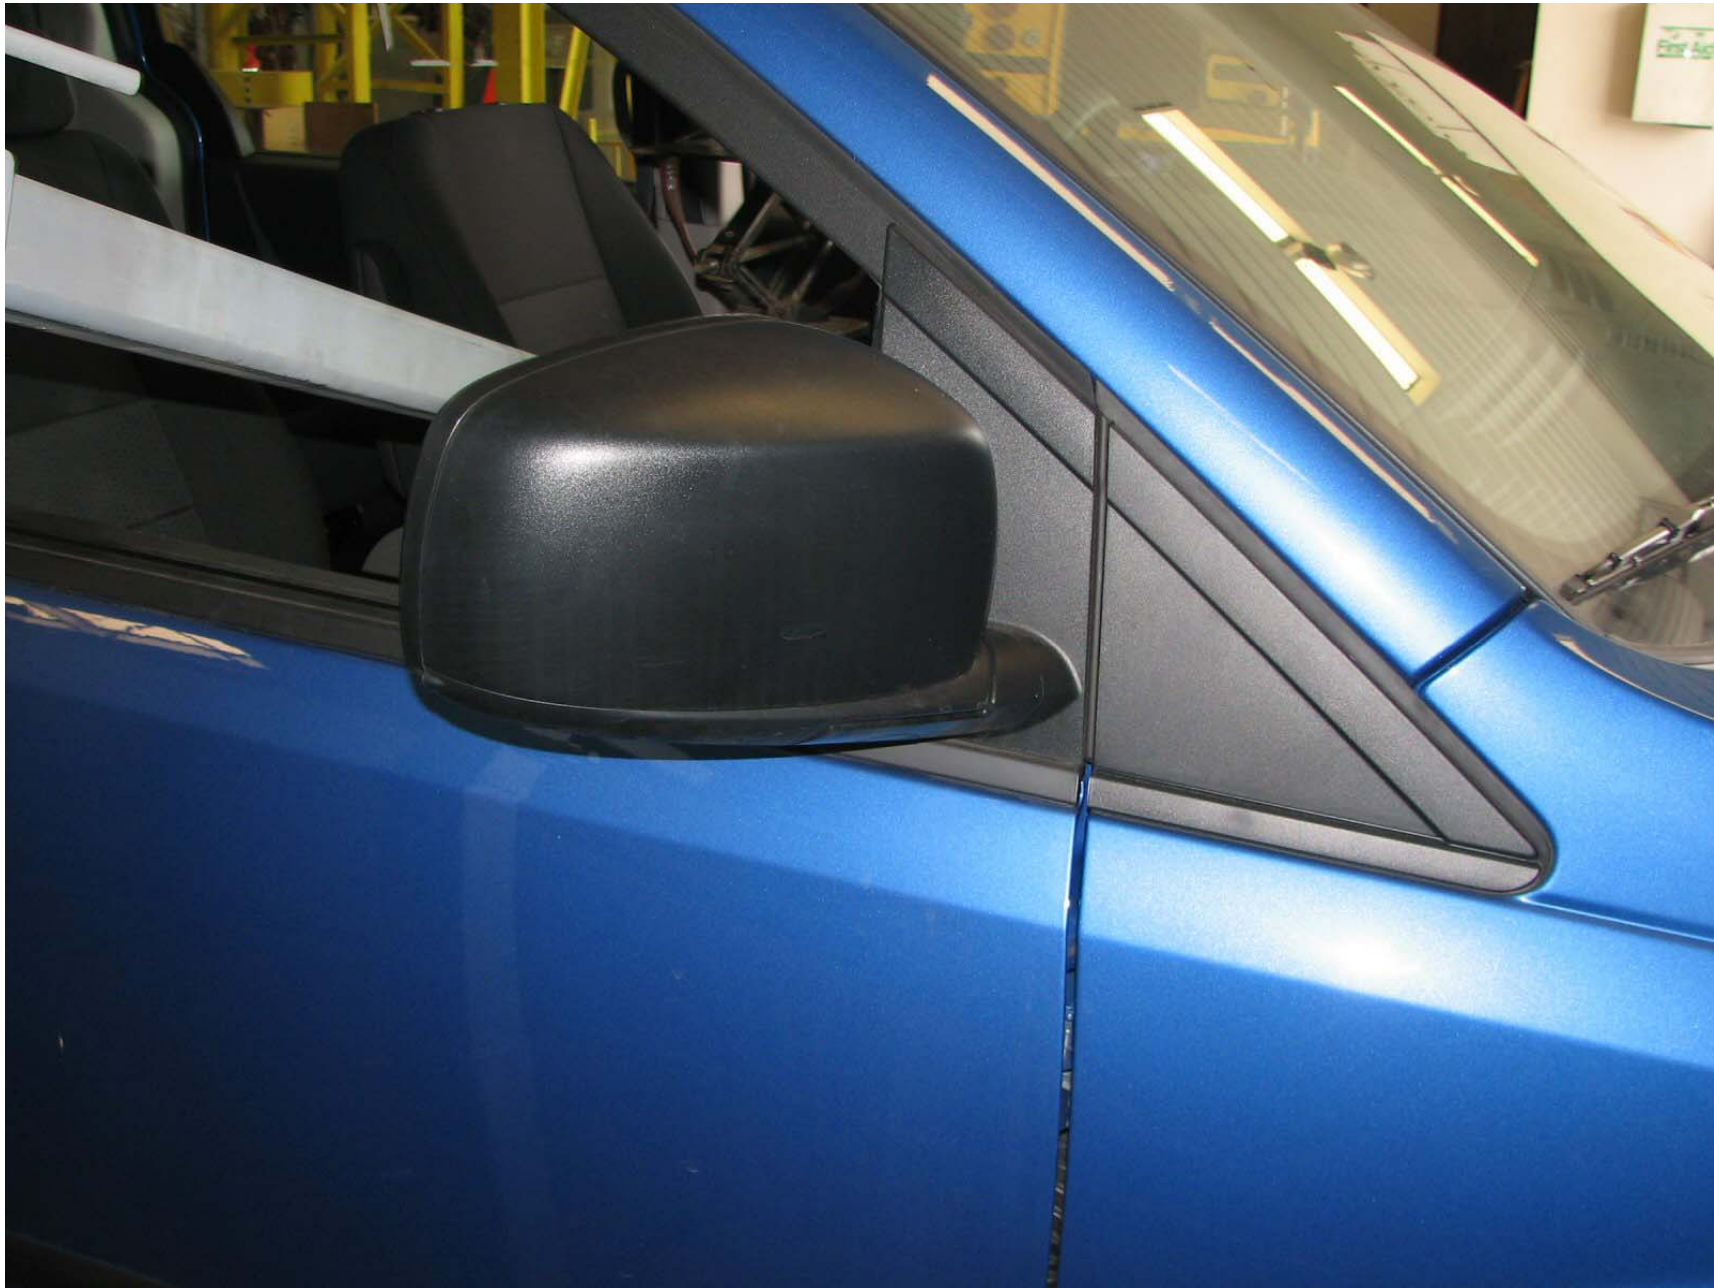
2008 DODGE GRAND CARAVAN SE FIGURE 8: PASSENGER SIDE REARVIEW MIRROR AND MOUNTING
NHTSA NO. C80305
FMVSS NO. 111

OUTSIDE PASSENGER MIRROR	PASS	FAIL	COMMENTS
STABLE SUPPORT	X		
ADJUSTABLE BY TILTING	X		
FREE OF SHARP EDGES	X		
UNIT OR CONVEX			Convex
LABELING	X		
REFLECTANCE	X

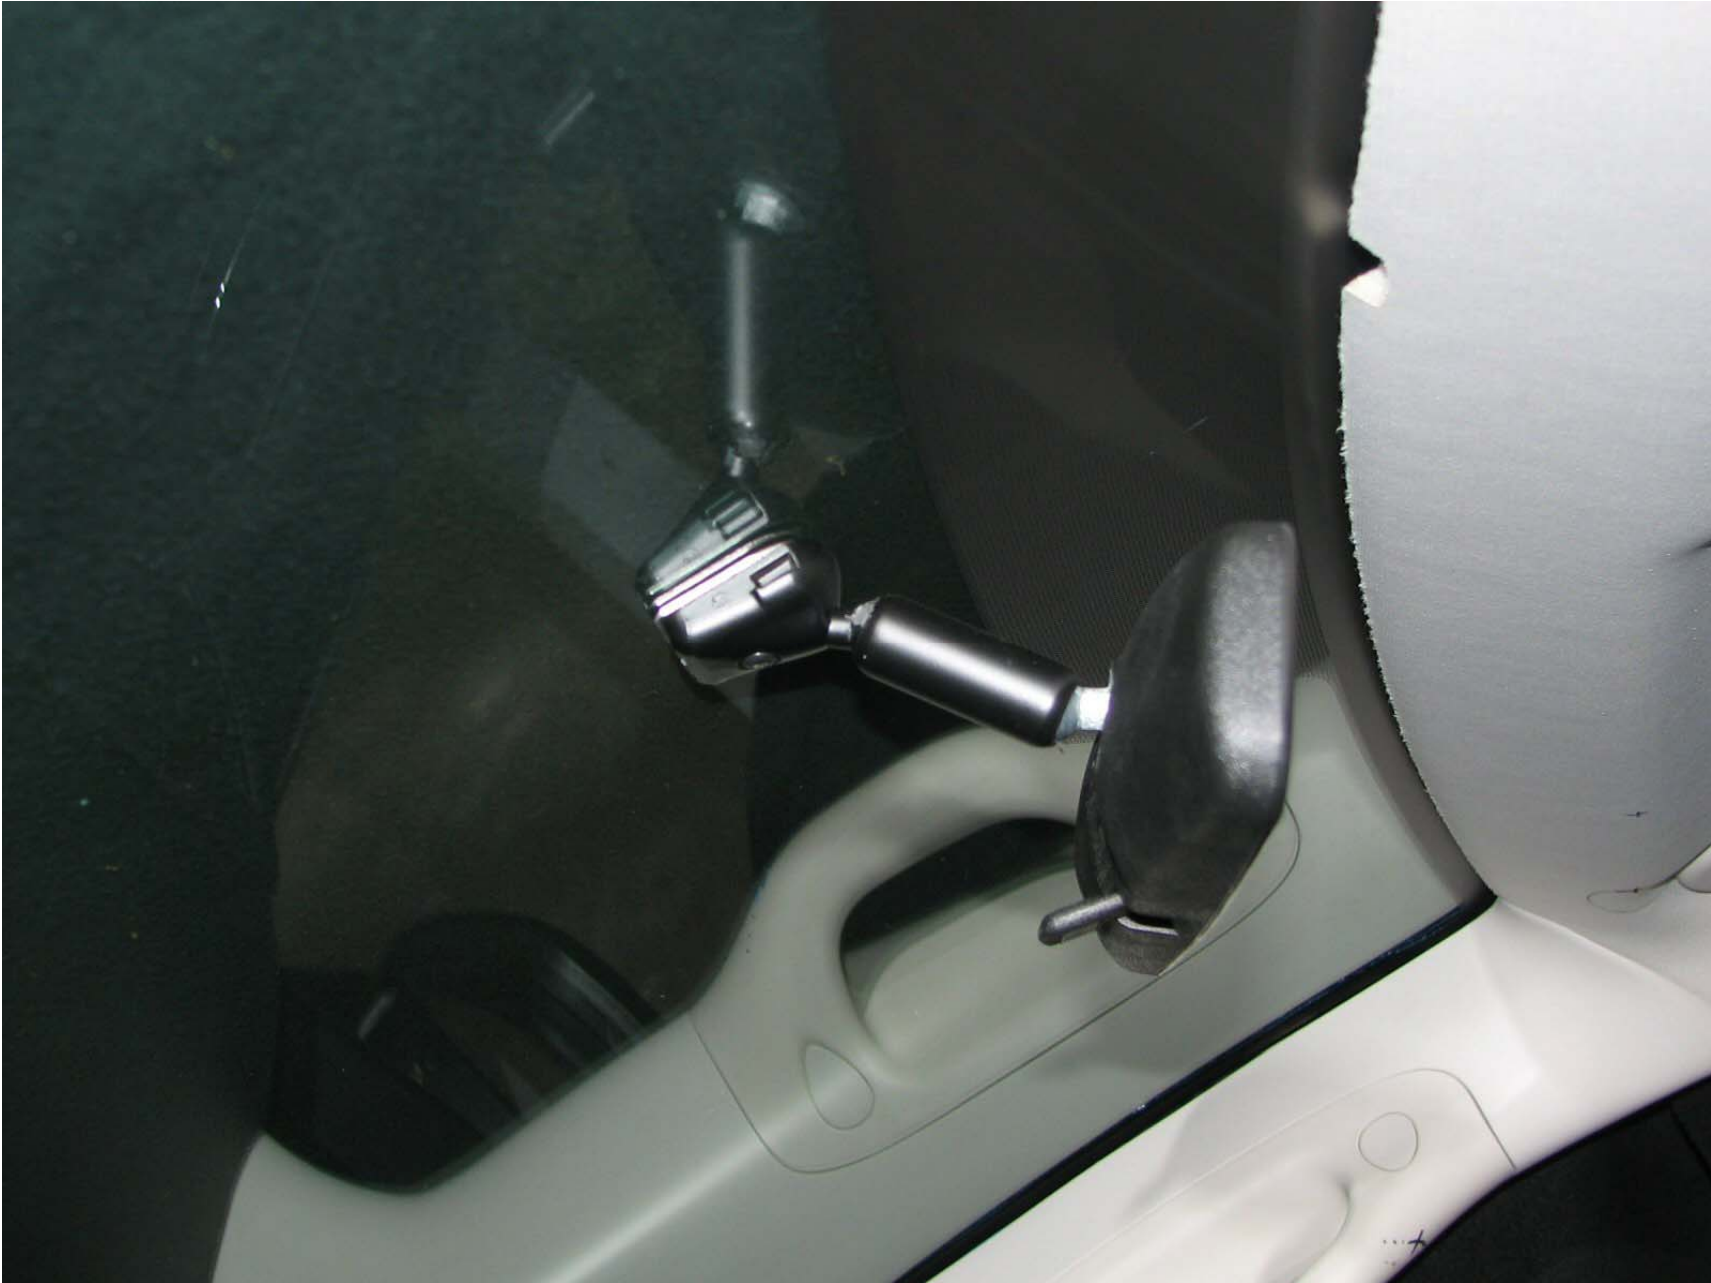
FIGURE 9: INSIDE REARVIEW MIRROR AND MOUNTING

INSIDE REARVIEW MIRROR	PASS	FAIL	COMMENTS
STABLE SUPPORT	X		
ADJUSTABLE BY TILTING	X		
FIELD-OF-VIEW	X		
REFLECTANCE	X		
BREAK AWAY	X		
UNIT MAGNIFICATION	X

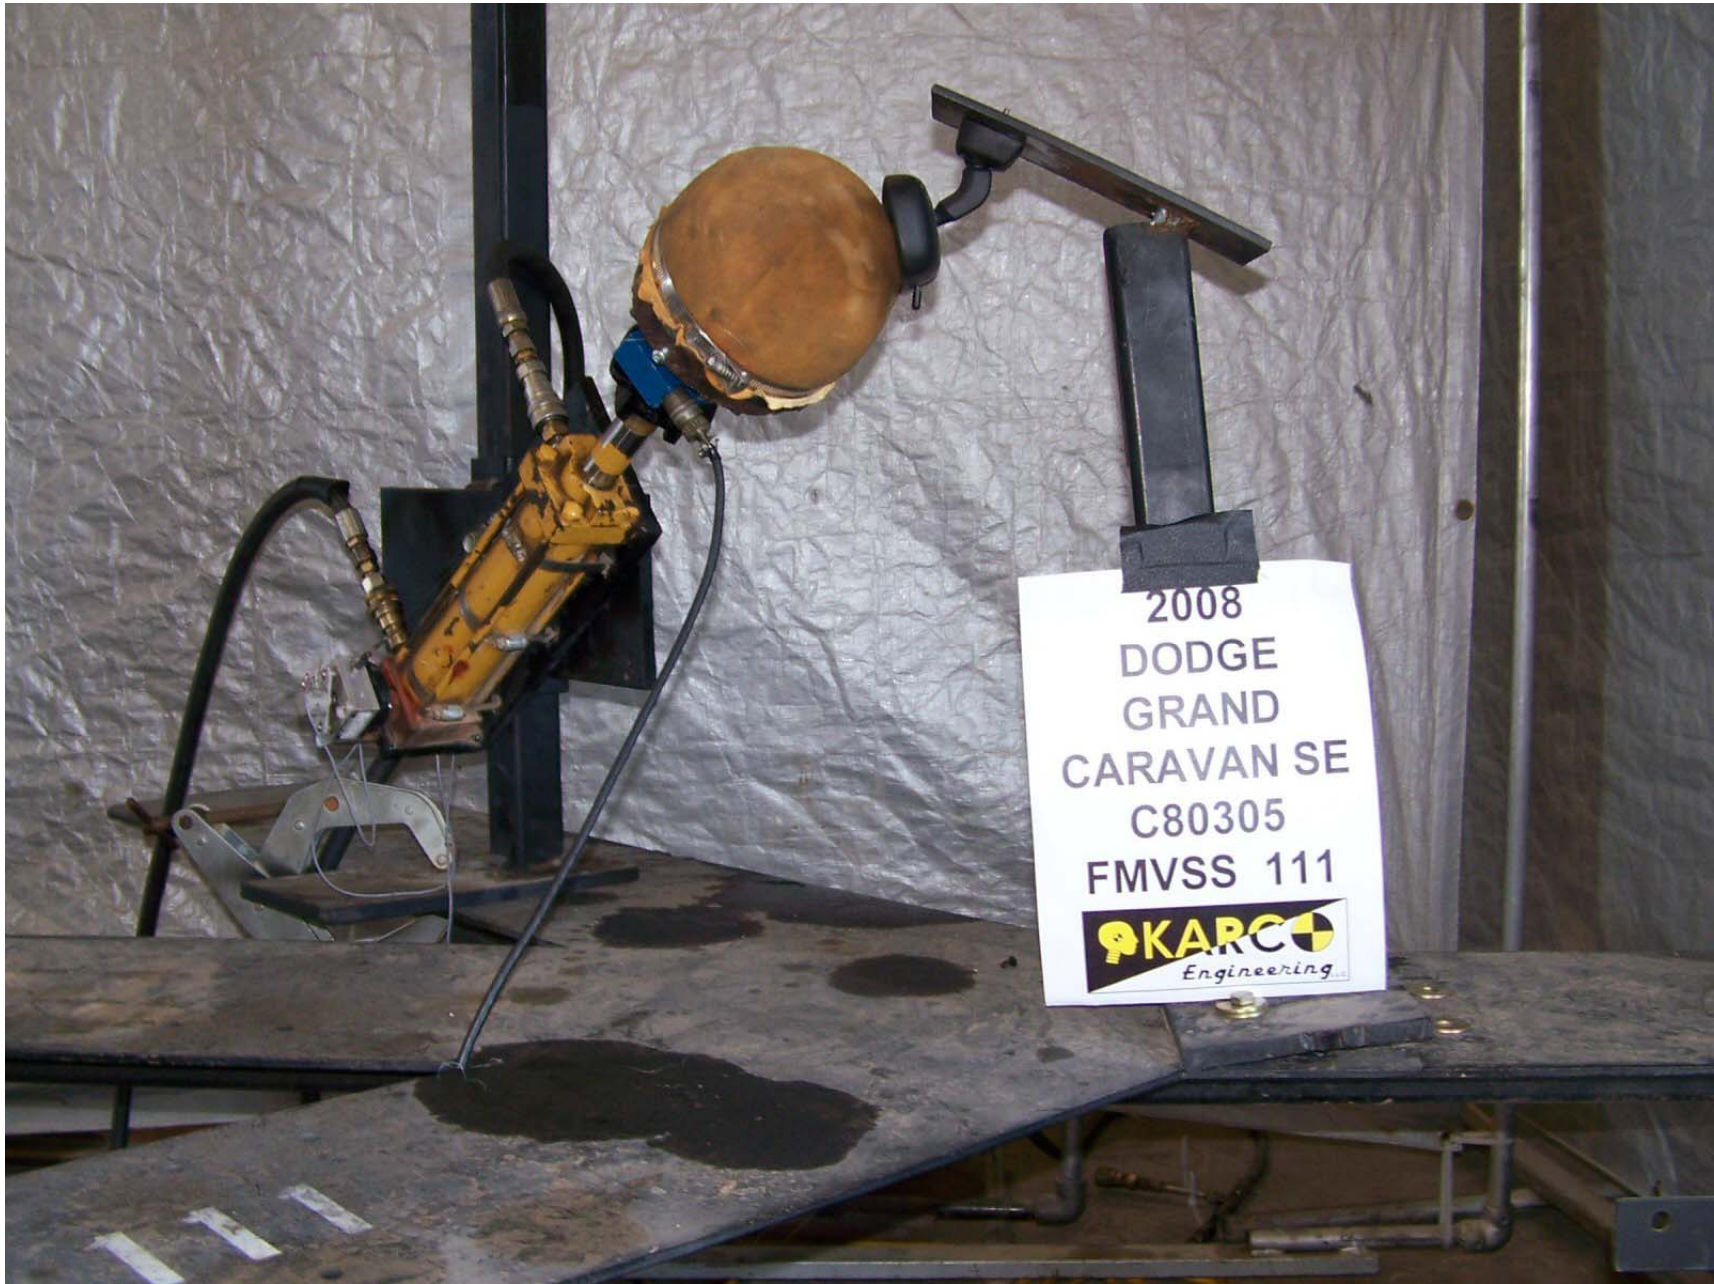
FIGURE 13:CLOSE-UP OF MIRROR BREAK- AWAY TEST

TEST NO.	LOAD DIRECTION VERTICAL/HORIZONTAL	MAXIMUM FORCE (N)	DISPLACEMENT (MM)	PASS	FAIL
1	0-90 DEGREES	281.5	13.4	X	
2	+45/90 DEGREES	47.7	5.4	X	
3	-45/90 DEGREES	175.5	38.0	X	
4	-45/+45 DEGREES	126.9	30.0	X	
5	+45/+45 DEGREES	73.5	53.8	X	
6	+45/-45 DEGREES	41.9	32.8	X	
7	-45/-45 DEGREES	66.5	7.4	X

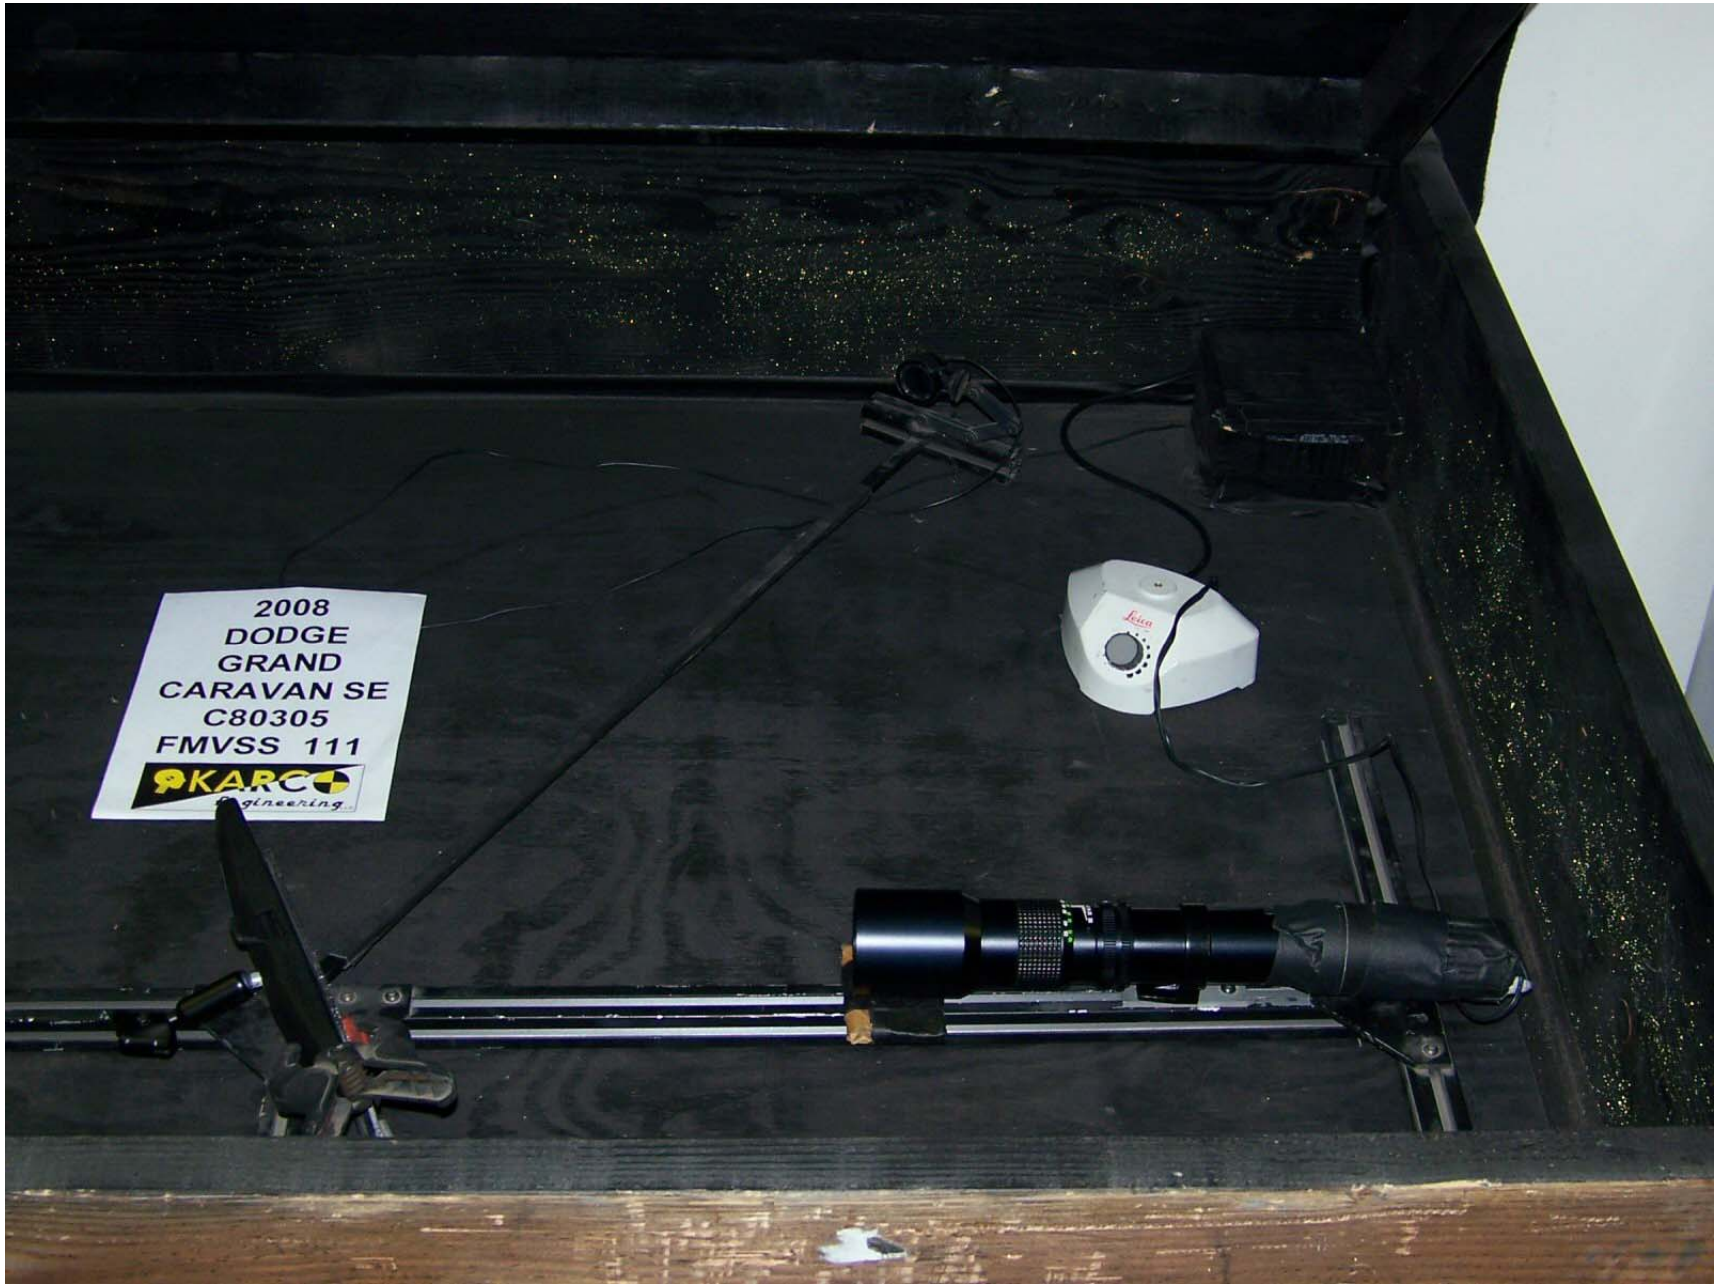
FIGURE 14: REFLECTION TEST SET-UP

DESCRIPTION OF TEST APPARATUS: THE APPARATUS CONSISTS OF AN INCANDESCENT TUNGSTEN FILAMENT LAMP OPERATING AT A NOMINAL COLOR TEMPERATURE OF 2,856 K, COLLIMATING OPTICS, A SAMPLE HOLDER POSITIONED AT 25°, A SILICON PHOTOCCELL, AND A FLUKE 45 DUAL DISPLAY MULTIMETER (CALIBRATION DUE DATE 3-26-08). REFLECTANCE TESTS ARE CONDUCTED IN A 4'X6' WOODEN CABINET PAINTED FLAT BLACK. FOR CONVEX MIRROR A 6" INTEGRATING SPHERE WAS INCORPORATED INTO THE RECEIVER.

REFLECTANCE (Day) = Voltage (Refl)/Voltage (Cal) = 0.954 x 100 = 95.4 percent
(Min. Required = 35%)

REFLECTANCE (Night) = Voltage (Refl)/Voltage (Cal) = 0.615 x 100 = 61.5 percent
(Min. Required = 4%)

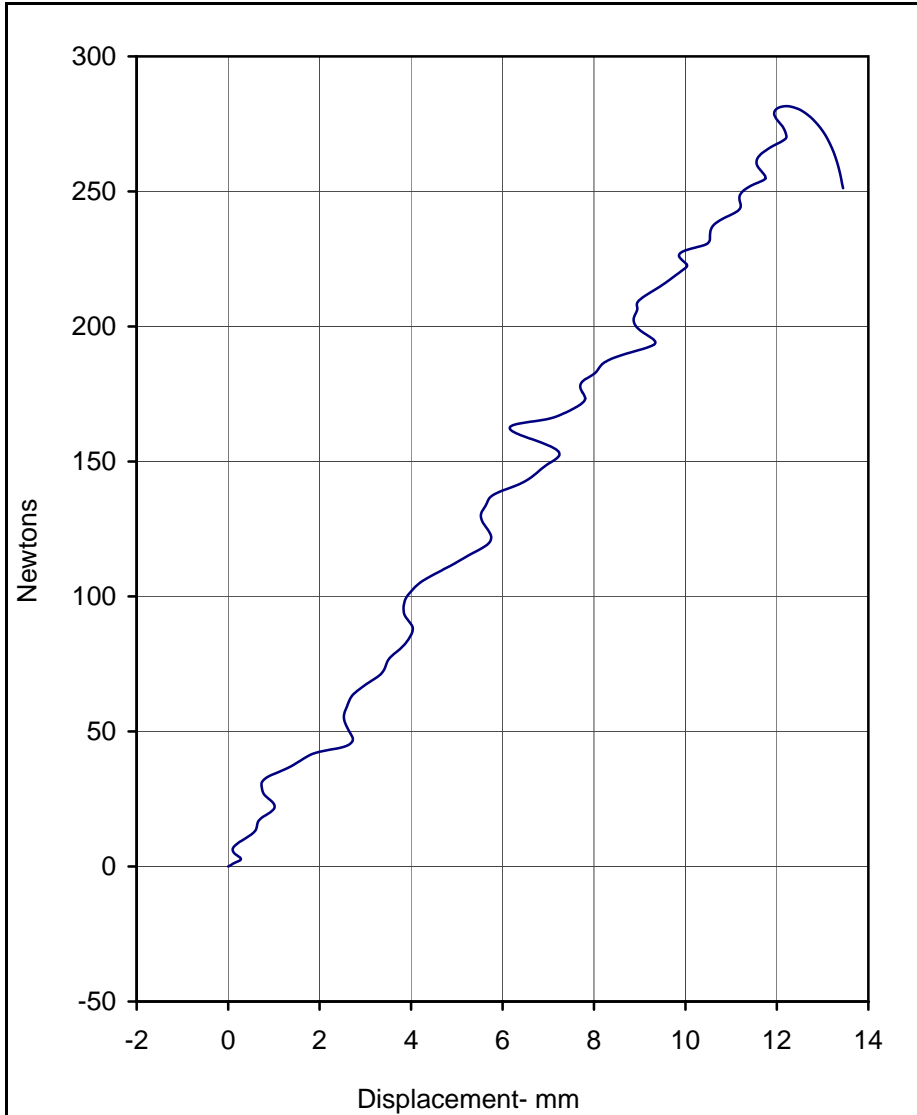
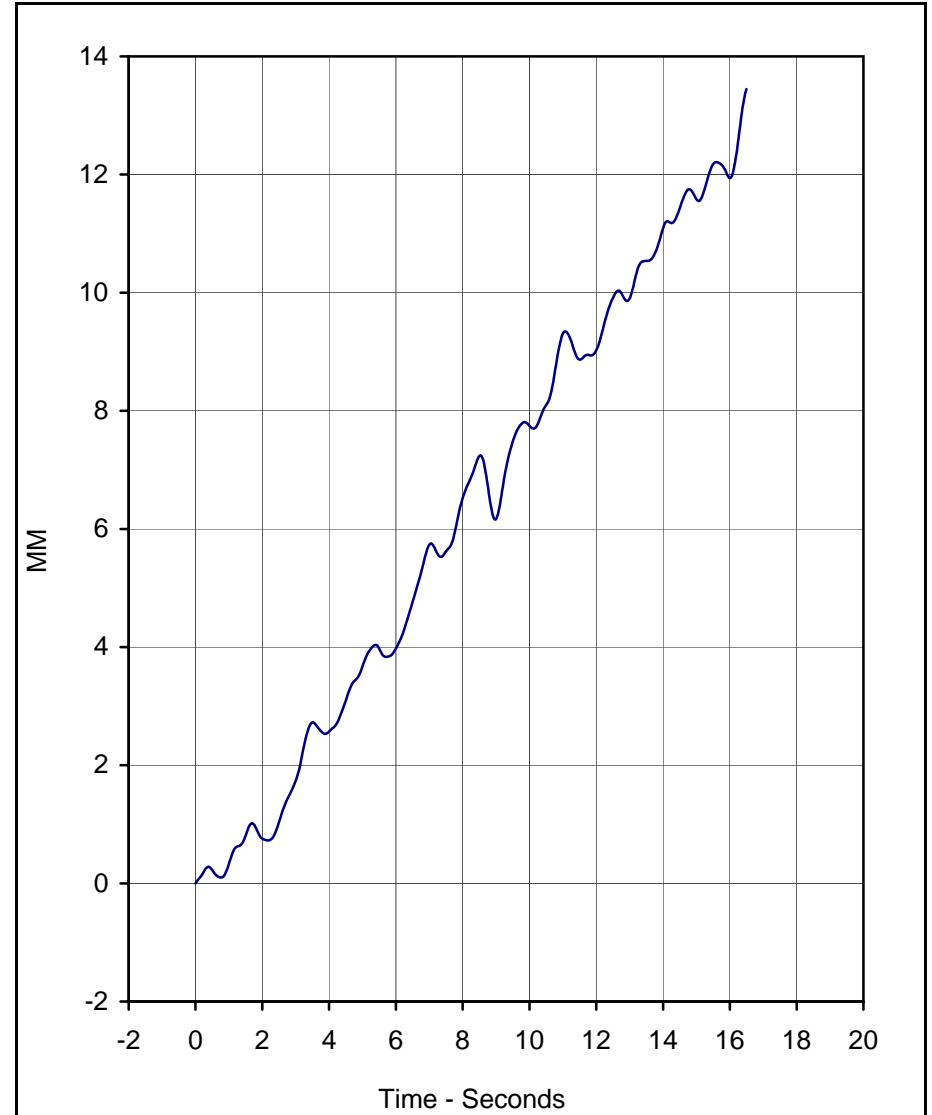
Load Direction: 0 / 90
 Test Date: 8/27/08

Units	Peak Force	Displacement	Filter (Hz)
Newtons	281.5	12.2	1

Units	Max	Time	Displ. Rate (mm/min.)	Filter (Hz)
MM	13.4	16.5	46.9	1

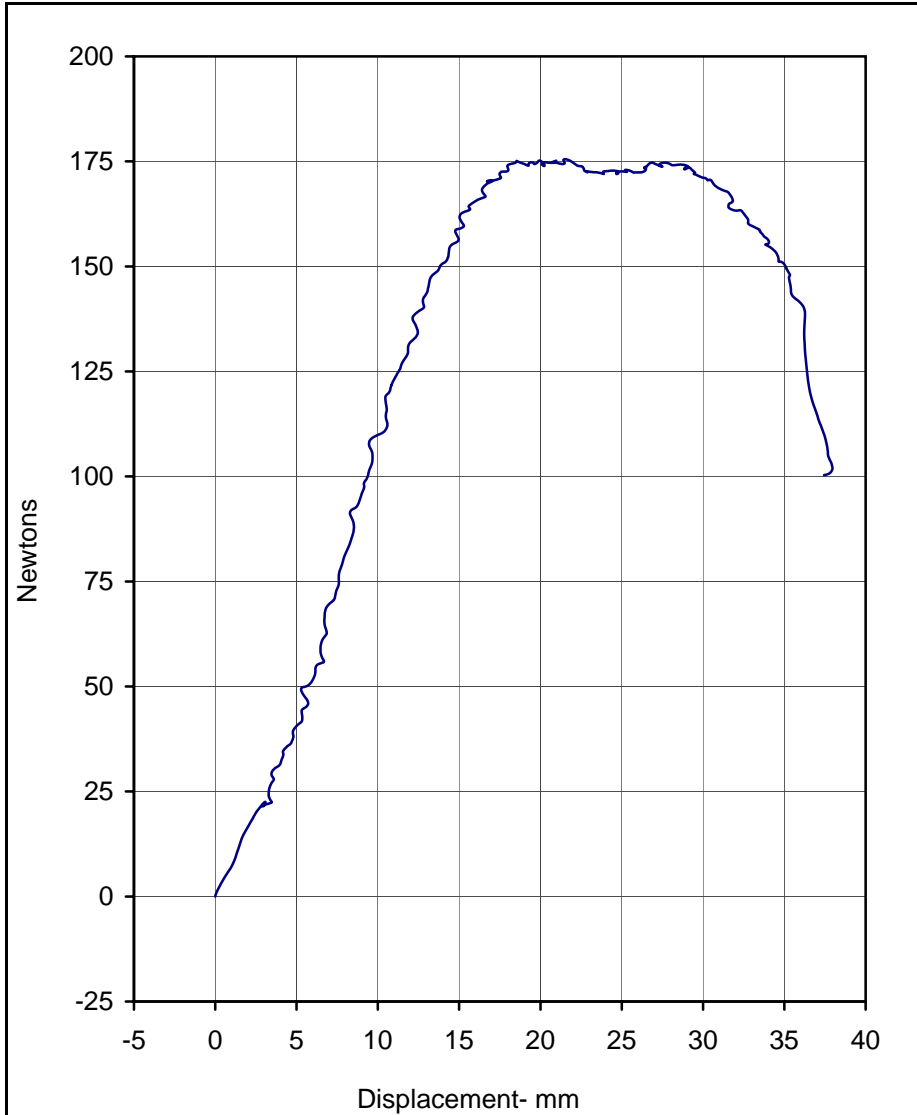
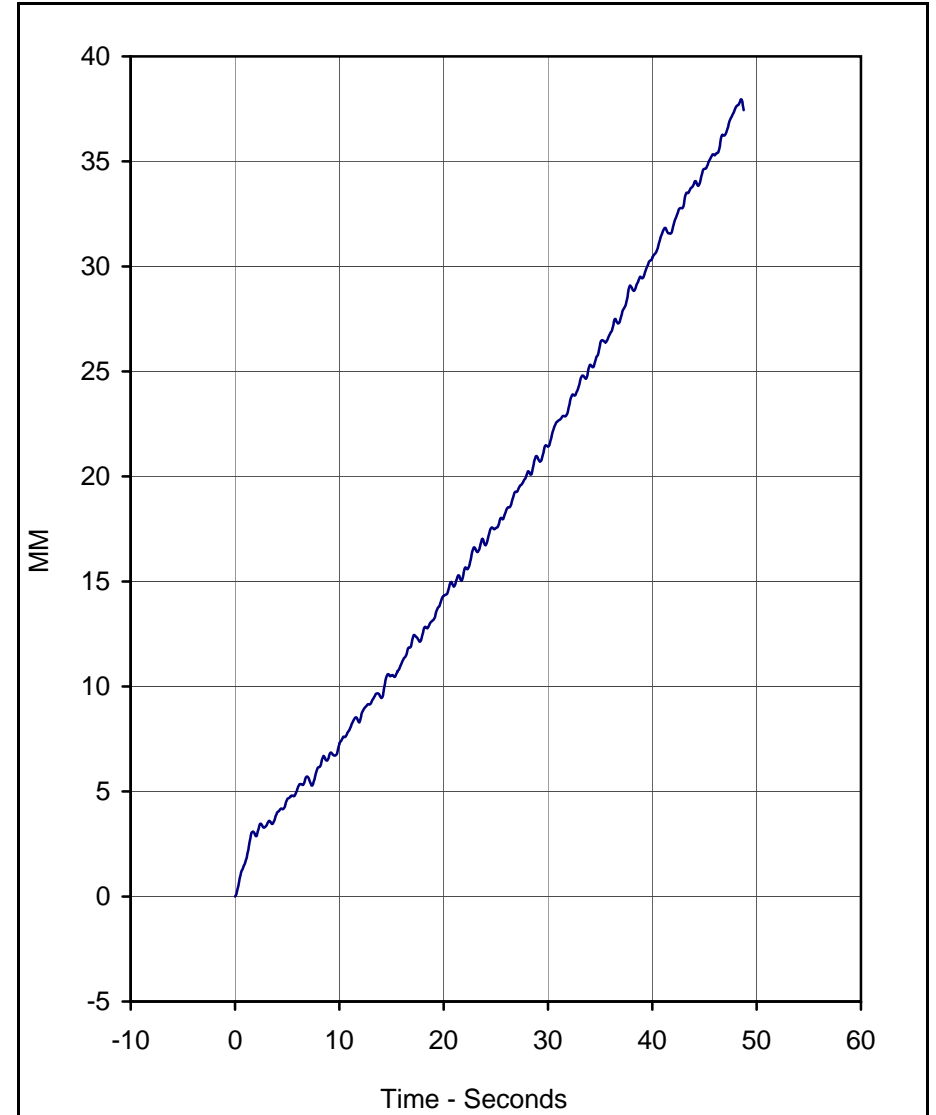
Load Direction: -45 / 90
 Test Date: 8/25/08

Units	Peak Force	Displacement	Filter (Hz)
Newtons	175.5	21.5	1

Units	Max	Time	Displ. Rate (mm/min.)	Filter (Hz)
MM	38.0	48.5	46.4	1

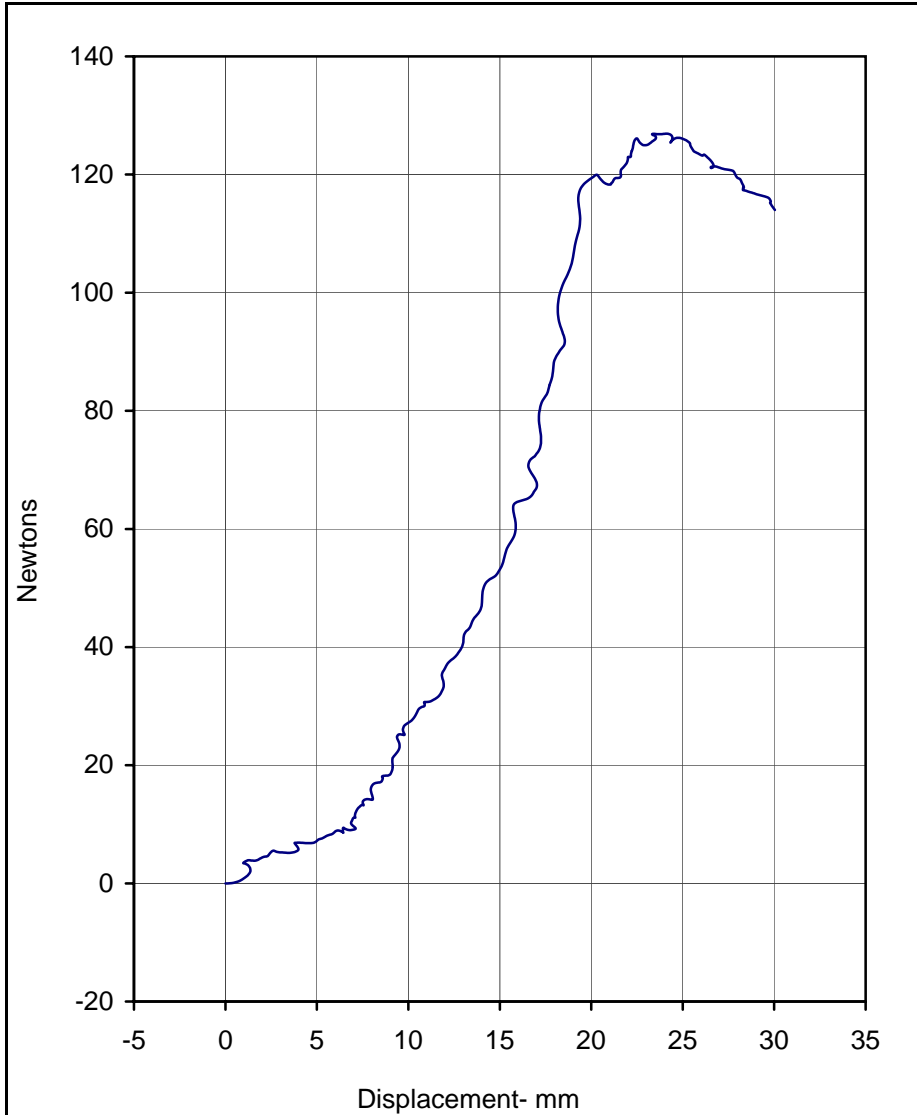
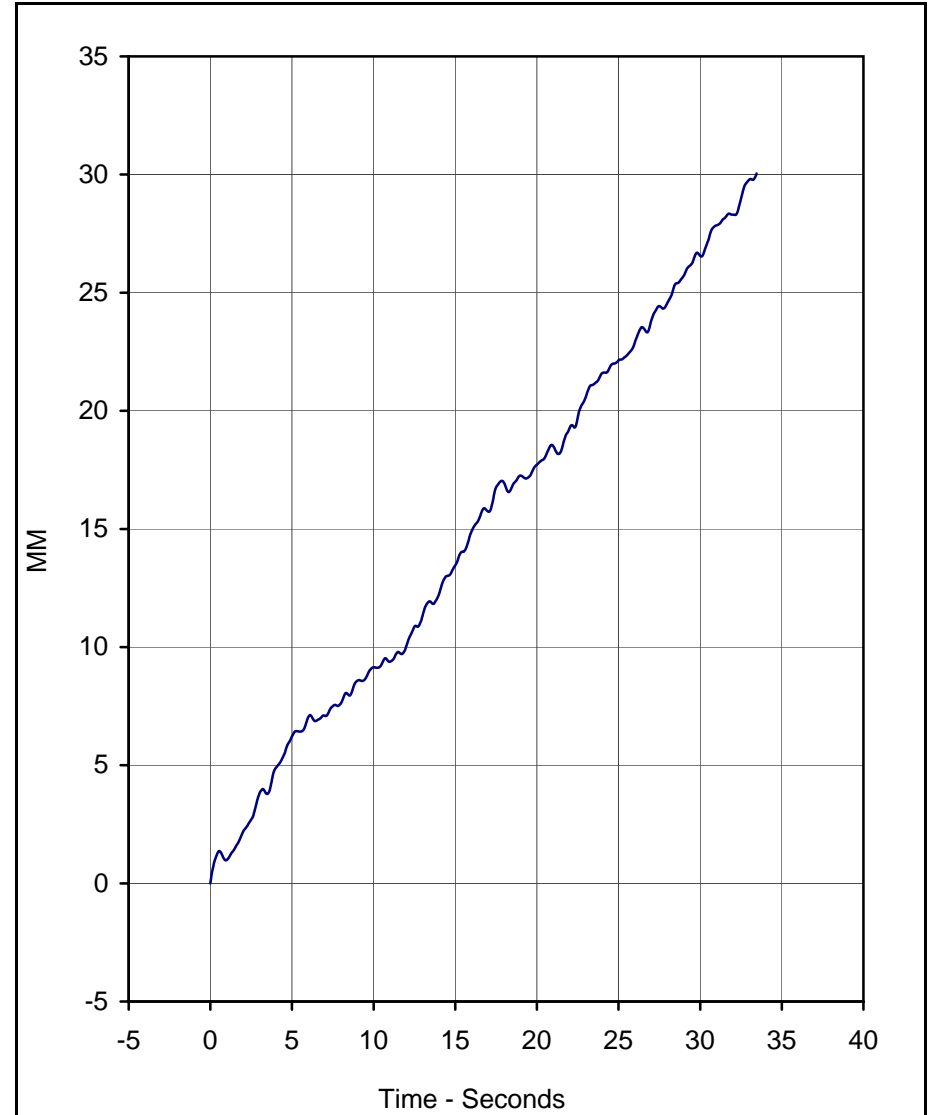
Load Direction: -45 / +45
 Test Date: 8/27/08

Units	Peak Force	Displacement	Filter (Hz)
Newtons	126.9	24.1	1

Units	Max	Time	Displ. Rate (mm/min.)	Filter (Hz)
MM	30.0	33.5	53.9	1

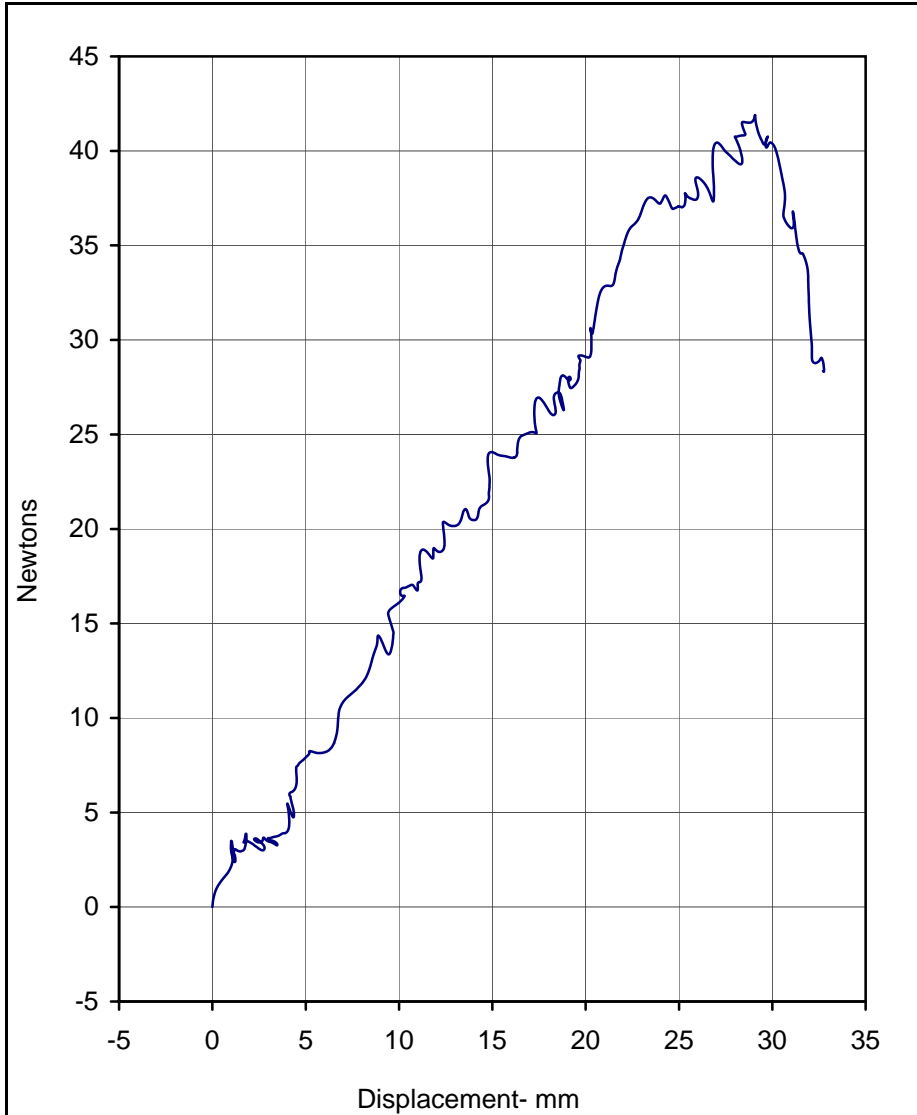
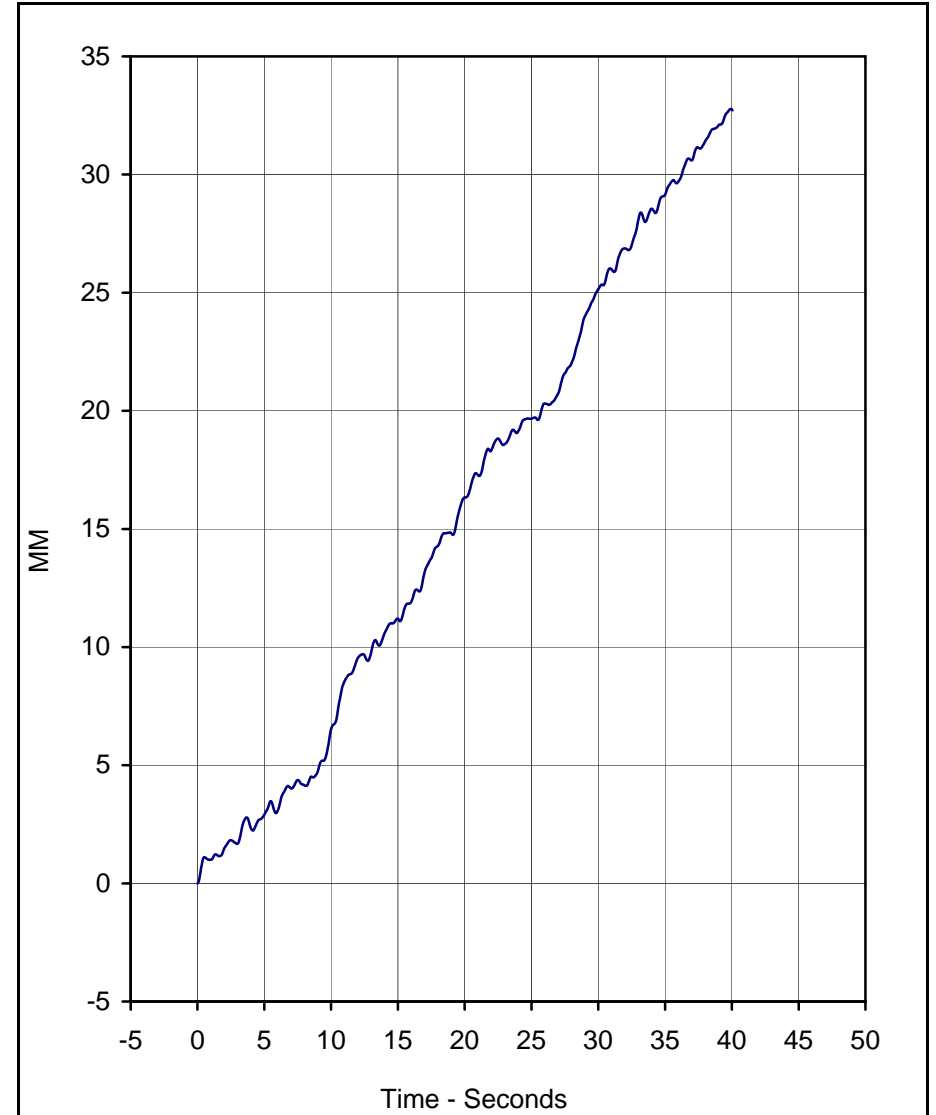
Load Direction: +45 / -45
 Test Date: 8/27/08

Units	Peak Force	Displacement	Filter (Hz)
Newtons	41.9	29.1	1

Units	Max	Time	Displ. Rate (mm/min.)	Filter (Hz)
MM	32.8	39.9	49.4	1

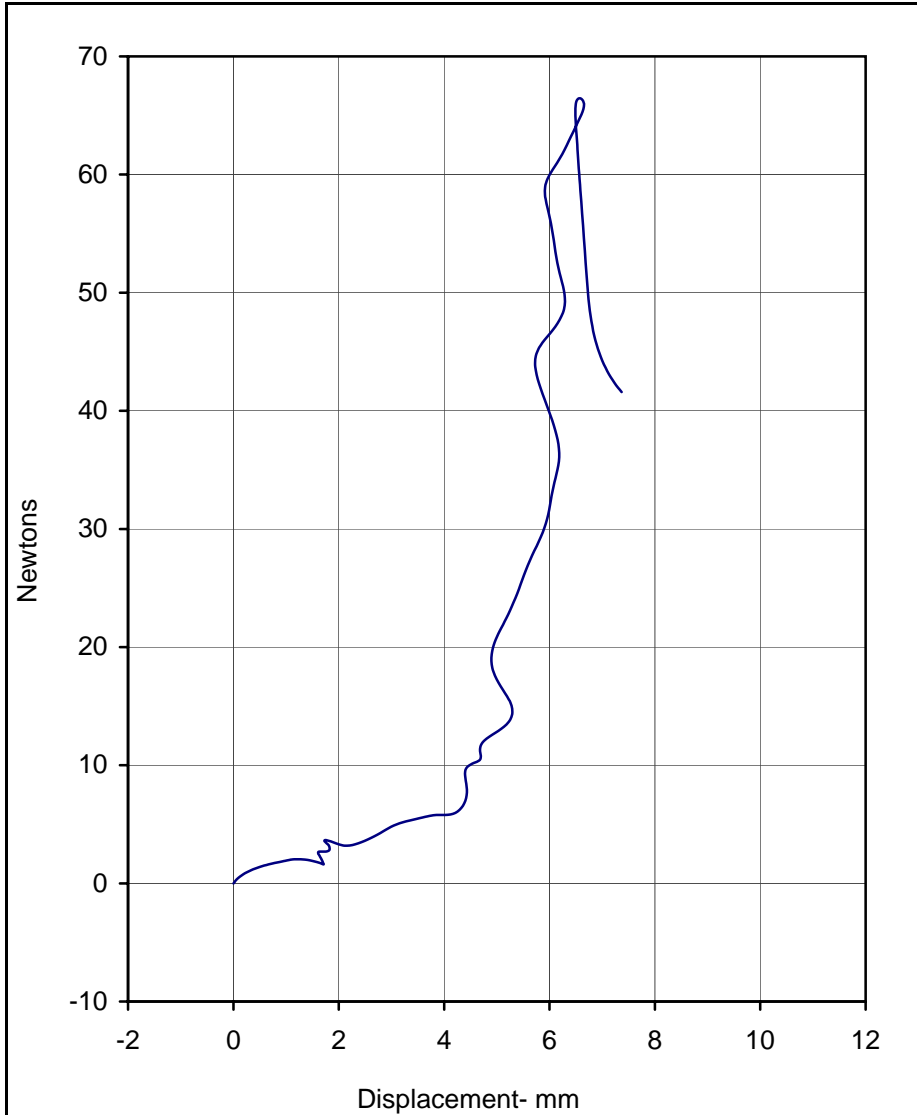
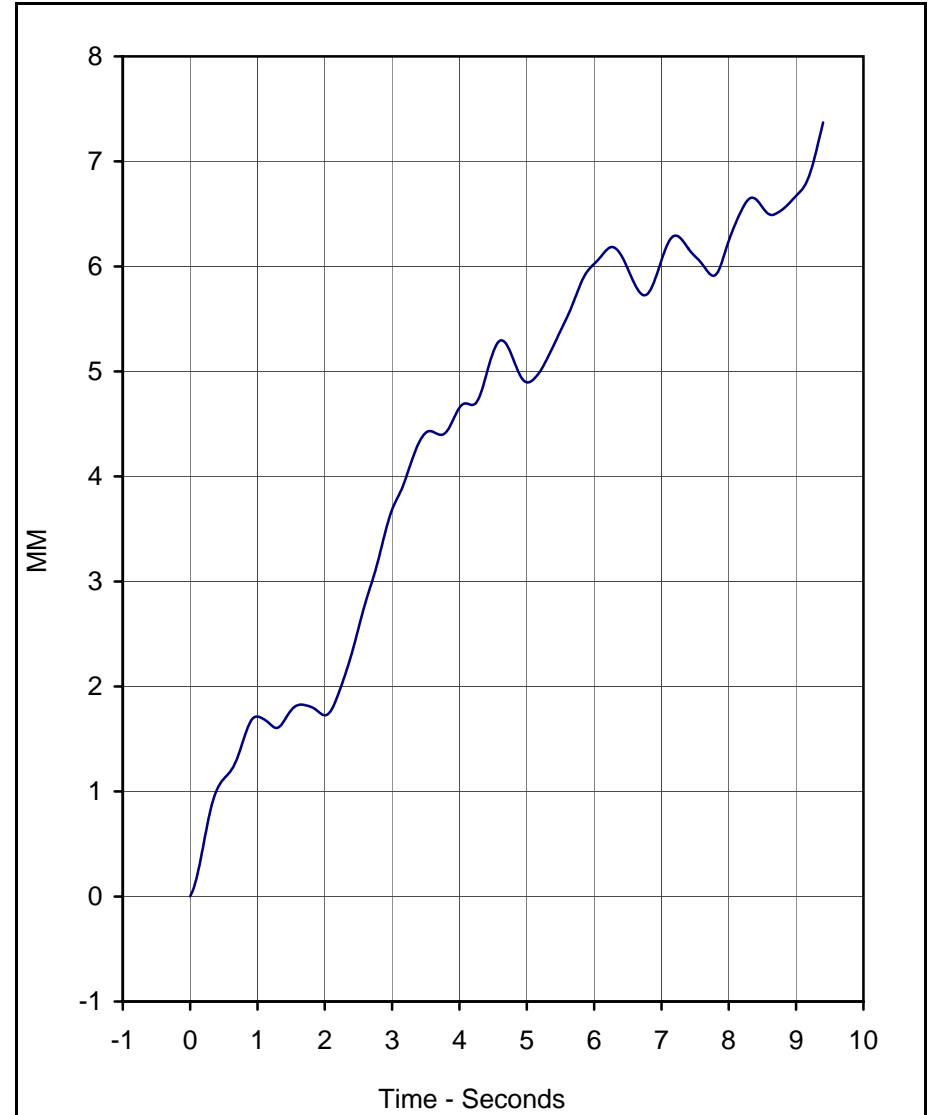
Units	Peak Force	Displacement	Filter (Hz)
Newtons	66.5	6.6	1

Units	Max	Time	Displ. Rate (mm/min.)	Filter (Hz)
MM	7.4	9.4	51.8	1
