REPORT NUMBER: 201UI-CAL-08-06

**SAFETY COMPLIANCE TESTING FOR FMVSS 201
OCCUPANT PROTECTION IN INTERIOR IMPACT
UPPER INTERIOR HEAD IMPACT PROTECTION**

**CHRYSLER LLC
2008 DODGE GRAND CARAVAN**

NHTSA NUMBER: C80305

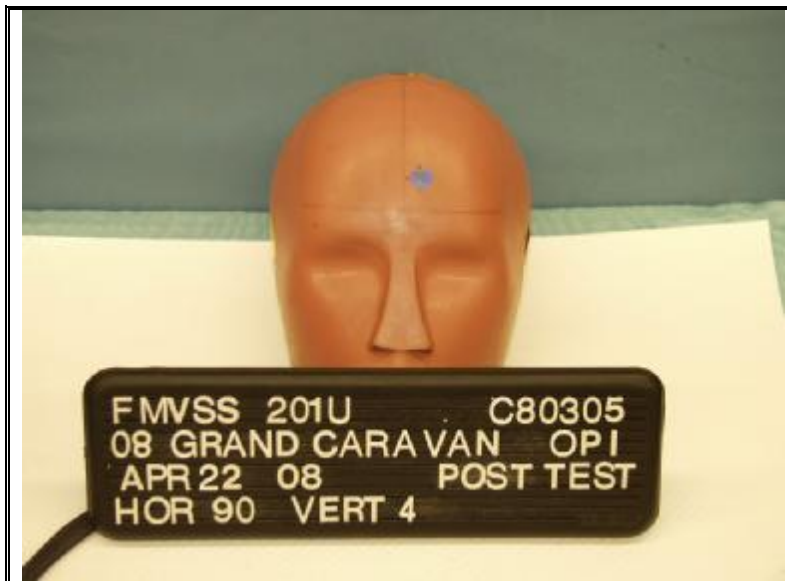
POST-IMPACT OP1 HEADFORM

Impact Point Description (from lower midpoint on midsagittal line)			
On Centerline	10	mm right	x mm left
On Centerline	17	mm up

Free Motion HIC	579.1
HIC(d)	603.3
Impact Velocity (kph)	23.4
HIC T1 (msec)	1.8
HIC T2 (msec)	8.8

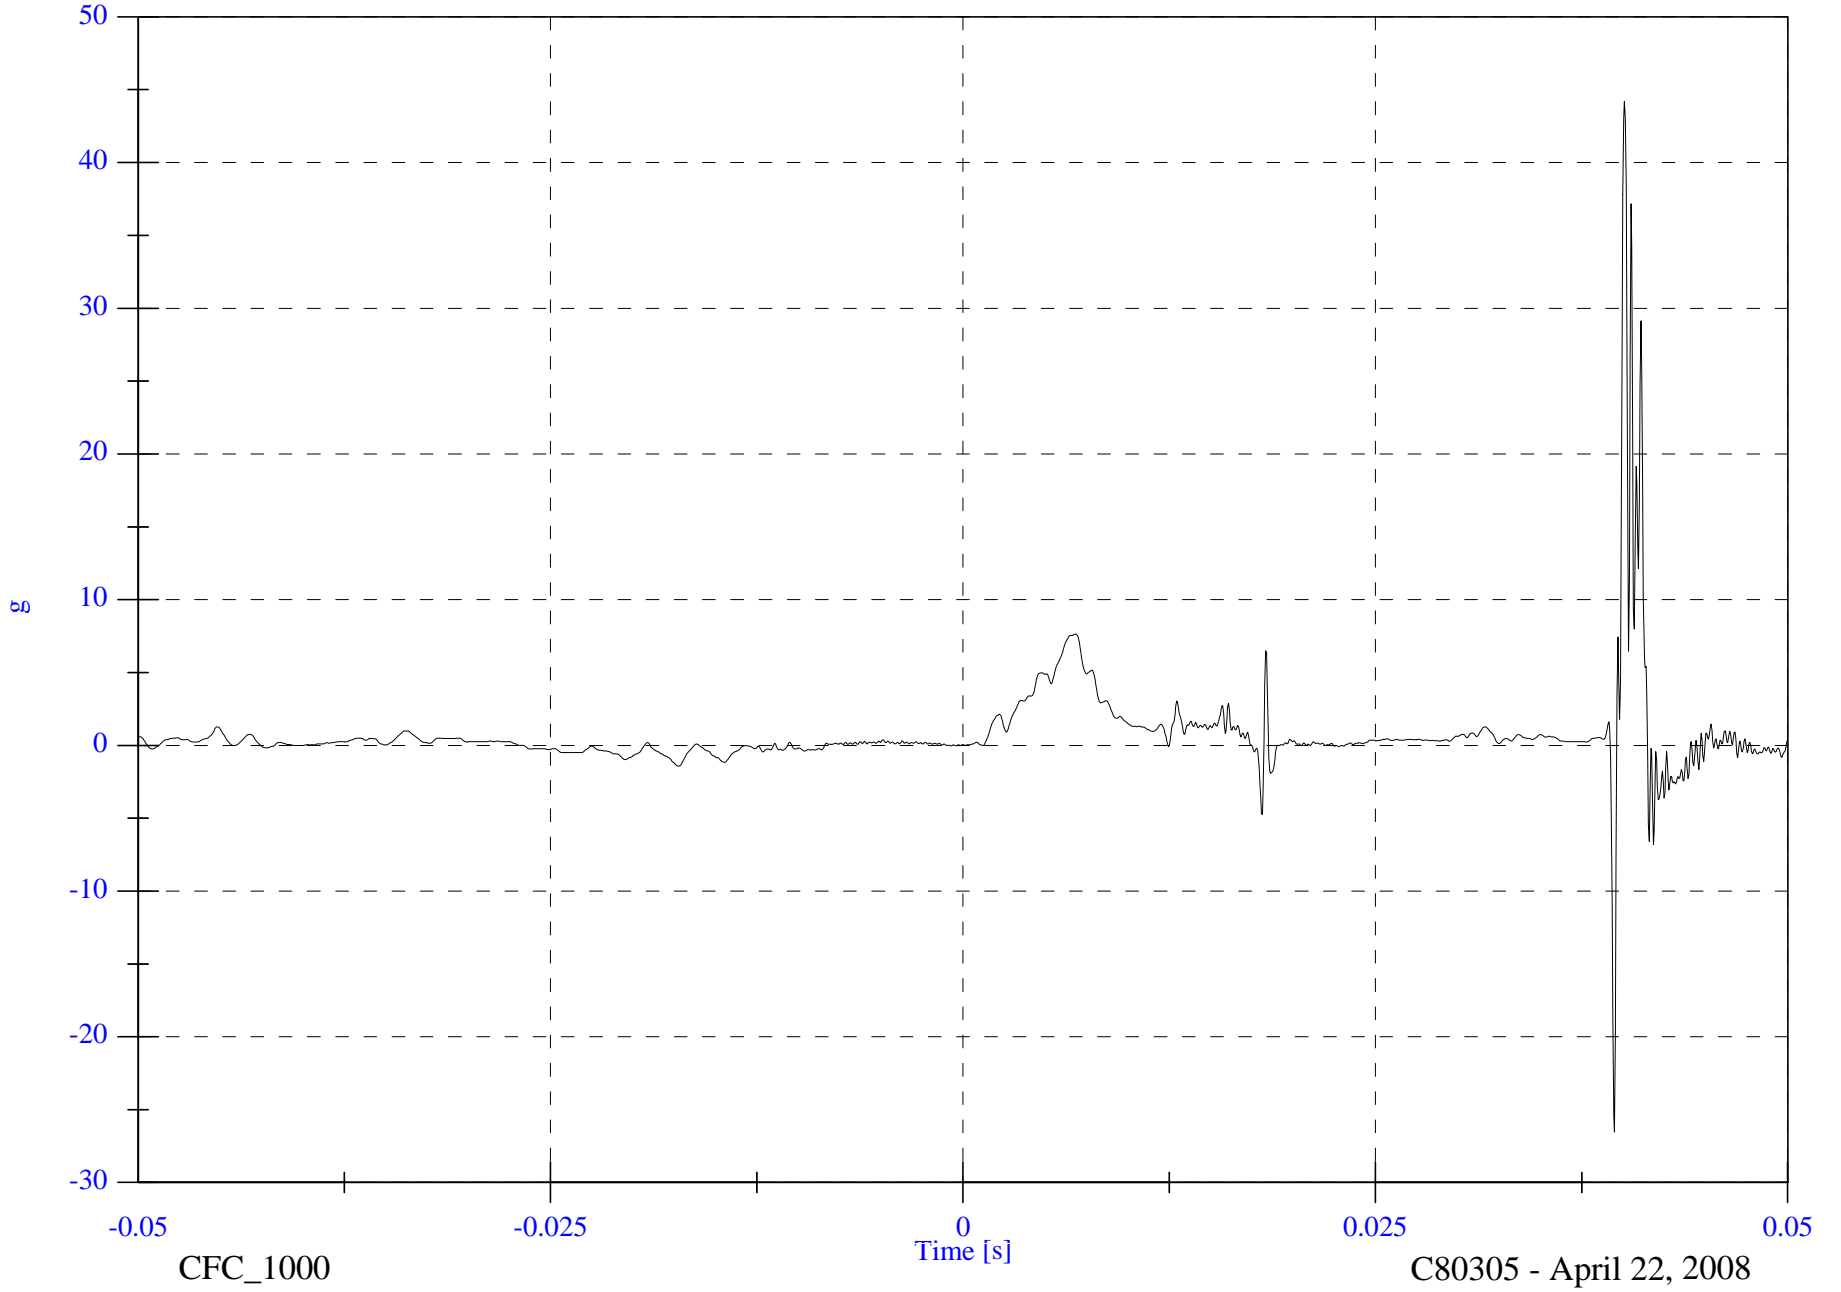
C80305 PASSENGER SIDE OP1 IMPACT PLOT #3

Headform Y Acceleration

Max: 44.2 [g] at 0.040 [s]

Min: -26.5 [g] at 0.039 [s]

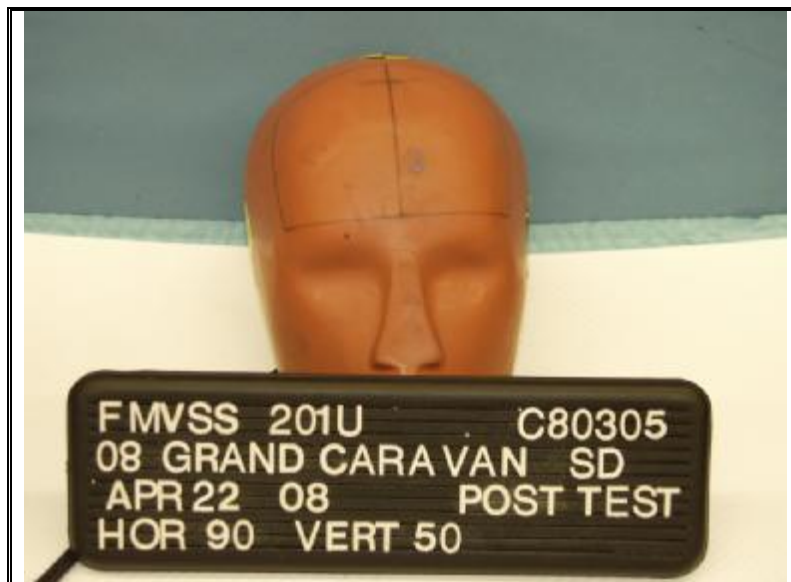
POST-IMPACT SD HEADFORM

Impact Point Description (from lower midpoint on midsagittal line)			
On Centerline	9	<input type="checkbox"/>	mm right <input checked="" type="checkbox"/> mm left
On Centerline	27		mm up

Free Motion HIC	129.5
HIC(d)	264.1
Impact Velocity (kph)	18.46
HIC T1 (msec)	6.7
HIC T2 (msec)	18.6

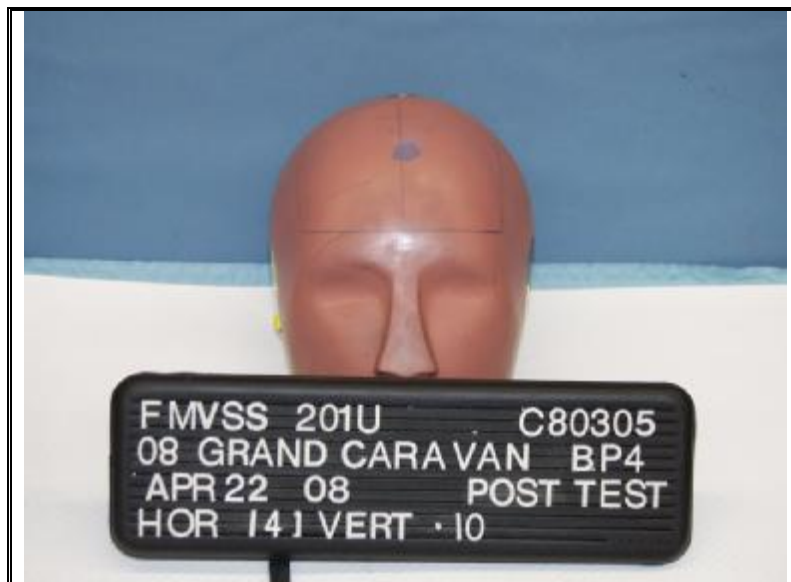
POST-IMPACT BP4 HEADFORM

Impact Point Description (from lower midpoint on midsagittal line)			
On Centerline	3	<input type="checkbox"/>	mm right <input checked="" type="checkbox"/> mm left
On Centerline	46		mm up

Free Motion HIC	700.5
HIC(d)	694.9
Impact Velocity (kph)	23.68
HIC T1 (msec)	1.8
HIC T2 (msec)	7.1

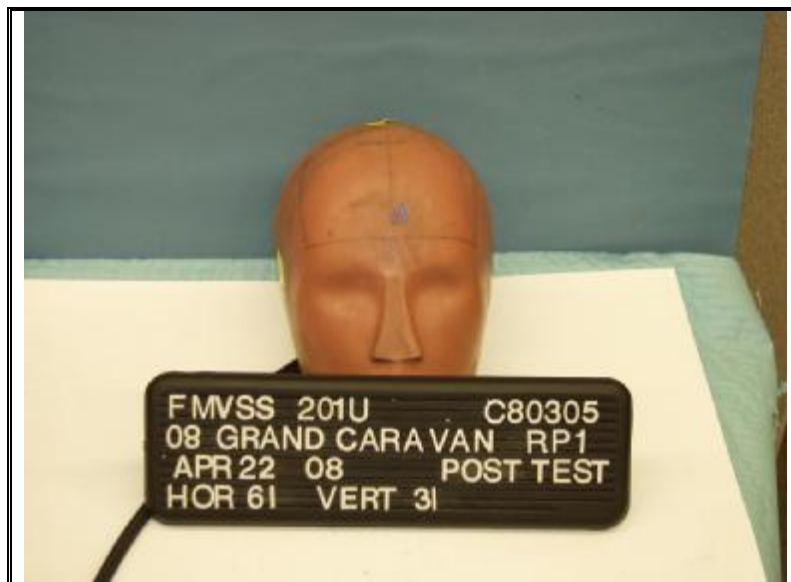
POST-IMPACT RP1 HEADFORM

Impact Point Description (from lower midpoint on midsagittal line)			
On Centerline	3	<input type="checkbox"/>	mm right <input checked="" type="checkbox"/> mm left
On Centerline	18		mm up

Free Motion HIC	141.3
HIC(d)	273.0
Impact Velocity (kph)	18.62
HIC T1 (msec)	5.2
HIC T2 (msec)	20.4

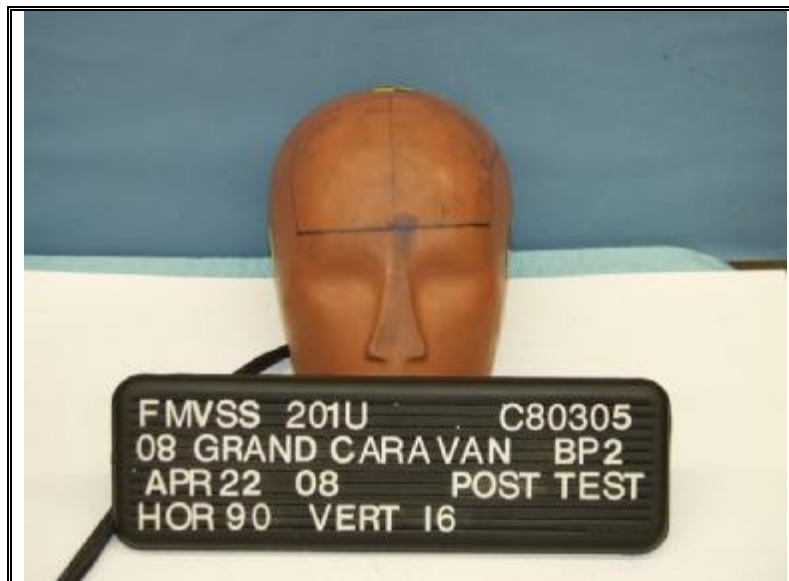
POST-IMPACT BP2 HEADFORM

Impact Point Description (from lower midpoint on midsagittal line)			
On Centerline	5	mm right	x mm left
On Centerline	2	mm up

Free Motion HIC	509.8
HIC(d)	551.0
Impact Velocity (kph)	23.62
HIC T1 (msec)	0.8
HIC T2 (msec)	9.0

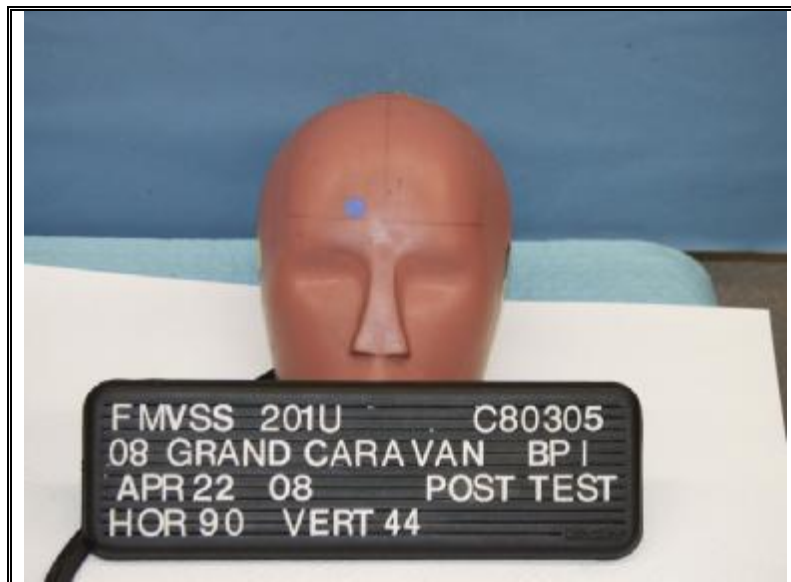
POST-IMPACT BP1 HEADFORM

Impact Point Description (from lower midpoint on midsagittal line)				
On Centerline	16	x	mm right	mm left
On Centerline	6		mm up

Free Motion HIC	252.0
HIC(d)	356.5
Impact Velocity (kph)	18.83
HIC T1 (msec)	6.6
HIC T2 (msec)	15.9

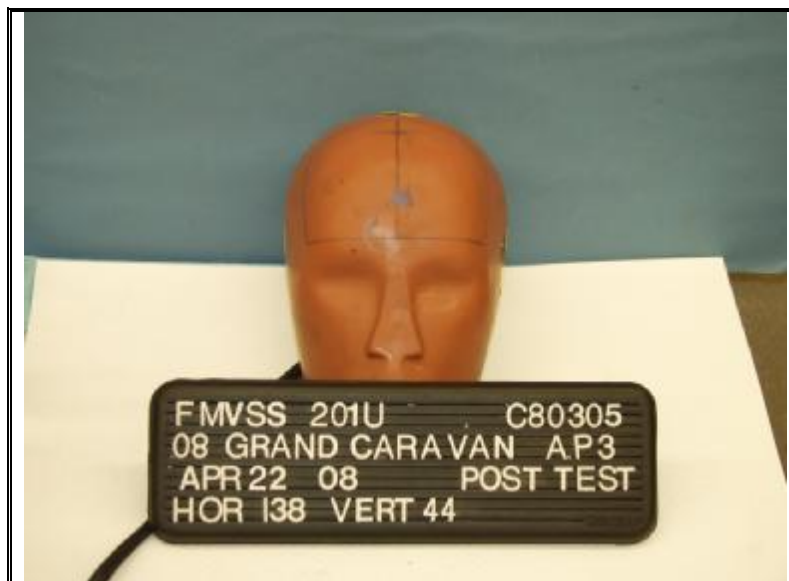
POST-IMPACT AP3 HEADFORM

Impact Point Description (from lower midpoint on midsagittal line)					
On Centerline	2	<input type="checkbox"/>	mm right	<input checked="" type="checkbox"/>	mm left
On Centerline	24				mm up

Free Motion HIC	250.0
HIC(d)	355.0
Impact Velocity (kph)	18.37
HIC T1 (msec)	2.4
HIC T2 (msec)	8.2

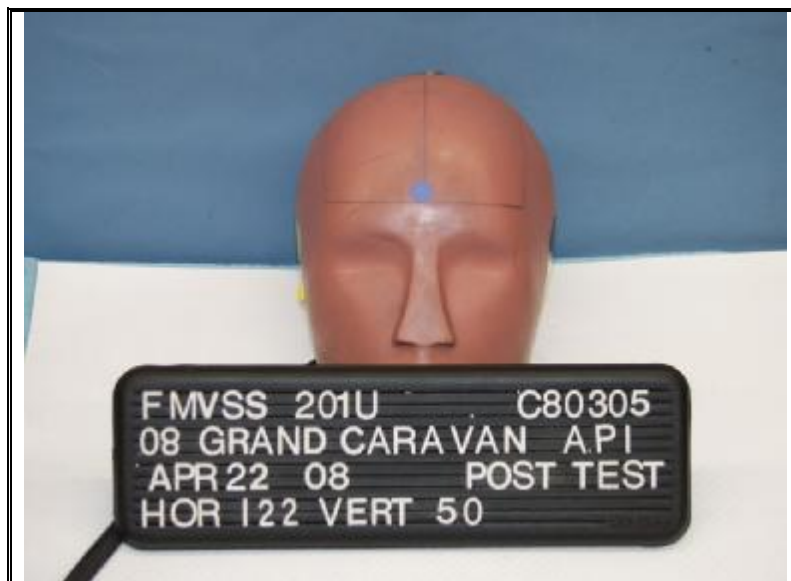
POST-IMPACT AP1 HEADFORM

Impact Point Description (from lower midpoint on midsagittal line)			
On Centerline	2	<input checked="" type="checkbox"/> mm right	<input type="checkbox"/> mm left
On Centerline	7	mm up

Free Motion HIC	442.6
HIC(d)	500.3
Impact Velocity (kph)	18.69
HIC T1 (msec)	7.6
HIC T2 (msec)	13.0

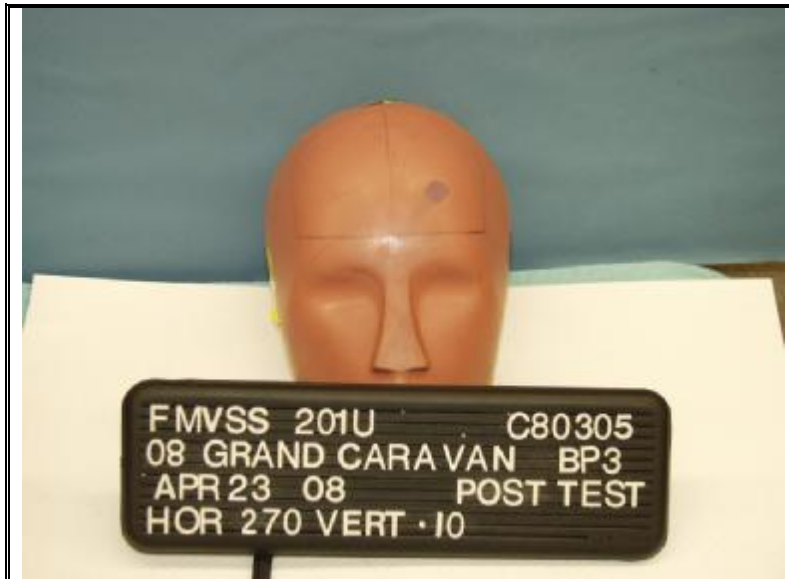
POST-IMPACT BP3 HEADFORM

Impact Point Description (from lower midpoint on midsagittal line)			
On Centerline	27	mm right	x mm left
On Centerline	26	mm up

Free Motion HIC	705.7
HIC(d)	698.8
Impact Velocity (kph)	23.75
HIC T1 (msec)	5.2
HIC T2 (msec)	11.0

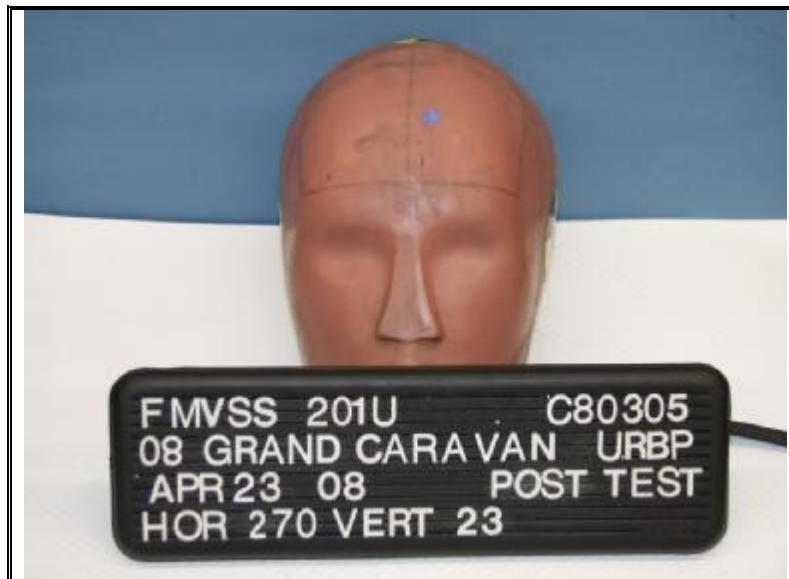
POST-IMPACT URBP HEADFORM

Impact Point Description (from lower midpoint on midsagittal line)			
On Centerline	10	mm right	x mm left
On Centerline	38	mm up

Free Motion HIC	238.0
HIC(d)	346.0
Impact Velocity (kph)	23.79
HIC T1 (msec)	1.7
HIC T2 (msec)	15.1

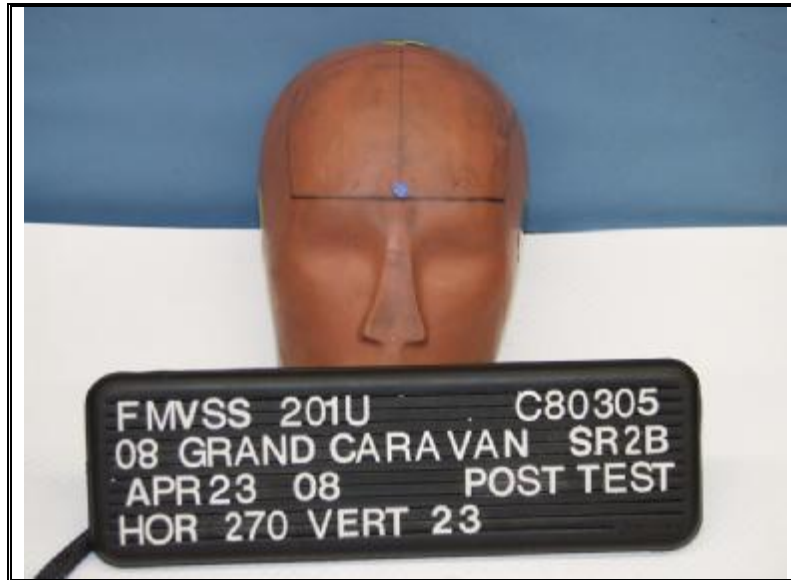
POST-IMPACT SR2B HEADFORM

Impact Point Description (from lower midpoint on midsagittal line)					
On Centerline	0	<input type="checkbox"/>	mm right	<input type="checkbox"/>	mm left
On Centerline	3				mm up

Free Motion HIC	175.5
HIC(d)	298.8
Impact Velocity (kph)	18.43
HIC T1 (msec)	3.8
HIC T2 (msec)	14.3

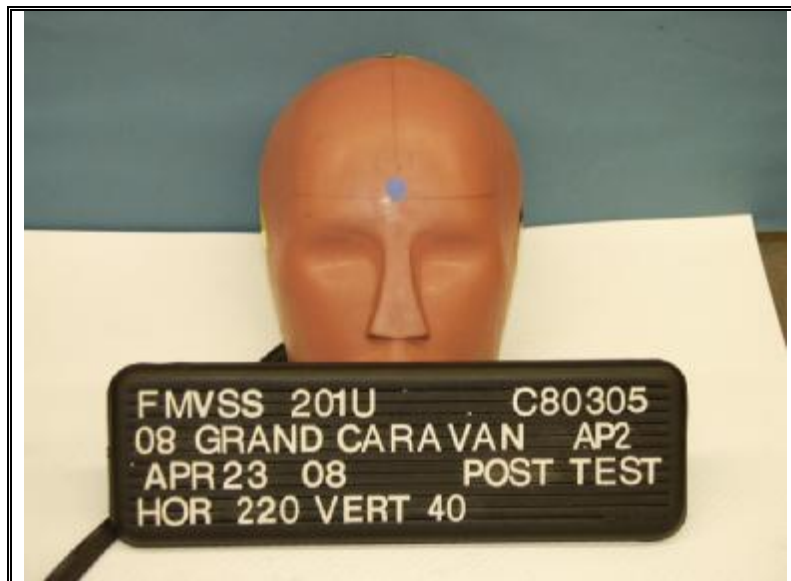
POST-IMPACT AP2 HEADFORM

Impact Point Description (from lower midpoint on midsagittal line)					
On Centerline	0	<input type="checkbox"/>	mm right	<input type="checkbox"/>	mm left
On Centerline	4				mm up

Free Motion HIC	273.0
HIC(d)	372.4
Impact Velocity (kph)	18.57
HIC T1 (msec)	2.2
HIC T2 (msec)	14.4

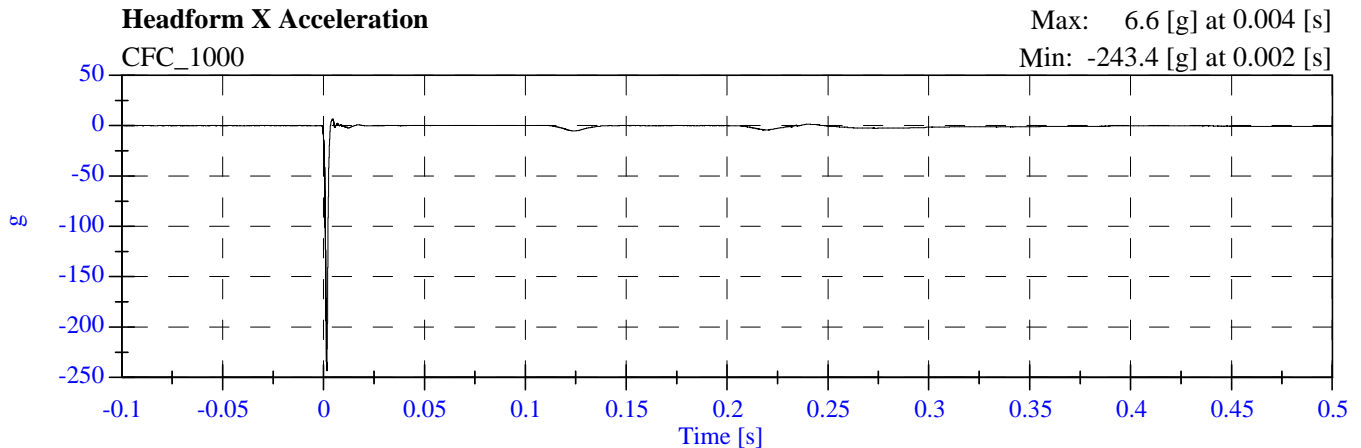
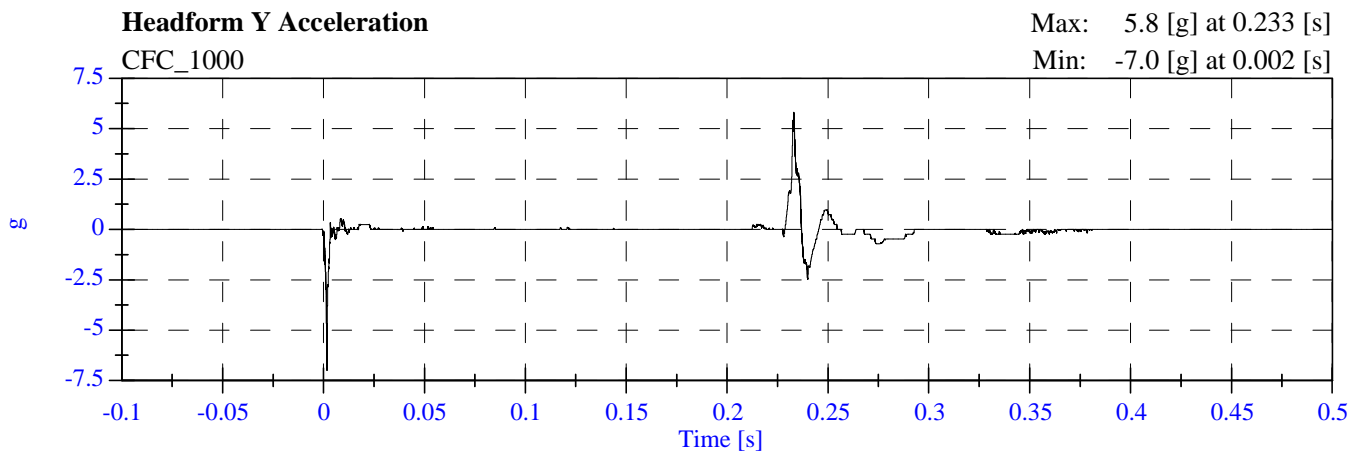
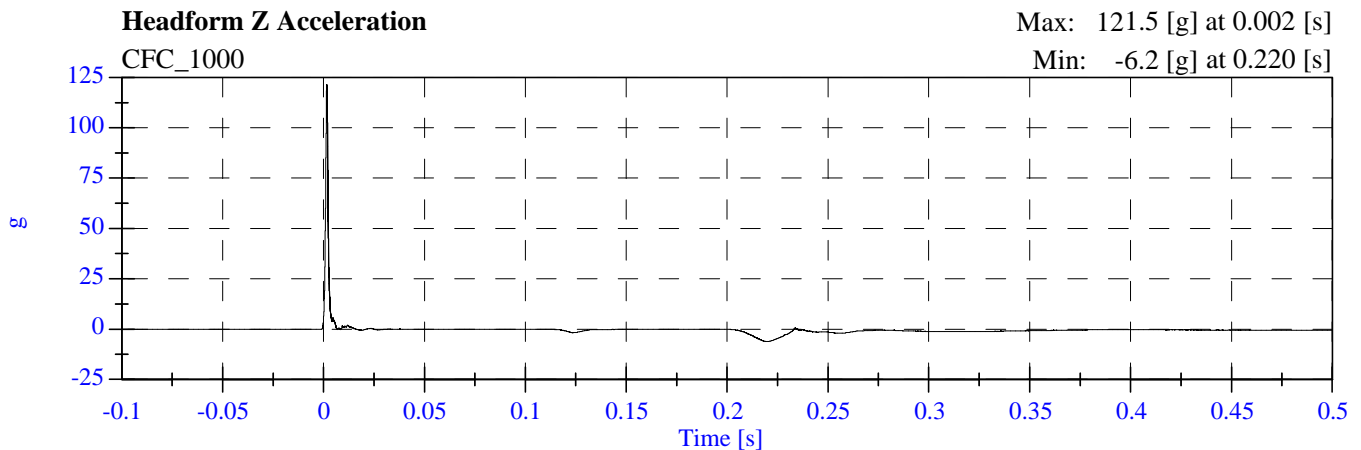
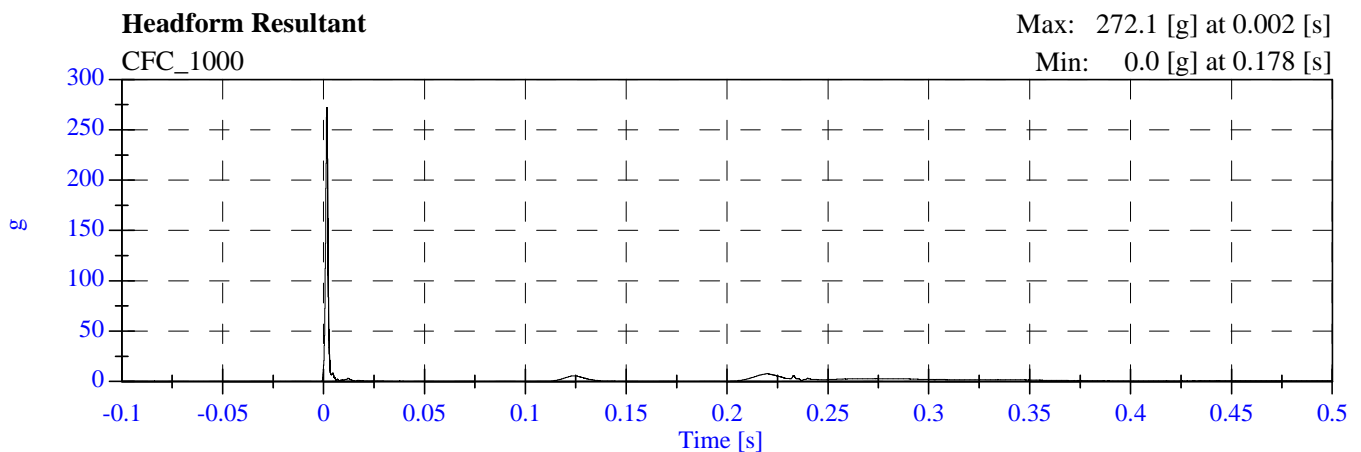
FMVSS 201U - Headform Calibration Drops C80305 - April 14, 2008

MANUFACTURER:		FIRST TECHNOLOGY SAFETY SYSTEMS	
SERIAL NUMBER:		1140	
CALIBRATION DATE:		APRIL 14, 2008	
TEST PARAMETER	SPECIFICATION	TEST RESULTS	
TEMPERATURE	19°C to 26°C	21.5	
RELATIVE HUMIDITY	10% to 70%	25	
PEAK RESULTANT ACCELERATION	225 Gs to 275 Gs	272.1	
PEAK LATERAL ACCELERATION	15 Gs Maximum	7.0	
IS ACCELERATION CURVE UNIMODAL?	YES	YES
