REPORT NUMBER: 201UI-CAL-08-08

**SAFETY COMPLIANCE TESTING FOR FMVSS 201  
OCCUPANT PROTECTION IN INTERIOR IMPACT  
UPPER INTERIOR HEAD IMPACT PROTECTION**

**TOYOTA MOTOR CORPORATION  
2009 TOYOTA COROLLA**

NHTSA NUMBER: C95103

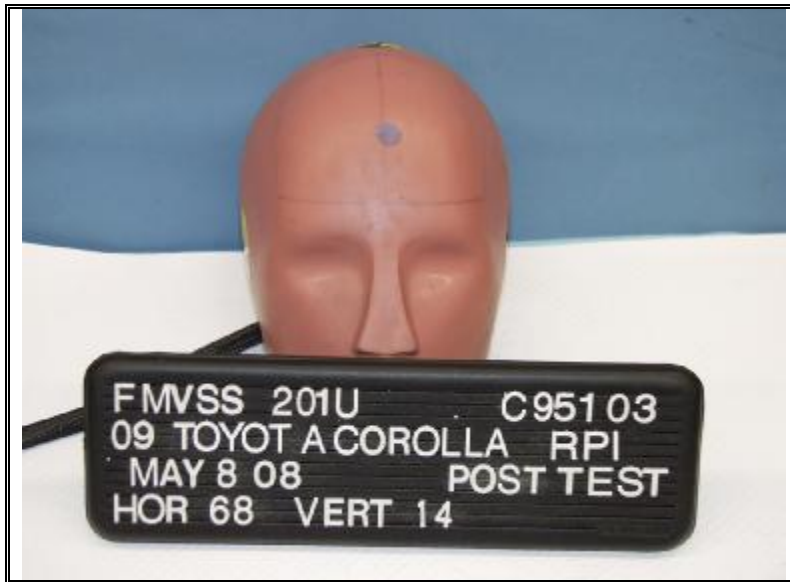
POST-IMPACT Pass. RP1 HEADFORM

Test Number:	01
Test Date:	05/08/08
Target Location:	REAR PILLAR
Target Code:	Pass. RP1
Horizontal Impact Angle:	68°
Vertical Impact Angle:	14°
Ambient Temperature:	20.5°C
Relative Humidity:	39.6
Time of Impact:	9:09
Headform Number:	1142

Impact Point Description (from lower midpoint on midsagittal line)					
On Centerline	3	<input type="checkbox"/>	mm right	<input checked="" type="checkbox"/>	mm left
On Centerline	34				mm up

Free Motion HIC	491.7
HIC(d)	537.3
Impact Velocity (kph)	23.74
HIC T1 (msec)	3.8
HIC T2 (msec)	12.8

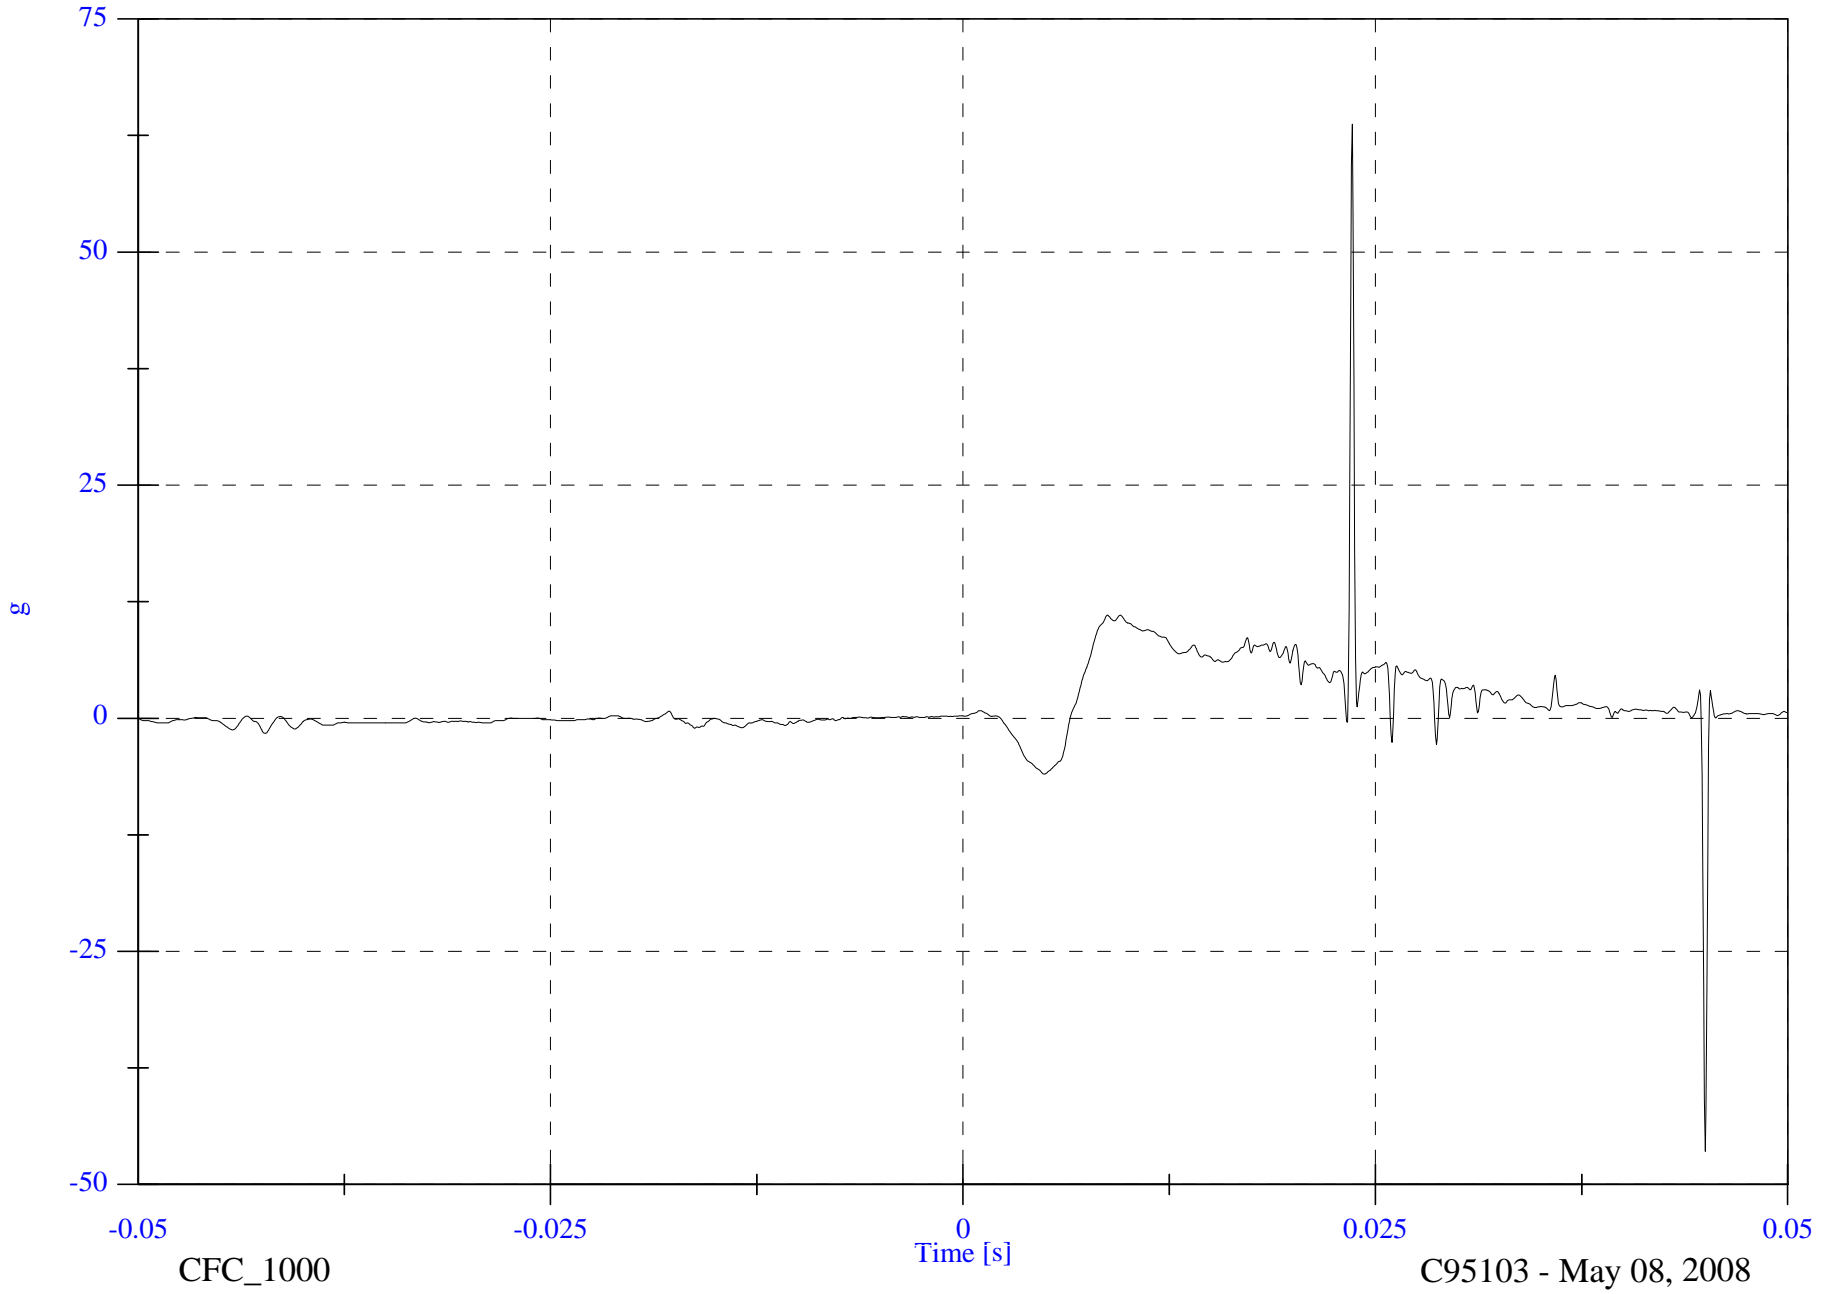
C95103 PASSENGER SIDE RPI IMPACT PLOT #3

Headform Y Acceleration

Max: 63.7 [g] at 0.024 [s]

Min: -46.5 [g] at 0.045 [s]

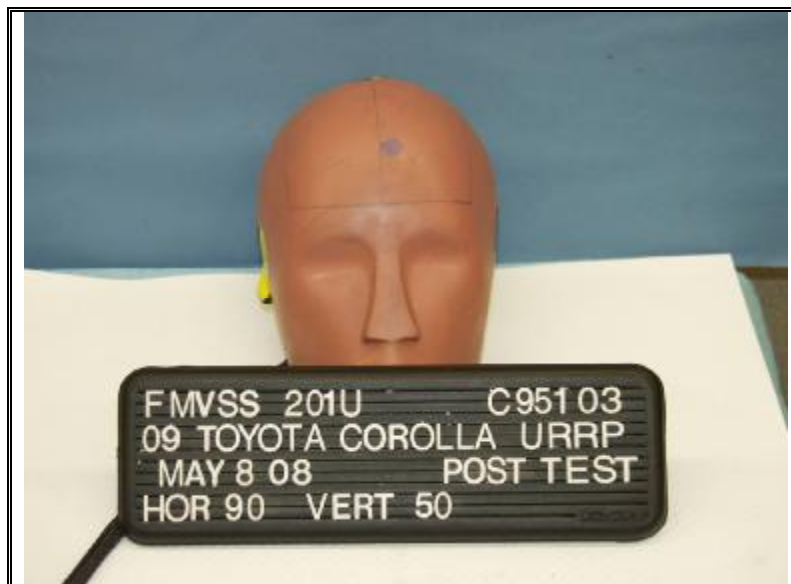
POST-IMPACT URRP HEADFORM

Test Number:	02
Test Date:	<b>05/08/08</b>
Target Location:	UPPER ROOF
Target Code:	URRP
Horizontal Impact Angle:	<b>90°</b>
Vertical Impact Angle:	<b>50°</b>
Ambient Temperature:	<b>20.5°C</b>
Relative Humidity:	<b>39.6</b>
Time of Impact:	<b>9:37</b>
Headform Number:	<b>1140</b>

Impact Point Description (from lower midpoint on midsagittal line)					
On Centerline	<b>6</b>	<input type="checkbox"/>	mm right	<input checked="" type="checkbox"/>	mm left
On Centerline	<b>35</b>				mm up

Free Motion HIC	<b>797.6</b>
HIC(d)	<b>768.2</b>
Impact Velocity (kph)	<b>23.74</b>
HIC T1 (msec)	<b>5.0</b>
HIC T2 (msec)	<b>11.1</b>

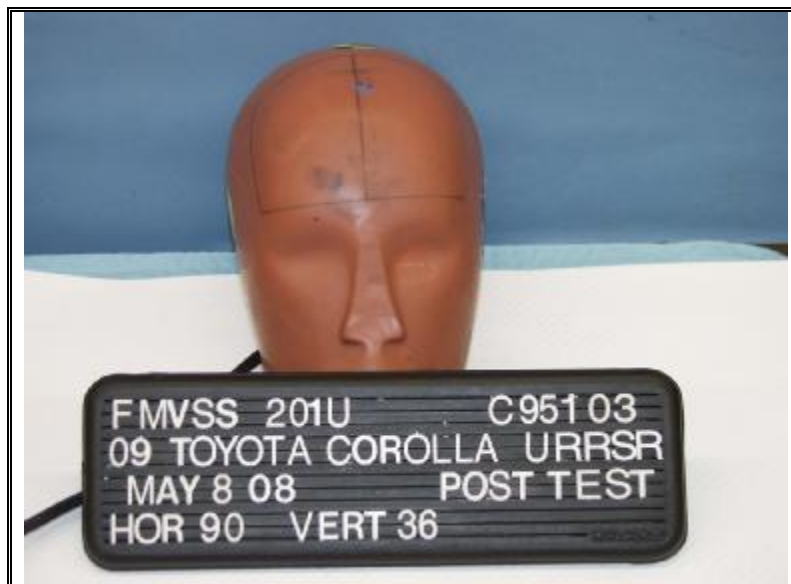
POST-IMPACT URRSR HEADFORM

Test Number:	03
Test Date:	<b>05/08/08</b>
Target Location:	UPPER ROOF
Target Code:	URRSR
Horizontal Impact Angle:	<b>90°</b>
Vertical Impact Angle:	<b>36°</b>
Ambient Temperature:	<b>20.5°C</b>
Relative Humidity:	<b>39.2</b>
Time of Impact:	<b>10:07</b>
Headform Number:	<b>0355</b>

Impact Point Description (from lower midpoint on midsagittal line)					
On Centerline	4	<input type="checkbox"/>	mm right	<input checked="" type="checkbox"/>	mm left
On Centerline	62				mm up

Free Motion HIC	592.5
HIC(d)	613.4
Impact Velocity (kph)	23.84
HIC T1 (msec)	3.8
HIC T2 (msec)	11.5

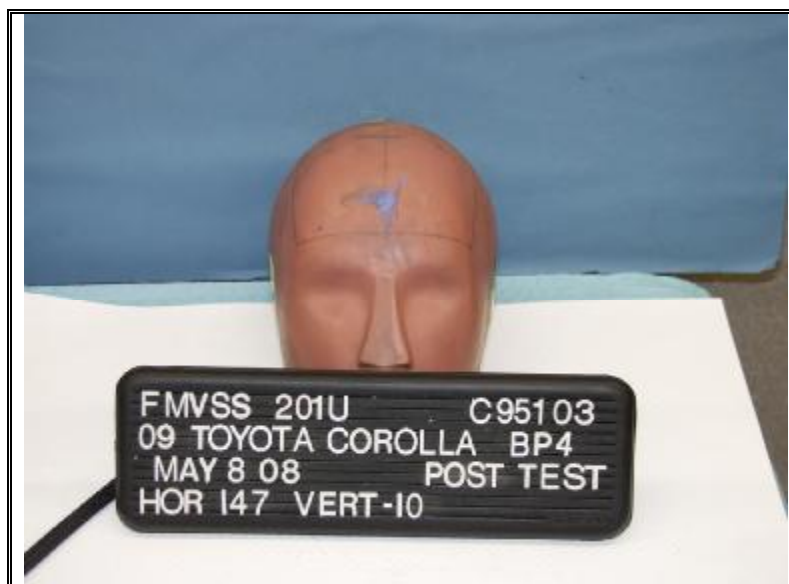
POST-IMPACT BP4 HEADFORM

Test Number:	04
Test Date:	<b>05/08/08</b>
Target Location:	B-PILLAR
Target Code:	BP4
Horizontal Impact Angle:	<b>147°</b>
Vertical Impact Angle:	<b>-10°</b>
Ambient Temperature:	<b>20.5°C</b>
Relative Humidity:	<b>38.3</b>
Time of Impact:	<b>10:50</b>
Headform Number:	<b>0805</b>

Impact Point Description (from lower midpoint on midsagittal line)					
On Centerline	<b>0</b>	<input type="checkbox"/>	mm right	<input type="checkbox"/>	mm left
On Centerline	<b>24</b>				mm up

Free Motion HIC	<b>297.6</b>
HIC(d)	<b>390.9</b>
Impact Velocity (kph)	<b>23.49</b>
HIC T1 (msec)	<b>1.3</b>
HIC T2 (msec)	<b>16.4</b>

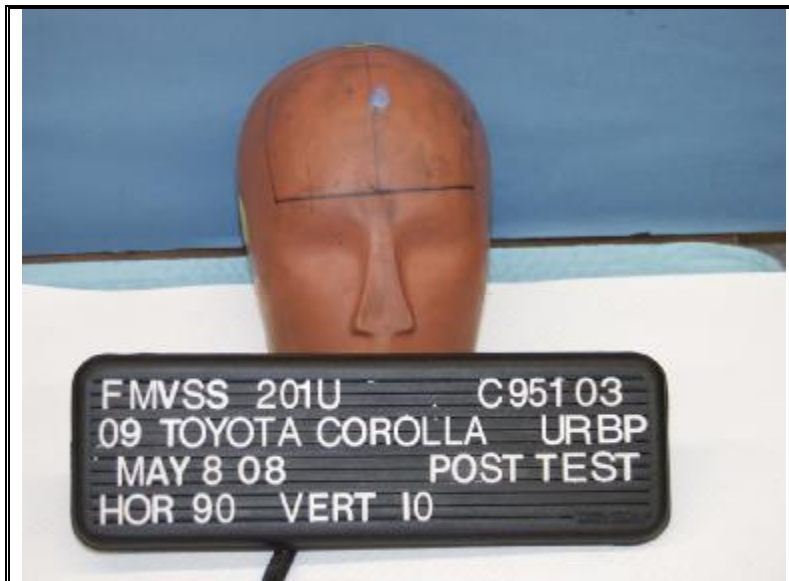
POST-IMPACT URBP HEADFORM (Vertical angle is 45 degrees)

Test Number:	05
Test Date:	05/08/08
Target Location:	UPPER ROOF
Target Code:	URBP
Horizontal Impact Angle:	90°
Vertical Impact Angle:	45°
Ambient Temperature:	20.5°C
Relative Humidity:	37.3
Time of Impact:	11:45
Headform Number:	0062

Impact Point Description (from lower midpoint on midsagittal line)			
On Centerline	4	<input type="checkbox"/>	mm right <input checked="" type="checkbox"/> mm left
On Centerline	51		mm up

Free Motion HIC	570.9
HIC(d)	597.1
Impact Velocity (kph)	23.67
HIC T1 (msec)	2.5
HIC T2 (msec)	12.8

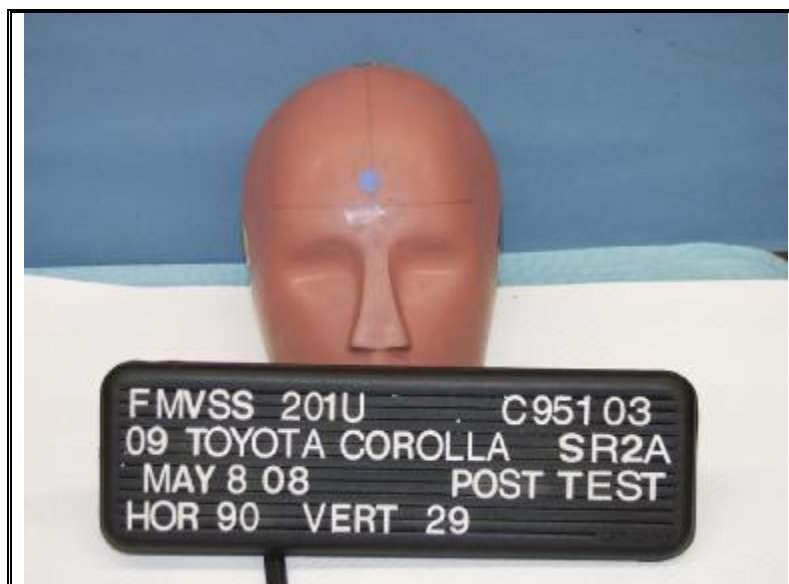
POST-IMPACT SR2A HEADFORM

Test Number:	06
Test Date:	05/08/08
Target Location:	SIDE RAIL
Target Code:	SR2A
Horizontal Impact Angle:	90°
Vertical Impact Angle:	29°
Ambient Temperature:	20.5°C
Relative Humidity:	36.4
Time of Impact:	13:00
Headform Number:	1142

Impact Point Description (from lower midpoint on midsagittal line)					
On Centerline	2	<input checked="" type="checkbox"/>	mm right	<input type="checkbox"/>	mm left
On Centerline	13				mm up

Free Motion HIC	280.2
HIC(d)	377.8
Impact Velocity (kph)	23.86
HIC T1 (msec)	1.3
HIC T2 (msec)	11.7

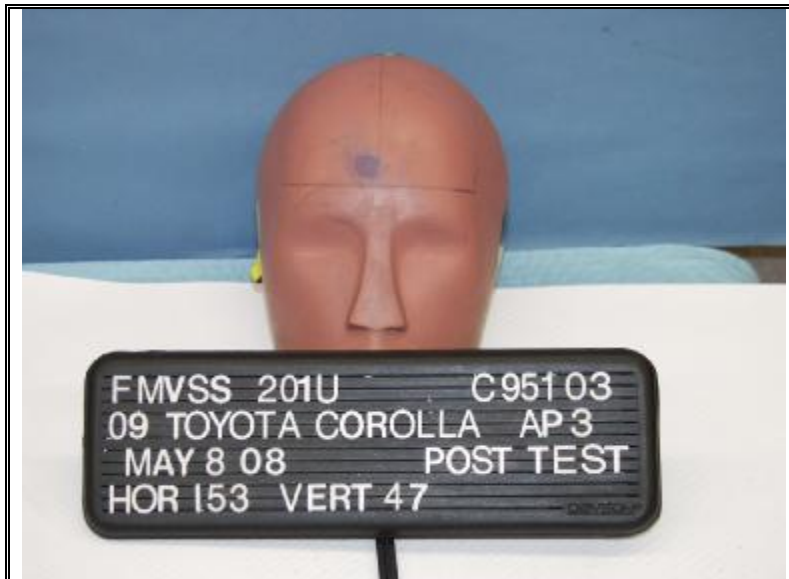
POST-IMPACT AP3 HEADFORM

Test Number:	07
Test Date:	<b>05/08/08</b>
Target Location:	A-PILLAR
Target Code:	AP3
Horizontal Impact Angle:	<b>153°</b>
Vertical Impact Angle:	<b>47°</b>
Ambient Temperature:	<b>20.5°C</b>
Relative Humidity:	<b>35.6</b>
Time of Impact:	<b>13:35</b>
Headform Number:	<b>1140</b>

Impact Point Description (from lower midpoint on midsagittal line)					
On Centerline	6	<input checked="" type="checkbox"/>	mm right	<input type="checkbox"/>	mm left
On Centerline	10				mm up

Free Motion HIC	971.7
HIC(d)	899.5
Impact Velocity (kph)	23.73
HIC T1 (msec)	6.7
HIC T2 (msec)	11.2

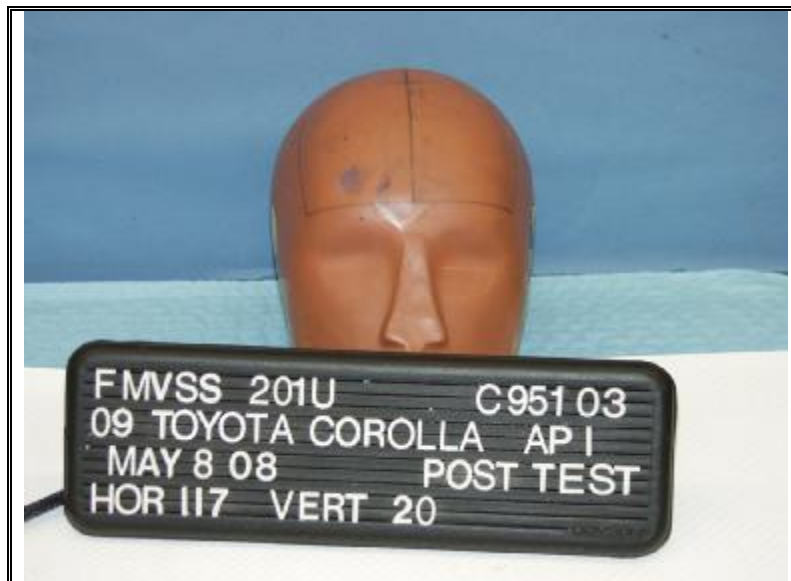
POST-IMPACT AP1 HEADFORM

Test Number:	08
Test Date:	<b>05/08/08</b>
Target Location:	A-PILLAR
Target Code:	AP1
Horizontal Impact Angle:	<b>117°</b>
Vertical Impact Angle:	<b>20°</b>
Ambient Temperature:	<b>20.5°C</b>
Relative Humidity:	<b>35.0</b>
Time of Impact:	<b>14:19</b>
Headform Number:	<b>355</b>

Impact Point Description (from lower midpoint on midsagittal line)					
On Centerline	<b>34</b>	<input checked="" type="checkbox"/>	mm right	<input type="checkbox"/>	mm left
On Centerline	<b>14</b>				mm up

Free Motion HIC	<b>239.0</b>
HIC(d)	<b>346.8</b>
Impact Velocity (kph)	<b>18.47</b>
HIC T1 (msec)	<b>7.4</b>
HIC T2 (msec)	<b>13.6</b>

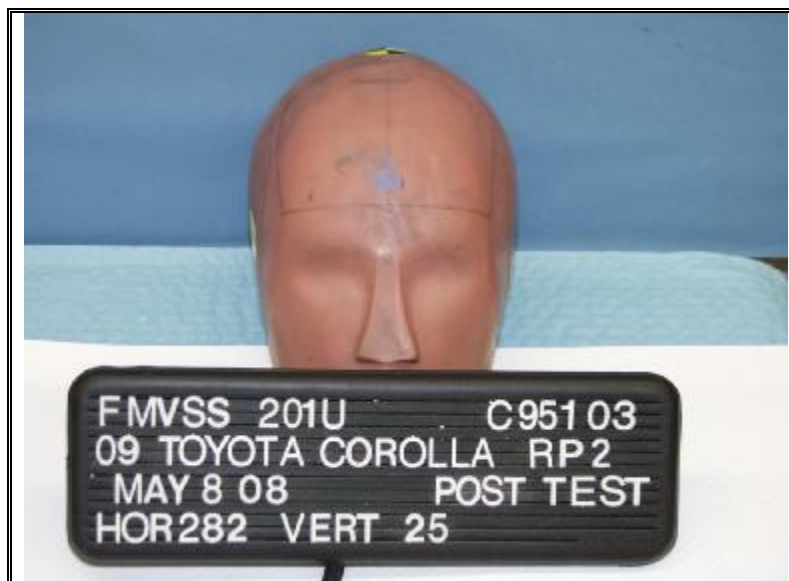
POST-IMPACT RP2 HEADFORM

Test Number:	09
Test Date:	05/08/08
Target Location:	REAR PILLAR
Target Code:	RP2
Horizontal Impact Angle:	282°
Vertical Impact Angle:	25°
Ambient Temperature:	20.5°C
Relative Humidity:	35
Time of Impact:	15:45
Headform Number:	0805

Impact Point Description (from lower midpoint on midsagittal line)					
On Centerline	0	<input type="checkbox"/>	mm right	<input type="checkbox"/>	mm left
On Centerline	16				mm up

Free Motion HIC	881.7
HIC(d)	831.6
Impact Velocity (kph)	23.74
HIC T1 (msec)	3.7
HIC T2 (msec)	10.1

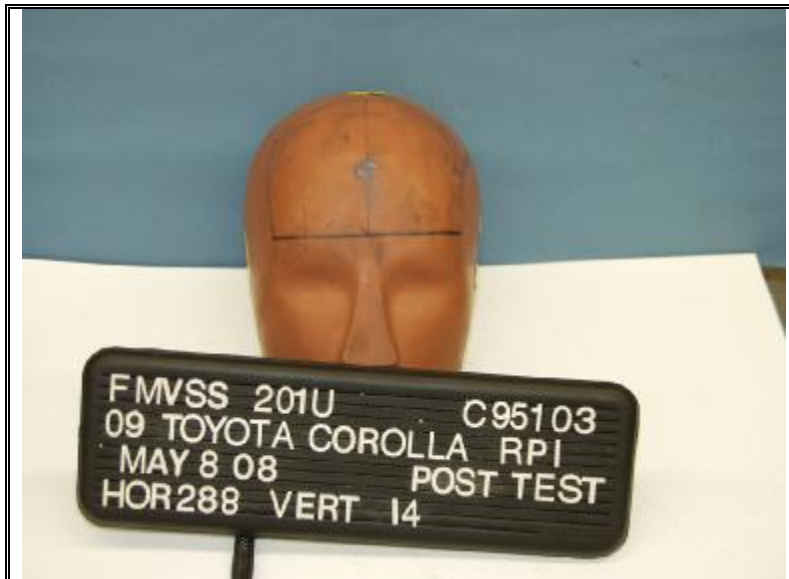
POST-IMPACT Driv. RP1 HEADFORM

Test Number:	10
Test Date:	05/08/08
Target Location:	REAR PILLAR
Target Code:	Driv. RP1
Horizontal Impact Angle:	288°
Vertical Impact Angle:	14°
Ambient Temperature:	20.5°C
Relative Humidity:	35.7
Time of Impact:	16:20
Headform Number:	0062

Impact Point Description (from lower midpoint on midsagittal line)					
On Centerline	0	<input type="checkbox"/>	mm right	<input type="checkbox"/>	mm left
On Centerline	35				mm up

Free Motion HIC	218.7
HIC(d)	331.4
Impact Velocity (kph)	18.55
HIC T1 (msec)	4.5
HIC T2 (msec)	14.7

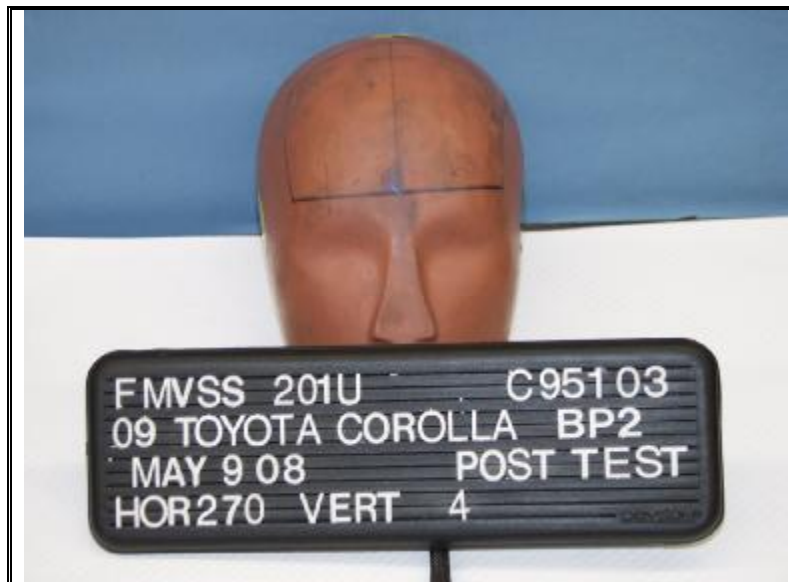
POST-IMPACT BP2HEADFORM

Test Number:	11
Test Date:	05/09/08
Target Location:	B-PILLAR
Target Code:	BP2
Horizontal Impact Angle:	270°
Vertical Impact Angle:	4°
Ambient Temperature:	20.0°C
Relative Humidity:	35.0
Time of Impact:	8:46
Headform Number:	0062

Impact Point Description (from lower midpoint on midsagittal line)					
On Centerline	3	<input checked="" type="checkbox"/>	mm right	<input type="checkbox"/>	mm left
On Centerline	5				mm up

Free Motion HIC	570.7
HIC(d)	597.0
Impact Velocity (kph)	23.61
HIC T1 (msec)	1.7
HIC T2 (msec)	10.8

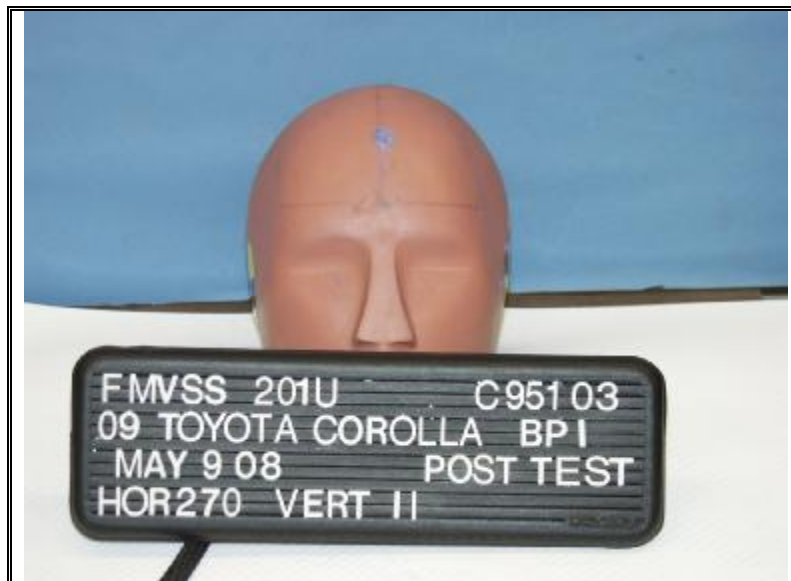
POST-IMPACT BP1 HEADFORM

Test Number:	12
Test Date:	<b>05/09/08</b>
Target Location:	<b>B-PILLAR</b>
Target Code:	BP1
Horizontal Impact Angle:	<b>270°</b>
Vertical Impact Angle:	<b>11°</b>
Ambient Temperature:	<b>20.0°C</b>
Relative Humidity:	<b>35.5</b>
Time of Impact:	<b>9:18</b>
Headform Number:	<b>1142</b>

Impact Point Description (from lower midpoint on midsagittal line)					
On Centerline	3	<input checked="" type="checkbox"/>	mm right	<input type="checkbox"/>	mm left
On Centerline	38				mm up

Free Motion HIC	<b>225.8</b>
HIC(d)	<b>336.8</b>
Impact Velocity (kph)	<b>18.88</b>
HIC T1 (msec)	7.3
HIC T2 (msec)	15.6

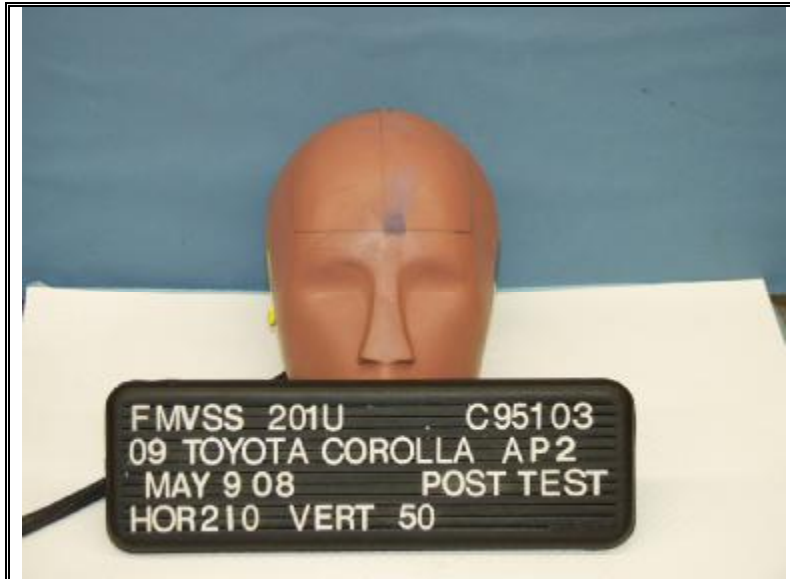
POST-IMPACT AP2 HEADFORM

Test Number:	13
Test Date:	05/09/08
Target Location:	A-PILLAR
Target Code:	AP2
Horizontal Impact Angle:	210°
Vertical Impact Angle:	50°
Ambient Temperature:	20.0°C
Relative Humidity:	35.7
Time of Impact:	10:00
Headform Number:	1140

Impact Point Description (from lower midpoint on midsagittal line)			
On Centerline	4	<input type="checkbox"/>	mm right <input checked="" type="checkbox"/> mm left
On Centerline	4		mm up

Free Motion HIC	250.7
HIC(d)	355.6
Impact Velocity (kph)	18.41
HIC T1 (msec)	9.5
HIC T2 (msec)	15.1
