REPORT NUMBER: 201UI-CAL-09-05

**SAFETY COMPLIANCE TESTING FOR FMVSS 201
OCCUPANT PROTECTION IN INTERIOR IMPACT
UPPER INTERIOR HEAD IMPACT PROTECTION**

**NISSAN MOTOR COMPANY, LTD.
2009 NISSAN SENTRA**

NHTSA NUMBER: C95206

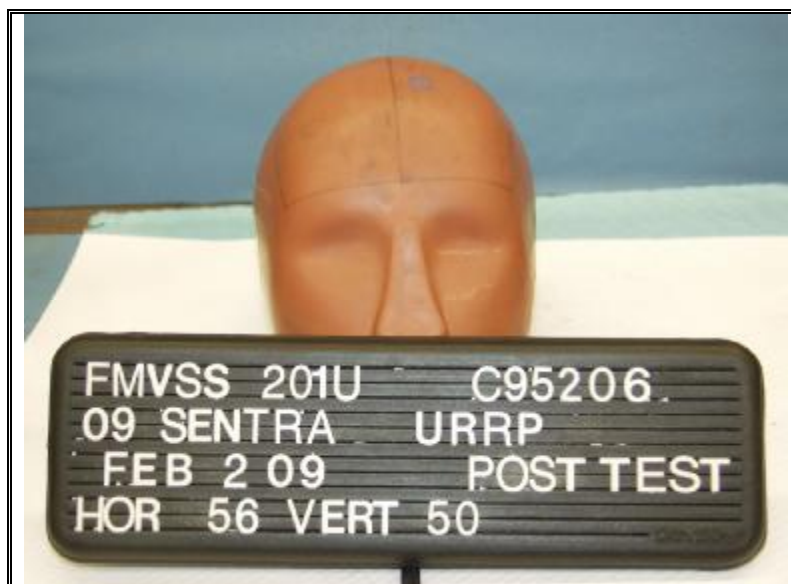
POST-IMPACT URRP HEADFORM

Test Number:	03
Test Date:	02/02/09
Target Location:	UPPER ROOF
Target Code:	URRP
Horizontal Impact Angle:	56°
Vertical Impact Angle:	50°
Ambient Temperature:	20°C
Relative Humidity:	23
Time of Impact:	9:50
Headform Number:	0355

Impact Point Description (from lower midpoint on midsagittal line)			
On Centerline	11	<input type="checkbox"/>	mm right <input checked="" type="checkbox"/> mm left
On Centerline	46		mm up

Free Motion HIC	495.8
HIC(d)	540.5
Impact Velocity (kph)	23.74
HIC T1 (msec)	6.0
HIC T2 (msec)	13.3

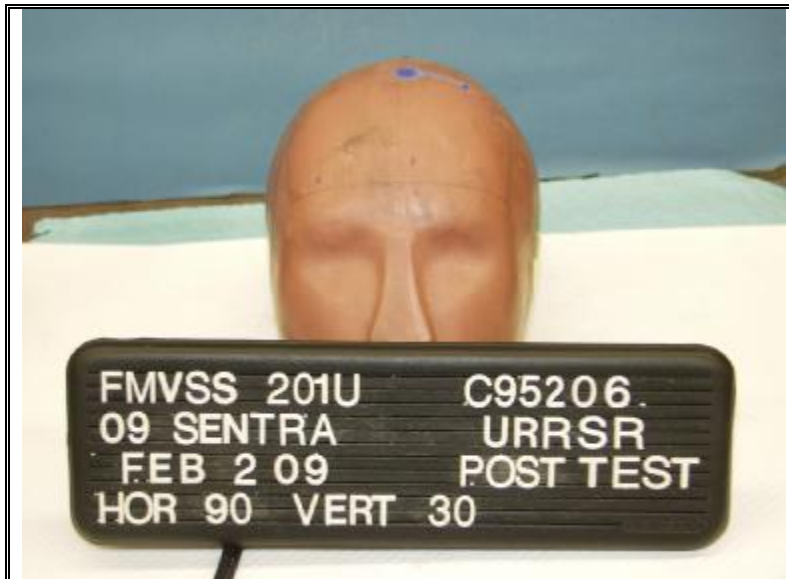
POST-IMPACT URRSR HEADFORM

Test Number:	05
Test Date:	02/02/09
Target Location:	UPPER ROOF
Target Code:	URRSR
Horizontal Impact Angle:	90°
Vertical Impact Angle:	30°
Ambient Temperature:	20°C
Relative Humidity:	23
Time of Impact:	11:15
Headform Number:	0805

Impact Point Description (from lower midpoint on midsagittal line)					
On Centerline	4	<input type="checkbox"/>	mm right	<input checked="" type="checkbox"/>	mm left
On Centerline	75				mm up

Free Motion HIC	849.7
HIC(d)	807.4
Impact Velocity (kph)	23.63
HIC T1 (msec)	4.5
HIC T2 (msec)	11.5

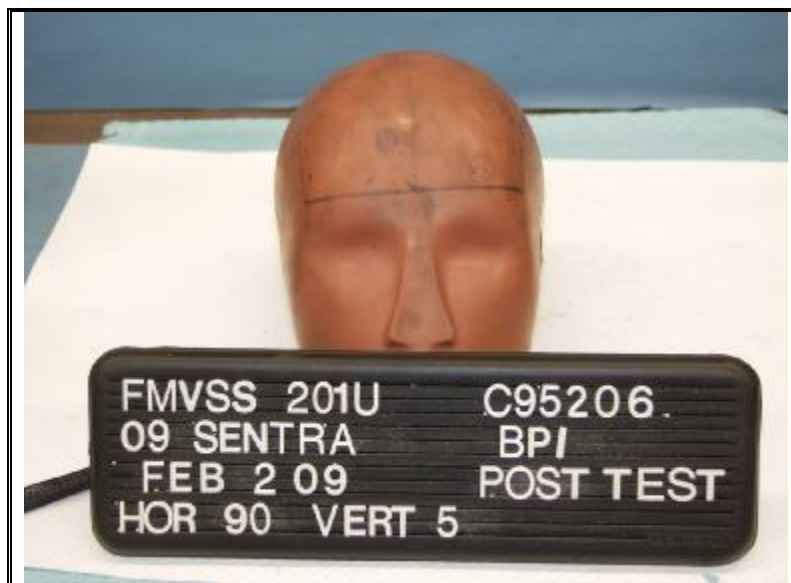
POST-IMPACT BP1 HEADFORM

Test Number:	06
Test Date:	02/02/09
Target Location:	B-PILLAR
Target Code:	BP1
Horizontal Impact Angle:	90°
Vertical Impact Angle:	5°
Ambient Temperature:	20°C
Relative Humidity:	23
Time of Impact:	12:00
Headform Number:	0062

Impact Point Description (from lower midpoint on midsagittal line)					
On Centerline	13	<input checked="" type="checkbox"/>	mm right	<input type="checkbox"/>	mm left
On Centerline	25				mm up

Free Motion HIC	368.4
HIC(d)	444.3
Impact Velocity (kph)	18.5
HIC T1 (msec)	3.5
HIC T2 (msec)	11.6

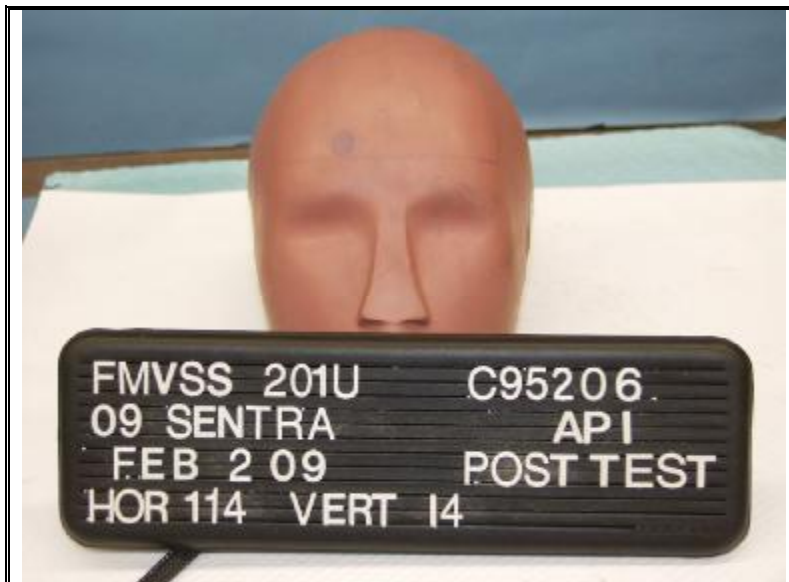
POST-IMPACT AP1 HEADFORM

Test Number:	09
Test Date:	02/02/09
Target Location:	A-PILLAR
Target Code:	AP1
Horizontal Impact Angle:	114°
Vertical Impact Angle:	14°
Ambient Temperature:	20°C
Relative Humidity:	23
Time of Impact:	14:40
Headform Number:	1140

Impact Point Description (from lower midpoint on midsagittal line)					
On Centerline	23	<input checked="" type="checkbox"/>	mm right	<input type="checkbox"/>	mm left
On Centerline	6				mm up

Free Motion HIC	209.8
HIC(d)	324.7
Impact Velocity (kph)	18.37
HIC T1 (msec)	4.4
HIC T2 (msec)	9.9
