REPORT NUMBER: 305-CAL-08-05

**SAFETY COMPLIANCE TESTING FOR FMVSS 305
ELECTRIC POWERED VEHICLES: ELECTROLYTE SPILLAGE
AND ELECTRICAL SHOCK PROTECTION**

FORD MOTOR COMPANY
2010 FORD FUSION HYBRID
4-DOOR SEDAN

NHTSA NUMBER: CA0200

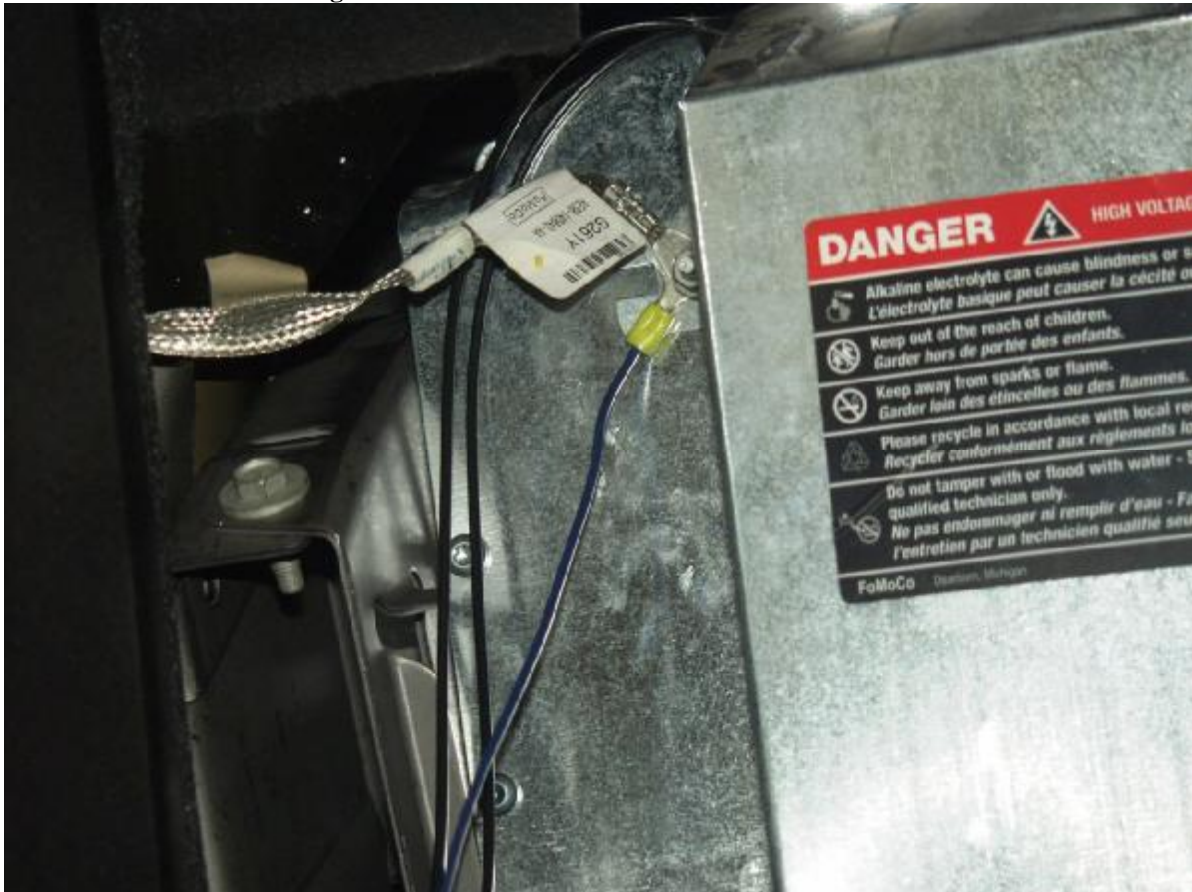
Figure A-6: Pre-Test Chassis Ground Point View

By removing the rear seat, located behind the seats trim panel located between the rear door opening and rear seat, a Grounding weld nut is found.

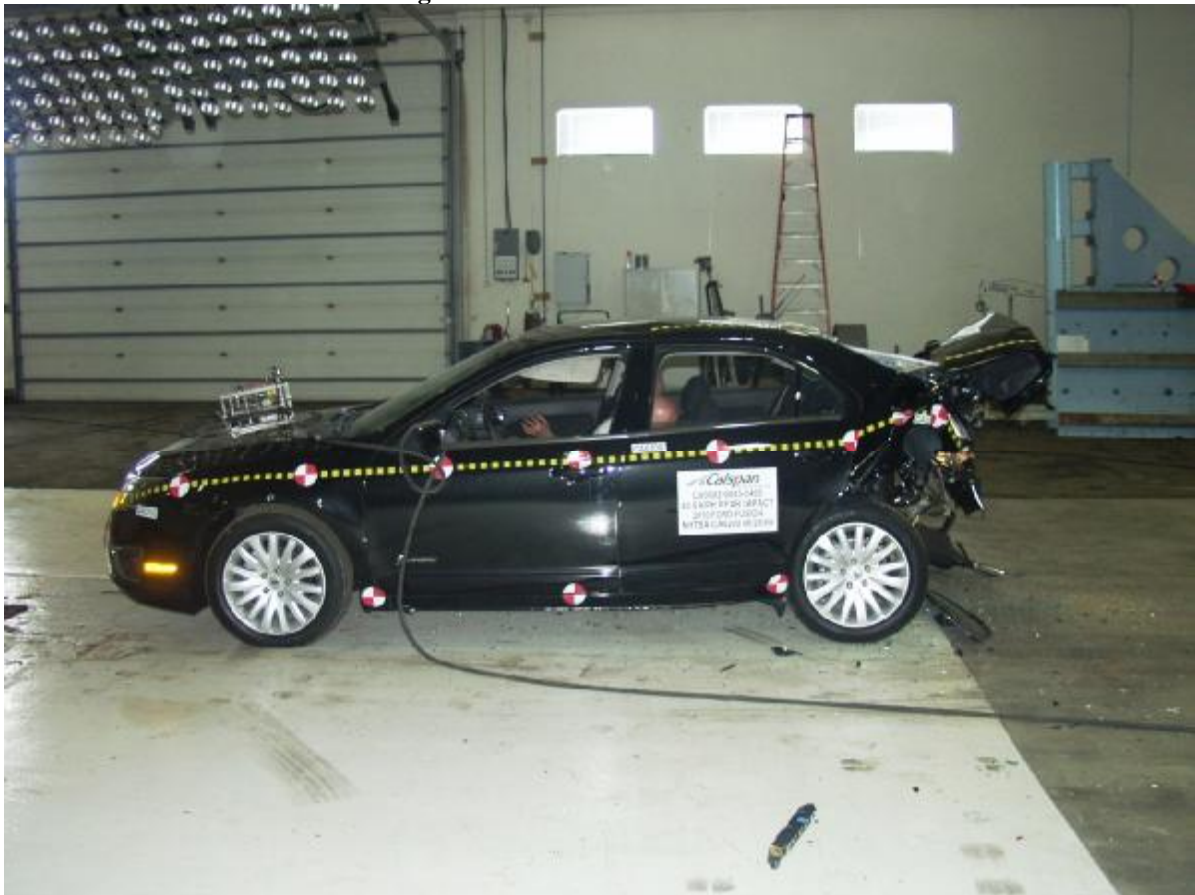
Figure A-10: Post-Test Left Side View

Left Side	Centerline	Right Side
Pre-Test	4715	4846	4715
Post-Test	4023	4125	4226
Crush	692	721	489

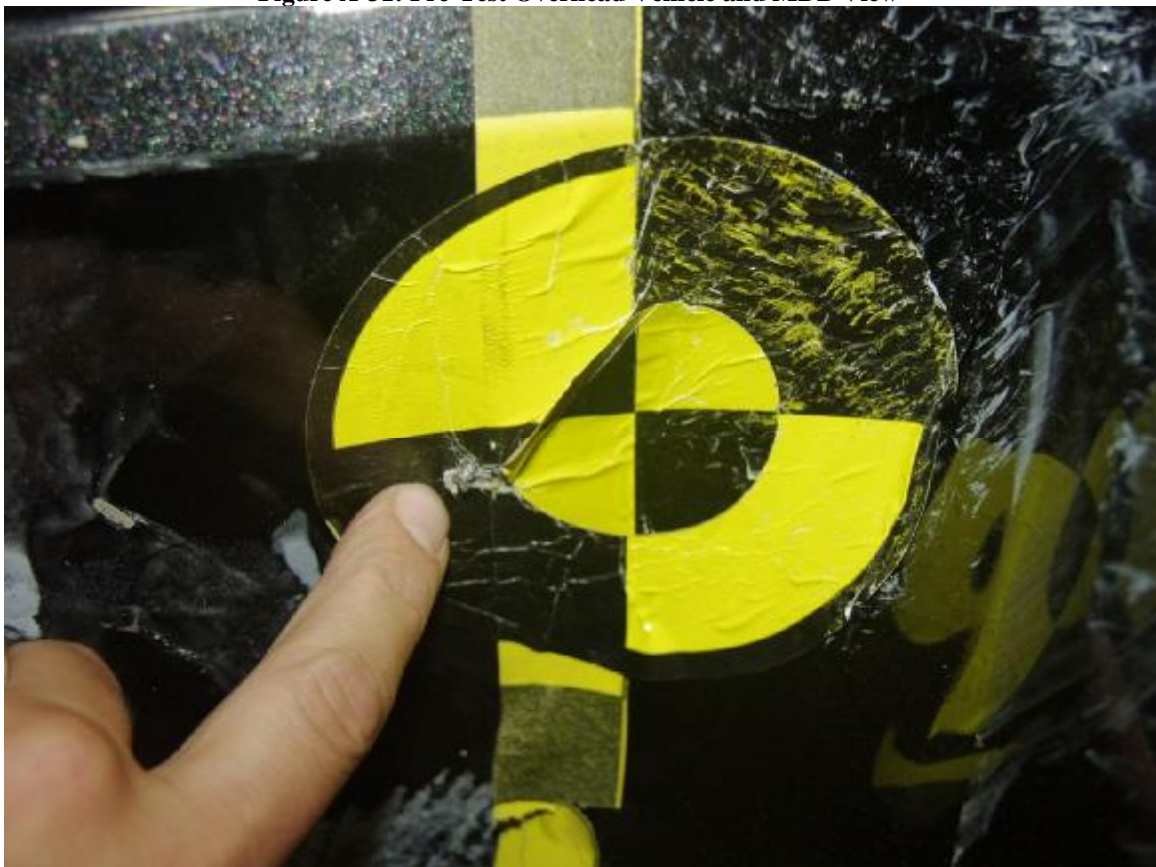
Figure A-32: Post-Test Impact Target View

-10 Vertical distance from target center (+ is above) Tolerance: ±40 mm

-30 Horizontal distance from target center (+ is right) Tolerance: ±50 mm

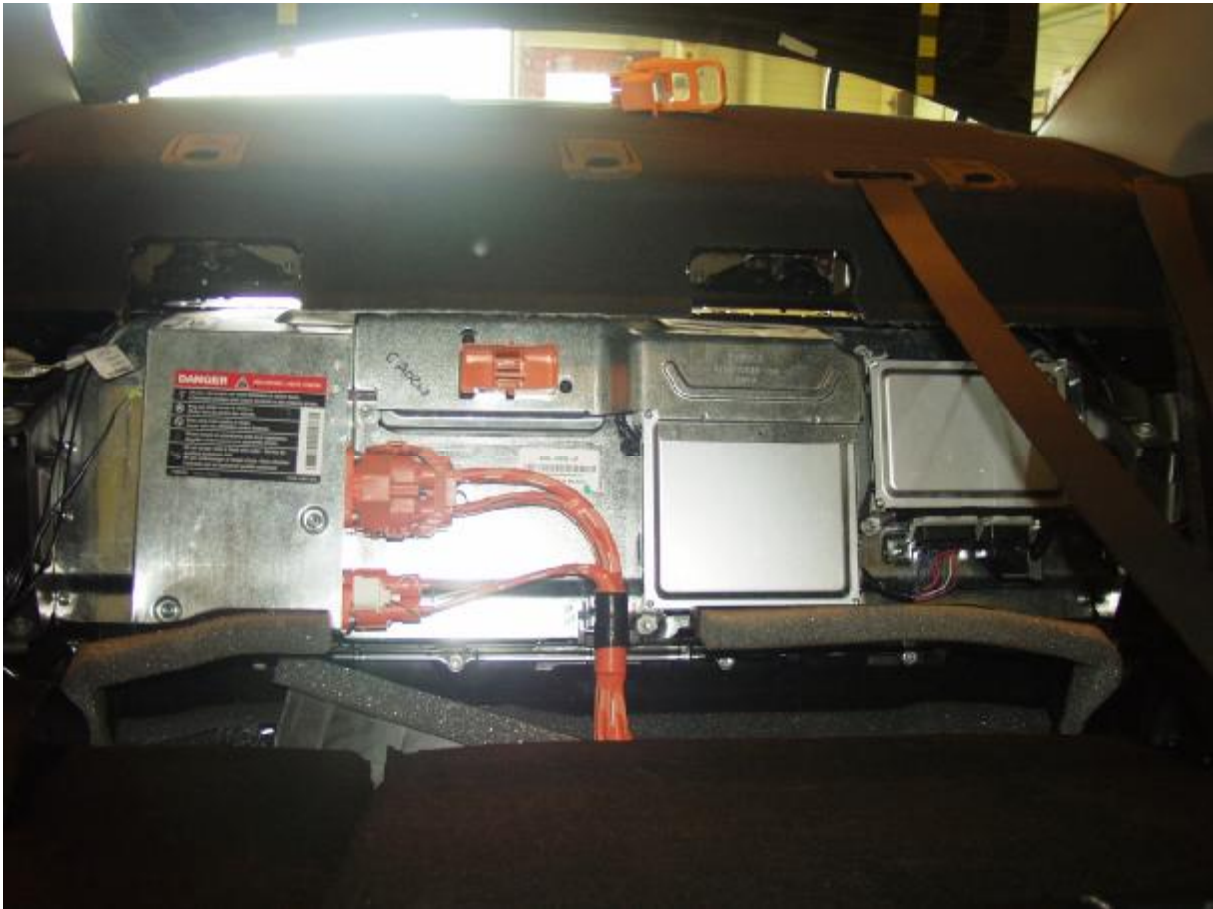
Figure A-33: Pre-Test Battery Propulsion Module(S) View

The main battery is located behind the rear passenger seat. Propulsion unit located in engine compartment.

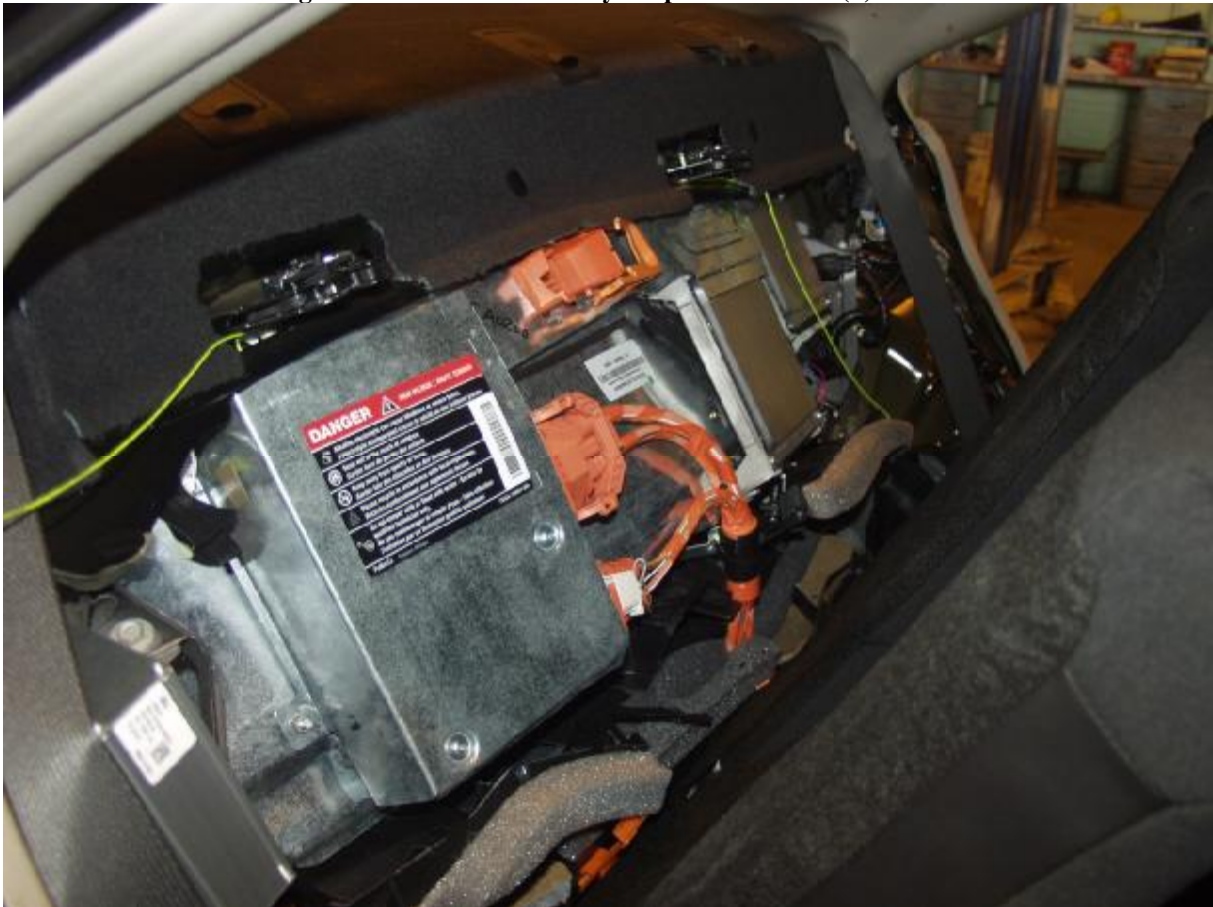
Figure A-34: Post-Test Battery Propulsion Module(S) View

Describe Propulsion Battery Module movement within occupant compartment:

None

Has the Propulsion Battery Module moved within the occupant compartment? - Yes(Fail) X No

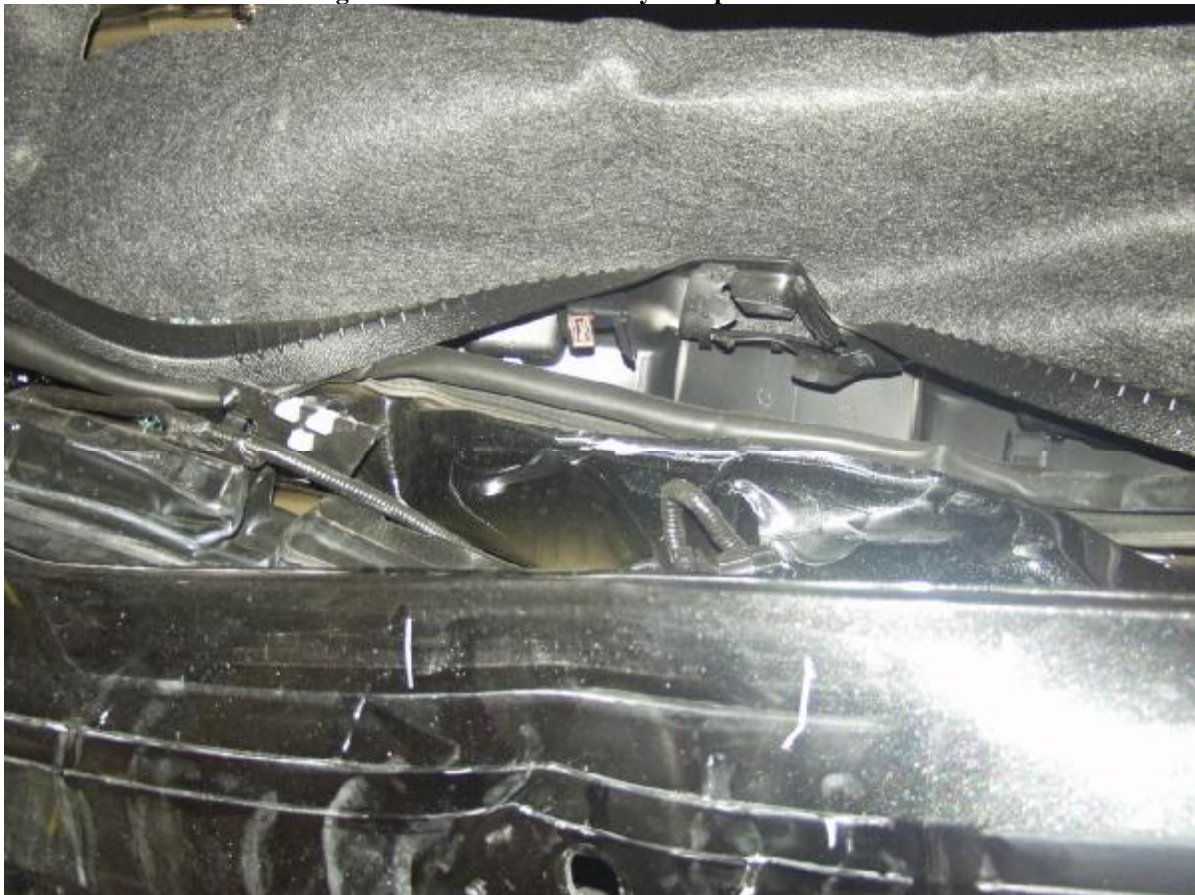
Figure A-40: Post-Test Battery Compartment View

Is Propulsion Battery electrolyte spillage visible in the occupant compartment? - Yes(Fail) X No

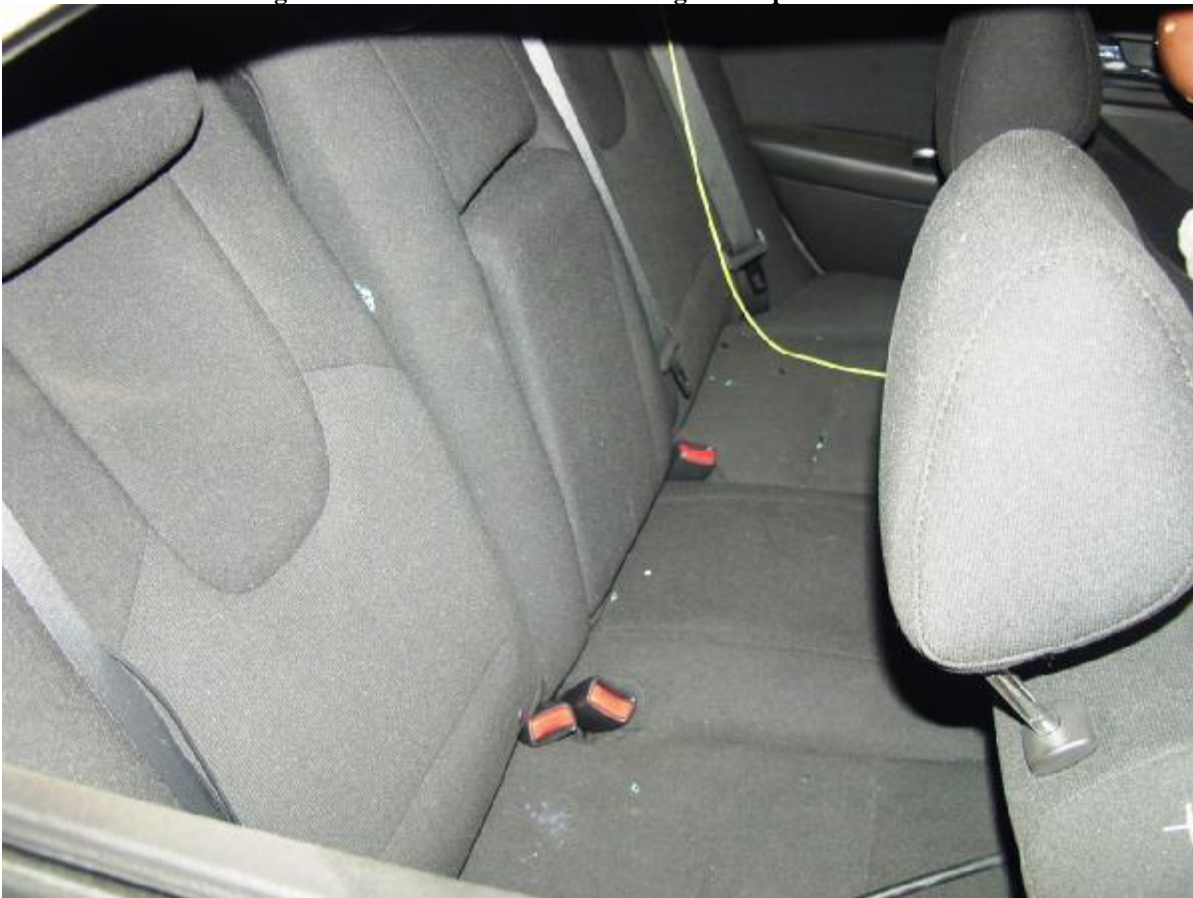
Figure A-48: Post-Test Vehicle Passenger Compartment View

LOCATION	SEAT MOVEMENT (mm)	SEAT BACK FAILURE
P1 (Left Front)	46 rearward	None – Reclined during impact
P2 (Right Front)	0	None – Reclined during impact

LOCATION	Position 1 (Driver)	Position 2 (Passenger)
Head	Rear of head to head restraint	Rear of head to head restraint
Chest	No Contact	No Contact
Abdomen	No Contact	No Contact
Left Knee	No Contact	No Contact
Right Knee	No Contact	No Contact

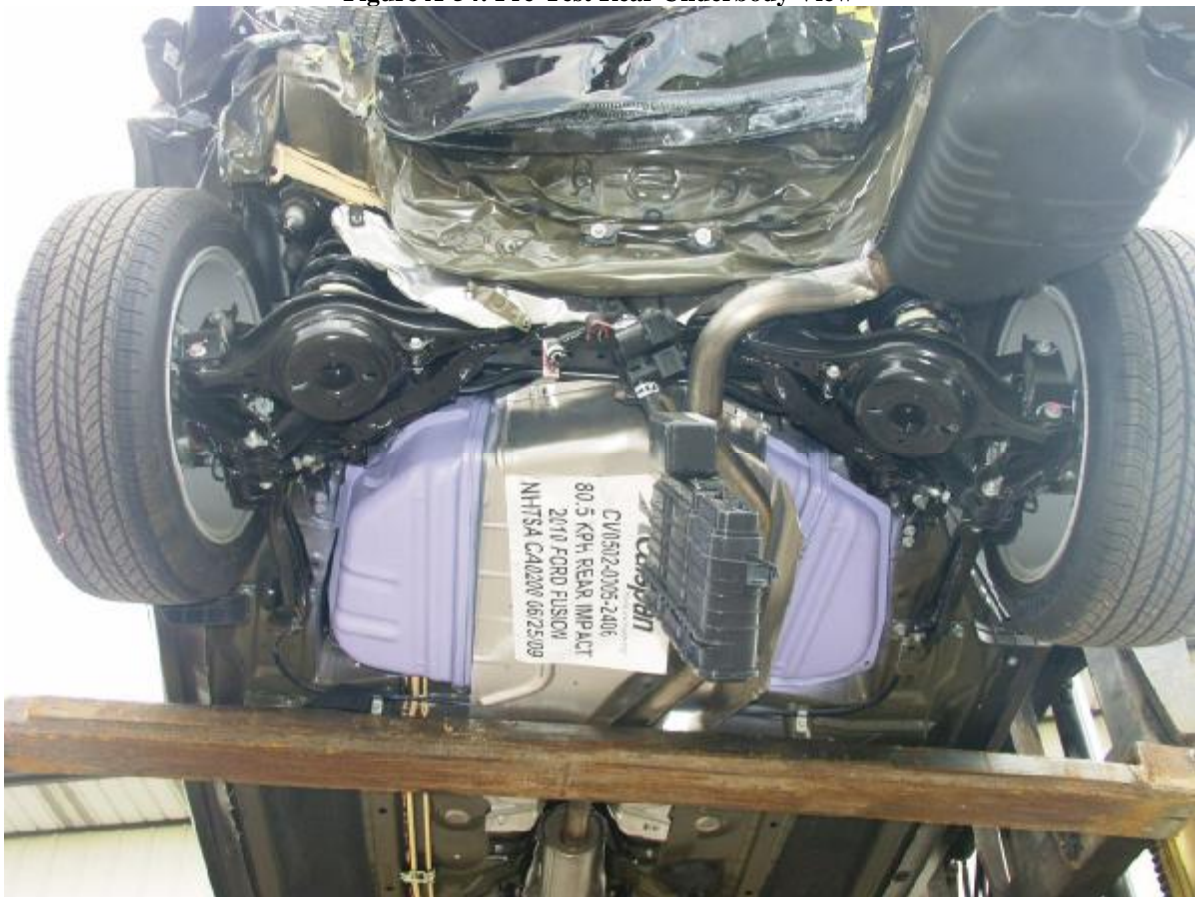
Figure A-55: Post-Test Rear Underbody View

A. Front impact until vehicle motion ceases -

Actual = 0 g Maximum Allowable = 28 g

B. For 5 minute period after vehicle motion ceases -

None

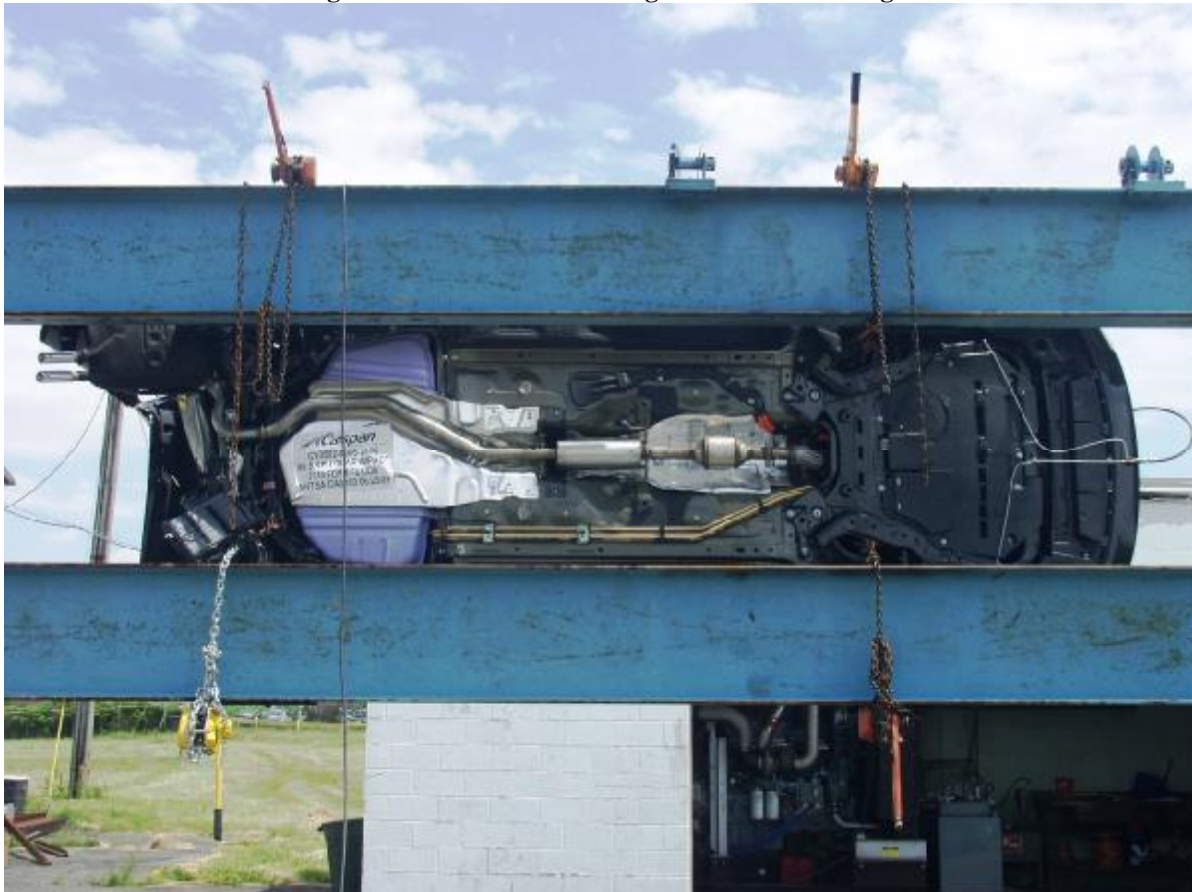
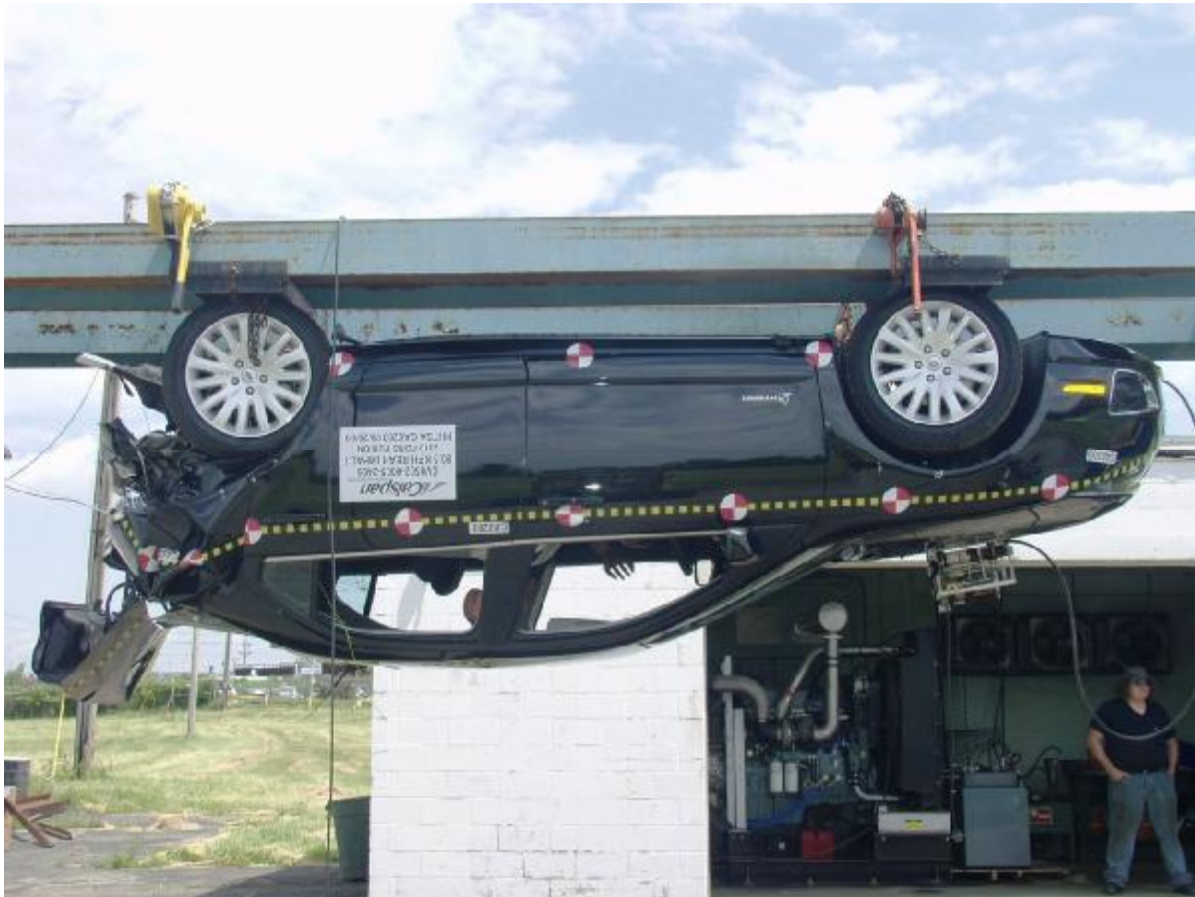
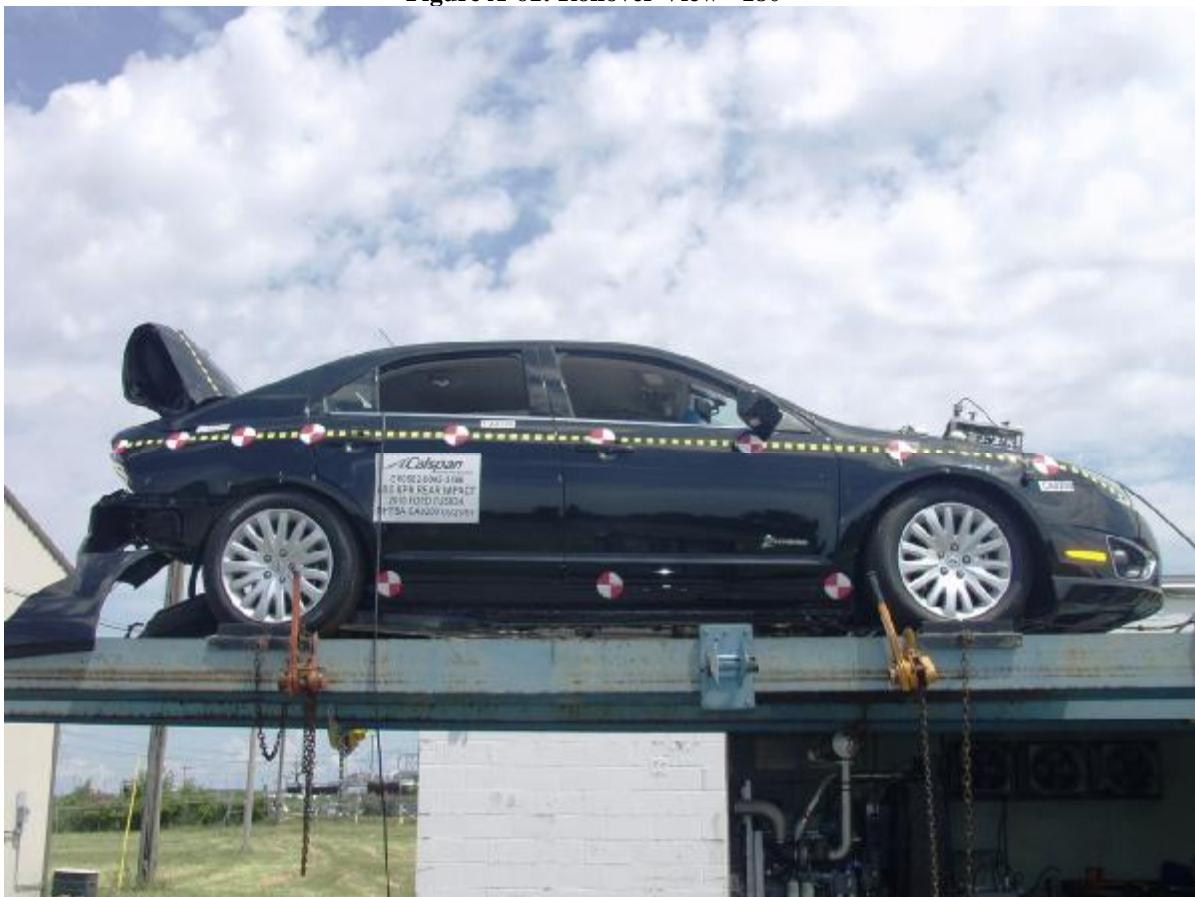
Rollover Stage	Spillage Location
0° - 90°	None
90° - 180°	None
180°-270°	None
270°-360°	None

Rollover Stage	Propulsion Battery Electrolyte Spillage (L)	Spillage Location
0-90°	0	None
90-180°	0	None
180-270°	0	None
270-360°	0	None

Total Spillage: 0 L
