REPORT NUMBER TR-P29009-04-NC

**SAFETY COMPLIANCE TESTING FOR FMVSS 124
ACCELERATOR CONTROL SYSTEMS**

**KIA MOTORS CORPORATION
2009 KIA RONDO
5-DOOR MPV**

NHTSA NUMBER: C90505

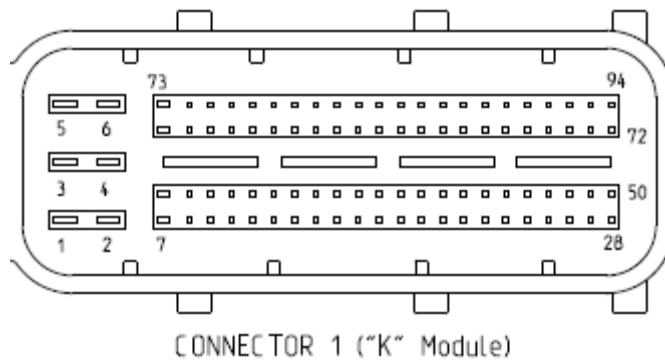
1. THROTTLE POSITION SENSOR CONNECTOR PIN ARRANGEMENT

- K80(6); Throttle position sensor 1
- K63(2); TPS supply voltage (5V)
- K59(3); TPS GROUND
- K32(5); Throttle position sensor 2
- K71(1); Electric throttle control DC motor 1
- K72(4); Electric throttle control DC motor 2

CONNECTOR 1 ("K" Module)
