REPORT NUMBER: 201UI-CAL-09-06

**SAFETY COMPLIANCE TESTING FOR FMVSS 201
OCCUPANT PROTECTION IN INTERIOR IMPACT
UPPER INTERIOR HEAD IMPACT PROTECTION**

**FORD MOTOR CO.
2009 FORD F150**

NHTSA NUMBER: C90206

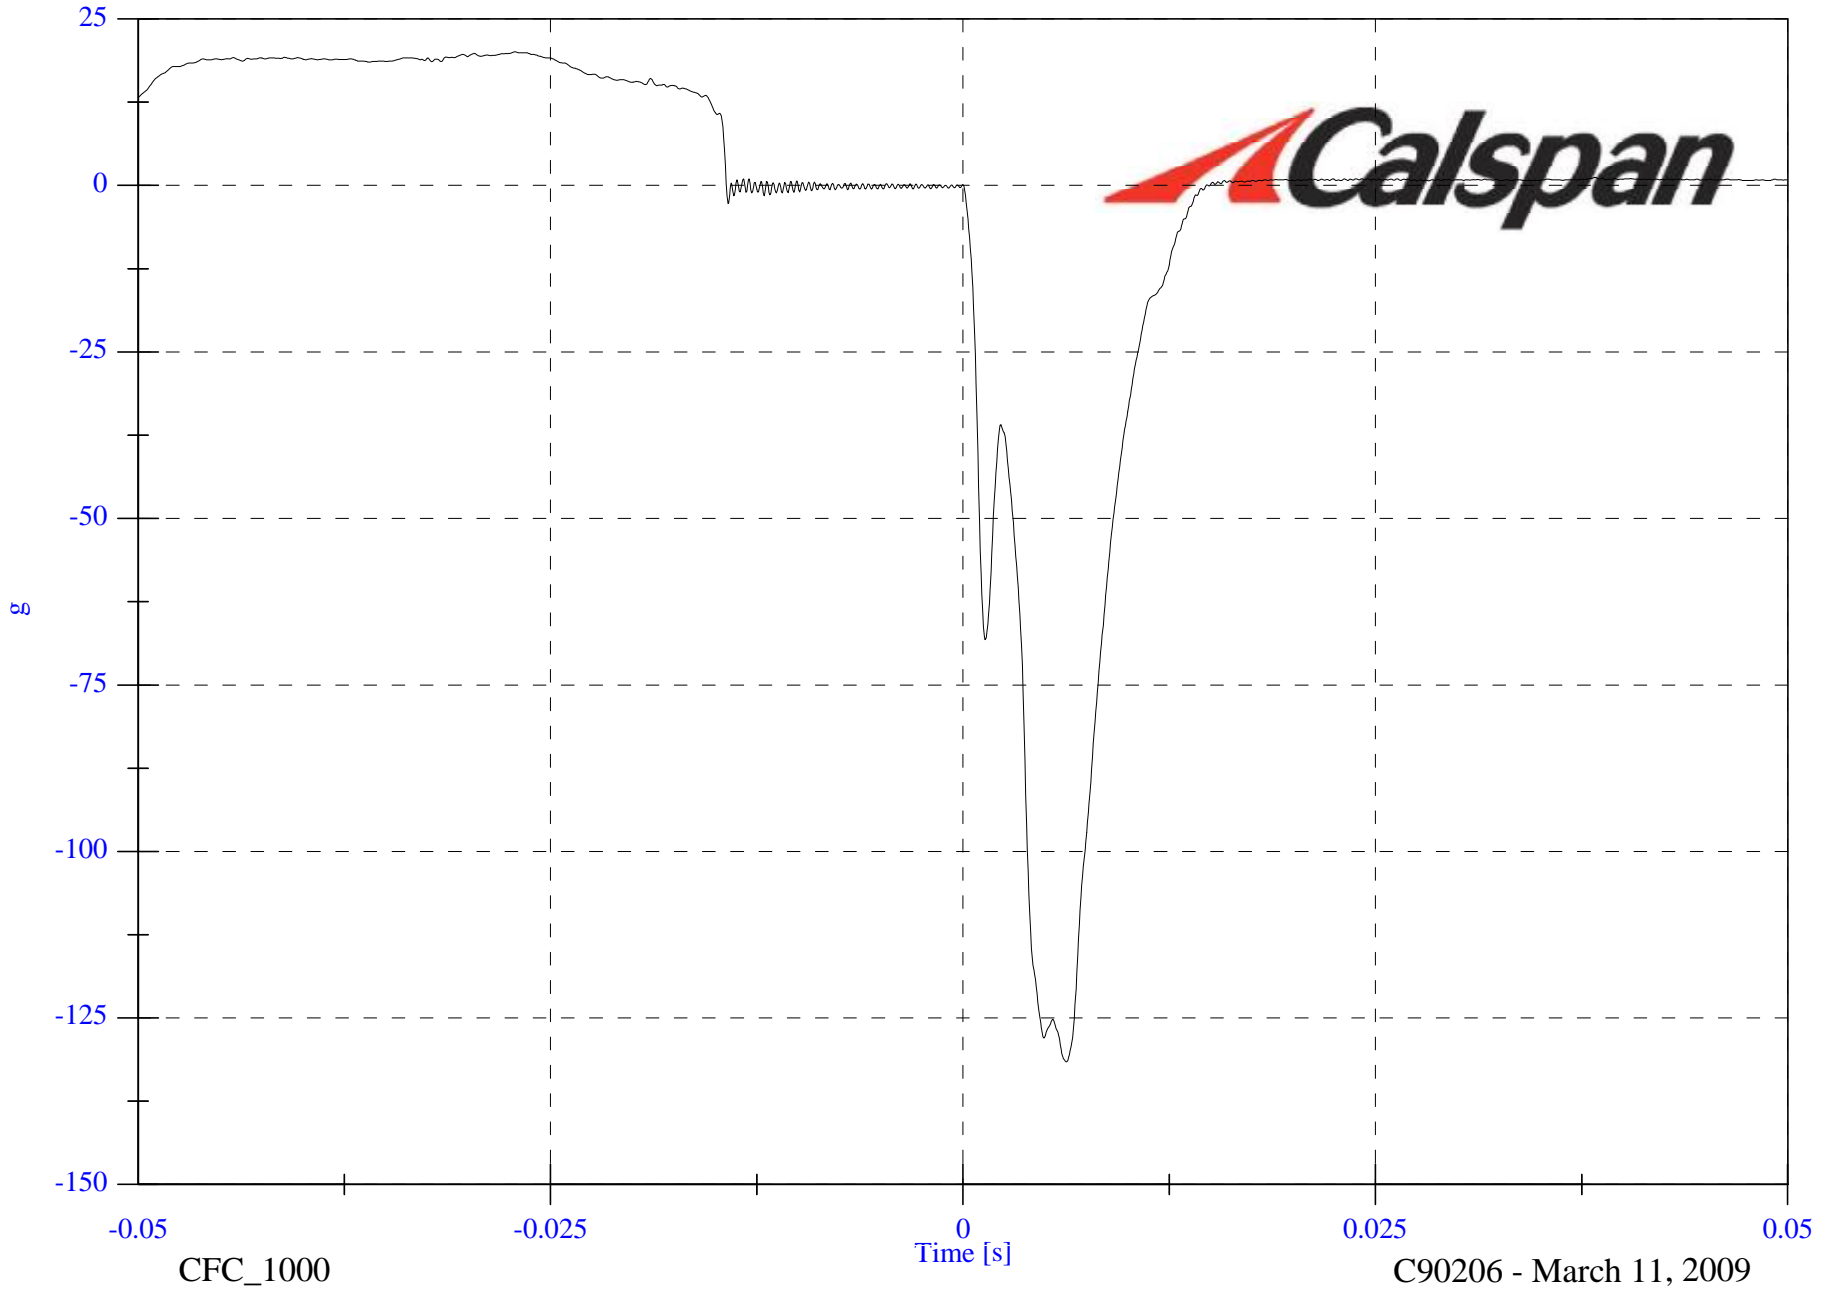
C90206 PASSENGER SIDE RP2 IMPACT PLOT #1

Min: -131.6 [g] at 0.006 [s]

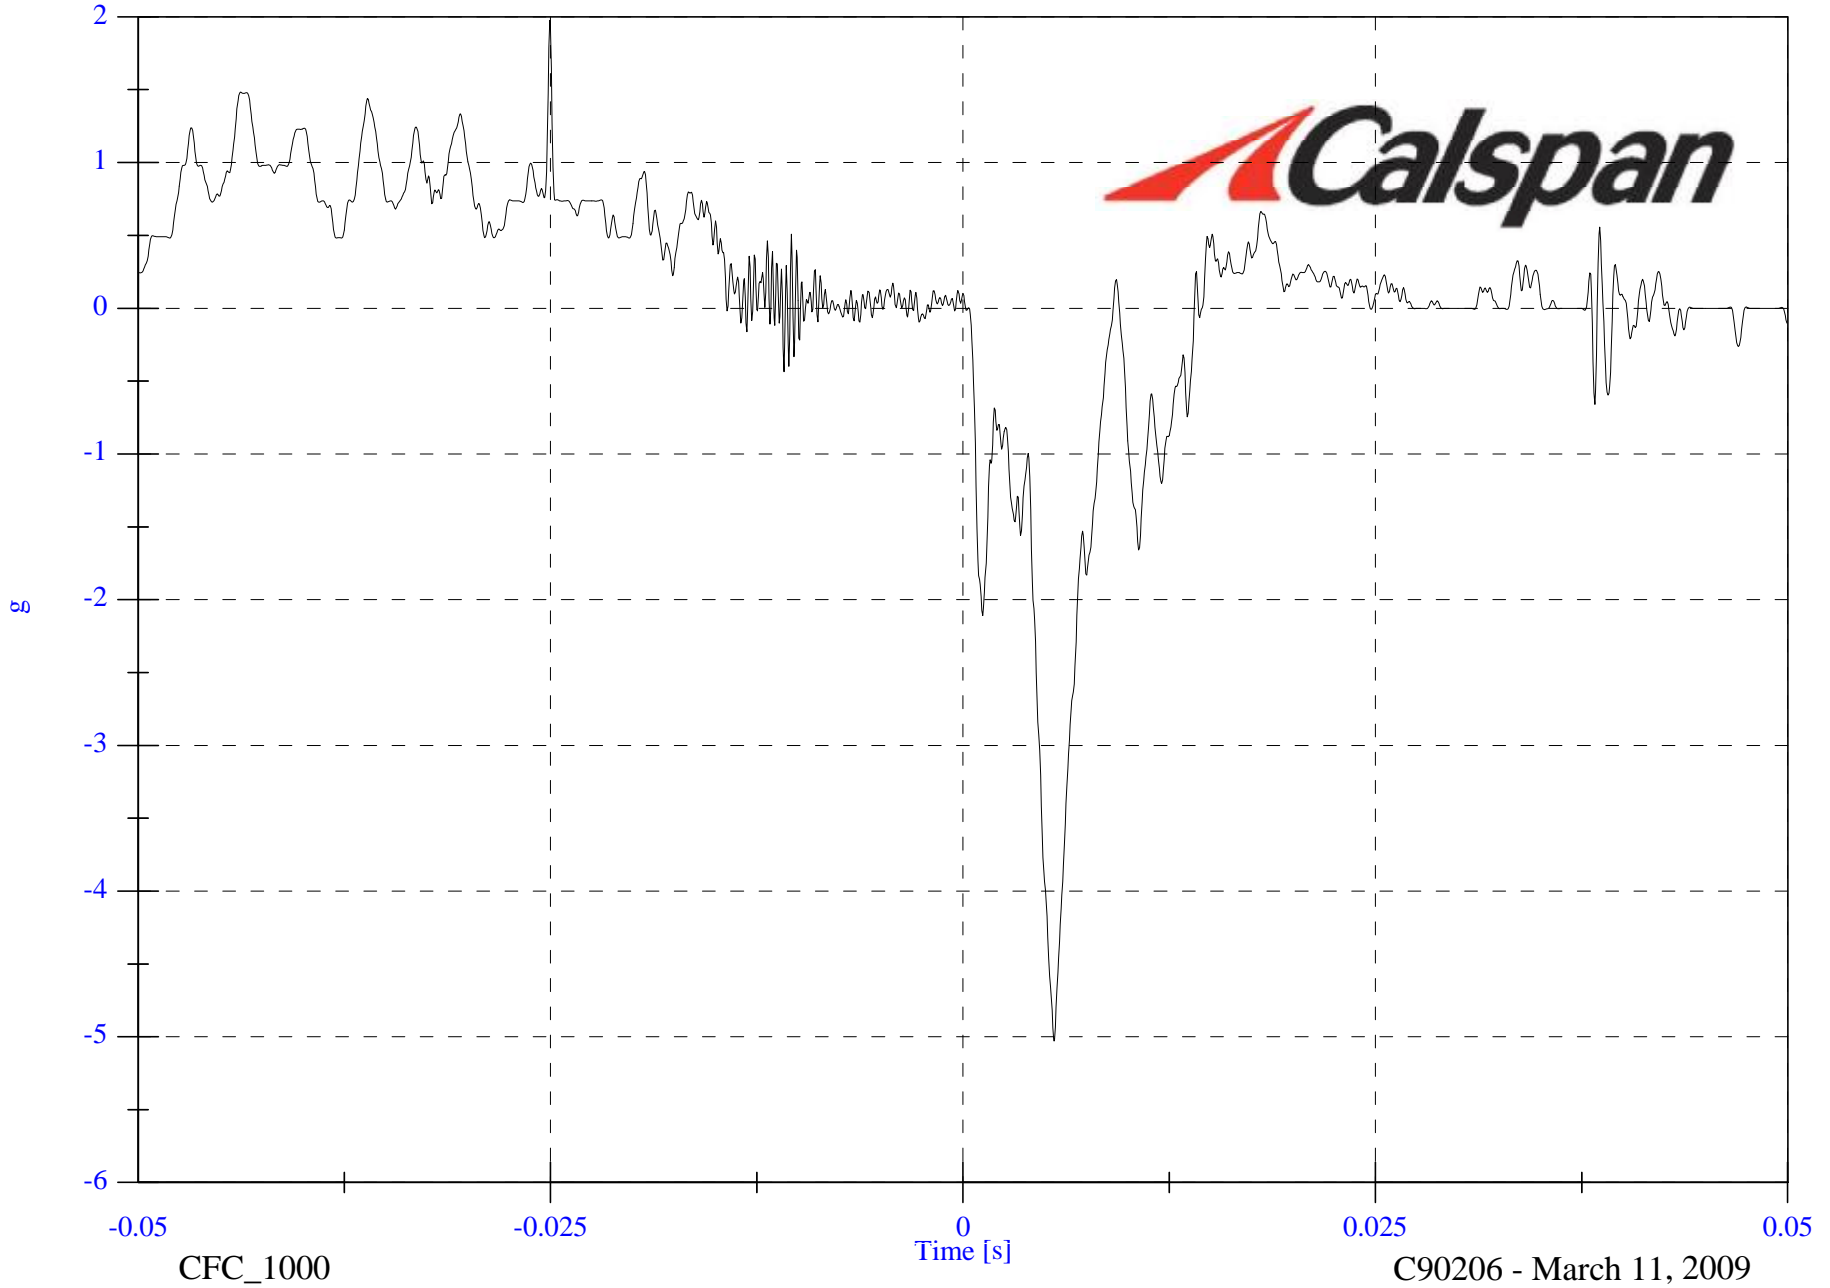
C90206 PASSENGER SIDE RP2 IMPACT PLOT #2

Min: -5.0 [g] at 0.006 [s]

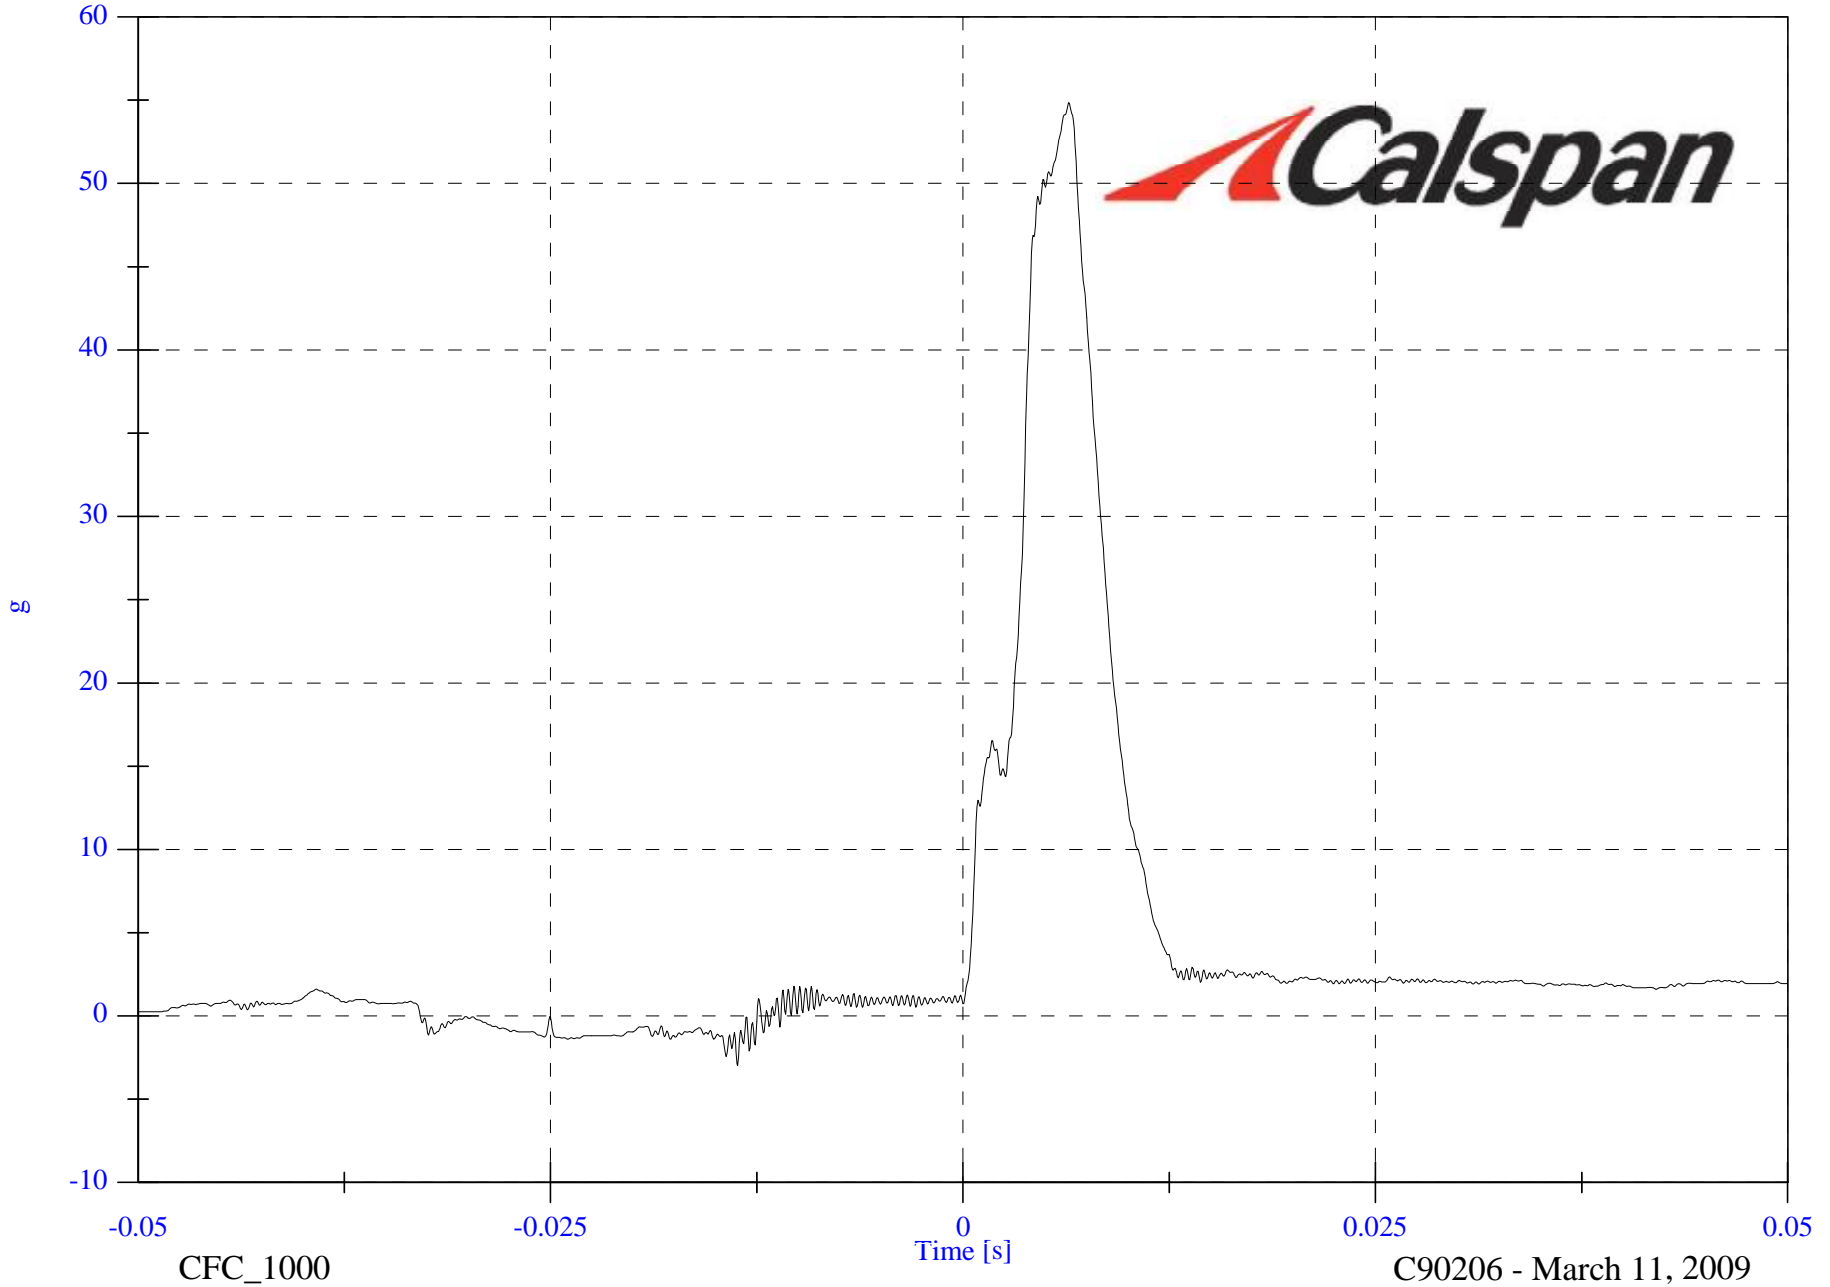
C90206 PASSENGER SIDE RP2 IMPACT PLOT #3

Min: -3.0 [g] at -0.014 [s]

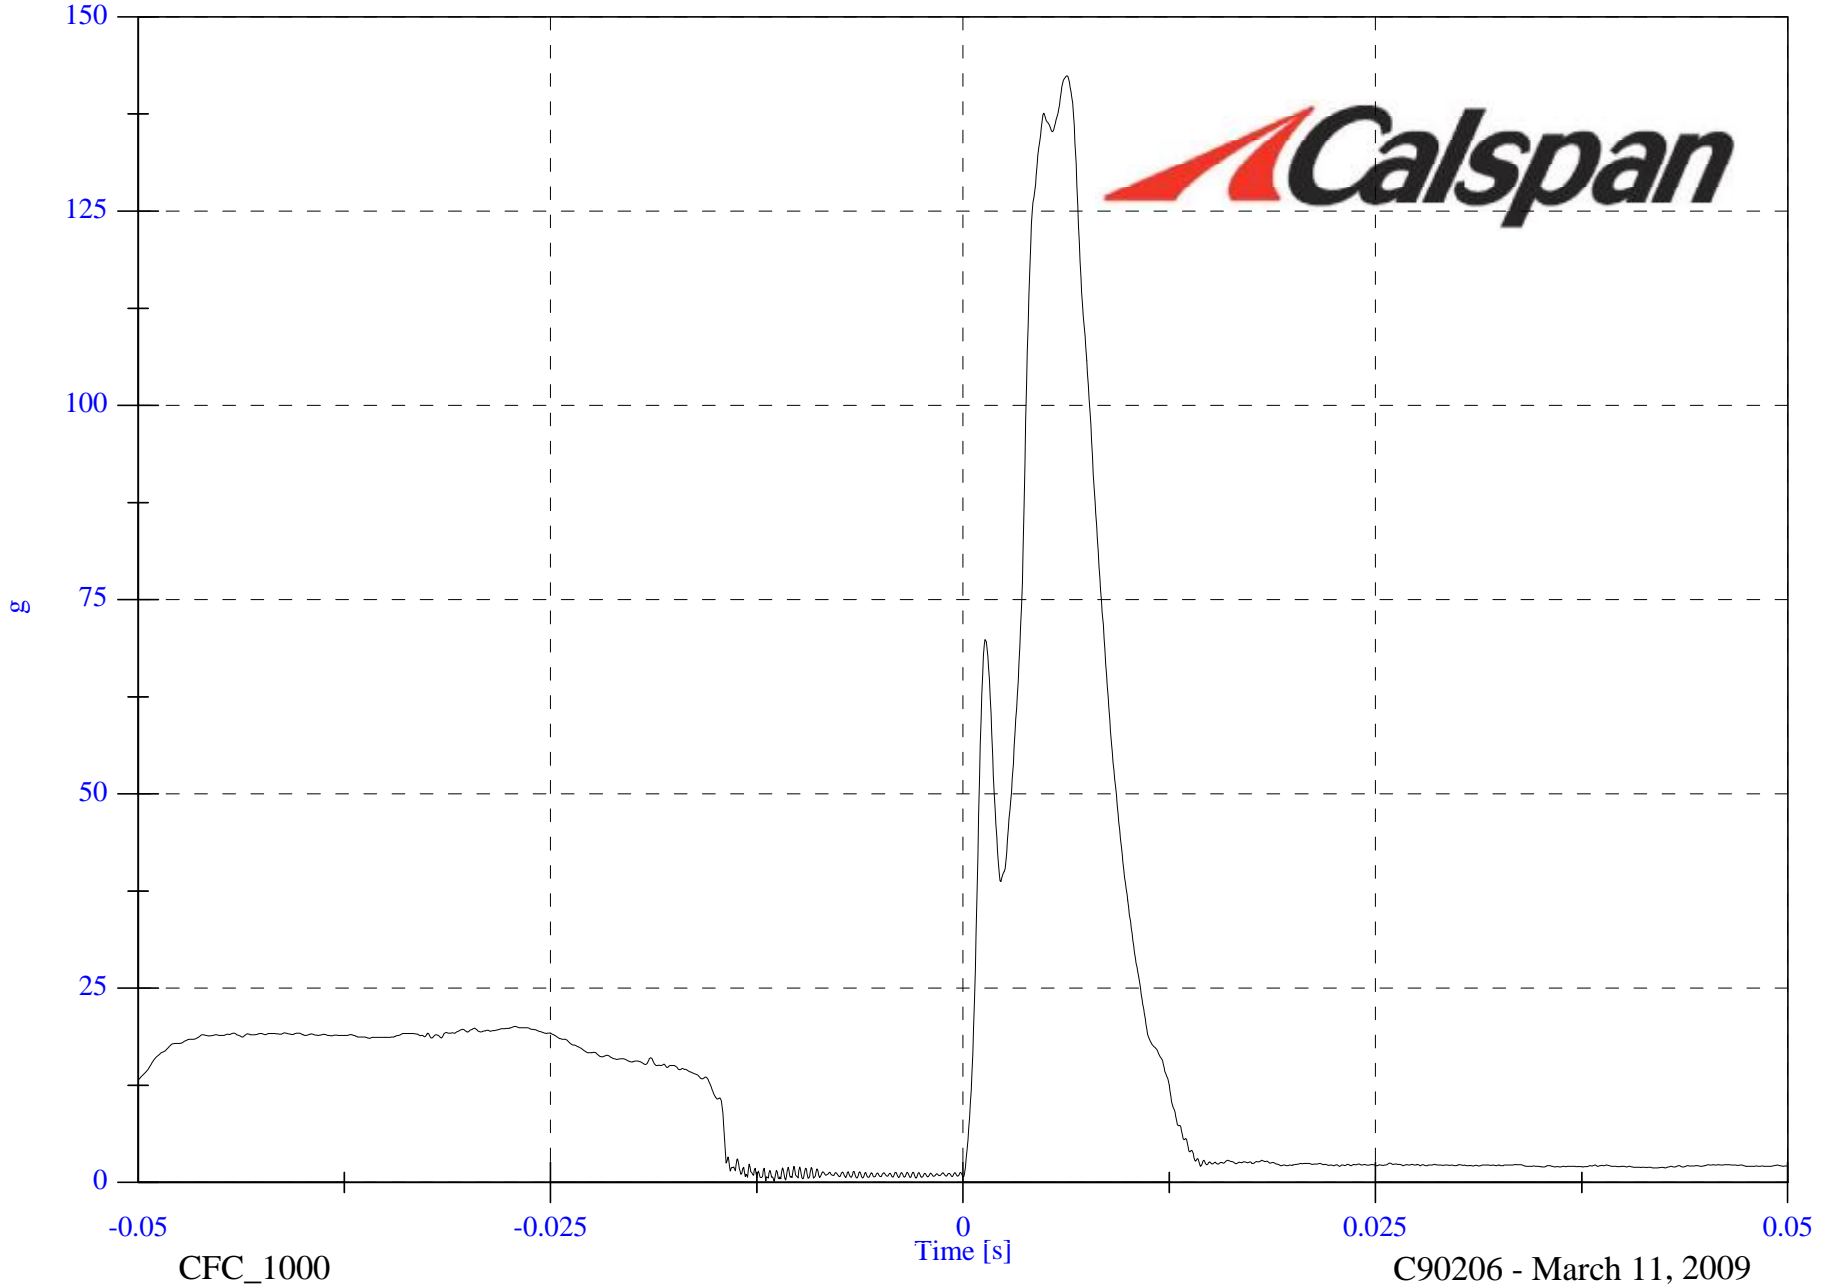
C90206 PASSENGER SIDE RP2 IMPACT PLOT #4

Min: 0.1 [g] at -0.011 [s]

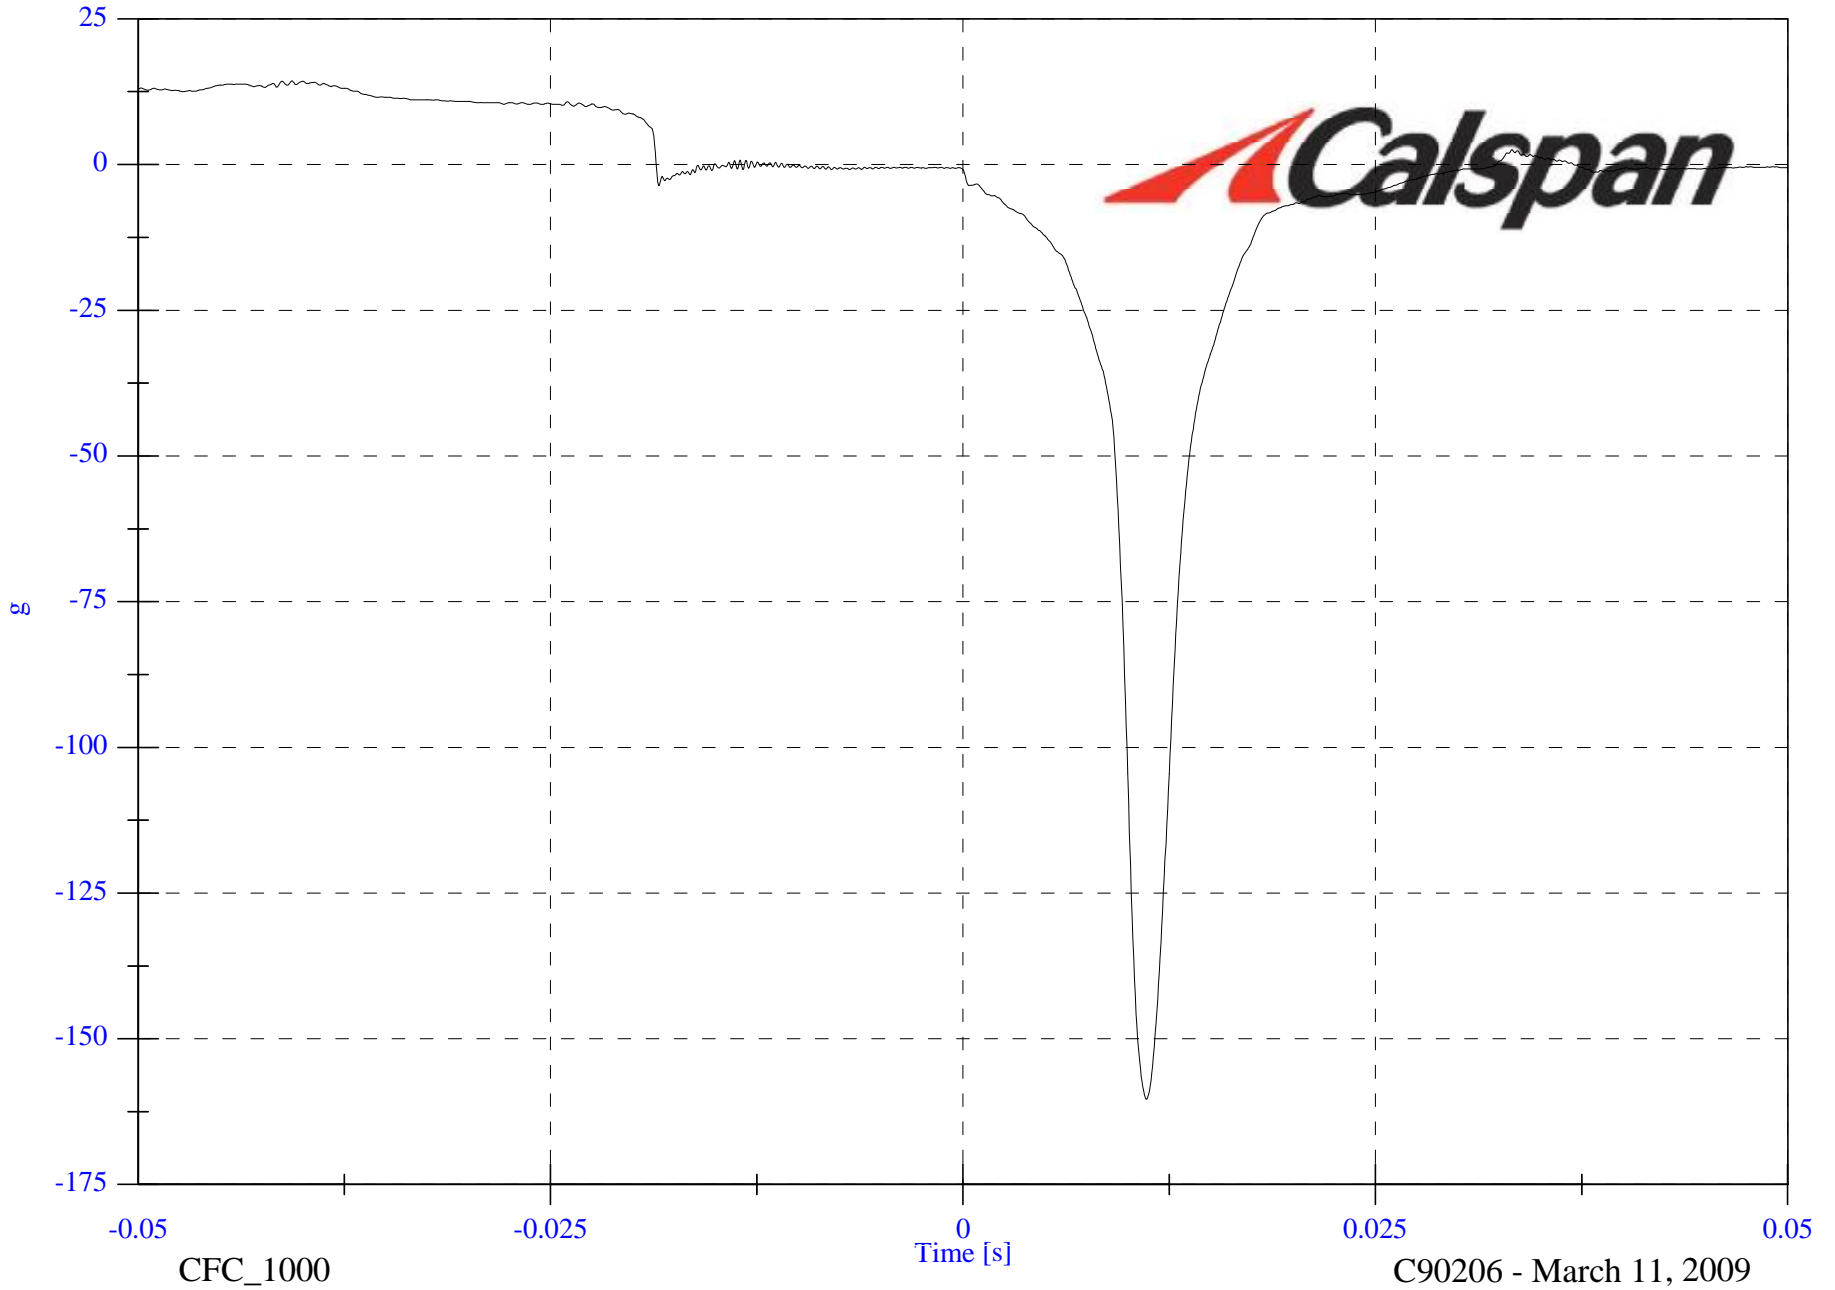
C90206 PASSENGER SIDE RPI IMPACT PLOT #1

Min: -160.4 [g] at 0.011 [s]

Headform X Acceleration

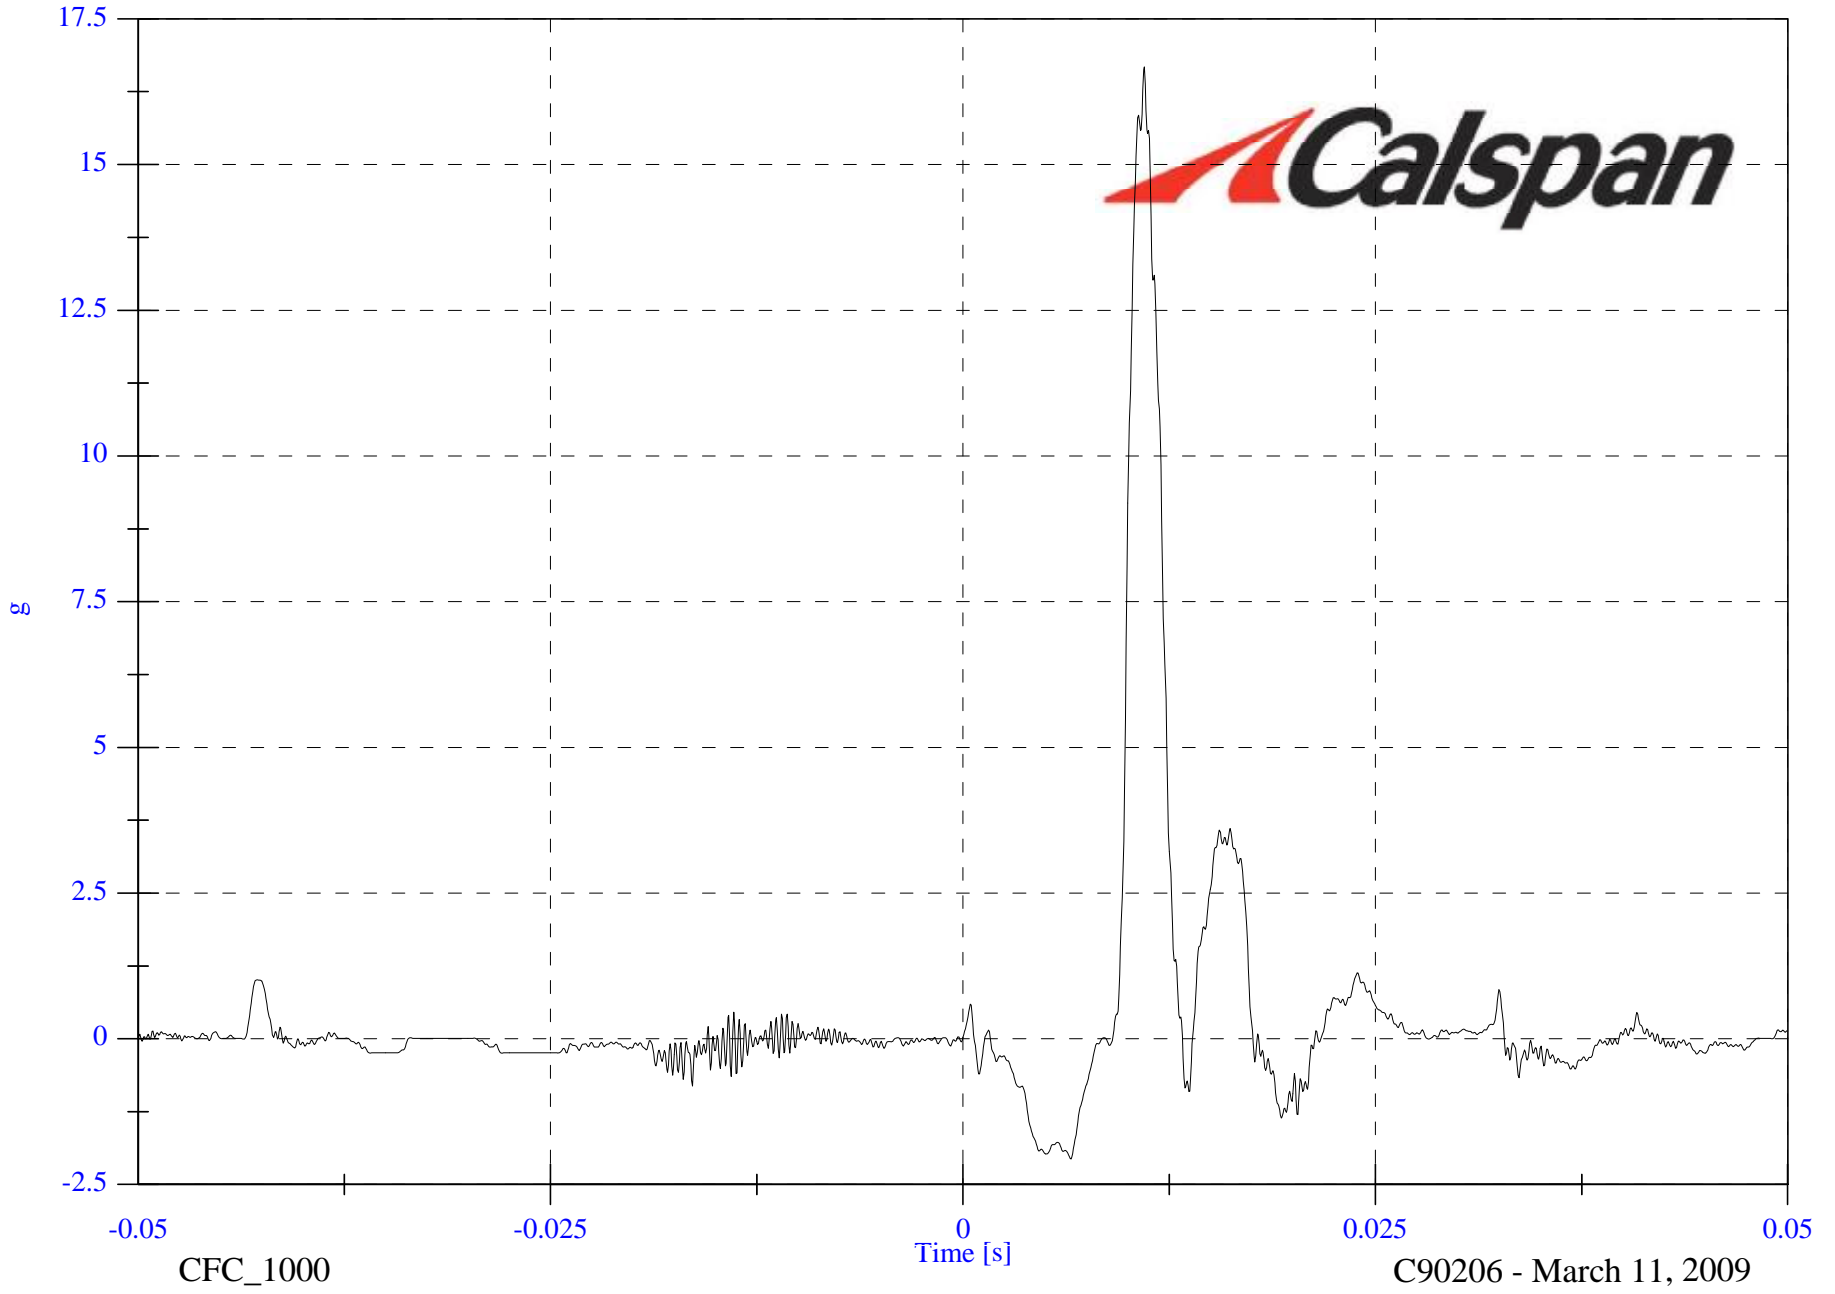
C90206 PASSENGER SIDE RP1 IMPACT PLOT #2

Min: -2.1 [g] at 0.007 [s]

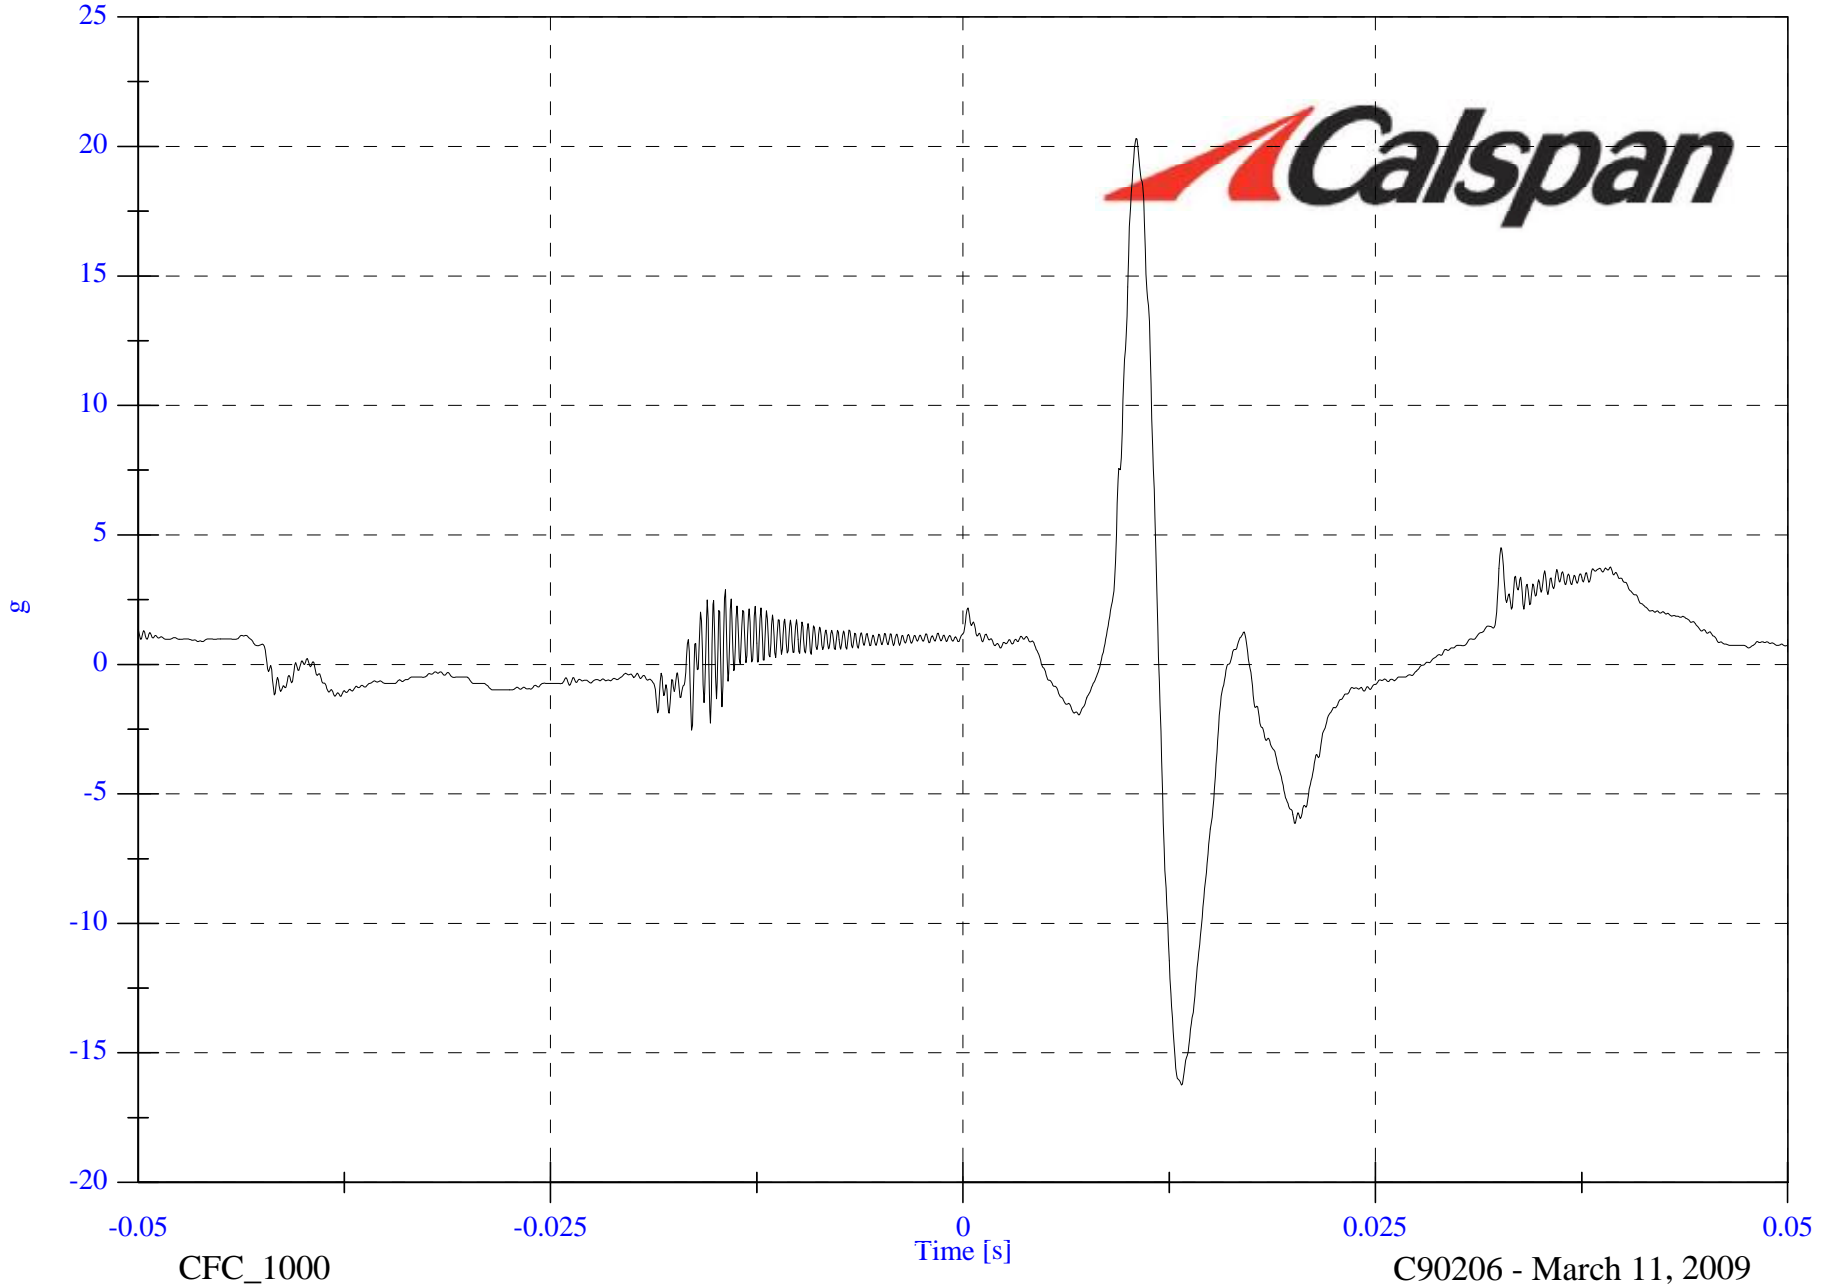
C90206 PASSENGER SIDE RPI IMPACT PLOT #3

Min: -16.2 [g] at 0.013 [s]

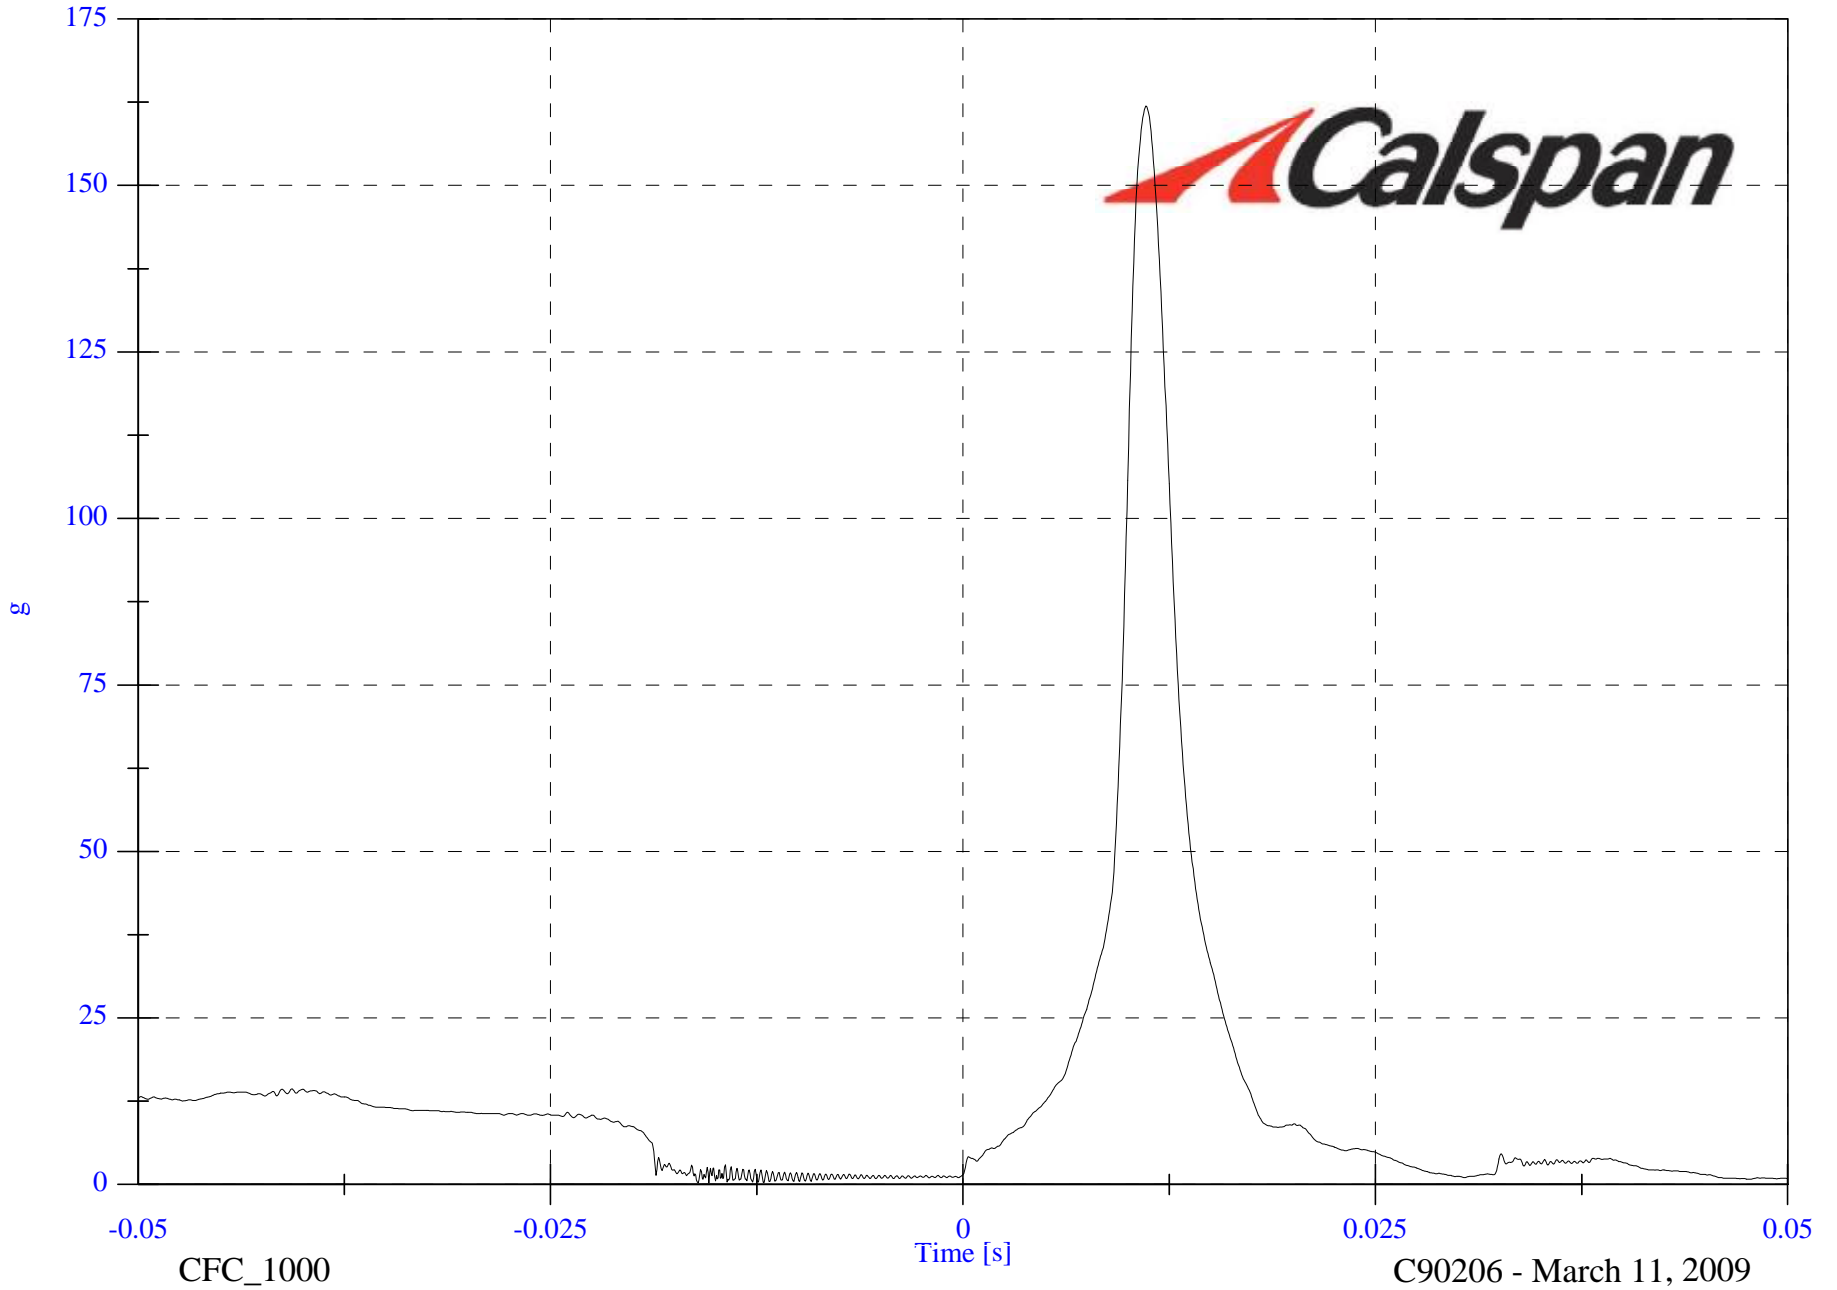
C90206 PASSENGER SIDE RPI IMPACT PLOT #4

Min: 0.2 [g] at -0.015 [s]

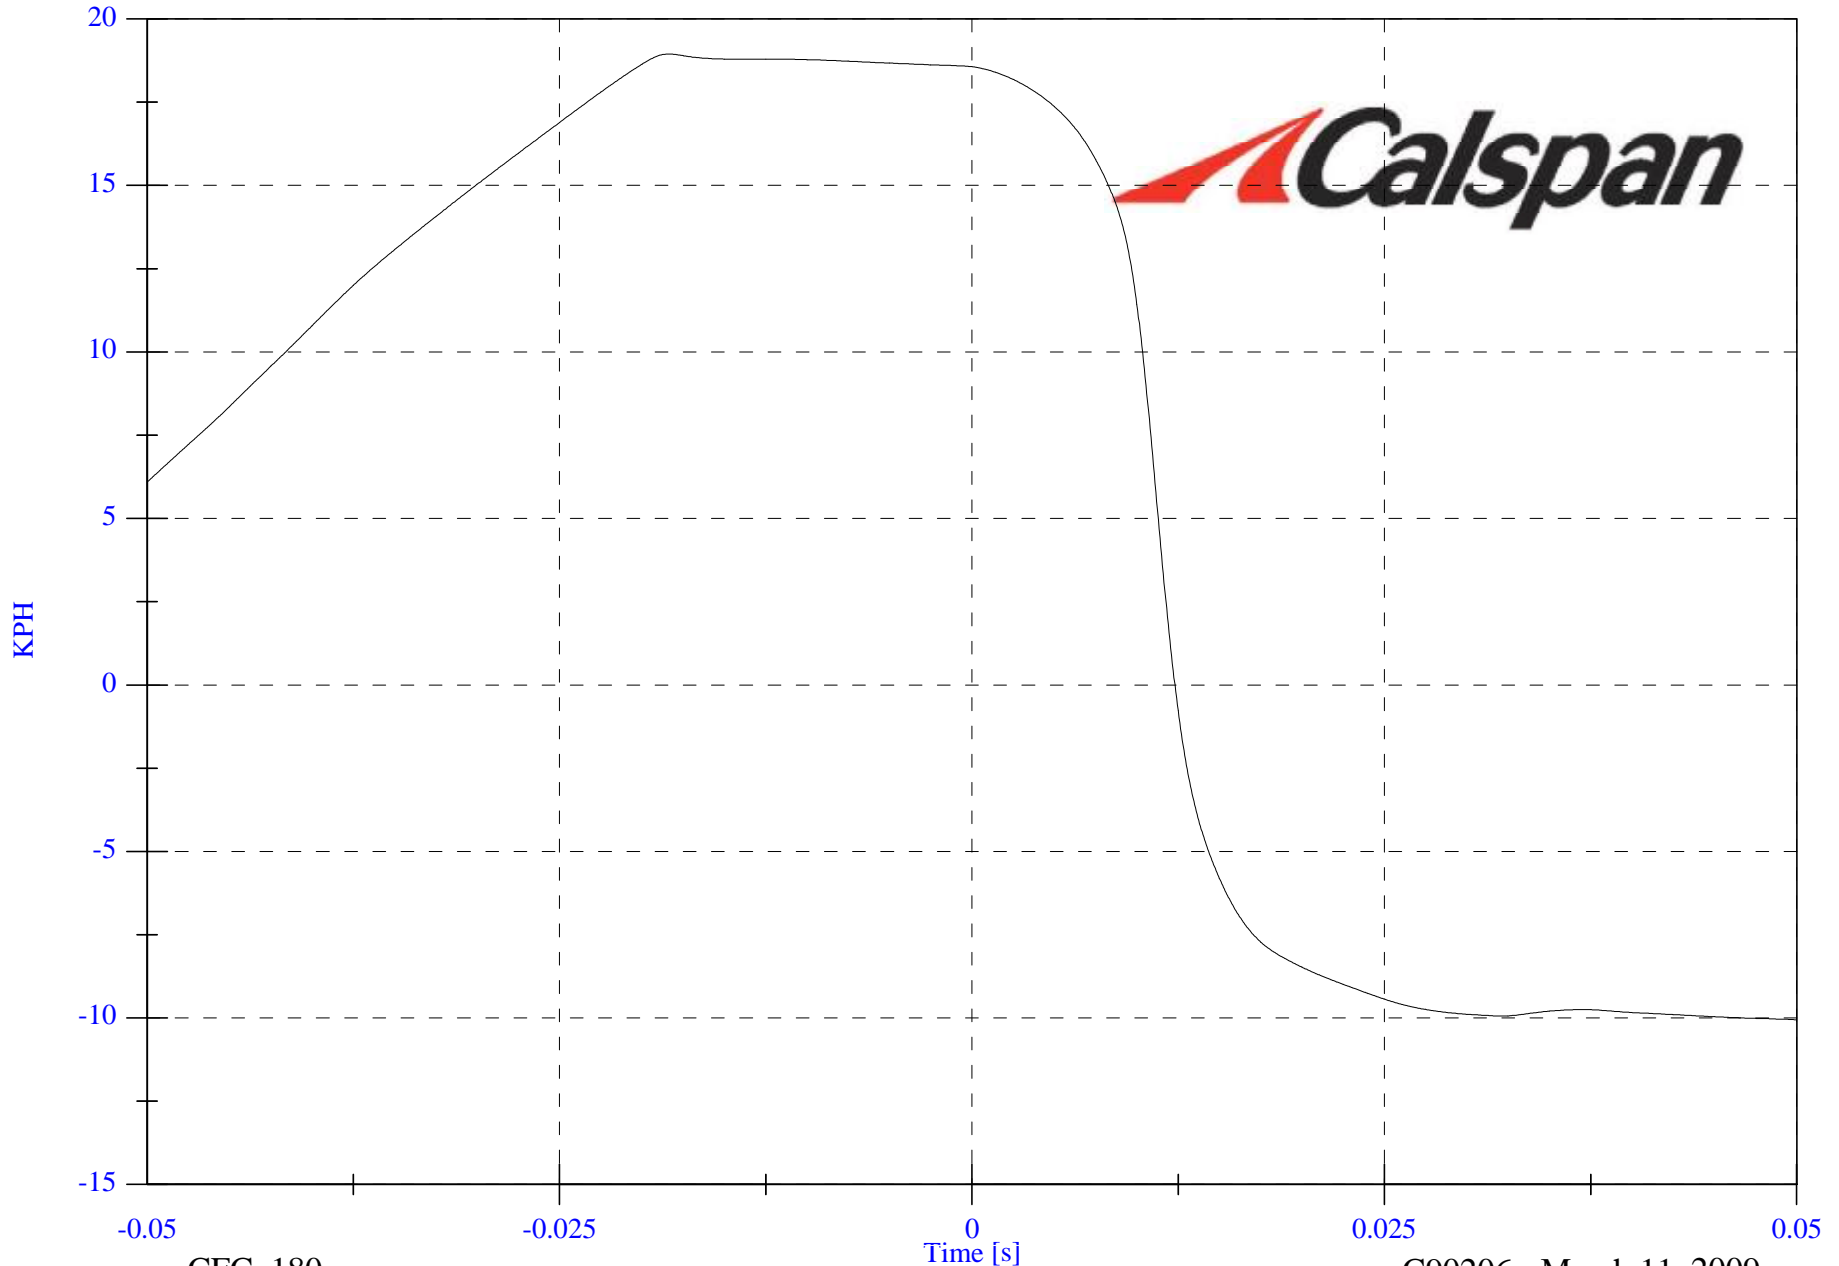
C90206 PASSENGER SIDE RPI IMPACT PLOT #5

Headform Velocity
