REPORT NUMBER: 201UI-CAL-09-06

**SAFETY COMPLIANCE TESTING FOR FMVSS 201
OCCUPANT PROTECTION IN INTERIOR IMPACT
UPPER INTERIOR HEAD IMPACT PROTECTION**

**FORD MOTOR CO.
2009 FORD F150**

NHTSA NUMBER: C90206

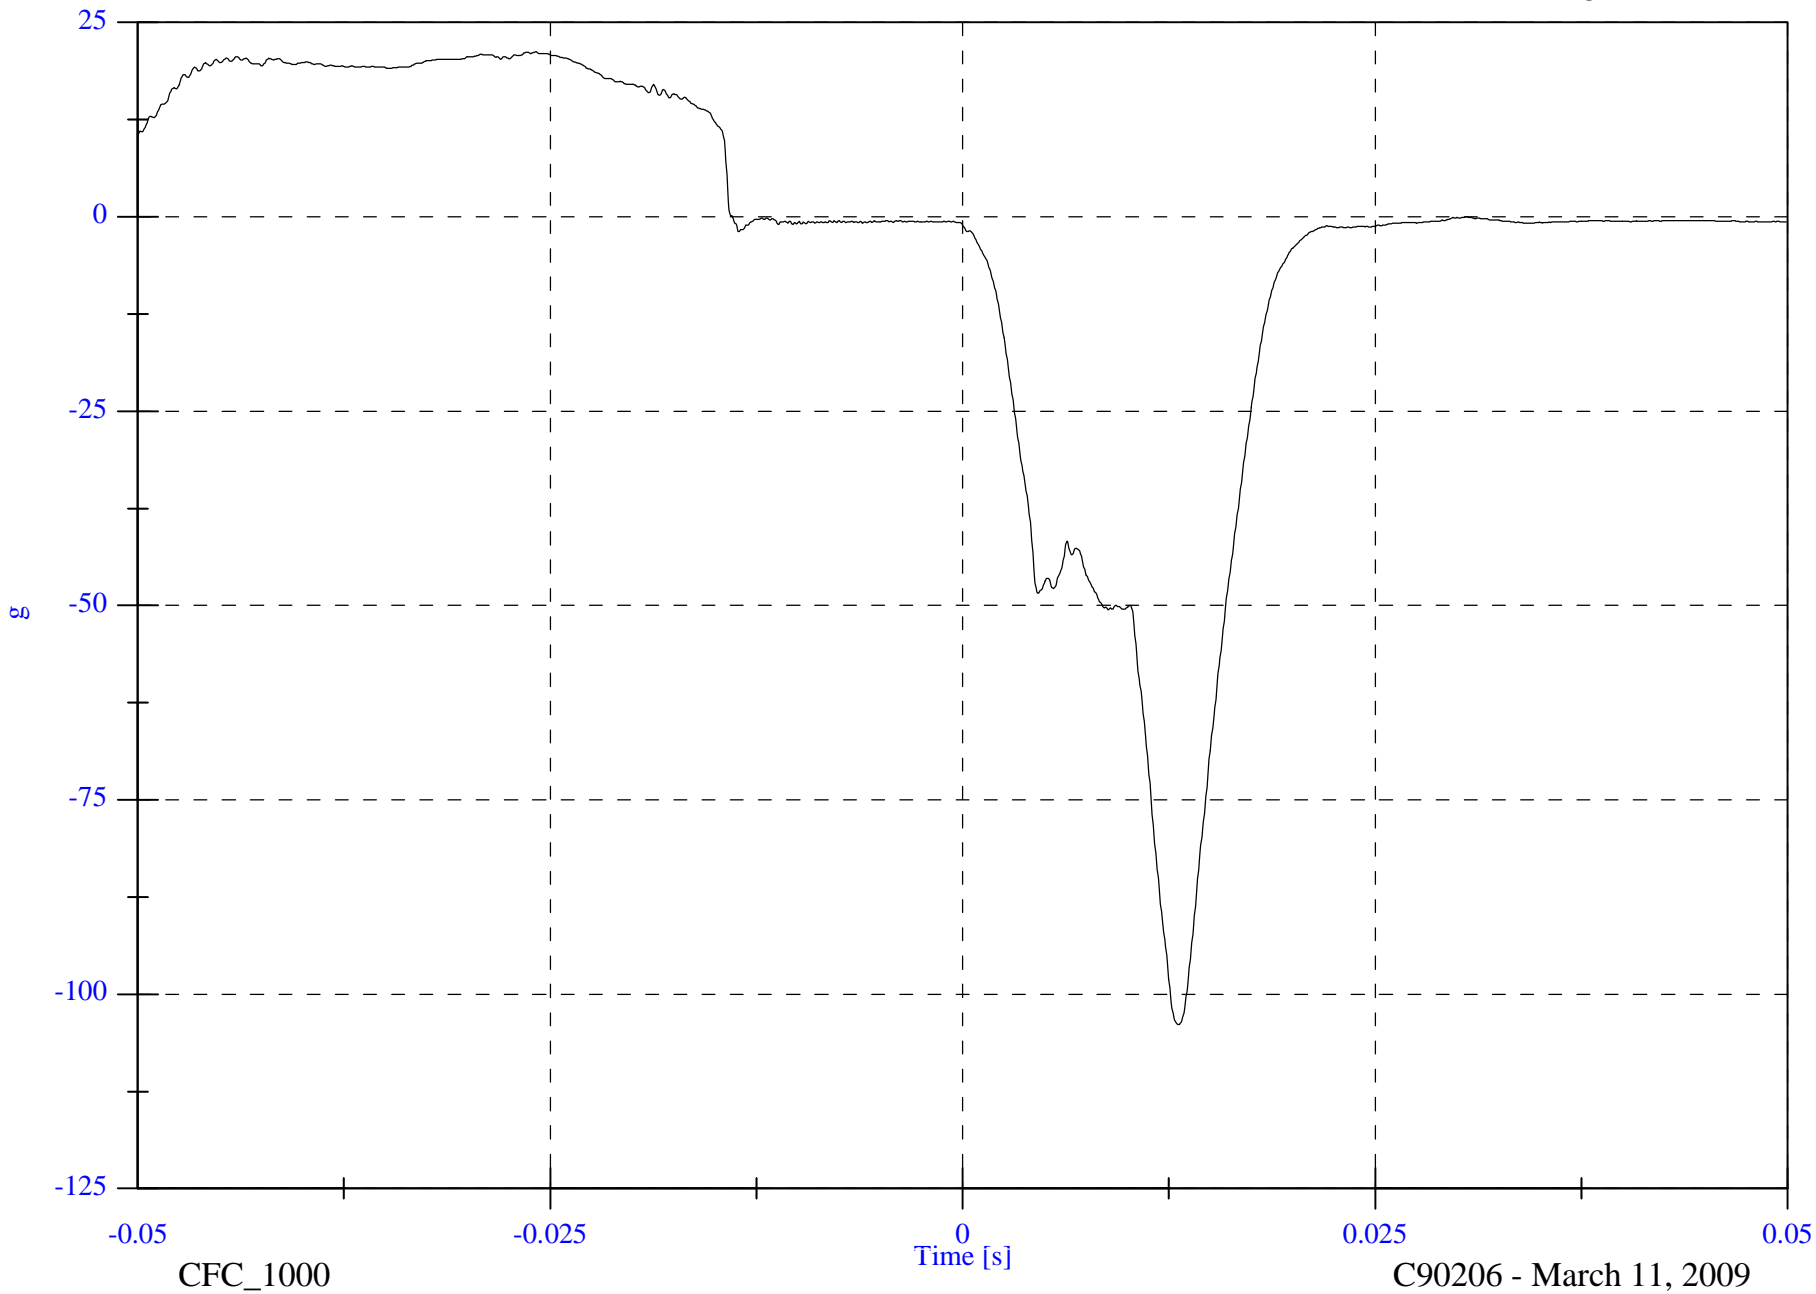
C90206 PASSENGER SIDE URSR2 IMPACT PLOT #1

Max: 21.2 [g] at -0.026 [s]

Min: -103.9 [g] at 0.013 [s]

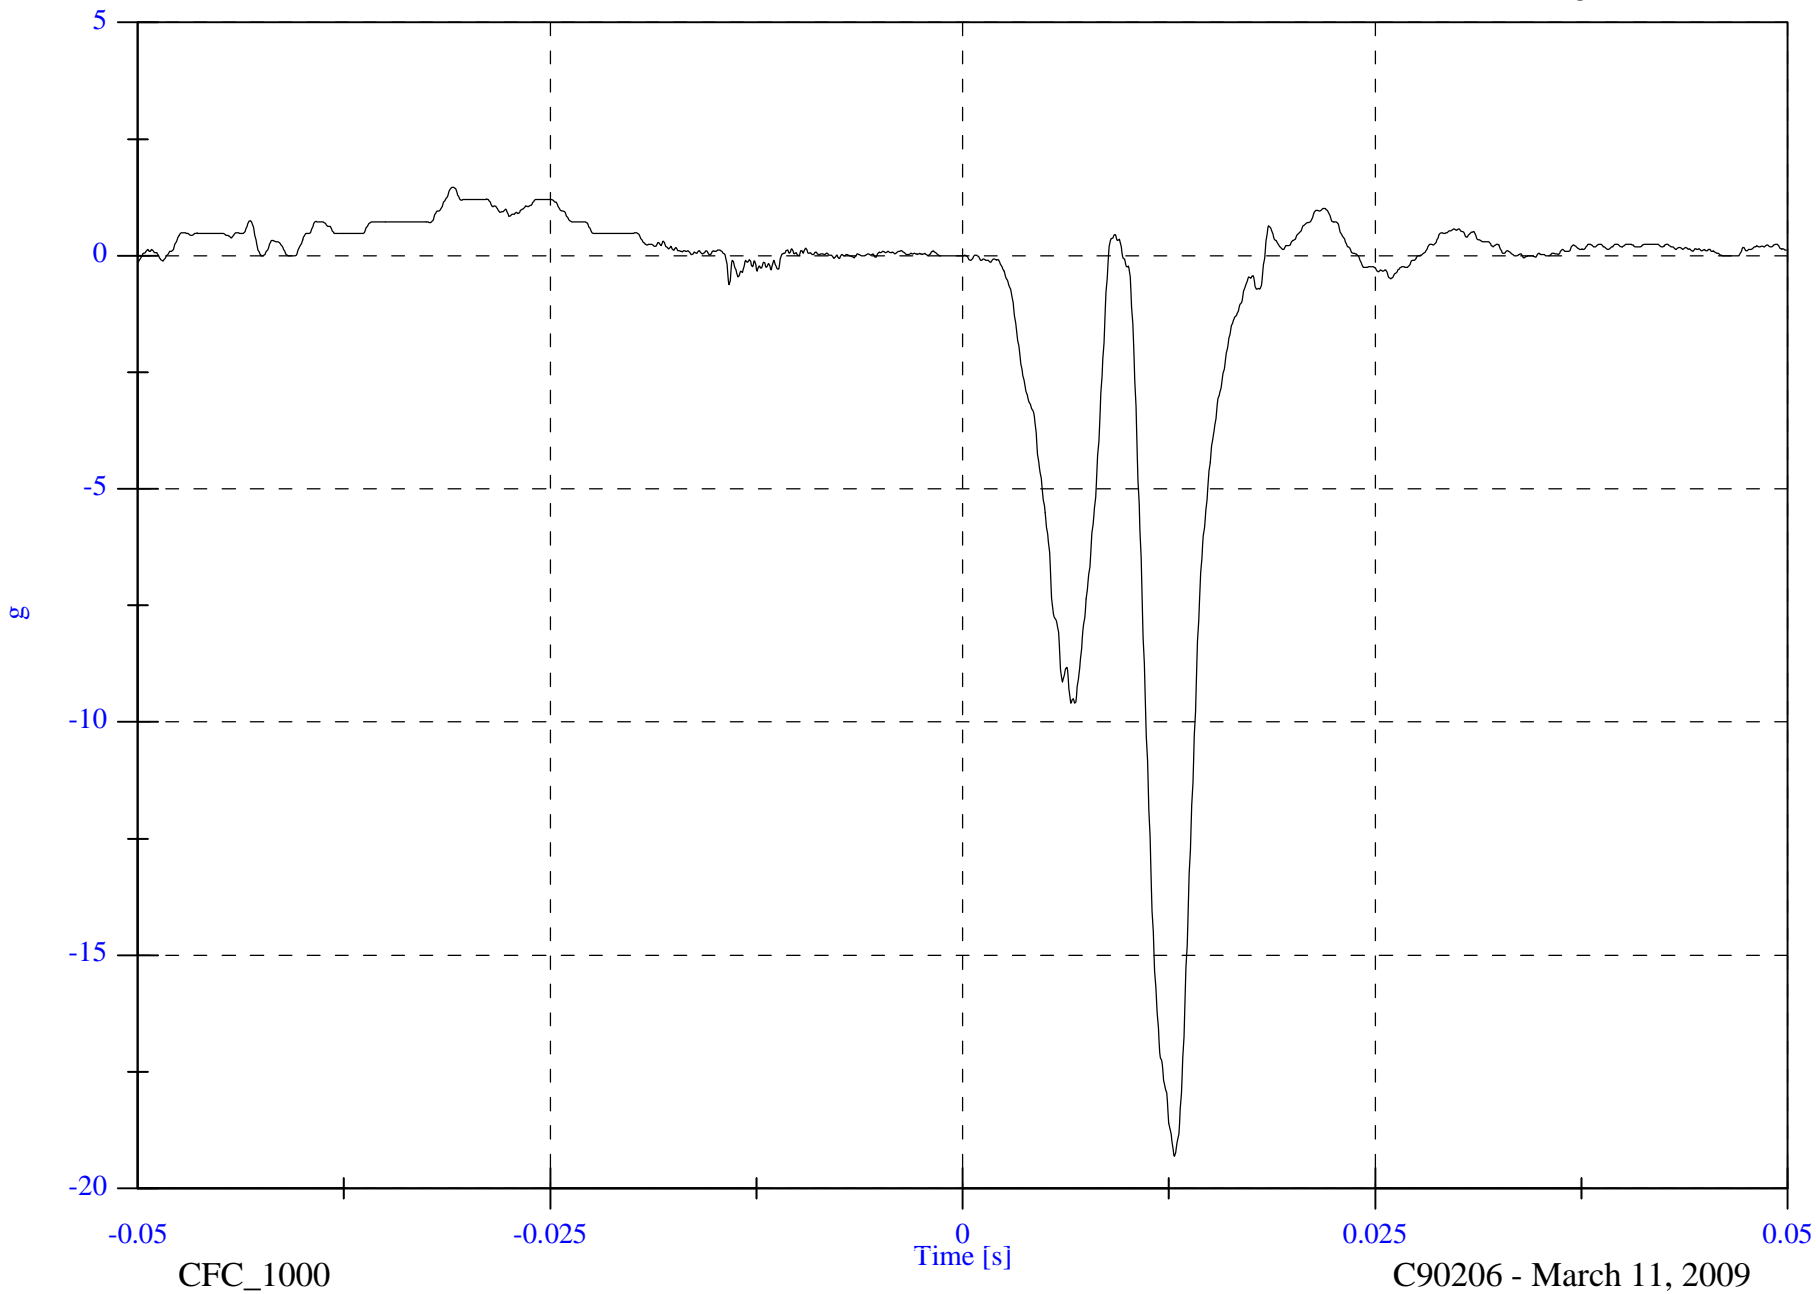
C90206 PASSENGER SIDE URSR2 IMPACT PLOT #2

Min: -19.3 [g] at 0.013 [s]

Headform Y Acceleration

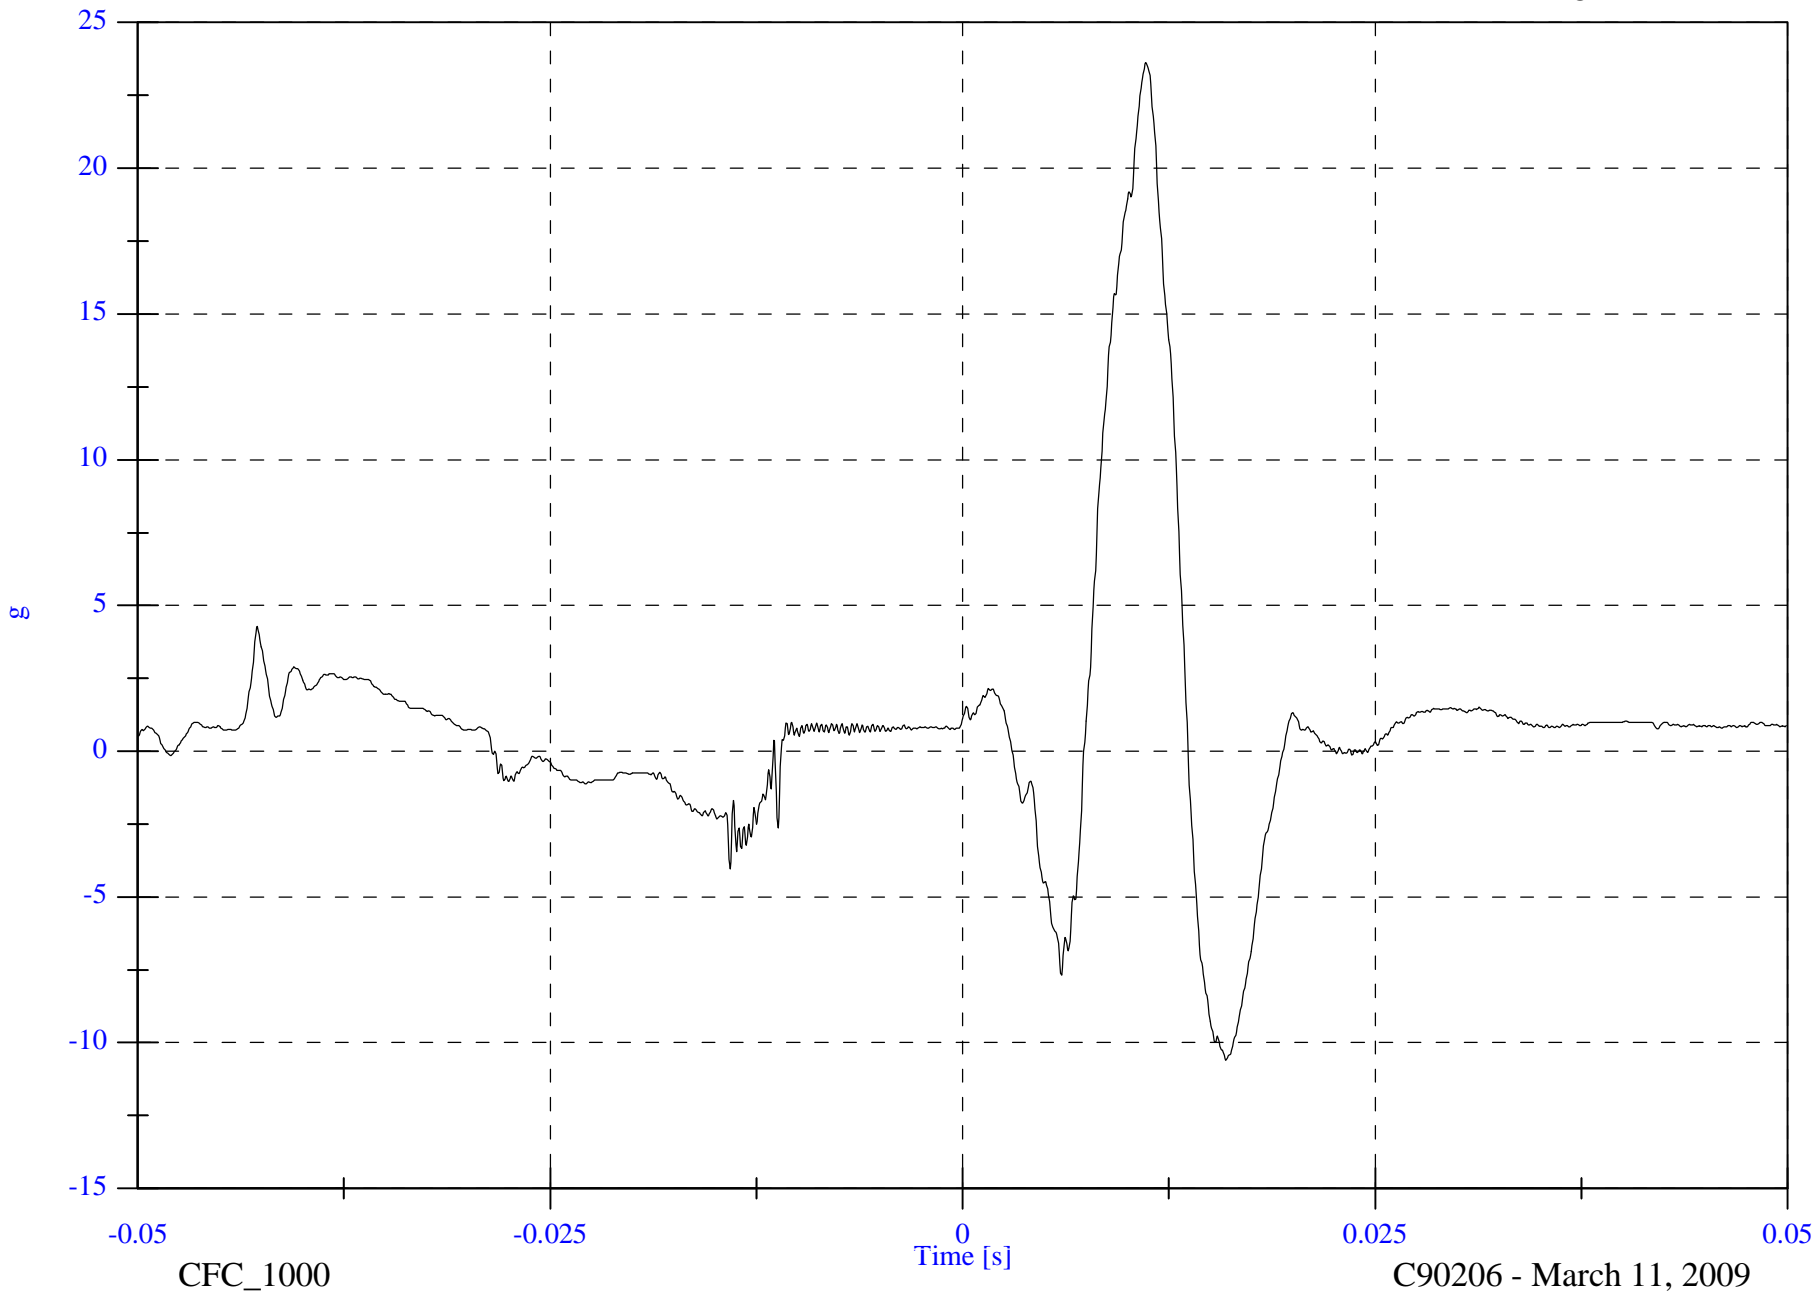
C90206 PASSENGER SIDE URSR2 IMPACT PLOT #3

Max: 23.6 [g] at 0.011 [s]

Min: -10.6 [g] at 0.016 [s]

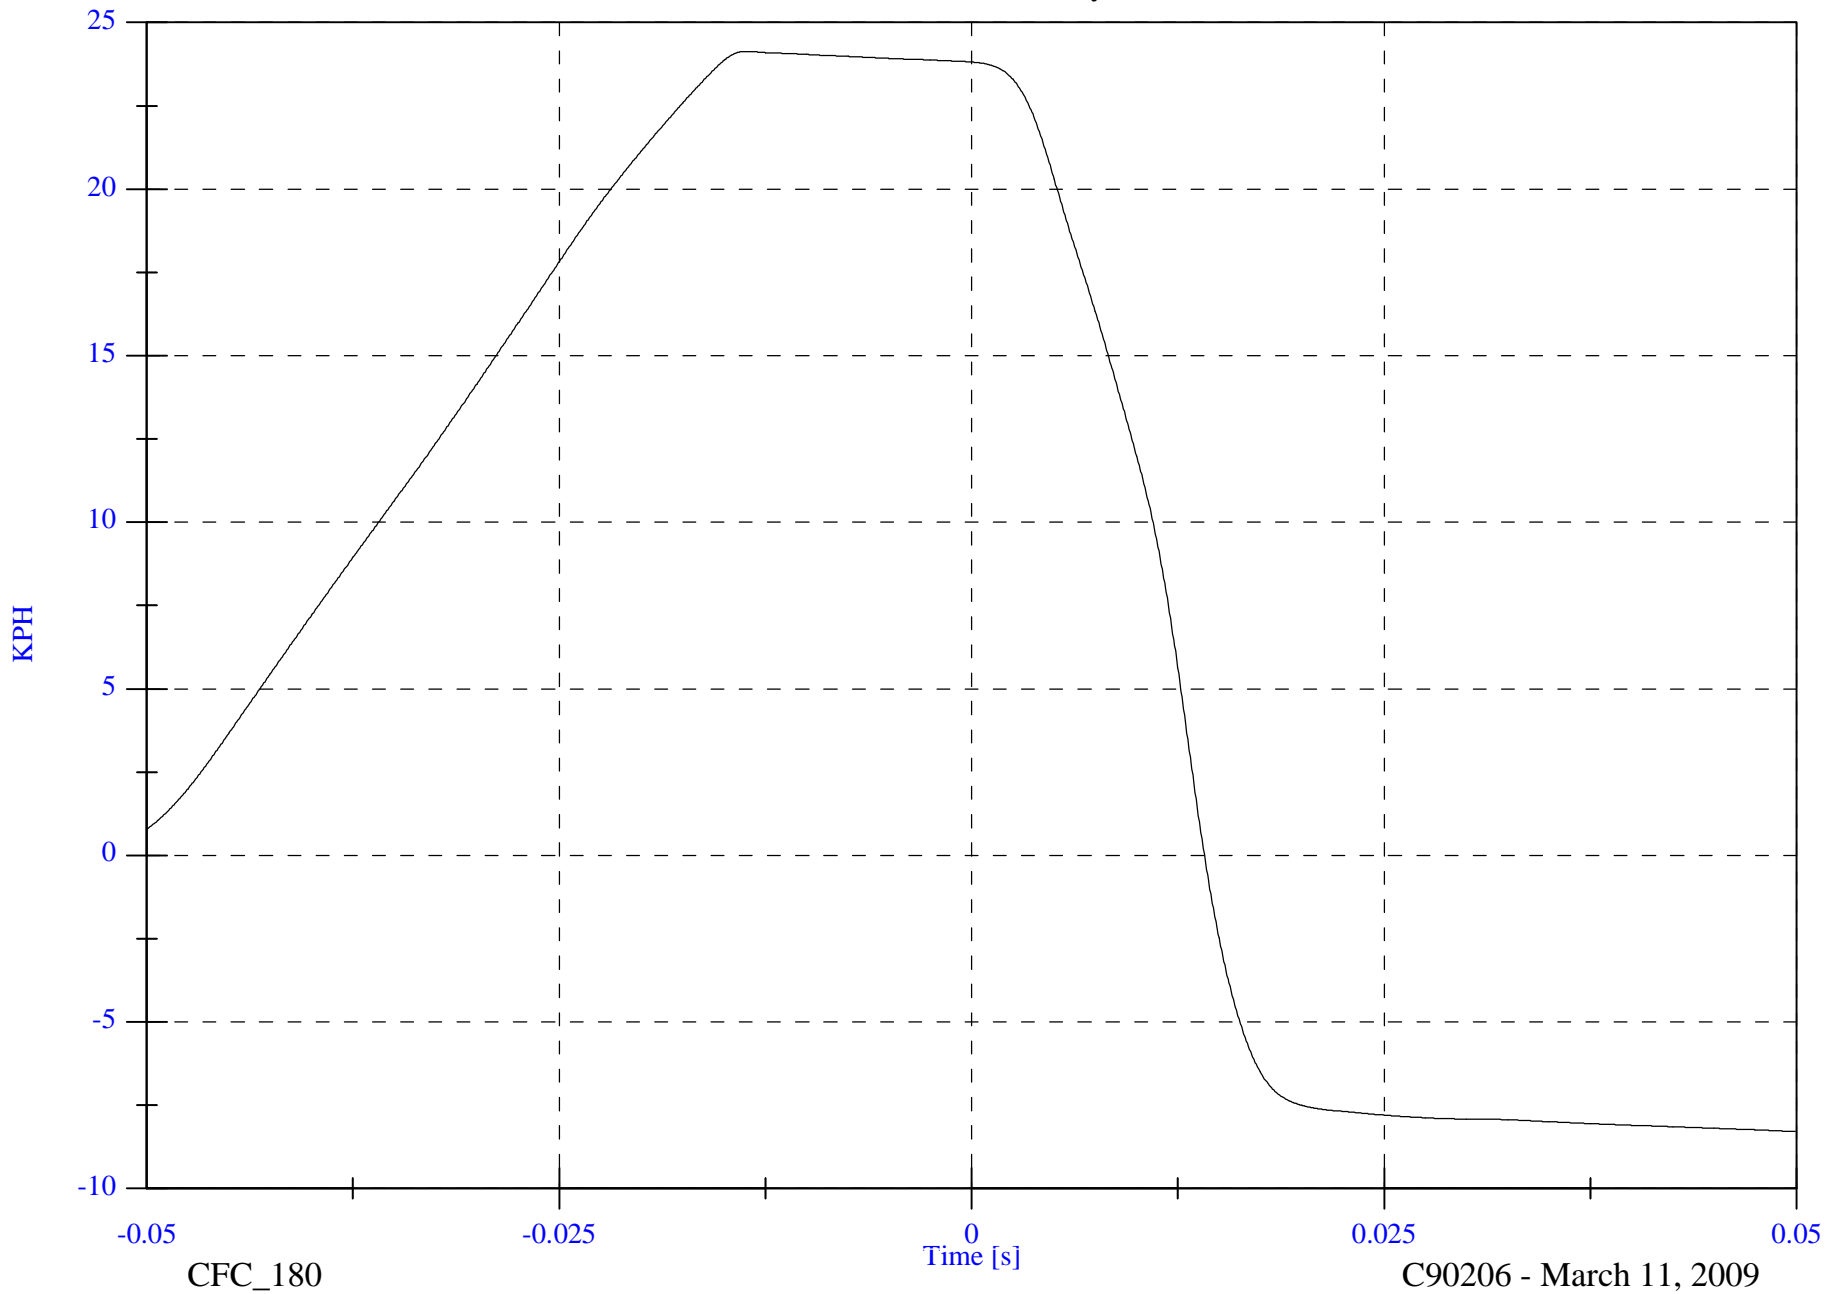
C90206 PASSENGER SIDE URSR2 IMPACT PLOT #5

Min: -8.3 [KPH] at 0.050 [s]

Headform Velocity

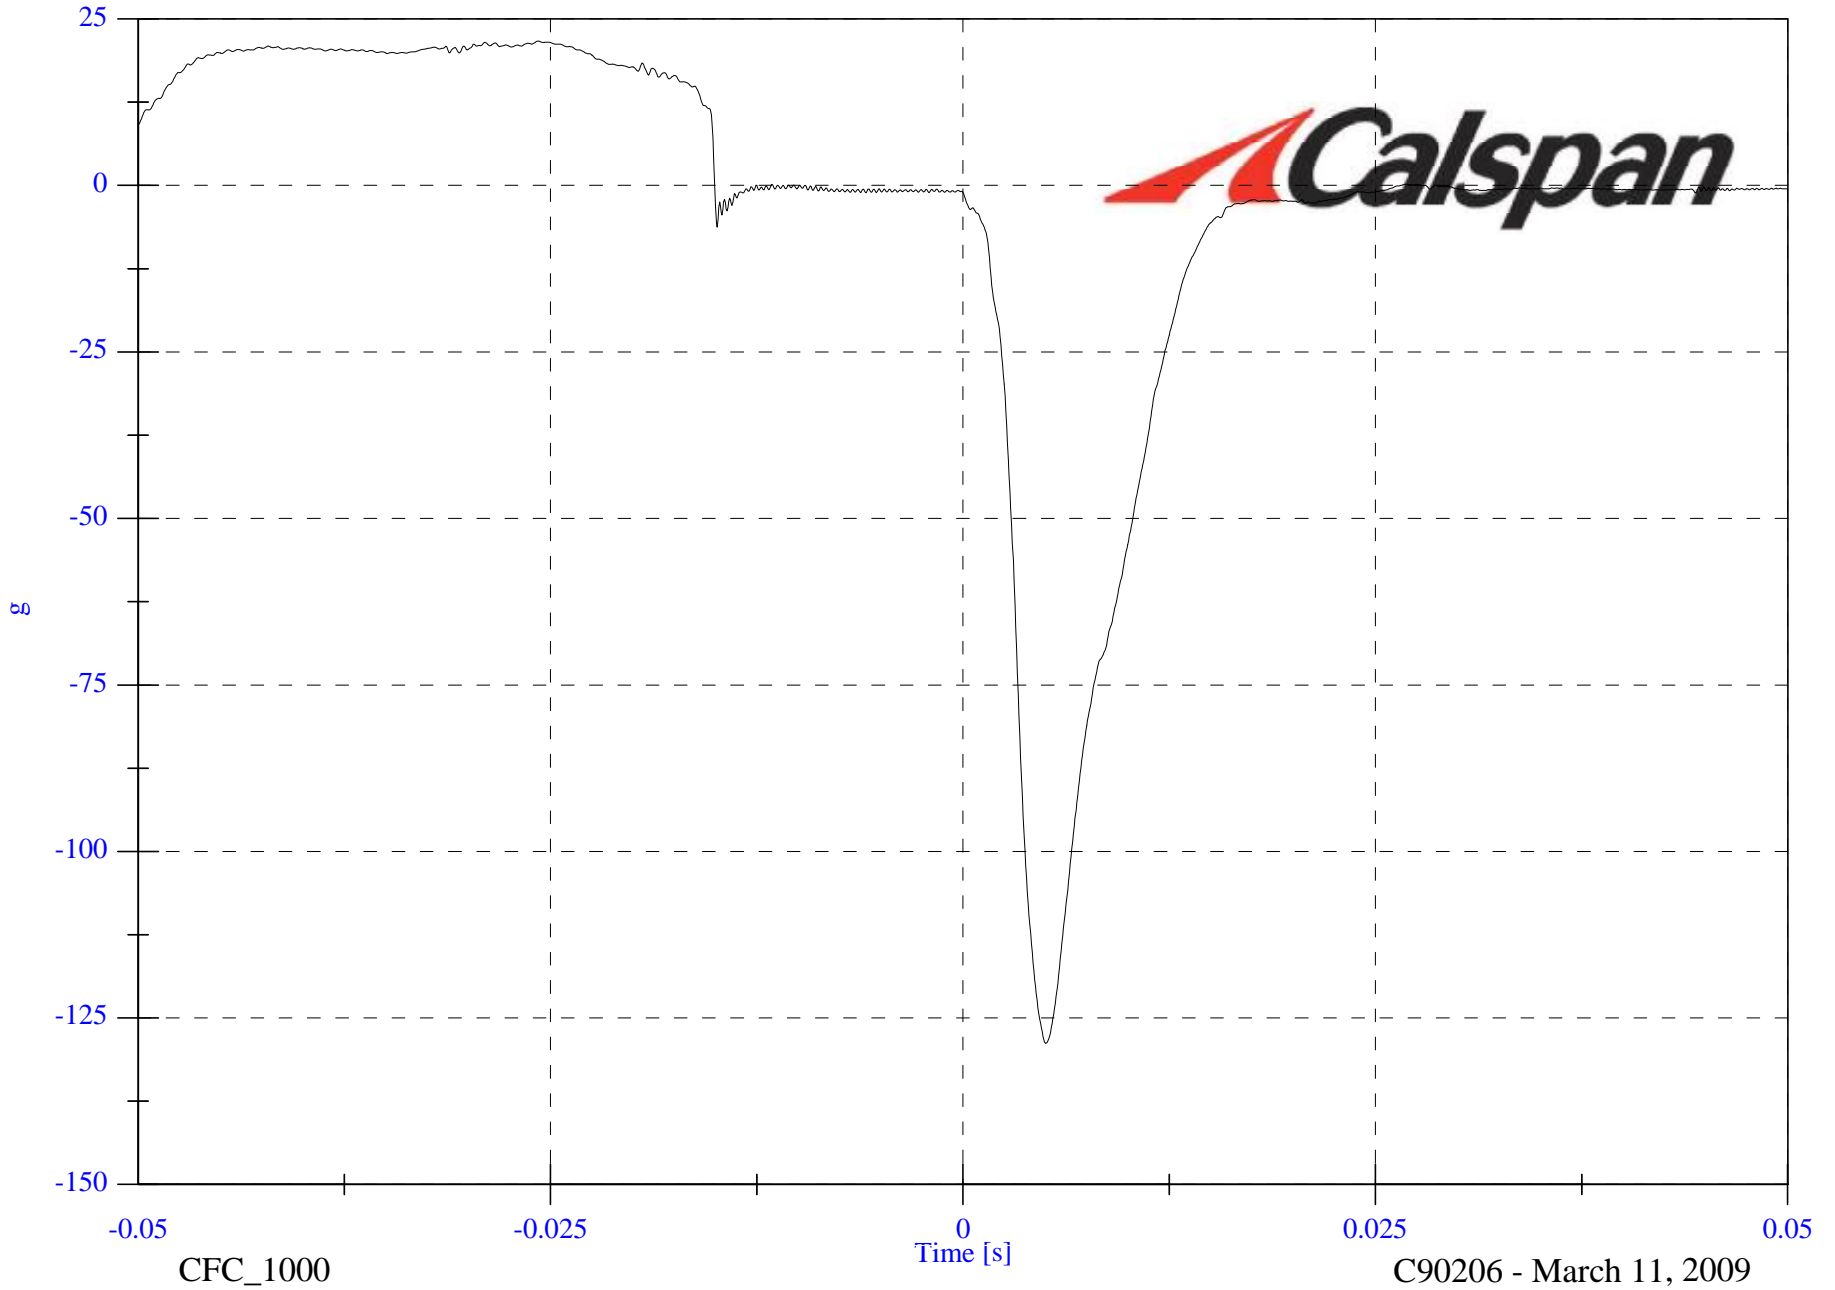
C90206 PASSENGER SIDE FH2 IMPACT PLOT #1

Max: 21.7 [g] at -0.026 [s]

Min: -128.8 [g] at 0.005 [s]

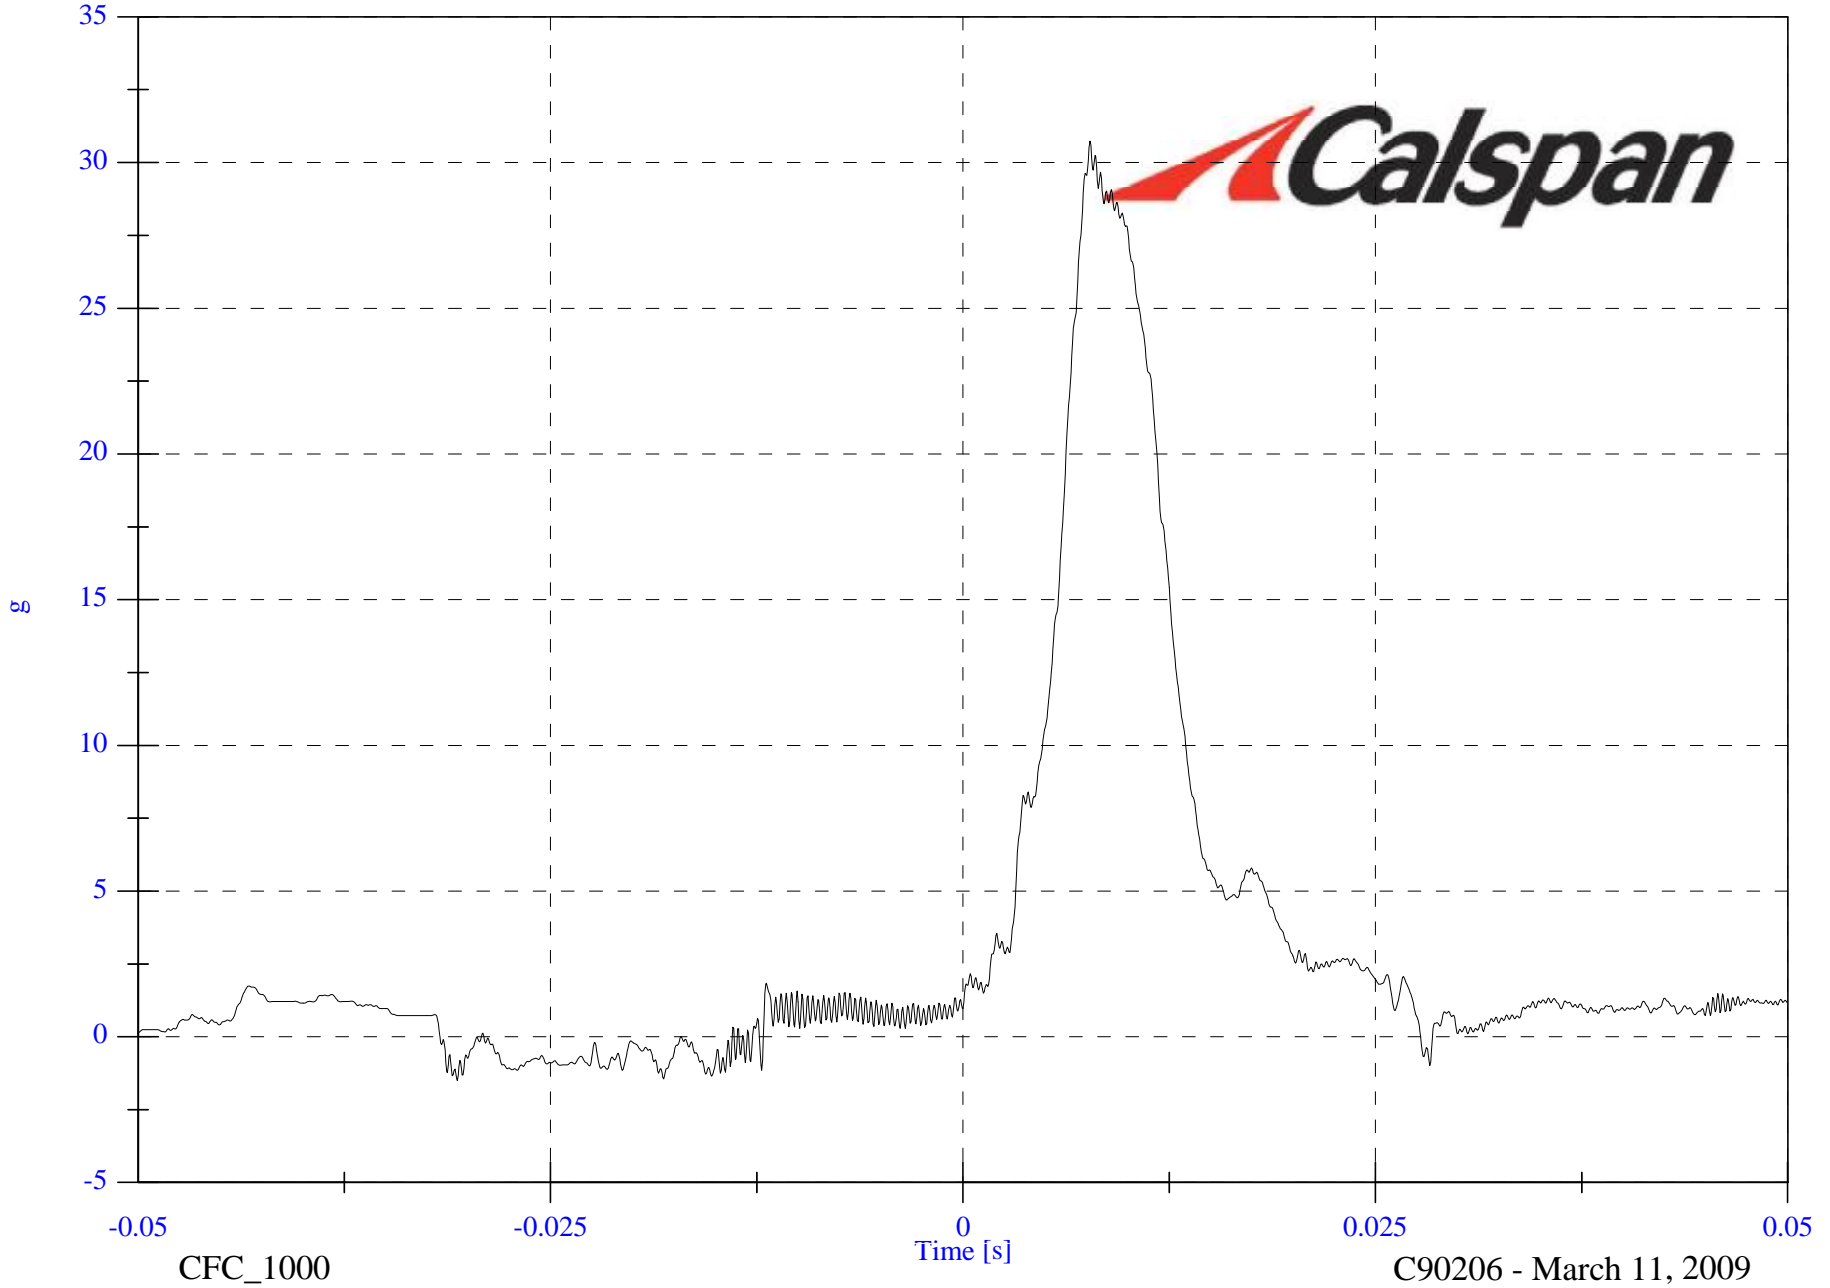
C90206 PASSENGER SIDE FH2 IMPACT PLOT #3

Min: -1.5 [g] at -0.031 [s]

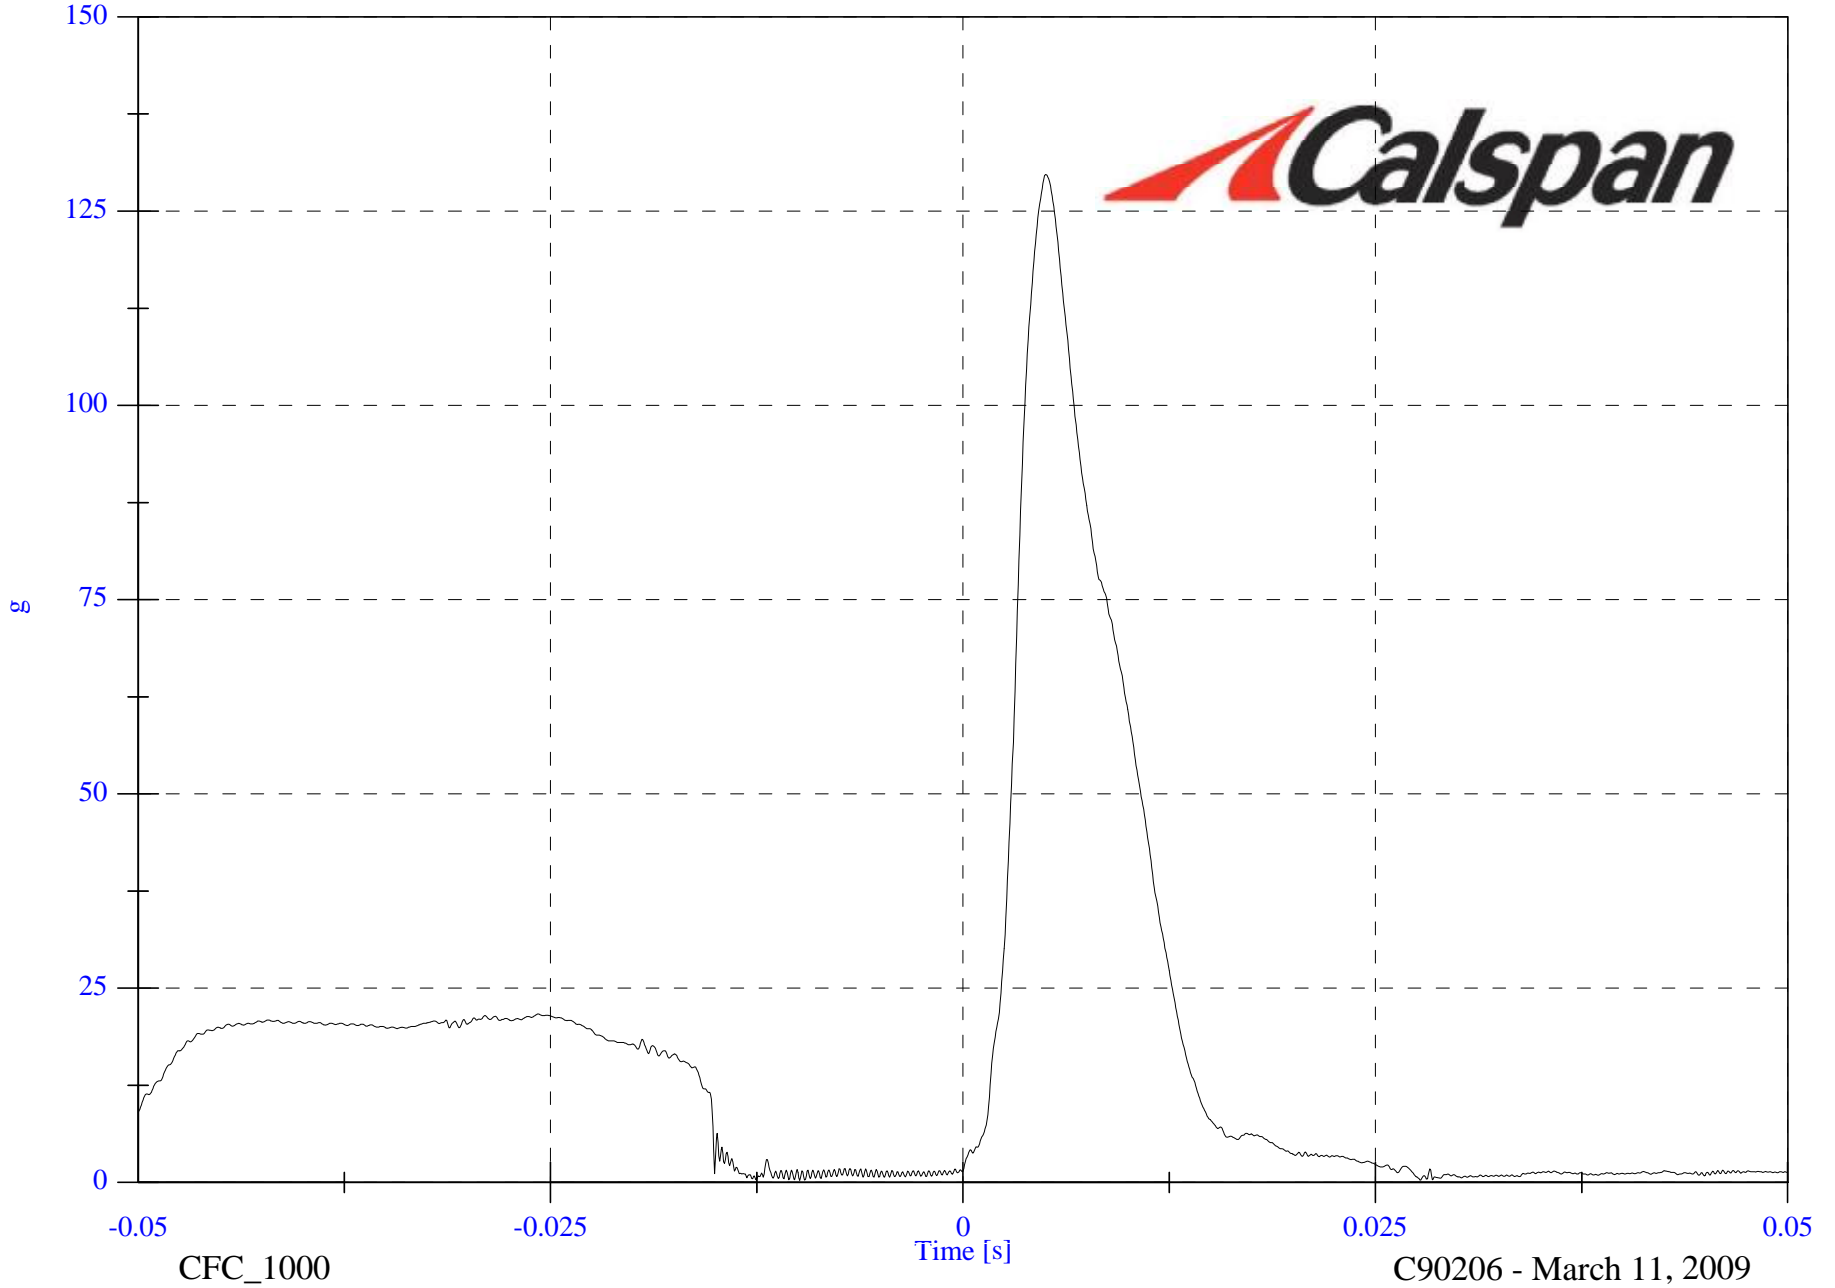
C90206 PASSENGER SIDE FH2 IMPACT PLOT #4

Min: 0.3 [g] at -0.010 [s]

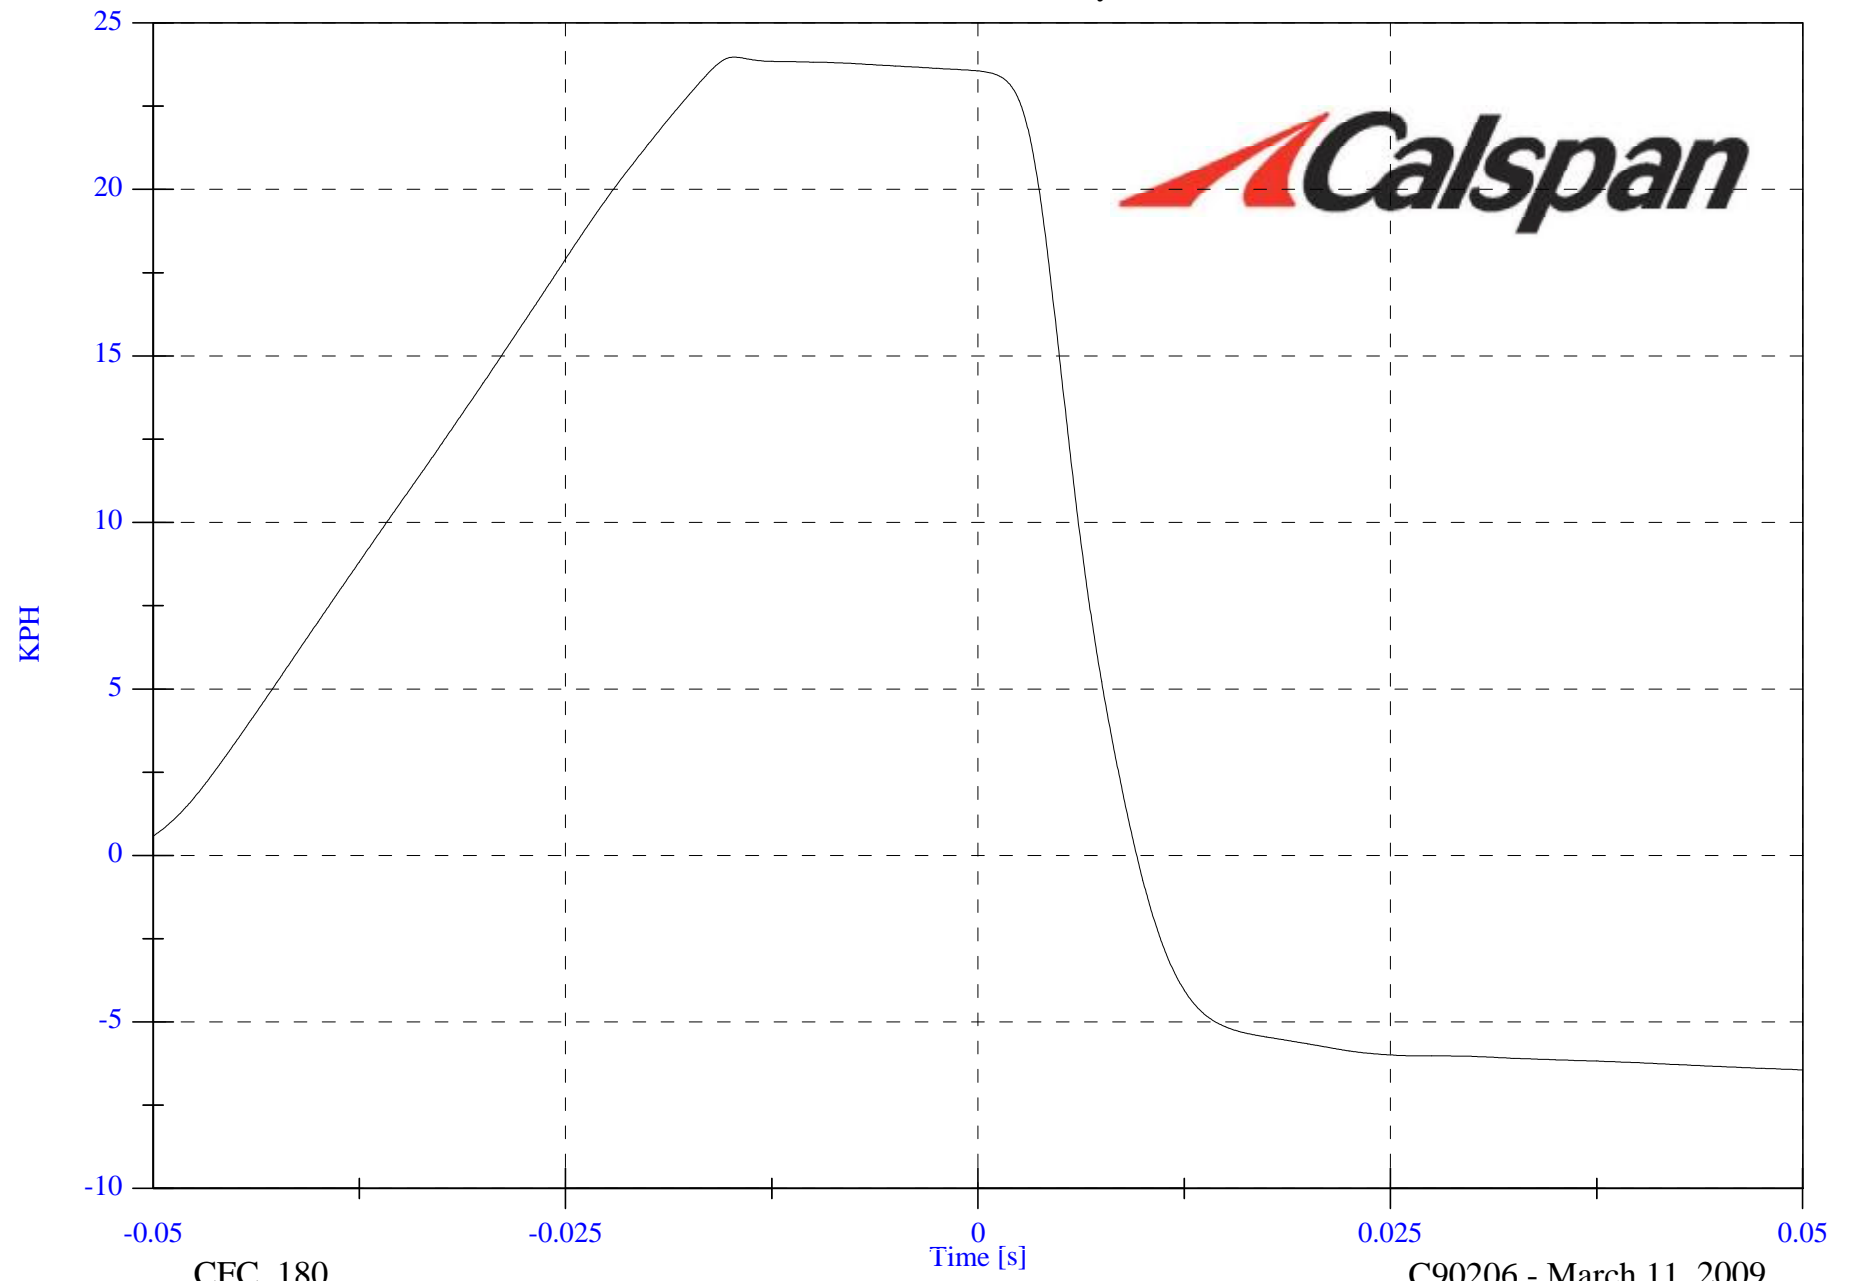
C90206 PASSENGER SIDE FH2 IMPACT PLOT #5

Max: 24.0 [KPH] at -0.015 [s]
Min: -6.4 [KPH] at 0.050 [s]
