**REPORT NUMBER: 221-MGA-2011-002**

**SAFETY COMPLIANCE TESTING FOR  
FMVSS NO.: 221  
SCHOOL BUS BODY JOINT STRENGTH**

**2011 GIRARDIN MICRO BIRD SCHOOL BUS  
NHTSA NO.: CB0903**

**PREPARED BY:  
MGA RESEARCH CORPORATION  
5000 WARREN ROAD  
BURLINGTON, WI 53105**

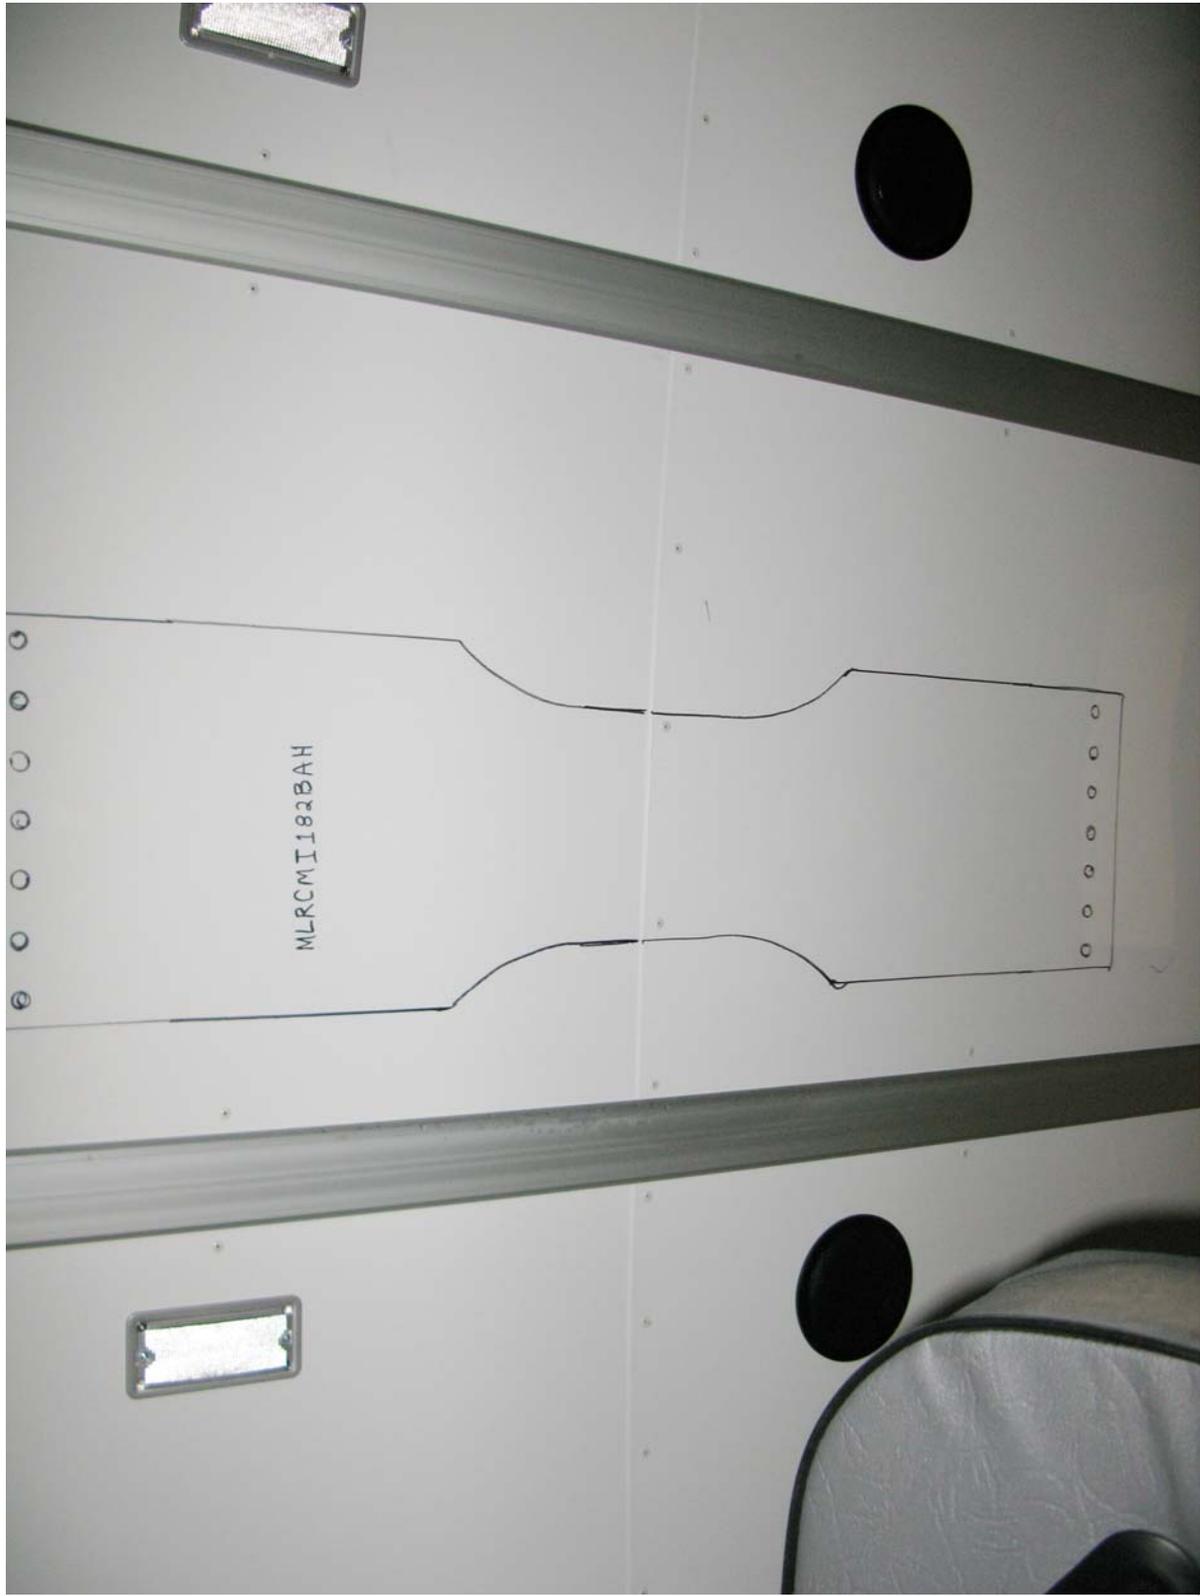
Location of Joint ID Number MLRCMI182BAH

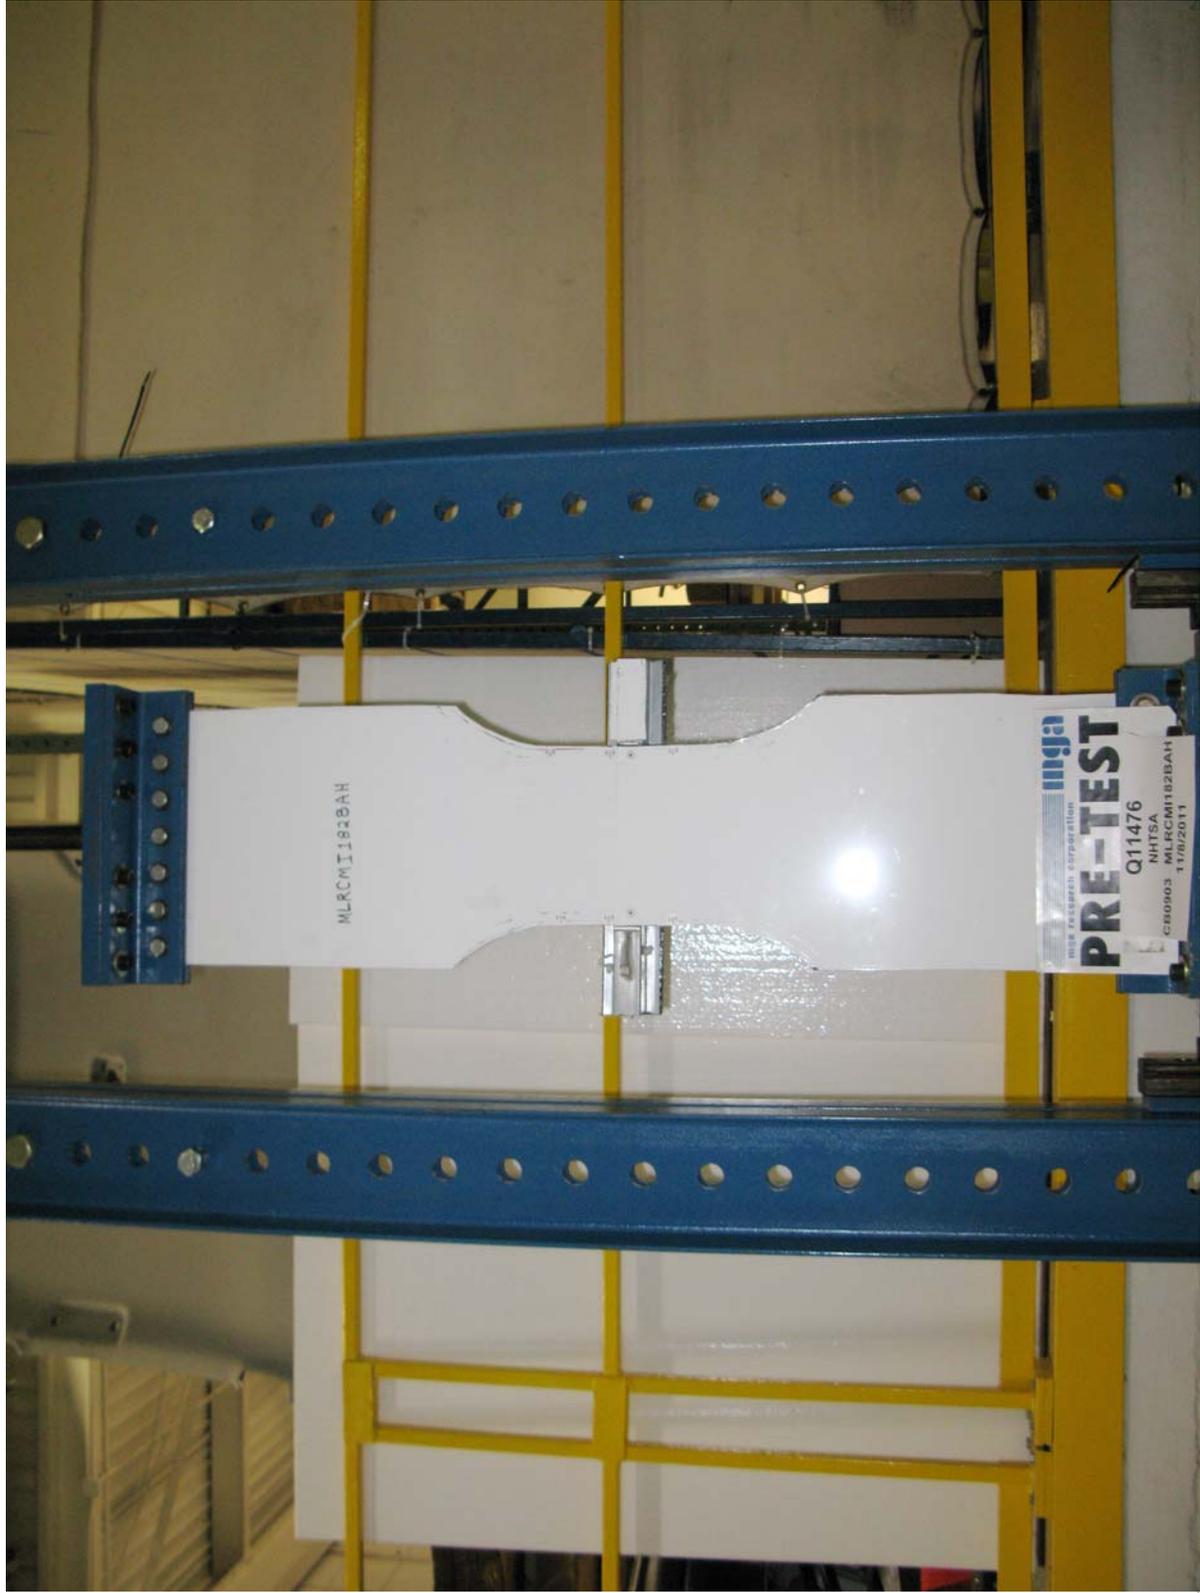
Specimen Description:	Interior Roof (Mid)		
Joint Number:	MLRCMI182BAH	Test Number:	Q11476

Weaker Member	Stronger Member
Material	Aluminum ASTM B19 5052-1-144	N/A
Tensile Strength (MPa)	262.0	N/A
Gage/Thickness (mm)	1.02	N/A
Fastener Holes (No./Diameter – mm.)	2 / 4.76	N/A
Net Area (Sq. mm.)	197.5	N/A
Material Strength (N)	51,757	N/A
60% of Material Strength (N)	31,054	N/A
Maximum Load From Tensile Test of Joint (N)	8,660	N/A
PASS/FAIL	<b>FAIL</b>	N/A

Pre-Test of Joint ID Number MLRCMI182BAH

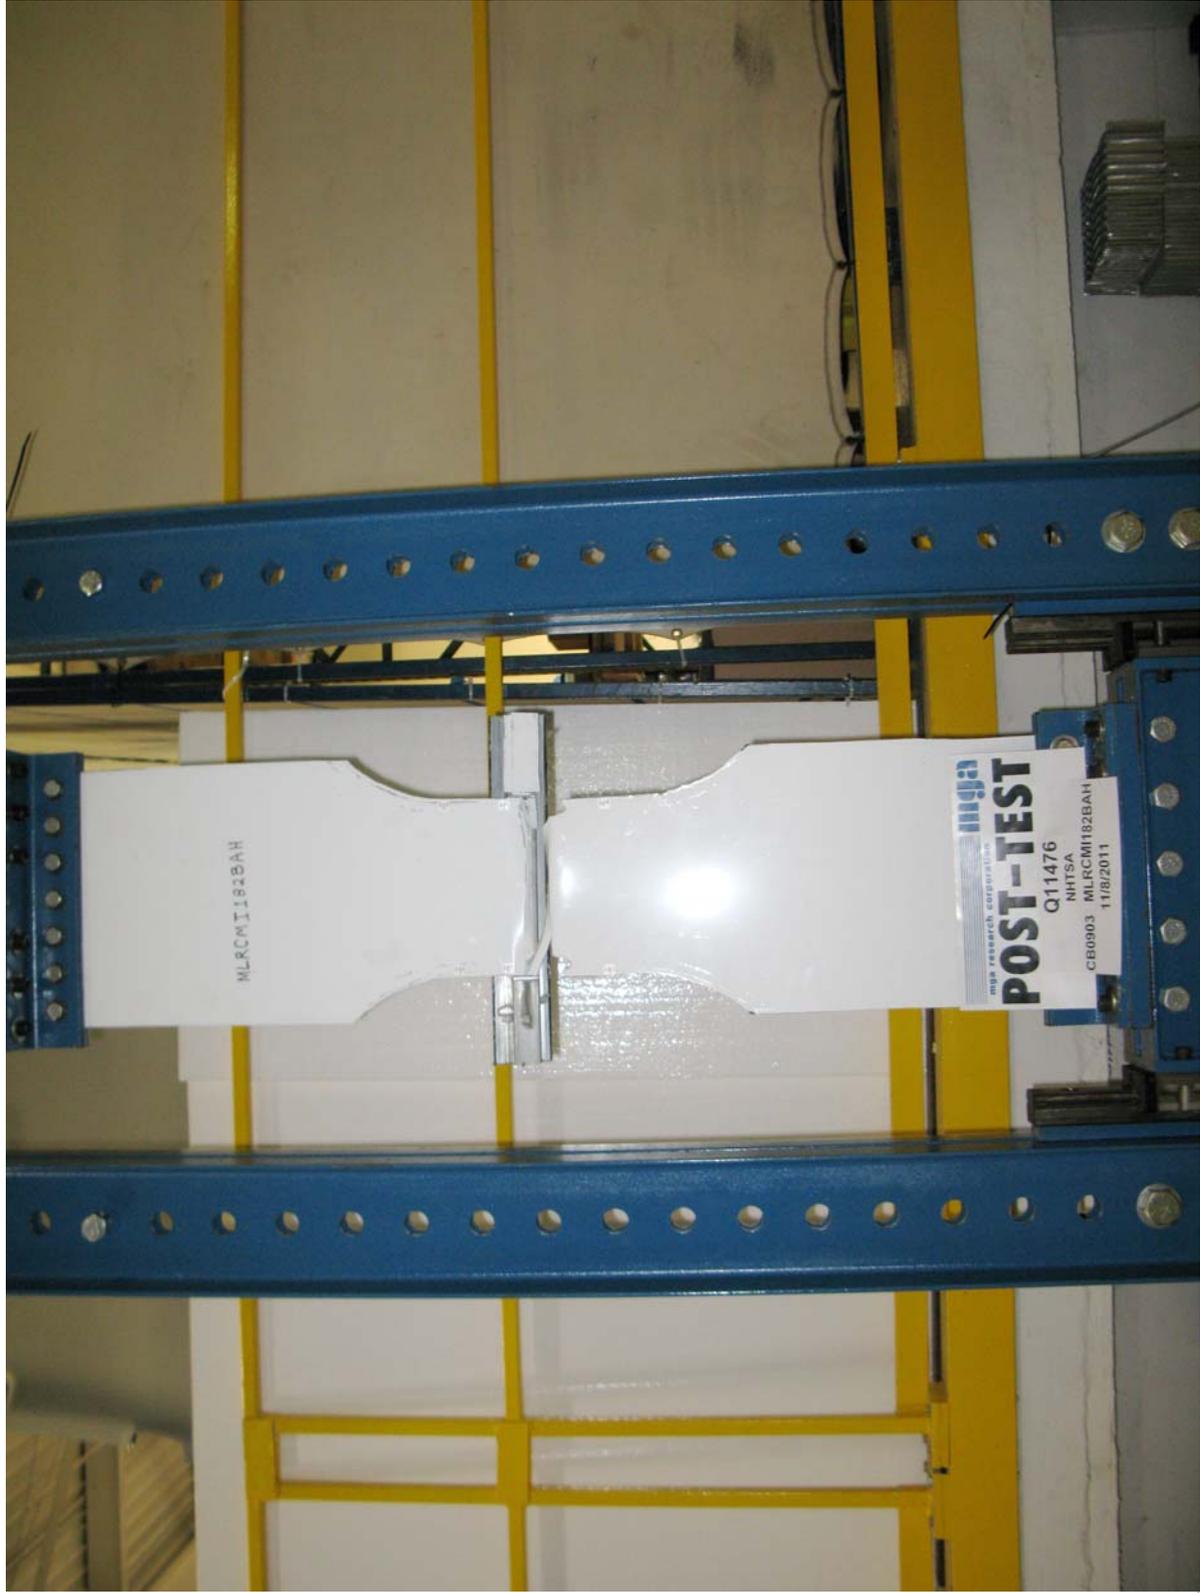
Joint Location	Joint Specimen I.D.	Maximum Load (N)	60% of Material Strength (N)	PASS/FAIL
Interior Roof (Middle)	MLRCMI182BAH	8,660	31,054	<b>FAIL</b>
Interior Roof (Middle)	Remedy Sample	44,369	27,193	<b>PASS</b>

Post-Test of Joint ID Number MLRCM182BAH

During the body joint test, sample MLRCMI182BAH, removed from the interior mid roof panel, failed to hold the body panel to the member it was joined when subjected to a force of 60 percent of the tensile strength of the weakest joined body panel, as required by S5.1 of FMVSS 221.

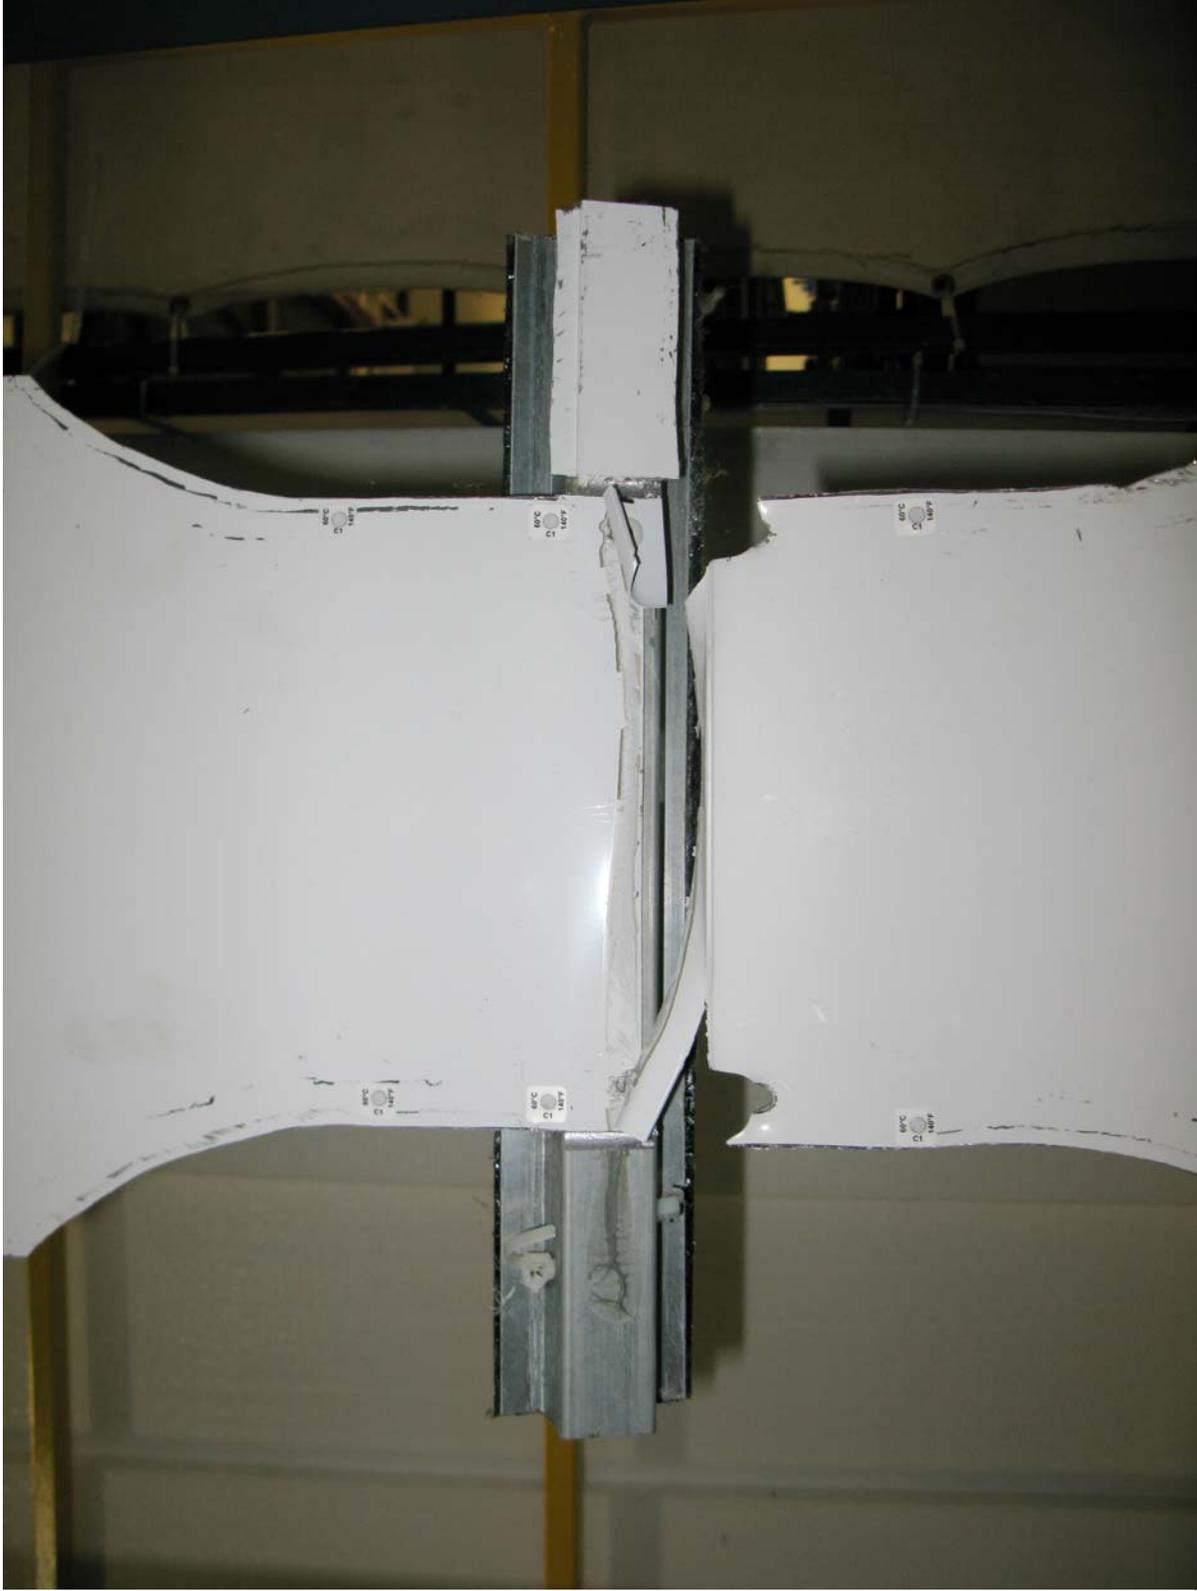
Post-Test of Joint ID Number MLRCMI182BAH, Close Up View

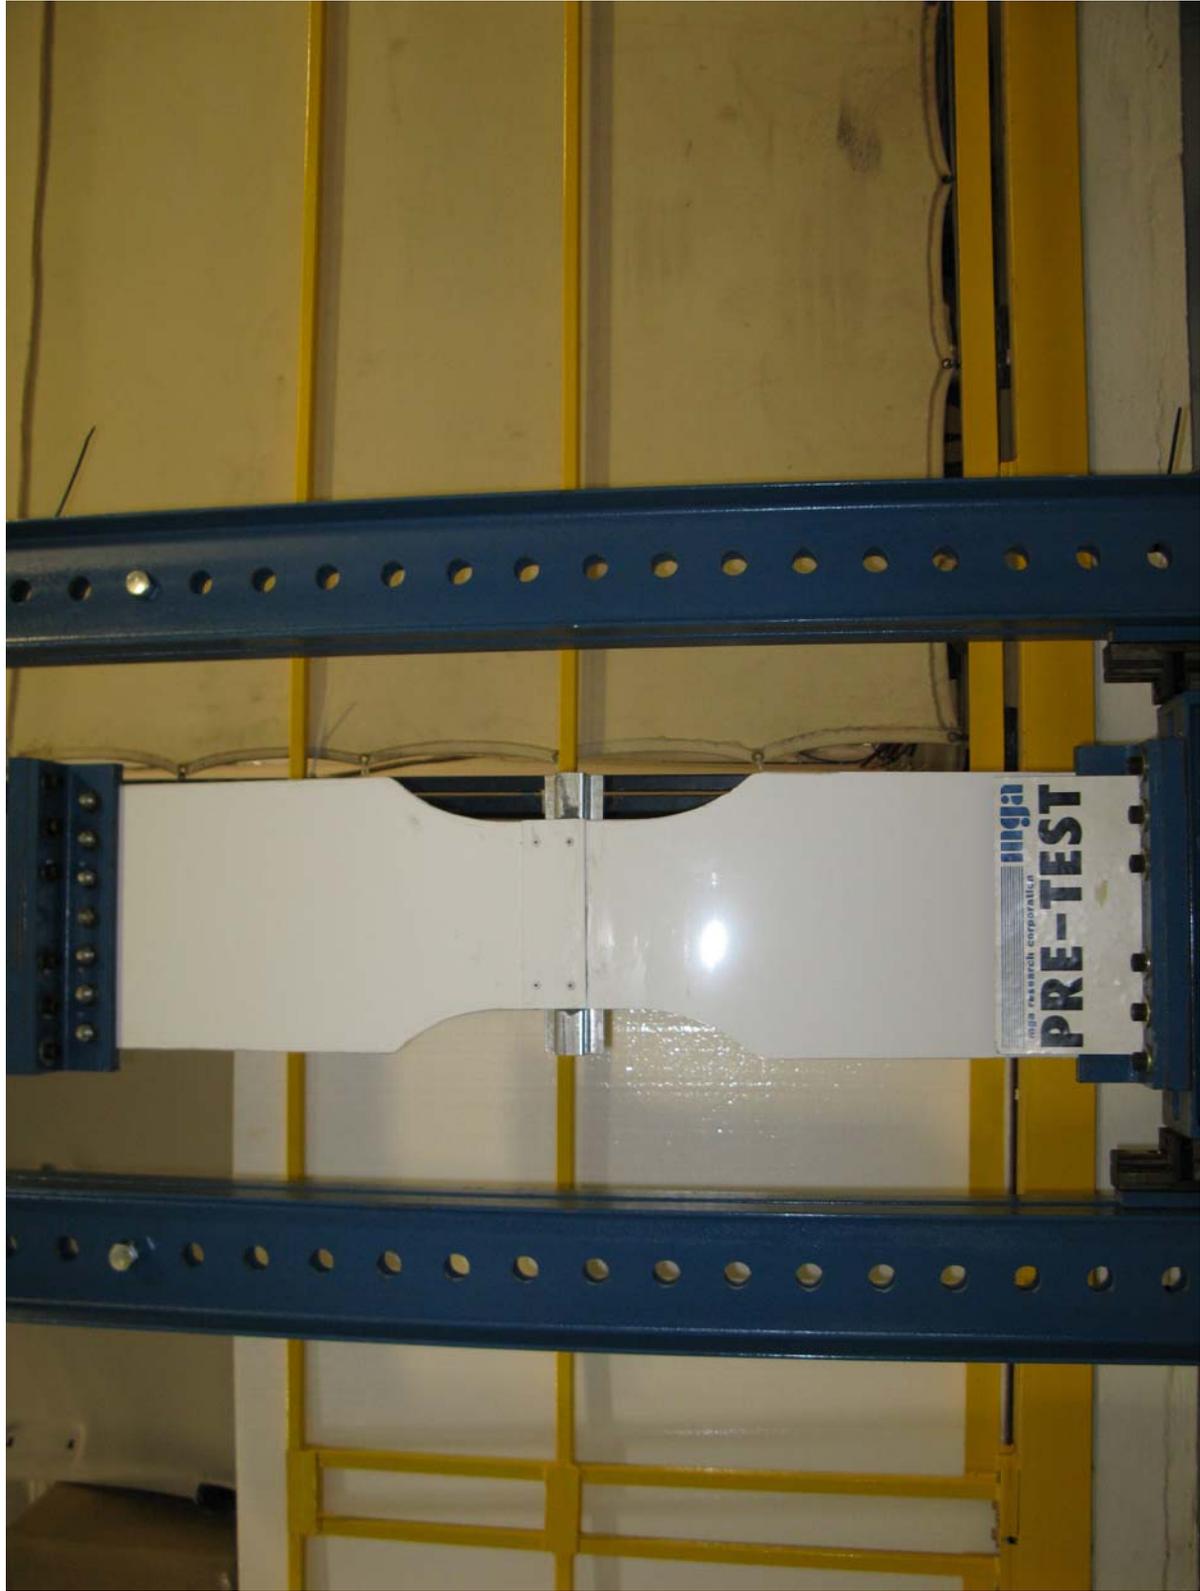
Specimen Description:	Interior Roof (Mid)		
Joint Number:	Remedy Sample	Test Number:	Q11514

Weaker Member	Stronger Member
Material	Aluminum ASTM B19 5052-1-144	N/A
Tensile Strength (MPa)	262.0	N/A
Gage/Thickness (mm)	0.99	N/A
Fastener Holes (No./Diameter – mm.)	6 / 4.76	N/A
Net Area (Sq. mm.)	173.0	N/A
Material Strength (N)	45,322	N/A
60% of Material Strength (N)	27,193	N/A
Maximum Load From Tensile Test of Joint (N)	44,369	N/A
PASS/FAIL	<b>PASS</b>	N/A

Pre-Test of Joint ID Remedy Sample

The joint samples were selected in conjunction with the Contract Officer's Technical Representative (COTR). One 12 x 48 inch sample was selected from the Bus. The sample was removed from the bus using a metal shear and/or SawzAll type of cutter. A second sample, identified as 'remedy sample', was provided by the manufacturer with the proposed remedy applied to it and at the approval of the COTR.

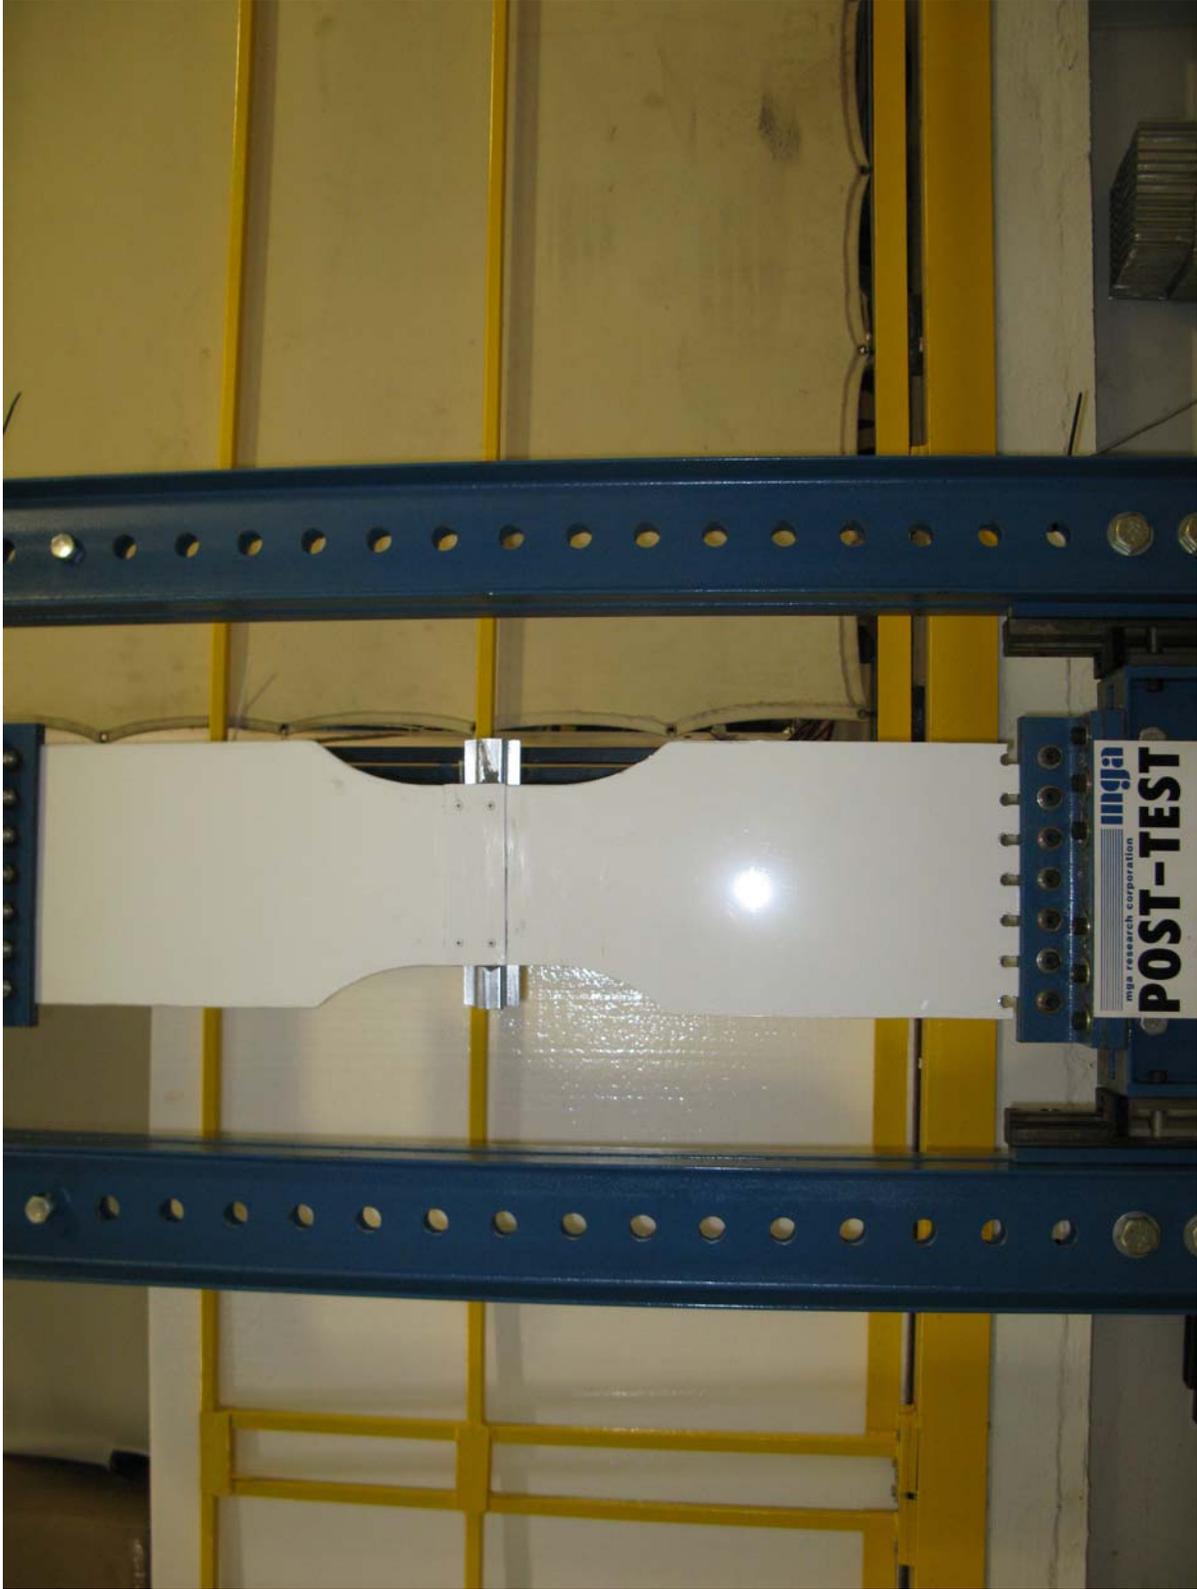
Post-Test of Joint ID Remedy Sample

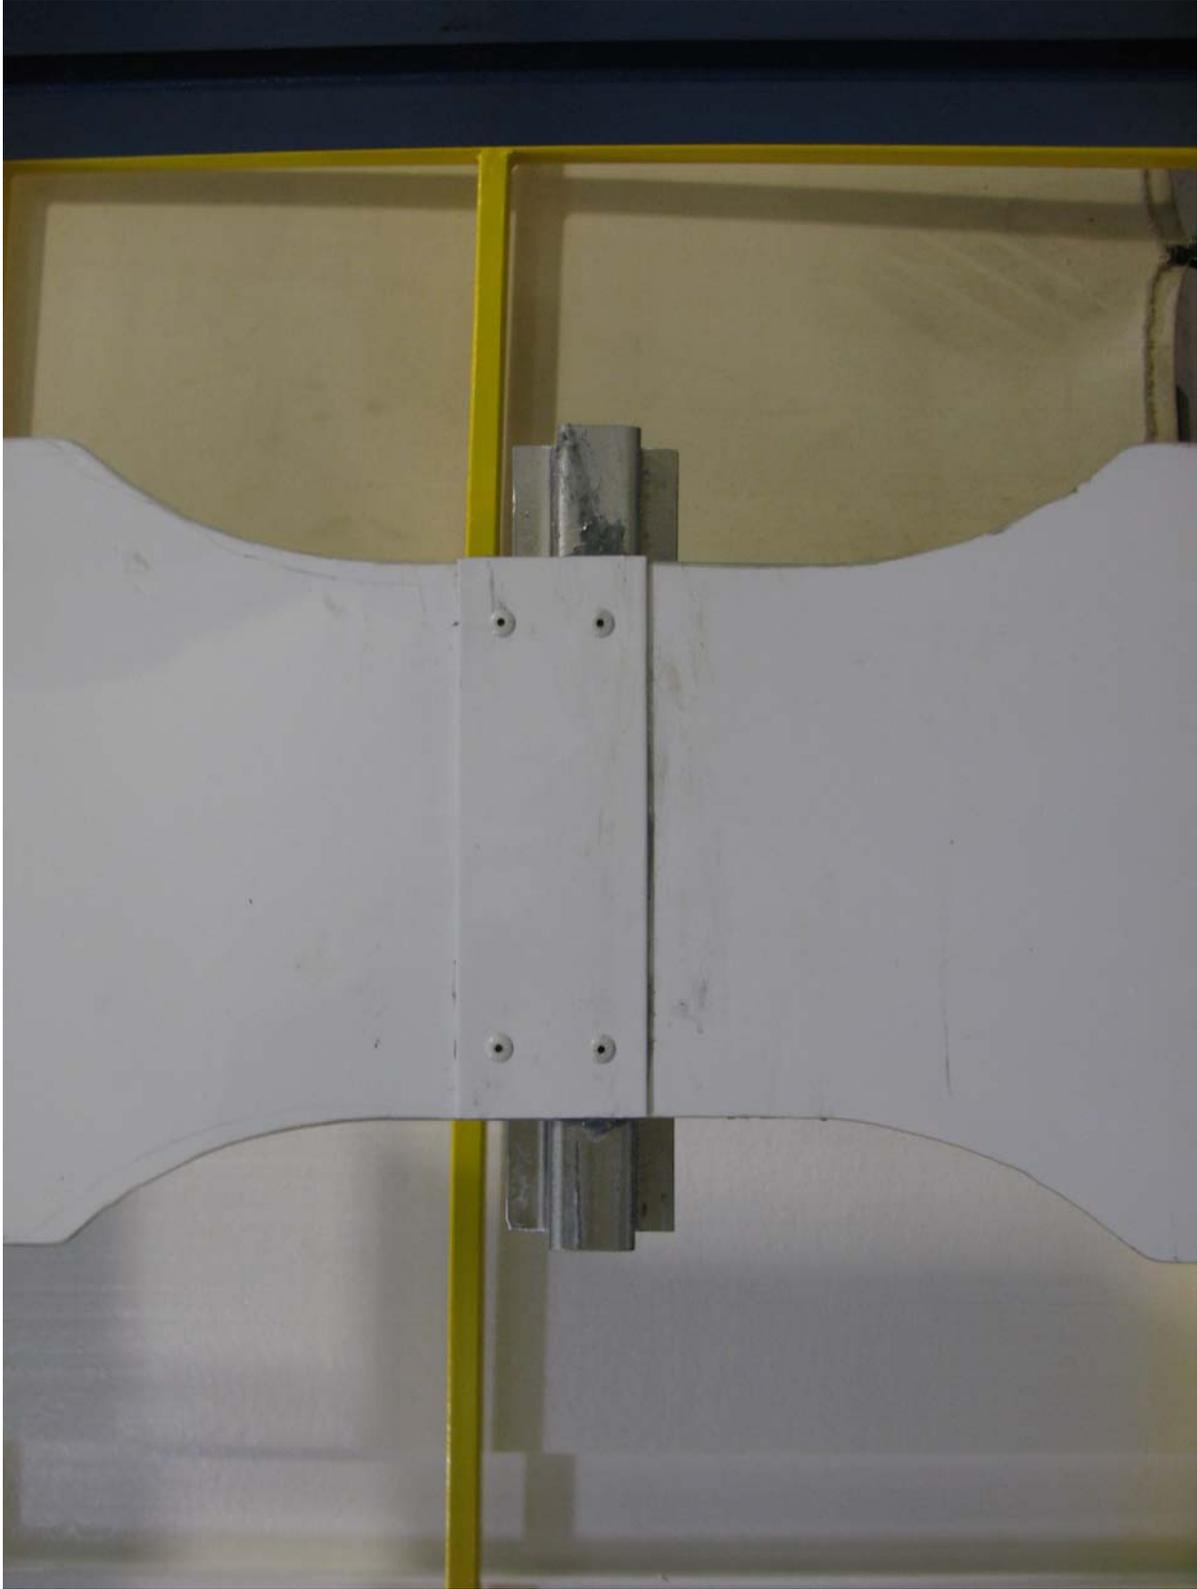
Post-Test of Joint ID Remedy Sample, Close Up View

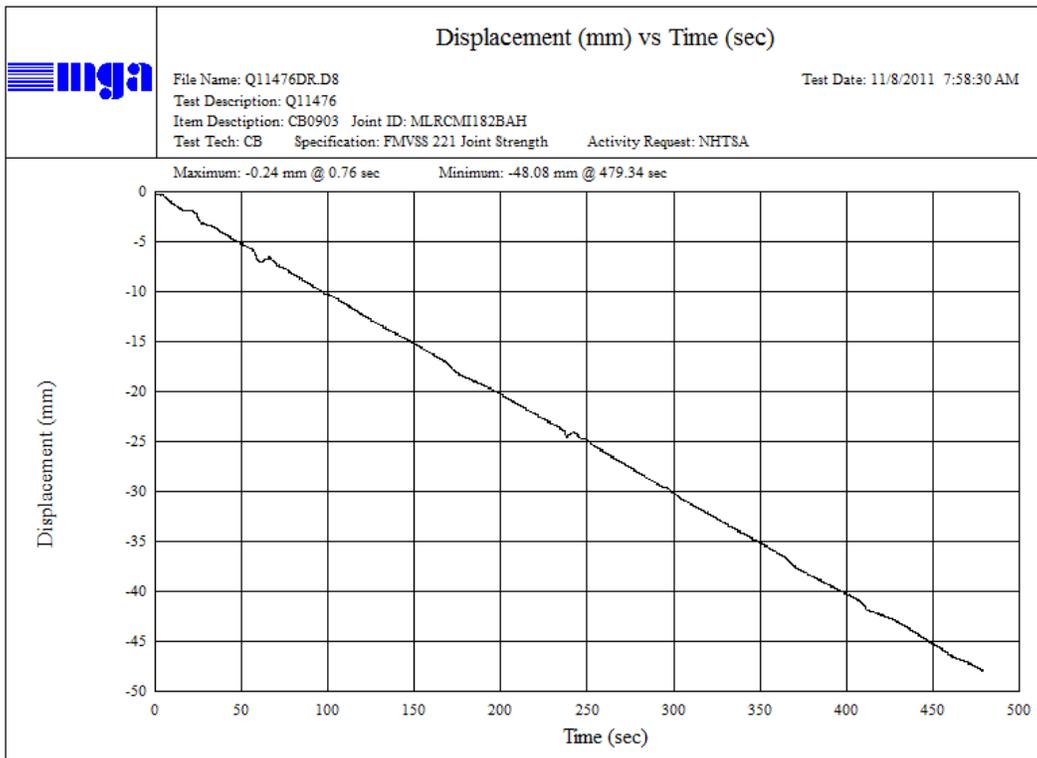
The rate of load application was ¼ inch per minute. The force and displacement were recorded and displacement vs. time was plotted to monitor the displacement rate.

Joint Strength, ID Number MLRCMI182BAH, Displacement vs. Time

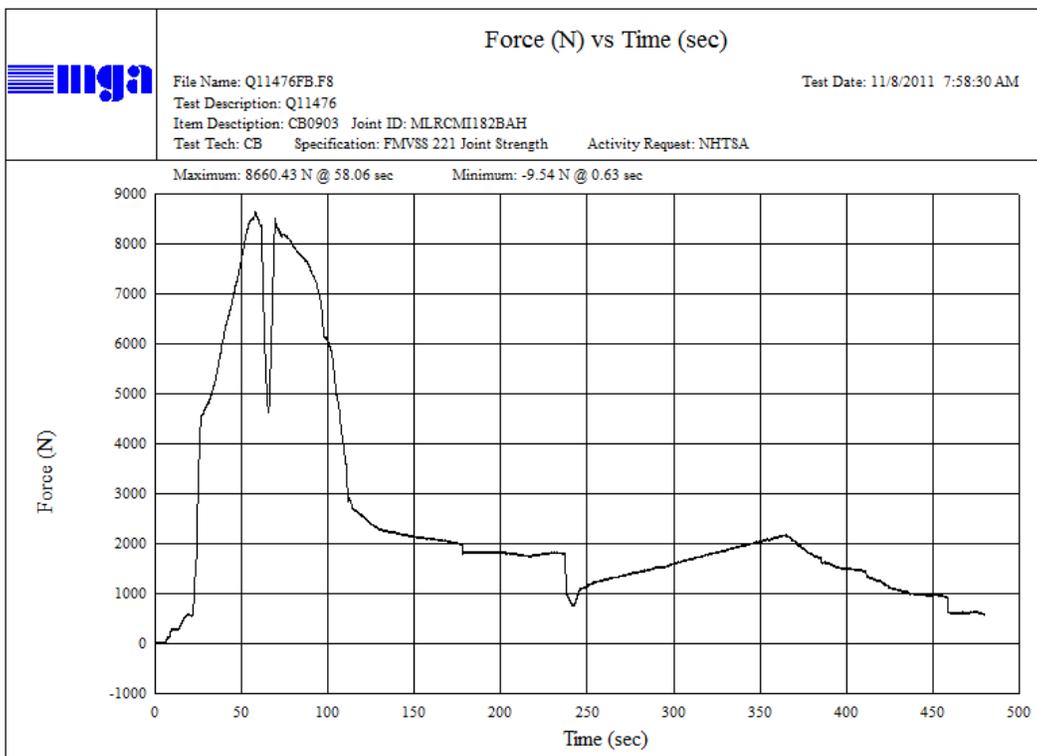
Joint Strength, ID Number MLRCMI182BAH, Force vs. Time

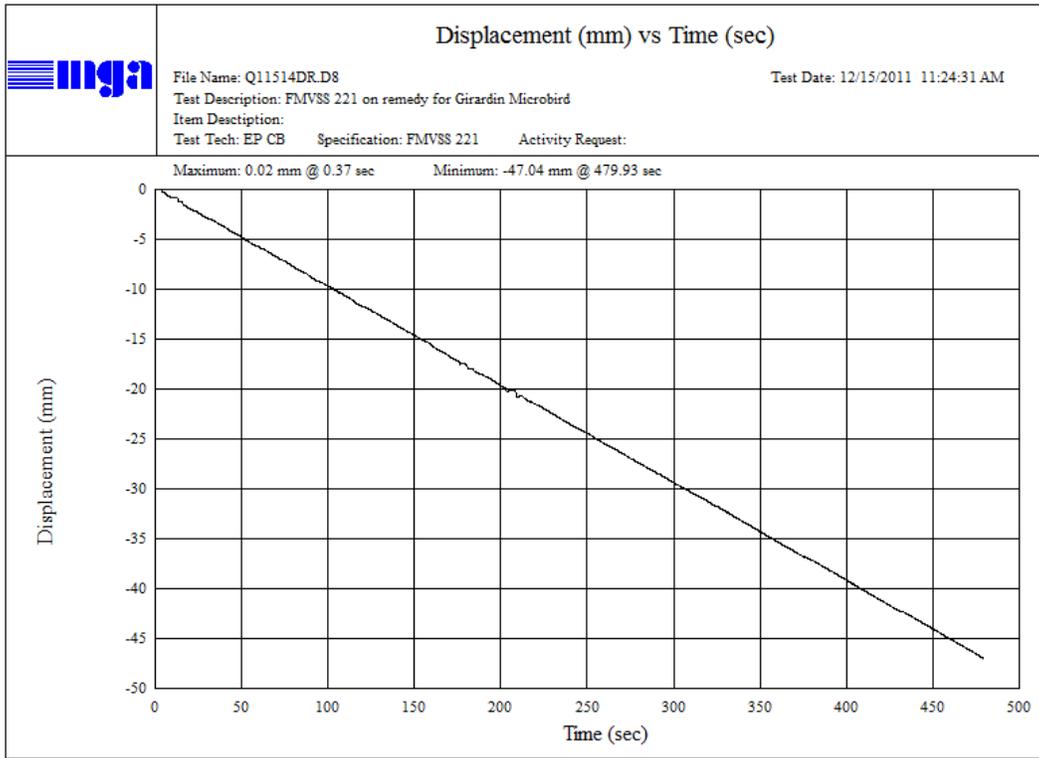
Joint Strength, ID Remedy Sample, Displacement vs. Time

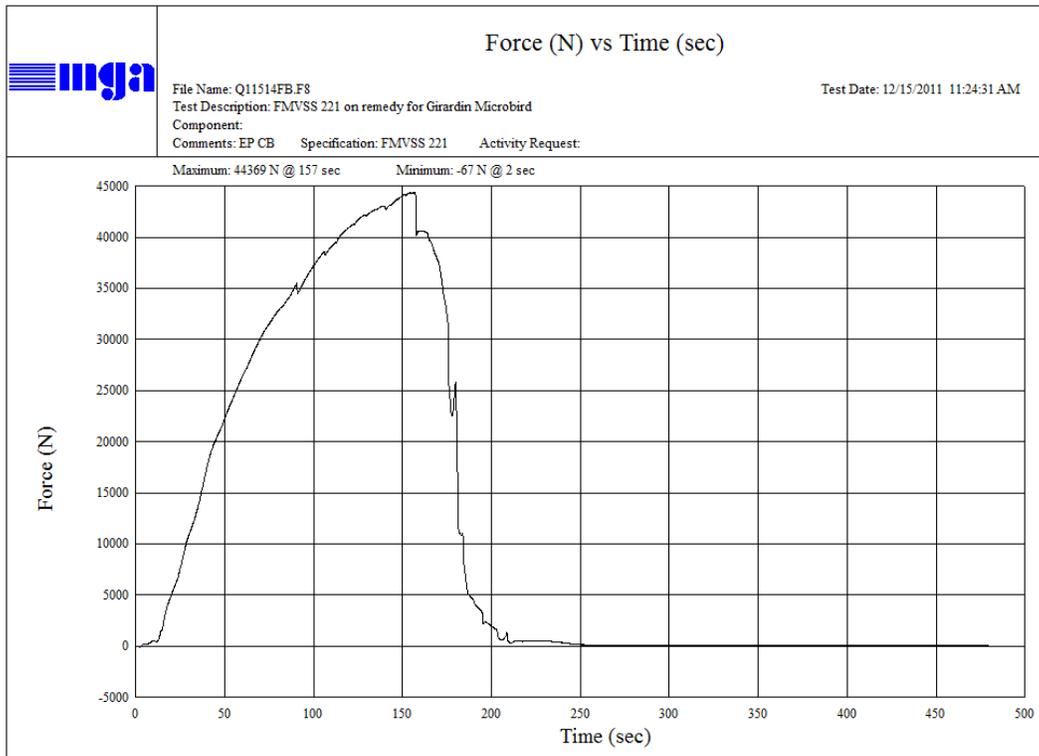
Joint Strength, ID Remedy Sample, Force vs. Time

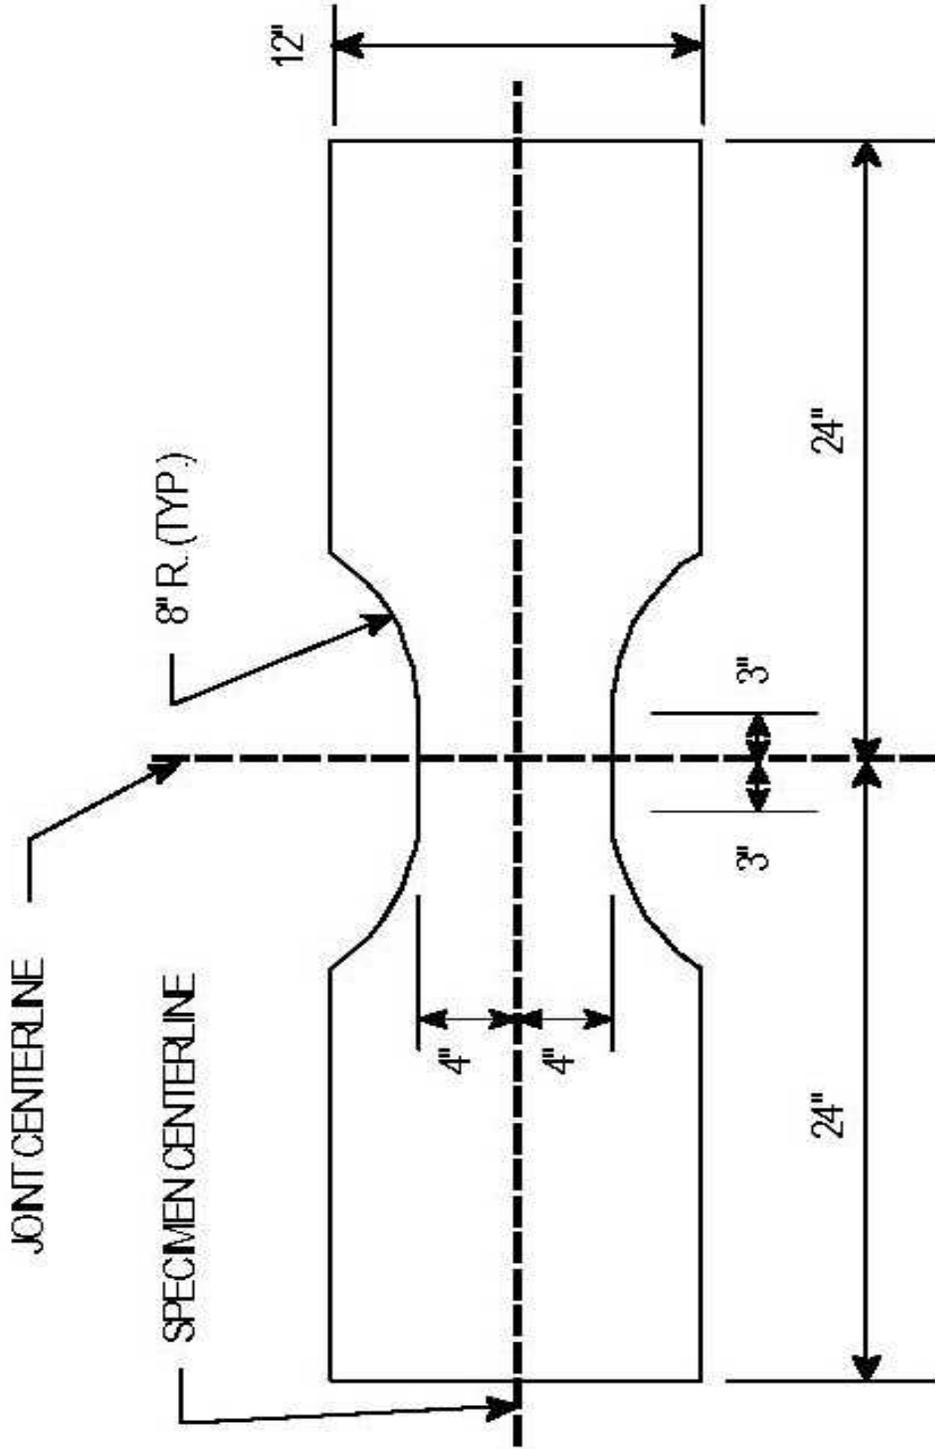
After the sample was removed from the bus, the sample was cut to the specific selected dimensions. The specimen was carefully shaped to the final size using supports as specified in FMVSS 221. Additionally, temperature monitoring stickers were placed at the specified locations of the samples to ensure the sample temperature did not exceed 140°F during the shaping operation.

**DIMENSION REQUIREMENTS OF BODY PANEL SPECIMEN  
WHOSE JOINT SEGMENT IS 8 INCHES LONG**

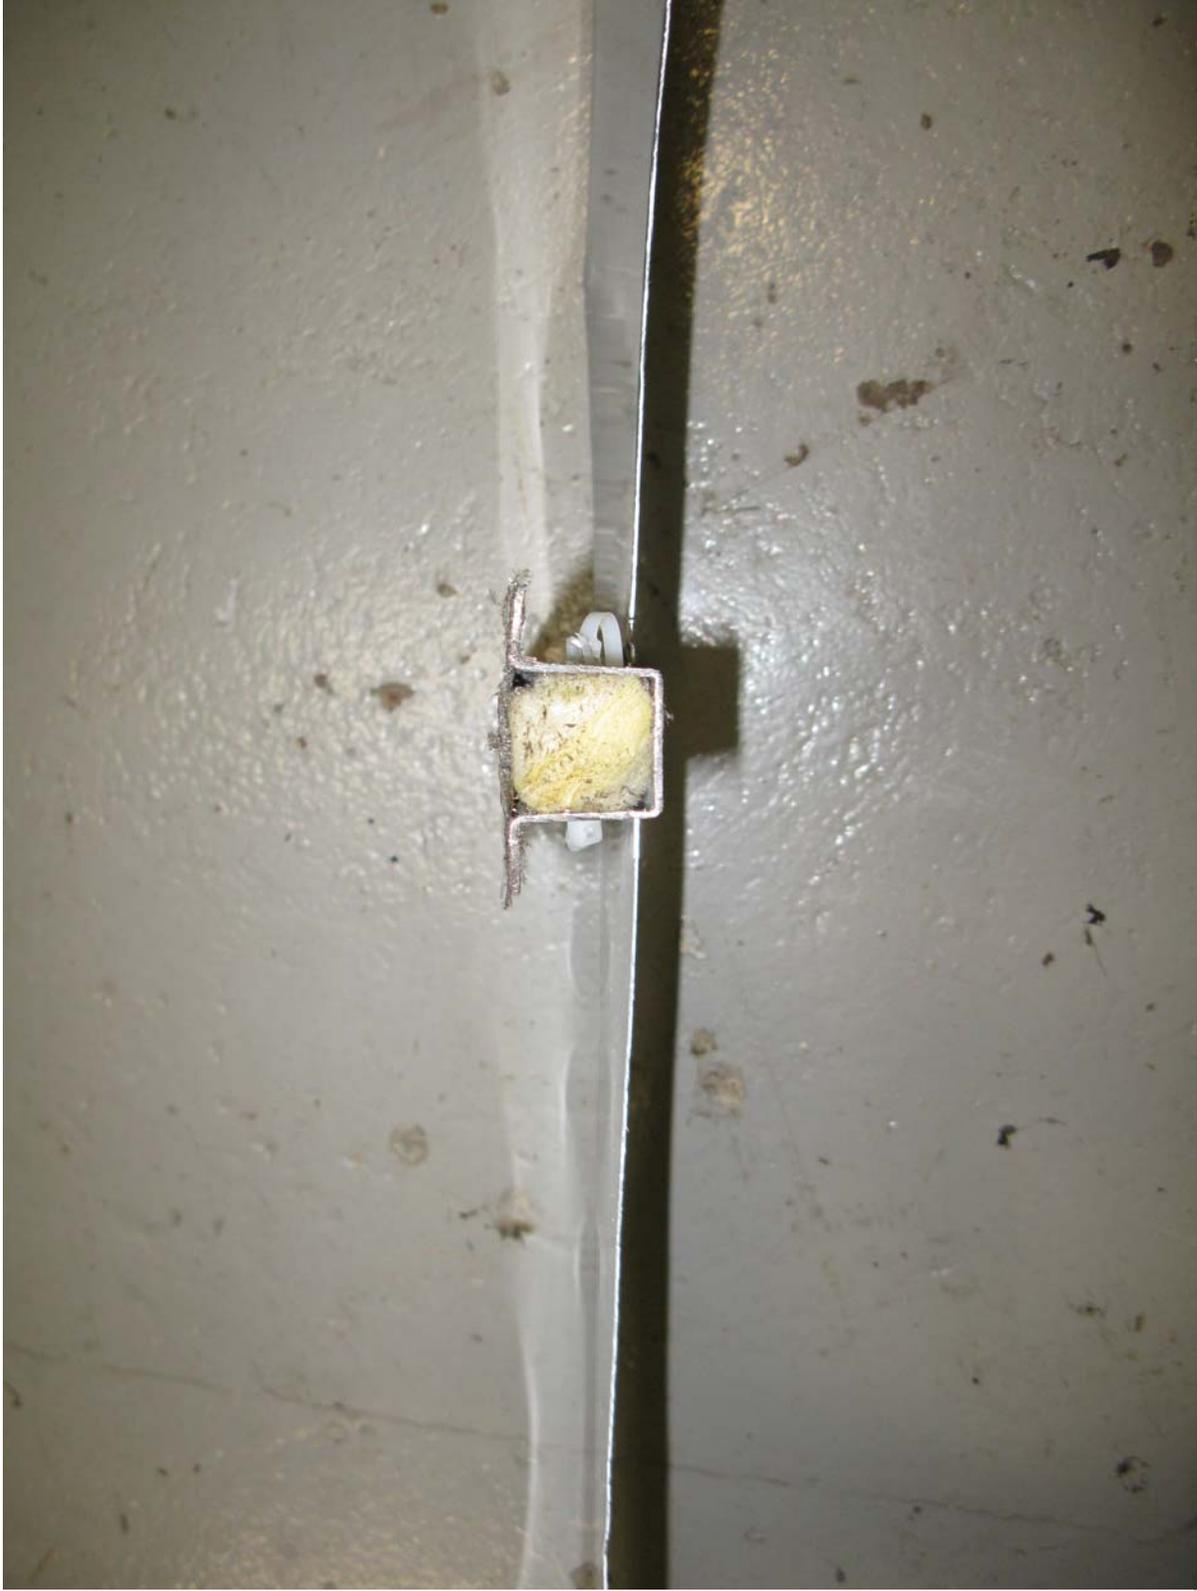
View of Joint ID Number MLRCMI182BAH

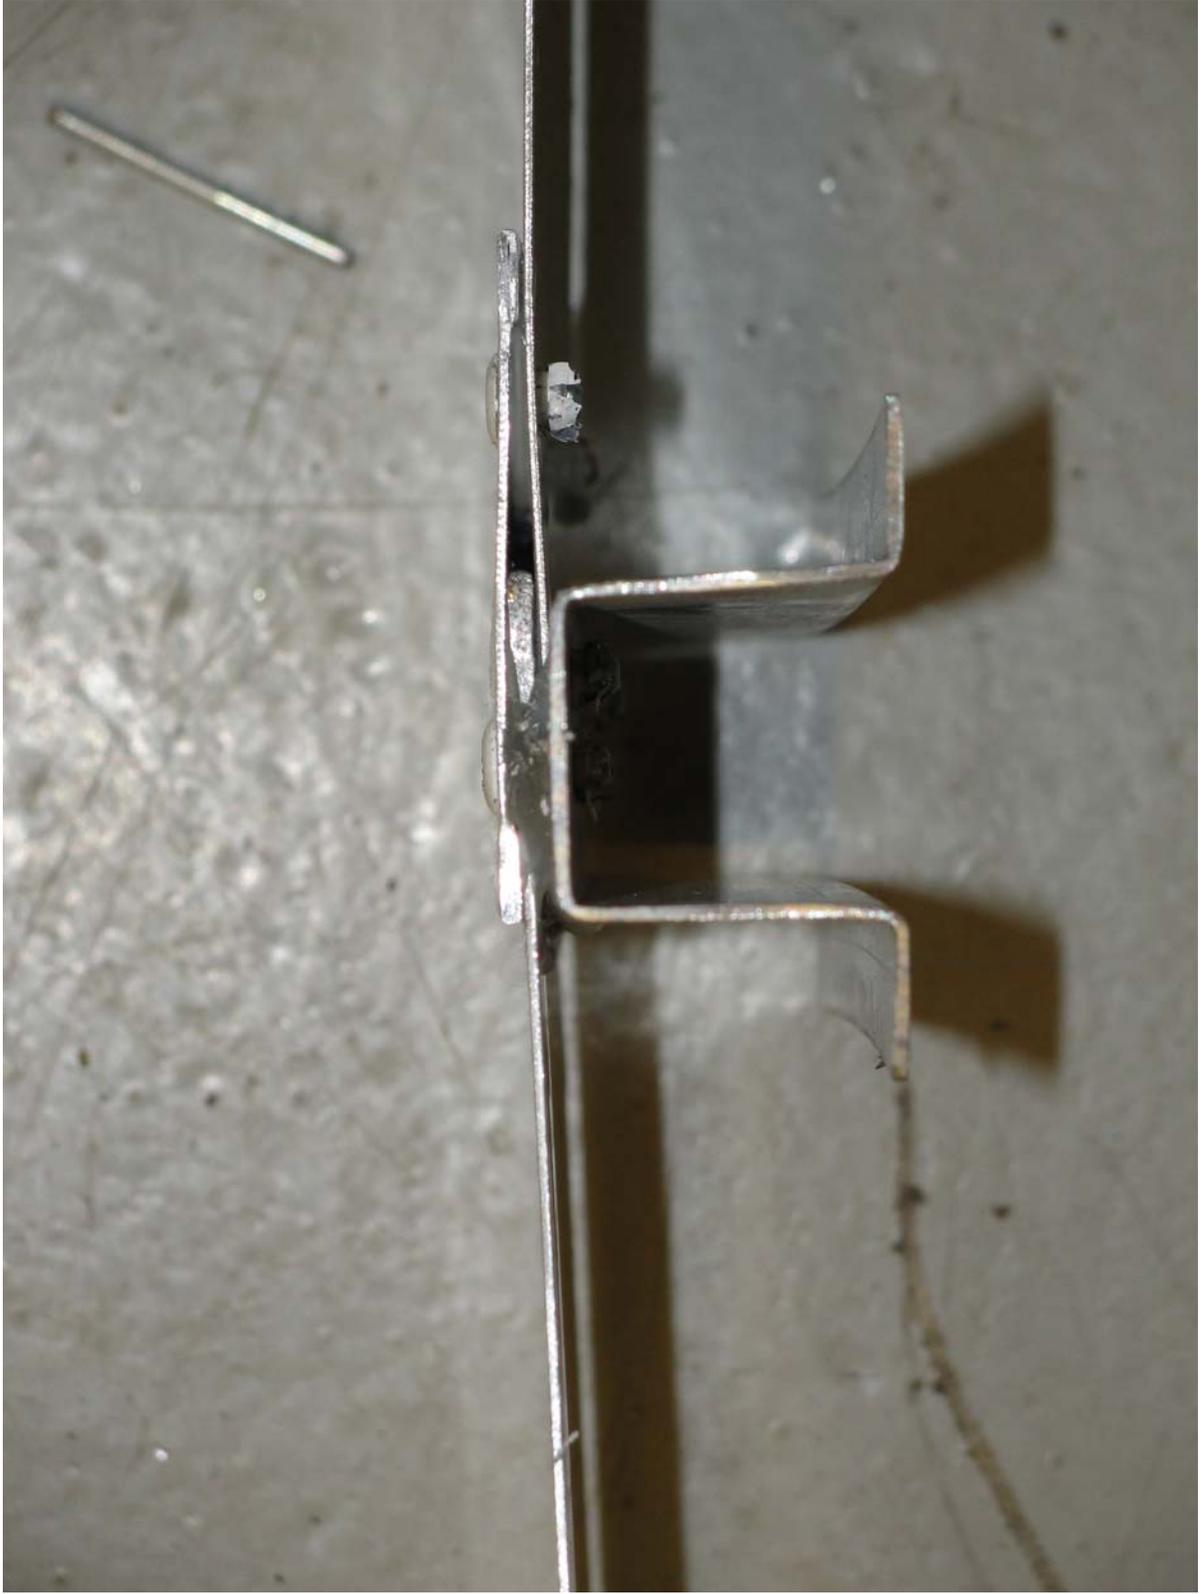
View of Joint ID Remedy Sample
