**REPORT NUMBER: 214P-MGA-2011-020**

**SAFETY COMPLIANCE TESTING FOR FMVSS 214  
DYNAMIC SIDE IMPACT PROTECTION  
RIGID POLE**

**GENERAL MOTORS LLC  
2011 CHEVROLET VOLT 5-DR HATCHBACK  
NHTSA NUMBER: CB0102**

**PREPARED BY:  
MGA RESEARCH CORPORATION  
5000 WARREN ROAD  
BURLINGTON, WI 53105**

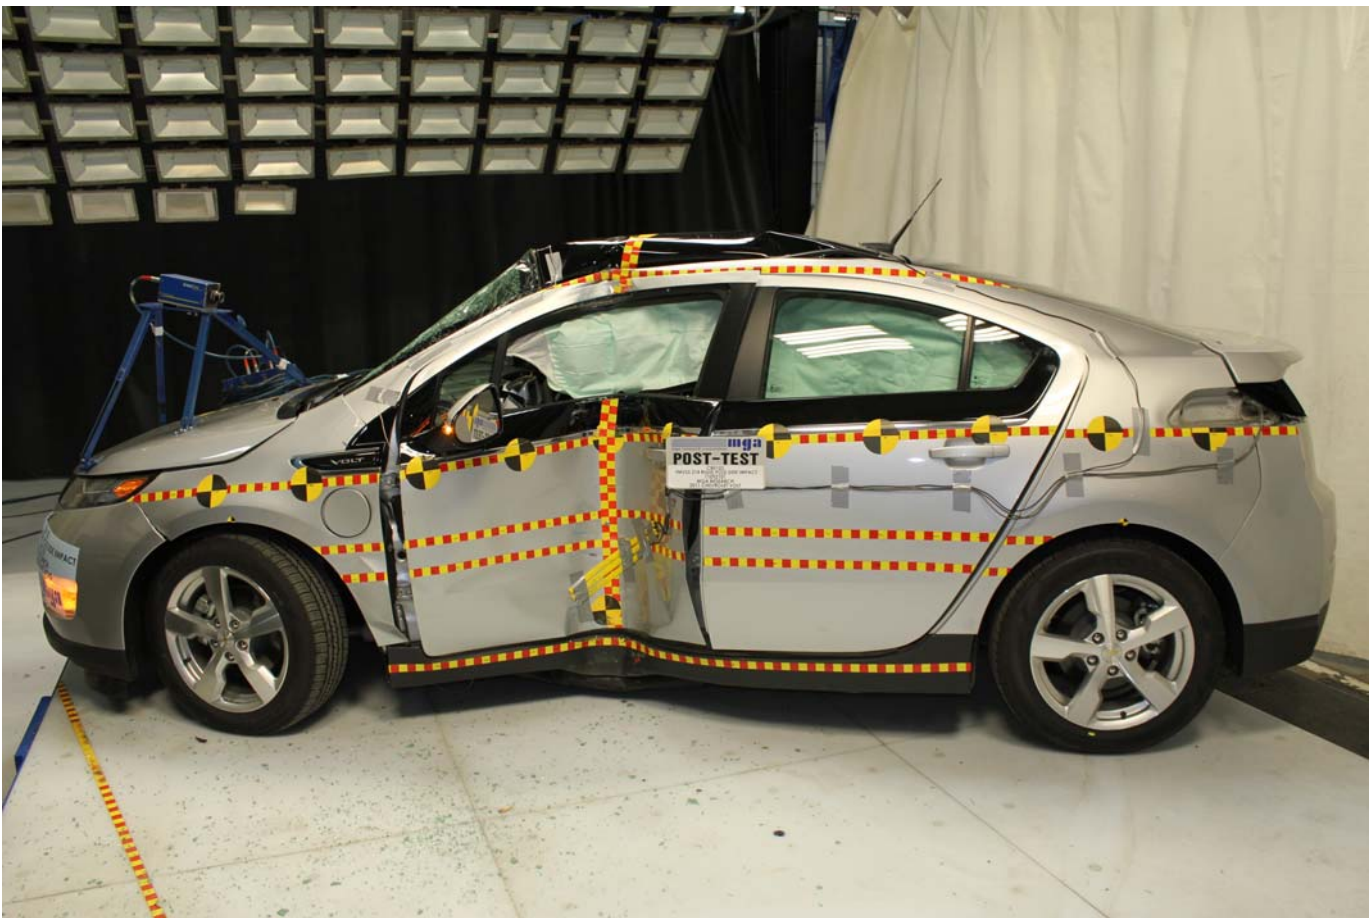
Post-Test Impacted Side View of Test Vehicle

Description	Front	Rear
Left Side Doors	Remained closed and jammed shut	Remained closed
Right Side Doors	Remained closed and operational	Remained closed and operational
Hatch and Other Doors		Remained closed and operational
Seat Movement	0	0
Seat Back Failure	None	None

Critical Areas of Performance	Observations and Conclusions
Pillar Performance	No Separation
Sill Separation	None
Windshield Damage	Cracked
Window Damage	Left Front Window Cracked
Other Notable Effects	None

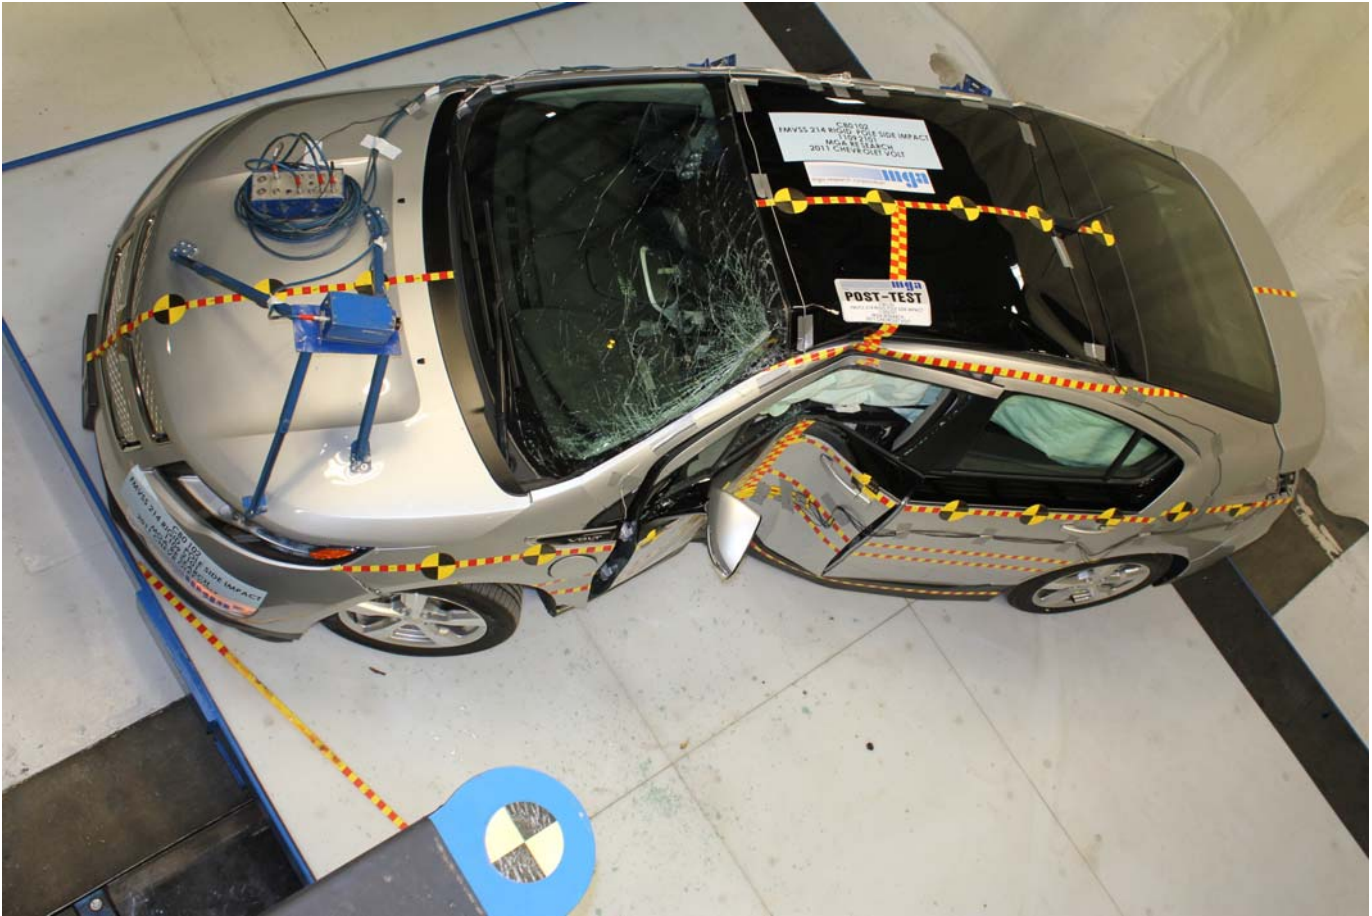
Post-Test Overhead View of Test Vehicle

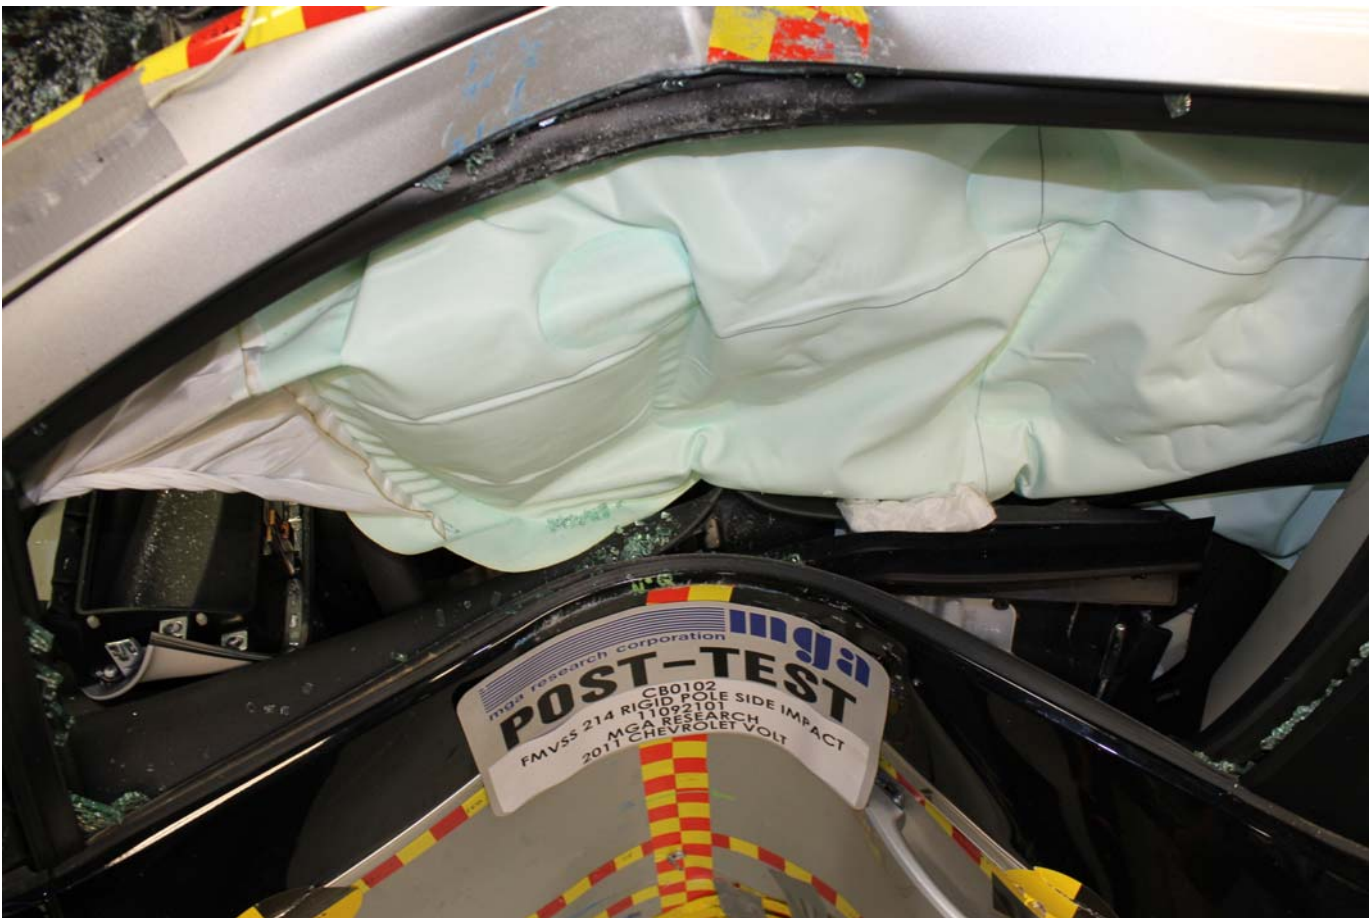
Post-Test Dummy Shoulder and Door Top View

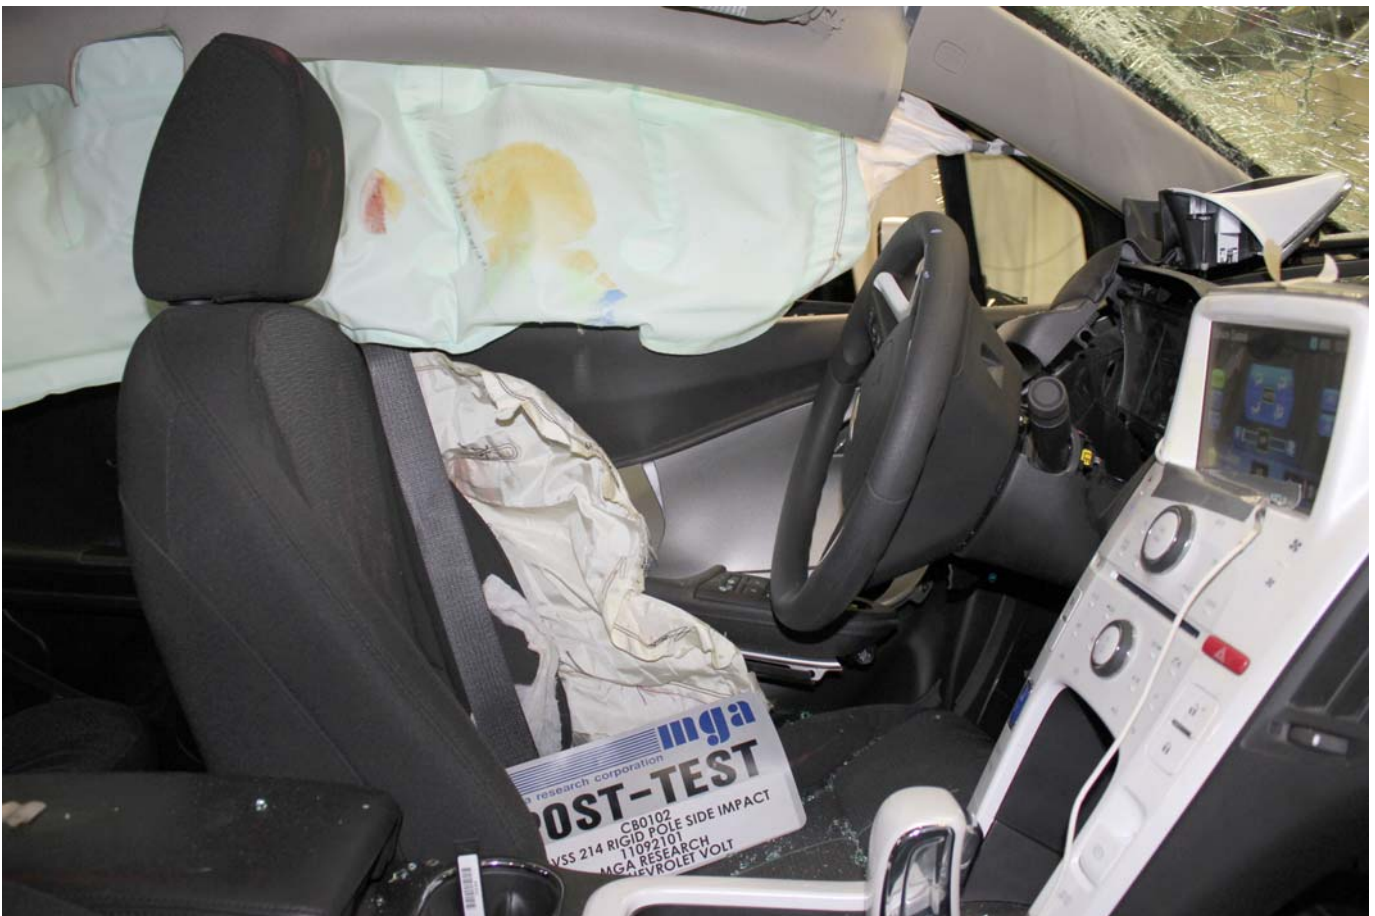
Post-Test Interior of Front Door Showing Dummy Impact Locations

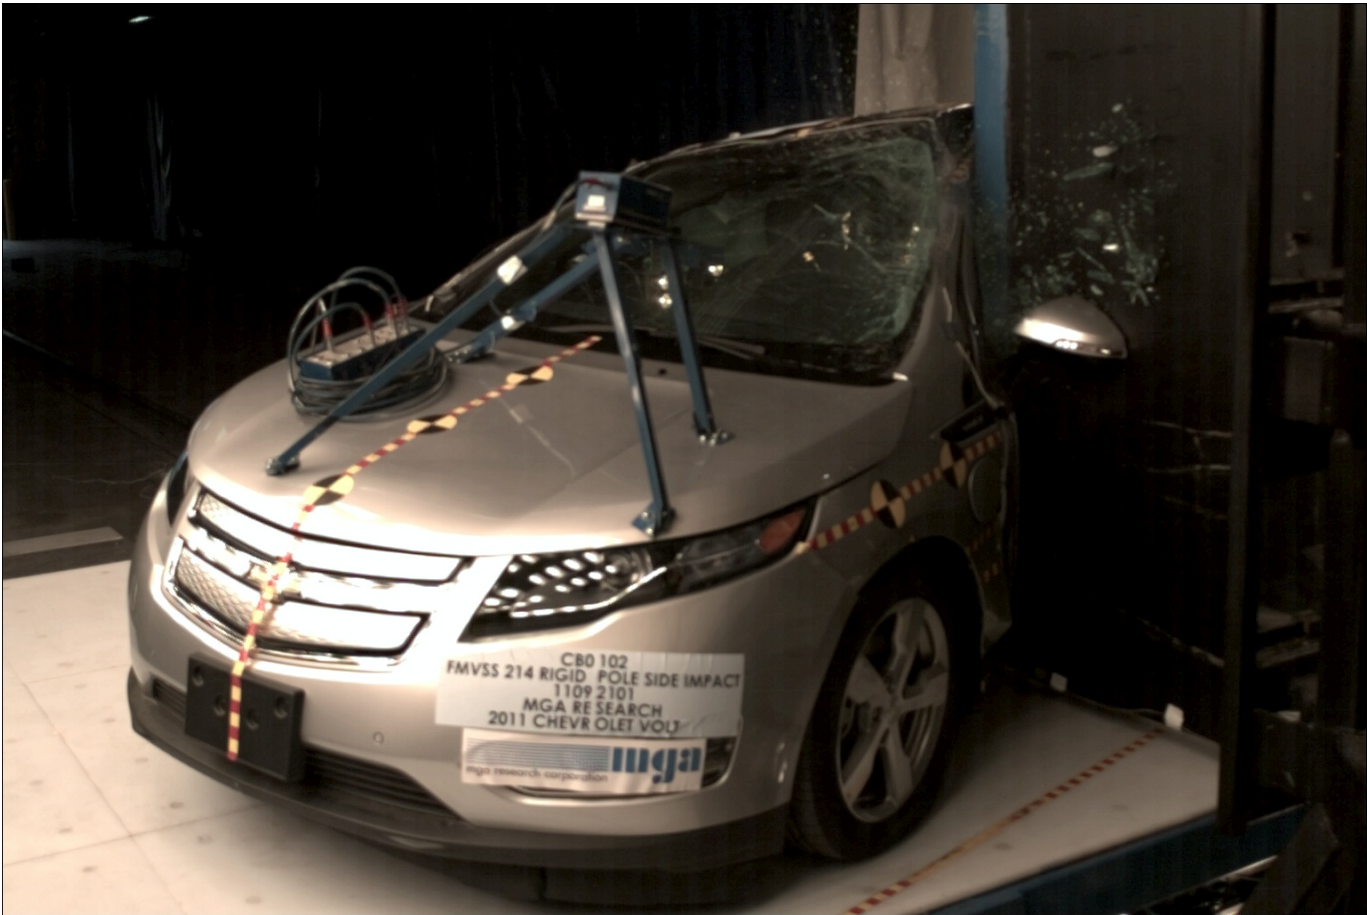
Impact Event

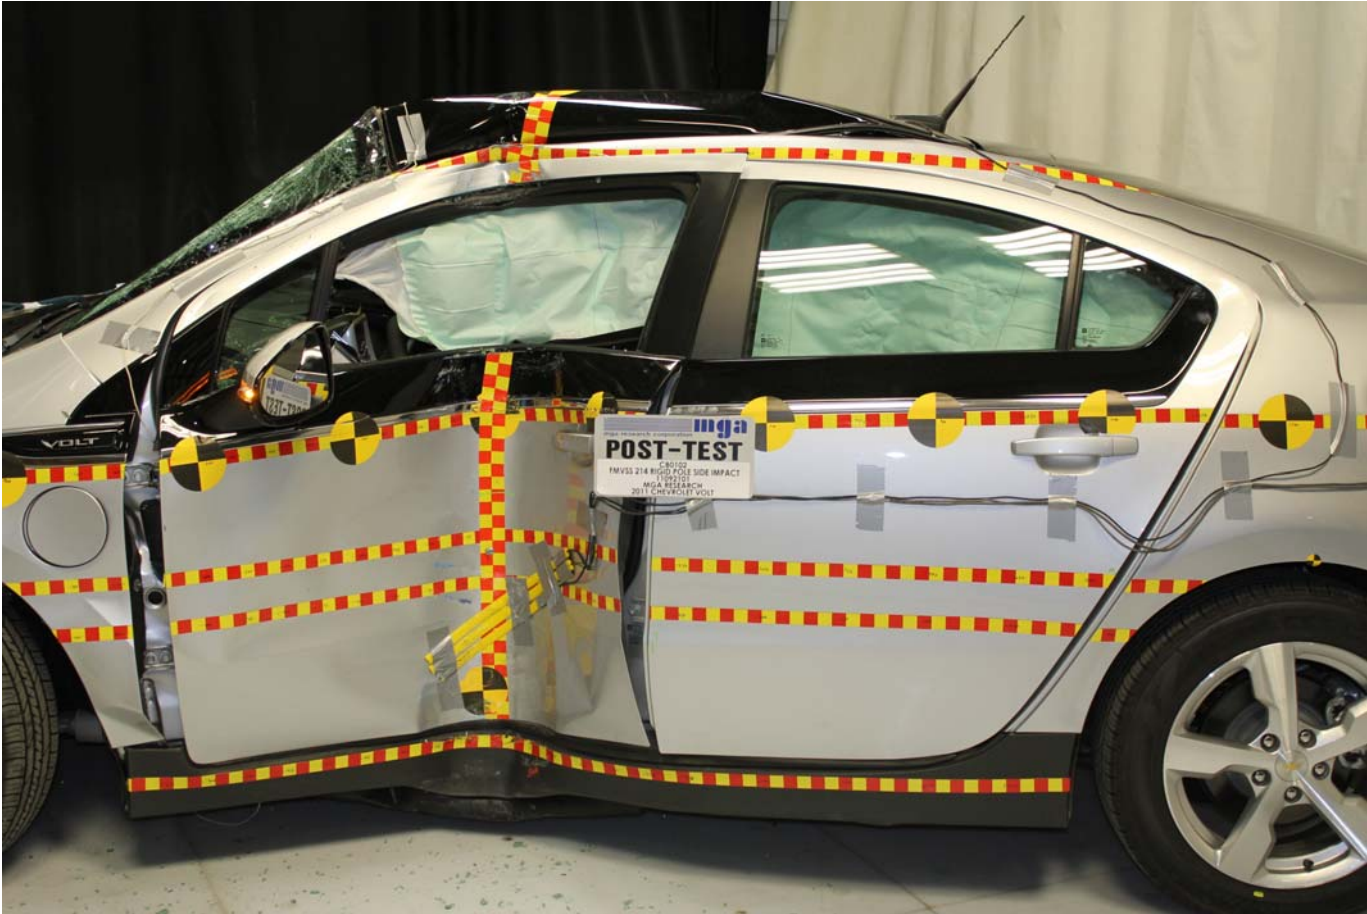
Post-Test Impact Zone Close-up View

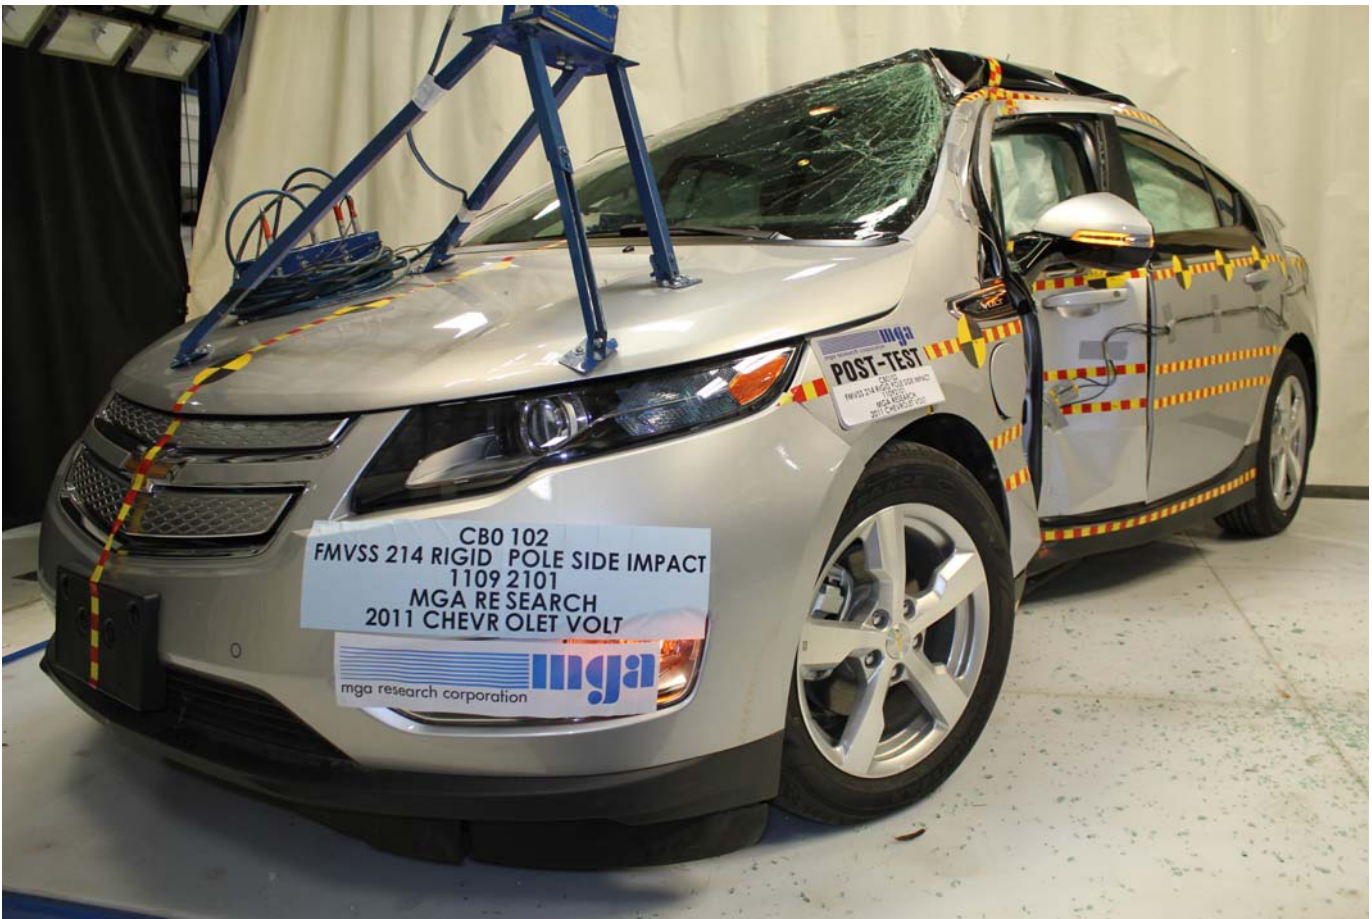
Post-Test  $\frac{3}{4}$  Front View of Impact Zone

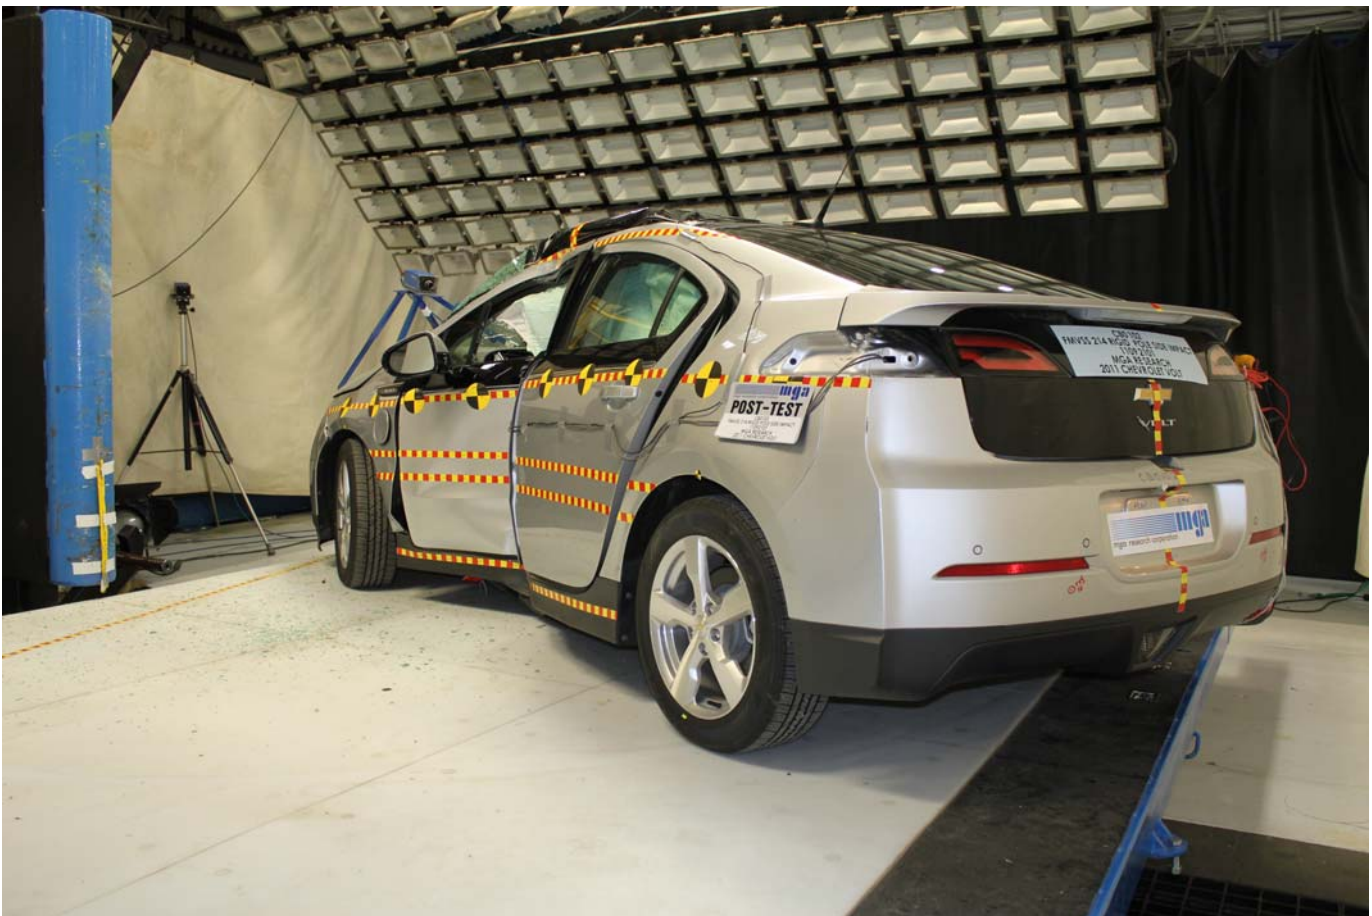
Post-Test  $\frac{3}{4}$  Rear View of Impact Zone

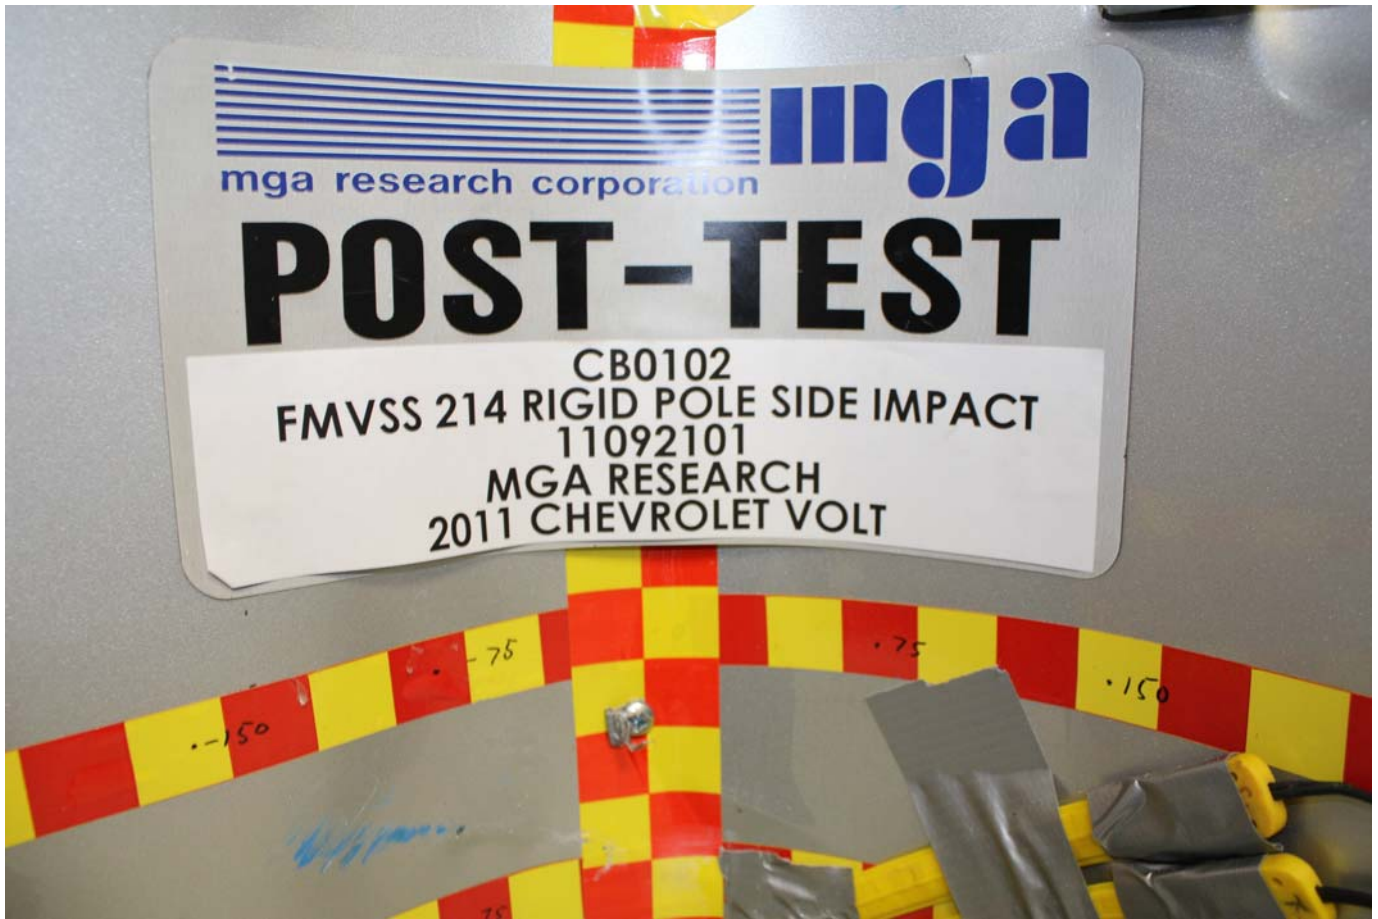
Post-Test Close-up View of Impact Point Target
