REPORT NUMBER: 301-MGA-2009-004

**SAFETY COMPLIANCE TESTING FOR
FMVSS NO. 301
FUEL SYSTEM INTEGRITY**

**GIRARDIN MINIBUS, INC.
2008 GIRARDIN G5 SCHOOL BUS
NHTSA NO.: C80902**

**PREPARED BY:
MGA RESEARCH CORPORATION
5000 WARREN ROAD
BURLINGTON, WI 53105**

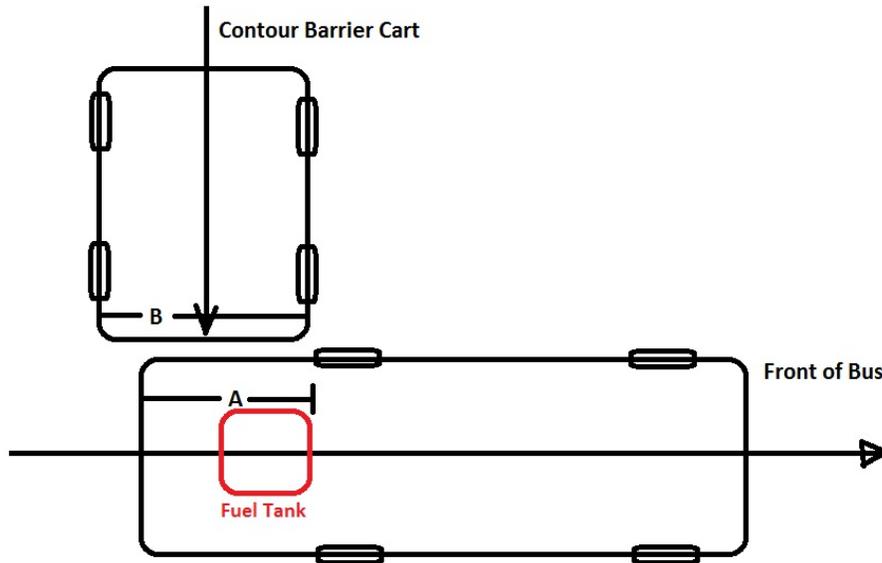
INDICATE IMPACT POINT BELOW:

LEGEND: Arrow indicates point and angle of barrier impact (C_L of arrow coincides with C_L of monorail).

DESCRIPTION: Fuel tank is located on the centerline of the vehicle, just rearward of the rear Axle.

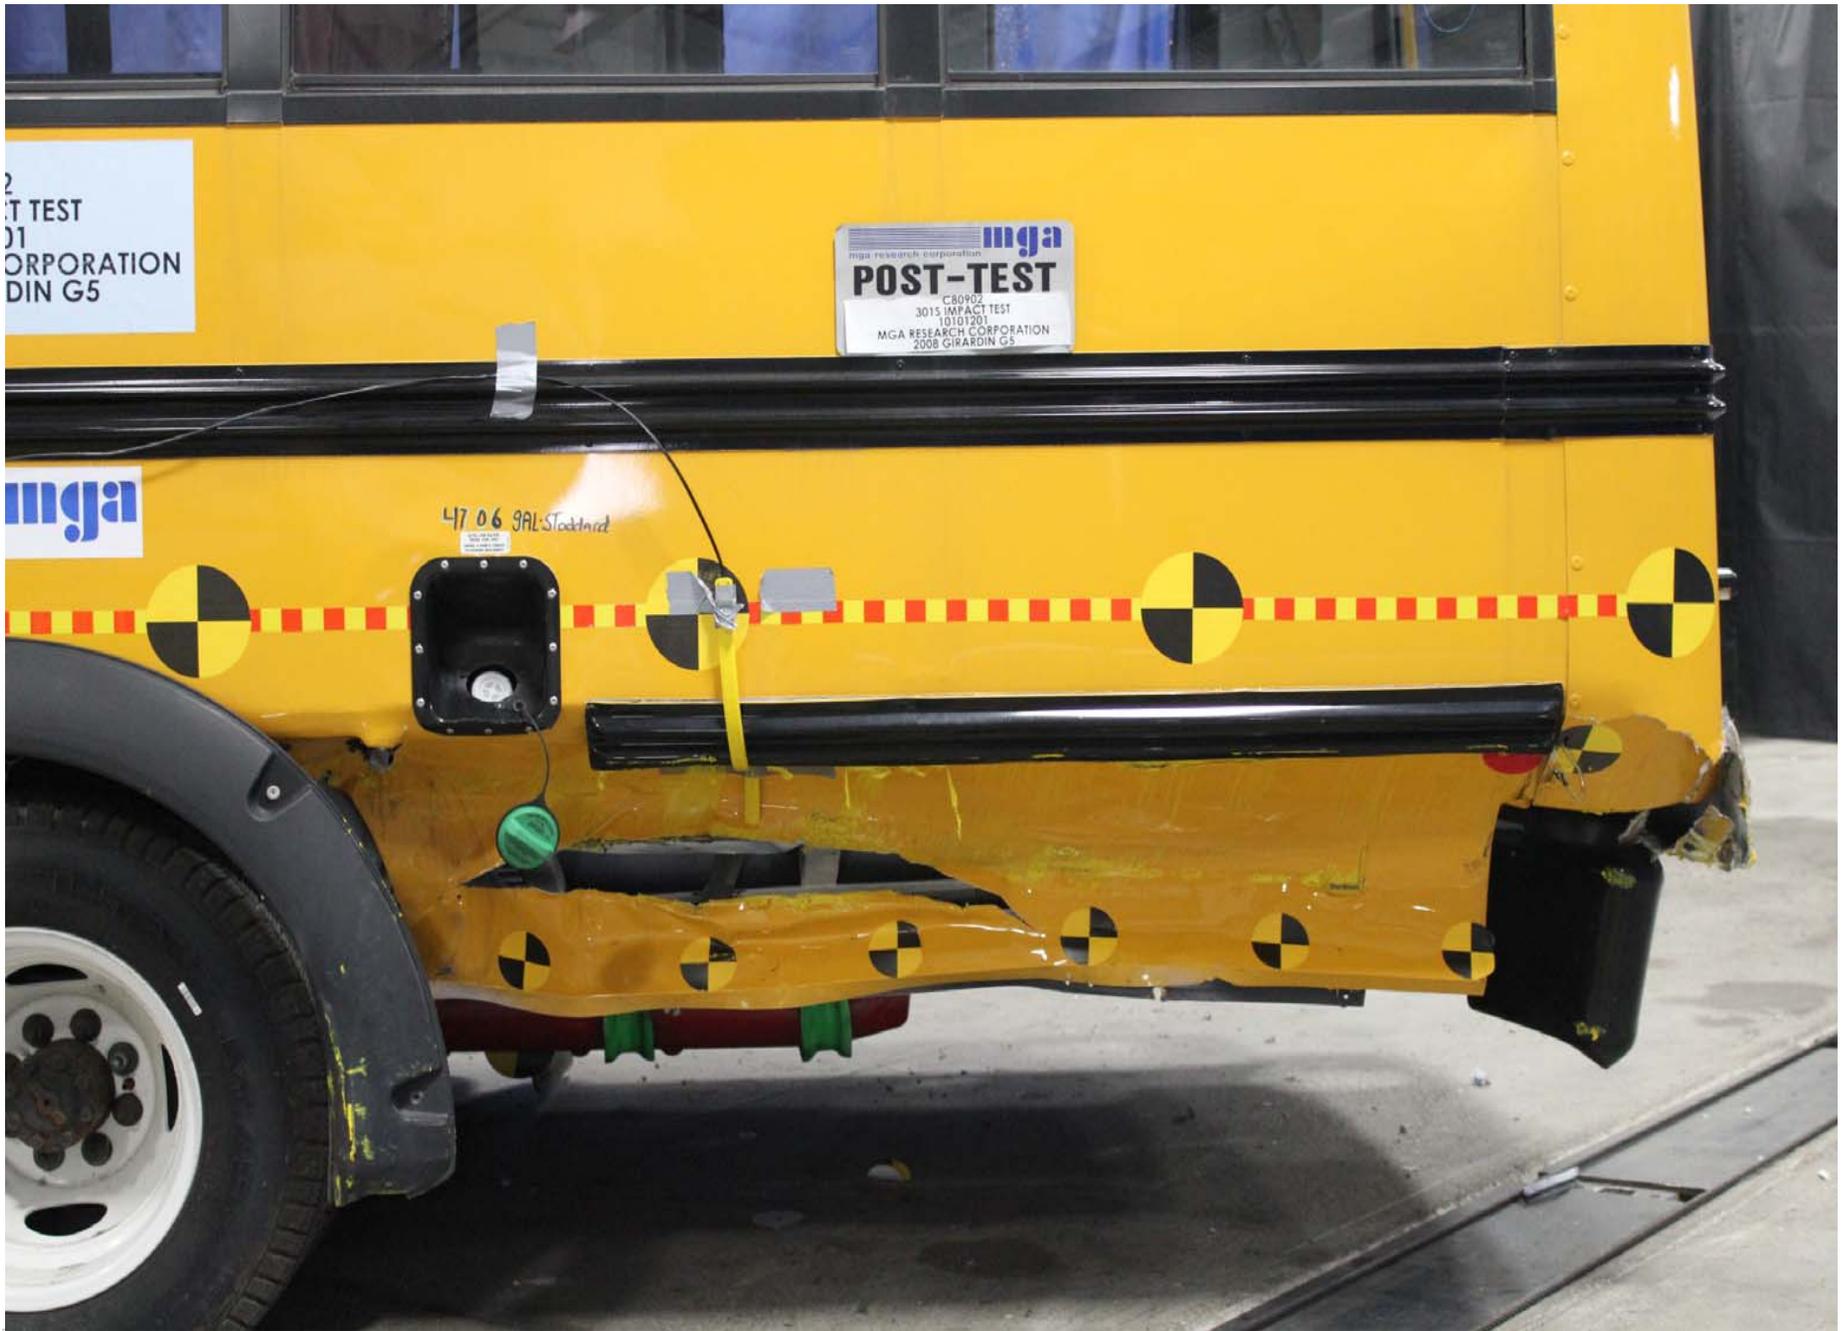
Post-Test Impact View 1

Time of Impact:	10:08 AM
Ambient Temperature (°C)	21
Barrier Velocity – Speed Trap 1 (kph):	47.5
Barrier Velocity – Speed Trap 2 (kph):	47.5
Barrier Penetration:	346 mm

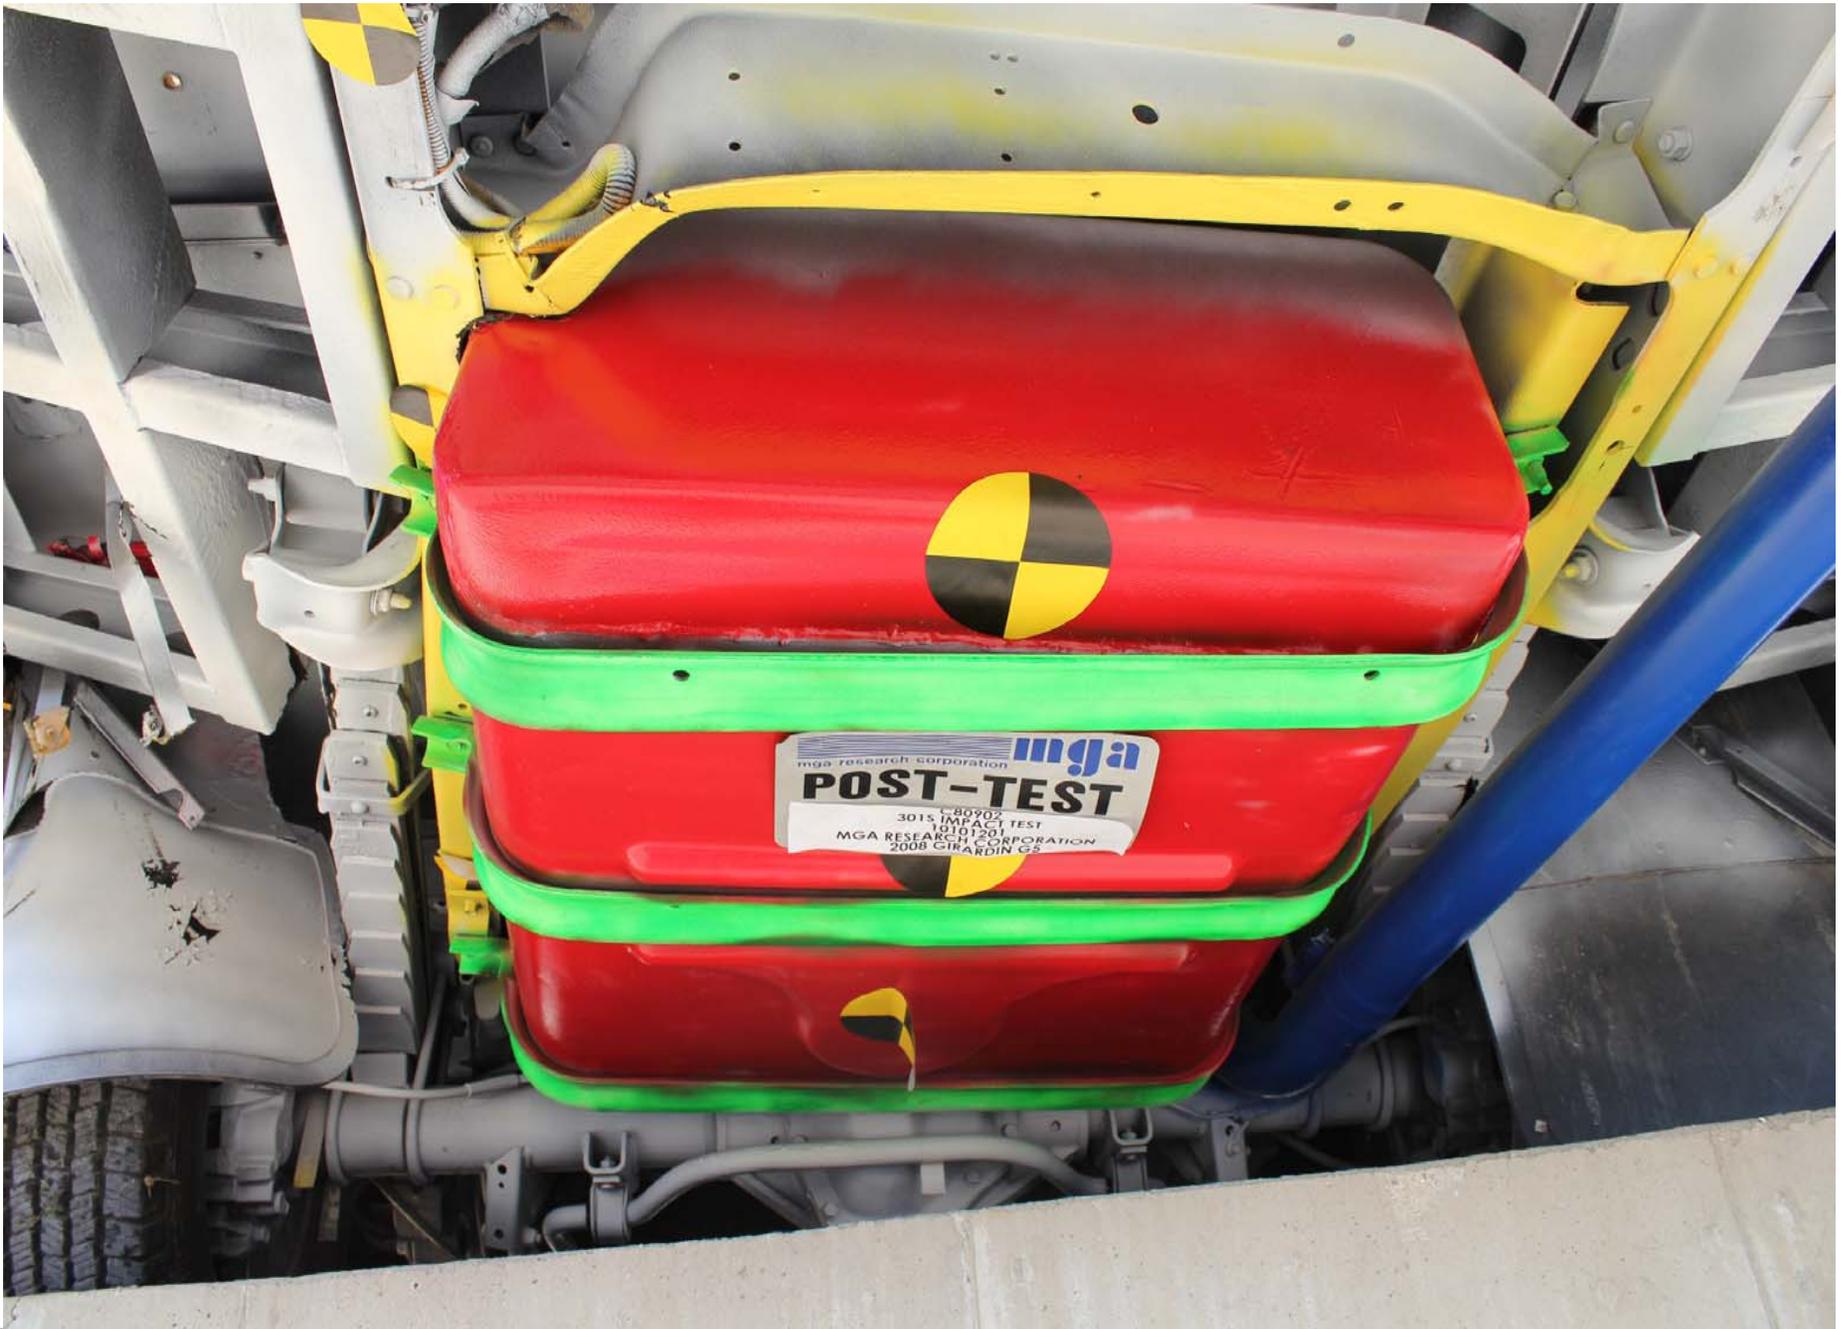
Post-Test Fuel Tank

Fuel Spillage Noted:	No
Failure, if applicable:	None

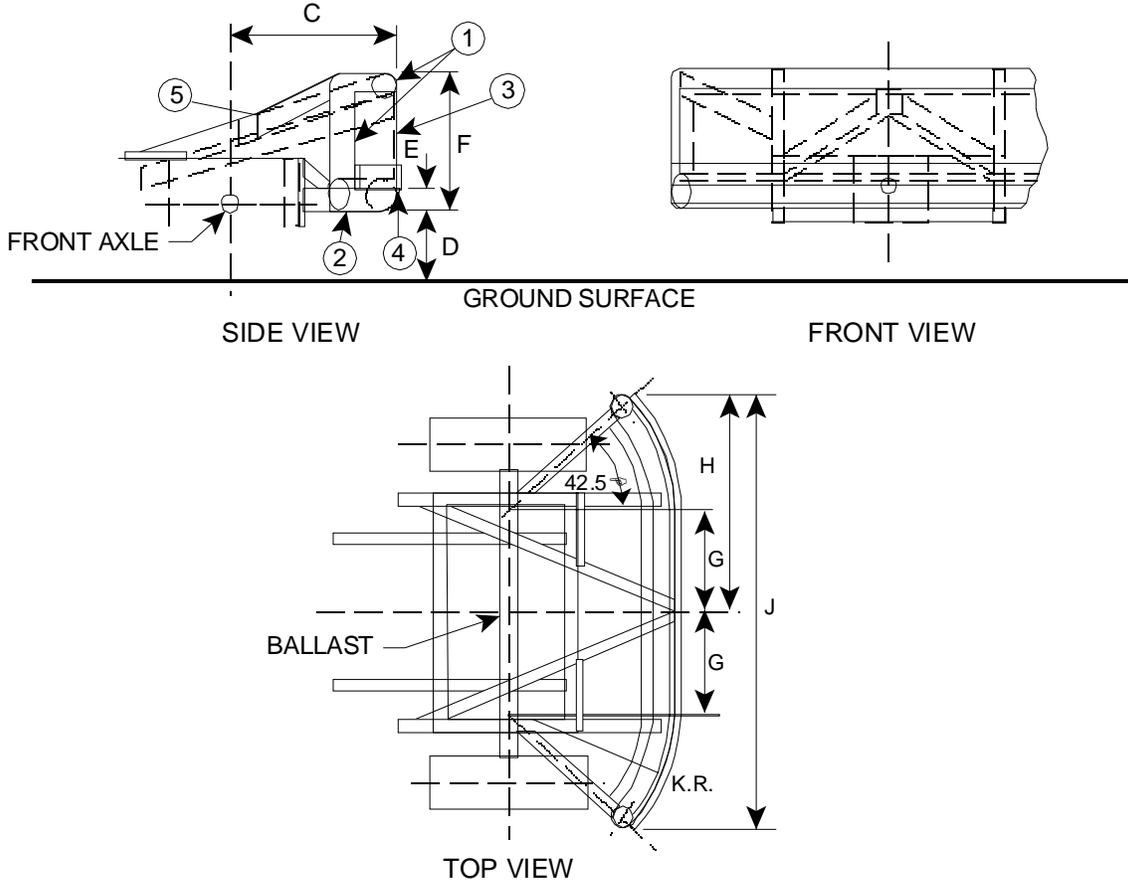
CONTOURED IMPACT SURFACE FOR COMMON CARRIAGE

1. Upper Frame 4.0 in. dia x 0.25 in. wall (102 mm dia x 6 mm wall)
Steel Tubing (3 Sides)
2. Lower Frame 6.0 in. dia x 0.50 in. wall (152 mm dia x 13 mm wall)
Steel Tubing
3. Face Plate 0.75 in. (19 mm) thick cold rolled steel
4. Leading Edge 1.0 s 4.0 in. (25 x 102 mm) steel band, sharp
edges broken
5. All Inner Reinforcements 4.0 x 2.0 x 0.19 in. (102 x 51 x 5 mm)
steel tubing

Total Weight = 4,000 ± 50 lbs (1,814.1 ± 22.7 kg)

Weight at each Rear Wheel =
900 ± 25 lbs (408.2 ± 11.3 kg)

Weight at each Front Wheel =
1,100 ± 25 lbs (499.0 ± 11.3 kg)

Moments of Inertia:

$I_x = 271 \pm 13.6 \text{ slug-ft}^2 (367 \pm 18.4 \text{ kg-m}^2)$

$I_z = 3,475 \pm 174 \text{ slug-ft}^2 (4,711 \pm 236 \text{ kg-m}^2)$

LETTER	INCHES	MILLIMETERS
A	54.0	1372
B	15.8	401
C	30.0	762
D	5.25	133
E	3.75	95
F	24.75	629
G	18.0	457
H	39.0	991
J	78.0	1981
K	30.0	762
