**REPORT NUMBER: 221-MGA-2009-006**

### SAFETY COMPLIANCE TESTING FOR FMVSS NO.: 221 SCHOOL BUS BODY JOINT STRENGTH

2008 GIRARDIN G5 SCHOOL BUS NHTSA NO.: C80902

### **FINAL REPORT**

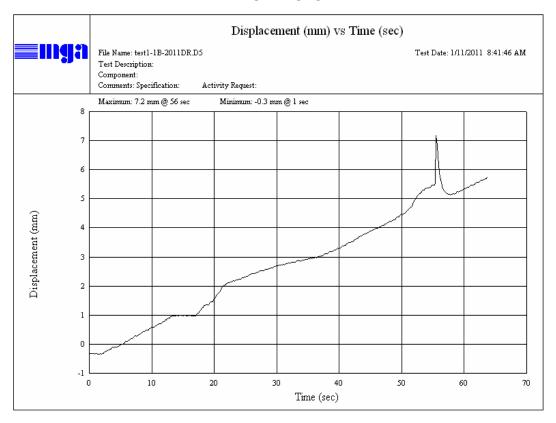
Joint Strength, ID Number GLSLMI181ARV, Displacement vs. Time

The rate of load application was ¼ inch per minute. The force and displacement were recorded and displacement vs. time was plotted to monitor the displacement rate.

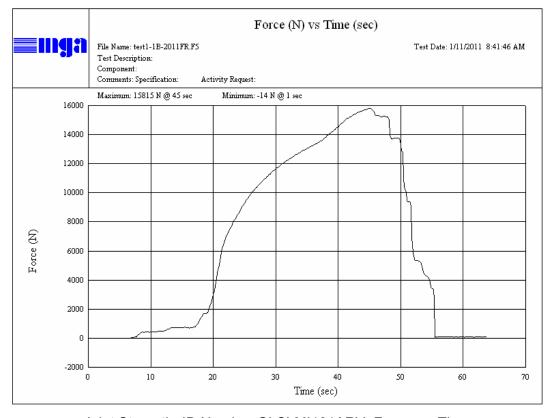
Joint Strength, ID Number GLSLMI181ARV, Force vs. Time

Joint Location	Joint Specimen I.D.	Maximum Load (N)	60% of Material Strength (N)	PASS/FAIL
Interior Driver Side Wall	GLSLMI181ARV	15,815	10,963	PASS

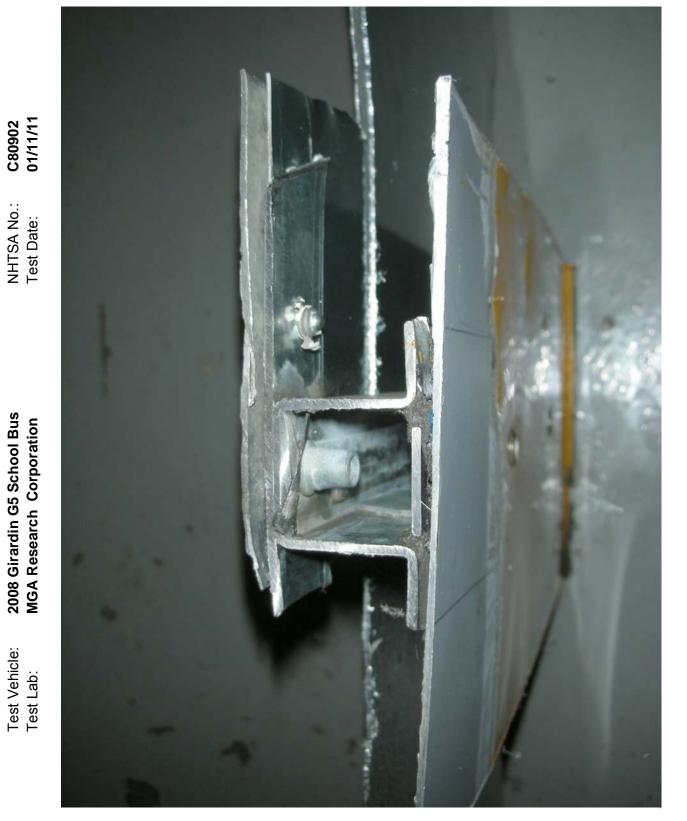
# 7 DIMENSION REQUIREMENTS OF BODY PANEL SPECIMEN WHOSE JOINT SEGMENT IS 8 INCHES LONG 74 8"R. (TYP.) ಕೊ ත JONTCENTERINE SPECMENCENTERINE 74"

Typical Test Sample Configuration
