REPORT NUMBER: 214P-MGA-2011-001

**SAFETY COMPLIANCE TESTING FOR FMVSS 214
DYNAMIC SIDE IMPACT PROTECTION
RIGID POLE**

**GENERAL MOTORS LLC
2011 CHEVROLET CRUZE LS 4-DR SEDAN
NHTSA NUMBER: CB0104**

**PREPARED BY:
MGA RESEARCH CORPORATION
5000 WARREN ROAD
BURLINGTON, WI 53105**

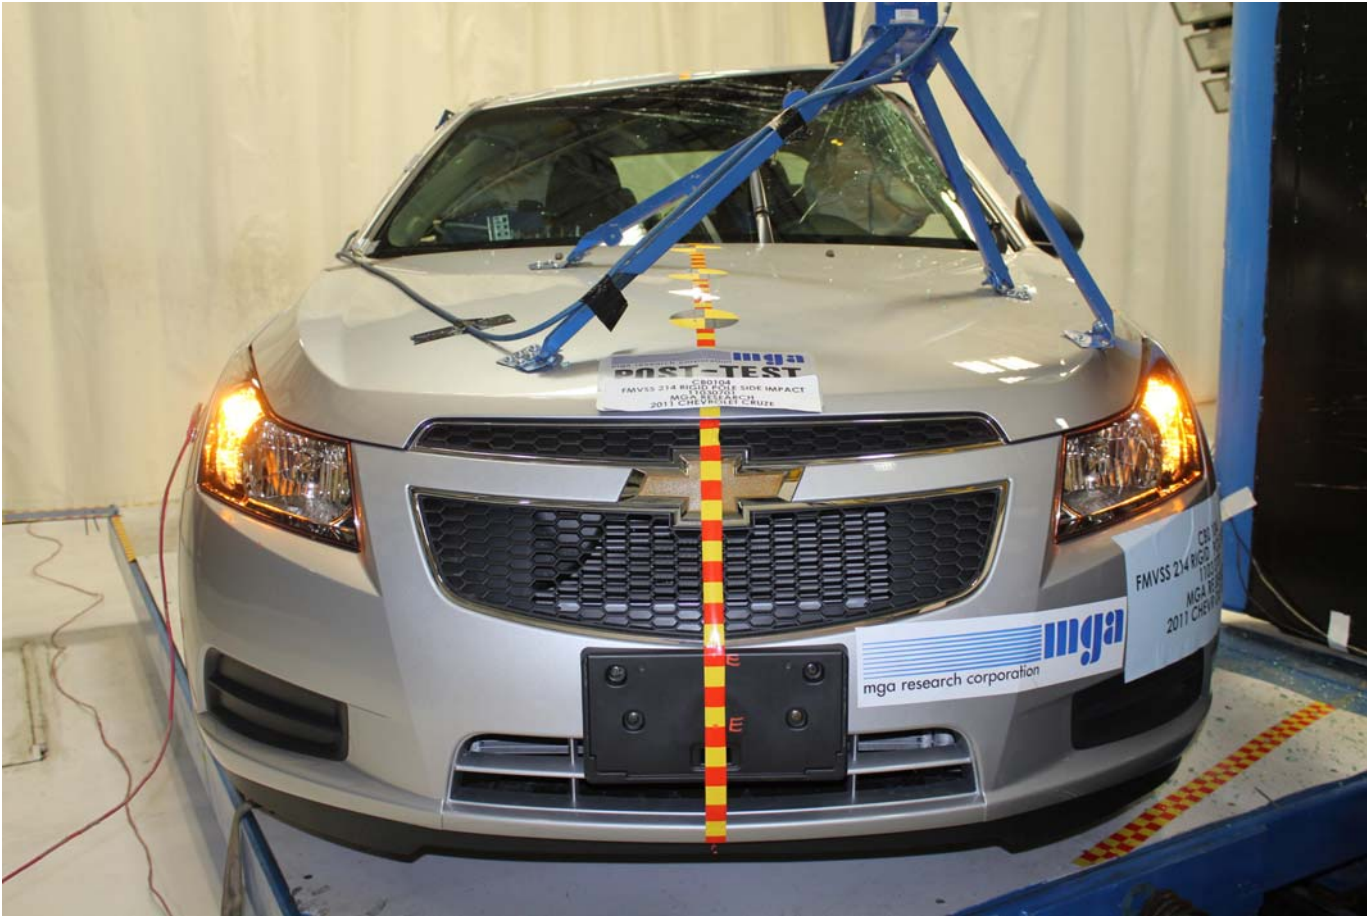
Post-Test Frontal View of Test Vehicle

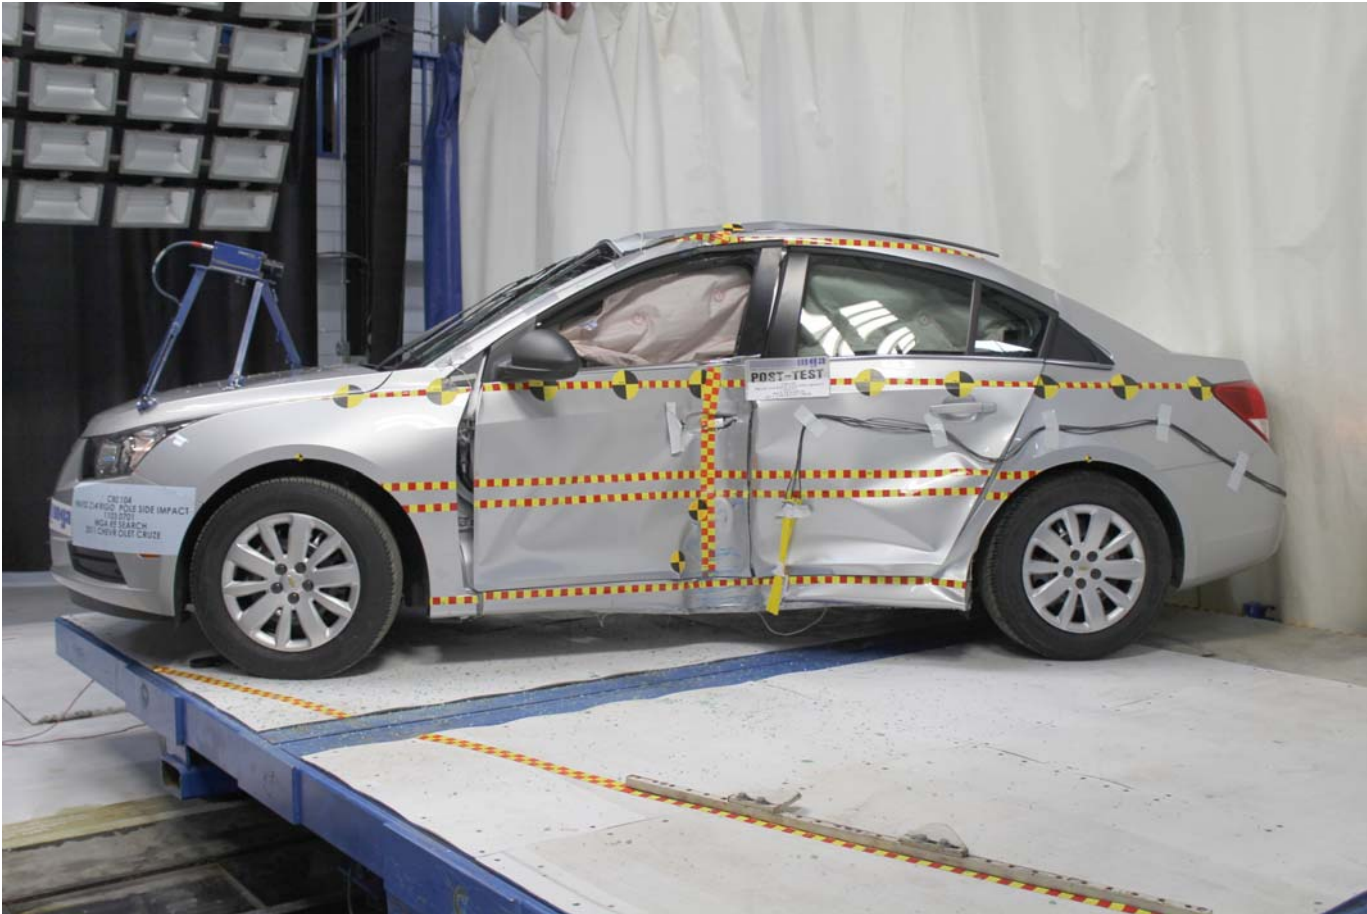
Post-Test Impacted Side View of Test Vehicle

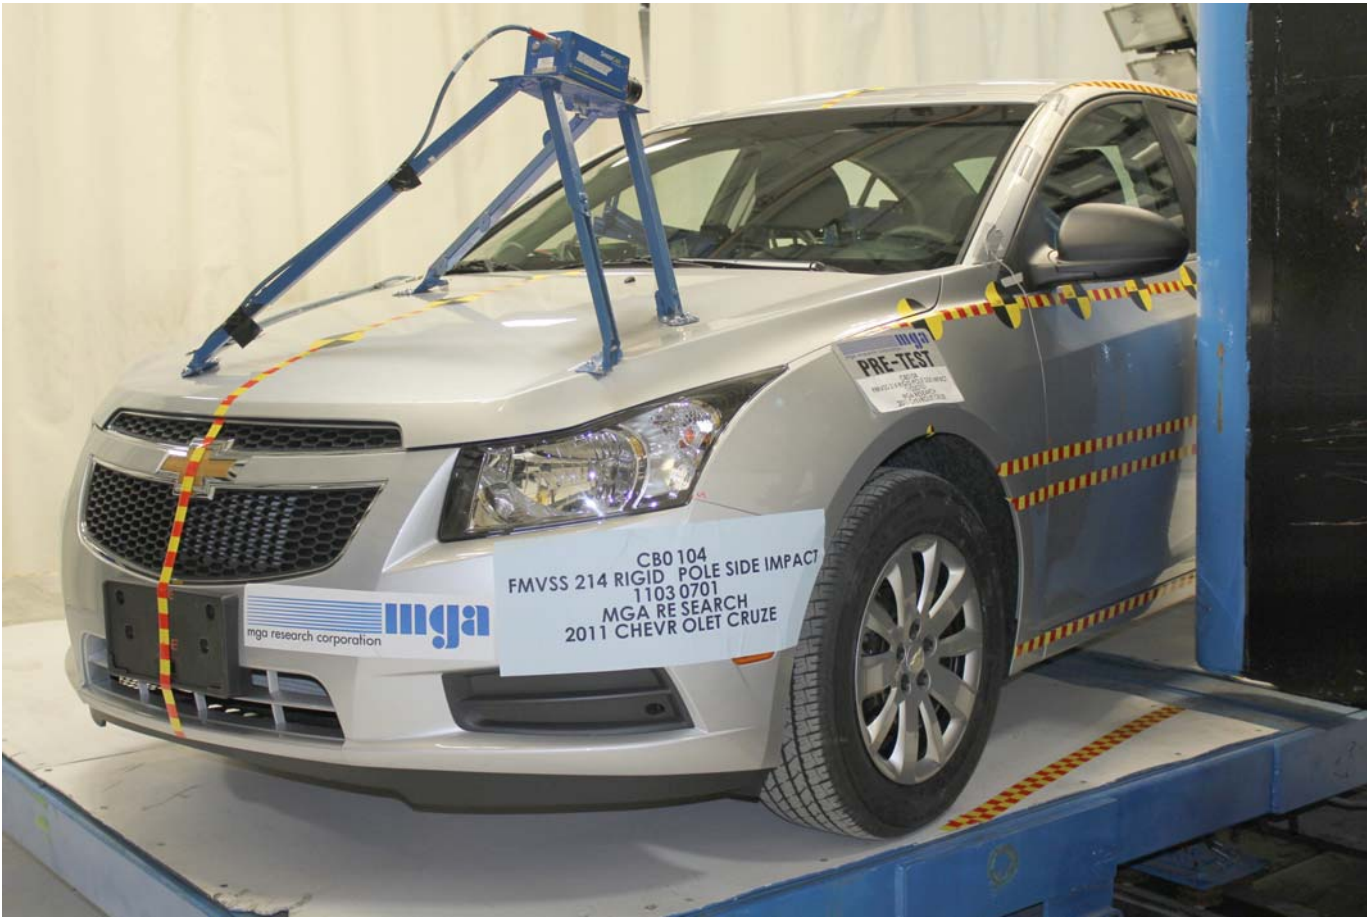
Pre-Test Left $\frac{3}{4}$ Front View of Vehicle and Pole

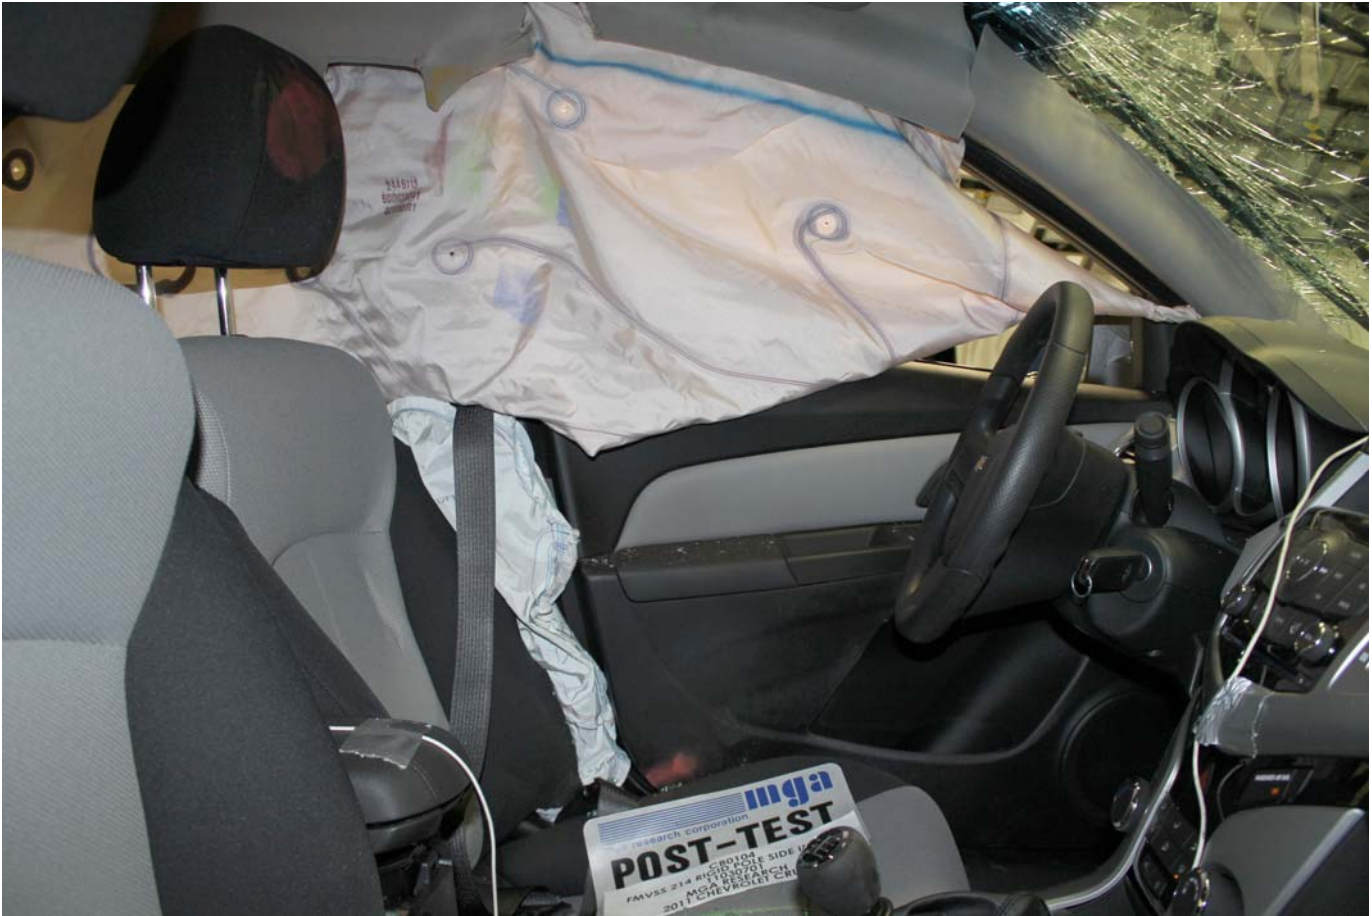
Post-Test Interior of Front Door Showing Dummy Impact Locations

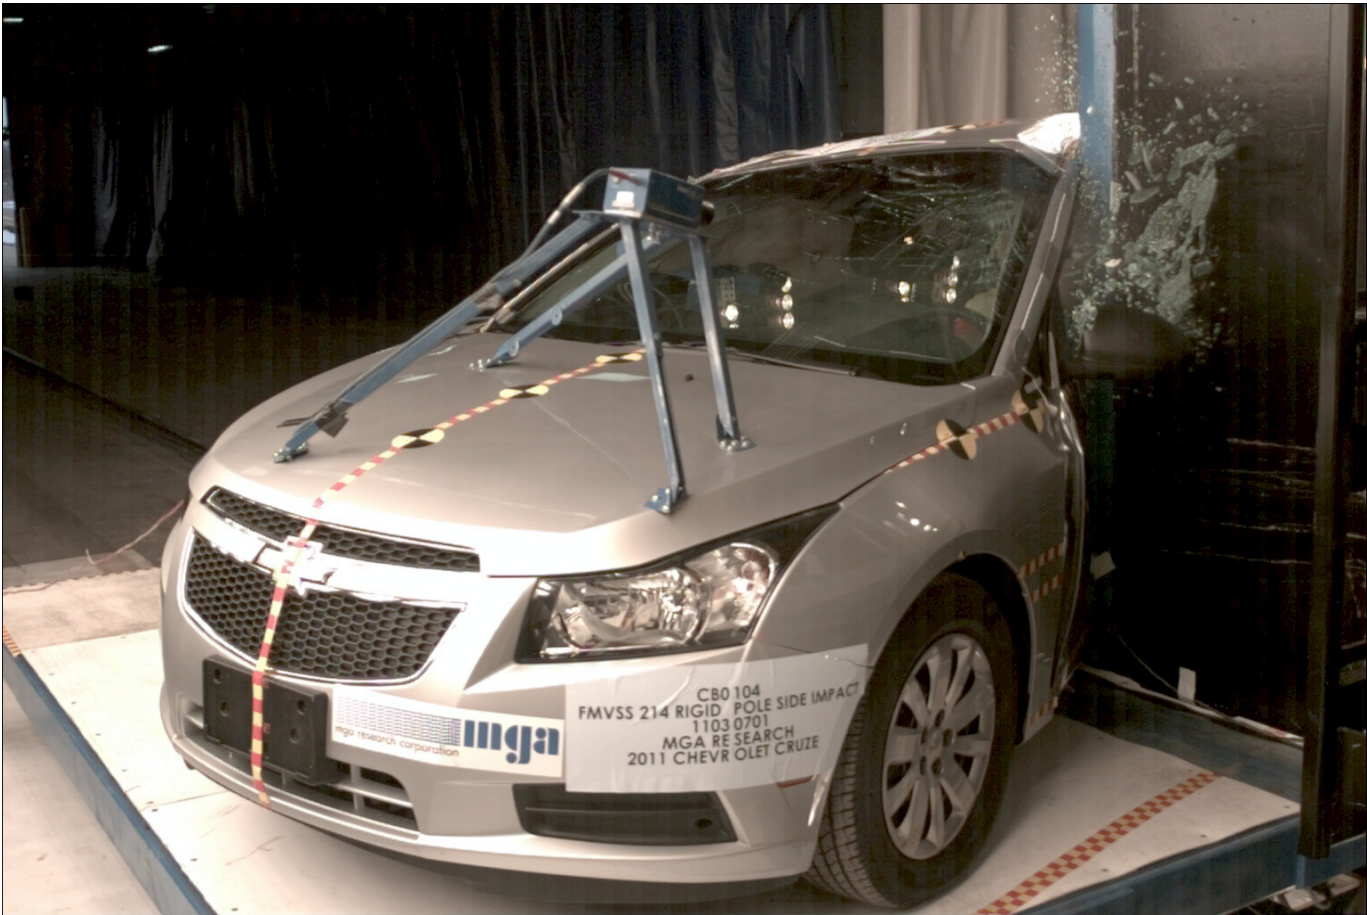
Impact Event

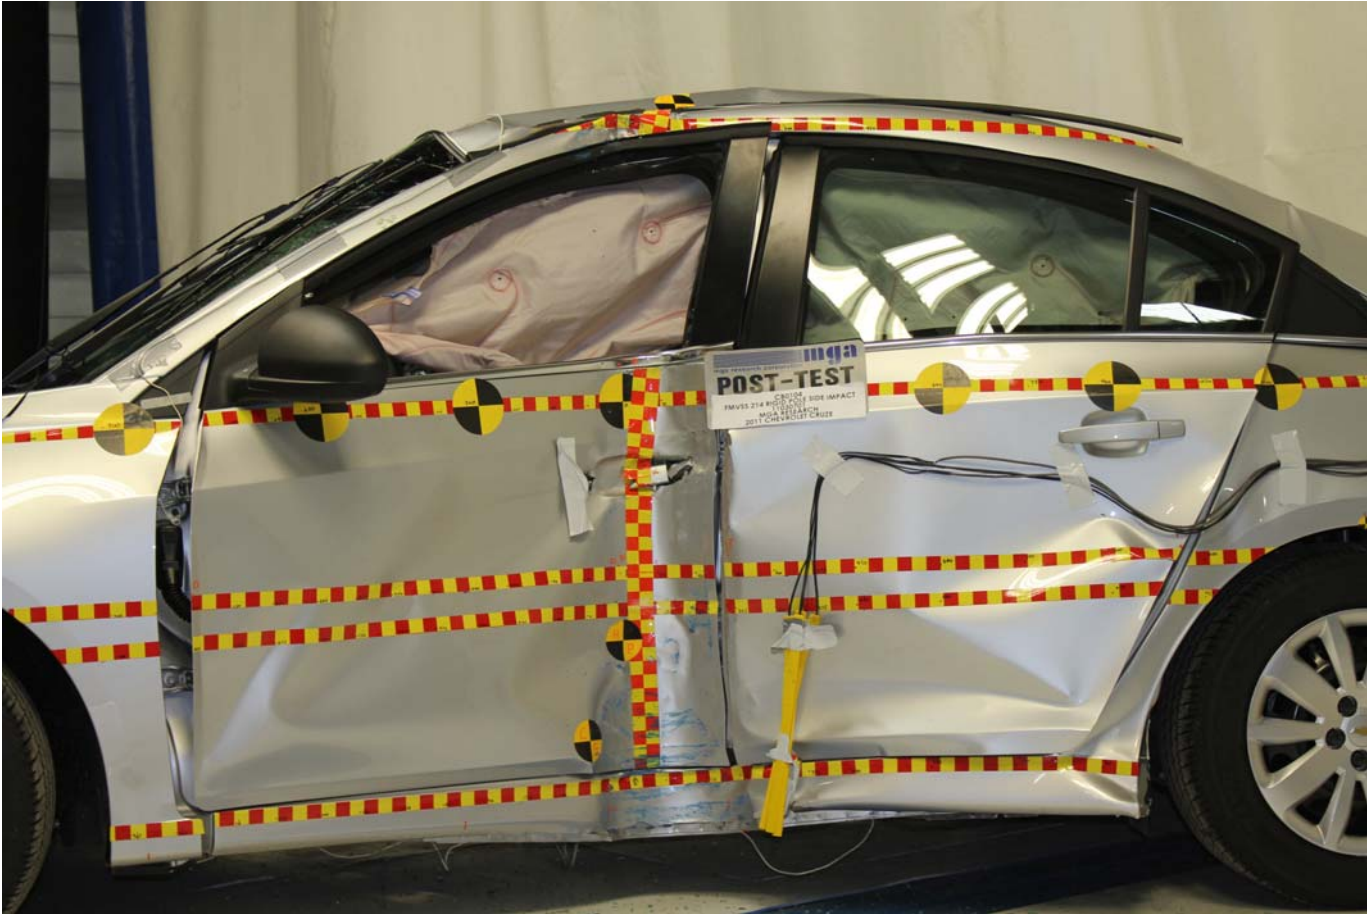
Post-Test Impact Zone Close-up View

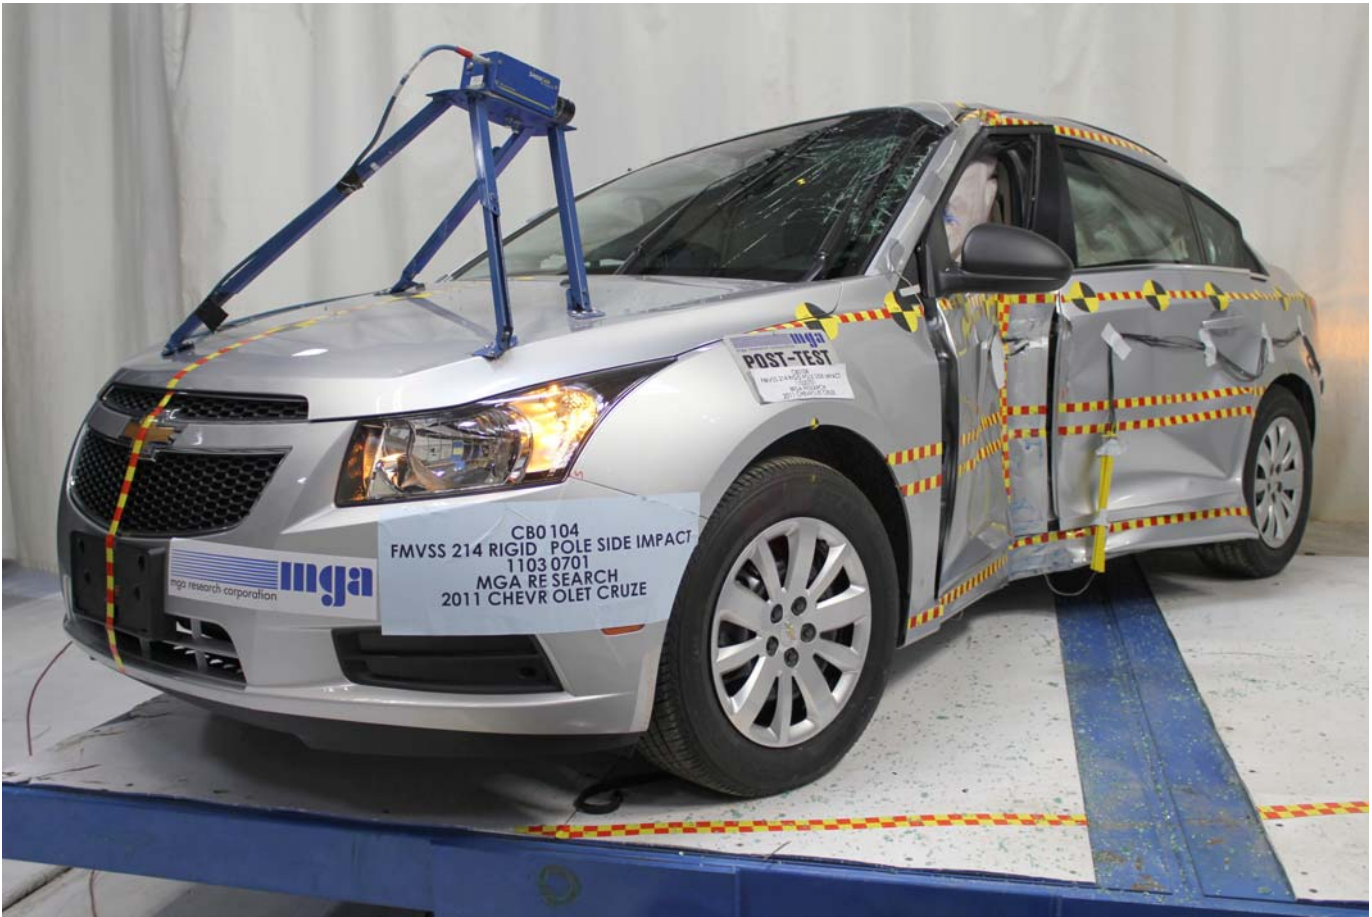
Post-Test $\frac{3}{4}$ Front View of Impact Zone

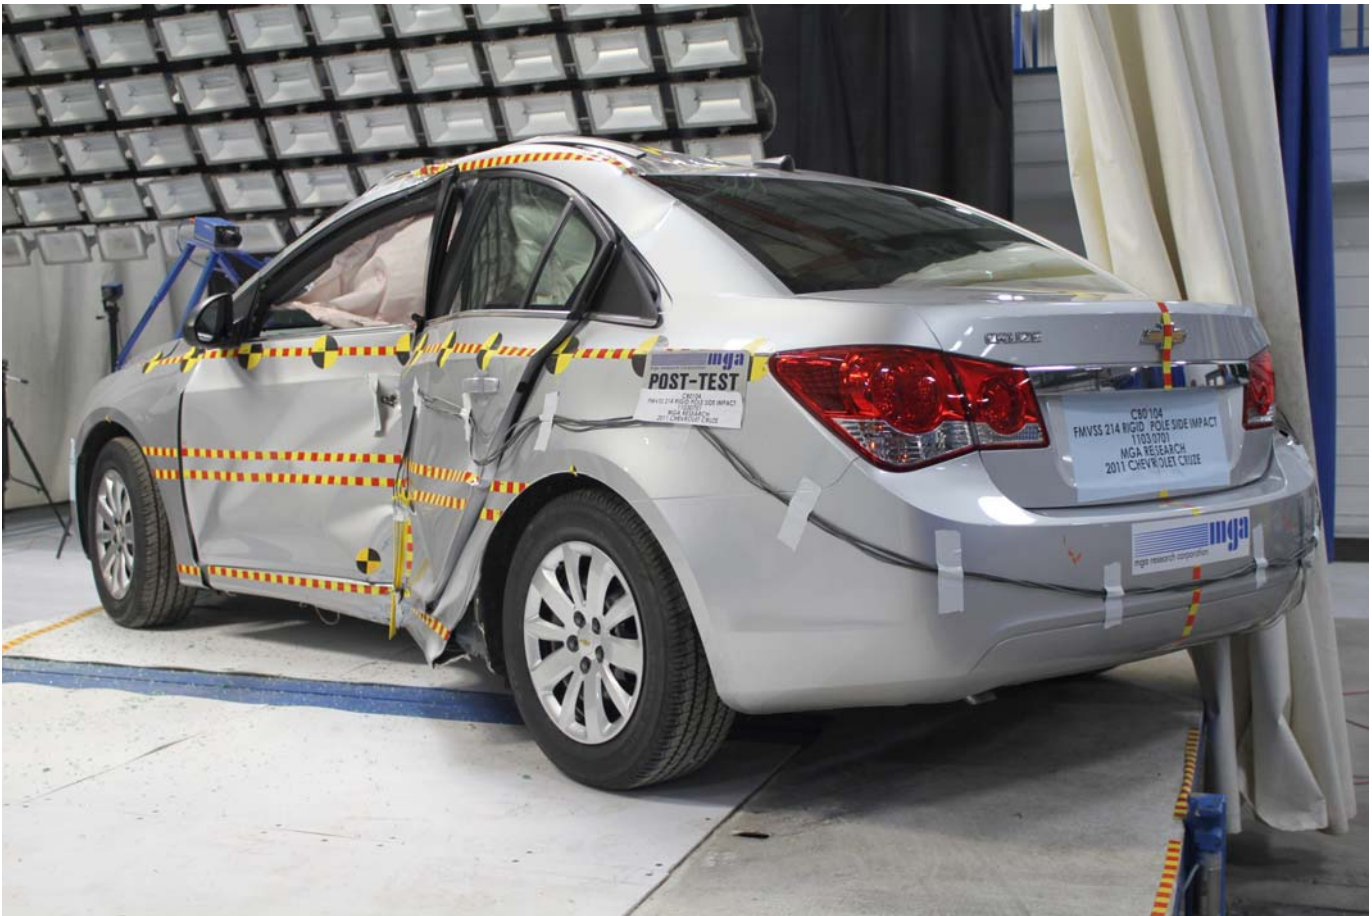
Post-Test $\frac{3}{4}$ Rear View of Impact Zone

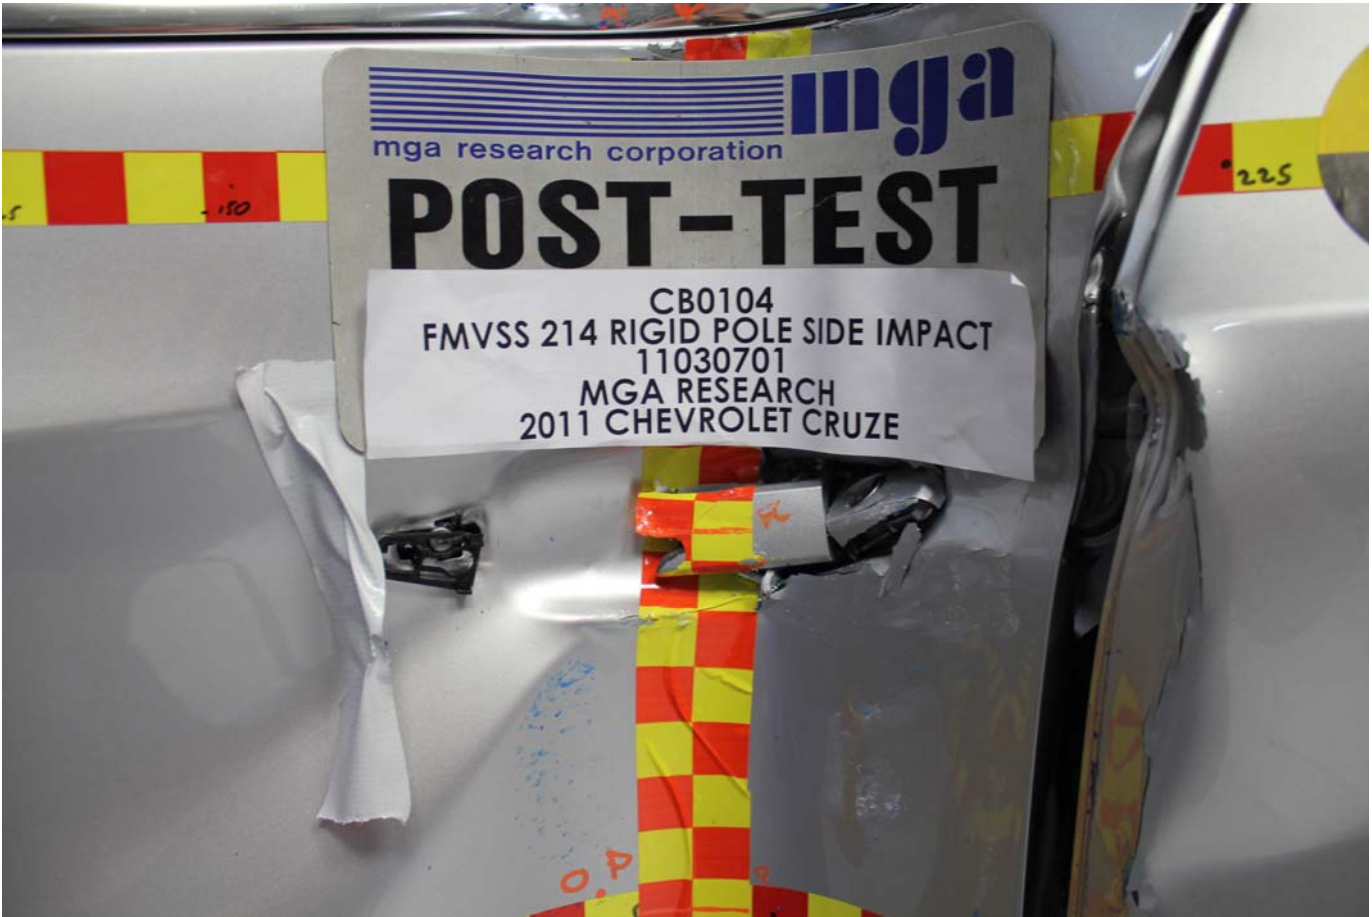
Post-Test Close-up View of Impact Point Target

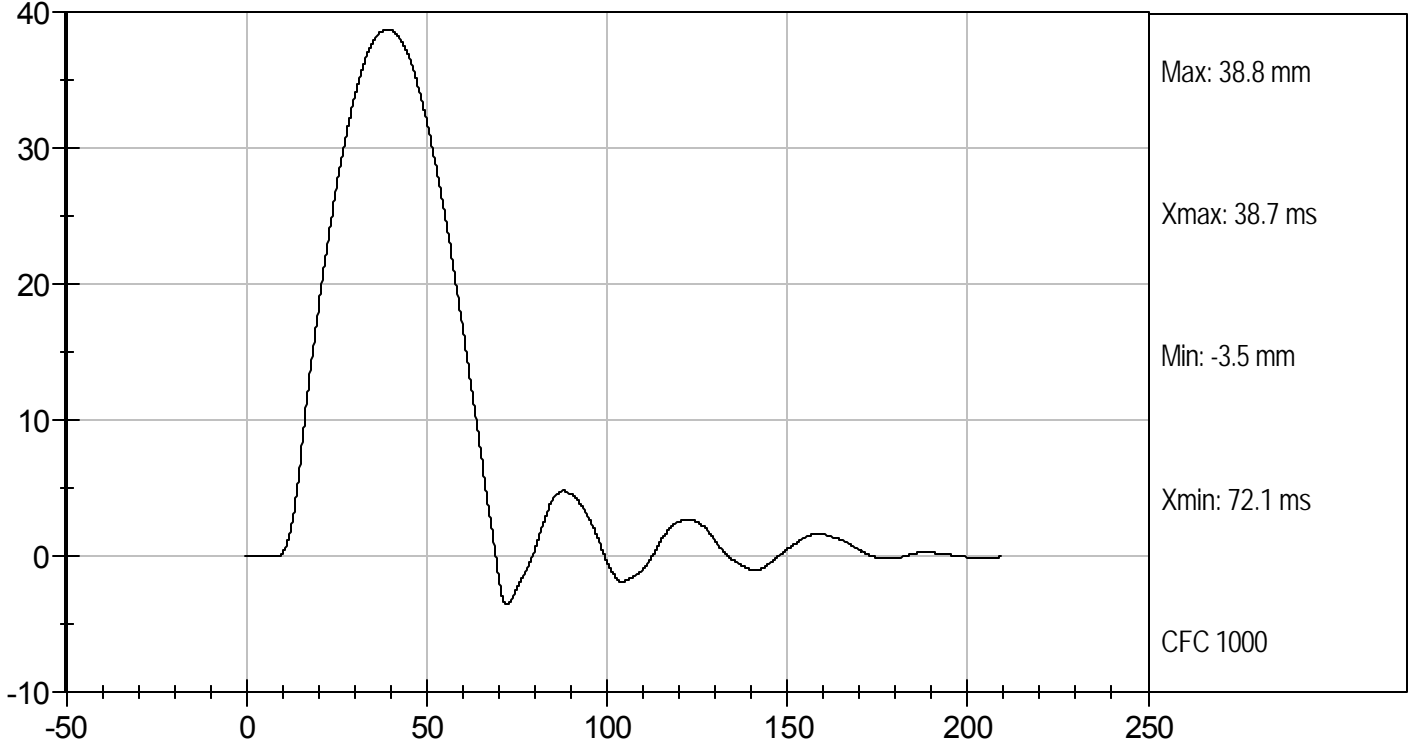
UPPER RIB DISPLACEMENT @ 4 M/SEC (mm) vs TIME (ms)

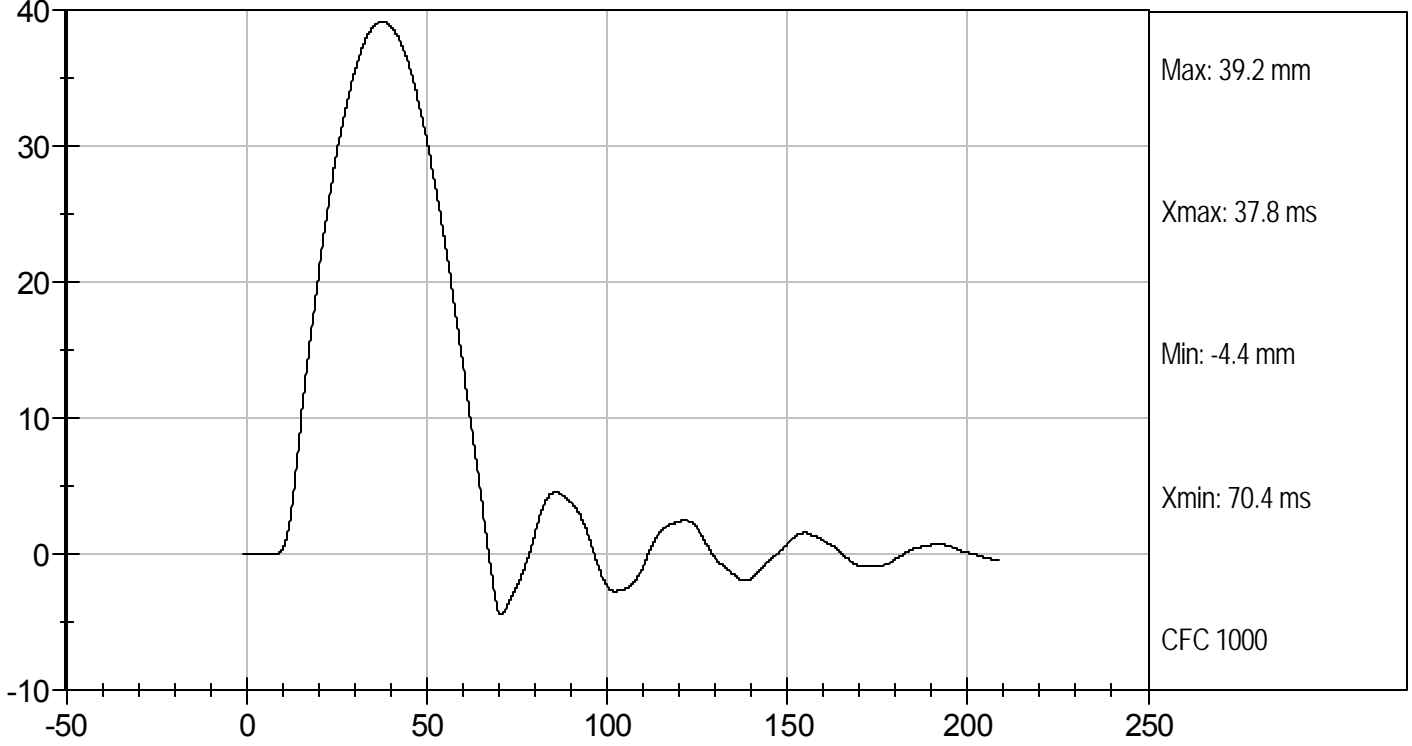
MID RIB DISPLACEMENT @ 4 M/SEC (mm) vs TIME (ms)

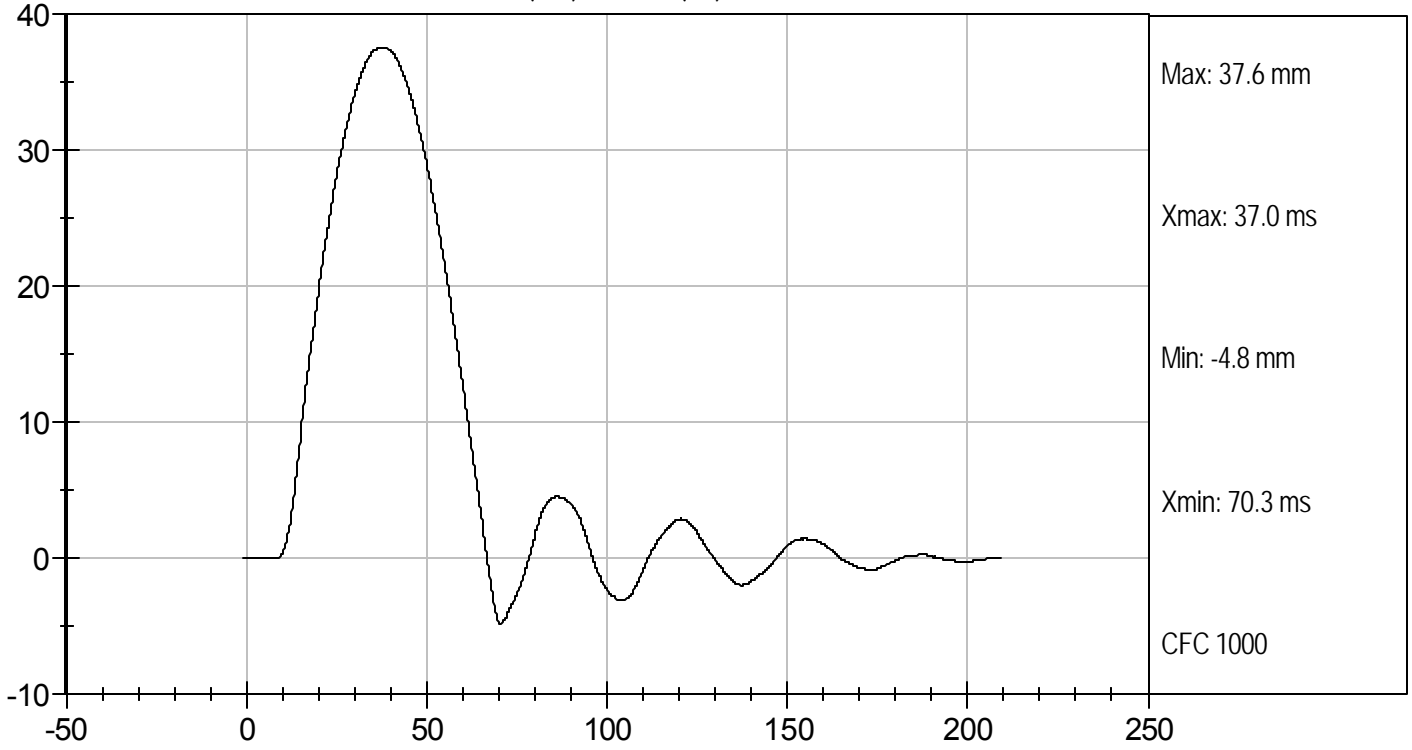
LOWER RIB DISPLACEMENT @ 4 M/SEC (mm) vs TIME (ms)

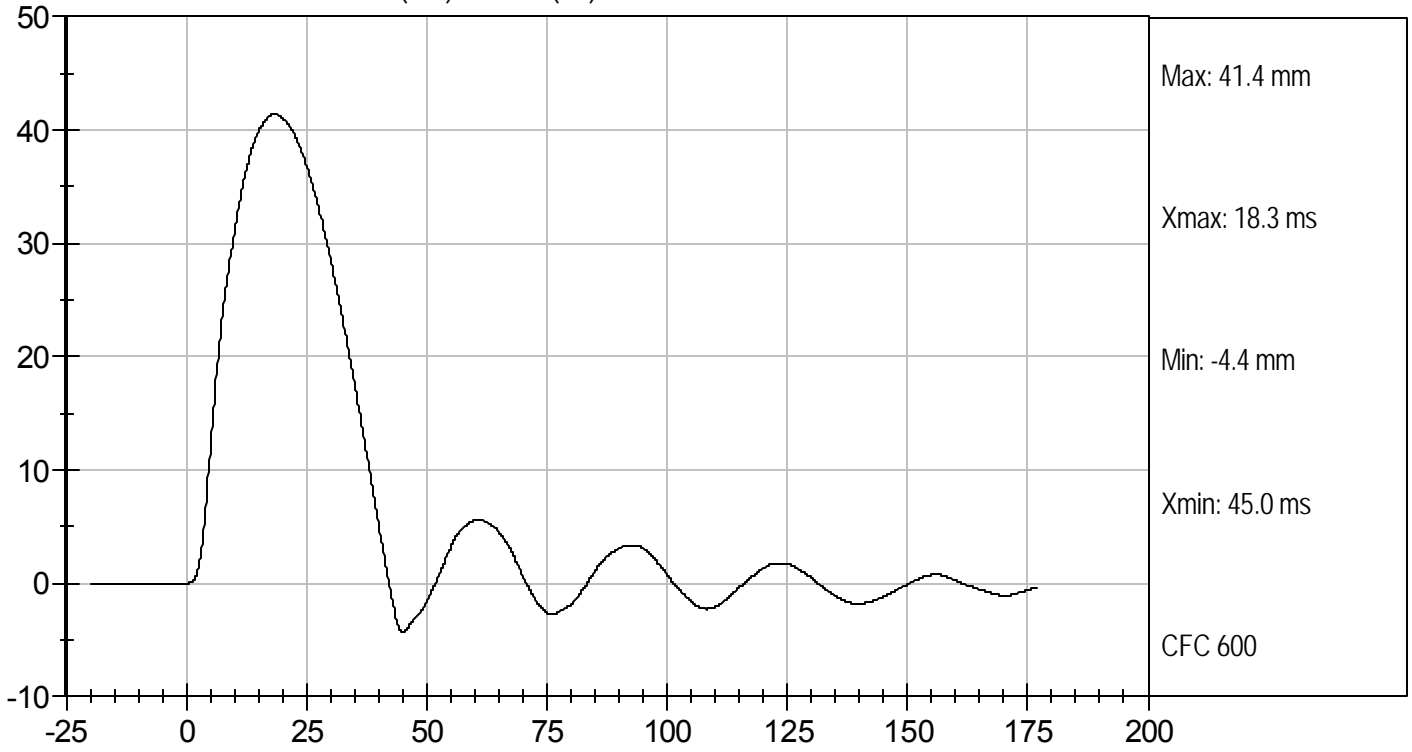
LOWER RIB DISPLACEMENT (mm) vs TIME (ms)

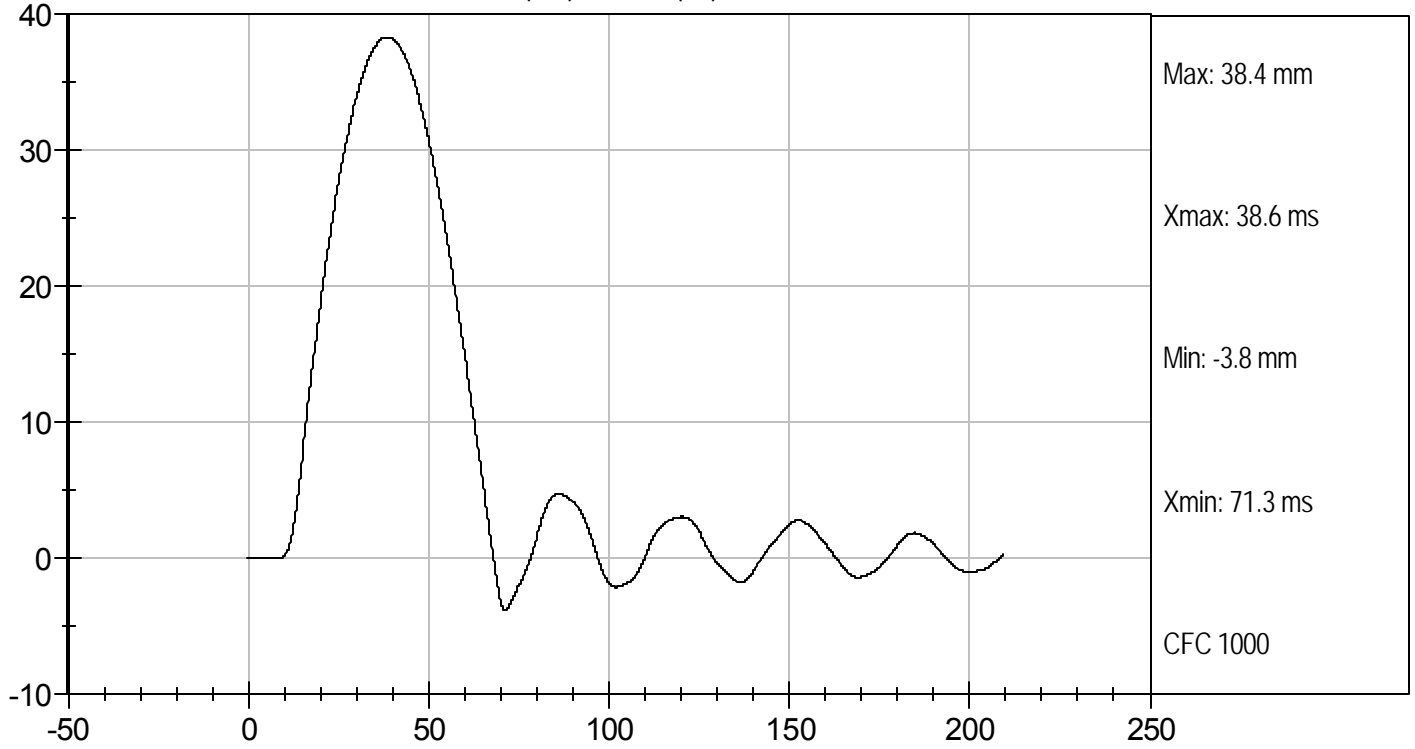
UPPER RIB DISPLACEMENT @ 4 M/SEC (mm) vs TIME (ms)
