REPORT NUMBER: 214P-MGA-2011-011

**SAFETY COMPLIANCE TESTING FOR FMVSS 214
DYNAMIC SIDE IMPACT PROTECTION
RIGID POLE**

**KIA MOTORS MANUFACTURING GEORGIA, INC.
2011 KIA SORENTO SUV
NHTSA NUMBER: CB0511**

**PREPARED BY:
MGA RESEARCH CORPORATION
5000 WARREN ROAD
BURLINGTON, WI 53105**

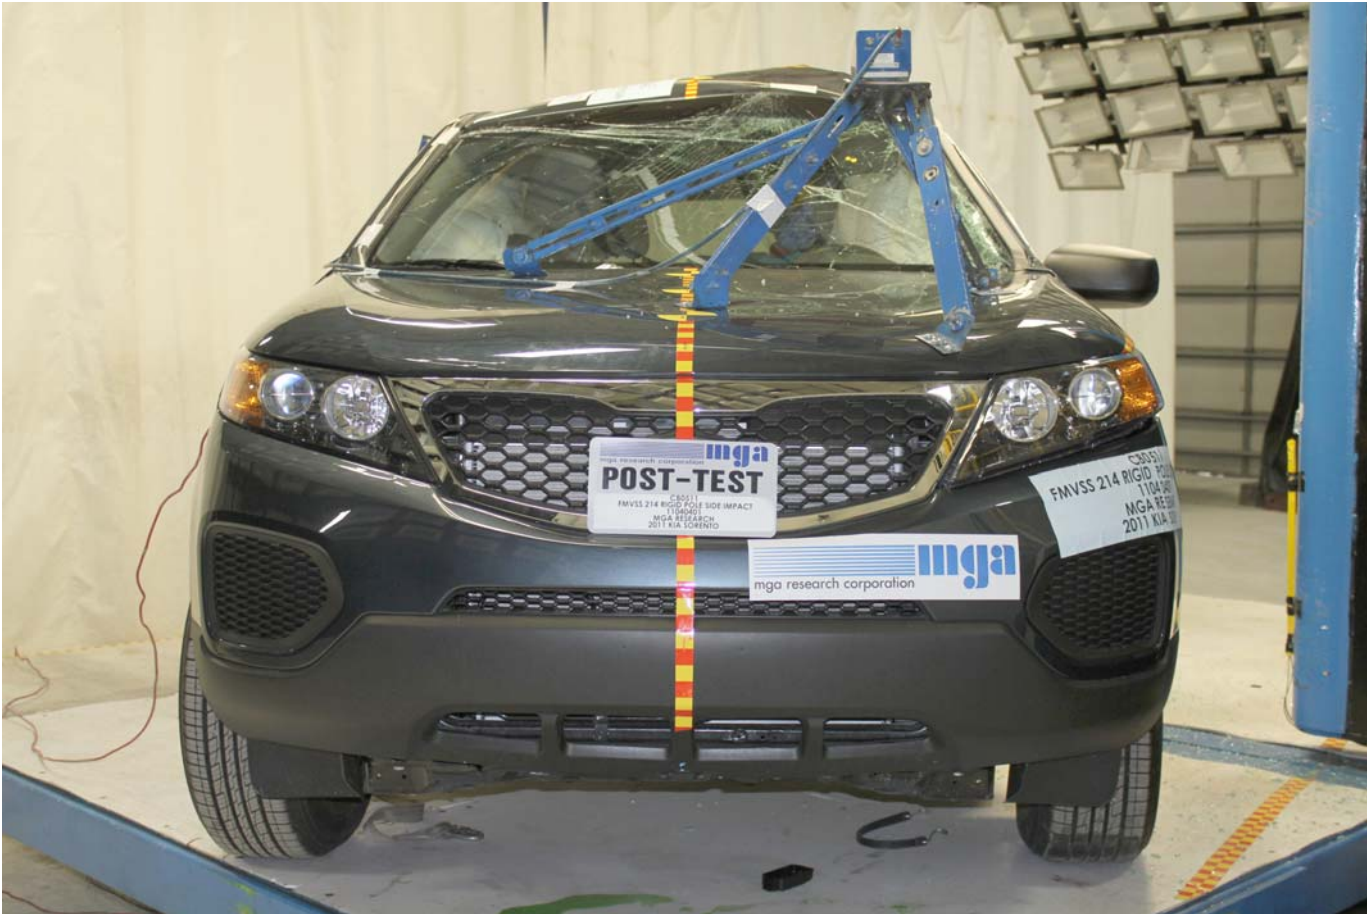
Post-Test Frontal View of Test Vehicle

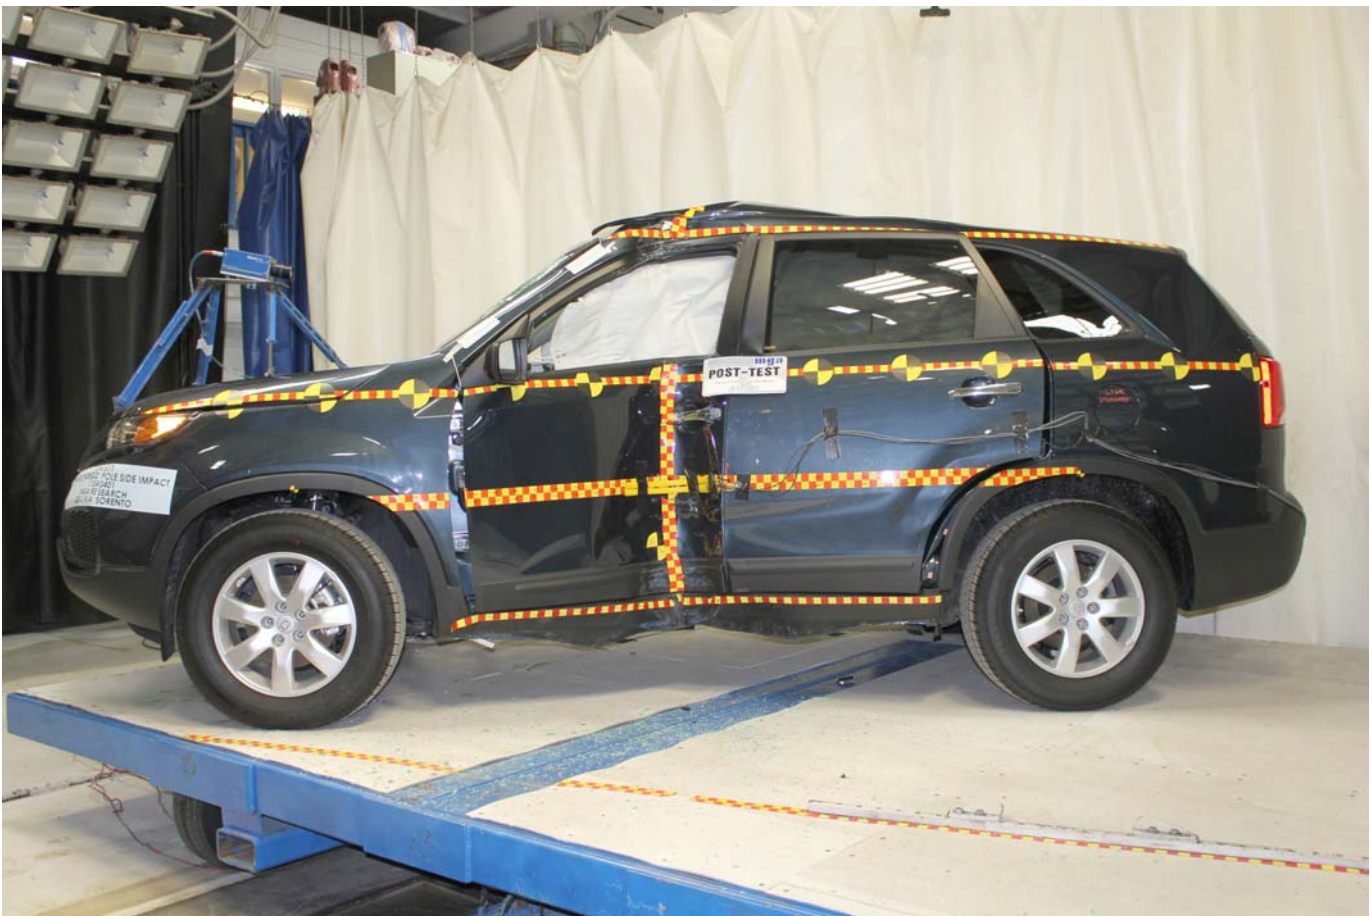
Critical Areas of Performance	Observations and Conclusions
Pillar Performance	No Separation
Sill Separation	None
Windshield Damage	Cracked
Window Damage	Left Front Window Broke
Other Notable Effects	None

Post-Test Impacted Side View of Test Vehicle

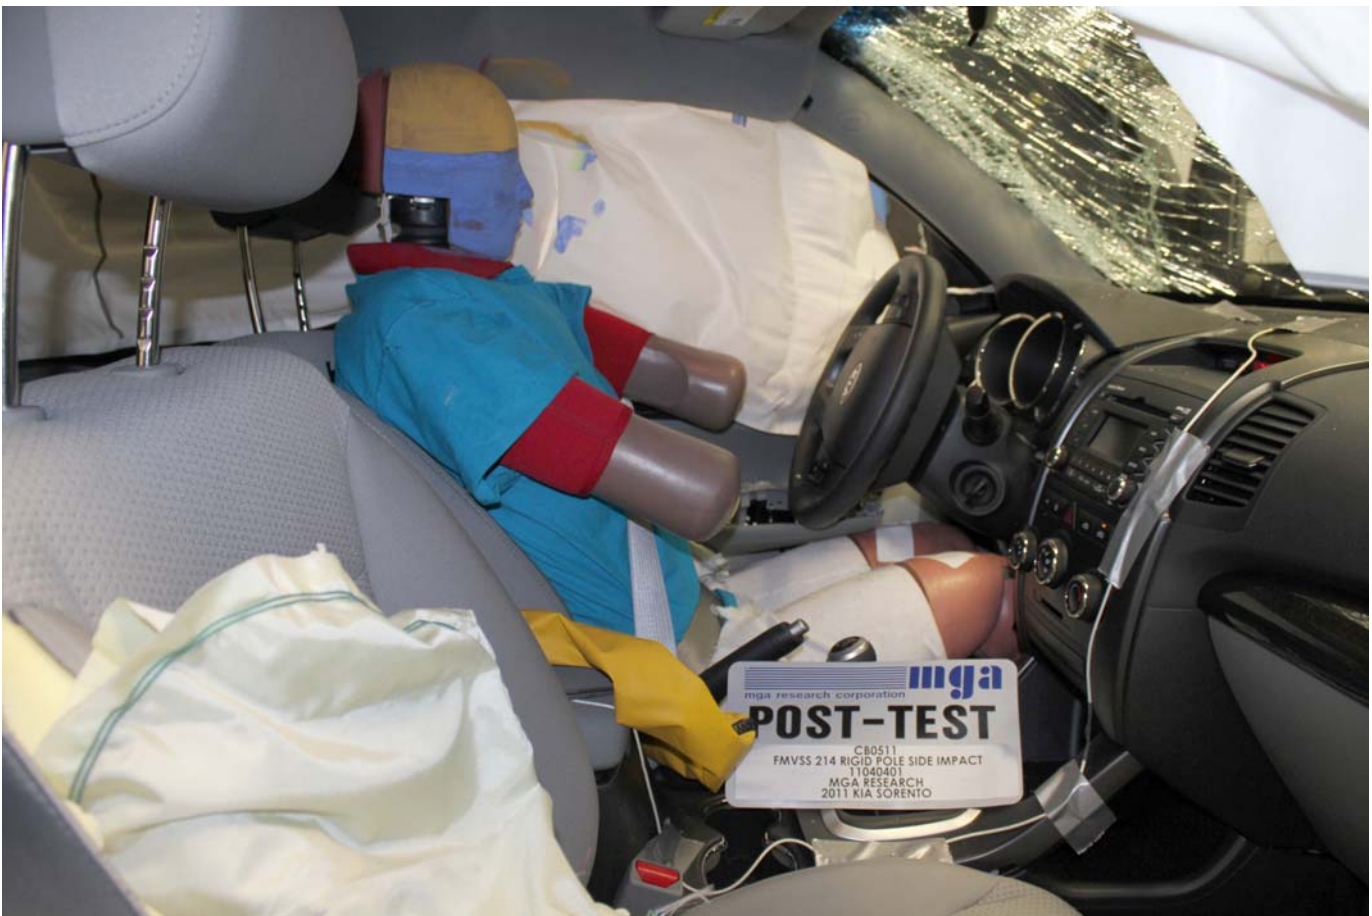
Post-Test Dummy Through Opposite Window

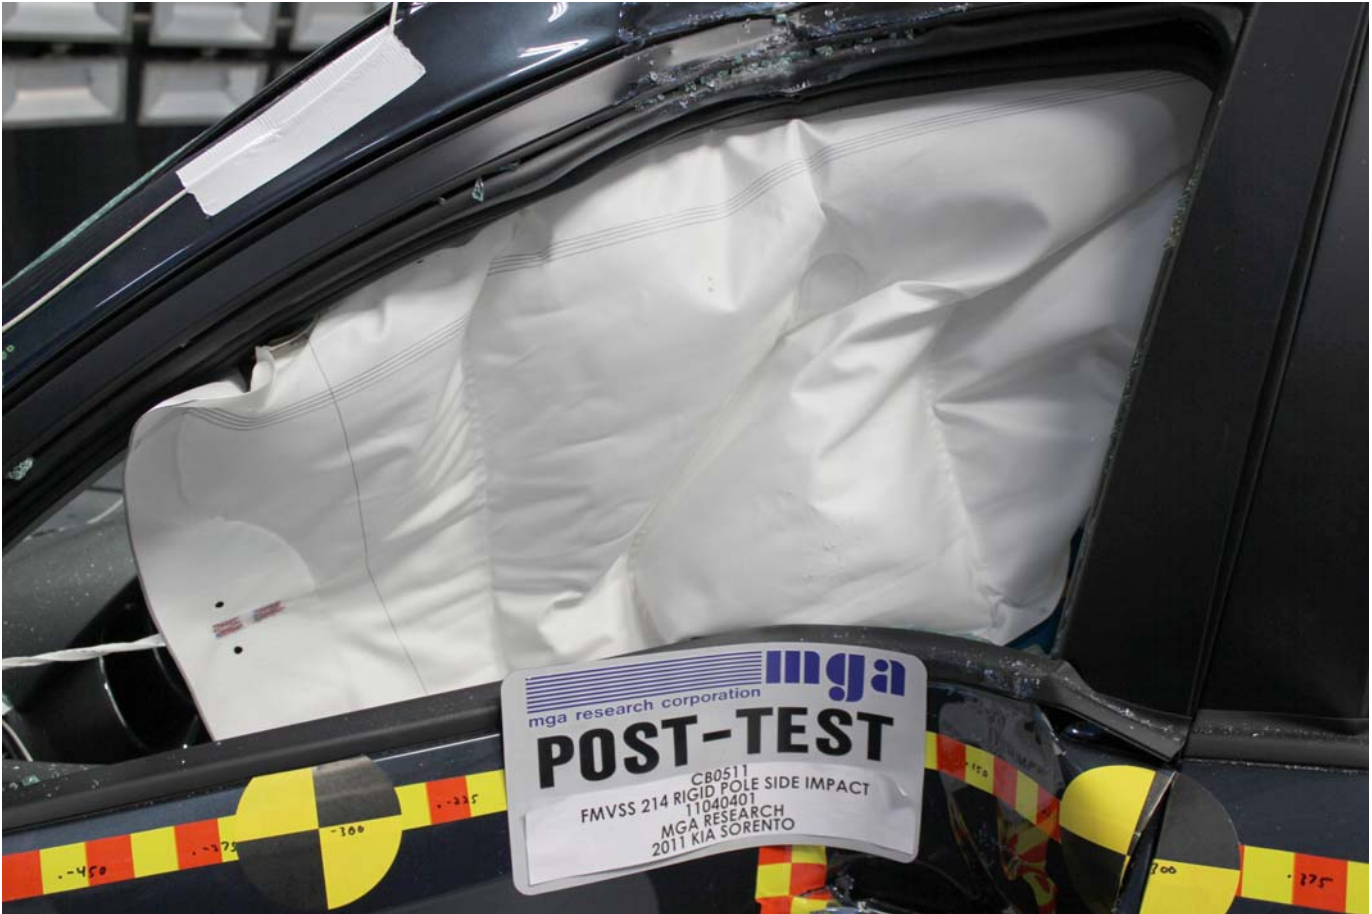
Description	Front	Rear
Left Side Doors	Remained closed and jammed shut	Remained closed and jammed shut
Right Side Doors	Remained closed and operational	Remained closed and operational
Hatch and Other Doors	Remained closed and operational	Remained closed and operational
Seat Movement	0	0
Seat Back Failure	None	None

Post-Test Dummy with Door Closed (Impact Side)

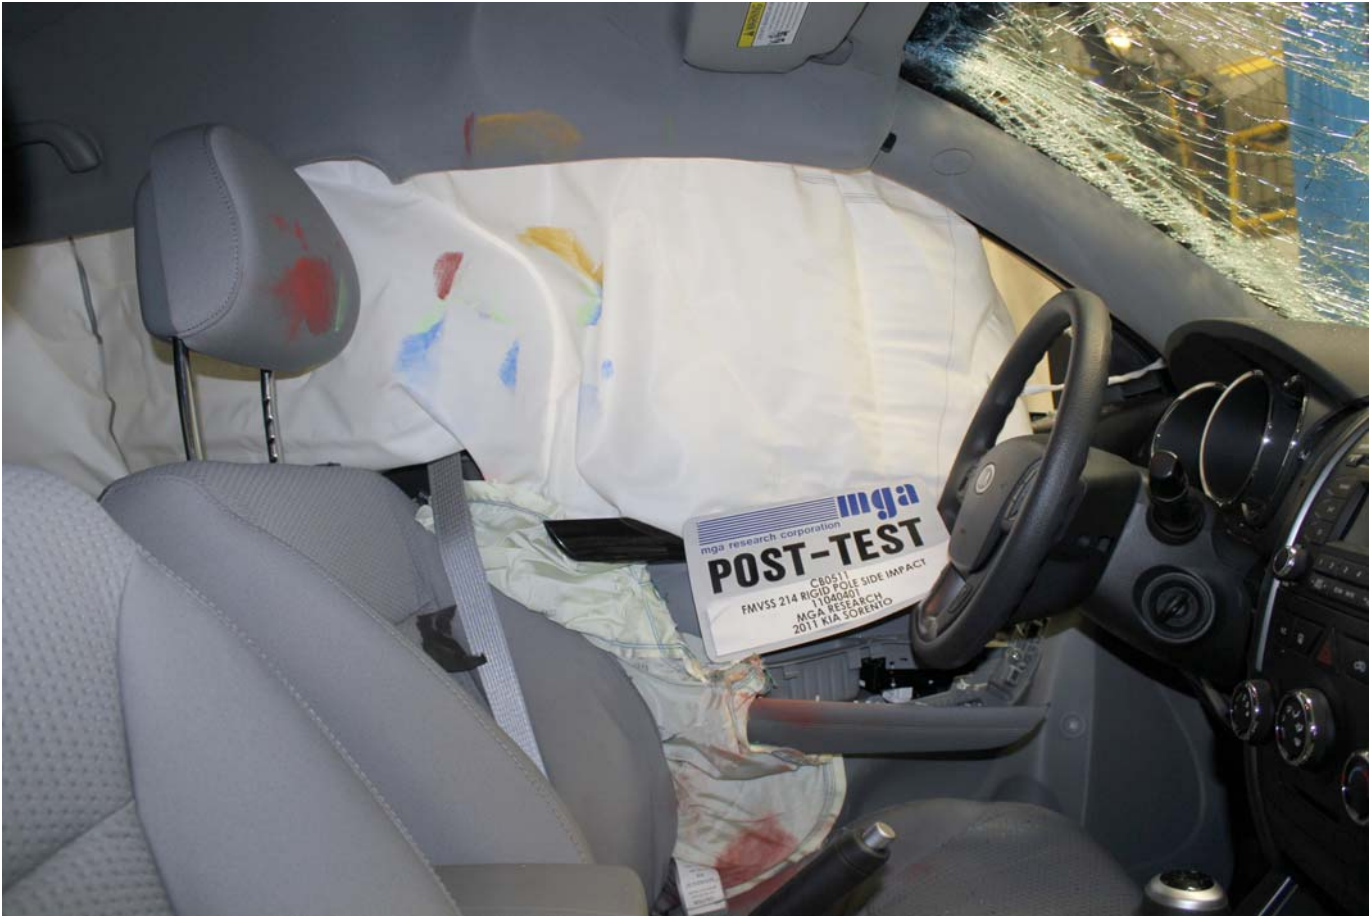
Post-Test Interior of Front Door Showing Dummy Impact Locations

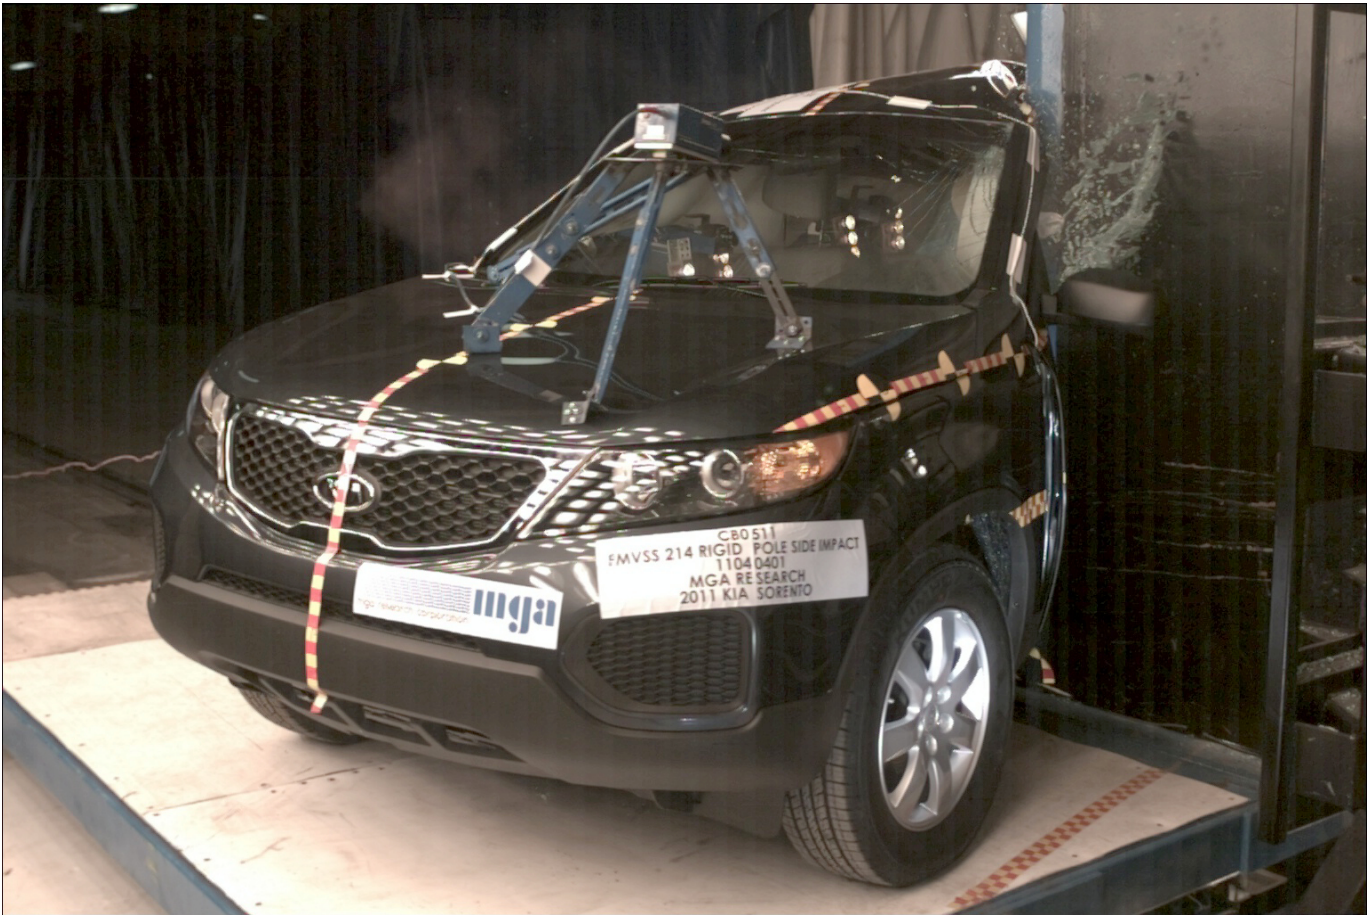
A rigid pole side impact test was conducted on a 2011 Kia Sorento SUV. The subject vehicle was towed into the rigid pole at an angle of 75° and a velocity of 31.5 km/h. The test was conducted by MGA Research Corporation in Burlington, Wisconsin, on April 4, 2011. Pre-test and post-test photographs of the test vehicle and side impact dummy are included in Appendix A of this report.

Impact Event

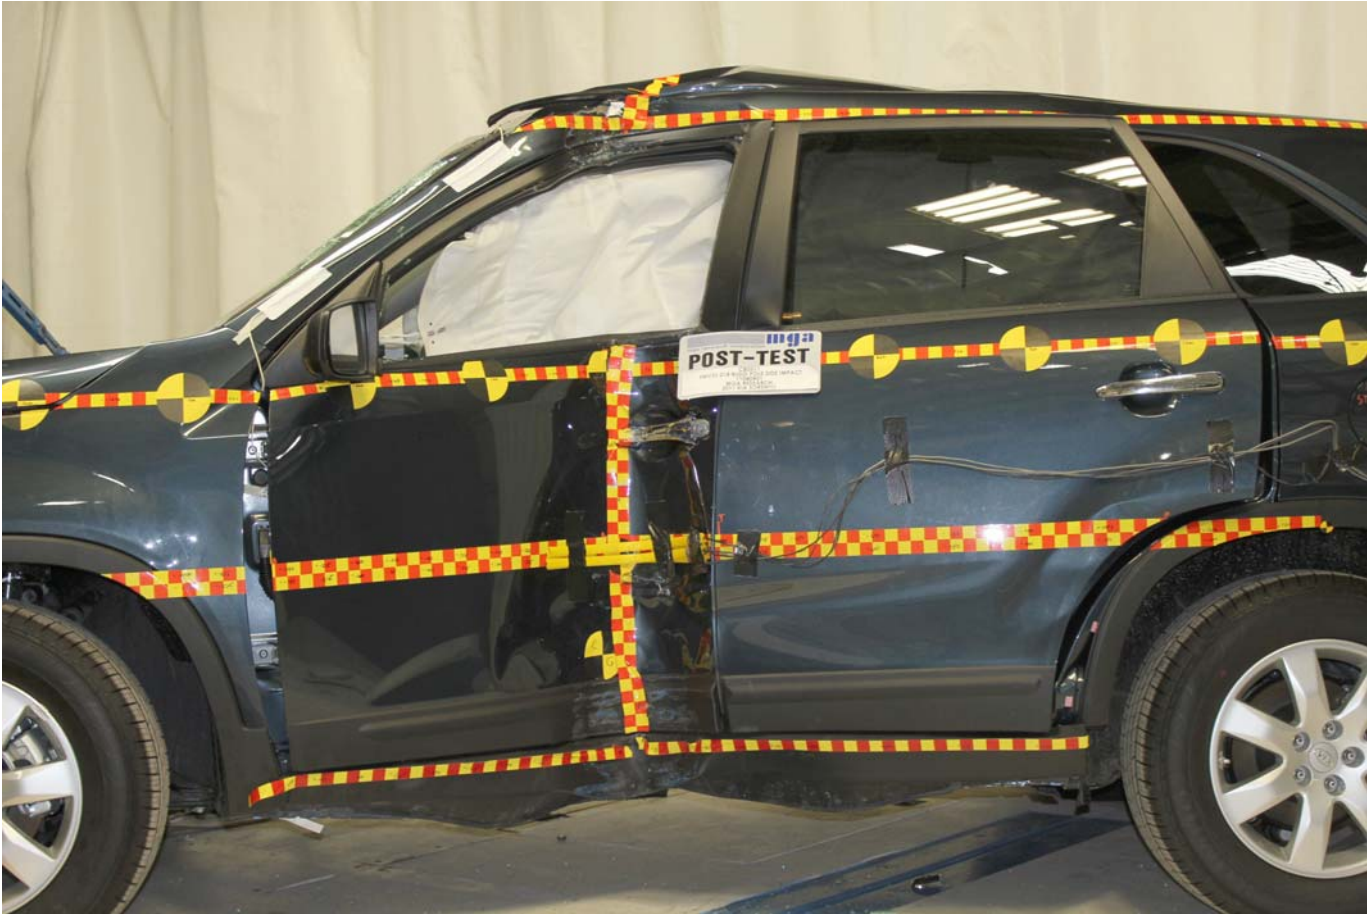
Post-Test Impact Zone Close-up View

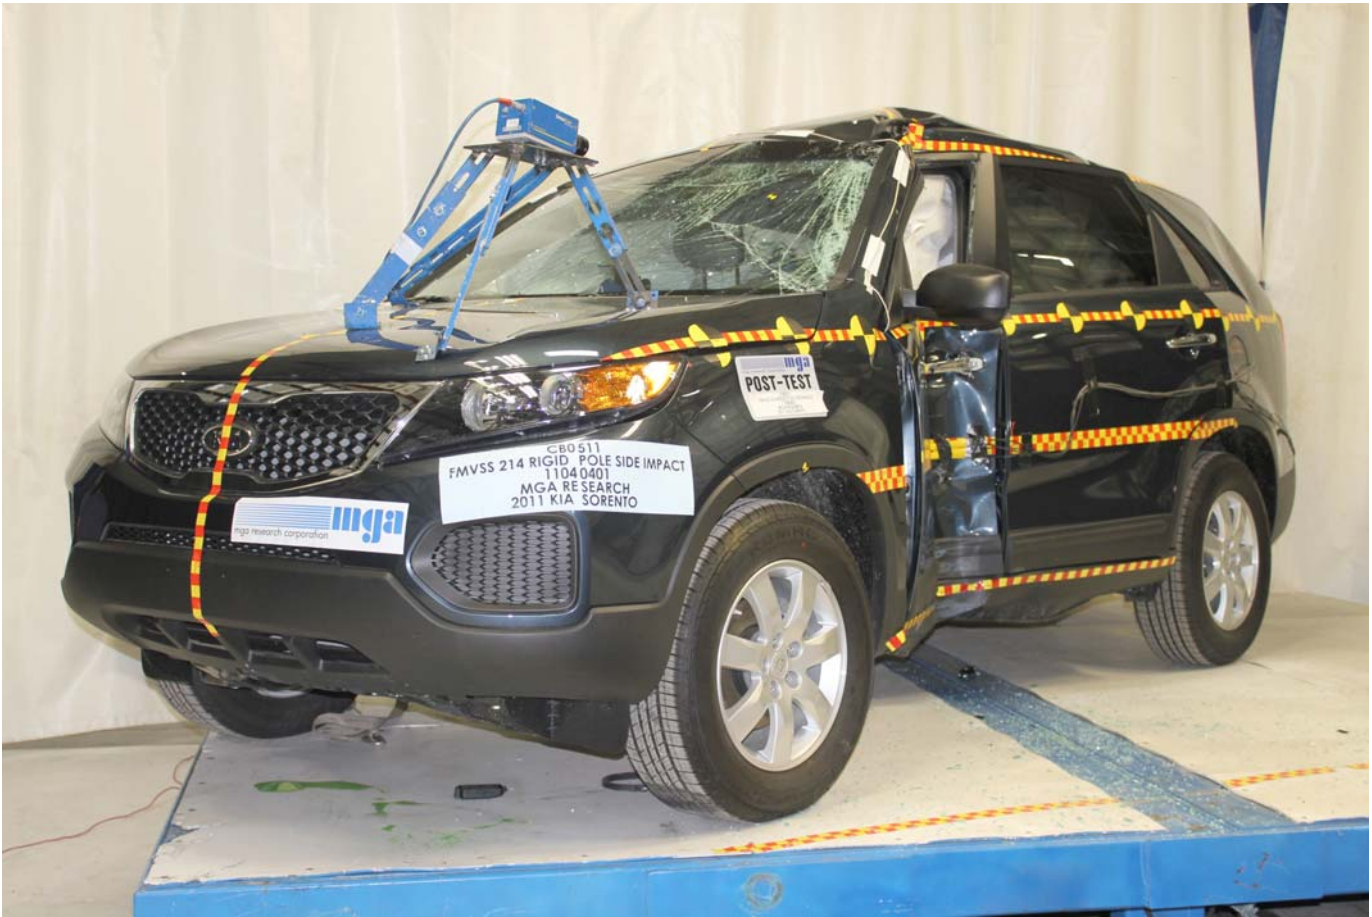
Post-Test $\frac{3}{4}$ Front View of Impact Zone

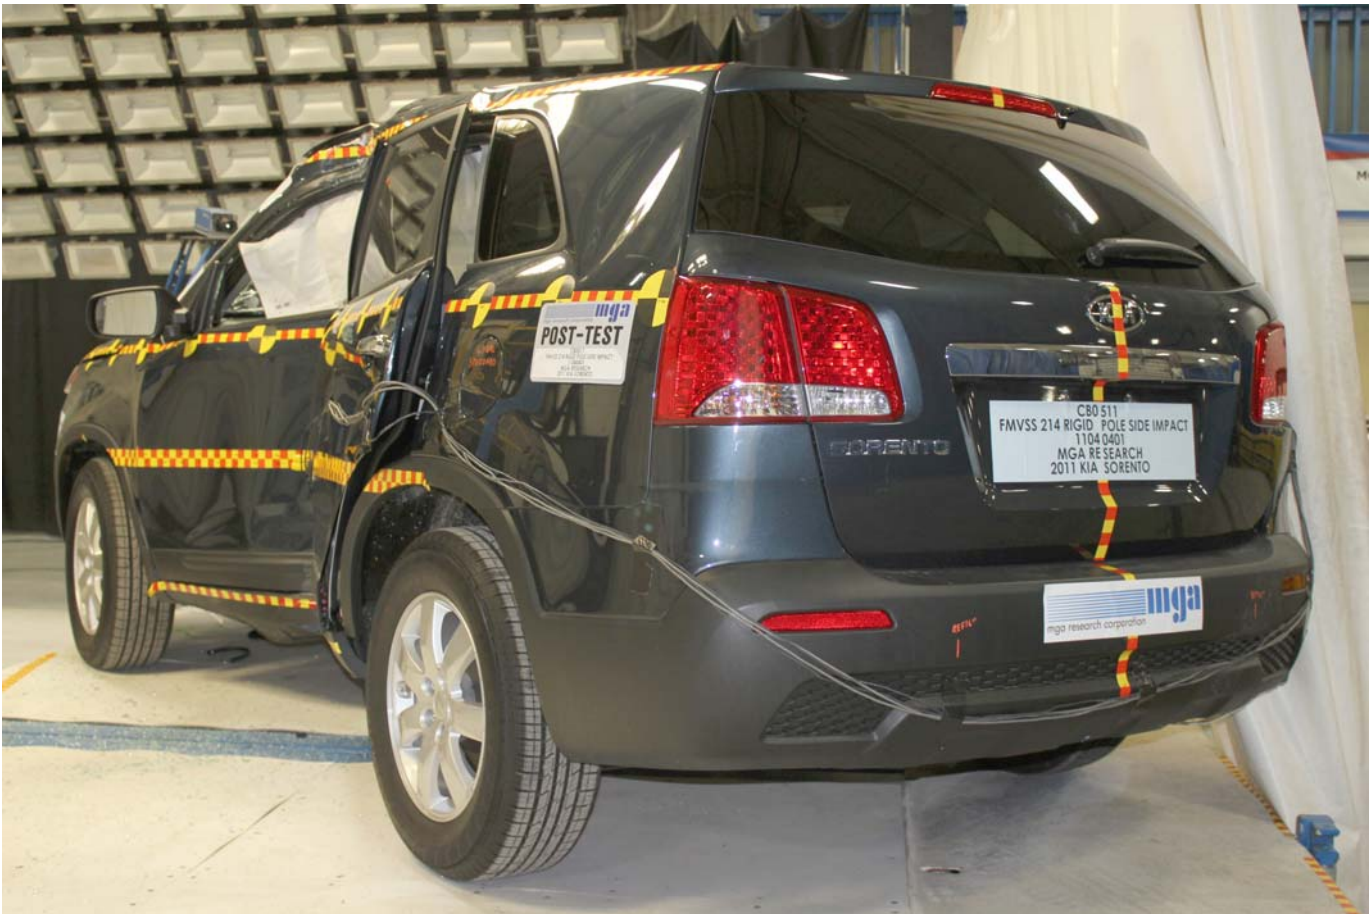
Post-Test $\frac{3}{4}$ Rear View of Impact Zone

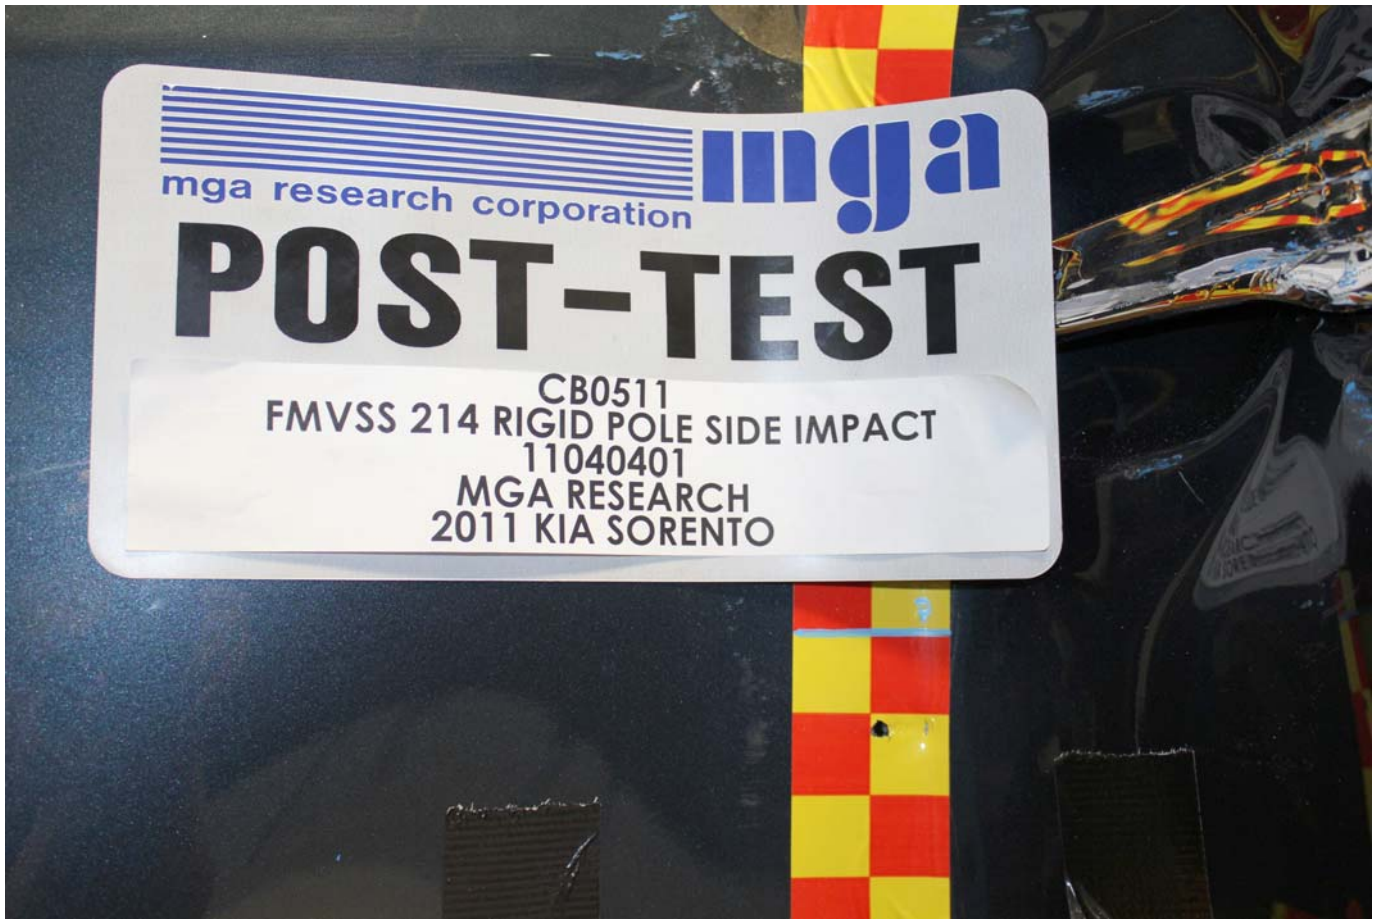
Post-Test Close-up View of Impact Point Target
