DOT HS 813 722

July 2025

# **Evaluation of FMVSS No. 305a Electric-Powered Vehicles: Water Exposure Safety**

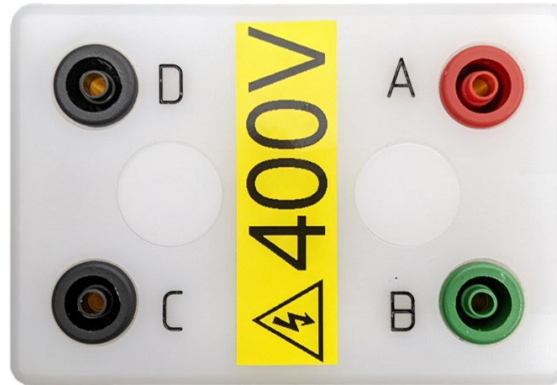
A breakout harness was connected to the REESS on the traction side of the automatic disconnect per Volvo’s recommendations. This was to support voltage measurements to determine electrical isolation from high-voltage sources. The breakout harness<sup>3</sup> was connected to a device provided by Volvo that facilitated direct access to the high-voltage circuit of the REESS. This device can be seen in Figure 1. The breakout device was connected to the vehicle via the manual service disconnect (MSD) port located in the floor directly behind the first-row passenger seat. The location of the MSD is shown in Figure 2.

*Figure 1. Breakout device provided by Volvo*

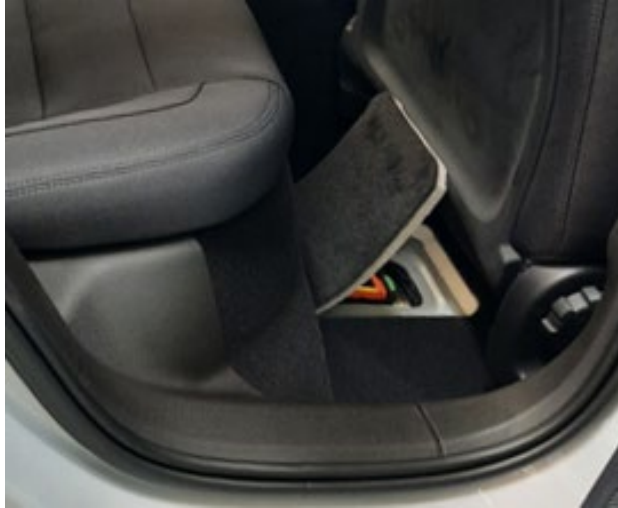
*Figure 2. Location of MSD behind first-row passenger seat*

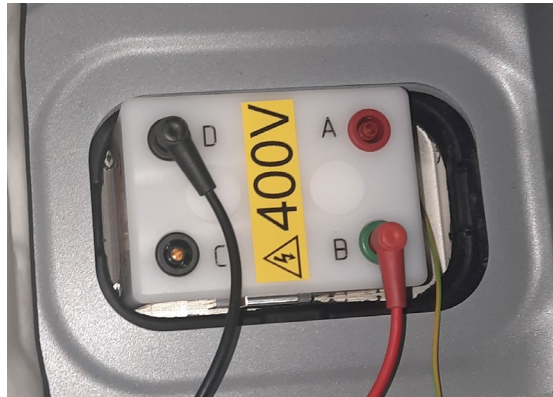
The manual service disconnect was removed and the breakout device inserted per Volvo's direction. The breakout device in the installed position can be seen in Figure 3.

*Figure 3. Breakout device installation*

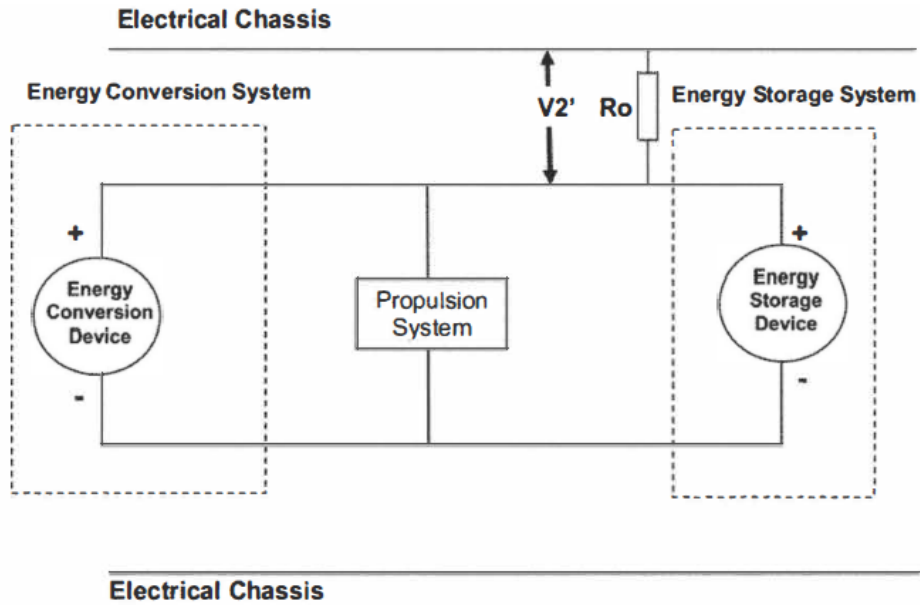
V2' was measured and recorded in a similar manner as seen in Figure 7.

Figure 7. Measurement of V2' voltage across resistor between positive side of the high voltage and the electrical chassis

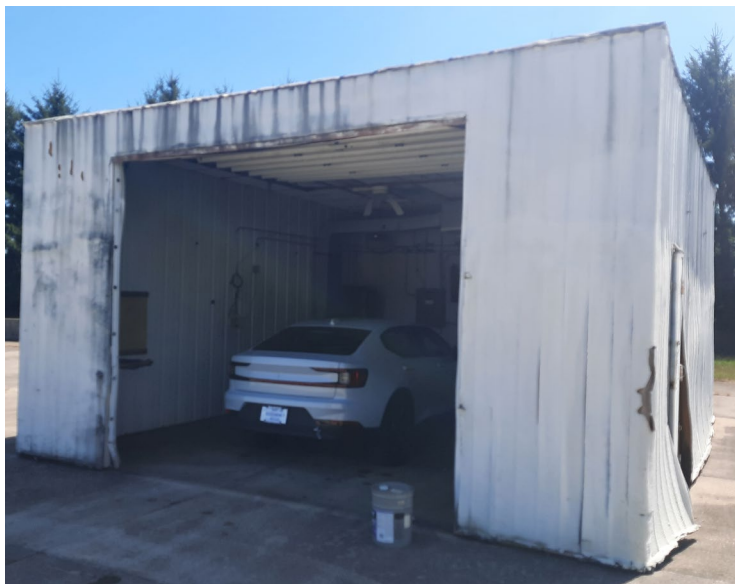
The post-test electrical isolation was checked immediately after the test and again after 24 hours. This was the same procedure as described previously in the electrical isolation baseline measurement. The vehicle was stored away from the building in a temporary shelter to prevent inadvertent exposure to environmental elements. This can be seen in Figure 12. The International Fire Code (IFC 2024) states that vehicles with damaged or defective batteries be stored protected from the weather and not less than 20 ft. from any building, public street, or public means of egress. This is done to mitigate the potential for fire damage to the main building in the event of a post-test fire resulting from thermal runaway in the lithium-ion battery.

*Figure 12. Temporary vehicle storage*

The post-test electrical isolation was checked immediately after the test and again after 24 hours. This was the same procedure as described in the electrical isolation baseline measurement. The vehicle was stored away from the building in a temporary shelter to prevent inadvertent exposure to environmental elements. This can be seen in Figure 12.

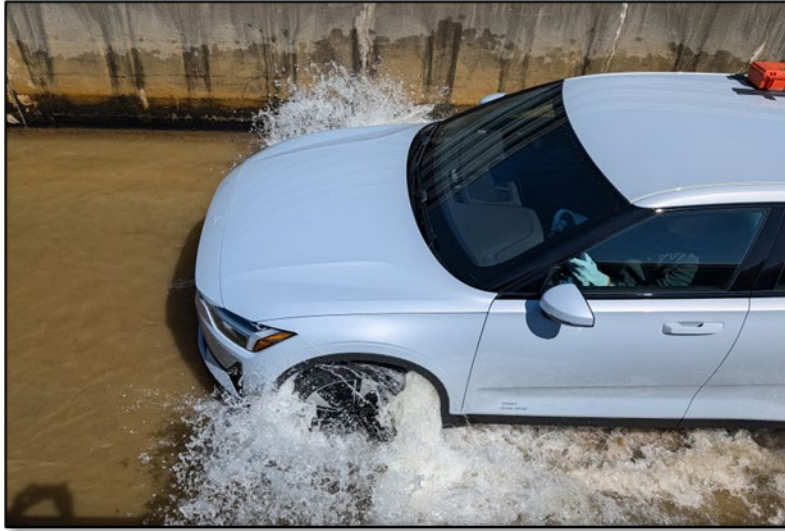
The vehicle was driven through the wade pool 17 times to meet the 500 m requirement. This can be seen in Figure 14.

*Figure 14. Wade pool testing*

The total test time to complete the 17 trips through the wade pool, at a vehicle speed of 20 km/hr, was 7.5 minutes. This was greater than the 5 minutes maximum test time proposed in the NRPM. The testing did include a 180° turn at the end of each lap, which may not have been considered in the NPRM.
