FINAL REPORT NUMBER 201UI-MGA-09-05

SAFETY COMPLIANCE TESTING FOR FMVSS 201
Occupant Protection In Interior Impact
Upper Interior Head Impact Protection

AUDI AG
2009 Audi A4 Sedan
NHTSA No. C95802

MGA RESEARCH CORPORATION
446 Executive Drive
Troy, Michigan 48083

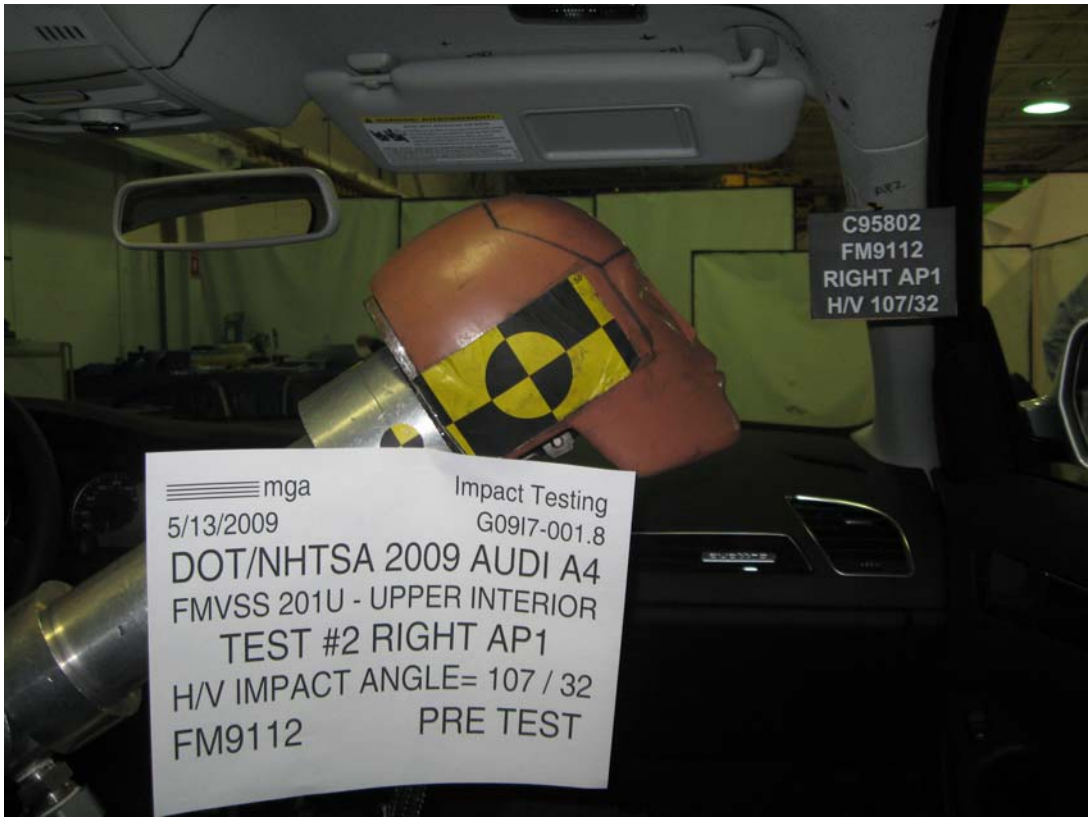
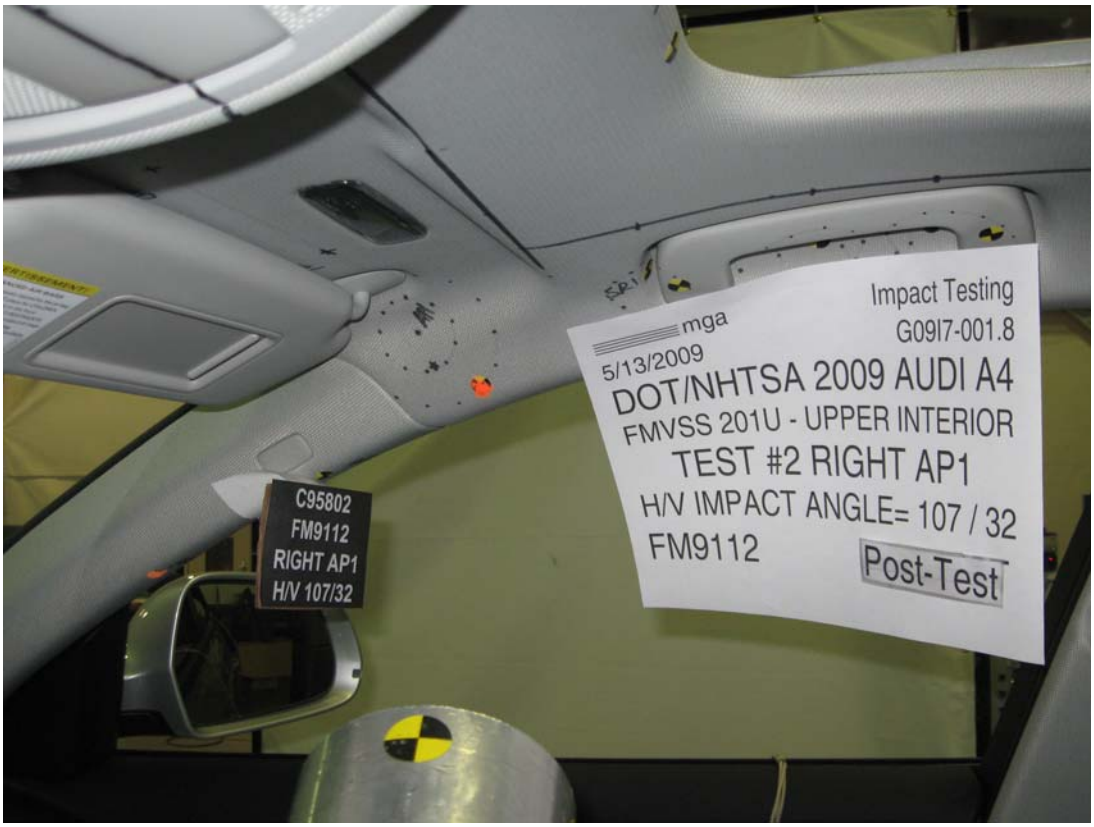
C95802
FM9112
RIGHT AP1
H/V 107/32
mga
5/13/2009
Impact Testing
G09I7-001.8
DOT/NHTSA 2009 AUDI A4
FMVSS 201U - UPPER INTERIOR
TEST #2 RIGHT AP1
H/V IMPACT ANGLE= 107 / 32
FM9112
Post-Test

No damage observed

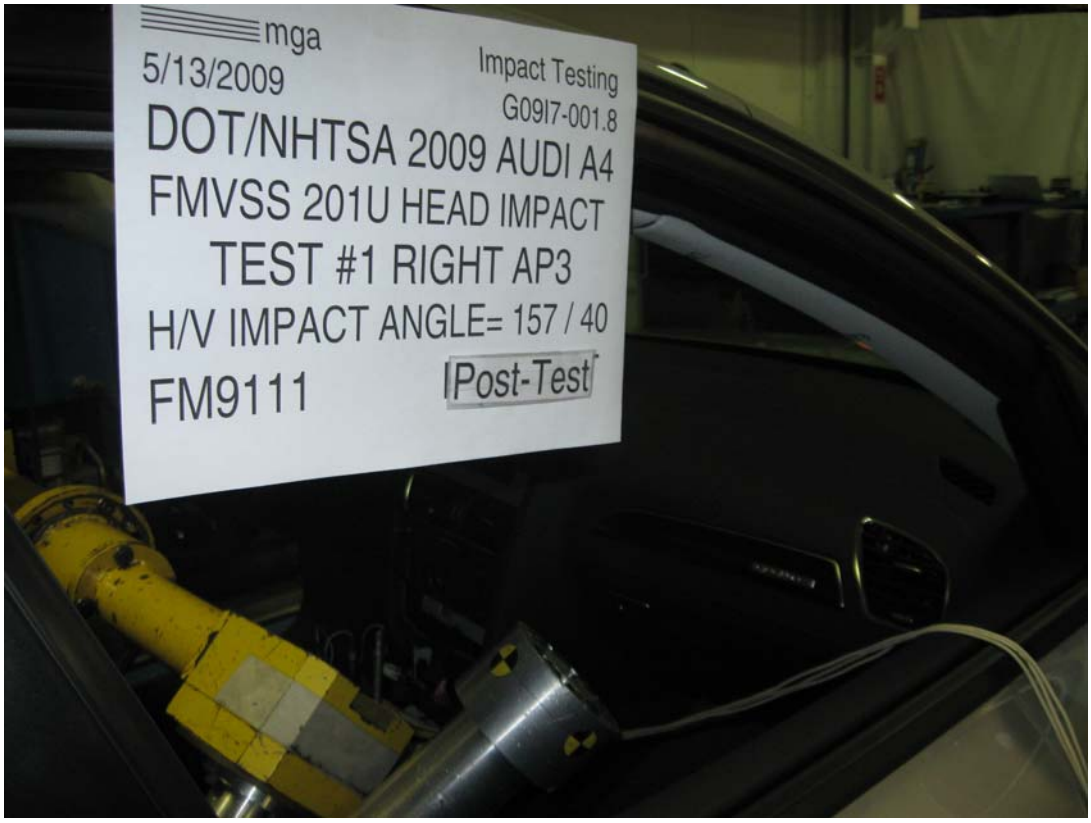
mga
5/13/2009
Impact Testing
G09I7-001.8
DOT/NHTSA 2009 AUDI A4
FMVSS 201U HEAD IMPACT
TEST #1 RIGHT AP3
H/V IMPACT ANGLE= 157 / 40
FM9111
Post-Test

No damage observed

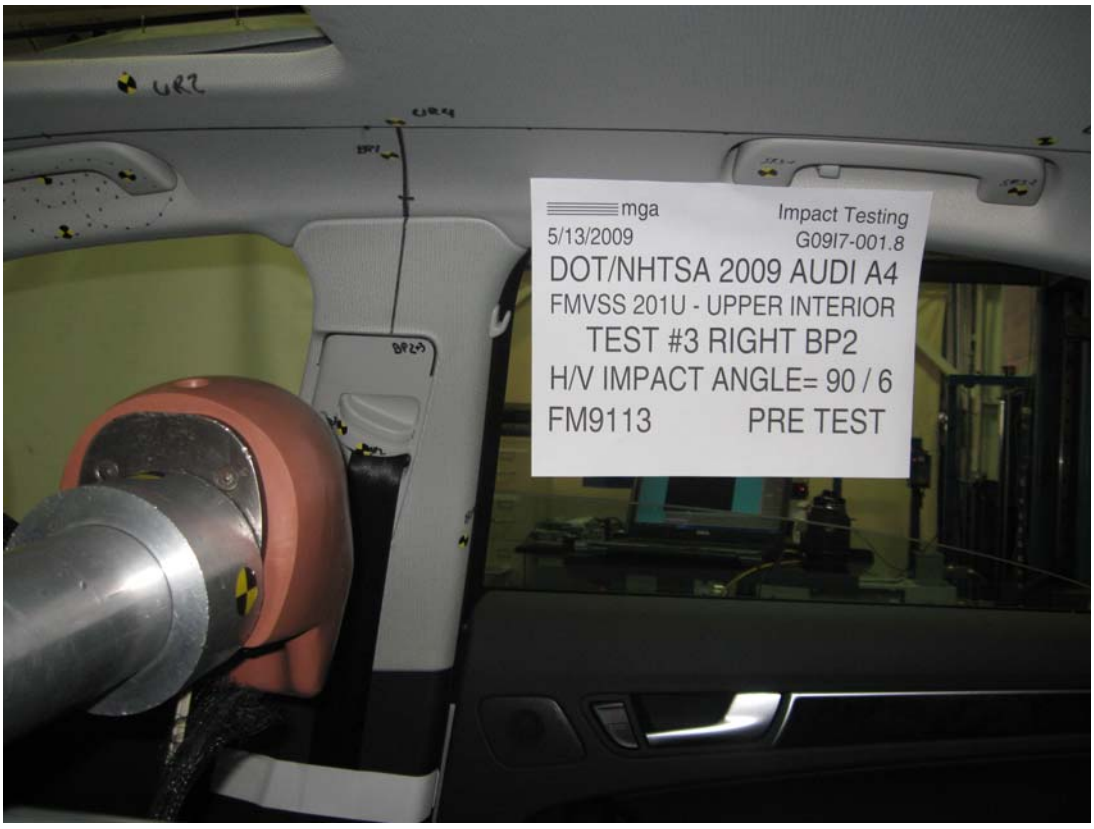
mga
Impact Testing
G09I7-001.8
5/13/2009
DOT/NHTSA 2009 AUDI A4
FMVSS 201U - UPPER INTERIOR
TEST #3 RIGHT BP2
H/V IMPACT ANGLE= 90 / 6
FM9113
PRE TEST

No damage observed

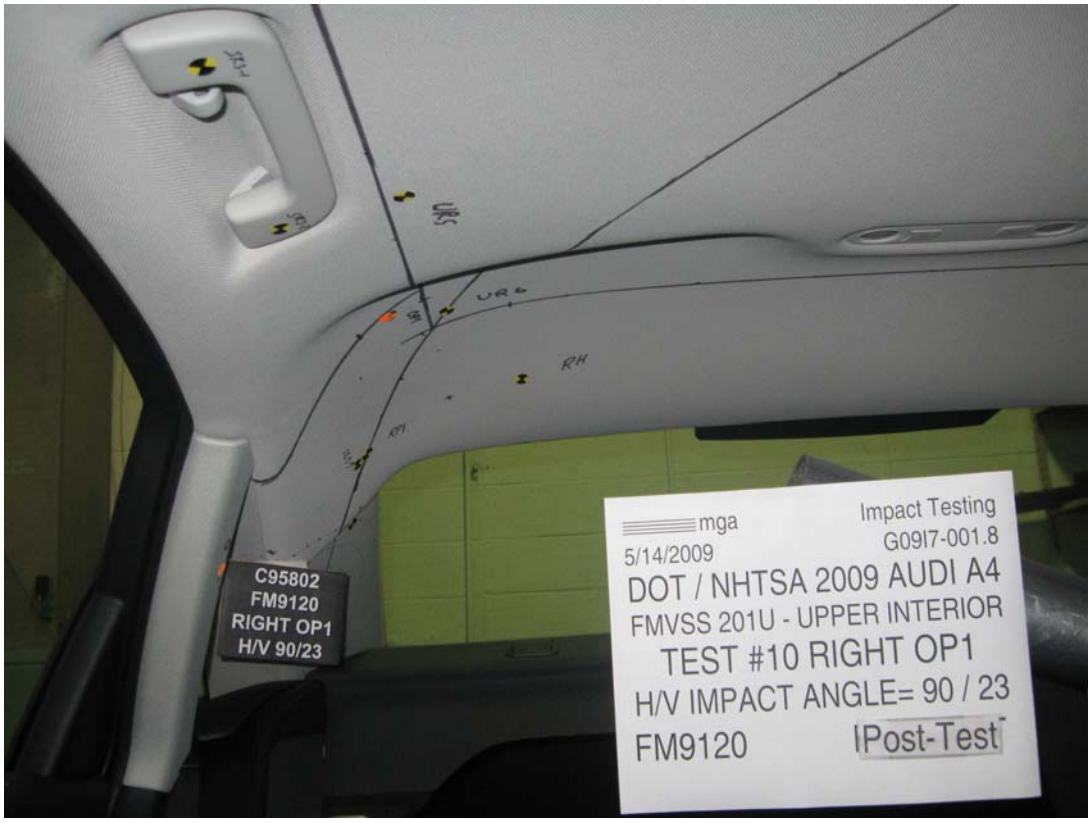
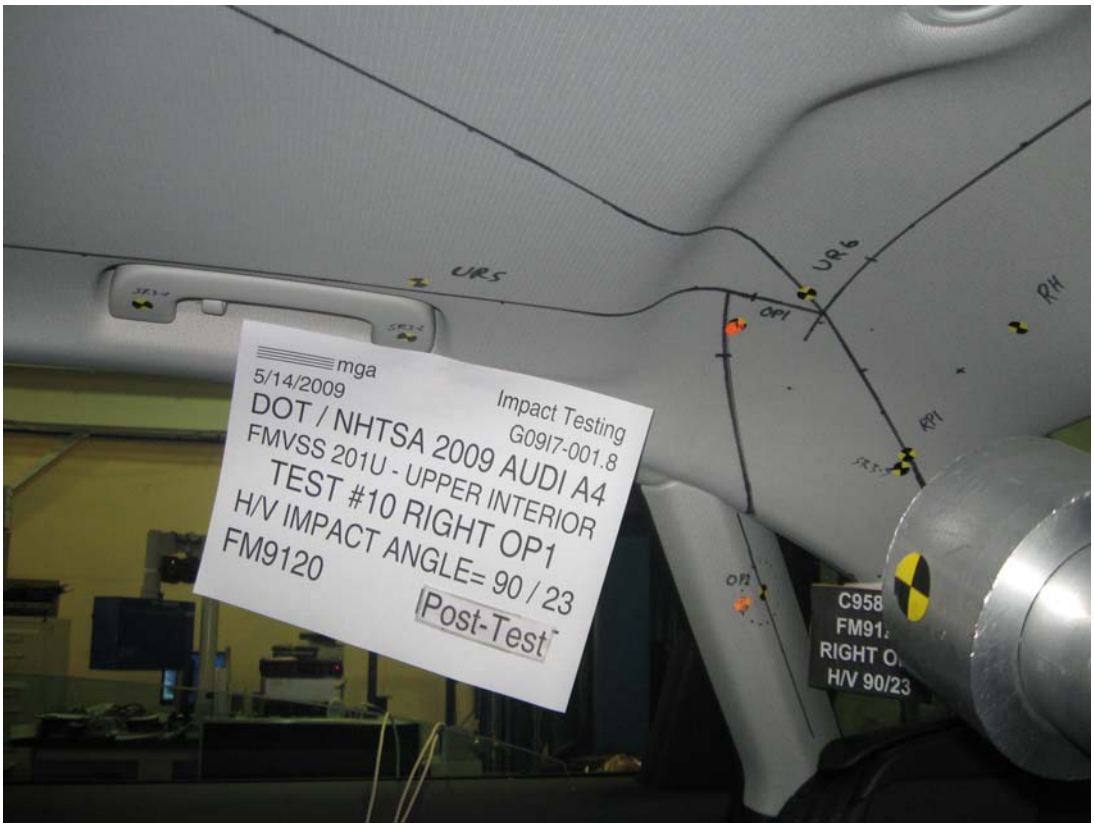
C95802
FM9120
RIGHT OP1
H/V 90/23
mga
5/14/2009
Impact Testing
G09I7-001.8
DOT / NHTSA 2009 AUDI A4
FMVSS 201U - UPPER INTERIOR
TEST #10 RIGHT OP1
H/V IMPACT ANGLE= 90 / 23
FM9120
Post-Test

No damage observed

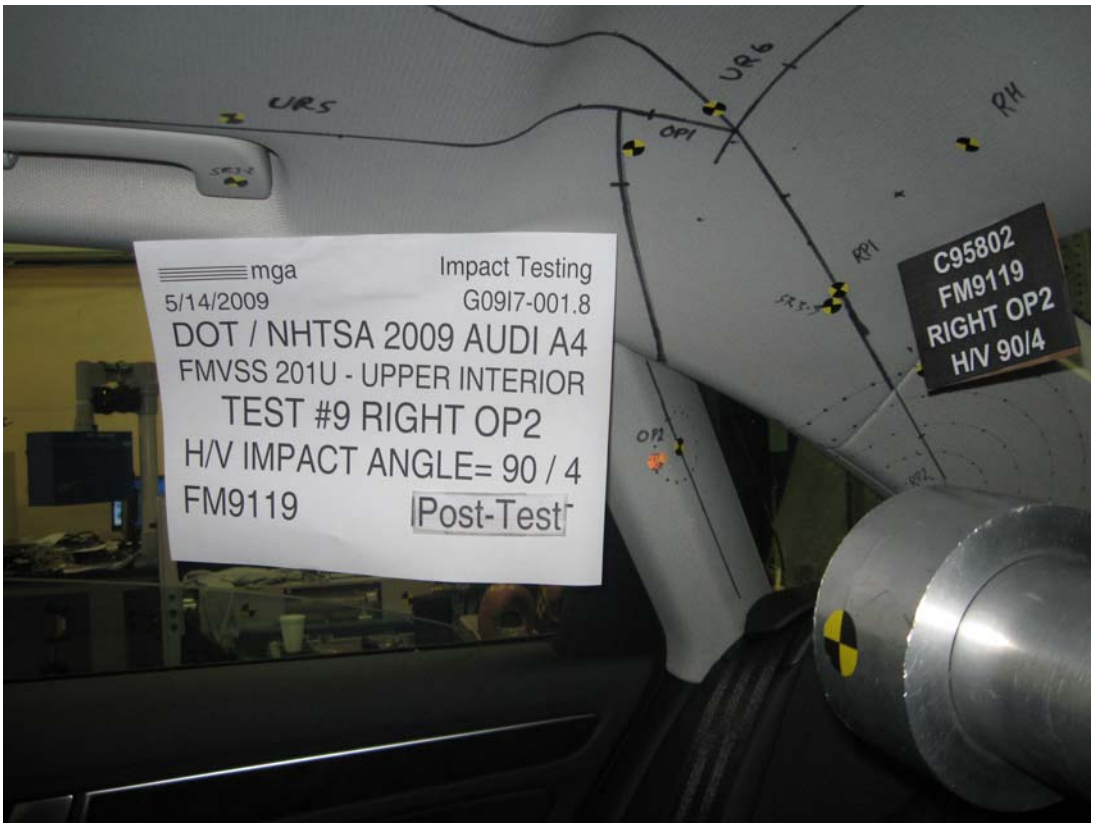
No damage observed

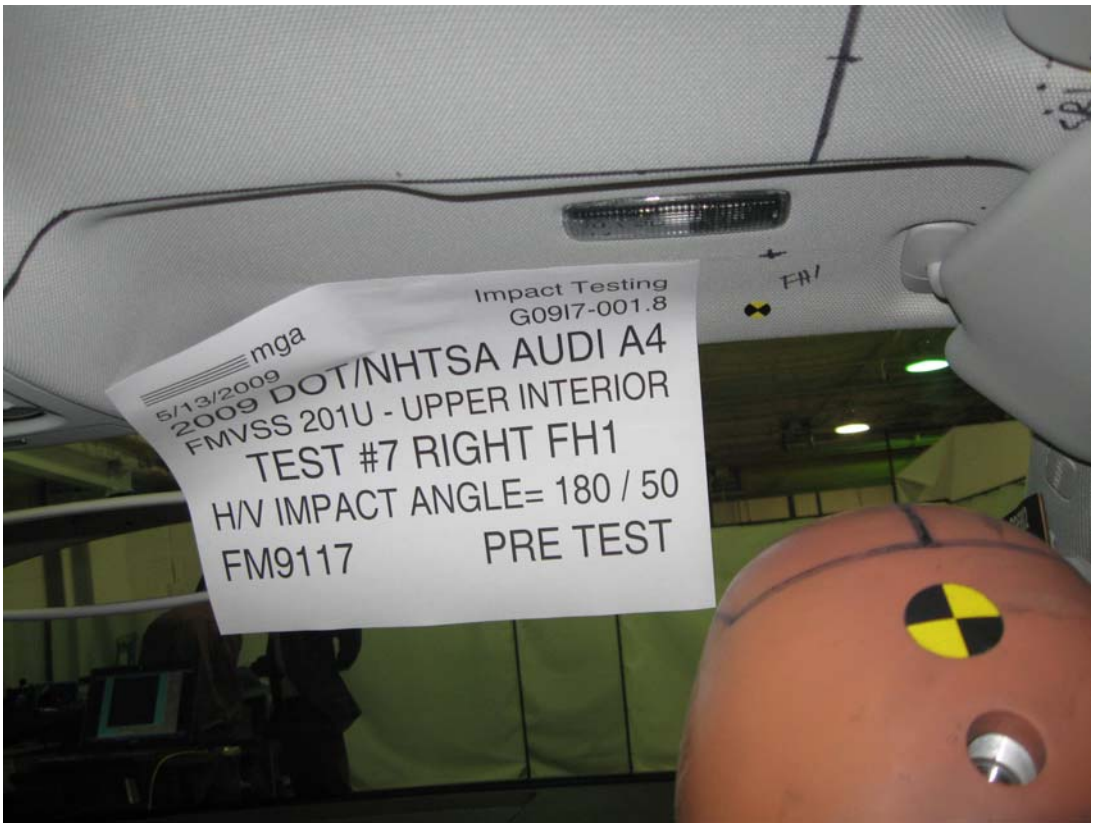
C95802
FM9117
RIGHT FH1
H/V 180/50
mga
Impact Testing
G09I7-001.8
5/13/2009
2009 DOT/NHTSA AUDI A4
FMVSS 201U - UPER INTERIOR
TEST #7 RIGHT FH1
H/V IMPACT ANGLE= 180 / 50
FM9117
PRE TEST

No visible damage

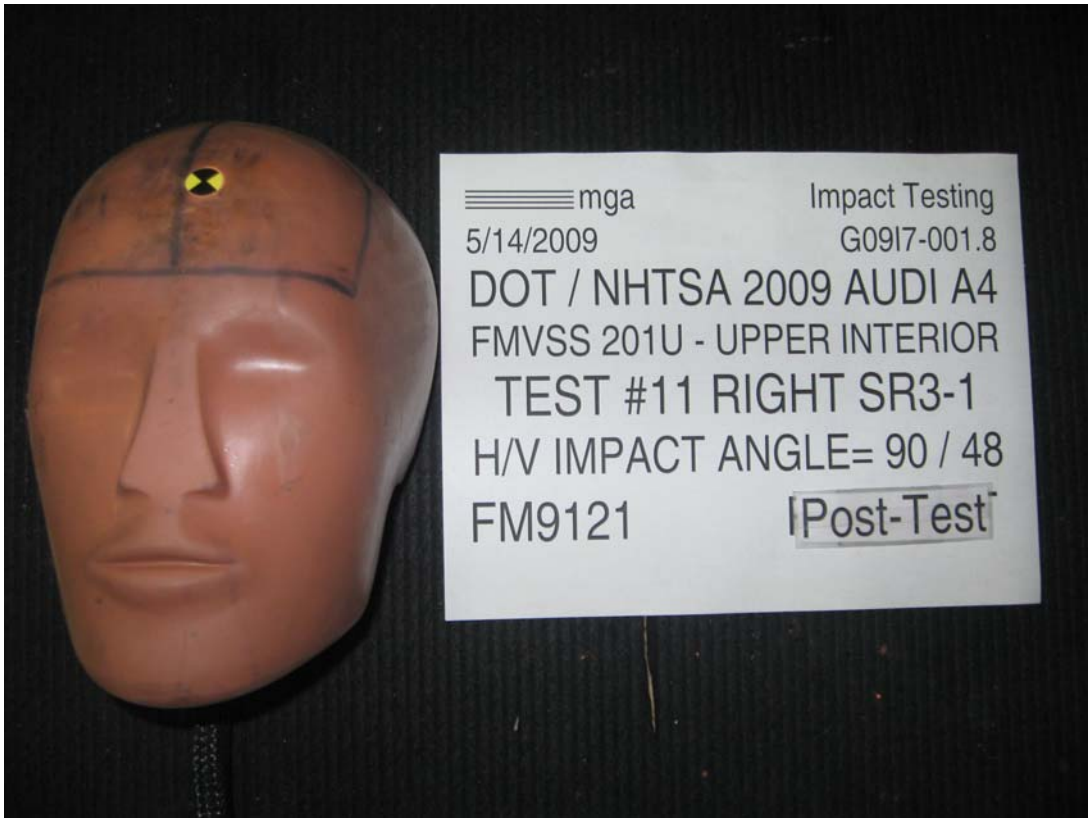
mga
Impact Testing
5/14/2009
G09I7-001.8
DOT / NHTSA 2009 AUDI A4
FMVSS 201U - UPPER INTERIOR
TEST #11 RIGHT SR3-1
H/V IMPACT ANGLE= 90 / 48
FM9121
Post-Test

No damage observed

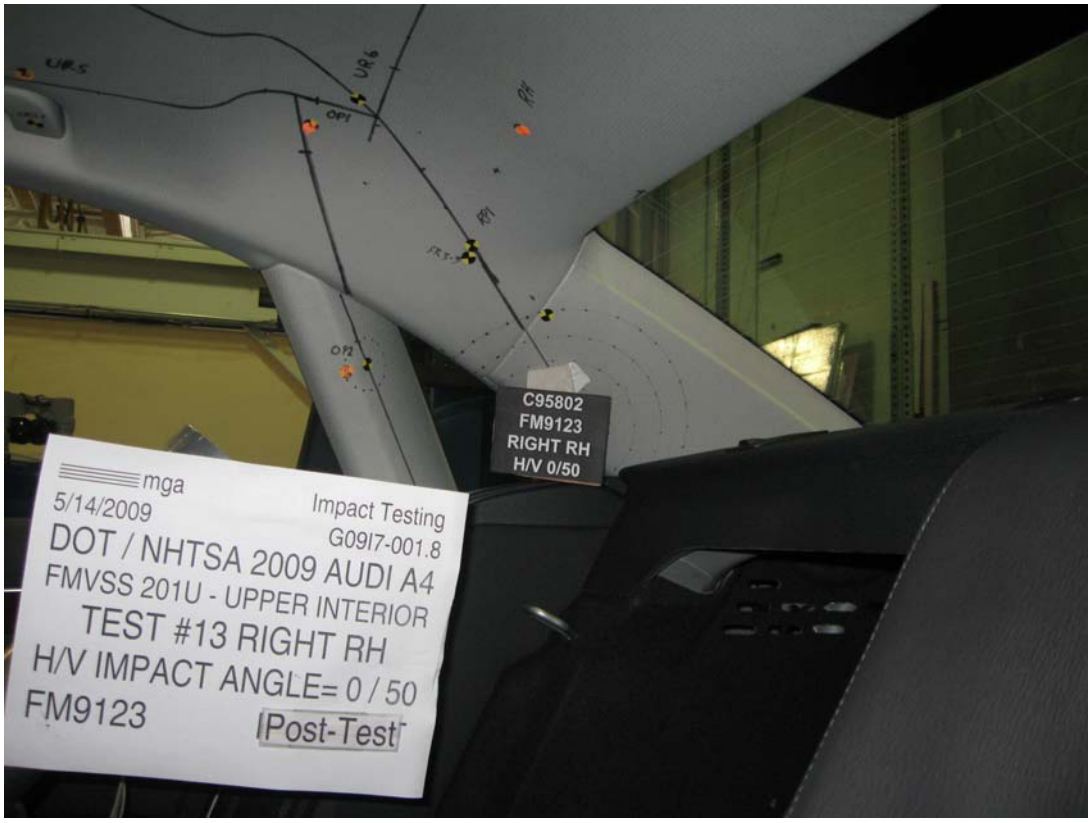
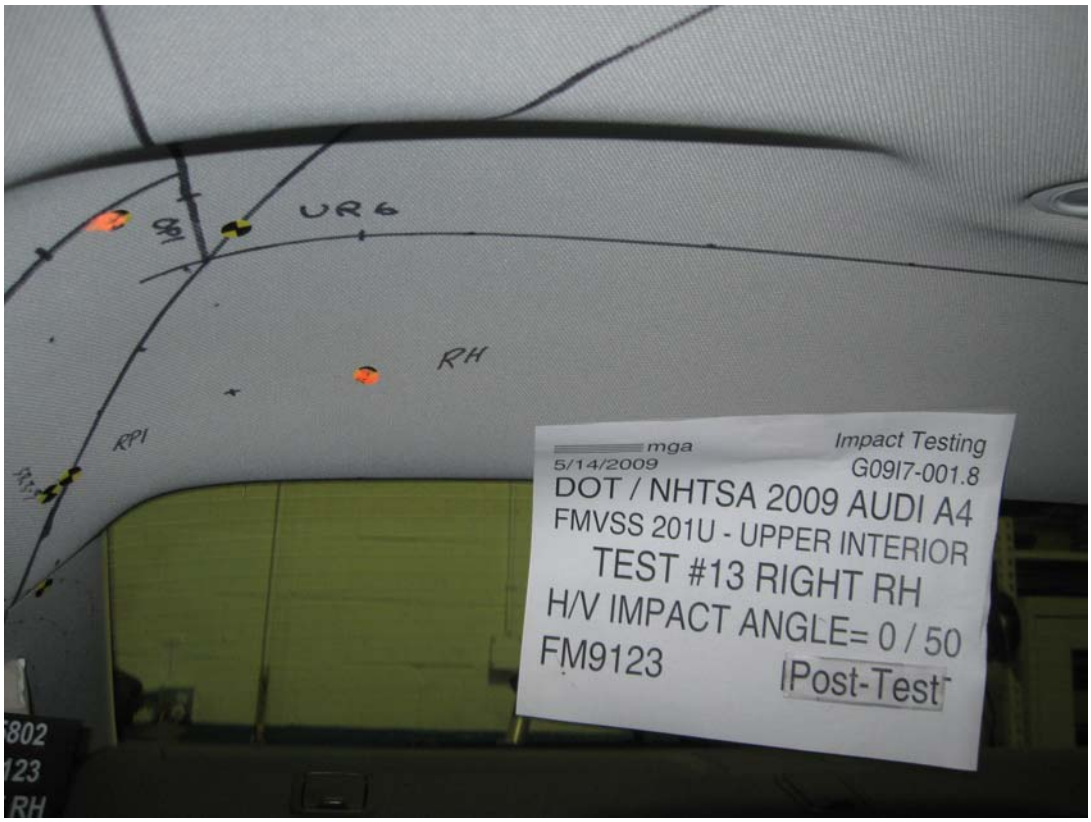
C95802
FM9123
RIGHT RH
H/V 0/50
mga
5/14/2009
Impact Testing
G09I7-001.8
DOT / NHTSA 2009 AUDI A4
FMVSS 201U - UPPER INTERIOR
TEST #13 RIGHT RH
H/V IMPACT ANGLE= 0 / 50
FM9123
Post-Test

No damage observed

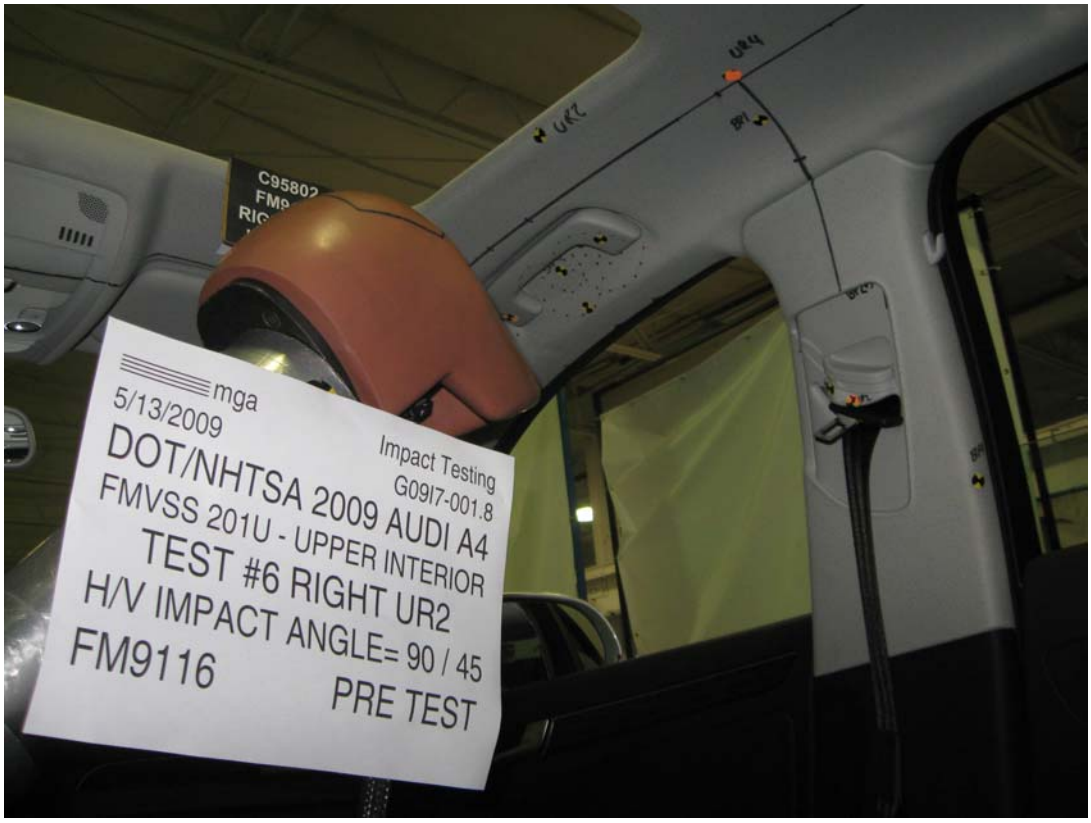
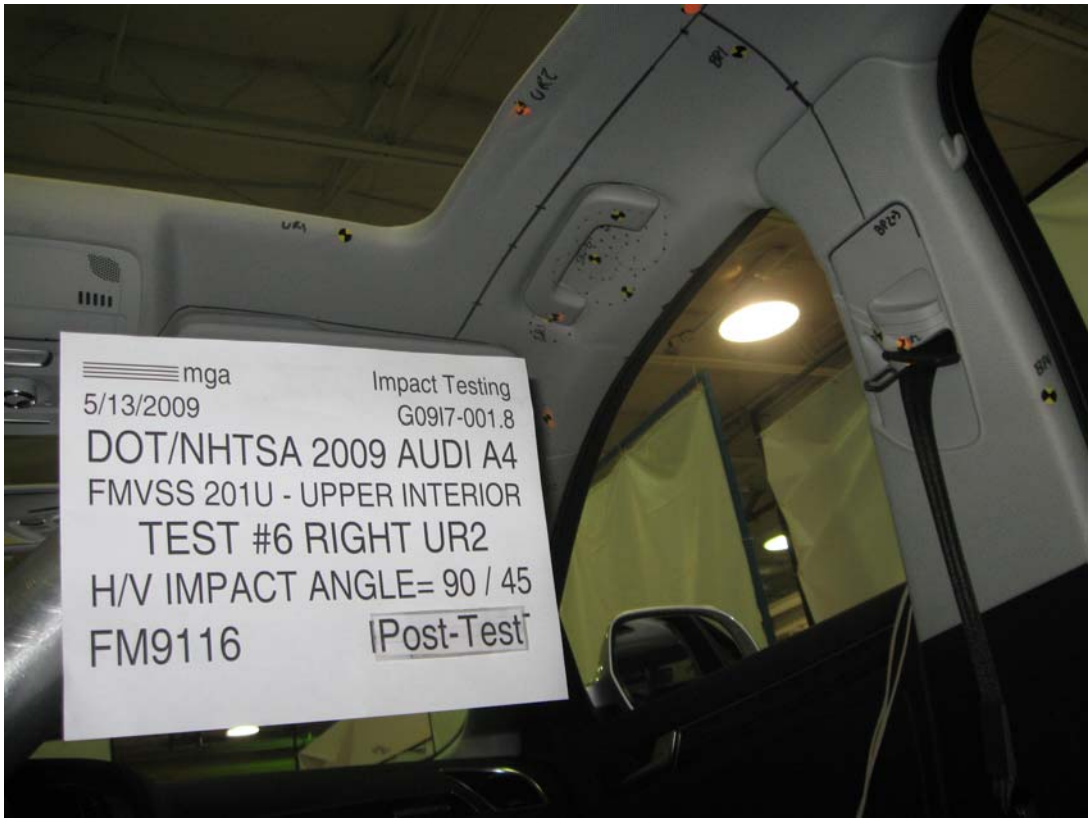
UR2
UR4
mga
5/13/2009
Impact Testing
G09I7-001.8
DOT/NHTSA 2009 AUDI A4
FMVSS 201U - UPPER INTERIOR
TEST #6 RIGHT UR2
H/V IMPACT ANGLE= 90 / 45
FM9116
PRE TEST

UR2
UR3
UR4
mga
5/13/2009
Impact Testing
G09I7-001.8
DOT/NHTSA 2009 AUDI A4
FMVSS 201U - UPPER INTERIOR
TEST #6 RIGHT UR2
H/V IMPACT ANGLE= 90 / 45
FM9116
Post-Test

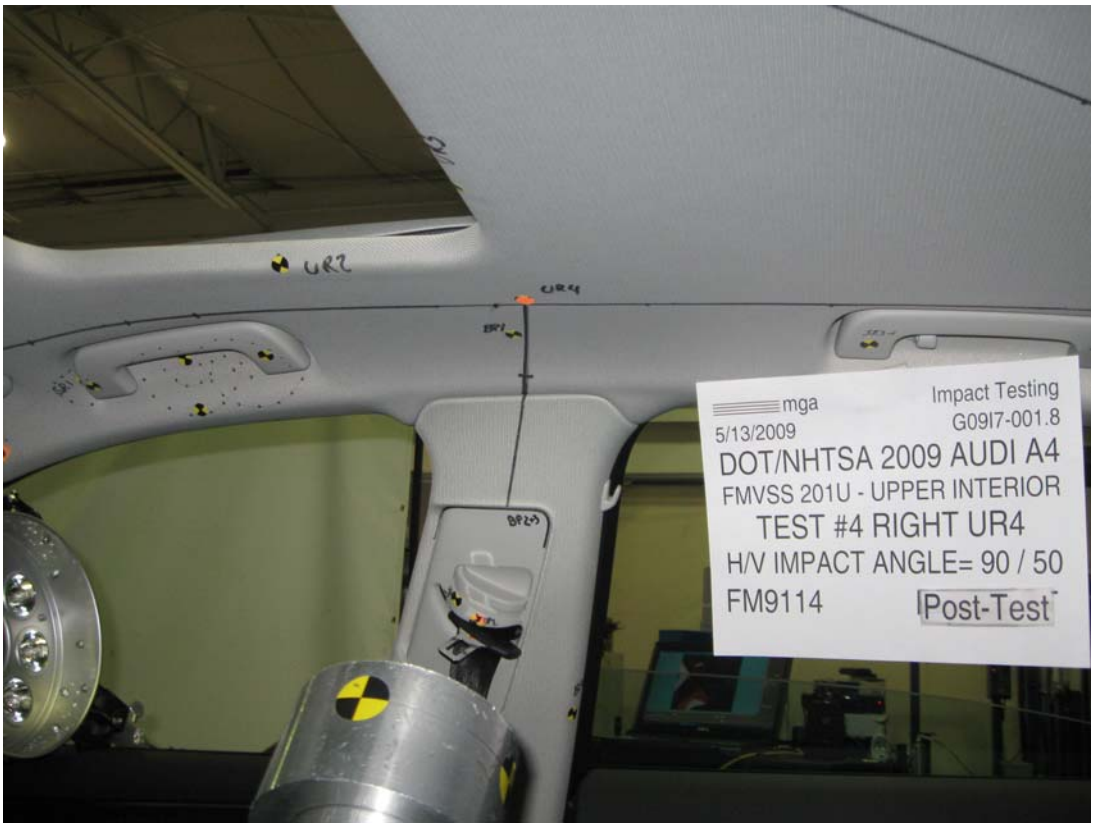
mga
5/13/2009
Impact Testing
G09I7-001.8
DOT/NHTSA 2009 AUDI A4
FMVSS 201U - UPPER INTERIOR
TEST #4 RIGHT UR4
H/V IMPACT ANGLE= 90 / 50
FM9114
Post-Test

No damage observed

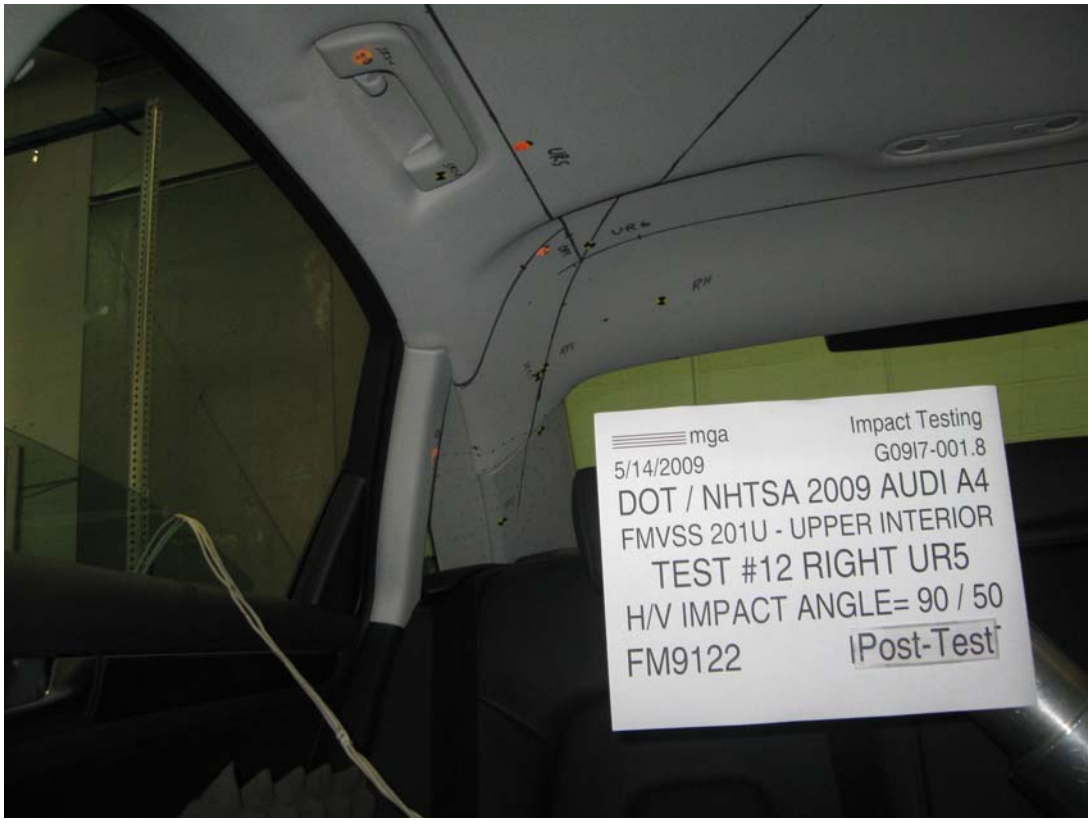
mga
Impact Testing
5/14/2009
G09I7-001.8
DOT / NHTSA 2009 AUDI A4
FMVSS 201U - UPPER INTERIOR
TEST #12 RIGHT UR5
H/V IMPACT ANGLE= 90 / 50
FM9122
Post-Test

No damage observed

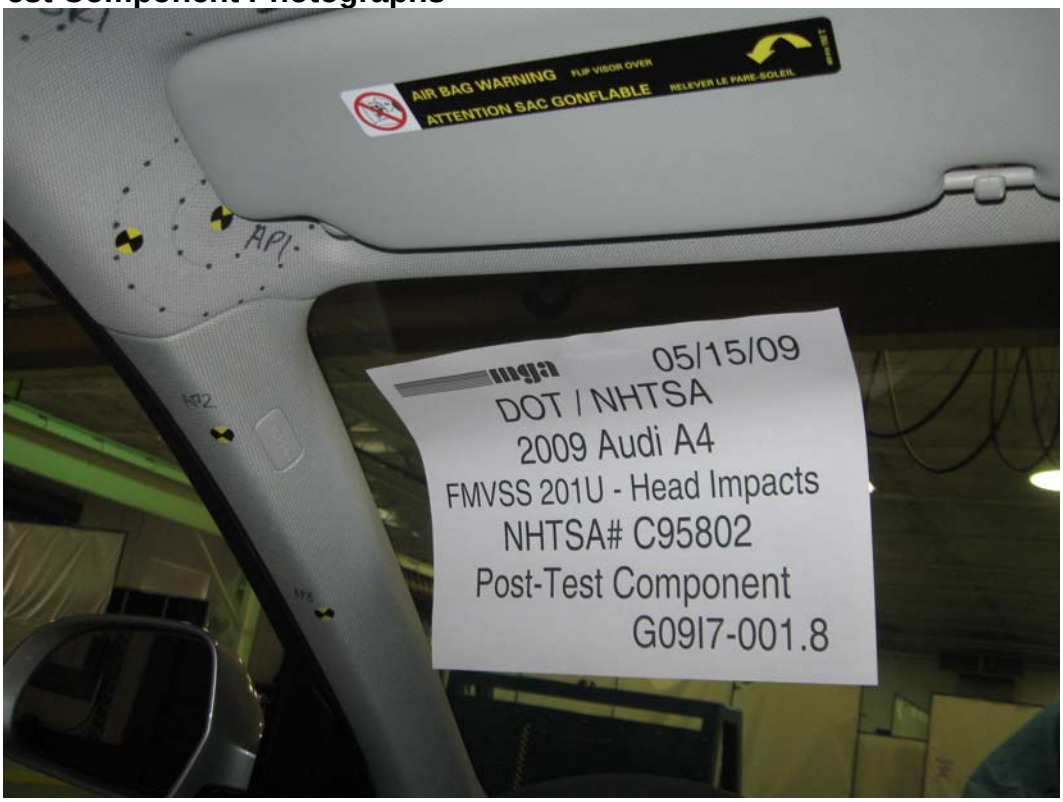
mga
05/15/09
DOT / NHTSA
2009 Audi A4
FMVSS 201U - Head Impacts
NHTSA# C95802
Post-Test Component
G09I7-001.8

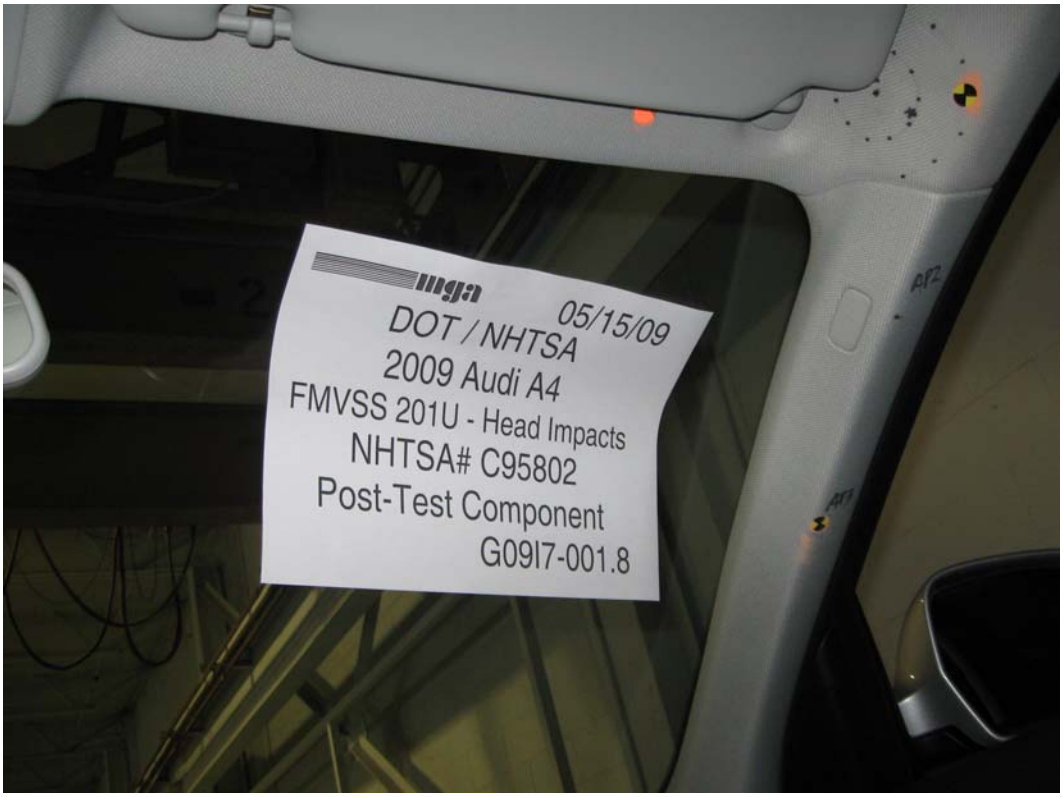
mga
05/15/09
DOT / NHTSA
2009 Audi A4
FMVSS 201U - Head Impacts
NHTSA# C95802
Post-Test Component
G09I7-001.8
