REPORT NO. 111-KAR-07-004

SAFETY COMPLIANCE TESTING FOR FMVSS 111

2008 ACURA RDX
5-DOOR MPV

NHTSA NO: C85300

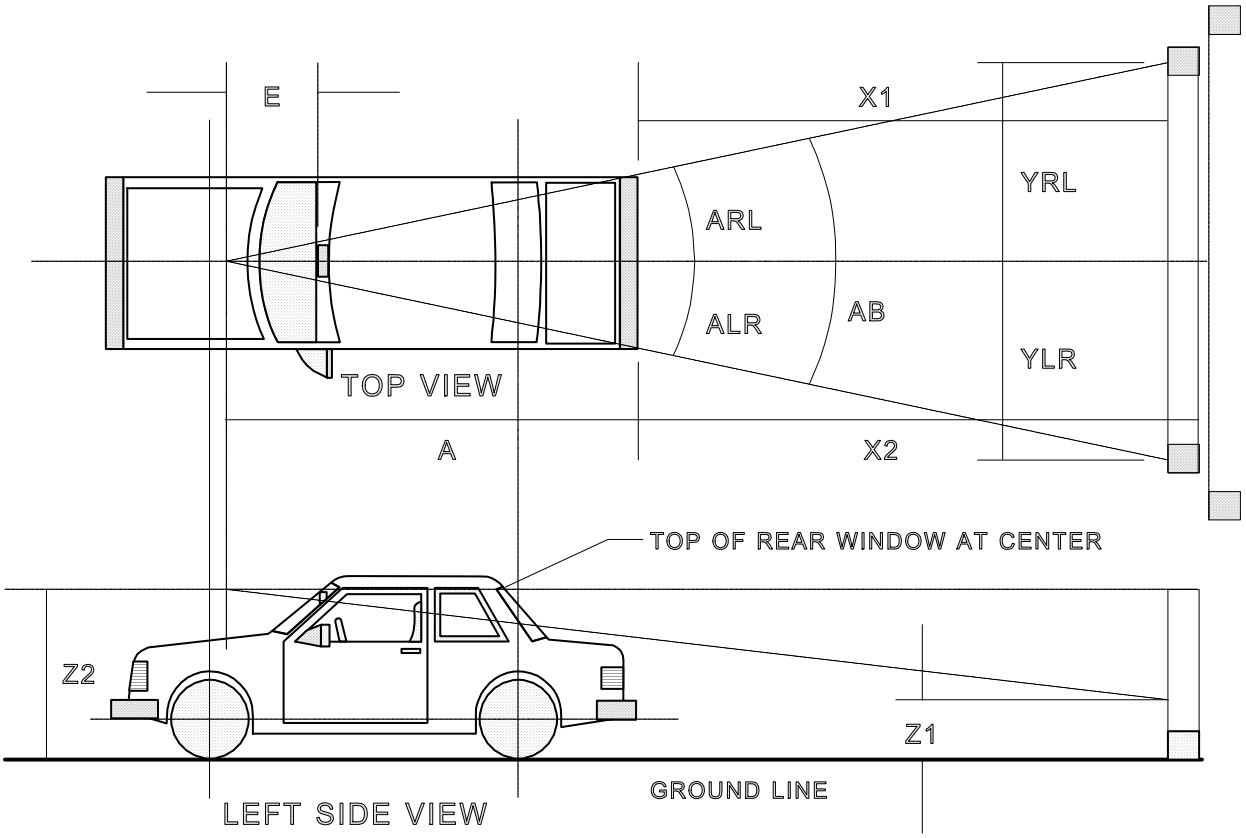
INSIDE REARVIEW MIRROR FIELD OF VIEW
TEST GRID AND MARKER SETUP

ANGLE AB = **22.53°** (S111 REQUIREMENT = 20 degrees minimum)

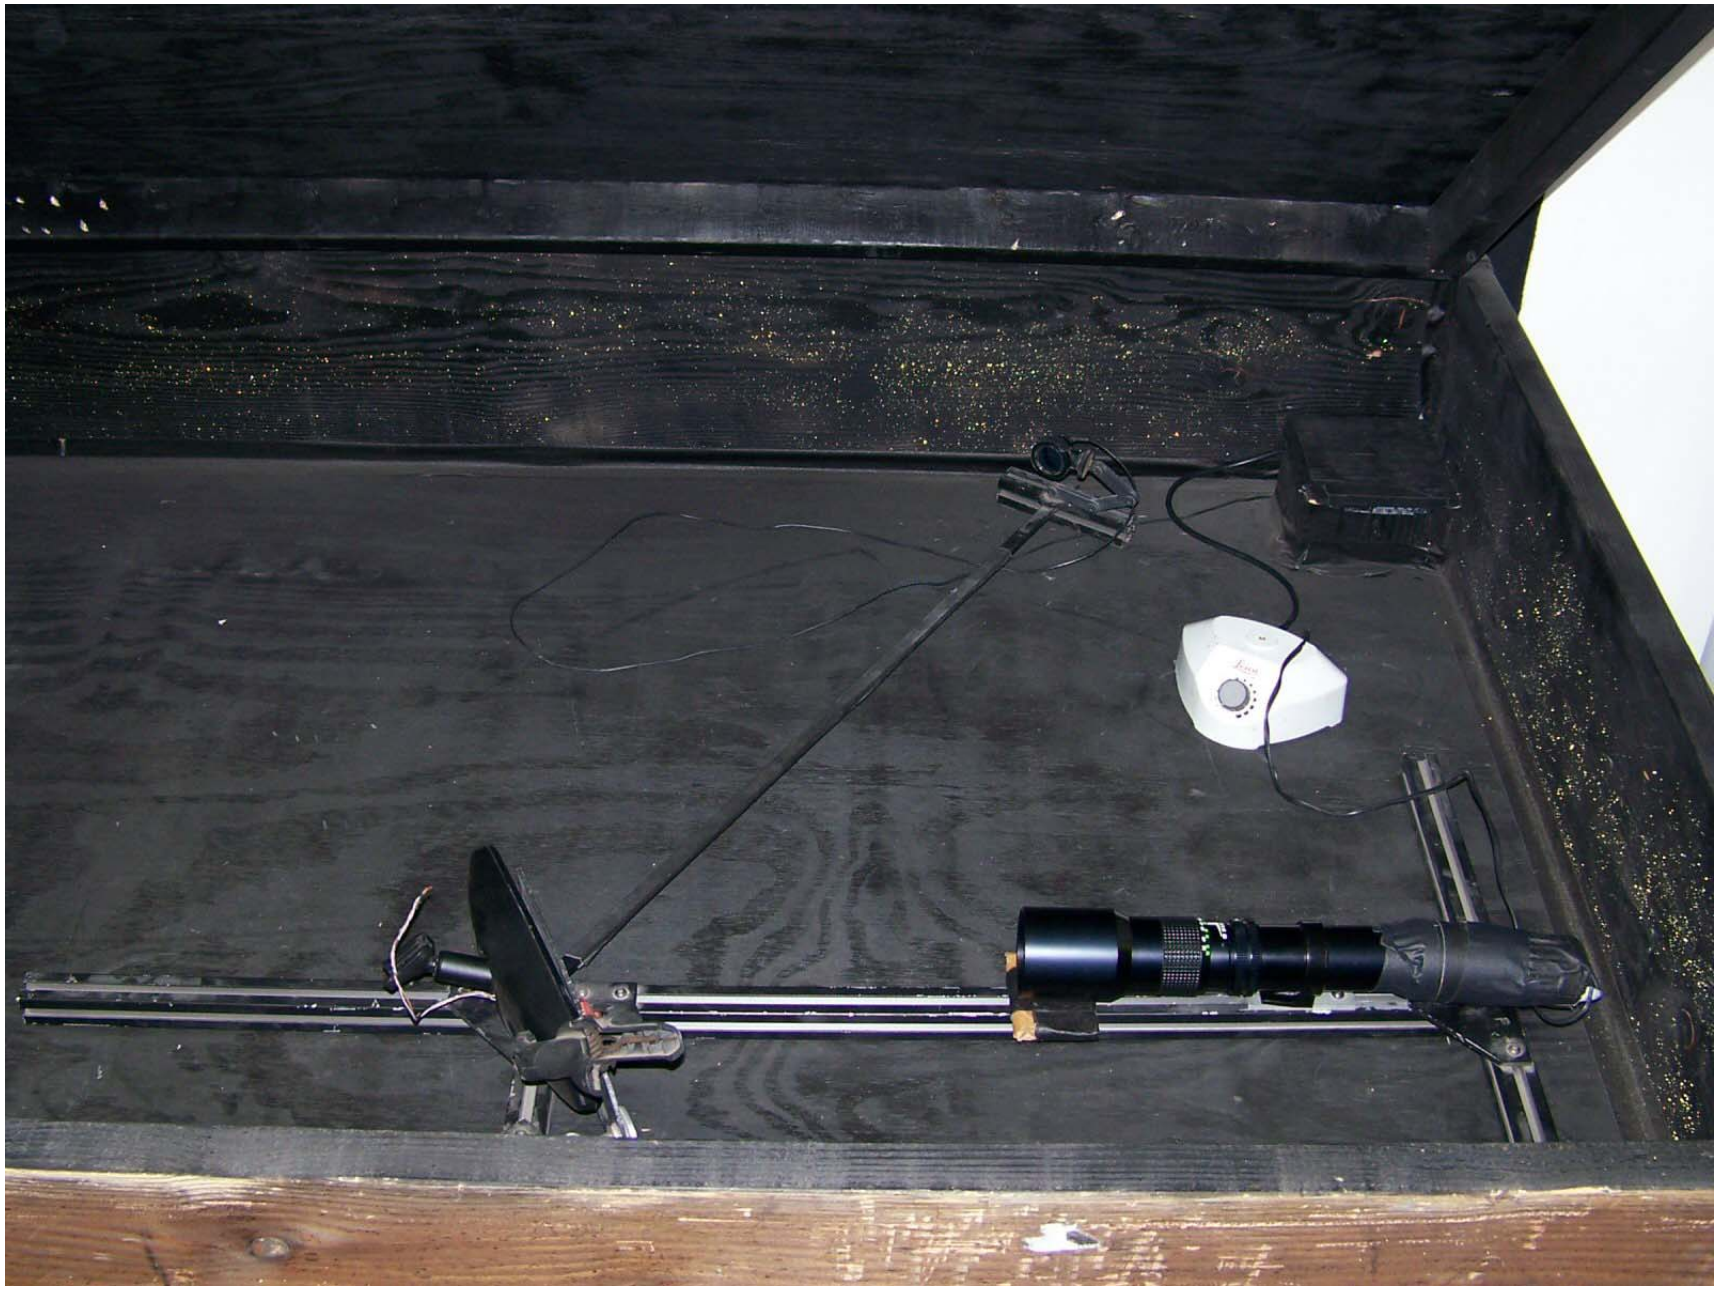
FIGURE 13:CLOSE-UP OF MIRROR BREAK- AWAY TEST

TEST NO.	LOAD DIRECTION VERTICAL/HORIZONTAL	MAXIMUM FORCE (N)	DISPLACEMENT (MM)	PASS	FAIL
1	**0-90 DEGREES**	**245.9**	**26.0**	**X**	
2	**+45/90 DEGREES**	**302.4**	**63.2**	**X**	
3	**-45/90 DEGREES**	**189.2**	**30.6**	**X**	
4	**-45/+45 DEGREES**	**153.3**	**37.8**	**X**	
5	**+45/+45 DEGREES**	**90.6**	**23.2**	**X**	
6	**+45/-45 DEGREES**	**96.2**	**16.6**	**X**	
7	**-45/-45 DEGREES**	**266.6**	**4.8**	**X**

NONE

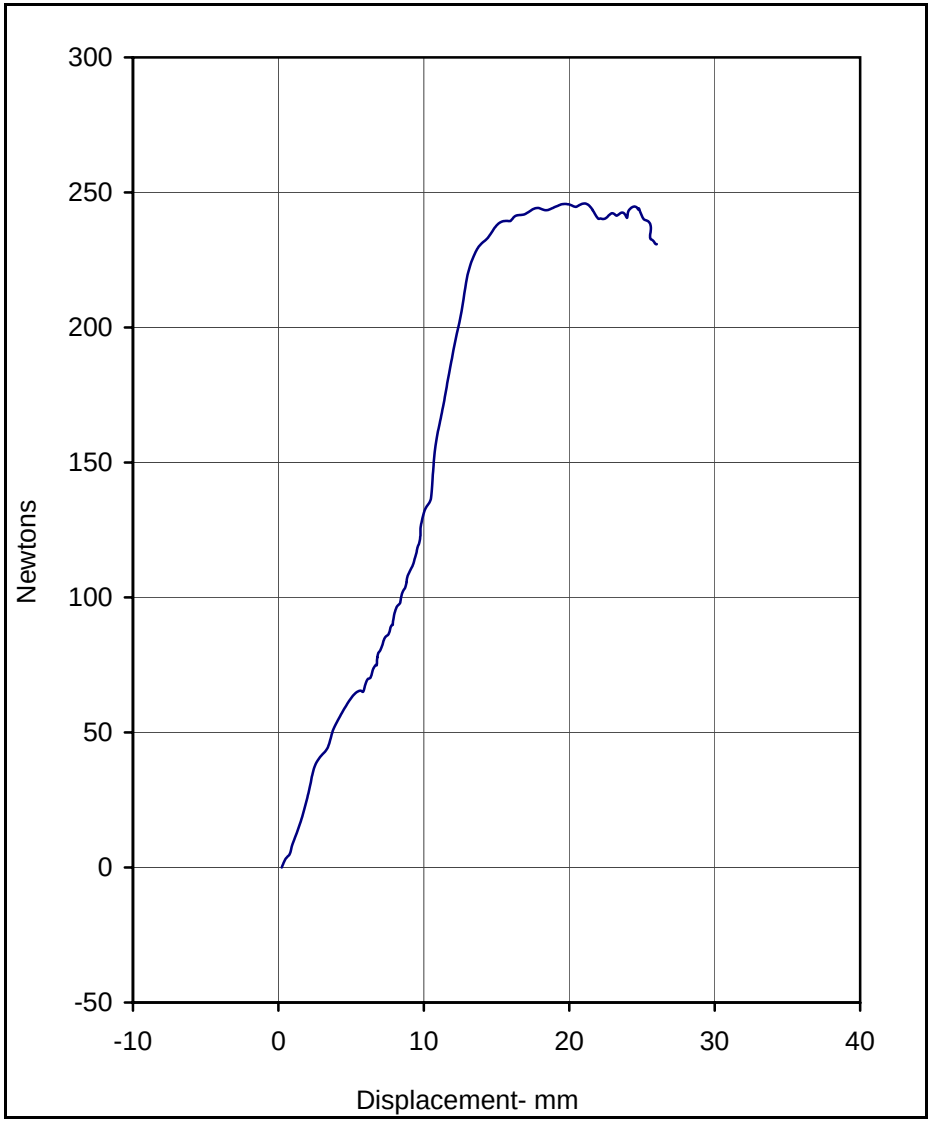
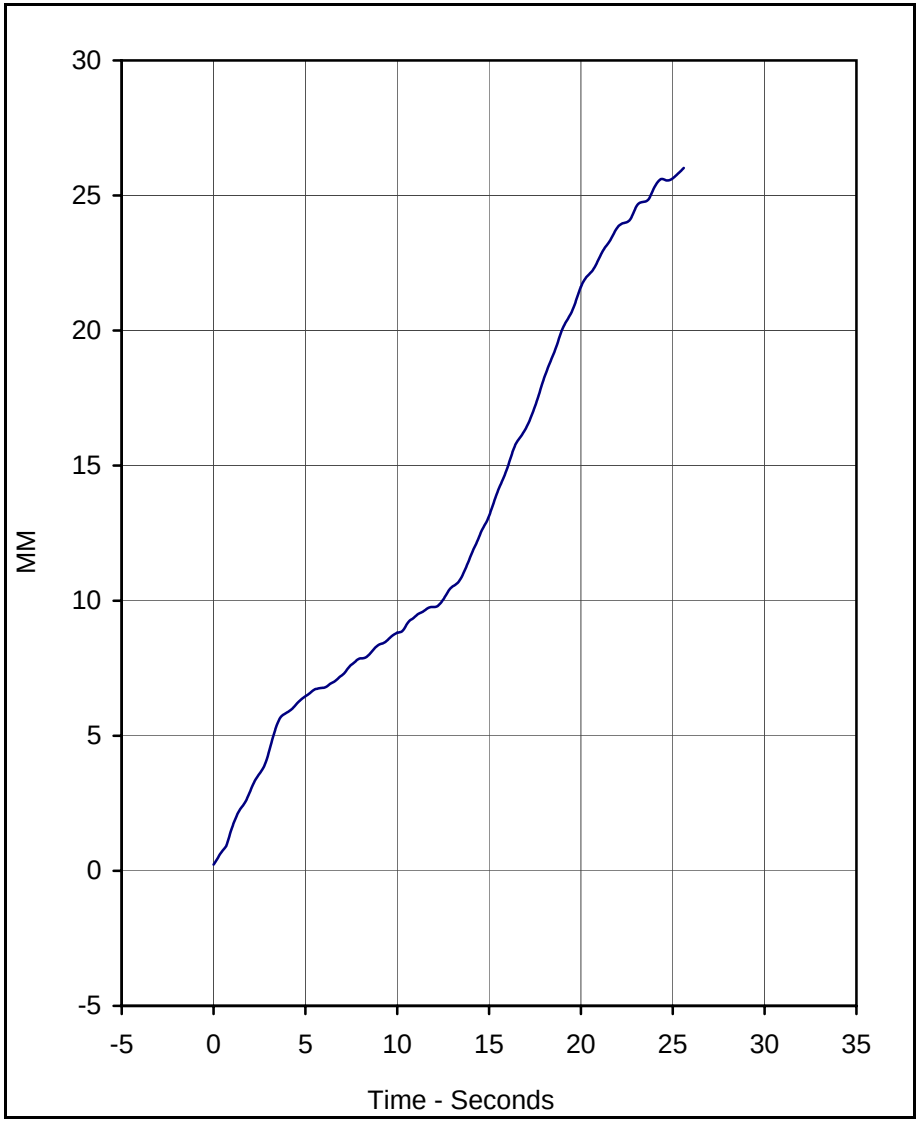
Units	Peak Force	Displacement	Filter (Hz)
Newtons	245.9	21.0	1

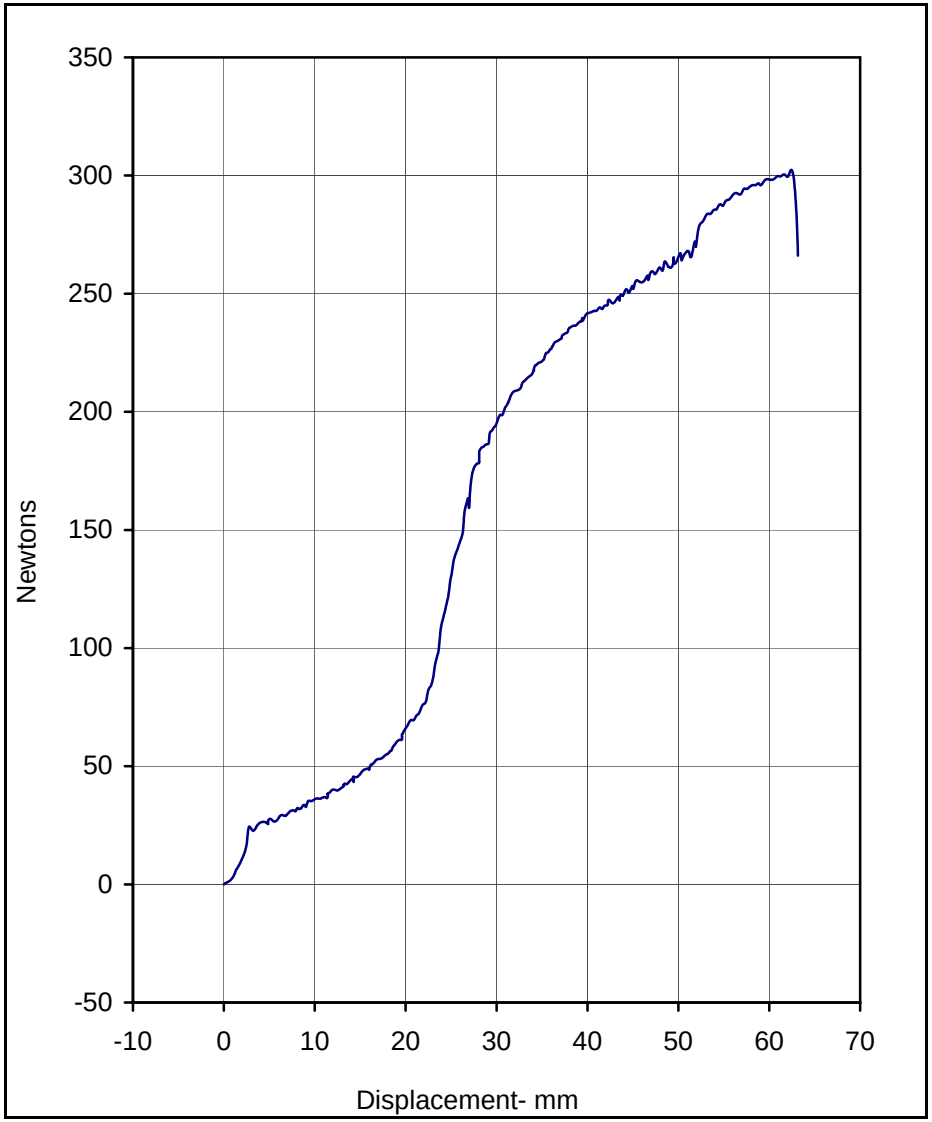
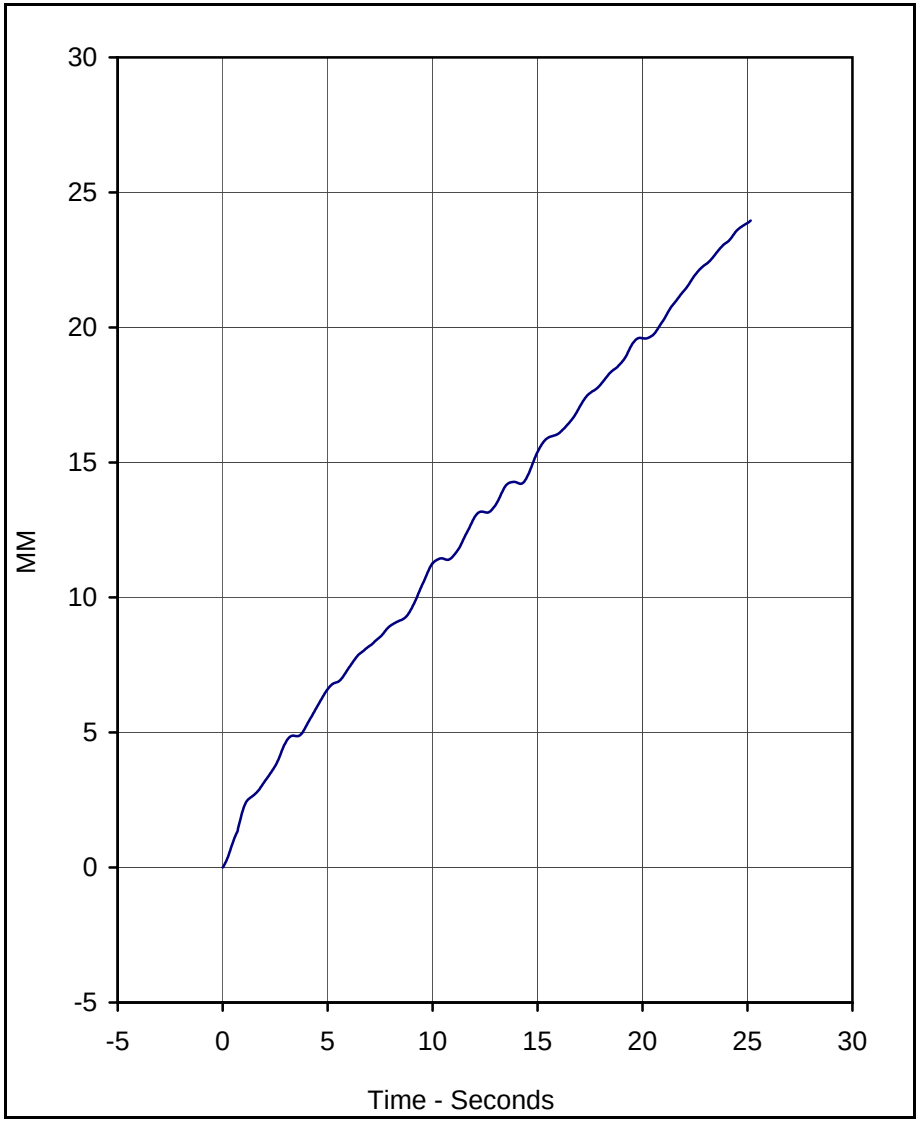
Units	Peak Force	Displacement	Filter (Hz)
Newtons	302.4	62.4	1

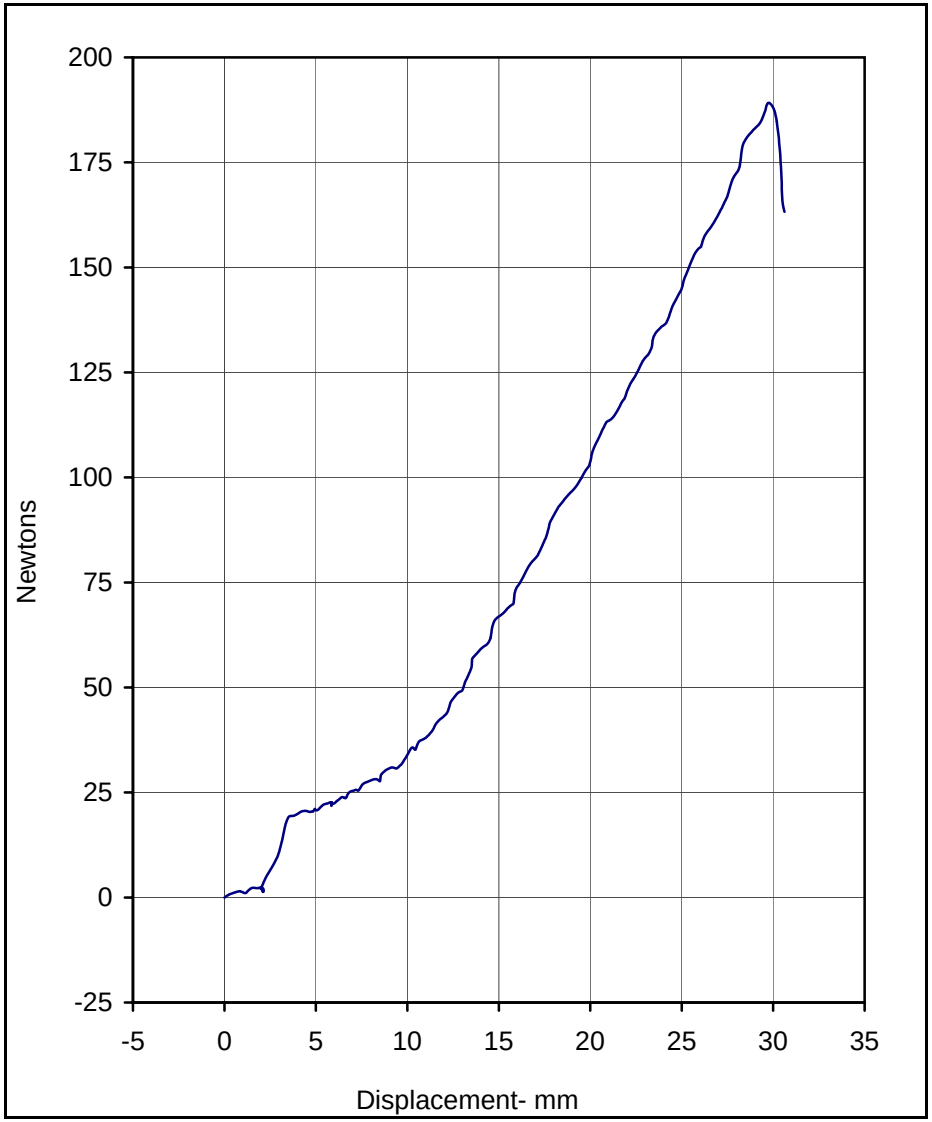
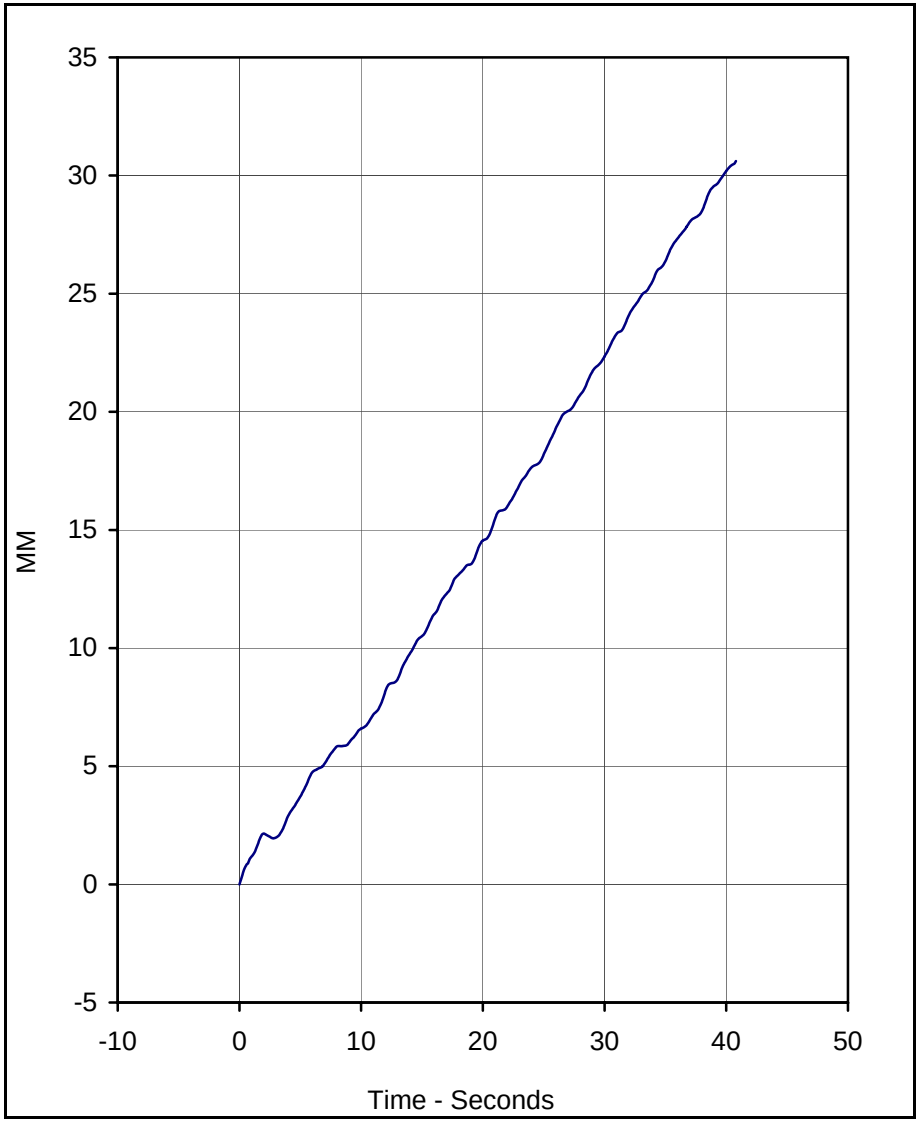
Units	Peak Force	Displacement	Filter (Hz)
Newtons	189.2	29.7	1

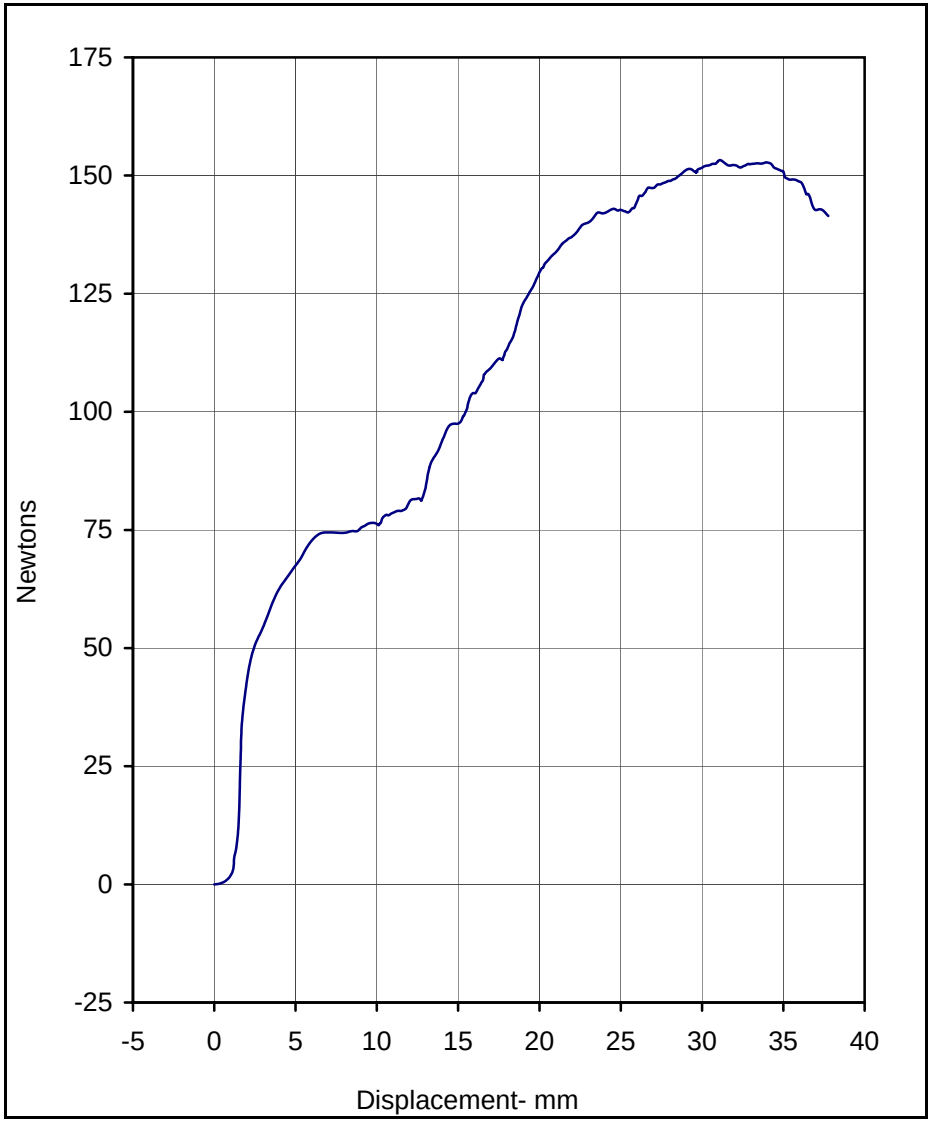
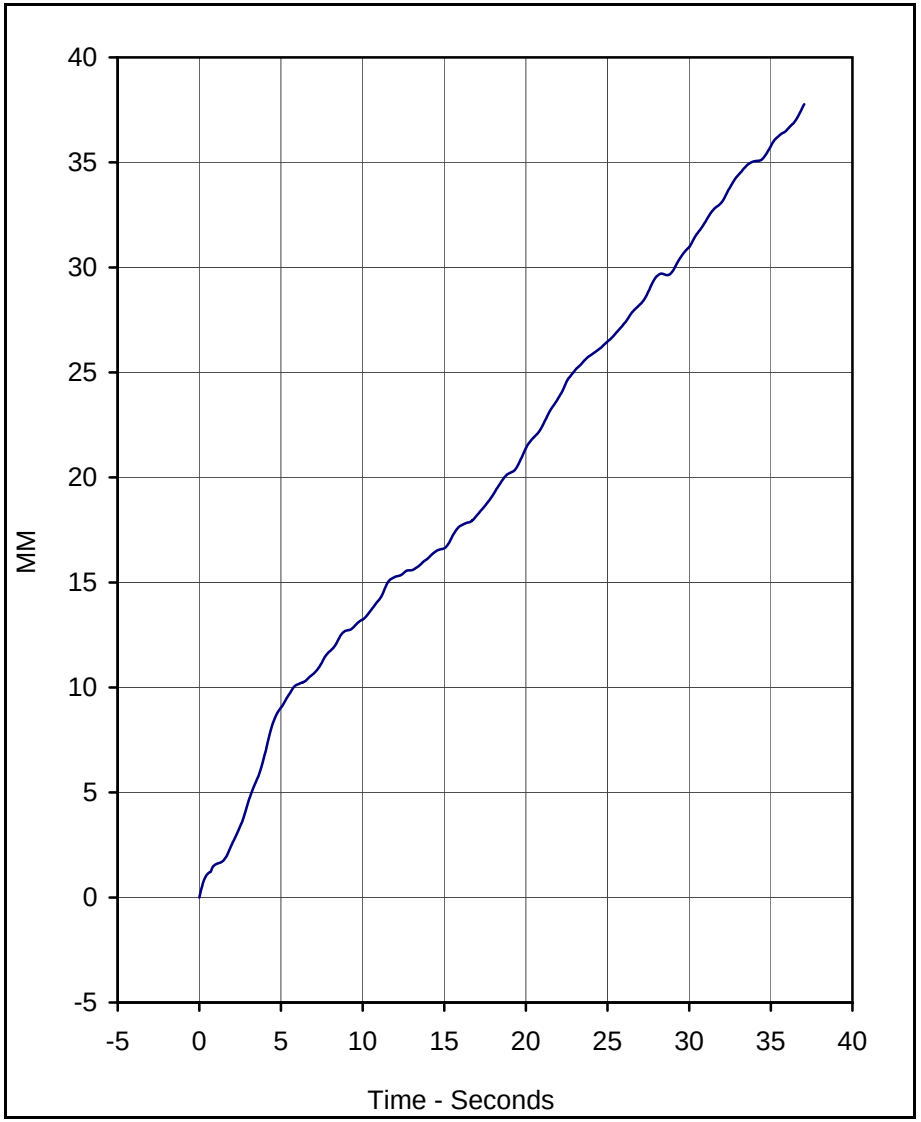
Units	Peak Force	Displacement	Filter (Hz)
Newtons	153.3	31.1	1

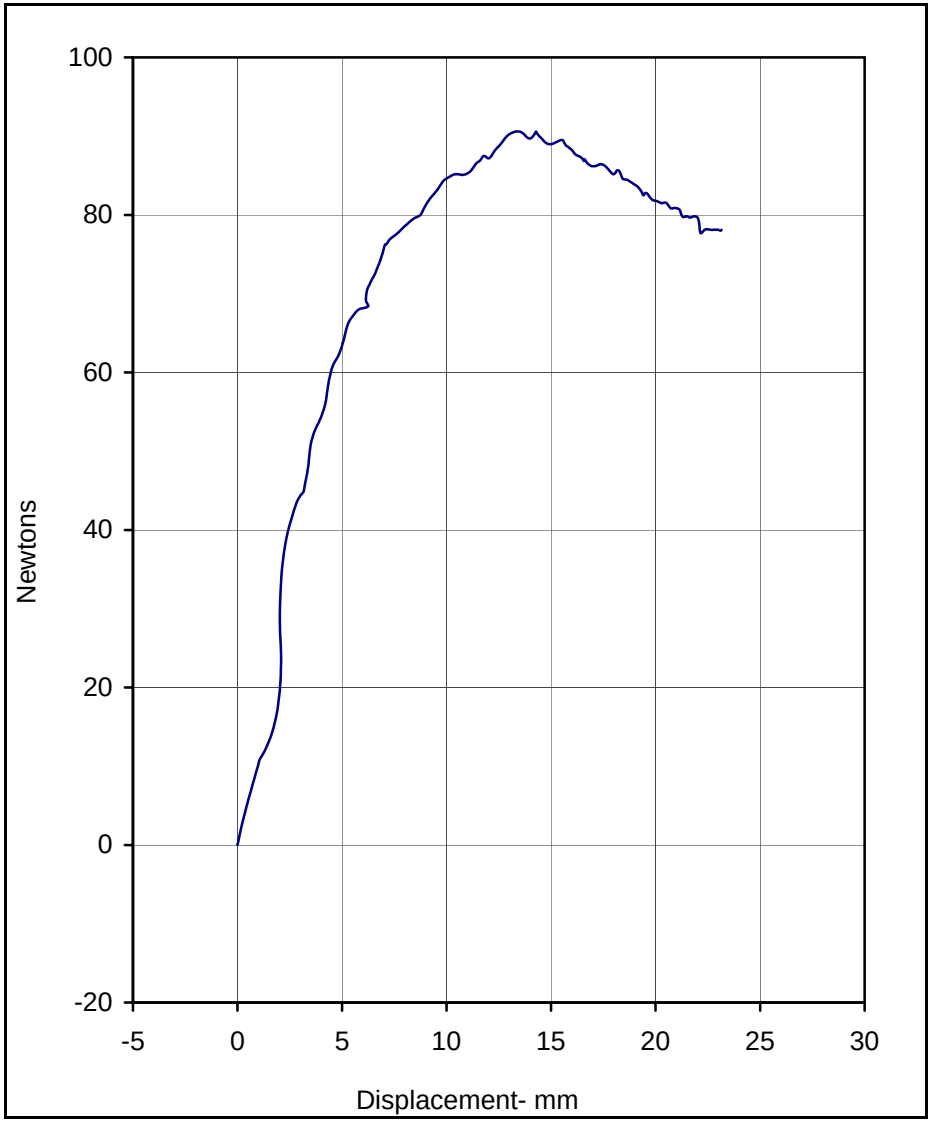
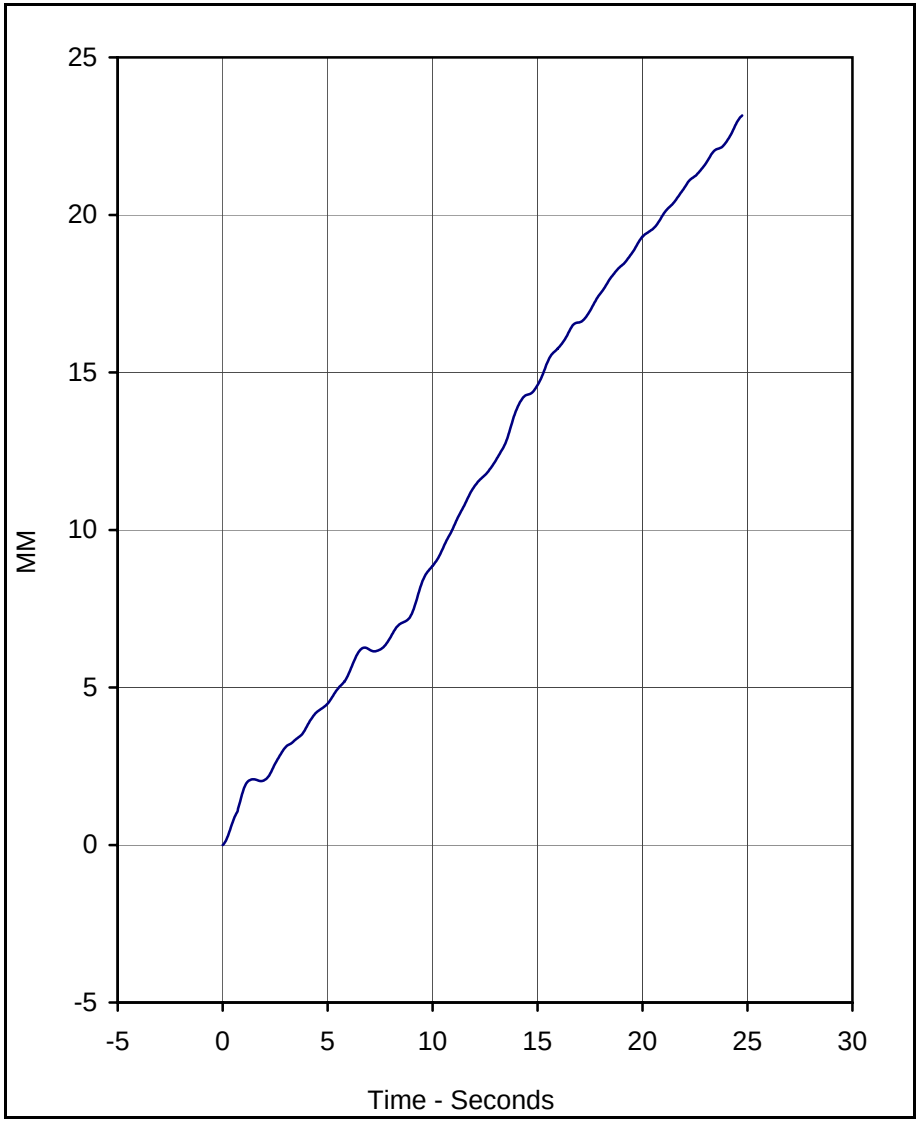
Units	Peak Force	Displacement	Filter (Hz)
Newtons	90.6	13.4	1

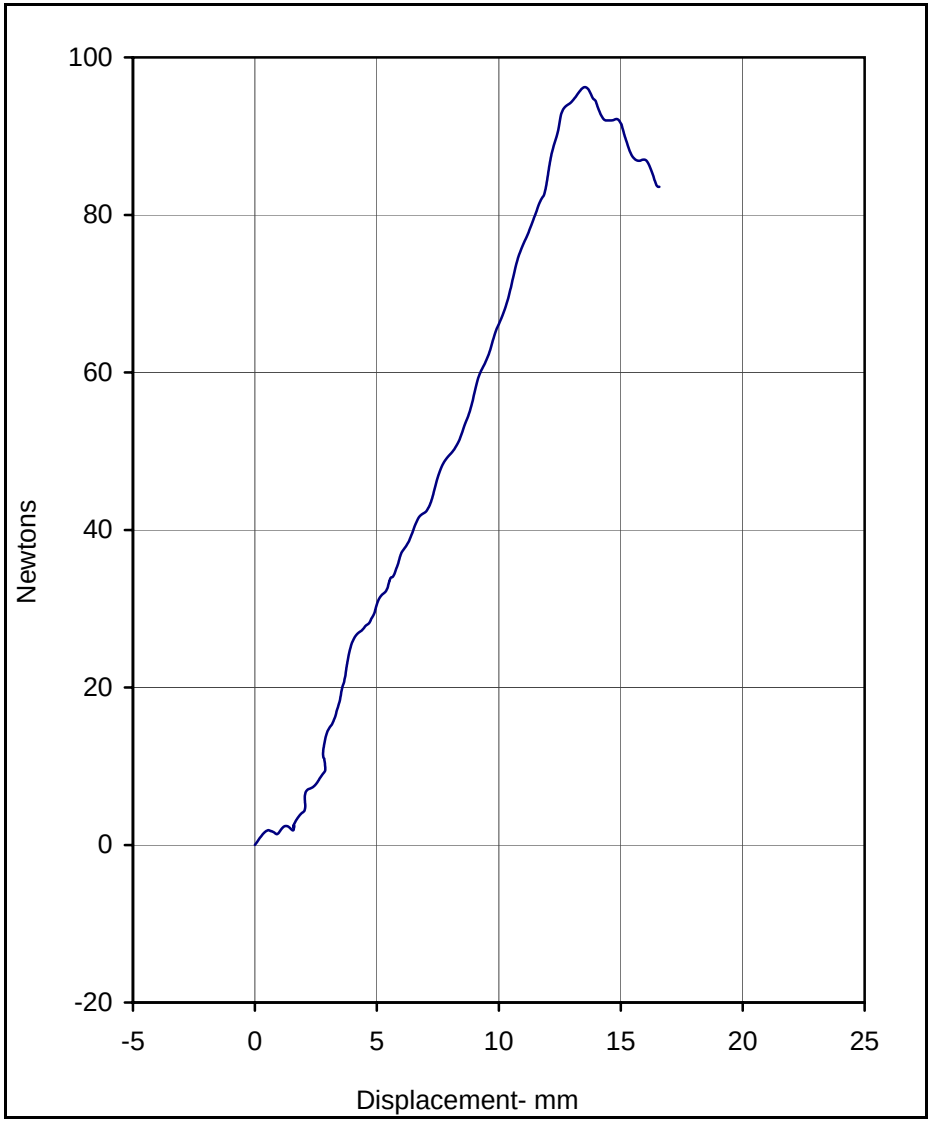
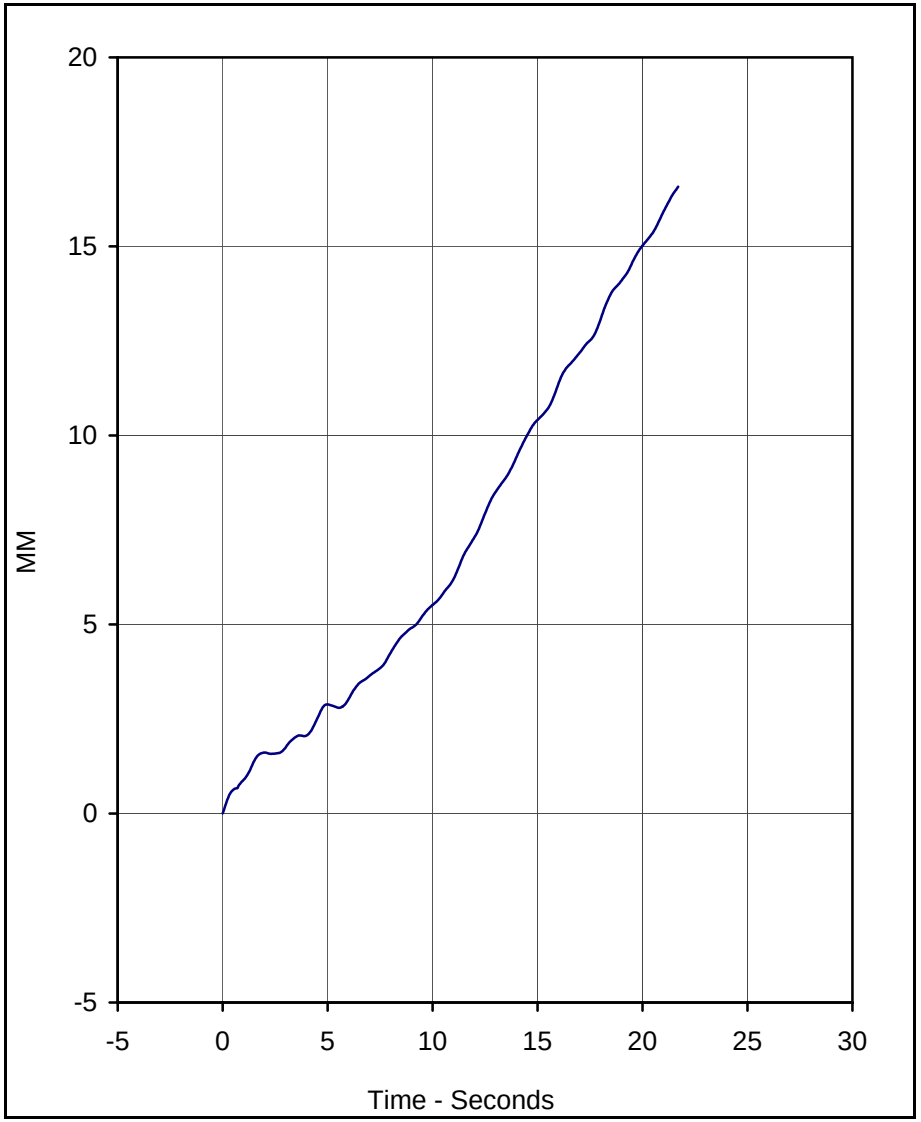
Units	Peak Force	Displacement	Filter (Hz)
Newtons	96.2	13.5	1

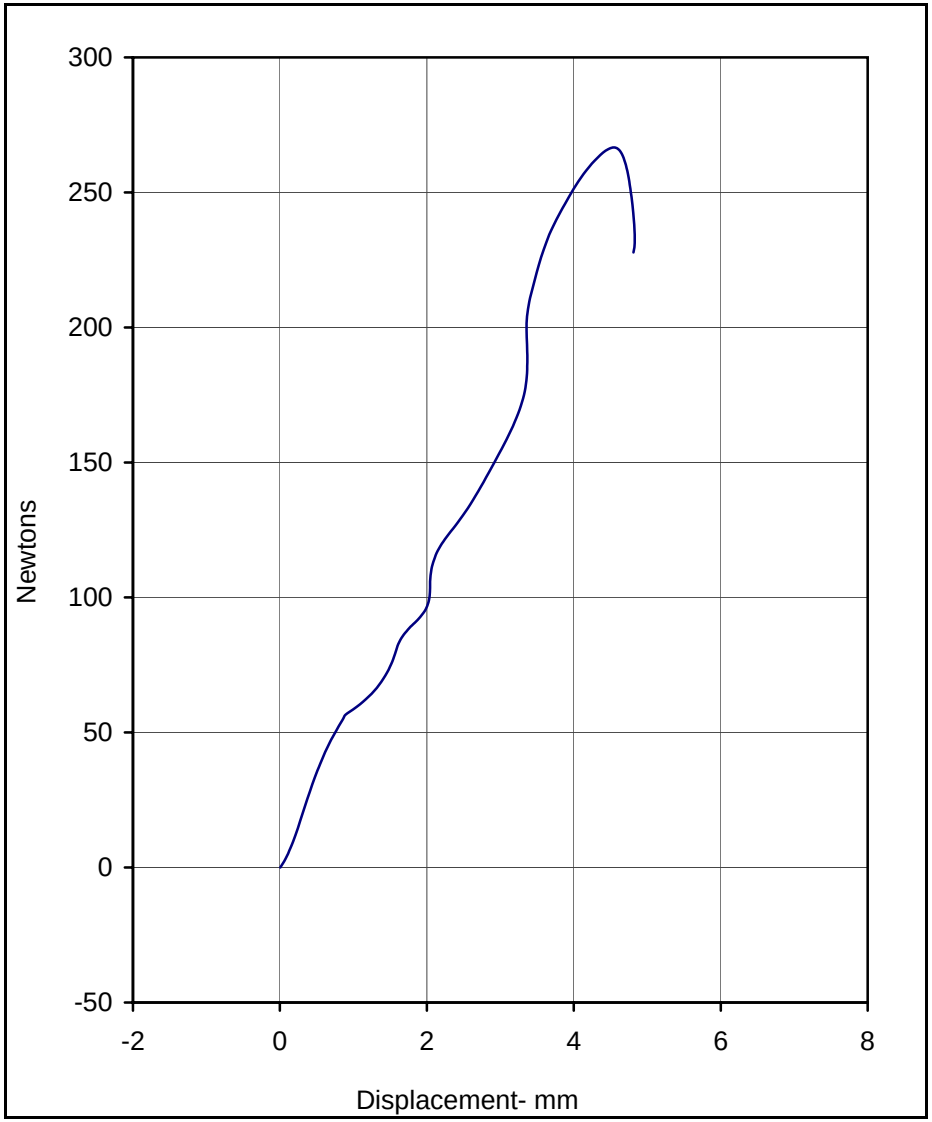
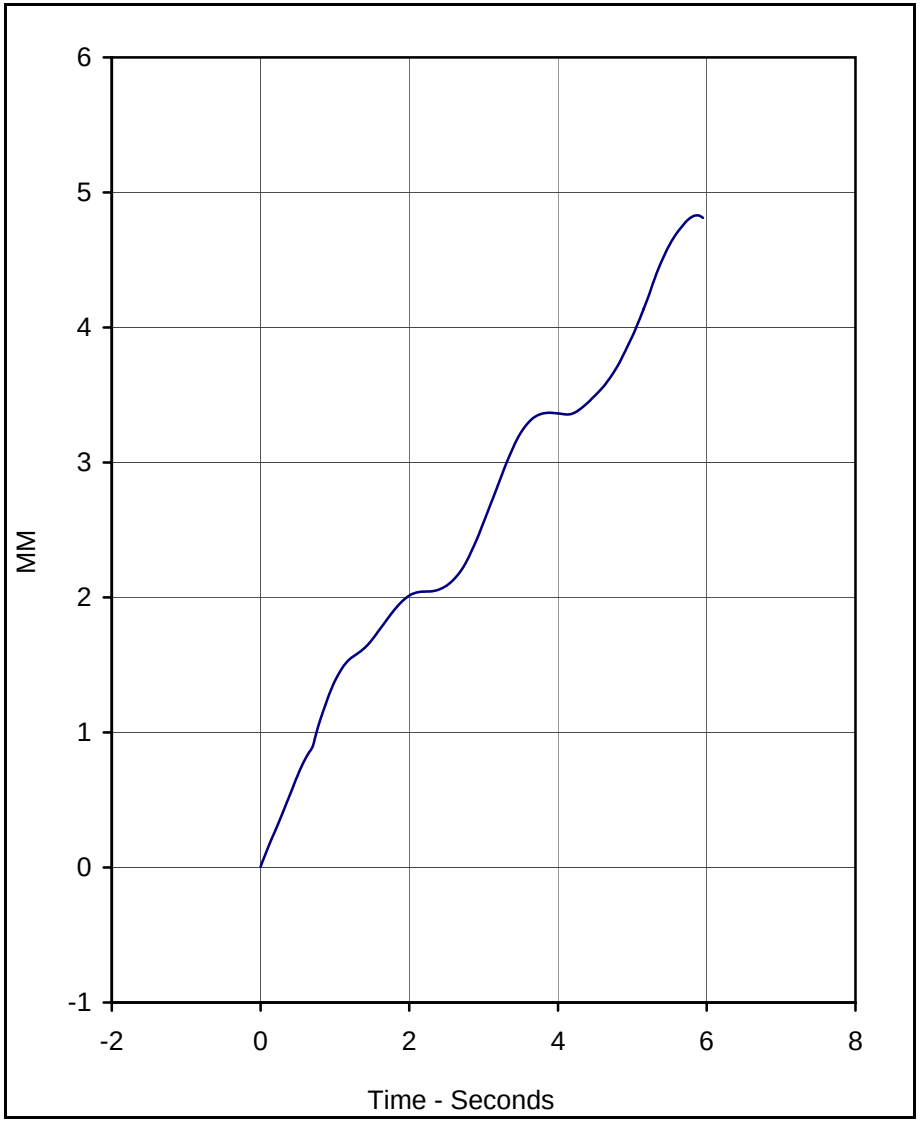
Units	Peak Force	Displacement	Filter (Hz)
Newtons	266.6	4.6	1
