REPORT NUMBER 214-GTL-09-003

SAFETY COMPLIANCE TESTING FOR FMVSS NO. 214S SIDE IMPACT PROTECTION (STATIC)

GENERAL MOTORS CORP.
2009 CHEVROLET COBALT, PASSENGER CAR
NHTSA NO. C90103

FINAL REPORT

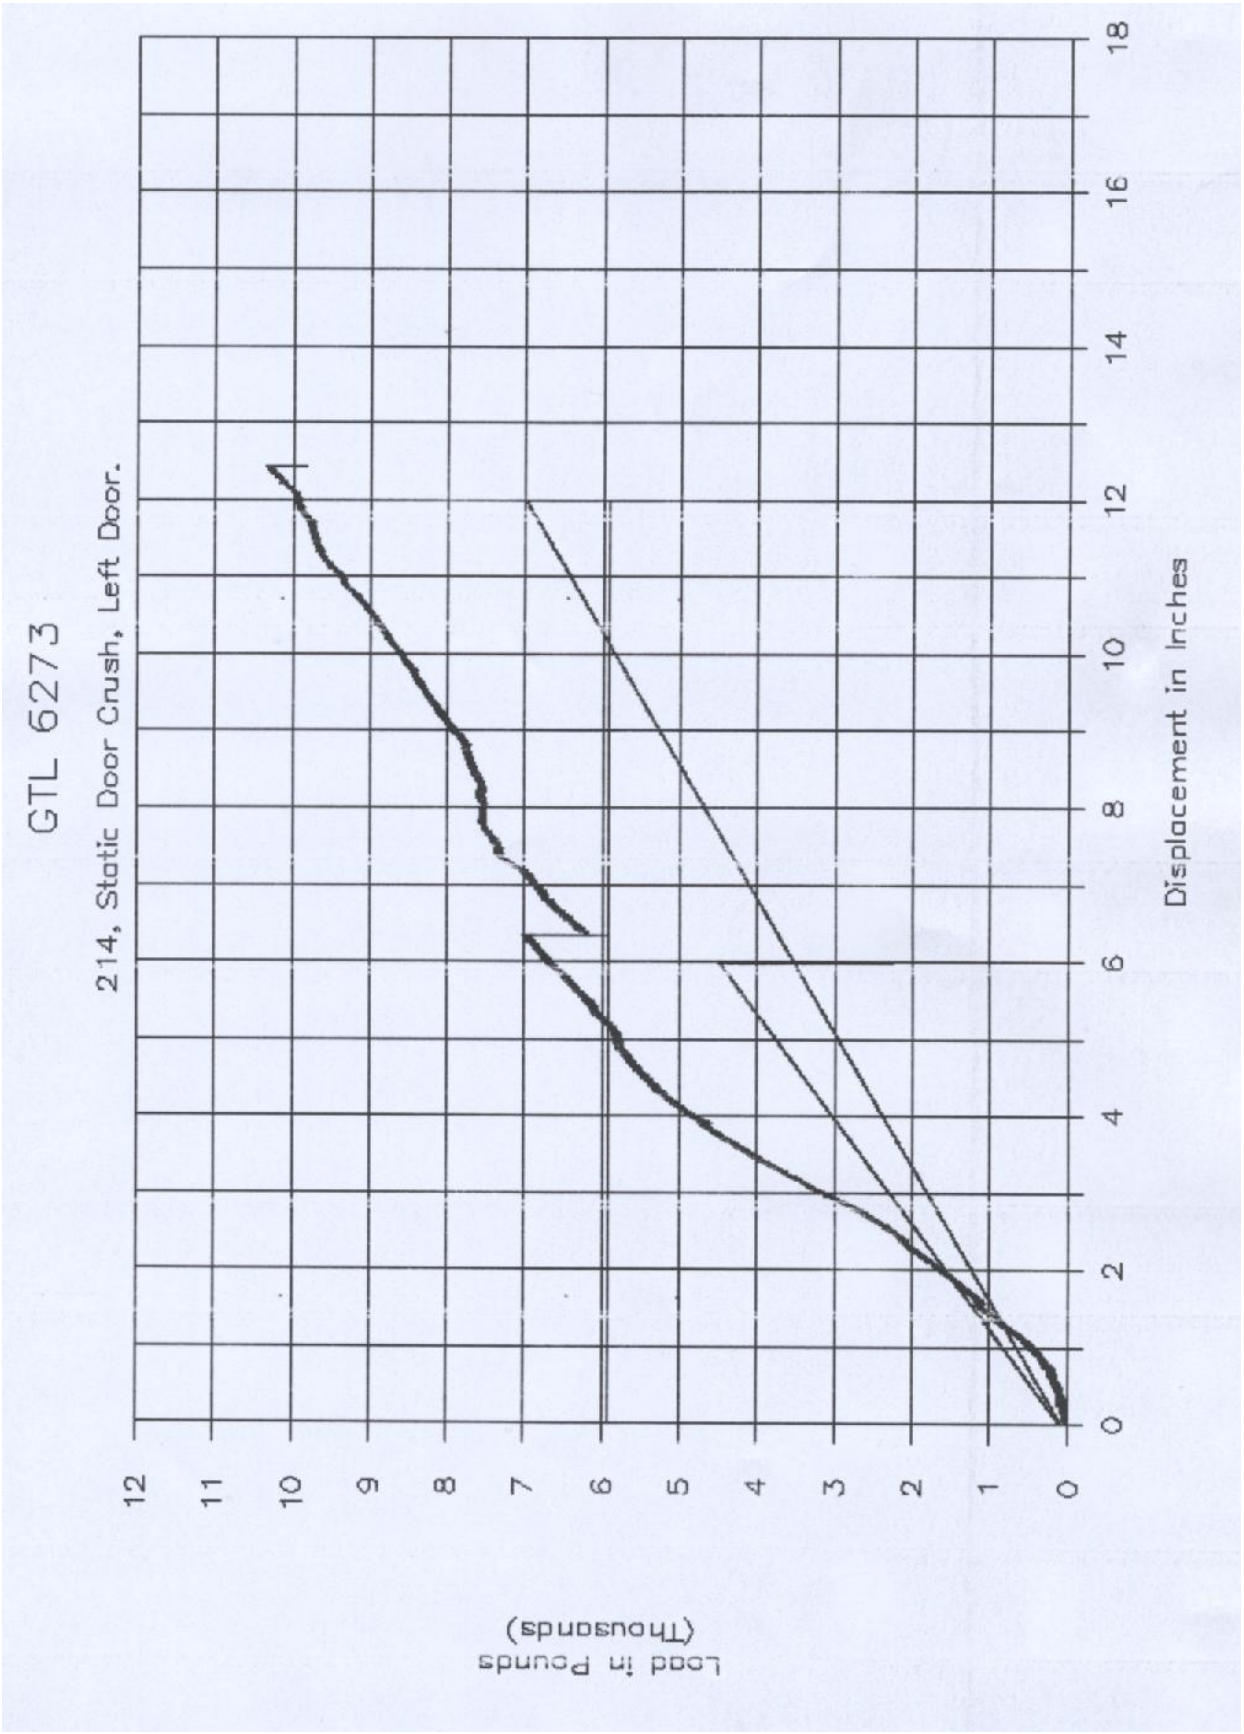
A. The initial crush resistance was 3385 lbs.
B. The intermediate crush resistance was 5806 lbs.
C. The peak crush resistance was 10,350 lbs at 12.4 inches

GTL 6273
214, Static Door Crush, Left Door.
Load in Pounds
(Thousands)
Displacement in Inches
0
1
2
3
4
5
6
7
8
9
10
11
12
0
2
4
6
8
10
12
14
16
18

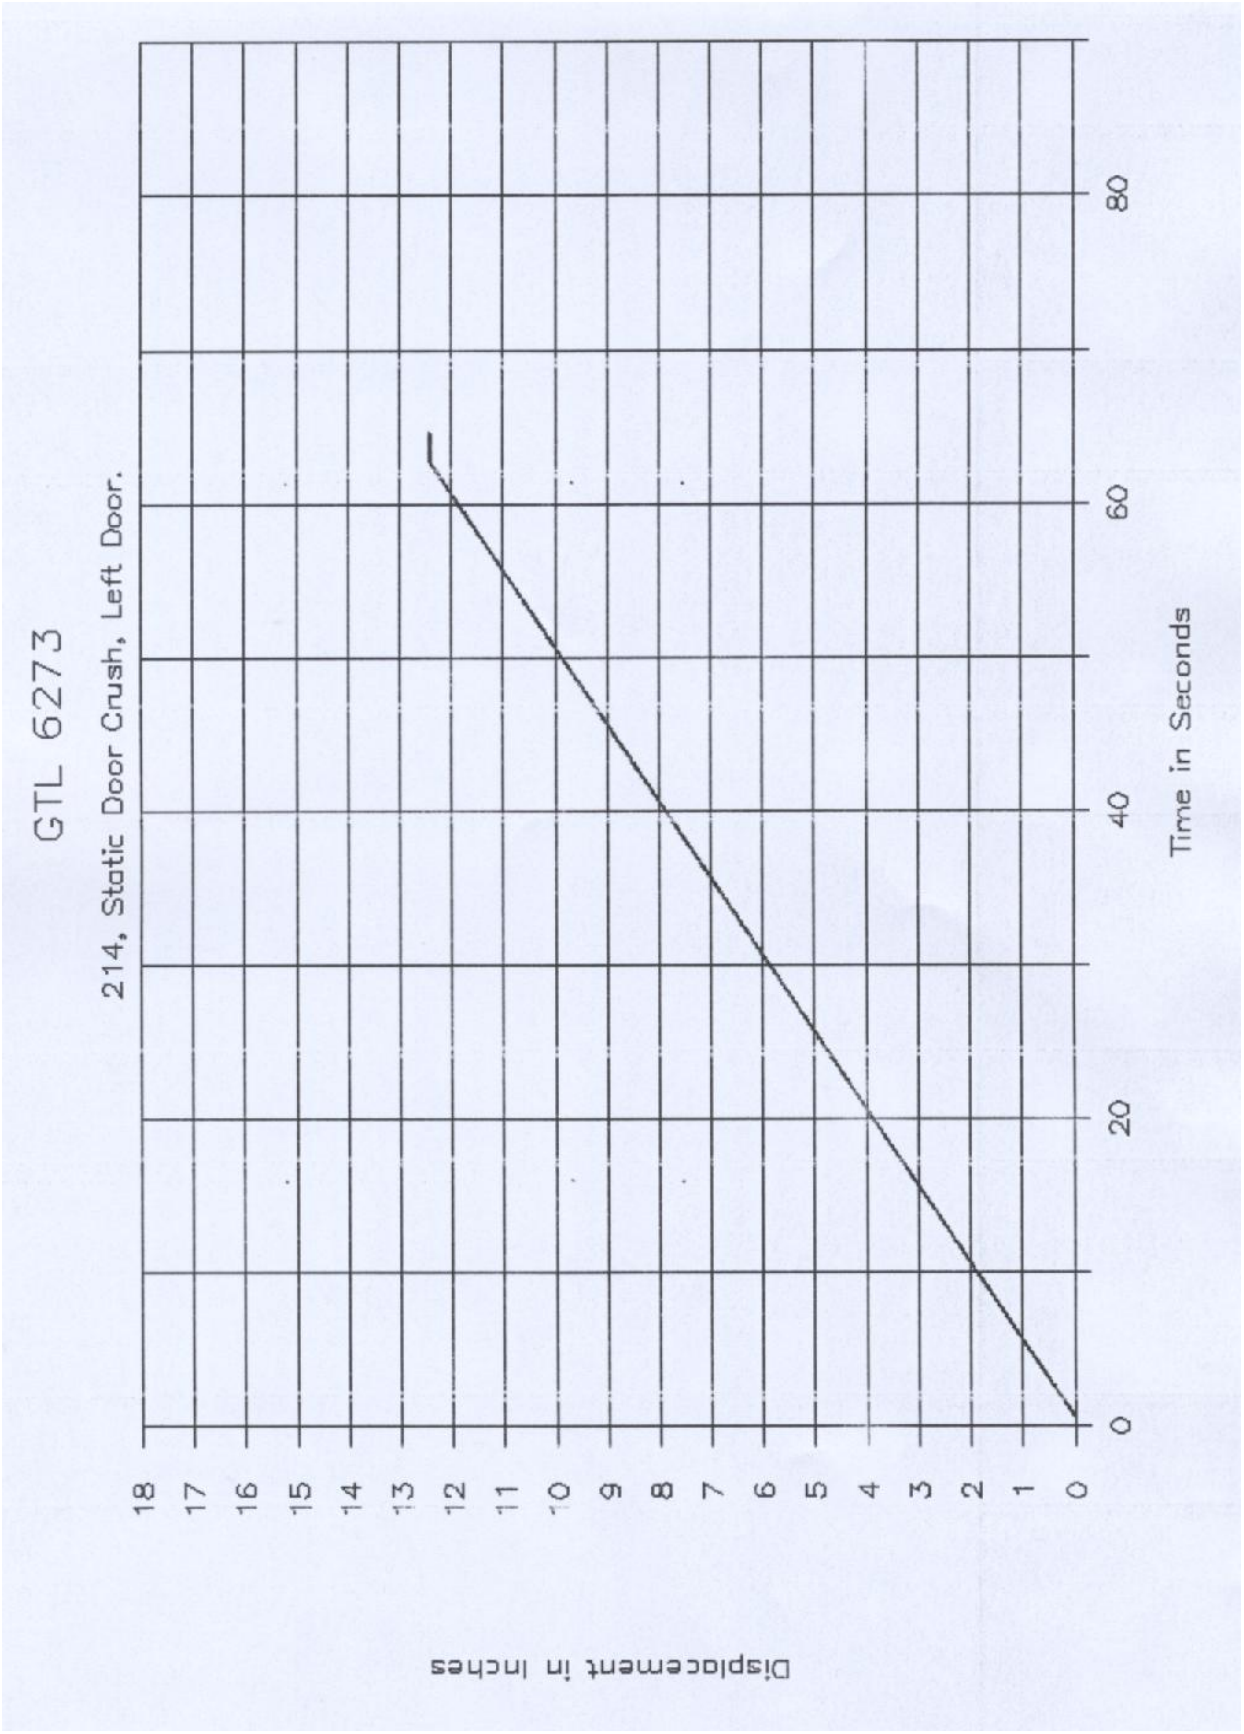
The rate of loading was .2"/sec

GTL 6273
214, Static Door Crush, Left Door.
Displacement in Inches
Time in Seconds
0
1
2
3
4
5
6
7
8
9
10
11
12
13
14
15
16
17
18
0
20
40
60
80

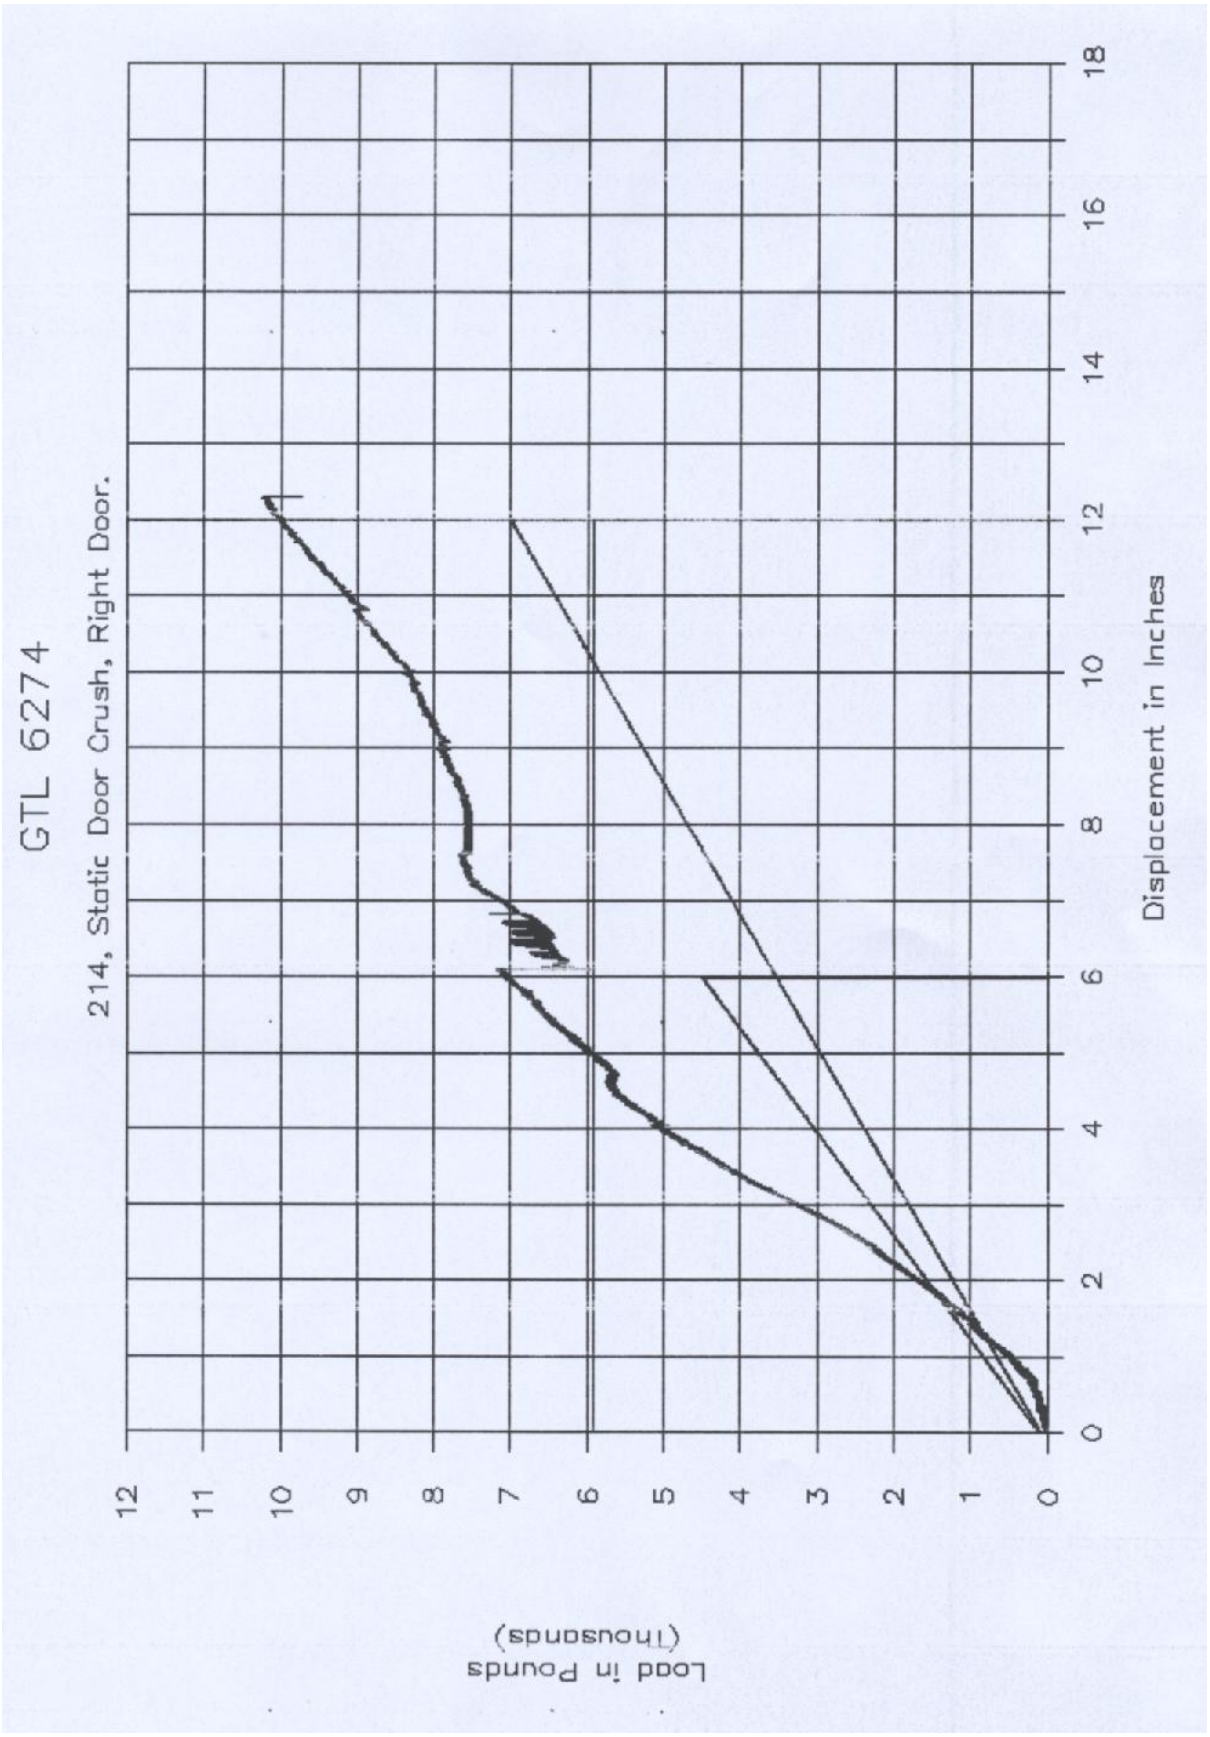
A. The initial crush resistance was 3482 lbs.
B. The intermediate crush resistance was 5819 lbs.
C. The peak crush resistance was 10,242 lbs at 12.3 inches

GTL 6274
214, Static Door Crush, Right Door.
Load in Pounds
(Thousands)
0
1
2
3
4
5
6
7
8
9
10
11
12
0
2
4
6
8
10
12
14
16
18
Displacement in Inches

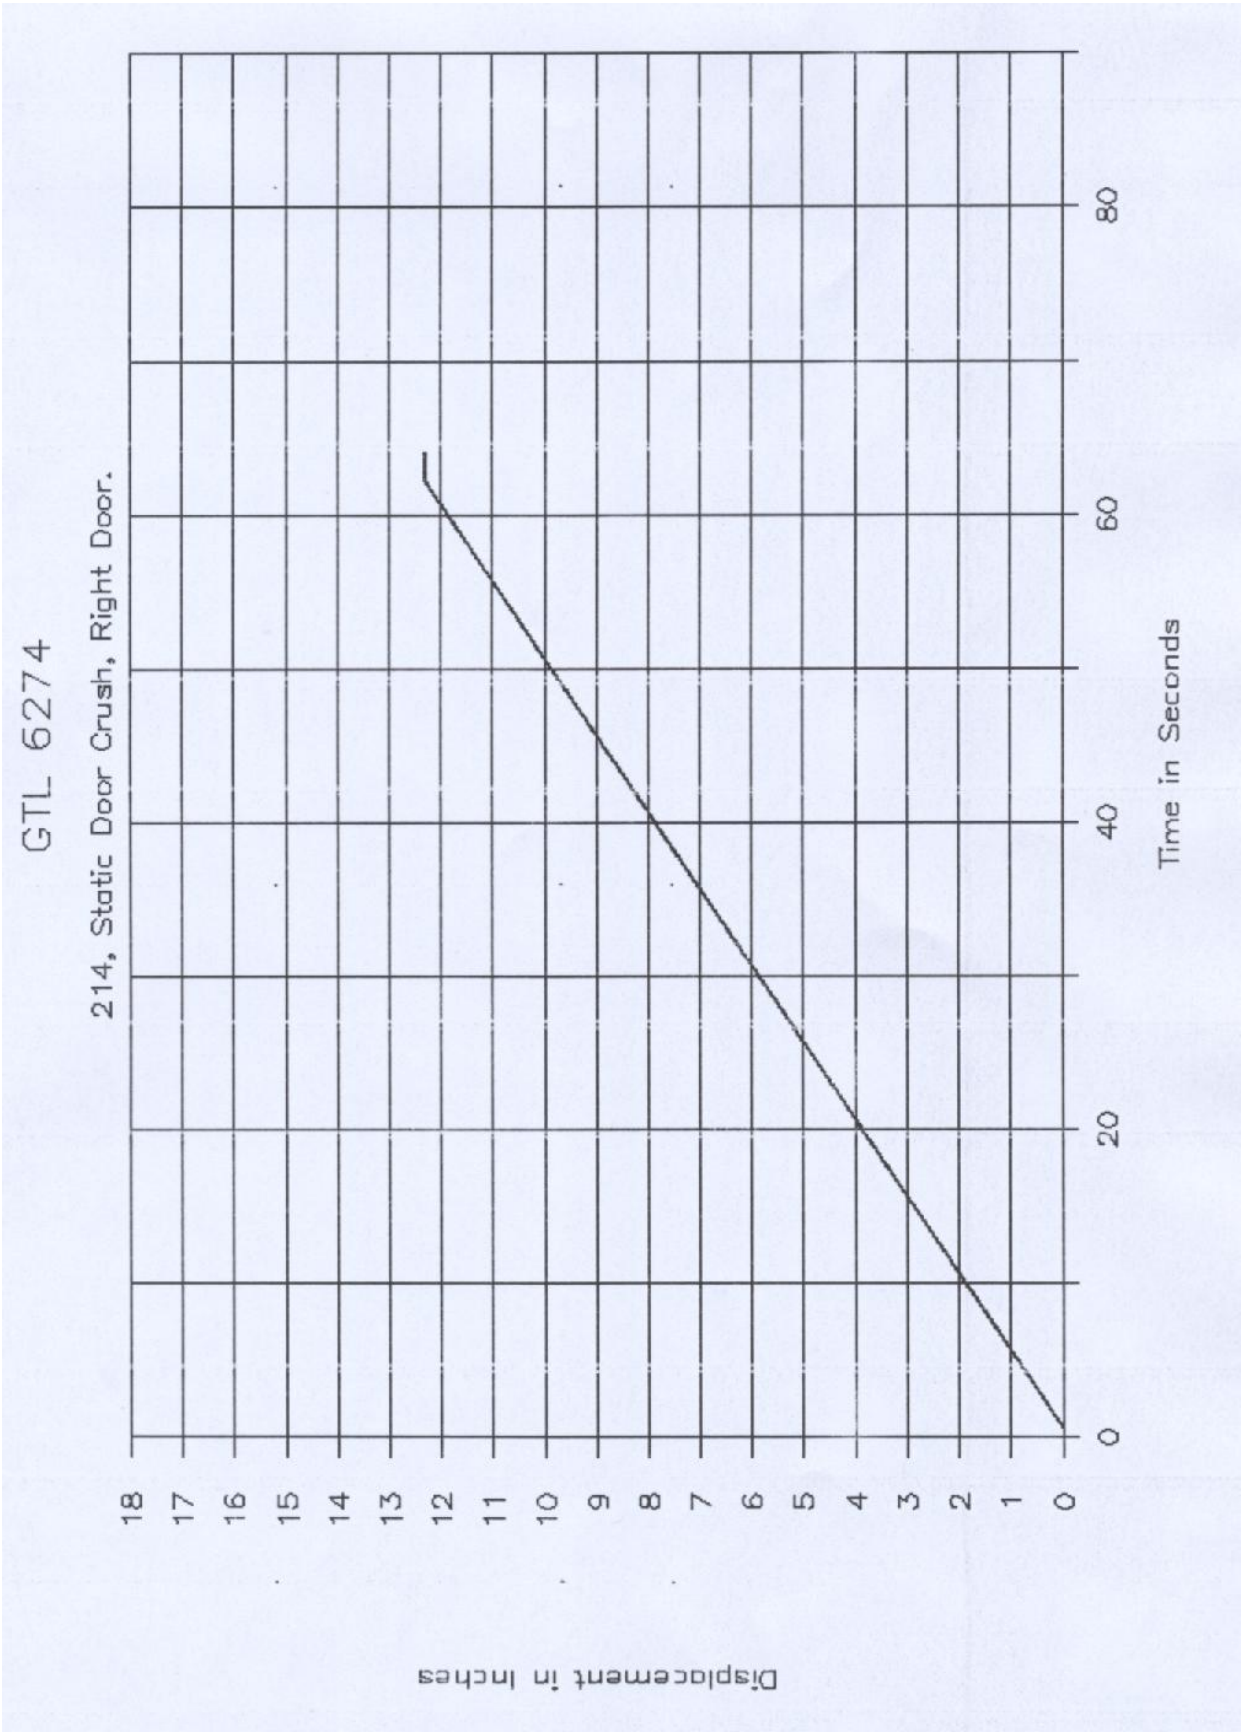
The rate of loading was .2"/sec

GTL 6274
214, Static Door Crush, Right Door.
Displacement in Inches
0
1
2
3
4
5
6
7
8
9
10
11
12
13
14
15
16
17
18
0
20
40
60
80
Time in Seconds
