FINAL REPORT NUMBER 201UI-MGA-09-04

SAFETY COMPLIANCE TESTING FOR FMVSS 201
Occupant Protection In Interior Impact
Upper Interior Head Impact Protection

JAGUAR CARS LTD.
2009 Jaguar XF
NHTSA No. C90205

MGA RESEARCH CORPORATION
446 Executive Drive
Troy, Michigan 48083

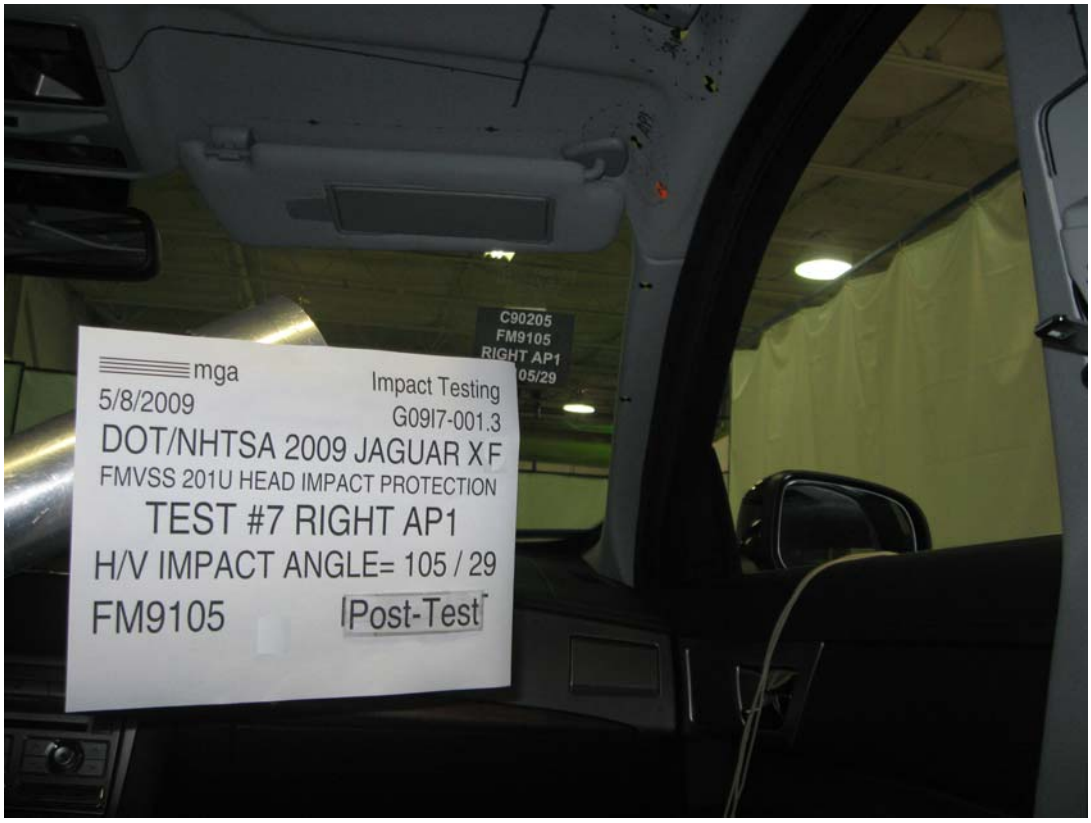
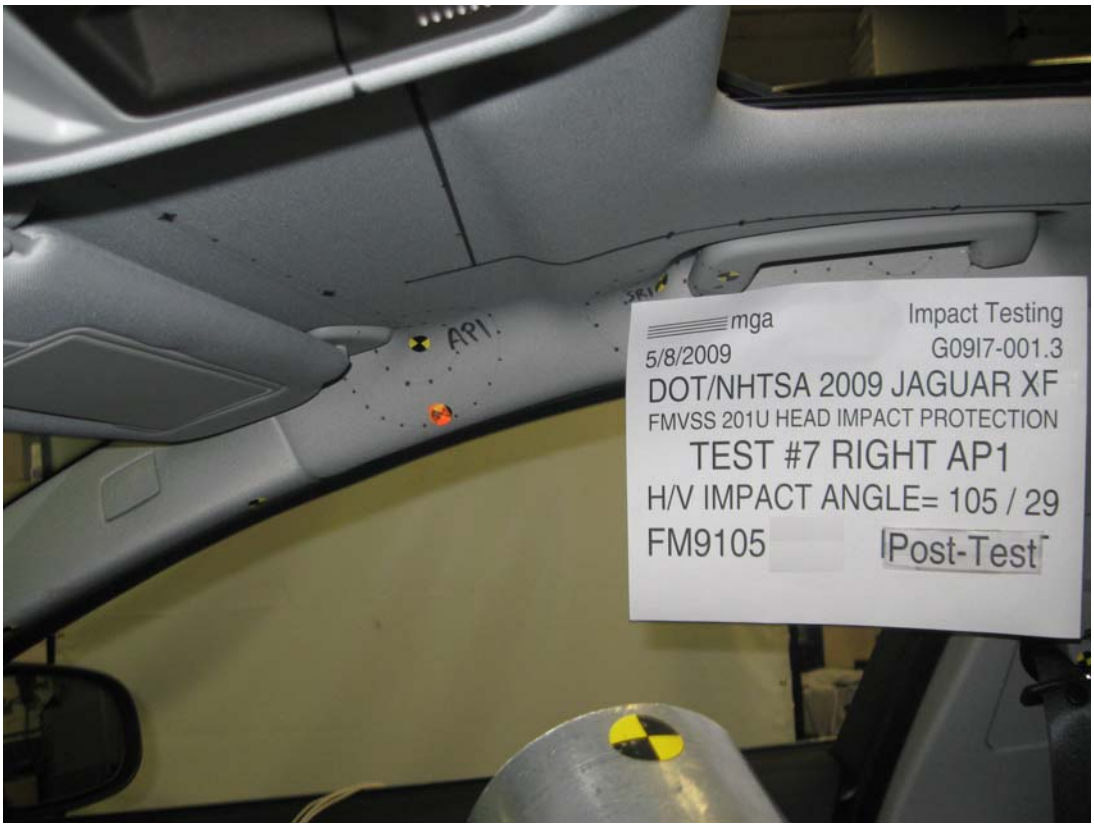
mga
5/8/2009
Impact Testing
G09I7-001.3
DOT/NHTSA 2009 JAGUAR XF
FMVSS 201U HEAD IMPACT PROTECTION
TEST #7 RIGHT AP1
H/V IMPACT ANGLE= 105 / 29
FM9105
Post-Test

No damage observed

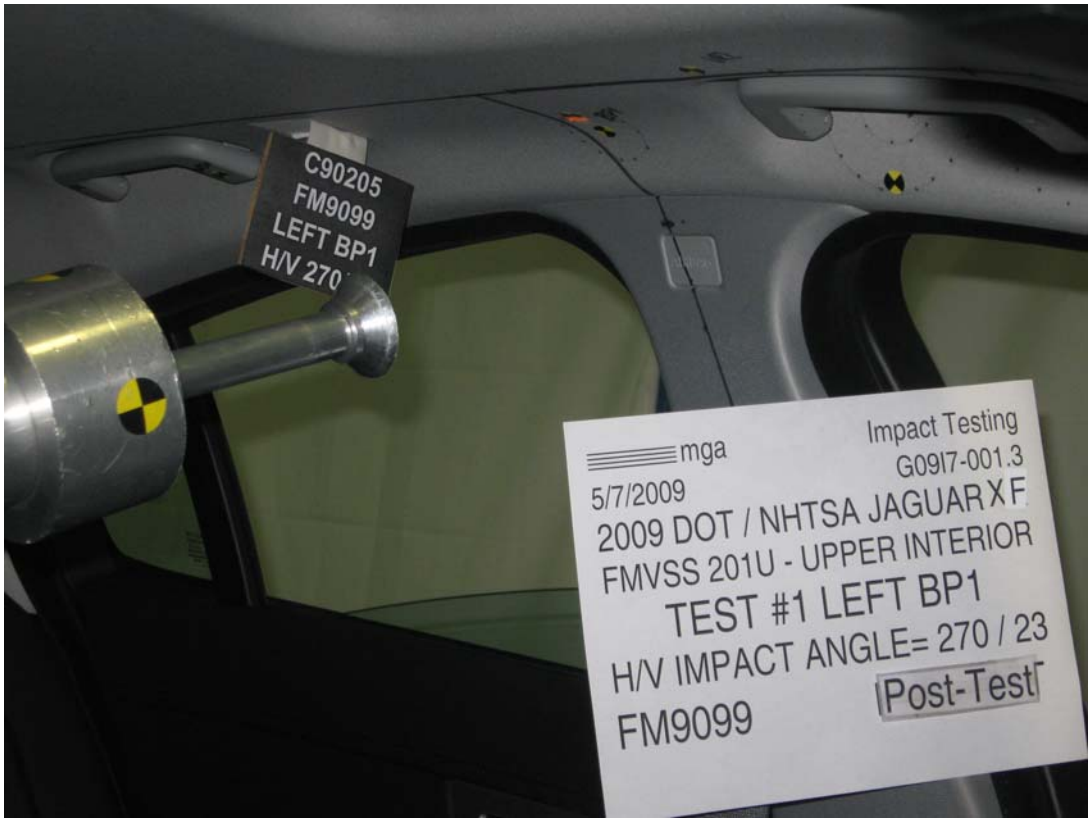
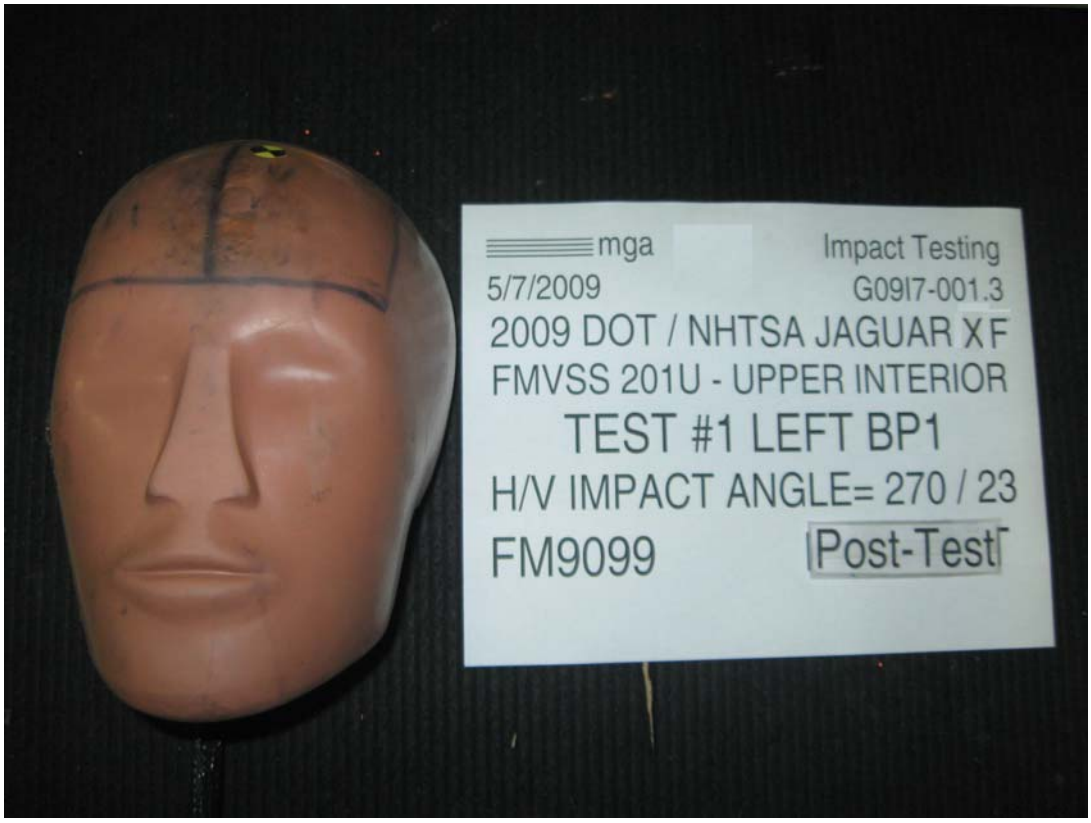
C90205
FM9099
LEFT BP1
H/V 270
mga
Impact Testing
G09I7-001.3
5/7/2009
2009 DOT / NHTSA JAGUAR XF
FMVSS 201U - UPPER INTERIOR
TEST #1 LEFT BP1
H/V IMPACT ANGLE= 270 / 23
FM9099
Post-Test

No visible damage

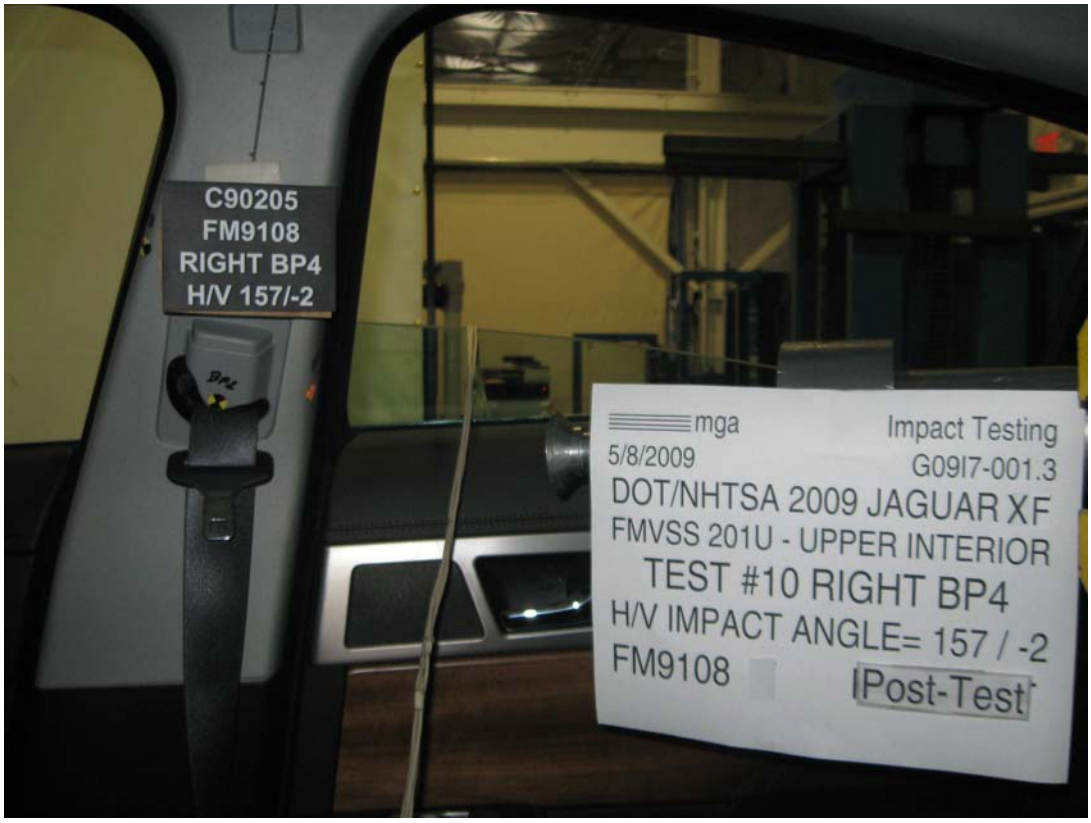
C90205
FM9108
RIGHT BP4
H/V 157/-2
mga
5/8/2009
Impact Testing
G09I7-001.3
DOT/NHTSA 2009 JAGUAR XF
FMVSS 201U - UPPER INTERIOR
TEST #10 RIGHT BP4
H/V IMPACT ANGLE= 157 / -2
FM9108
Post-Test

No damage observed

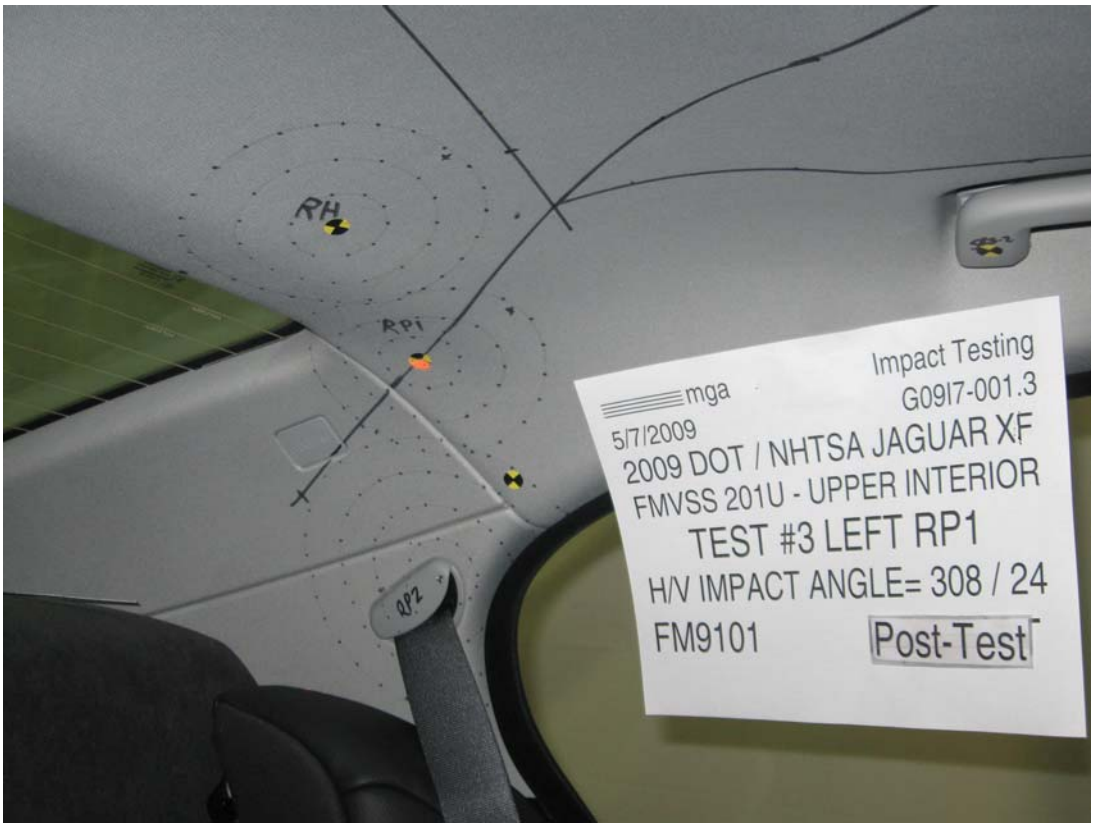
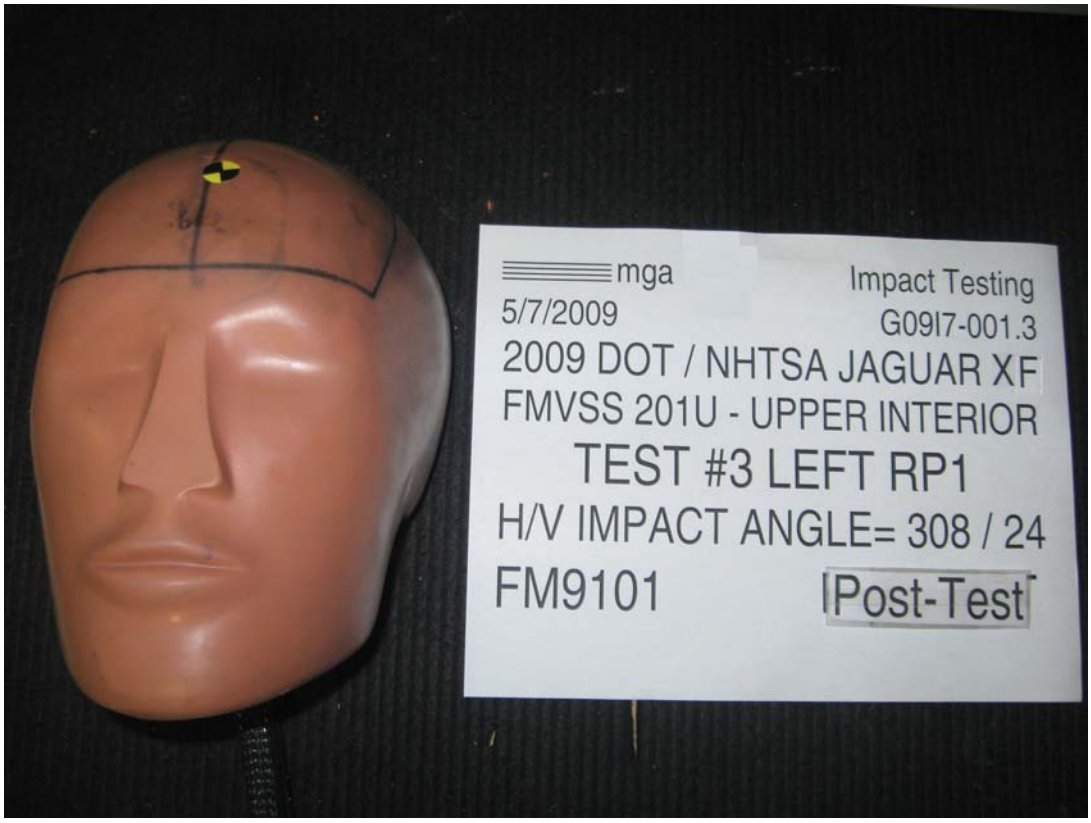
RH
RPi
QP2
mga
Impact Testing
G09I7-001.3
5/7/2009
2009 DOT / NHTSA JAGUAR XF
FMVSS 201U - UPPER INTERIOR
TEST #3 LEFT RP1
H/V IMPACT ANGLE= 308 / 24
FM9101
Post-Test

No visible damage.

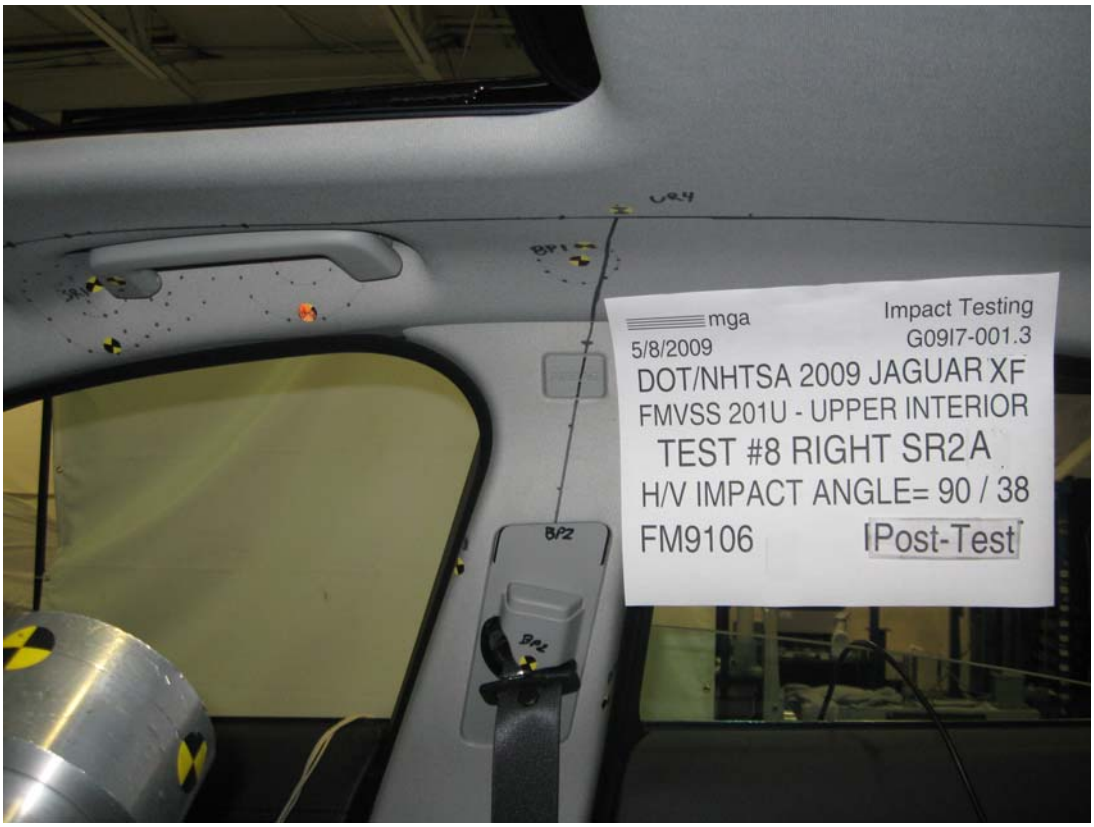
mga
Impact Testing
5/8/2009
G09I7-001.3
DOT/NHTSA 2009 JAGUAR XF
FMVSS 201U - UPPER INTERIOR
TEST #8 RIGHT SR2A
H/V IMPACT ANGLE= 90 / 38
FM9106
Post-Test

No damage observed

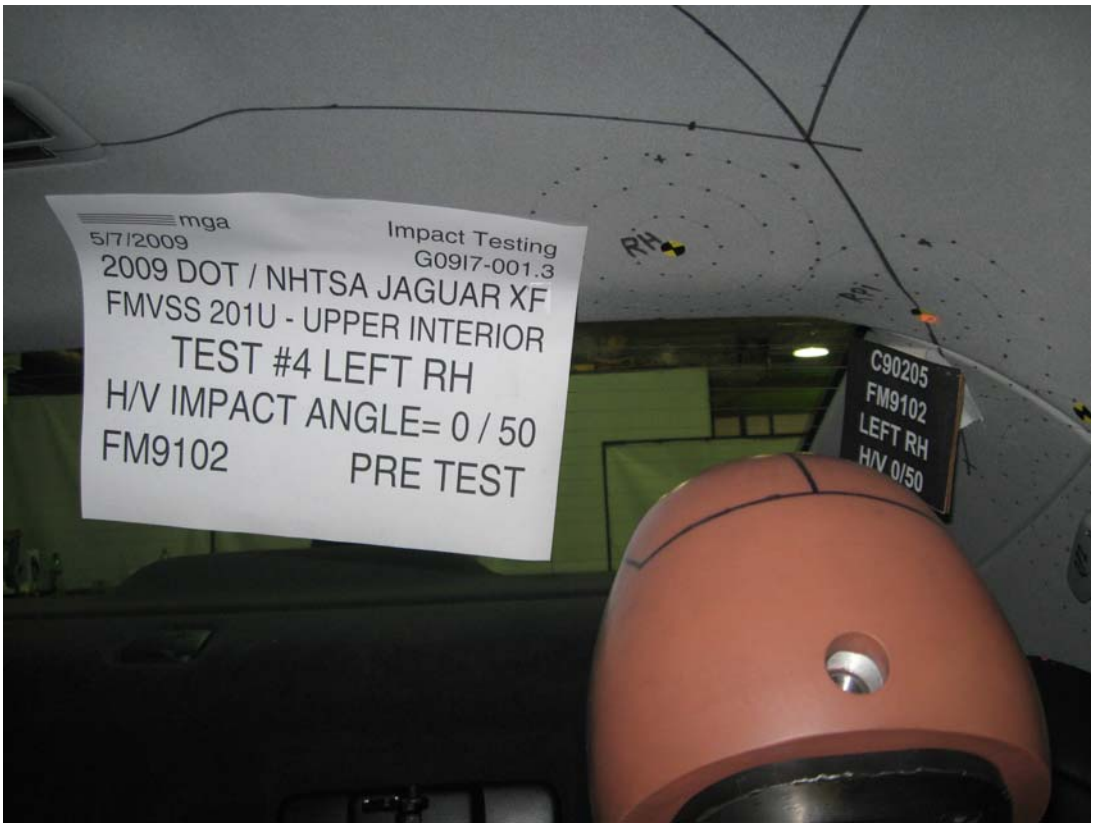
mga
5/7/2009
Impact Testing
G09I7-001.3
2009 DOT / NHTSA JAGUAR XF
FMVSS 201U - UPPER INTERIOR
TEST #4 LEFT RH
H/V IMPACT ANGLE= 0 / 50
FM9102
PRE TEST
C90205
FM9102
LEFT RH
H/V 0/50

No visible damage

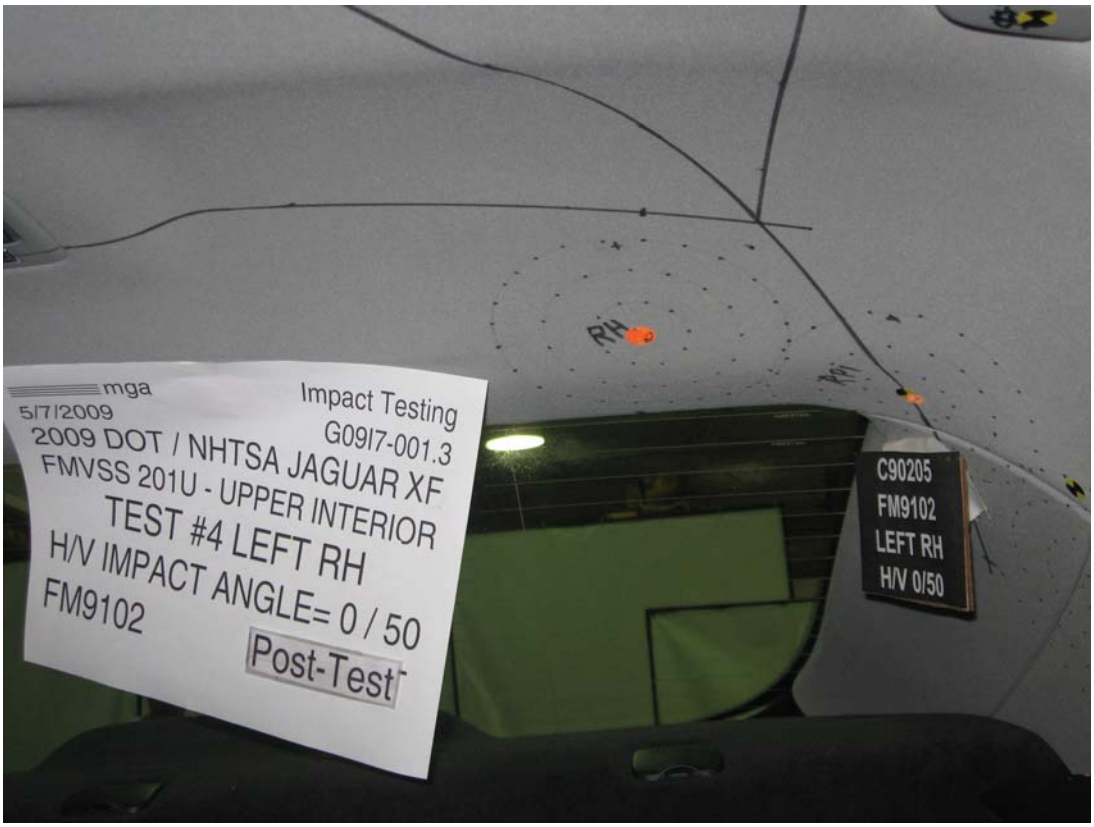
mga
Impact Testing
5/7/2009
G09I7-001.3
2009 DOT / NHTSA JAGUAR XF
FMVSS 201U - UPPER INTERIOR
TEST #4 LEFT RH
H/V IMPACT ANGLE= 0 / 50
FM9102
Post-Test
C90205
FM9102
LEFT RH
H/V 0/50

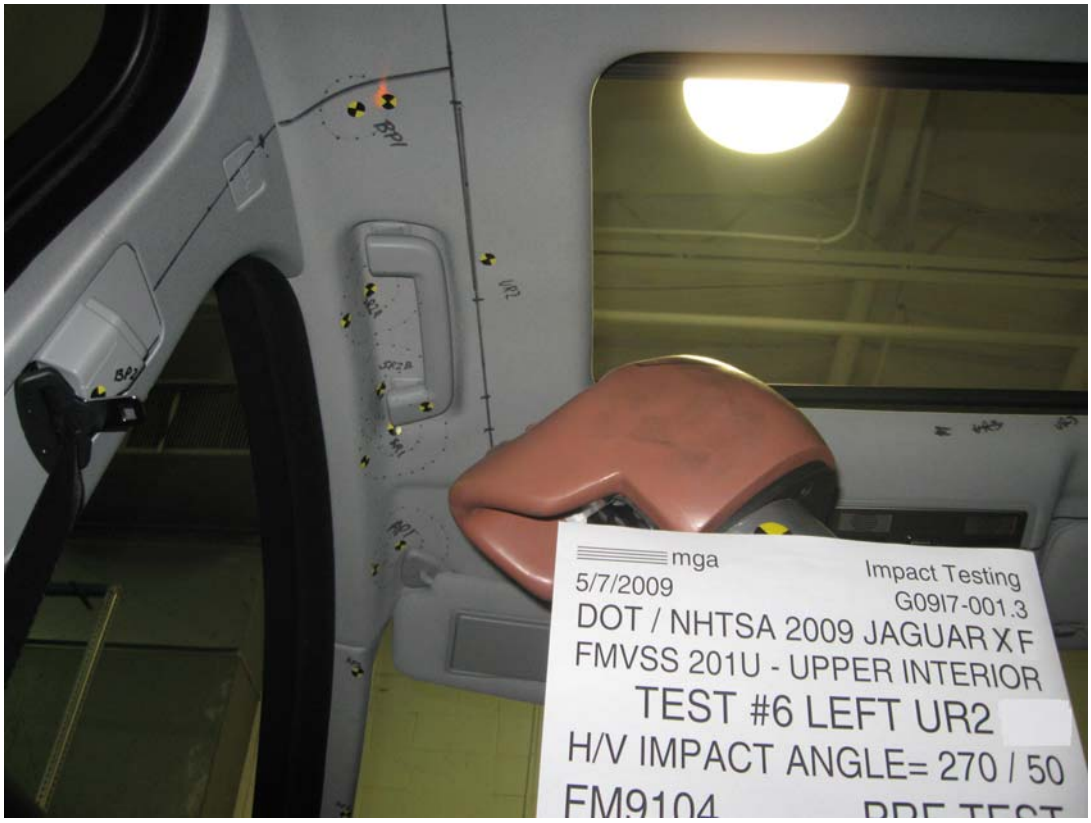
mga
5/7/2009
Impact Testing
G09I7-001.3
DOT / NHTSA 2009 JAGUAR XF
FMVSS 201U - UPPER INTERIOR
TEST #6 LEFT UR2
H/V IMPACT ANGLE= 270 / 50
FM9104

No visible damage.

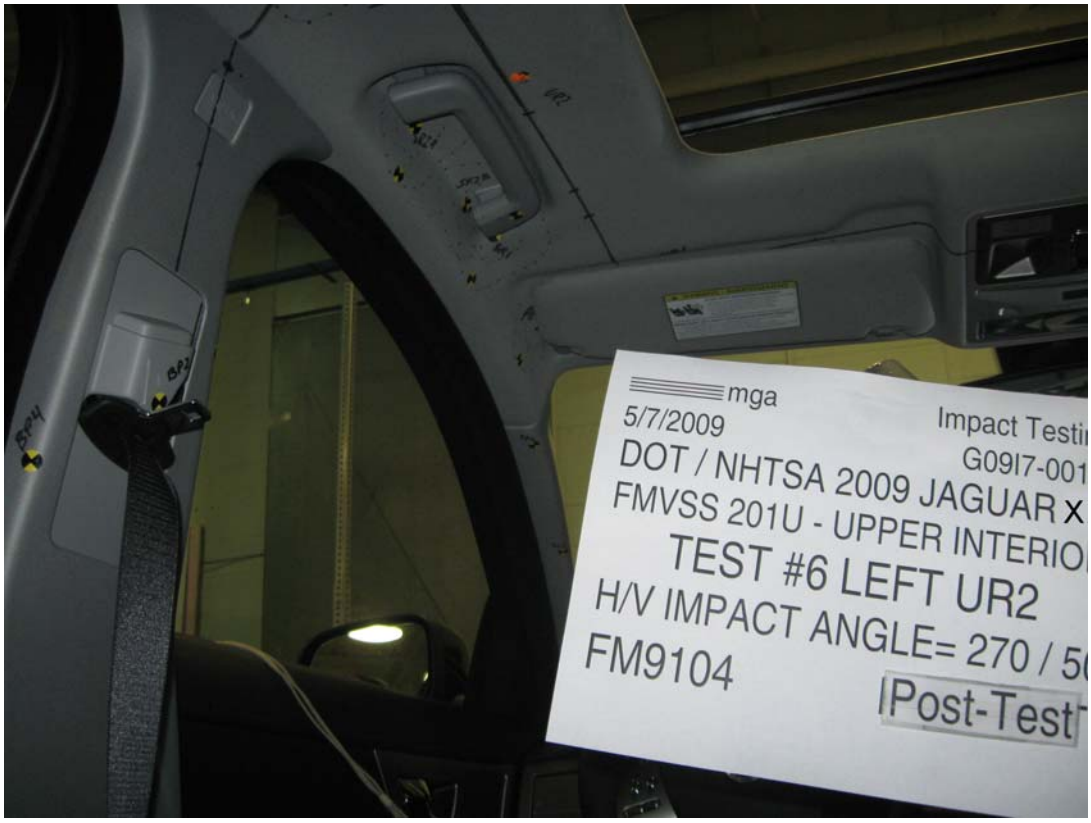
mga
5/7/2009
Impact Testi
G09I7-001
DOT / NHTSA 2009 JAGUAR X
FMVSS 201U - UPPER INTERIO
TEST #6 LEFT UR2
H/V IMPACT ANGLE= 270 / 5
FM9104
Post-Test

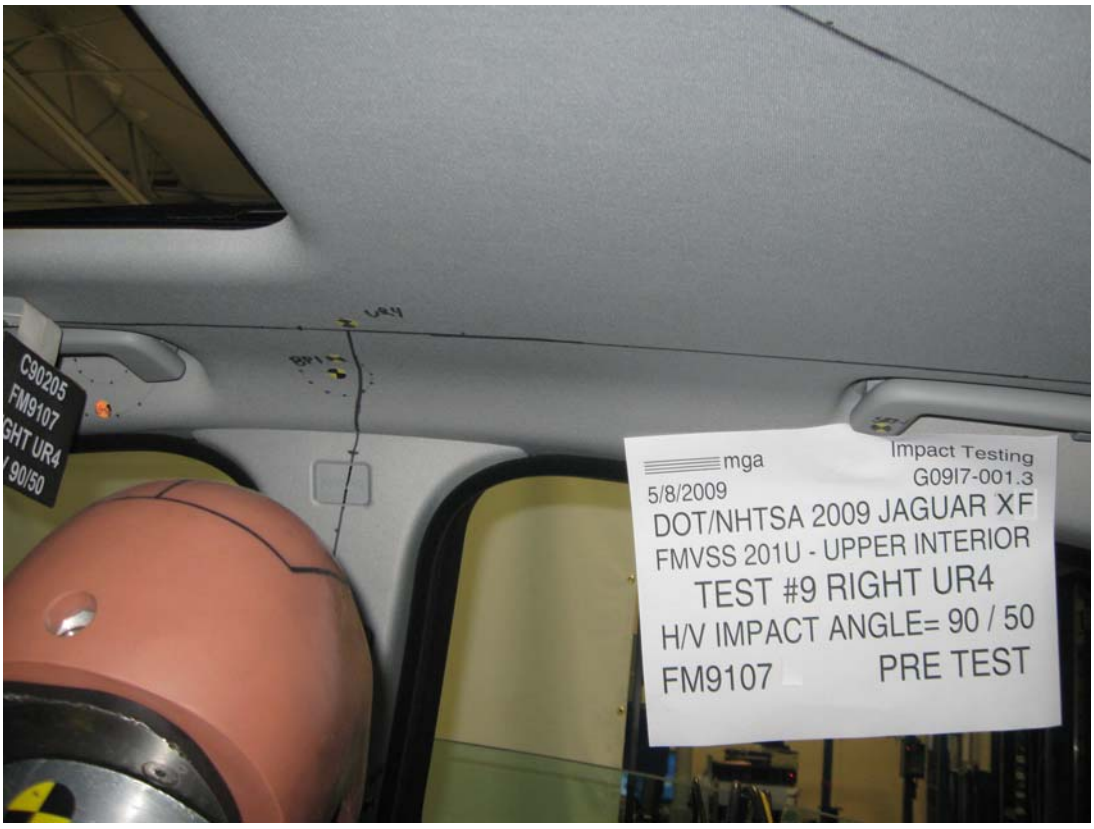
C90205
FM9107
mga
5/8/2009
Impact Testing
G09I7-001.3
DOT/NHTSA 2009 JAGUAR XF
FMVSS 201U - UPPER INTERIOR
TEST #9 RIGHT UR4
H/V IMPACT ANGLE= 90 / 50
FM9107
PRE TEST

No damage observed

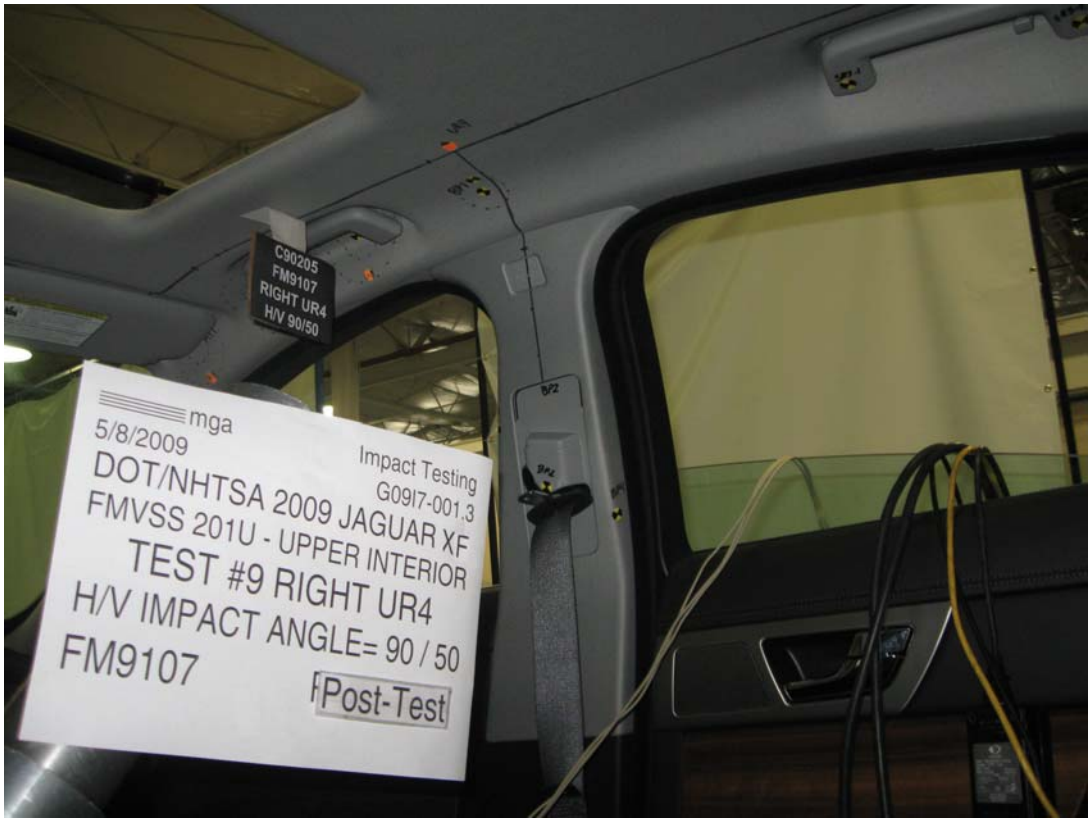
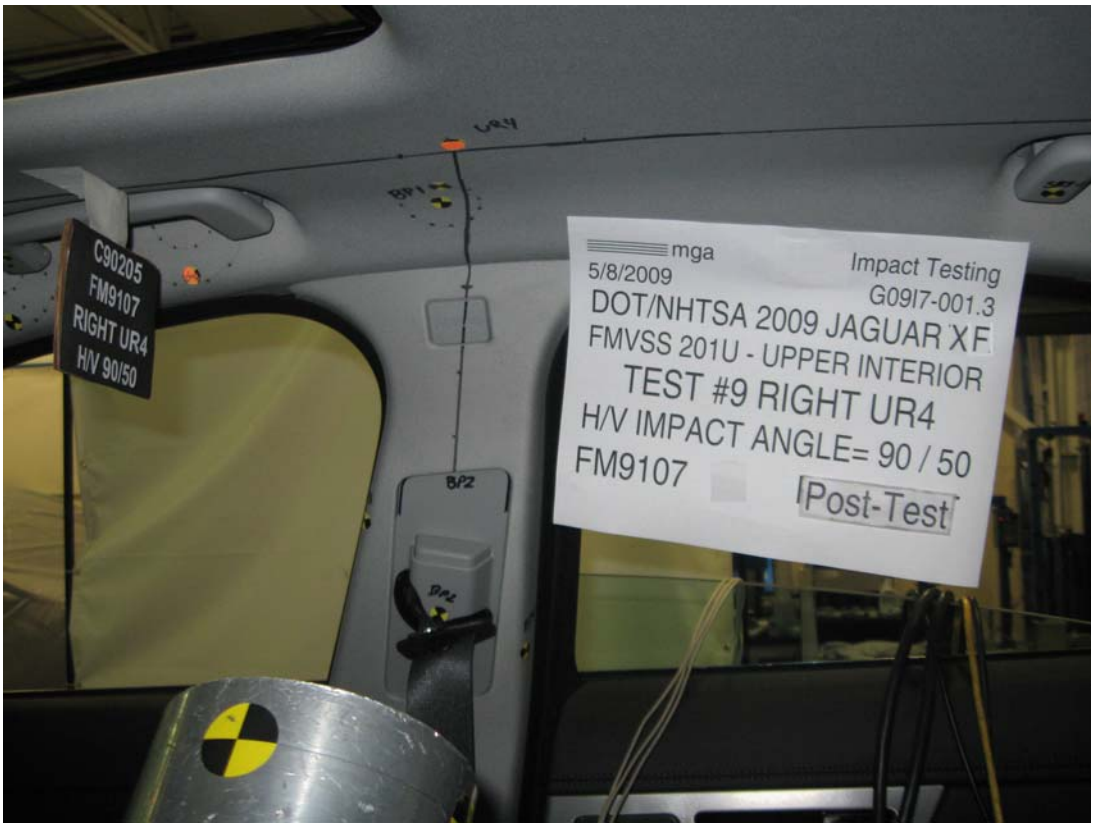
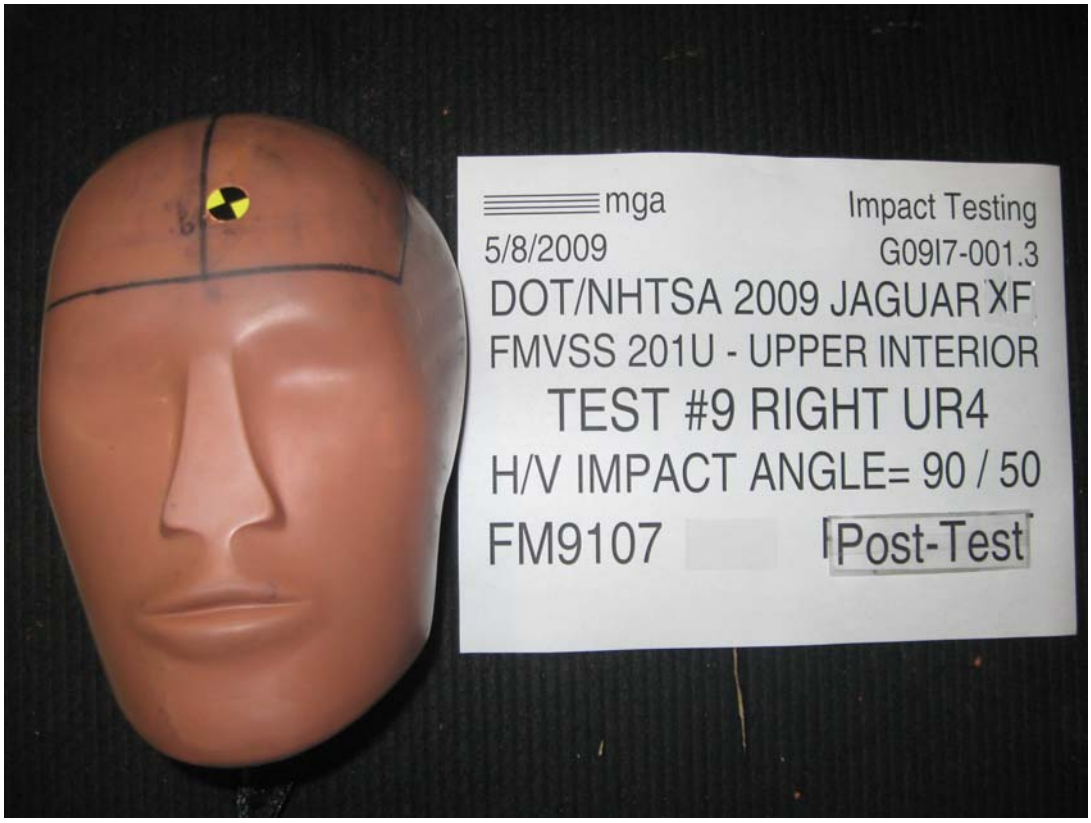
C90205
FM9107
RIGHT UR4
H/V 90/50
mga
5/8/2009
Impact Testing
G09I7-001.3
DOT/NHTSA 2009 JAGUAR XF
FMVSS 201U - UPPER INTERIOR
TEST #9 RIGHT UR4
H/V IMPACT ANGLE= 90 / 50
FM9107
Post-Test
