REPORT NUMBER 138-STF-08-005

SAFETY COMPLIANCE TESTING FOR FMVSS NO. 138 TIRE PRESSURE MONITORING SYSTEMS

HONDA MOTOR CORPORATION
2008 ACCORD
FOUR-DOOR PASSENGER CAR
NHTSA NO. C85306

FINAL REPORT

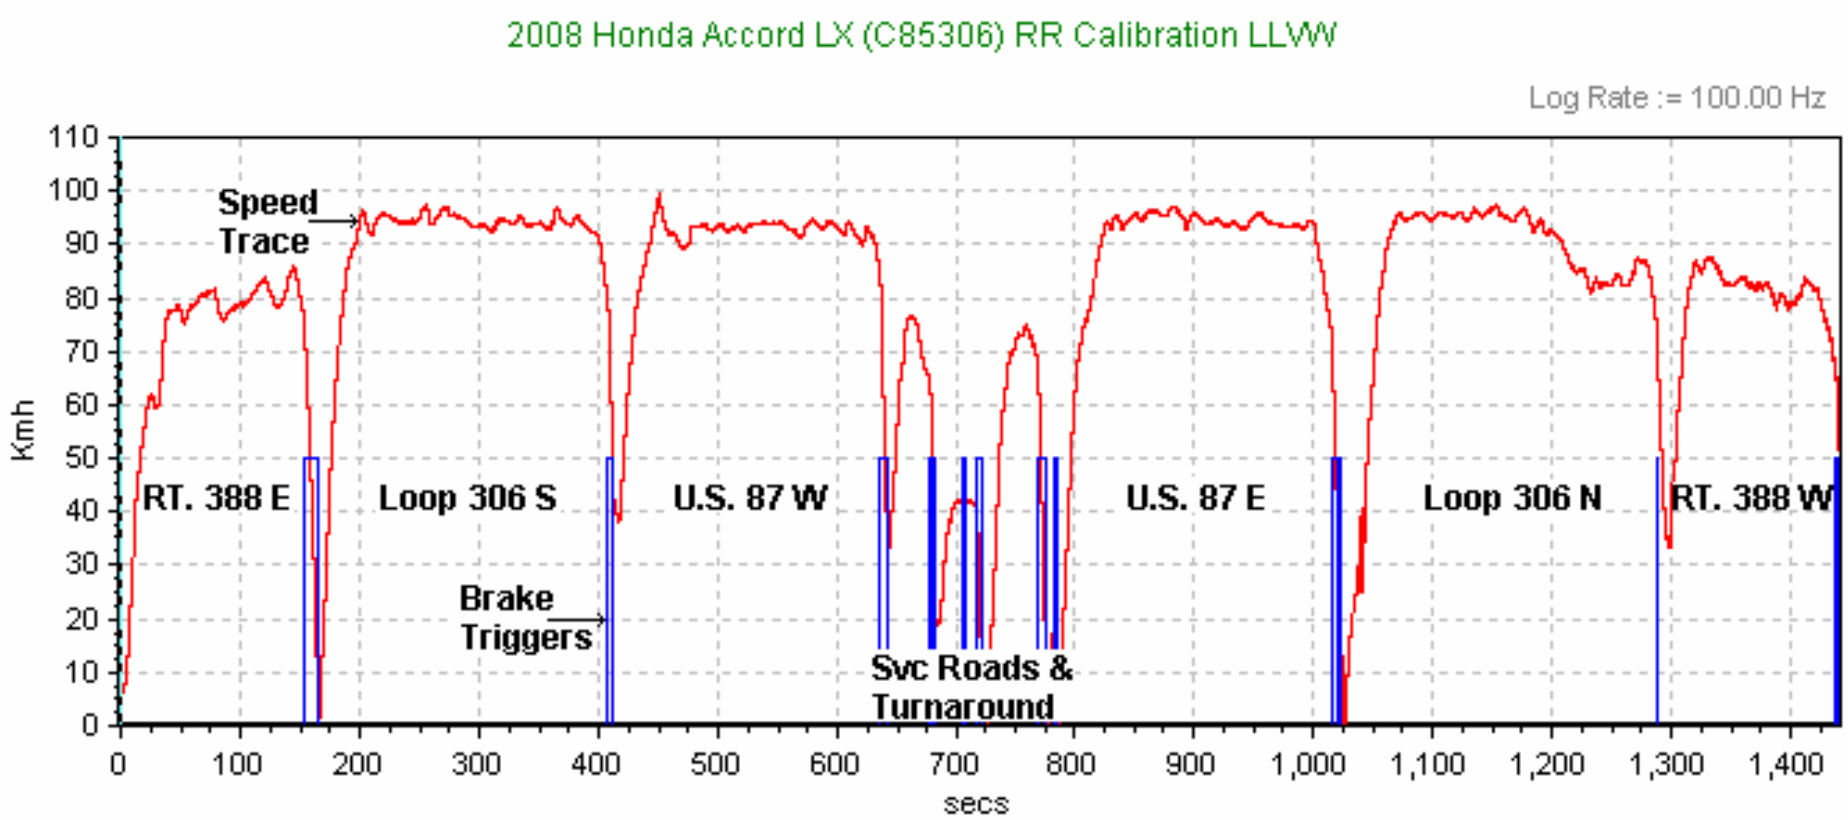
Scenario A: Right Rear Tire at LLVW
Test Date: 8/6/08
Data File Time: 24:02 minutes
Cumulative Driving Time: 20:41 minutes
Start Point: GAFB North Gate

RR Detection Phase: Telltale illumination in 1:30 minutes. Driving above 50 km/h (31 mph) was not required.

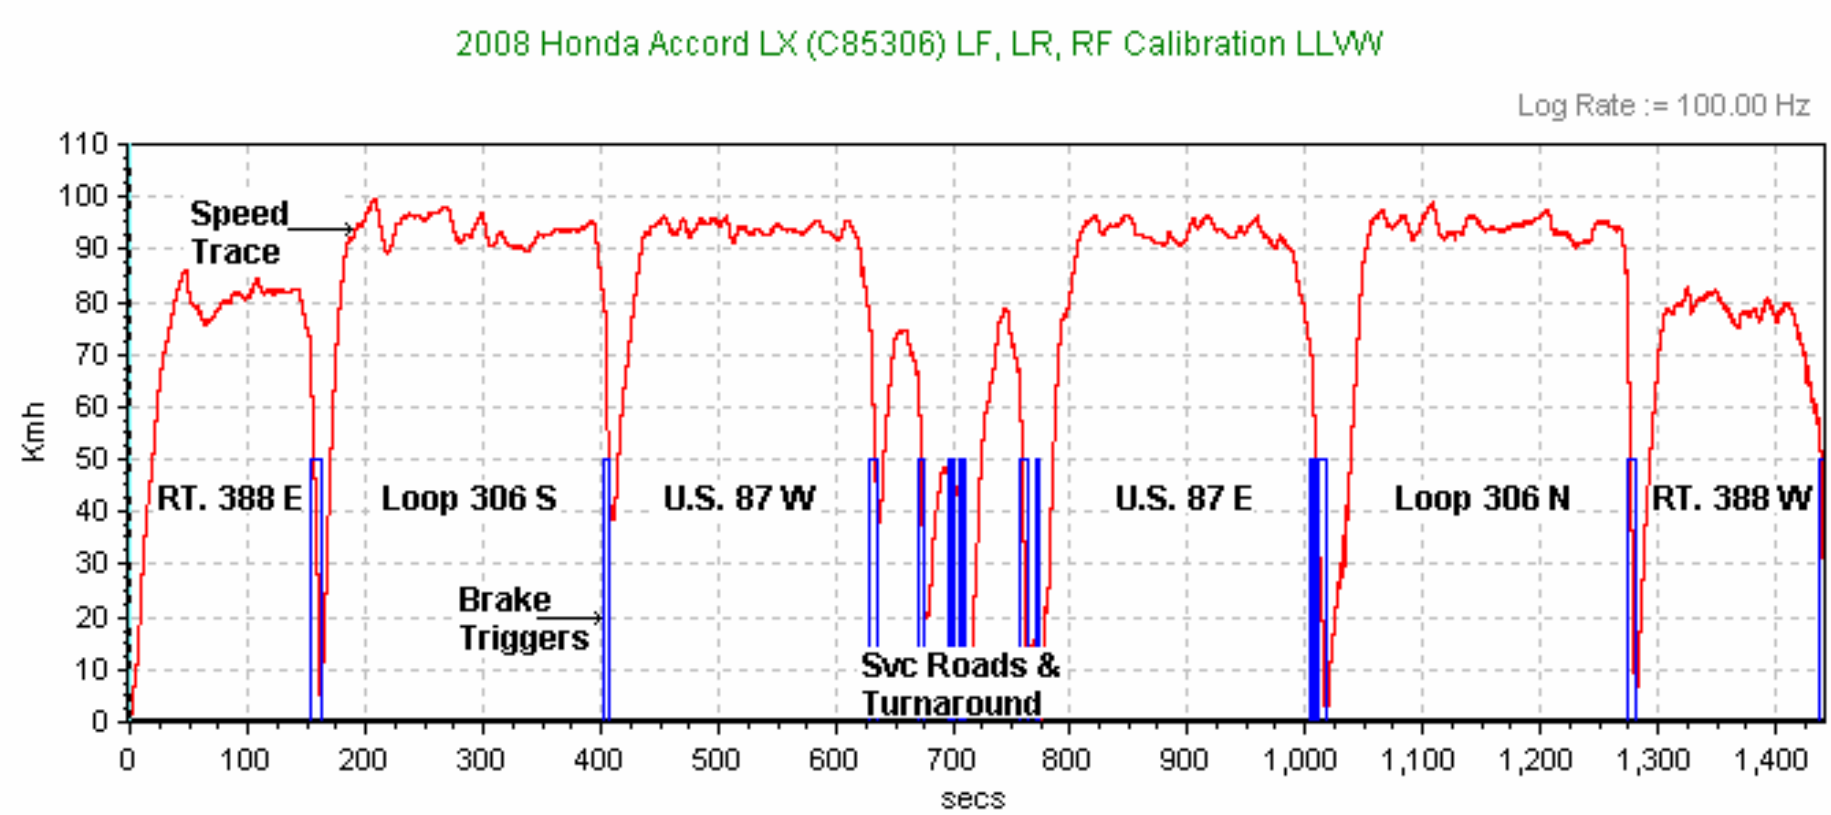
Scenario B:	Left Front, Left Rear, Right Front Tires at LLVW
Test Date:	8/6/08
Data File Time:	24:02 minutes
Cumulative Driving Time:	20:39 minutes
Start Point:	GAFB North Gate

LF, LR, RF Detection Phase: illumination in 1:47 minutes. Driving above 50 km/h (31 mph) was not required.

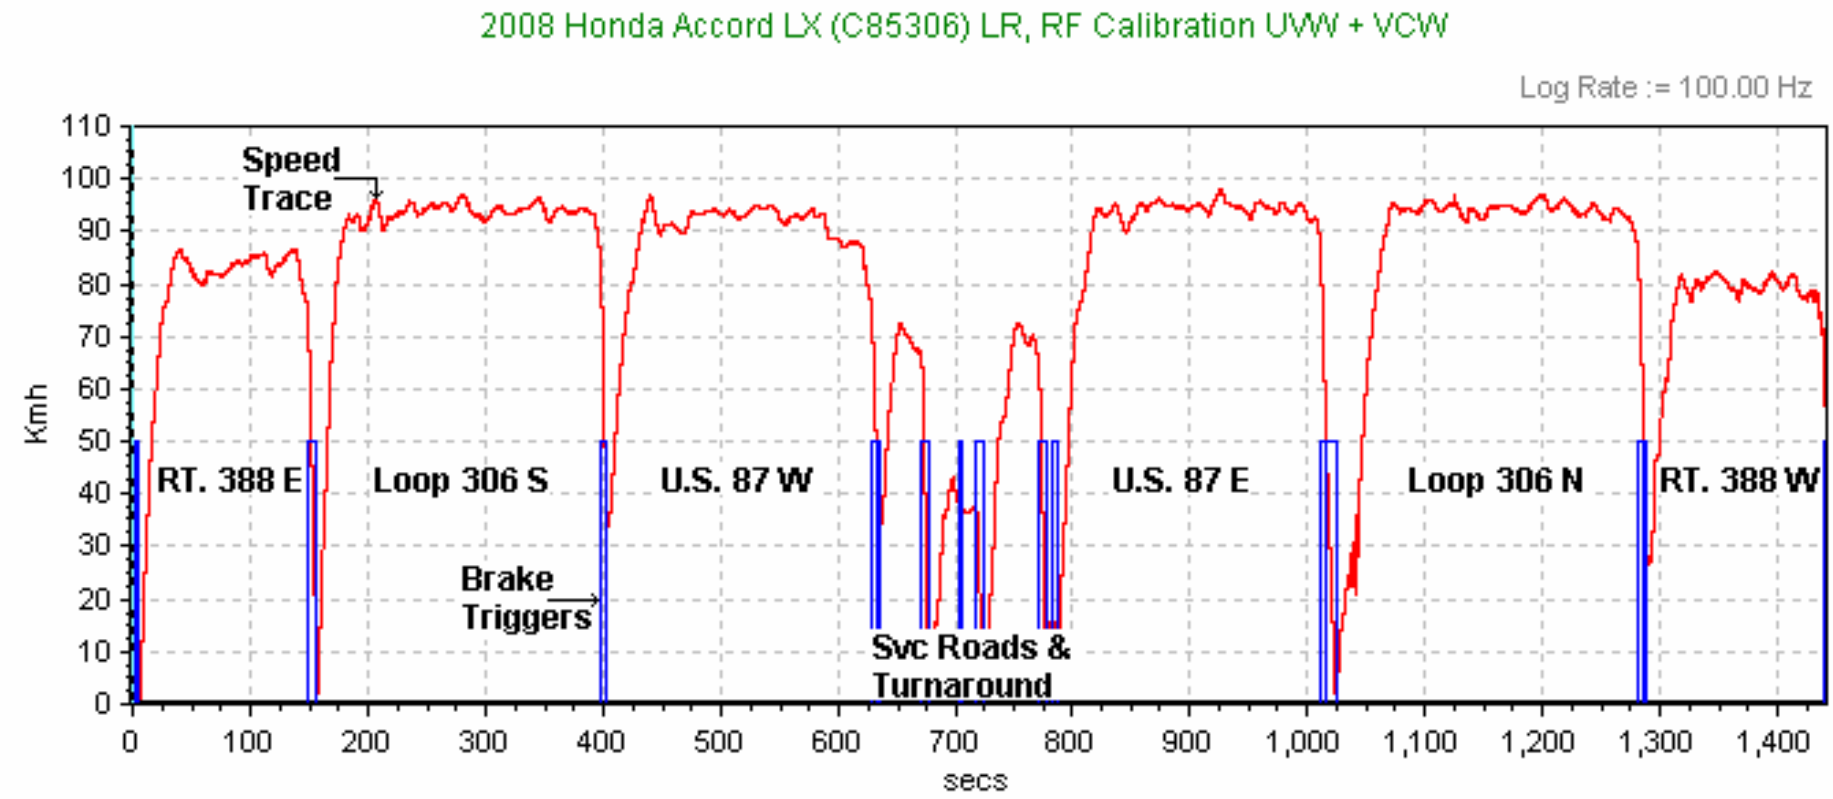
Scenario C:	Left Rear, Right Front Tires at UVW + VCW
Test Date:	8/7/08
Data File Time:	24:02 minutes
Cumulative Driving Time:	20:35minutes
Start Point:	GAFB North Gate

LR, RF Detection Phase: Telltale illumination in 0:59 minutes. Driving above 50 km/h (31 mph) was not required.

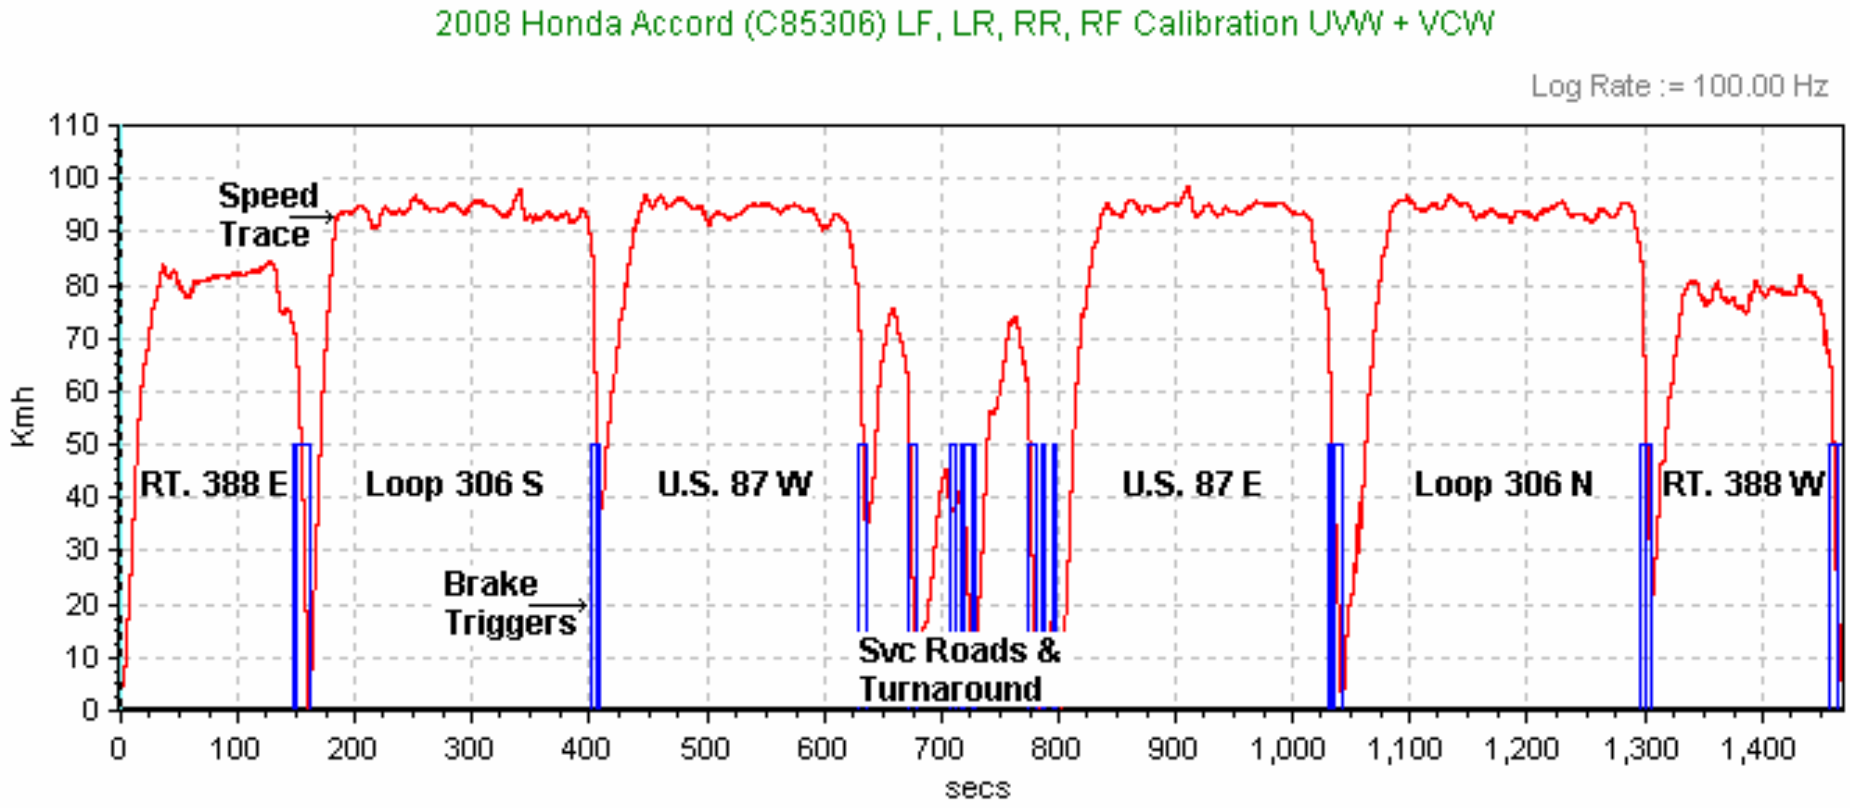
Scenario D:	Left Front, Left Rear, Right Rear, Right Front Tires at UVW + VCW
Test Date:	8/7/08
Data File Time:	24:29 minutes
Cumulative Driving Time:	20:35 minutes
Start Point:	GAFB North Gate

LF, LR, RR, RF Detection Phase: Telltale illumination in 0:02 minutes. Driving above 50 km/h (31 mph) was not required.
