FINAL REPORT NUMBER 201UI-MGA-08-07

SAFETY COMPLIANCE TESTING FOR FMVSS 201
Occupant Protection In Interior Impact
Upper Interior Head Impact Protection

HONDA OF AMERICA MFG., INC.
2008 Honda Accord, 4-Door Sedan
NHTSA No. C85306

Test Dates: June 13-17, 2008
Report Date: July 25, 2008

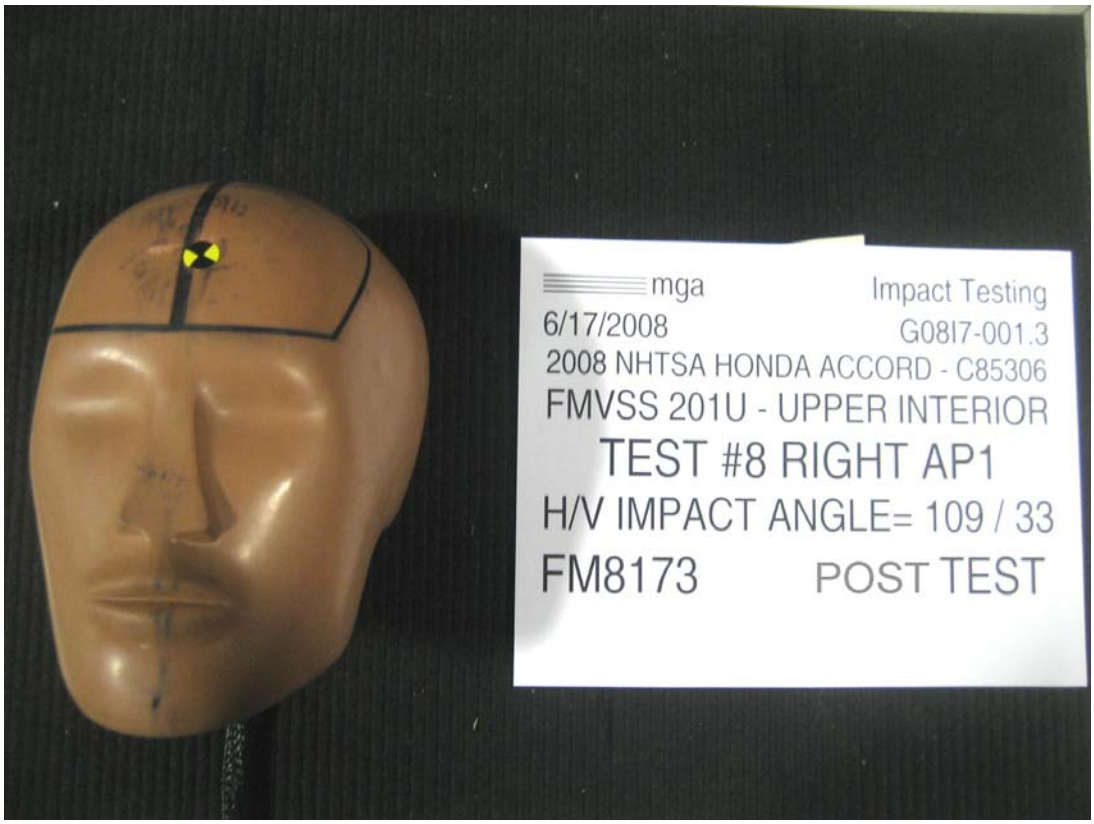
mga
Impact Testing
6/17/2008
G08I7-001.3
2008 NHTSA HONDA ACCORD - C85306
FMVSS 201U - UPPER INTERIOR
TEST #8 RIGHT AP1
H/V IMPACT ANGLE= 109 / 33
FM8173
POST TEST

No visible damage.

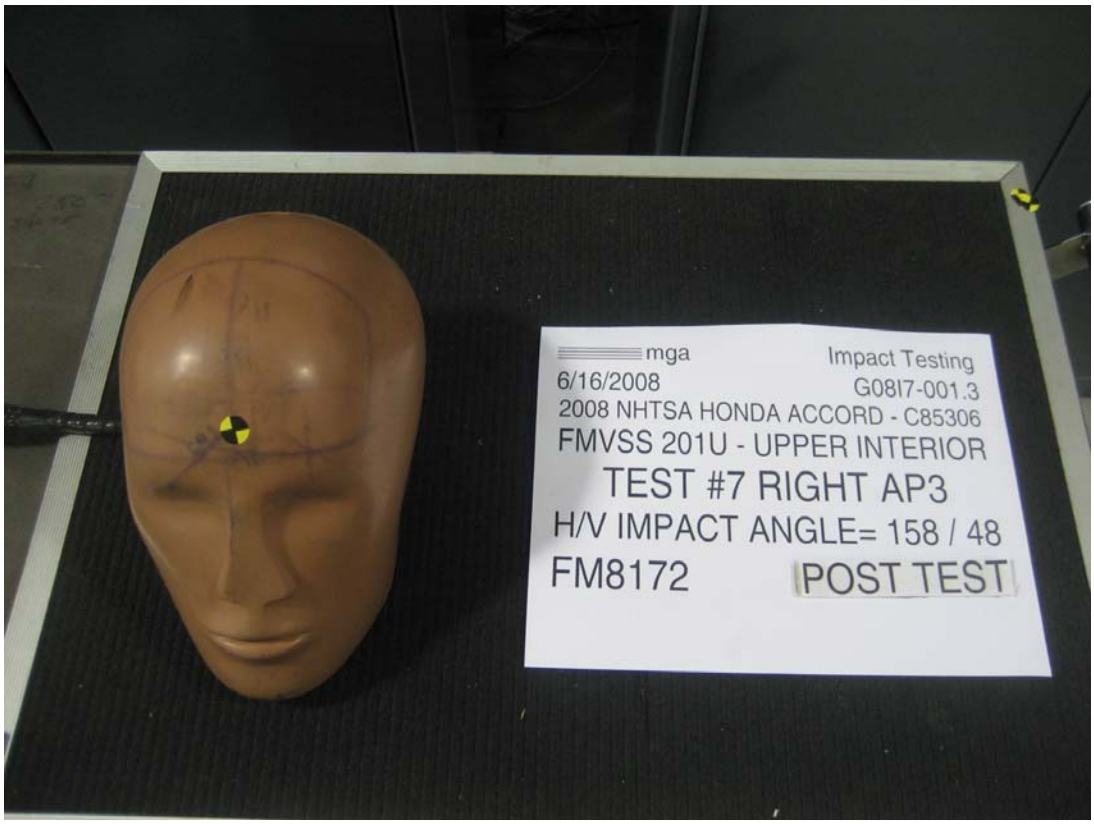
mga
Impact Testing
6/16/2008
G08I7-001.3
2008 NHTSA HONDA ACCORD - C85306
FMVSS 201U - UPPER INTERIOR
TEST #7 RIGHT AP3
H/V IMPACT ANGLE= 158 / 48
FM8172
POST TEST

No visible damage.

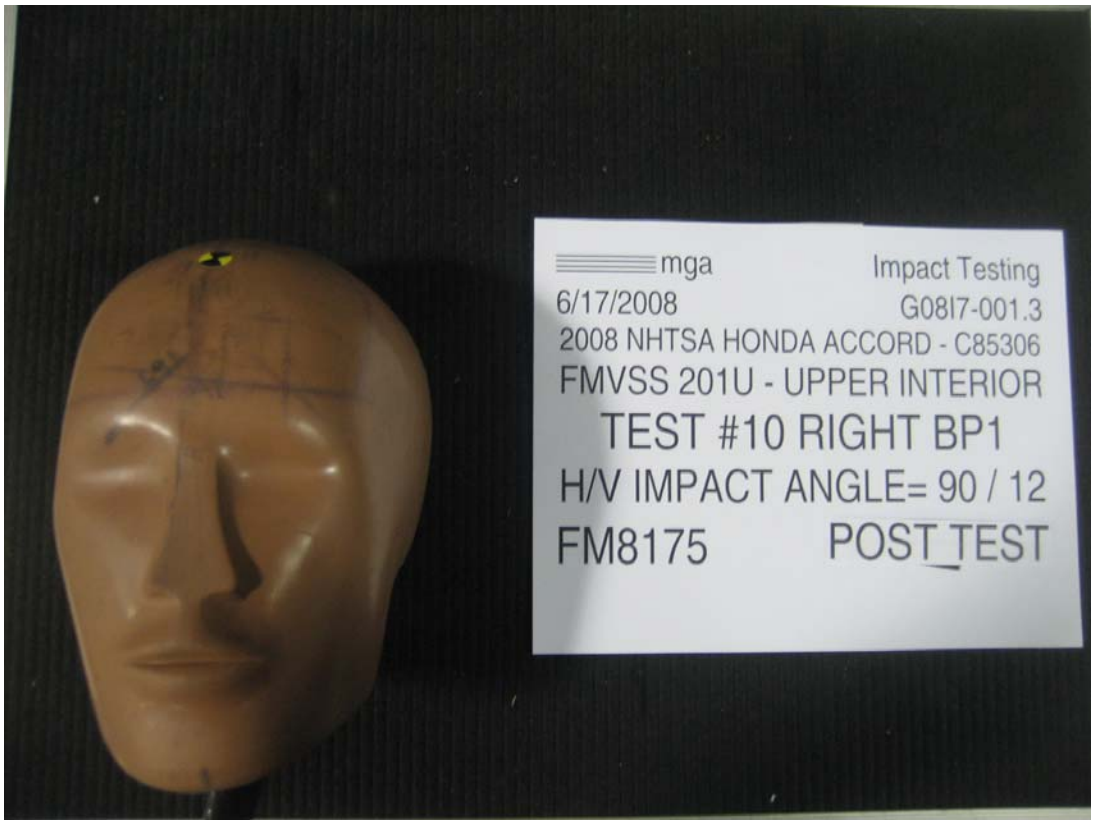
mga
Impact Testing
6/17/2008
G08I7-001.3
2008 NHTSA HONDA ACCORD - C85306
FMVSS 201U - UPPER INTERIOR
TEST #10 RIGHT BP1
H/V IMPACT ANGLE= 90 / 12
FM8175
POST TEST

No visible damage.

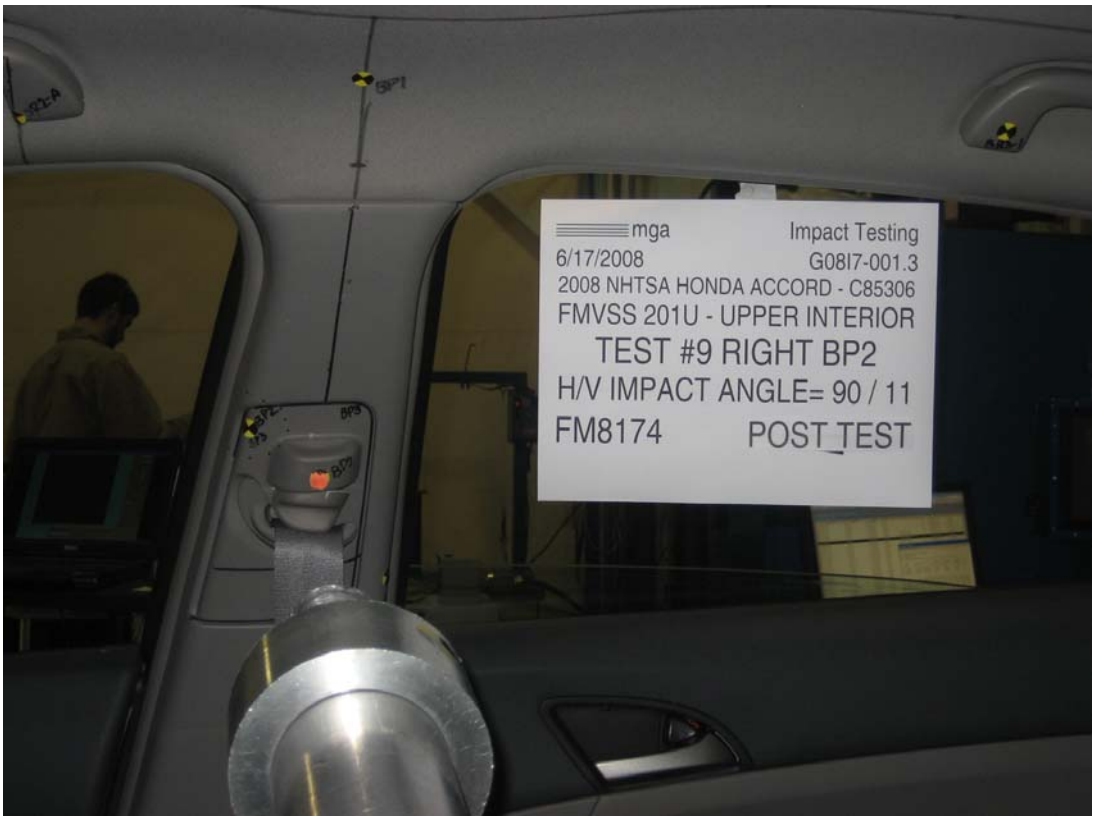
mga
Impact Testing
6/17/2008
G08I7-001.3
2008 NHTSA HONDA ACCORD - C85306
FMVSS 201U - UPPER INTERIOR
TEST #9 RIGHT BP2
H/V IMPACT ANGLE= 90 / 11
FM8174
PRE TEST

BP2 Right: D-ring cover broken.

D-ring cover broken.

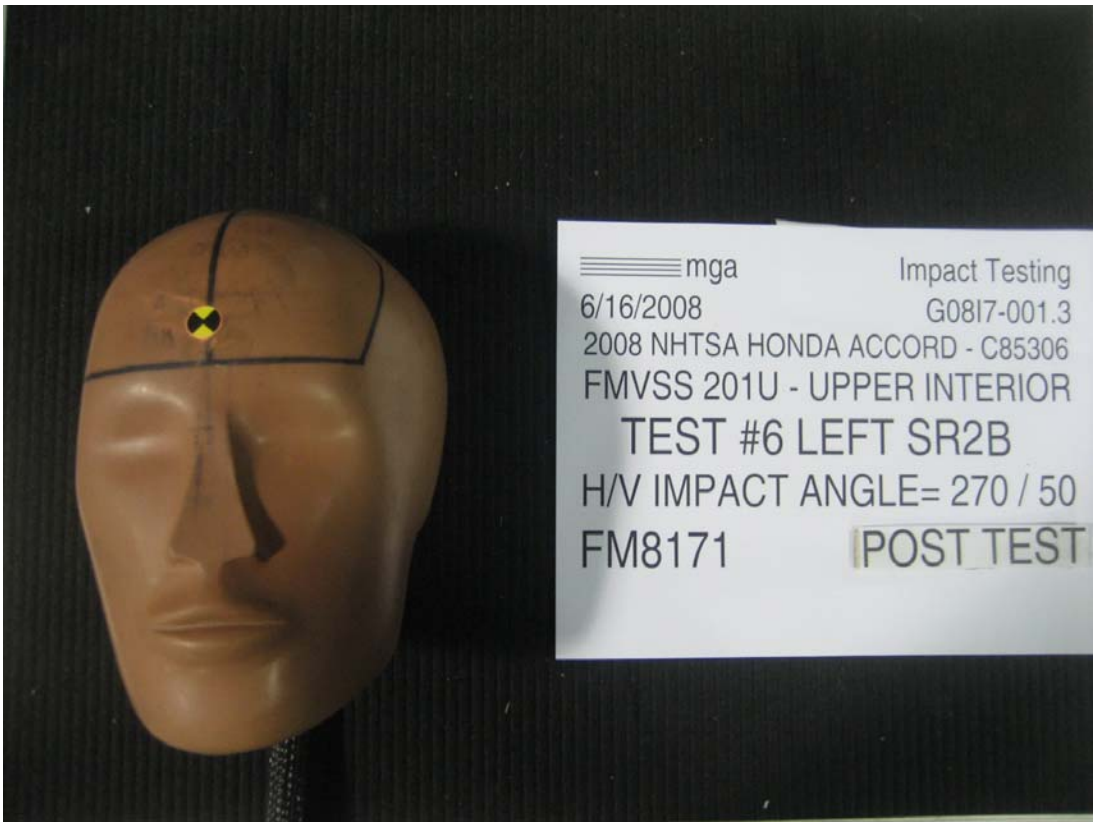
mga
Impact Testing
6/16/2008
G08I7-001.3
2008 NHTSA HONDA ACCORD - C85306
FMVSS 201U - UPPER INTERIOR
TEST #6 LEFT SR2B
H/V IMPACT ANGLE= 270 / 50
FM8171
POST TEST

No visible damage.
