REPORT NUMBER: 111SB-MGA-2009-004

SAFETY COMPLIANCE TESTING FOR FMVSS NO. 111SB SCHOOL BUS REARVIEW MIRRORS

BLUE BIRD BODY COMPANY
2009 BLUE BIRD MICRO BIRD SCHOOL BUS
NHTSA NO.: C90902

PREPARED BY:
MGA RESEARCH CORPORATION
5000 WARREN ROAD
BURLINGTON, WI 53105

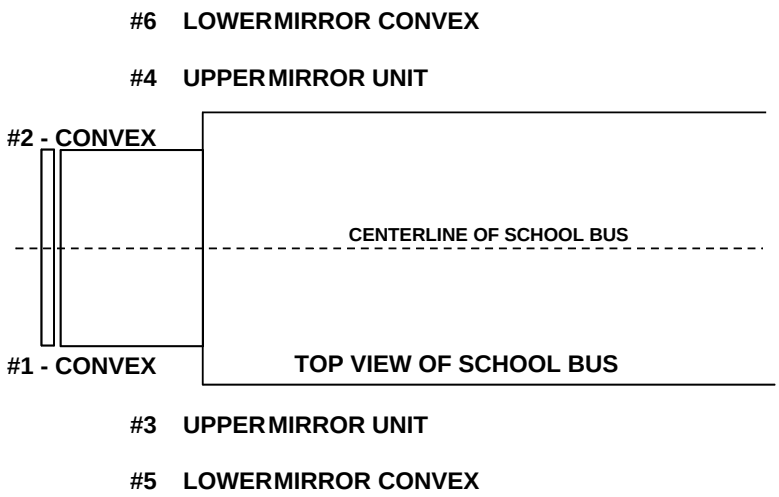
MIRROR DIAGRAM

MIRROR NO.	TYPE	MIRROR SYSTEM	CYLINDERS VIEWED (ENTIRE TOP SURFACE)
1	CROSS VIEW/CONVEX	B	B, C, D, E, F, G, H, I, J, L, M
2	CROSS VIEW/CONVEX	B	A, D, E, F, G, H, I, K, N, O, P
3	UNIT MAGNIFICATION	A	61 Meter INDICATOR
4	UNIT MAGNIFICATION	A	61 Meter INDICATOR
5	CONVEX	A	L, M
6	CONVEX	A	N, O

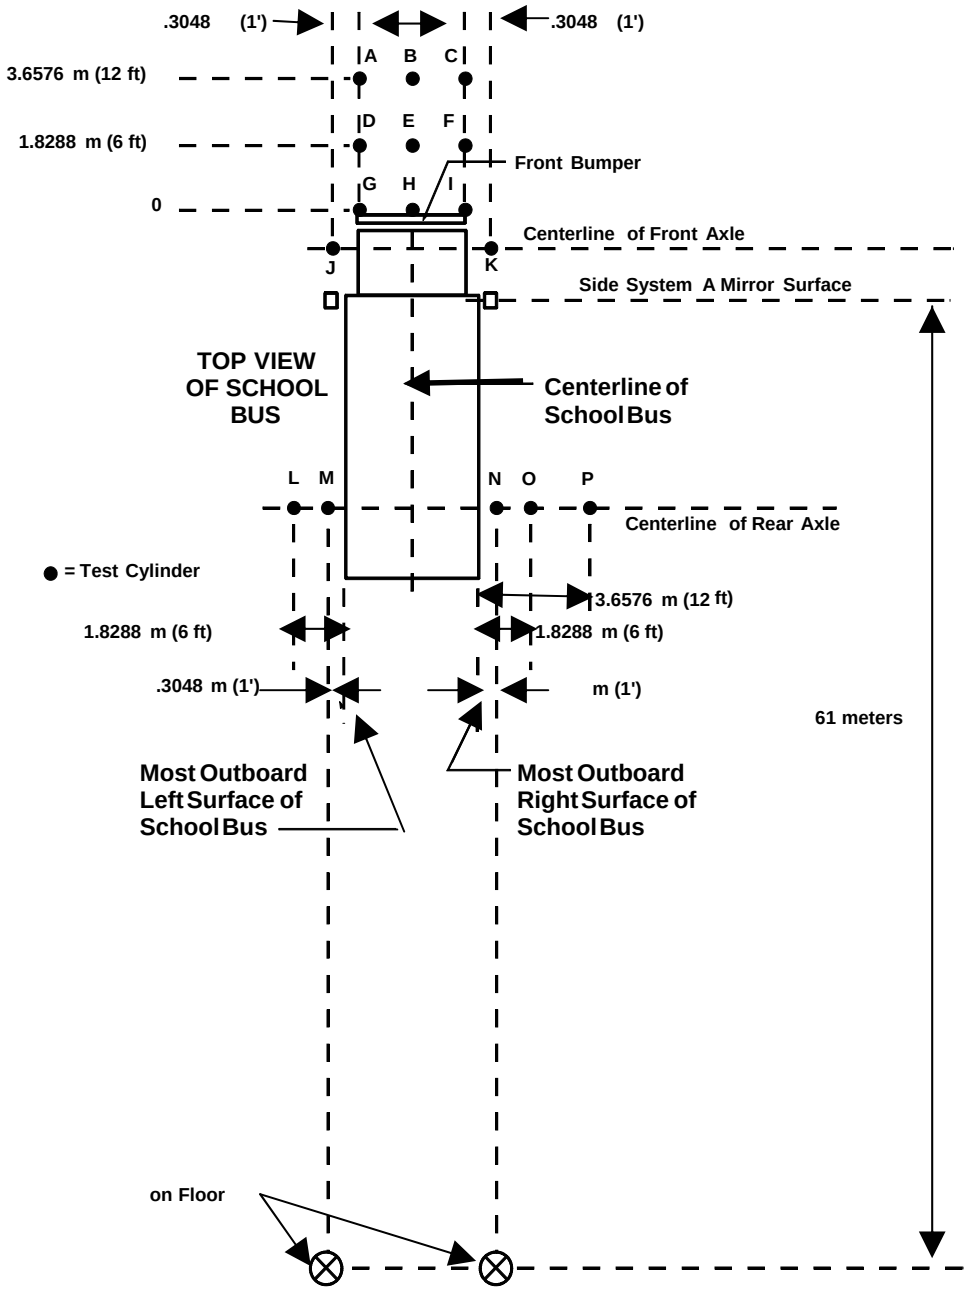
MIRROR LOCATIONS OF TEST CYLINDERS AND INDICATOR

System A Mirrors	Pass/Fail
Entire top surface of cylinder N and the indicator 61 meters (200 feet) rearward of the mirror surface can be viewed in the photograph	**Pass**
Entire top surface of cylinder M and indicator 61 meters (200 feet) rearward of the mirror surface can be viewed in the photograph	**Pass**
Which test cylinders A through P can not be photographed directly from the driver's eye location within the semi-circle viewing area using no mirror system:	A, B, C, D, E, F, G, H, I, J, K, L, M, N, O, P
