On-scene Investigation / Vehicle to Vehicle Dynamic Science, Inc. / Case Number:DS00-006 2000 Ford Taurus California May, 2000 This document is disseminated under the sponsorship of the Department of Transportation in the interest of information exchange. The United States Government assumes no responsibility for the contents or use thereof.

Dynamic Science, Inc. Accident Investigation Case Number: DS00-006

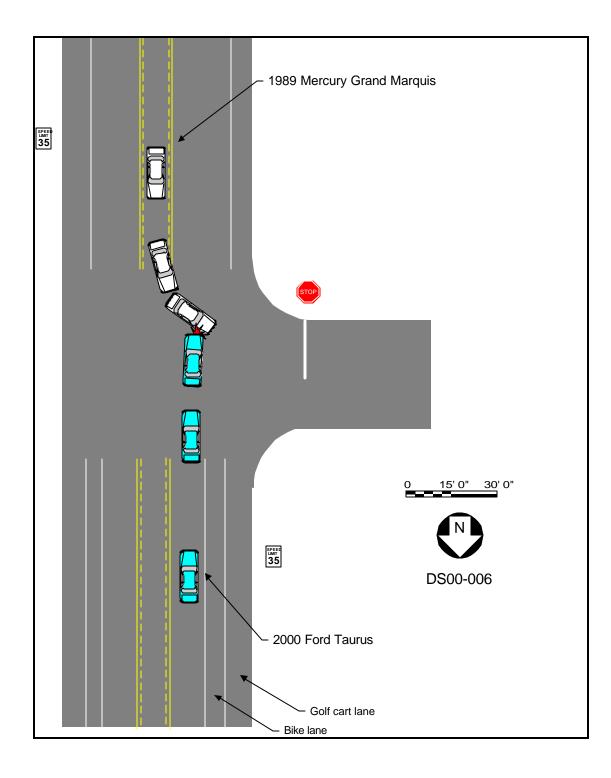
Scene Diagram

This crash occurred in California in May, 2000 at 1042 hours. The crash took place in a three-leg intersection. The weather was clear and the asphalt roadway was dry and free of defects. The north-south undivided roadway is comprised of a northbound travel lane, a southbound travel lane, and a middle turn lane. The western edge of the northbound roadway is marked for bicycle traffic by a single white line. Adjacent to this lane is a marked area for parking. There are no controls for north or southbound traffic. The speed limit is 56 km/h (35 mph) in both
