**TRANSPORTATION SCIENCES
CRASH DATA RESEARCH CENTER**

INVESTIGATION

CASE NO: CA03-048

VEHICLE: 2003 CHEVROLET SILVERADO

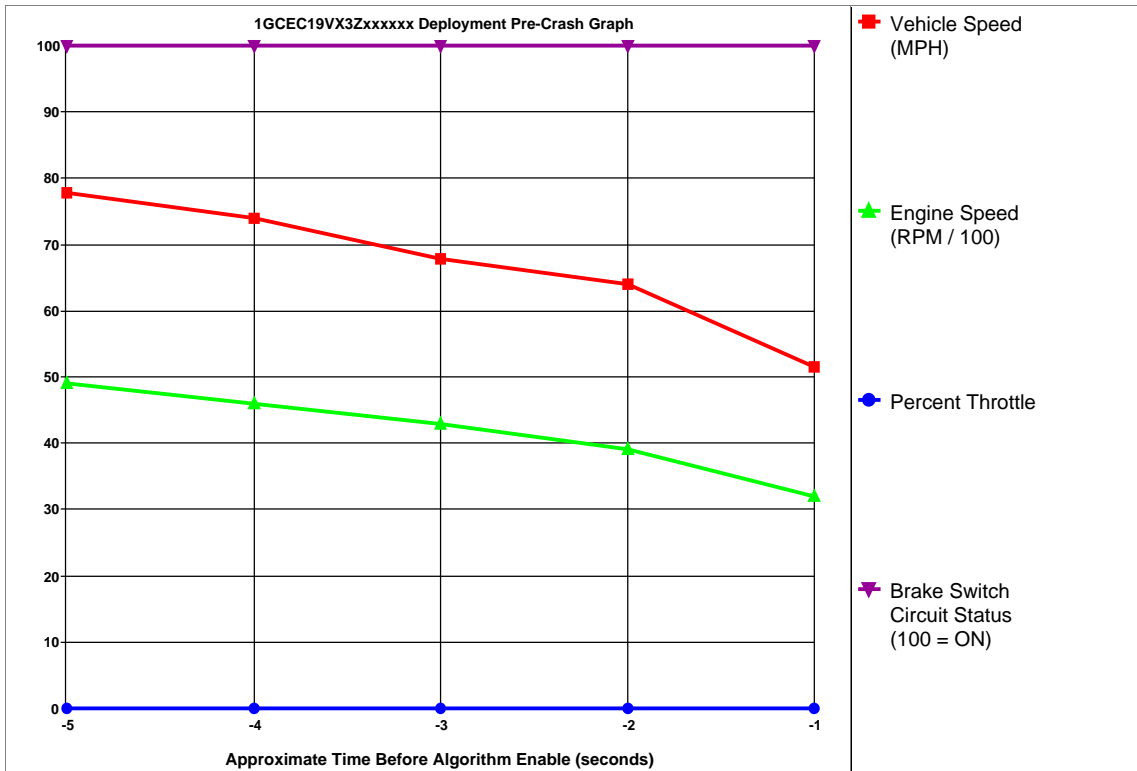
System Status At Deployment

SIR Warning Lamp Status	OFF
Driver's Belt Switch Circuit Status	UNBUCKLED
Ignition Cycles At Deployment	1806
Ignition Cycles At Investigation	1807
Maximum SDM Recorded Velocity Change (MPH)	-7.60
Algorithm Enable to Maximum SDM Recorded Velocity Change (msec)	182.5
Driver First Stage Time Algorithm Enabled to Deployment Command Criteria Met (msec)	30
Driver Second Stage Time Algorithm Enabled to Deployment Command Criteria Met (msec)	N/A
Passenger First Stage Time Algorithm Enabled to Deployment Command Criteria Met (msec)	N/A
Passenger Second Stage Time Algorithm Enabled to Deployment Command Criteria Met (msec)	N/A
Time Between Non-Deployment And Deployment Events (sec)	N/A
Frontal Deployment Level Event Counter	1
Event Recording Complete	Yes
Multiple Events Associated With This Record	No
One Or More Associated Events Not Recorded	No

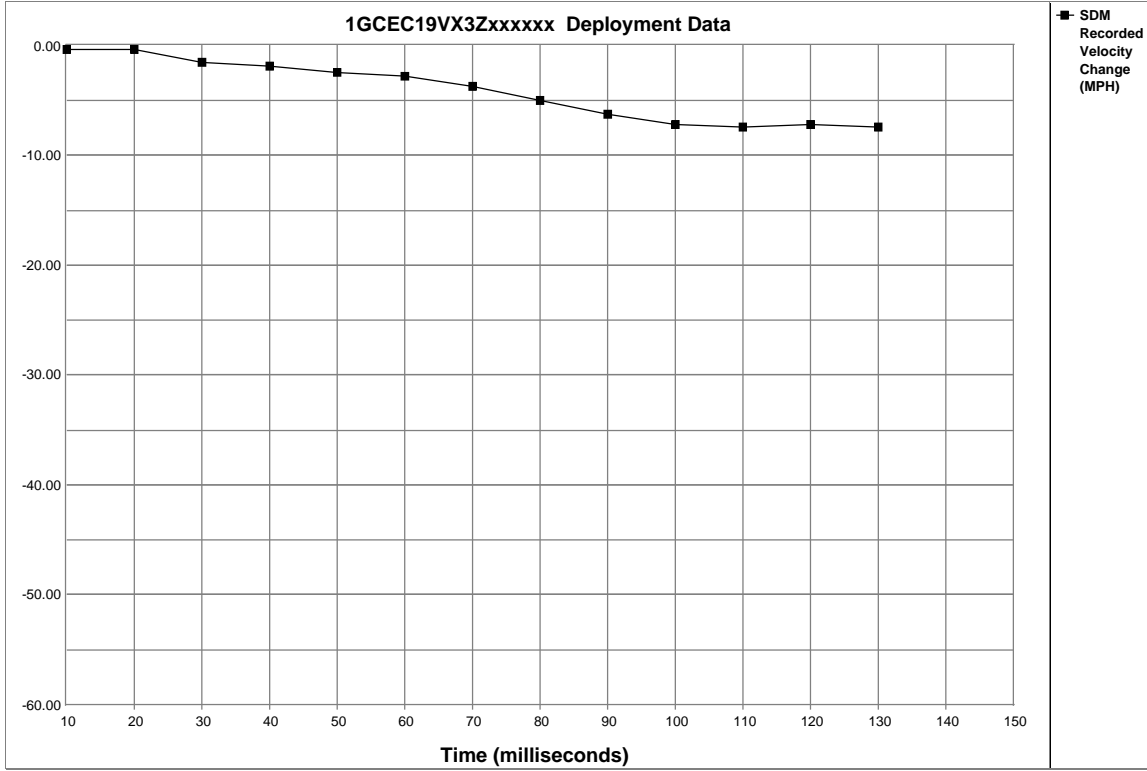
Seconds Before AE	Vehicle Speed (MPH)	Engine Speed (RPM)	Percent Throttle	Brake Switch Circuit Status
-5	78	4864	0	ON
-4	74	4608	0	ON
-3	68	4288	0	ON
-2	64	3904	0	ON
-1	52	3200	0	ON

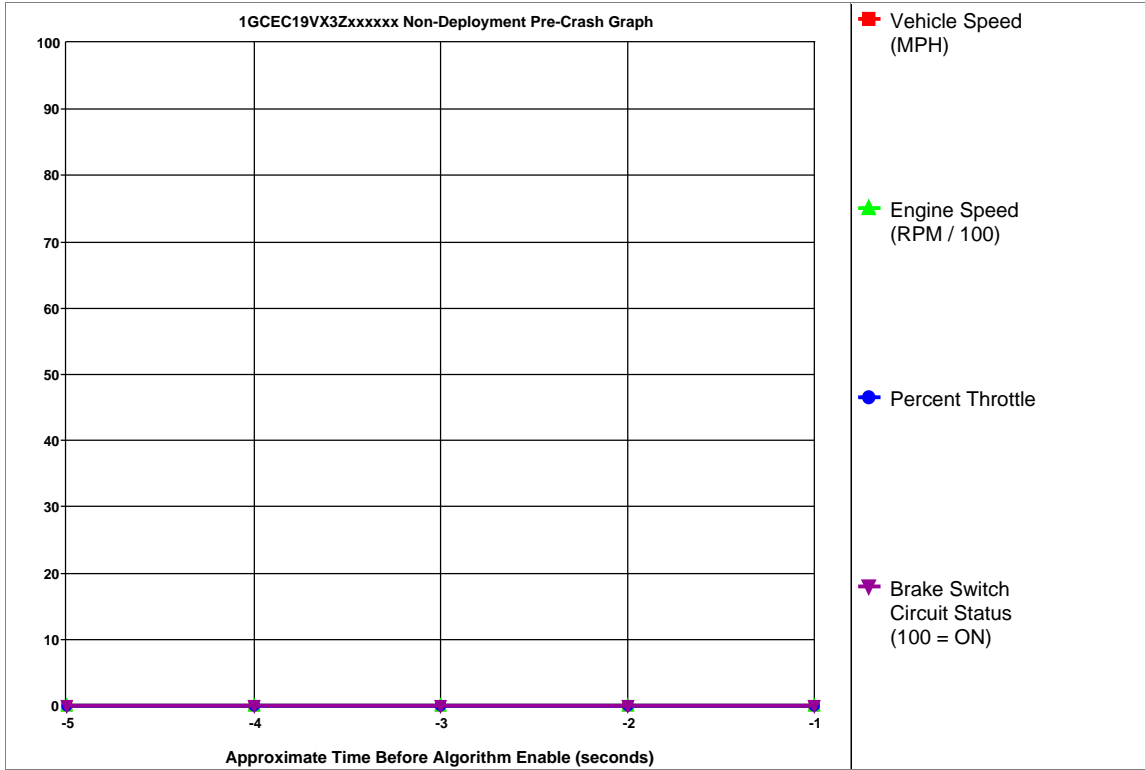
System Status At Non-Deployment

SIR Warning Lamp Status	OFF
Driver's Belt Switch Circuit Status	UNBUCKLED
Ignition Cycles At Non-Deployment	1693
Ignition Cycles At Investigation	1807
Maximum SDM Recorded Velocity Change (MPH)	0.00
Algorithm Enable to Maximum SDM Recorded Velocity Change (msec)	0
Event Recording Complete	Yes
Multiple Events Associated With This Record	No
One Or More Associated Events Not Recorded	No

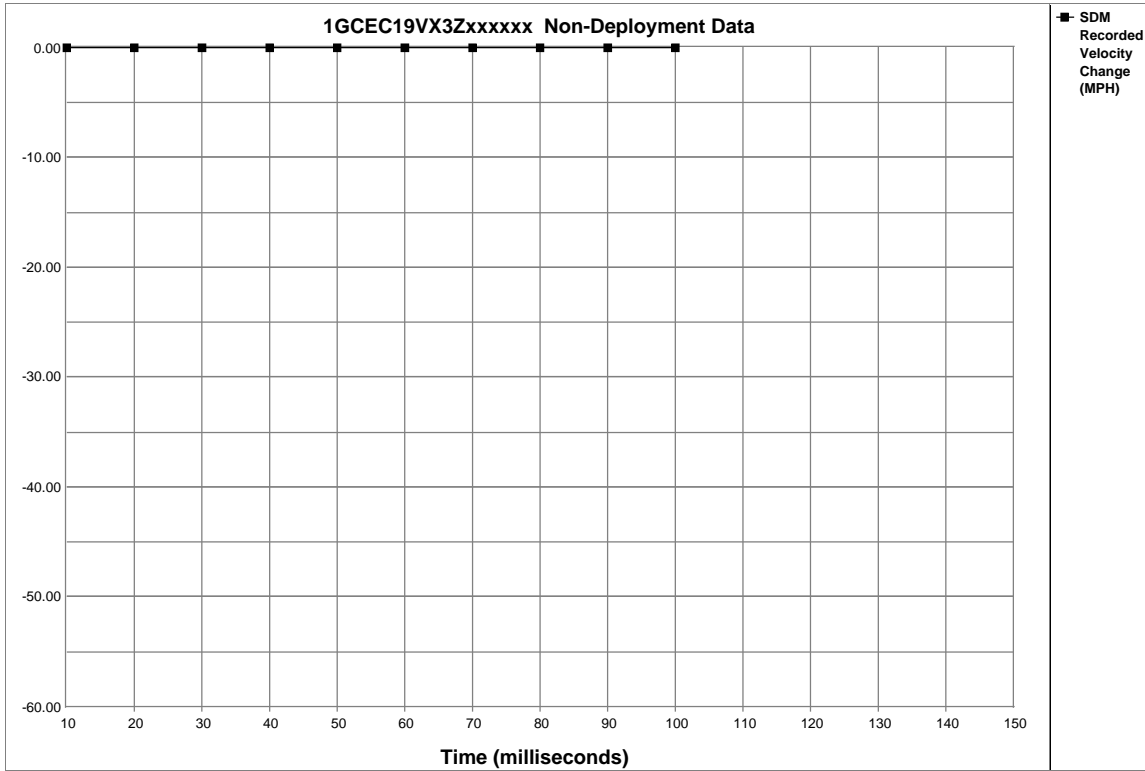
Seconds Before AE	Vehicle Speed (MPH)	Engine Speed (RPM)	Percent Throttle	Brake Switch Circuit Status
-5	0	0	0	OFF
-4	0	0	0	OFF
-3	0	0	0	OFF
-2	0	0	0	OFF
-1	0	0	0	OFF
