**ON-SITE CERTIFIED ADVANCED 208-COMPLIANT VEHICLE CRASH
INVESTIGATION
CALSPAN CASE NO: CA04-001**

VEHICLE: 2003 CHEVROLET C1500 SILVERADO PICK-UP TRUCK

**LOCATION: MARYLAND
CRASH DATE: DECEMBER, 2003**

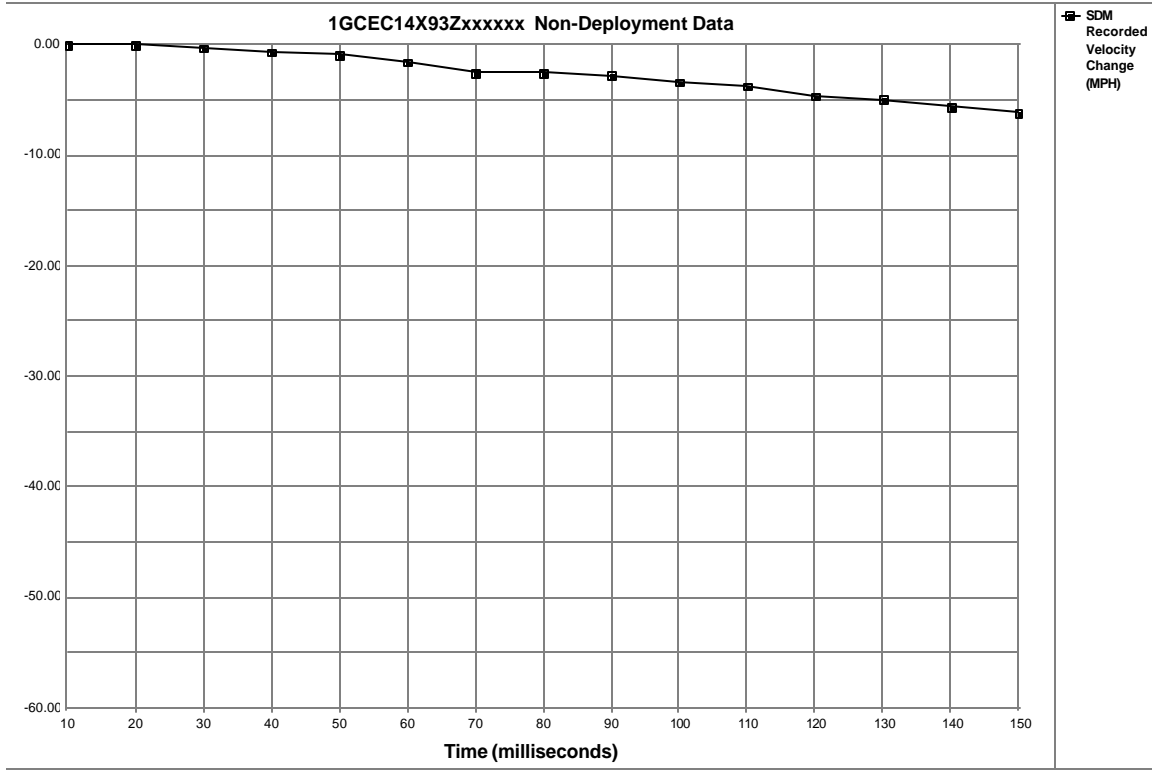
Time (milliseconds)	10	20	30	40	50	60	70	80	90	100	110	120	130	140	150
Recorded Velocity Change (MPH)	0.00	0.00	-0.31	-0.62	-0.93	-1.55	-2.48	-2.48	-2.79	-3.41	-3.72	-4.65	-4.96	-5.58	-6.20
