Vehicle Defect - Tour Bus Investigation / Vehicle to Object
Dynamic Science, Inc. / Case Number: DS04014
1997 Van Hool tour bus
Arizona
June 2004

1. Report No. DS04014	2. Government Accession No.		3. Recipient Catalog No.	
4. Title and Subtitle Vehicle Defect - Tour Bus Investigation			5. Report Date August 3, 2006

The focus of this on site investigation was the performance of the brake system on a 1997 Van Hool tour bus.

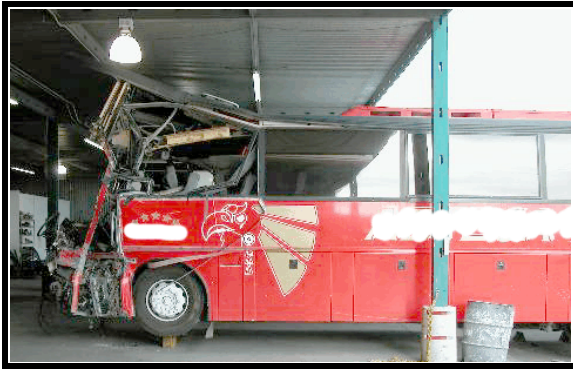
Figure 8. Left side, case vehicle

Damage Description: The Van Hool bus sustained major external damage. The front end was entirely caved in. There was 78 cm (31 in) of crush at the front right corner. Both A pillars and the windshield header were forced rearward causing the roof to buckle upwards. The front right entry way was crushed rearward, with a maximum opening width of 56 cm (22 in) at the bottom and a minimum opening width of 12 cm (5 in) at the belt line. Both front seats were crushed by instrument panel/dash intrusion. The front right tire was flattened and restricted. The left front tire was flattened. There was side swiping type contact damage down the entire right side extending vertically from the frame level to 59 cm (23 in) at the highest point. There was also scraping contacts along the right side undercarriage.

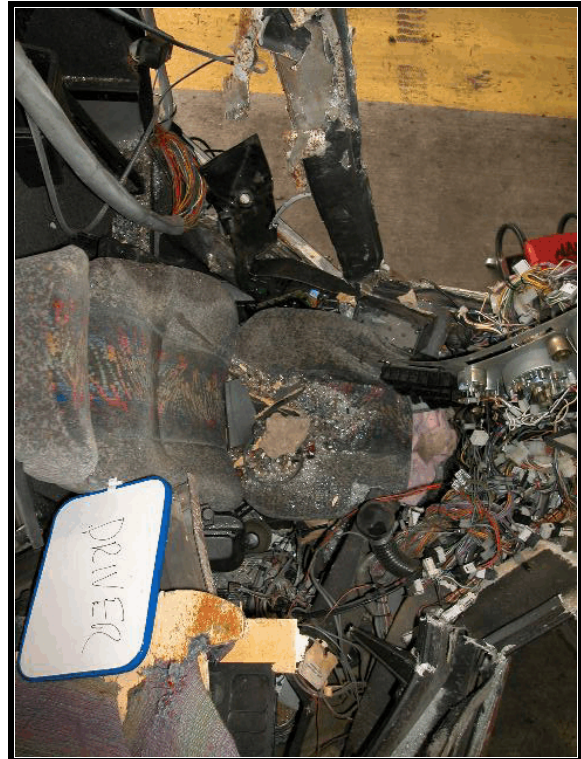
The 42-year-old male driver was seated in an upright posture. According to the police, he was not restrained. Both hands were likely on the steering wheel. His right foot appeared to be on the brake. The seat track position is not known. During the curb and fence impacts there would have been little occupant movement—given the speed and mass of the bus. At impact with the portable storage structure, the driver began a forward trajectory. At this same time, the metal structure began intruding into the passenger compartment. The driver sustained multiple facial and head injuries due to contact with the metal structure as it penetrated into the bus. The driver sustained lower extremity injuries due to contact with the steering wheel rim, the lower instrument panel and the brake pedal. The driver was killed instantly. He was entrapped in the wreckage and it took several hours for rescue personnel to extricate his body.

Figure 13. Overview of driver's seated position

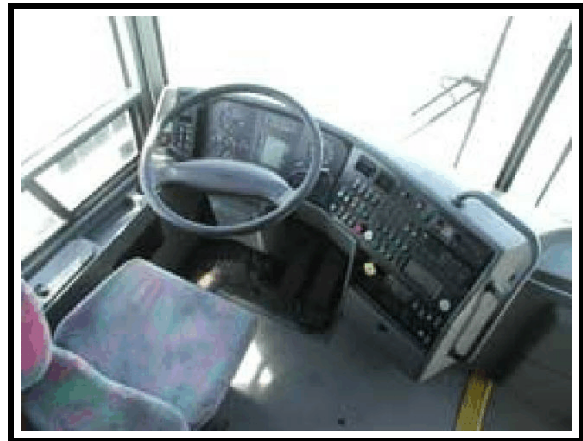
Figure 14. Exemplar view of driver's seated position
