**CALSPAN ON-SITE CERTIFIED ADVANCED 208-COMPLIANT VEHICLE
CRASH INVESTIGATION**

CALSPAN CASE NO: CA05-002

VEHICLE: 2004 CHEVROLET SILVERADO

CRASH DATE: DECEMBER 2004

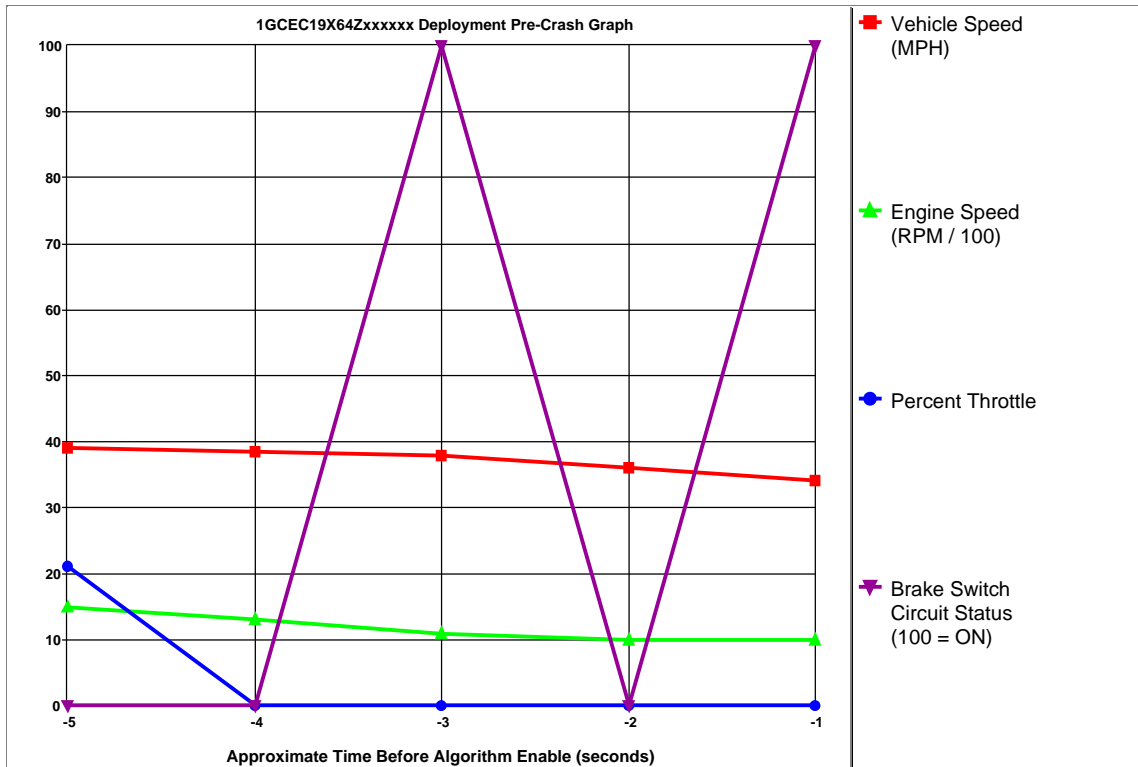
Based on the dynamics of the crash and the SCI reconstruction, the EDR Non-Deployment data was related to the secondary side slap. Examination of the data indicated that some of the pre-crash values were invalid. Invalid data is generally associated with a lack of battery power. This was consistent with the frontal crash damage that involved the front left area where the battery was located.

SIR Warning Lamp Status	OFF
Driver's Belt Switch Circuit Status	BUCKLED
Passenger's Belt Switch Circuit Status	UNBUCKLED
Ignition Cycles At Deployment	2953
Ignition Cycles At Investigation	2954
Maximum SDM Recorded Velocity Change (MPH)	-25.69
Algorithm Enable to Maximum SDM Recorded Velocity Change (msec)	97.5
Driver First Stage Time Algorithm Enabled to Deployment Command Criteria Met (msec)	5
Driver Second Stage Time Algorithm Enabled to Deployment Command Criteria Met (msec)	N/A
Passenger First Stage Time Algorithm Enabled to Deployment Command Criteria Met (msec)	Suppressed
Passenger Second Stage Time Algorithm Enabled to Deployment Command Criteria Met (msec)	N/A
Time Between Non-Deployment And Deployment Events (sec)	N/A
Frontal Deployment Level Event Counter	1
Automatic Passenger SIR Suppression System Status	Air Bag Suppressed
Event Recording Complete	Yes
Multiple Events Associated With This Record	No

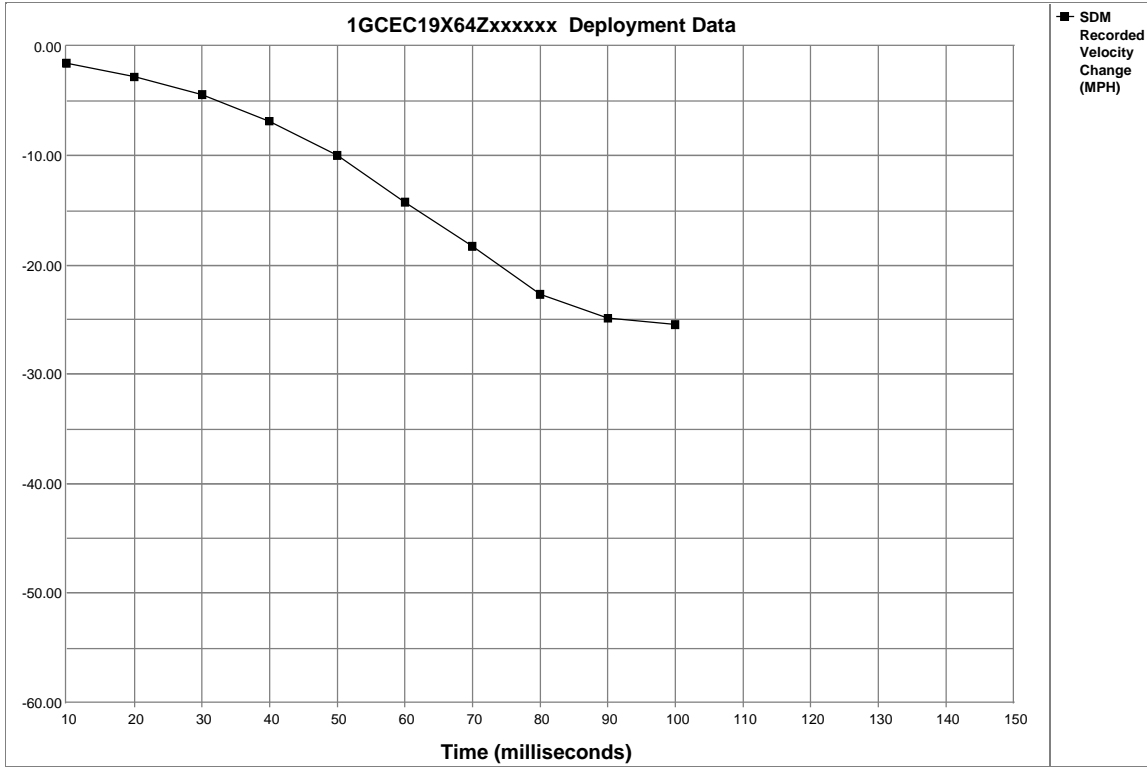
Seconds Before AE	Vehicle Speed (MPH)	Engine Speed (RPM)	Percent Throttle	Brake Switch Circuit Status
-5	39	1536	21	OFF
-4	39	1344	0	OFF
-3	38	1088	0	ON
-2	36	1024	0	OFF
-1	34	960	0	ON

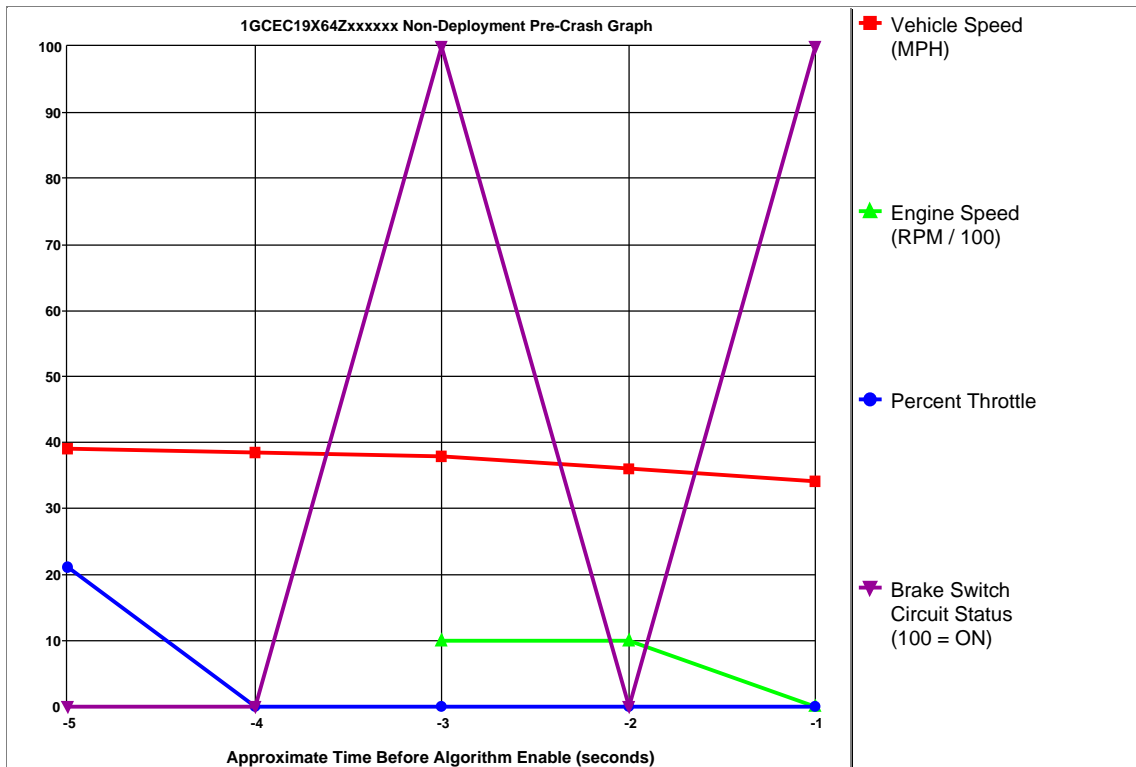
SIR Warning Lamp Status	OFF
Driver's Belt Switch Circuit Status	BUCKLED
Passenger's Belt Switch Circuit Status	UNBUCKLED
Ignition Cycles At Non-Deployment	2953
Ignition Cycles At Investigation	2954
Maximum SDM Recorded Velocity Change (MPH)	-0.16
Algorithm Enable to Maximum SDM Recorded Velocity Change (msec)	80
Event Recording Complete	Yes
Multiple Events Associated With This Record	No
One Or More Associated Events Not Recorded	No

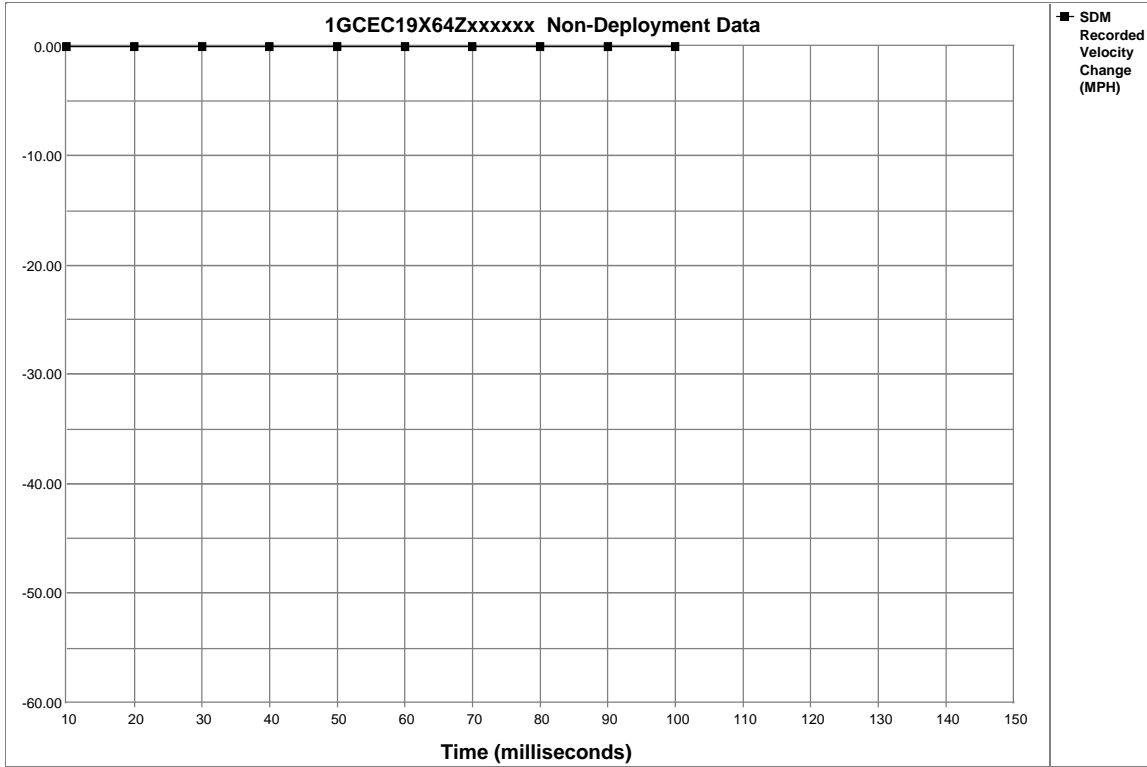
Seconds Before AE	Vehicle Speed (MPH)	Engine Speed (RPM)	Percent Throttle	Brake Switch Circuit Status
-5	39	Invalid	21	OFF
-4	39	Invalid	0	OFF
-3	38	1024	0	ON
-2	36	960	0	OFF
-1	34	0	0	ON

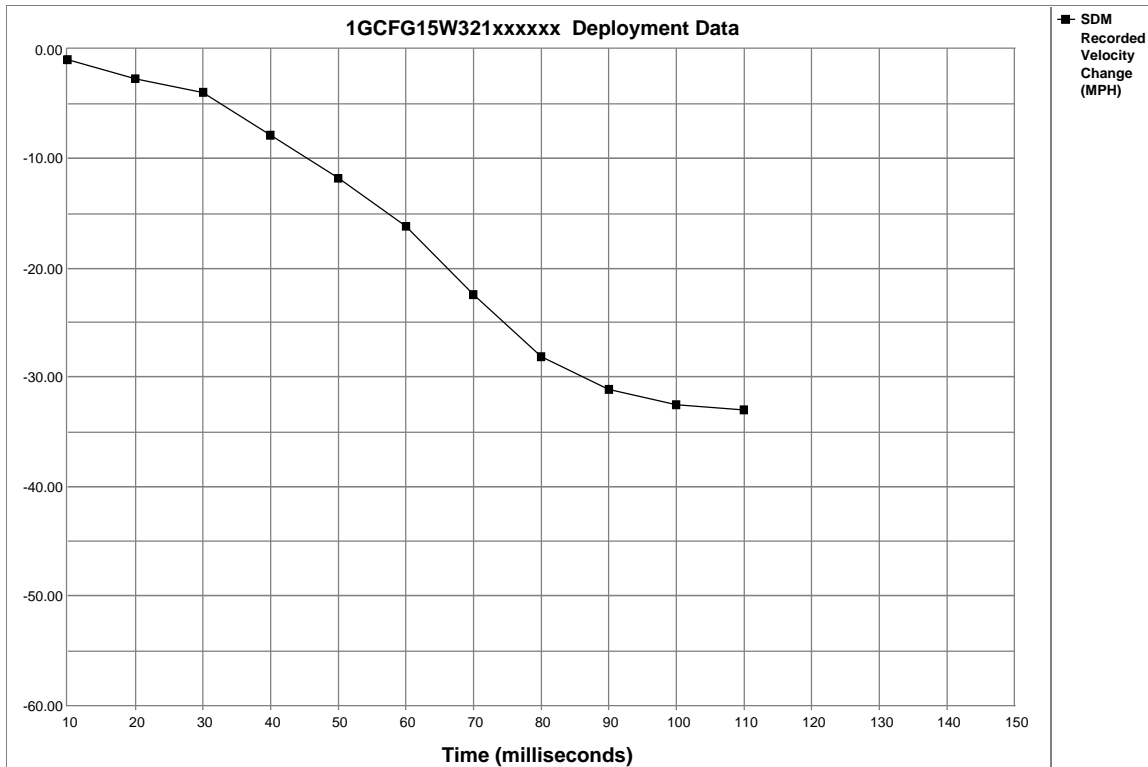
SIR Warning Lamp Status	OFF
Driver's Belt Switch Circuit Status	BUCKLED
Passenger Front Air Bag Suppression Switch Circuit Status	Air Bag Not Suppressed
Ignition Cycles At Deployment	8494
Ignition Cycles At Investigation	8495
Maximum SDM Recorded Velocity Change (MPH)	-33.24
Algorithm Enable to Maximum SDM Recorded Velocity Change (msec)	107.5
Time Between Non-Deployment And Deployment Events (sec)	N/A
Time From Algorithm Enable to Deployment Command Criteria Met (msec)	12.5

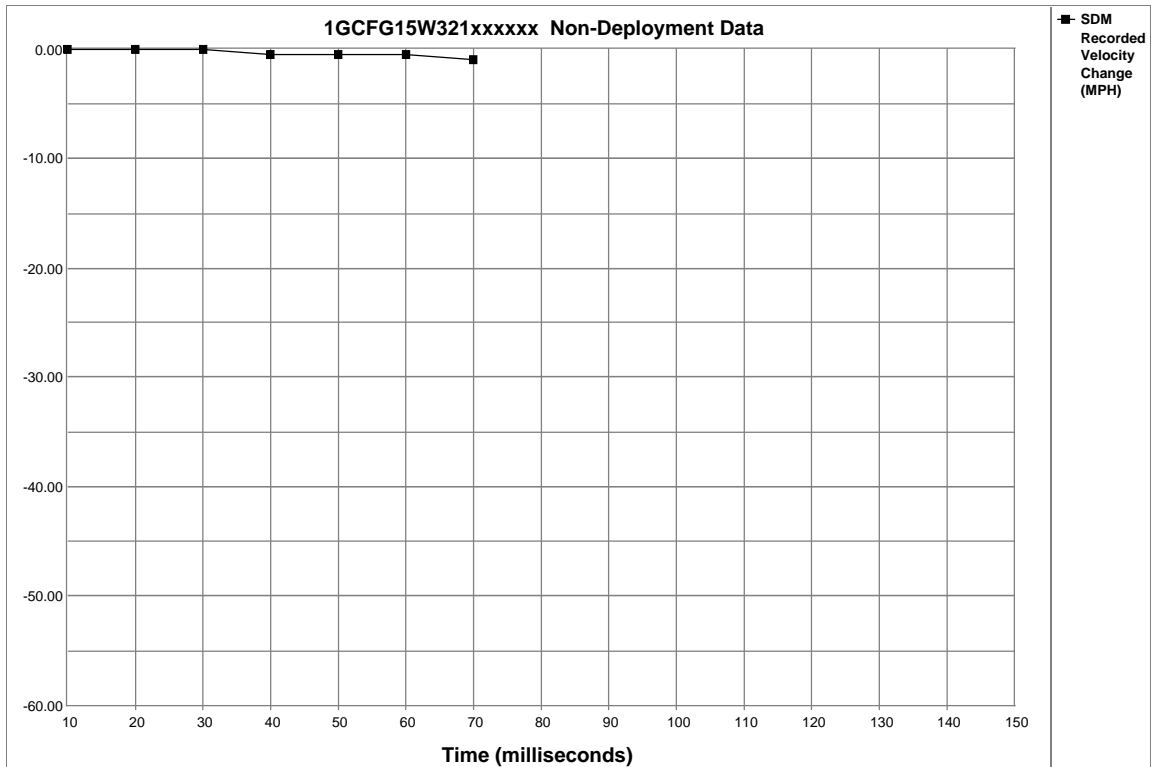
SIR Warning Lamp Status	OFF
Driver's Belt Switch Circuit Status	BUCKLED
Passenger Front Air Bag Suppression Switch Circuit Status	Air Bag Not Suppressed
Ignition Cycles At Non-Deployment	8413
Ignition Cycles At Investigation	8495
Maximum SDM Recorded Velocity Change (MPH)	-0.99
Algorithm Enable to Maximum SDM Recorded Velocity Change (msec)	70
