On-Site Rollover / Child Safety Seat Investigation
Dynamic Science, Inc. (DSI), Case Number (DS08005)
2003 Mercedes-Benz ML500
Oregon
January 2008

1. Report No. DS08005		2. Government Accession No.		3. Recipient Catalog No.	
4. Title and Subtitle Rollover/Child Safety Seat Investigation				5. Report Date April 24, 2008

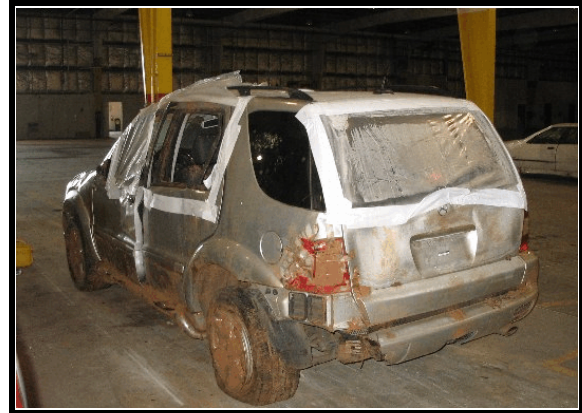
Figure 1. 2003 Mercedes-Benz ML500

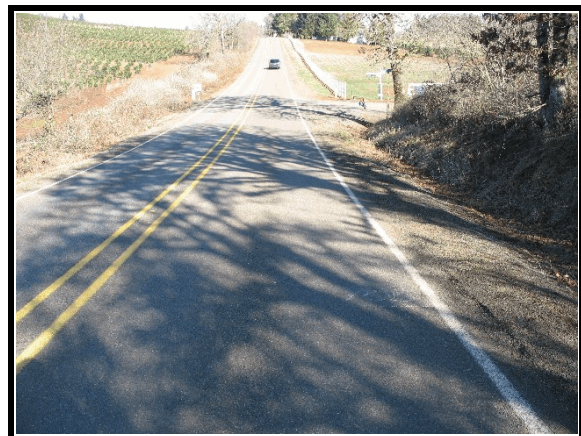
This single vehicle crash occurred on a two-lane roadway at 0847 hours in January 2008. The crash occurred near the intersection of a driveway and the roadway. At the time of the crash, the asphalt roadway surface was reported to be icy. The north/south roadway was configured with single lanes in each direction that were separated by a double-yellow painted centerline. At 30.4 m (100 ft) south of the impact area, the grade was -11%. At the area of impact, the grade was -1.4%. North of the driveway, there is a plastic fence. The fence runs parallel to the north/south roadway and at a 45 degree angle from the driveway entrance. Just north of the driveway, there was an

Figure 2. Approach to area of impact

irregularly shaped sink hole that was perpendicular to the roadway and extended beyond the fence to the east. The sink hole contained running water.

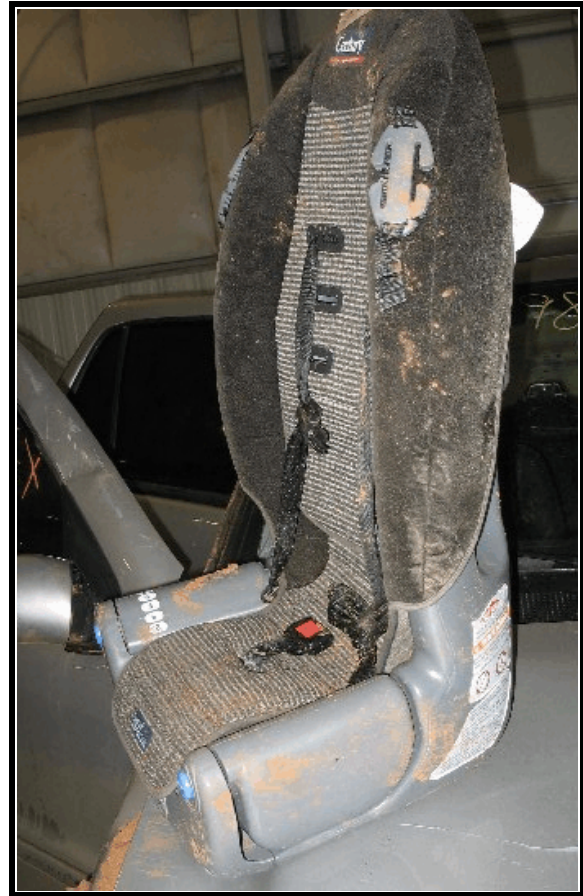
The child seat was installed in a forward facing configuration and anchored to the vehicle using the Mercedes' 3-point manual lap and shoulder belt. The father of the child had installed the CSS several months earlier. The safety belt was found to be in the ALR mode and the seat was secured inside the vehicle. There was approximately 5.0 cm (1.9 in) movement in the forward direction and approximately 7.0 cm (2.8 in) movement laterally.

Figure 12. Century Next Step CSS, side view showing armrest adjustments

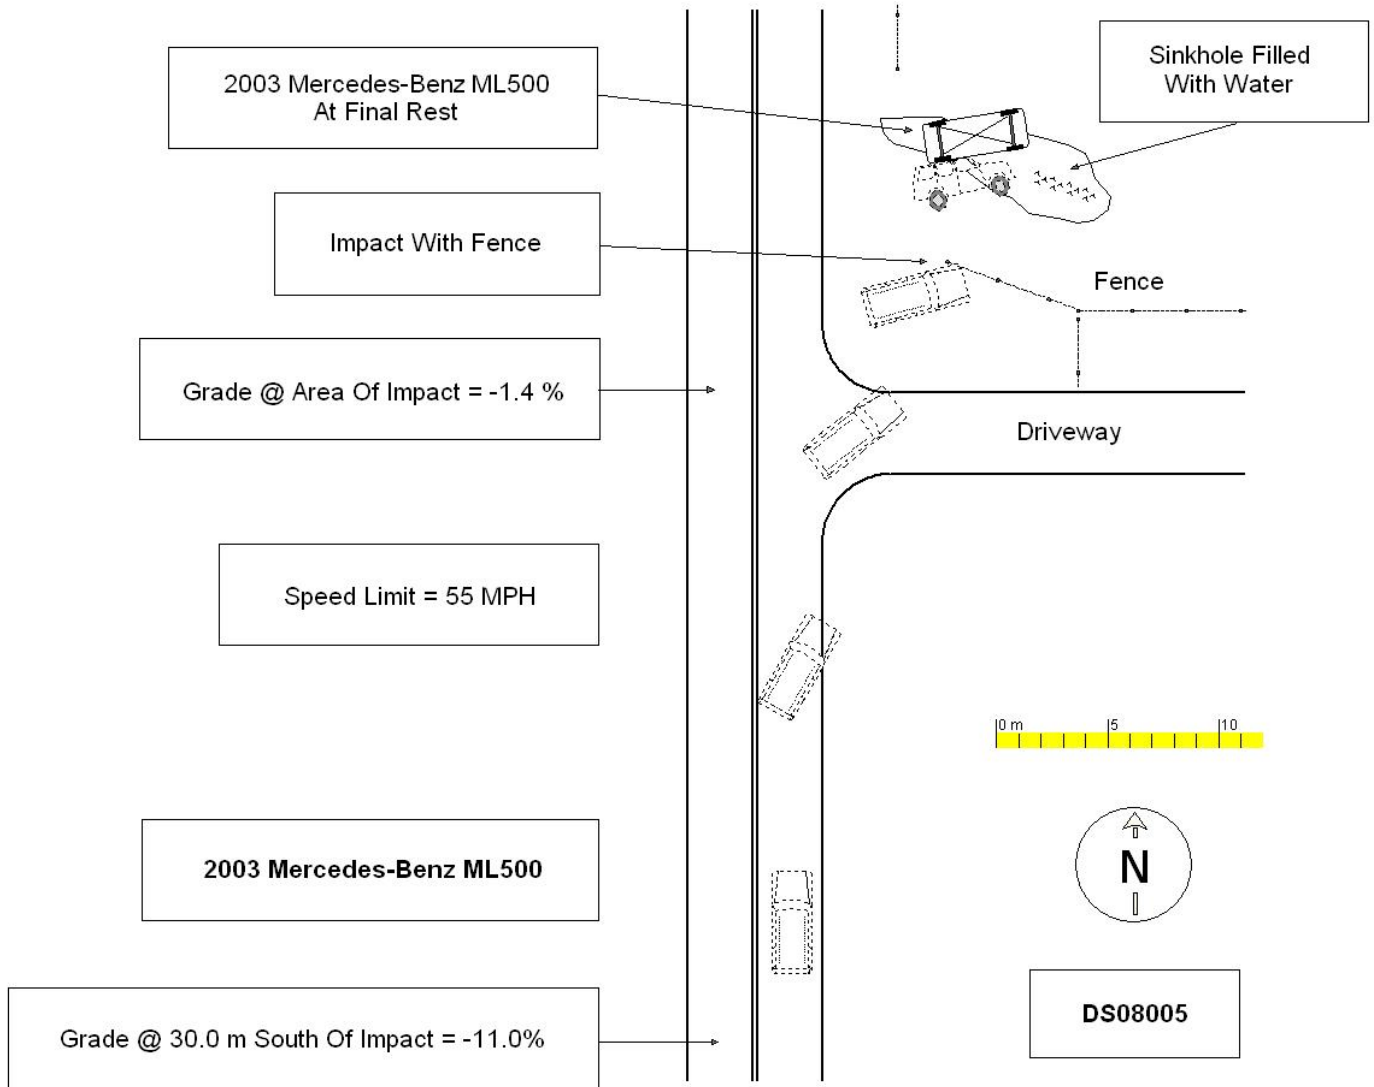
Attachment 1. Scene Diagram

The Mercedes traversed the driveway and struck the plastic fence with its left side. The Mercedes then tripped with its left side leading and began to overturn. The left side tires likely dropped into the sinkhole which caused the tripping motion. The Mercedes rolled over two quarter turns and came to rest on its roof in the sinkhole in a nose down configuration.
