On-Site Rollover Investigation
Dynamic Science, Inc. (DSI), Case Number DS08032
2007 Chevrolet C1500 Silverado
California
July 2008

1. Report No. DS08032		2. Government Accession No.		3. Recipient Catalog No.	
4. Title and Subtitle On-Site Rollover Investigation			5. Report Date August 14, 2009

**Dynamic Science, Inc.
Crash Investigation
Case Number: DS08032**

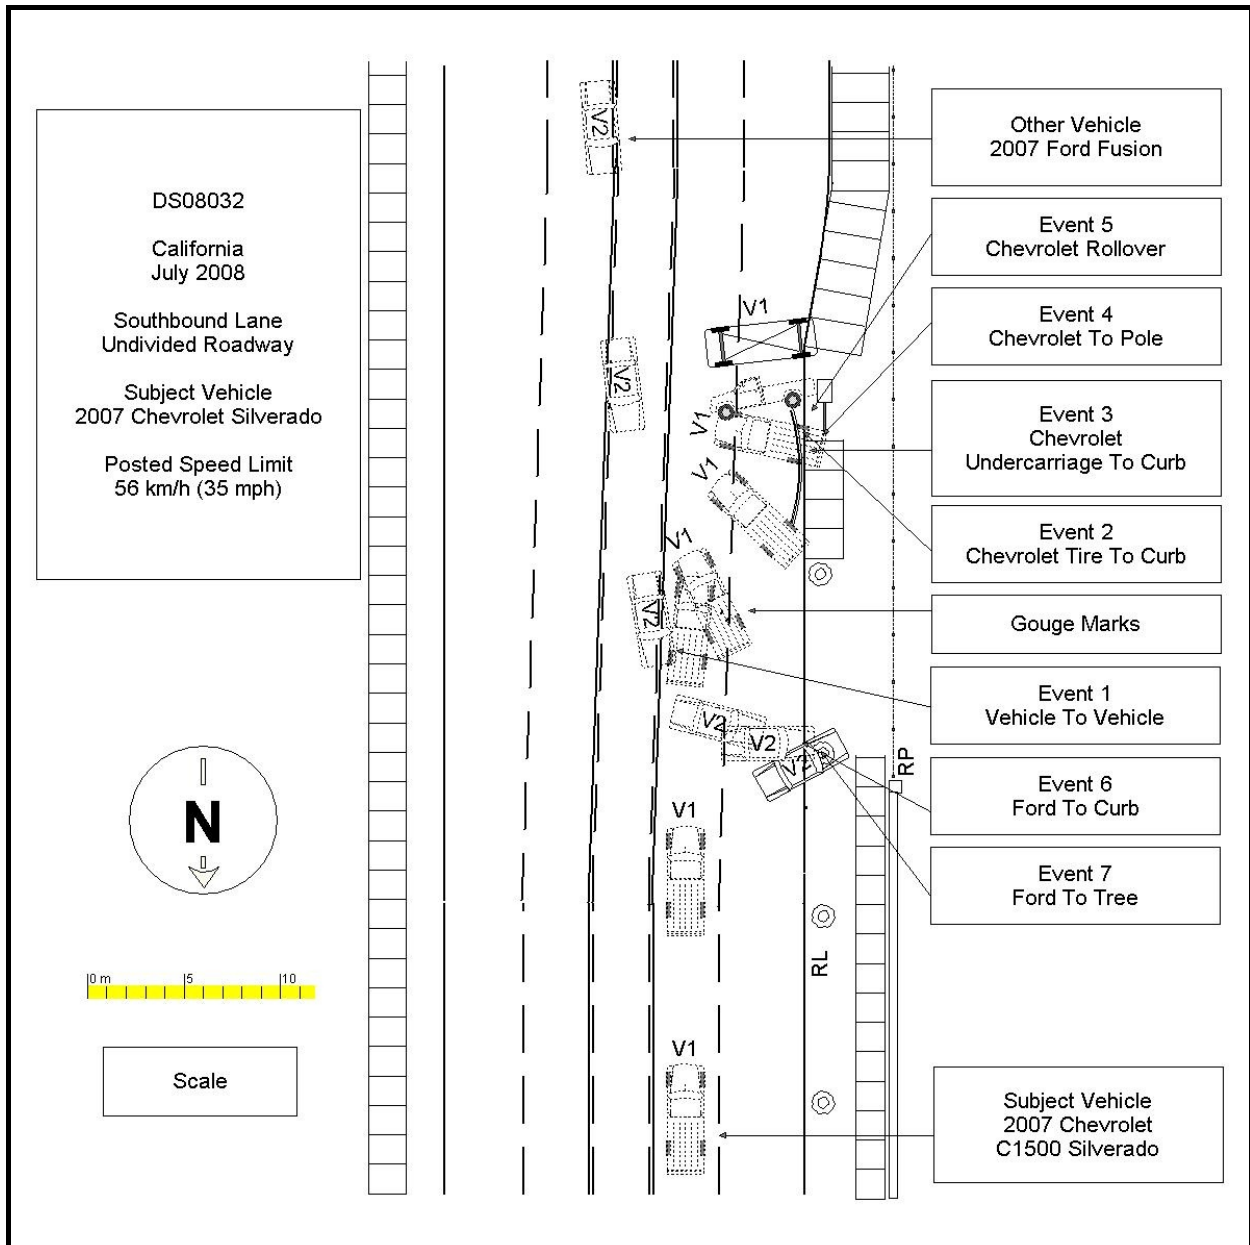
Attachment 1. Scene Diagram

As the vehicle traveled laterally along the curb, the right side tires engaged the roadway and the vehicle initiated a right side leading trip-over. The vehicle came to rest on its roof and facing east. Based on the scene evidence and vehicle damage, the estimated rollover distance was 5 m (16.4 ft).
