**CALSPAN ON-SITE ROLLOVER CRASH INVESTIGATION
SCI CASE NO: CA09004**

VEHICLE: 2009 MERCEDES-BENZ ML 350

LOCATION: STATE OF PENNSYLVANIA

CRASH DATE: DECEMBER 2008

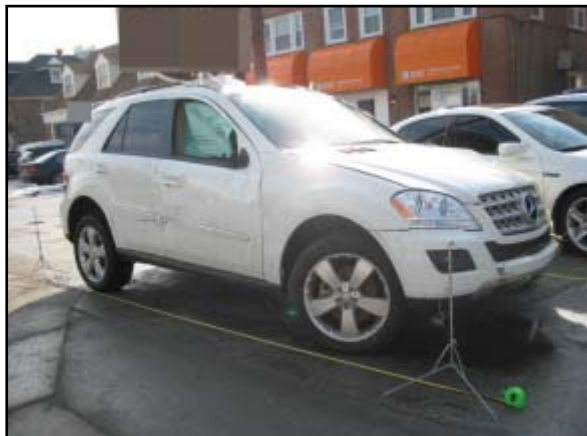
Figure 1. Case vehicle, 2009 Mercedes-Benz ML 350.

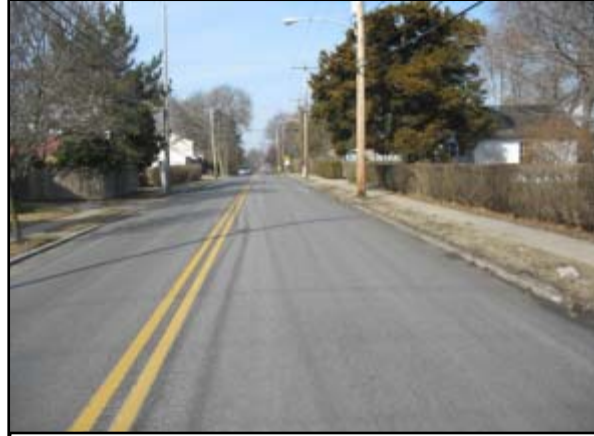
The restrained 49-year-old female driver of the Mercedes-Benz was operating the vehicle eastbound on the two-lane roadway (**Figure 2**). The driver stated to the SCI investigator that she was stopped for a red light at an intersection. This intersection was located approximately 100 meters (328 feet) west of the crash site. While stopped at this intersection, the driver inhaled a dose of medication that she had recently purchased at a pharmacy. As the driver accelerated to continue her eastbound trajectory, she stated that she had a reaction to the medication which caused her to lose consciousness. The vehicle traveled approximately 100 meters (328 feet), and crossed the centerline, and traversed the westbound travel lane. It's unknown if the PRESAFE system activated prior to the crash.

Figure 2. Mercedes-Benz eastbound trajectory.

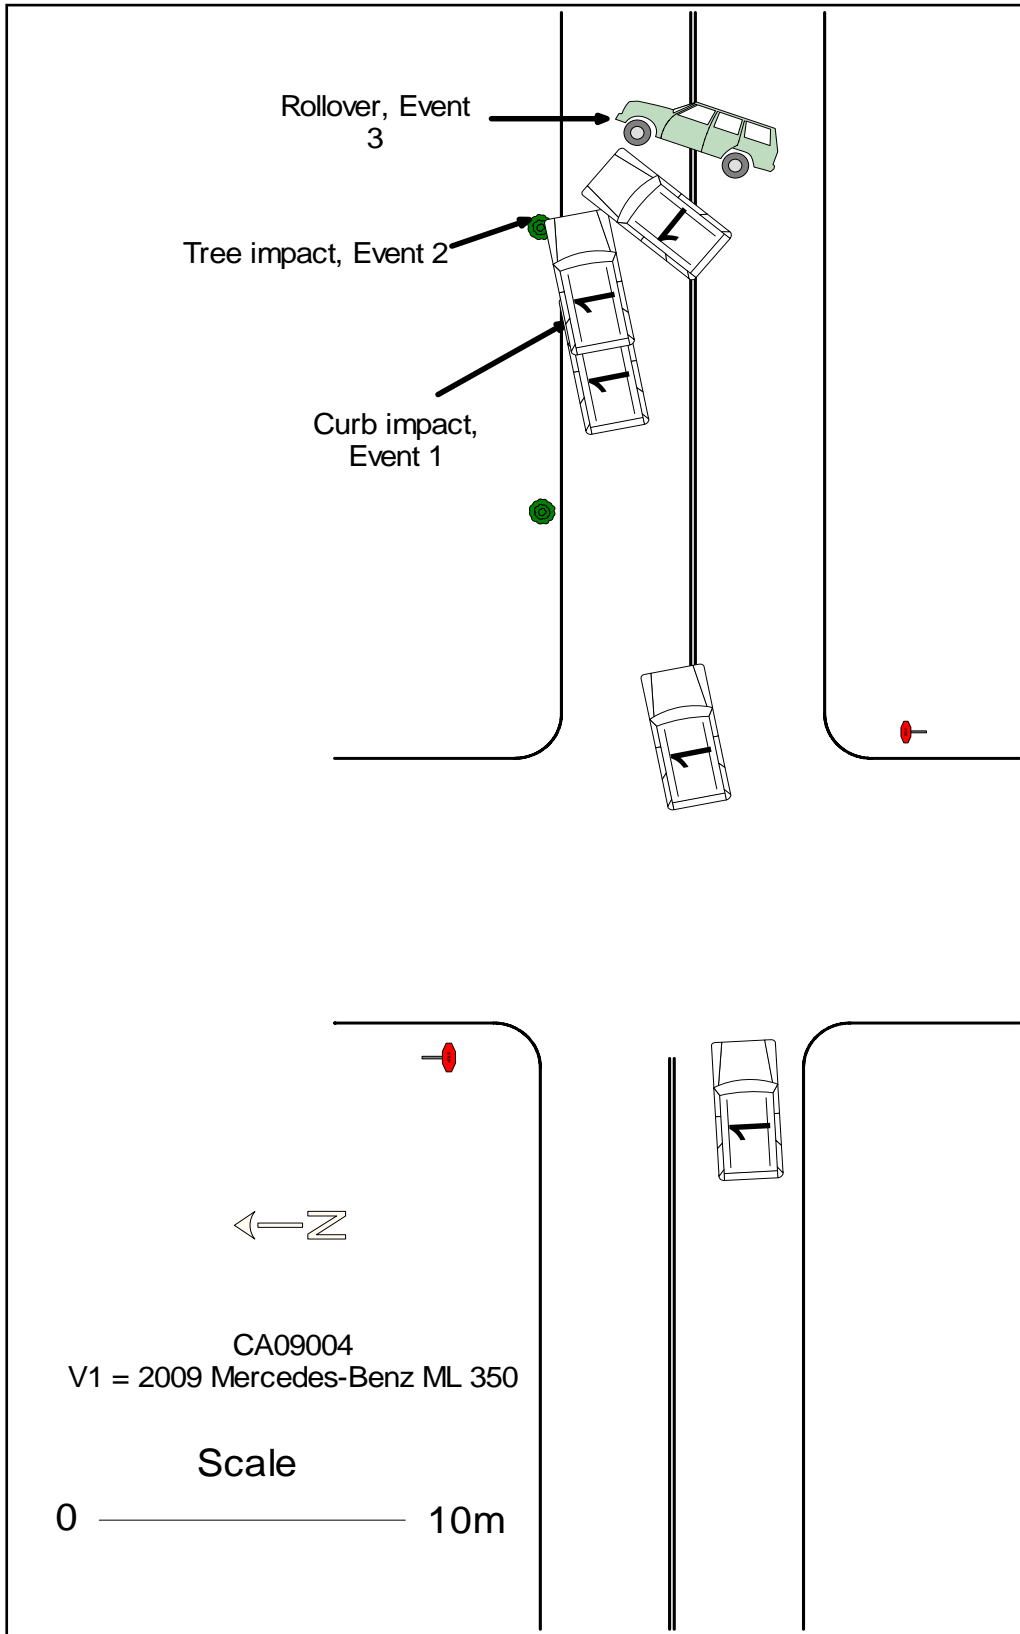
Figure 9: Scene Schematic

This crash occurred during the daylight hours of December 2008 on the north roadside of a two-lane east/west roadway. At the time of the crash, the road surface was dry and the weather conditions were reported as clear. The east/west roadway was configured with one travel lane in each direction. The travel lanes were surfaced with asphalt and separated by double yellow centerlines. The posted speed limit for the roadway was 40 km/h (25 mph). In the vicinity of the crash site, a north/south roadway intersected the east/west travel lanes forming a four-leg intersection. The intersection was controlled by stop signs for the north/southbound traffic. The roadsides were bordered by concrete barrier curbs. Beyond the north curb, the roadside consisted of a grass area with a tree line, concrete sidewalk, a lawn with a wooden fence, and a private residence. The scene schematic is included as **Figure 9** of this report.
