## ON-SITE OTHER INFLATABLE OCCUPANT PROTECTION INVESTIGATION

CASE NUMBER - IN10008

LOCATION - KENTUCKY

VEHICLE - 2008 CHEVROLET IMPALA LT

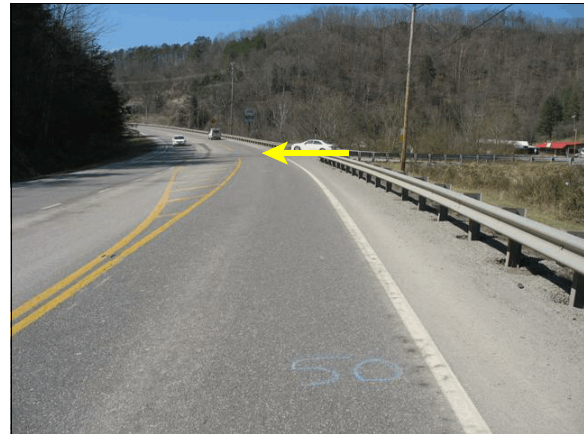
**Figure 2:** Approach of the Jeep; arrow shows the approach of the Chevrolet

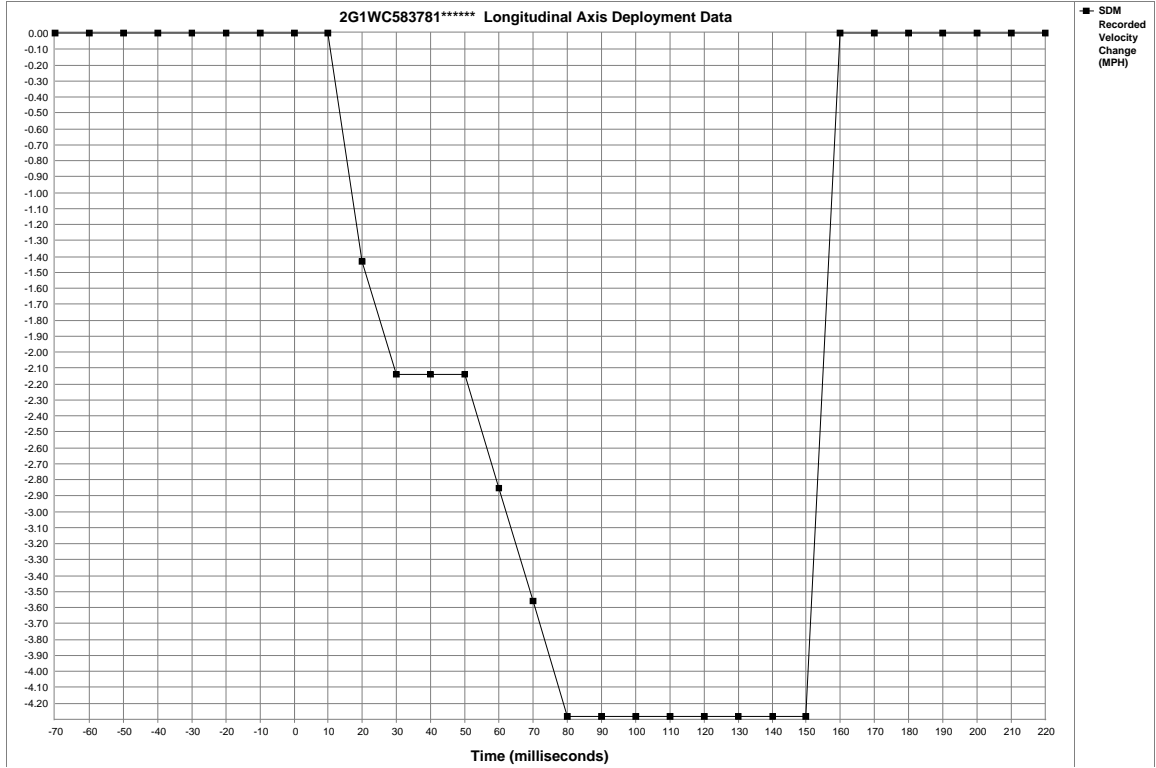
Time (milliseconds)	-70	-60	-50	-40	-30	-20	-10	0	10	20	30	40	50	60	70
SDM Longitudinal Axis Recorded Velocity Change (MPH)	0.00	0.00	0.00	0.00	0.00	0.00	0.00	0.00	0.00	-1.43	-2.14	-2.14	-2.14	-2.85	-3.56
Time (milliseconds)	80	90	100	110	120	130	140	150	160	170	180	190	200	210	220
SDM Longitudinal Axis Recorded Velocity Change (MPH)	-4.28	-4.28	-4.28	-4.28	-4.28	-4.28	-4.28	-4.28	0.00	0.00	0.00	0.00	0.00	0.00	0.00

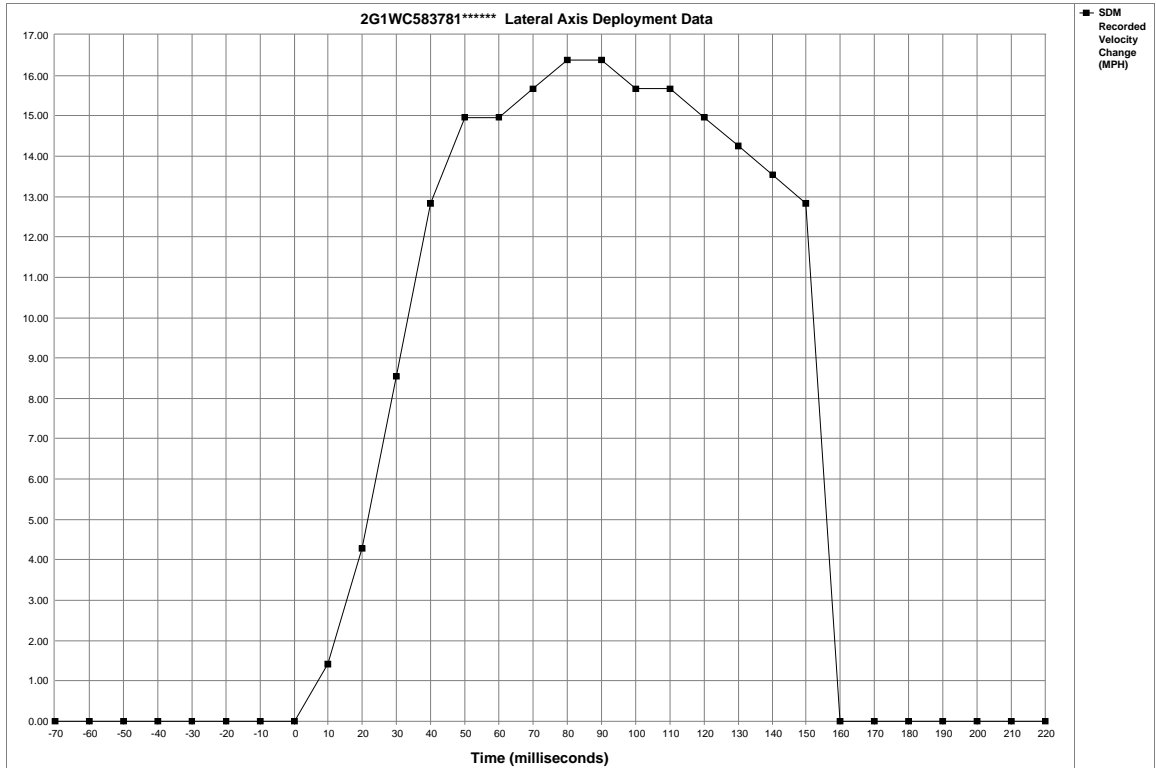
Time (milliseconds)	-70	-60	-50	-40	-30	-20	-10	0	10	20	30	40	50	60	70
SDM Lateral Axis Recorded Velocity Change (MPH)	0.00	0.00	0.00	0.00	0.00	0.00	0.00	0.00	1.43	4.28	8.55	12.83	14.97	14.97	15.68
Time (milliseconds)	80	90	100	110	120	130	140	150	160	170	180	190	200	210	220
SDM Lateral Axis Recorded Velocity Change (MPH)	16.39	16.39	15.68	15.68	14.97	14.25	13.54	12.83	0.00	0.00	0.00	0.00	0.00	0.00	0.00
