CALSPAN ON-SITE ROLLOVER CRASH INVESTIGATION
SCI CASE NO.: CA10034

VEHICLE: 2008 CHEVROLET SILVERADO CREW CAB 4X2

LOCATION: NORTH CAROLINA

CRASH DATE: AUGUST 2010

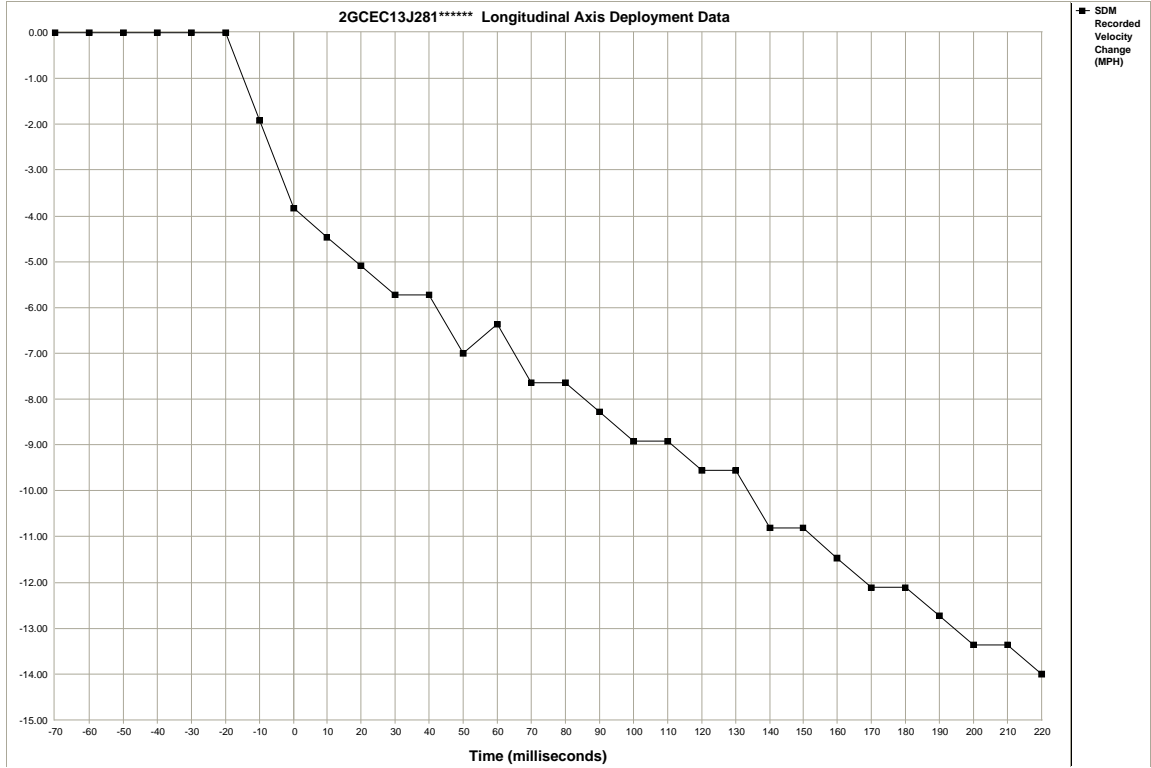
Time (milliseconds)	-70	-60	-50	-40	-30	-20	-10	0	10	20	30	40	50	60	70
SDM Longitudinal Axis Recorded Velocity Change (MPH)	0.00	0.00	0.00	0.00	0.00	0.00	-1.91	-3.82	-4.46	-5.09	-5.73	-5.73	-7.00	-6.37	-7.64
Time (milliseconds)	80	90	100	110	120	130	140	150	160	170	180	190	200	210	220
SDM Longitudinal Axis Recorded Velocity Change (MPH)	-7.64	-8.28	-8.91	-8.91	-9.55	-9.55	-10.82	-10.82	-11.46	-12.10	-12.10	-12.73	-13.37	-13.37	-14.01

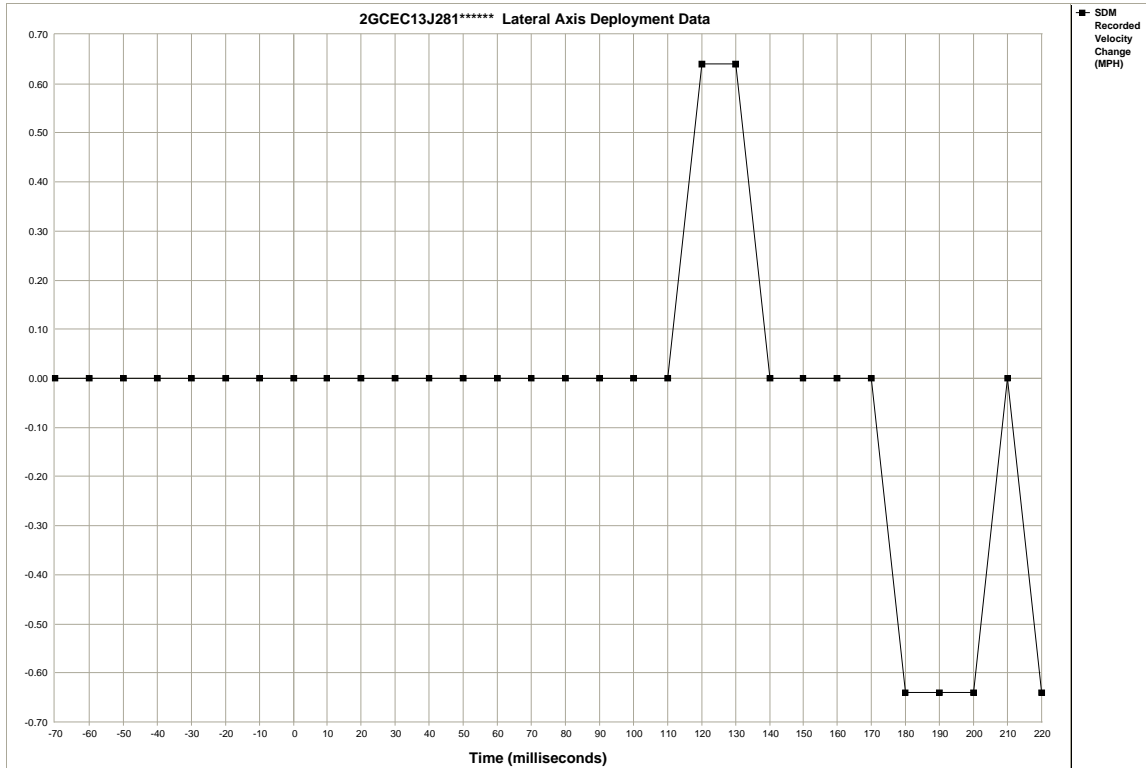
Time (milliseconds)	-70	-60	-50	-40	-30	-20	-10	0	10	20	30	40	50	60	70
SDM Lateral Axis Recorded Velocity Change (MPH)	0.00	0.00	0.00	0.00	0.00	0.00	0.00	0.00	0.00	0.00	0.00	0.00	0.00	0.00	0.00
Time (milliseconds)	80	90	100	110	120	130	140	150	160	170	180	190	200	210	220
SDM Lateral Axis Recorded Velocity Change (MPH)	0.00	0.00	0.00	0.00	0.64	0.64	0.00	0.00	0.00	0.00	-0.64	-0.64	-0.64	0.00	-0.64

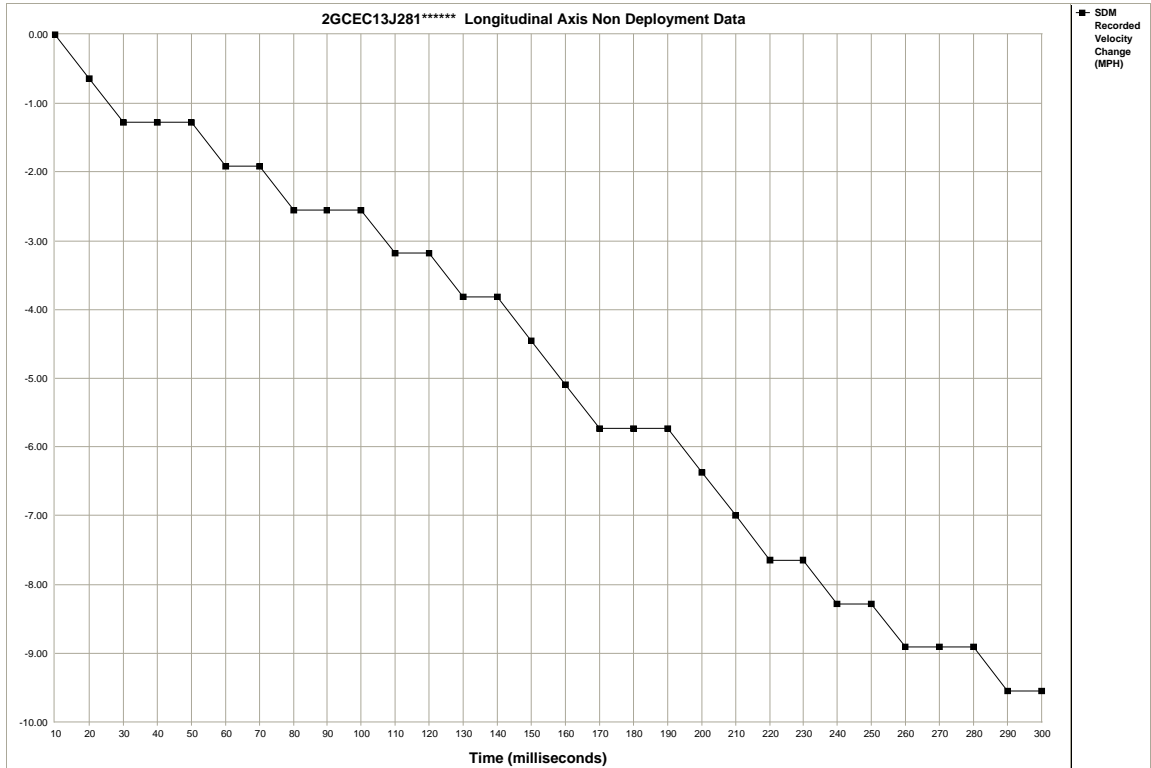
Time (milliseconds)	10	20	30	40	50	60	70	80	90	100	110	120	130	140	150
SDM Longitudinal Axis Recorded Velocity Change (MPH)	0.00	-0.64	-1.27	-1.27	-1.27	-1.91	-1.91	-2.55	-2.55	-2.55	-3.18	-3.18	-3.82	-3.82	-4.46
Time (milliseconds)	160	170	180	190	200	210	220	230	240	250	260	270	280	290	300
SDM Longitudinal Axis Recorded Velocity Change (MPH)	-5.09	-5.73	-5.73	-5.73	-6.37	-7.00	-7.64	-7.64	-8.28	-8.28	-8.91	-8.91	-8.91	-9.55	-9.55

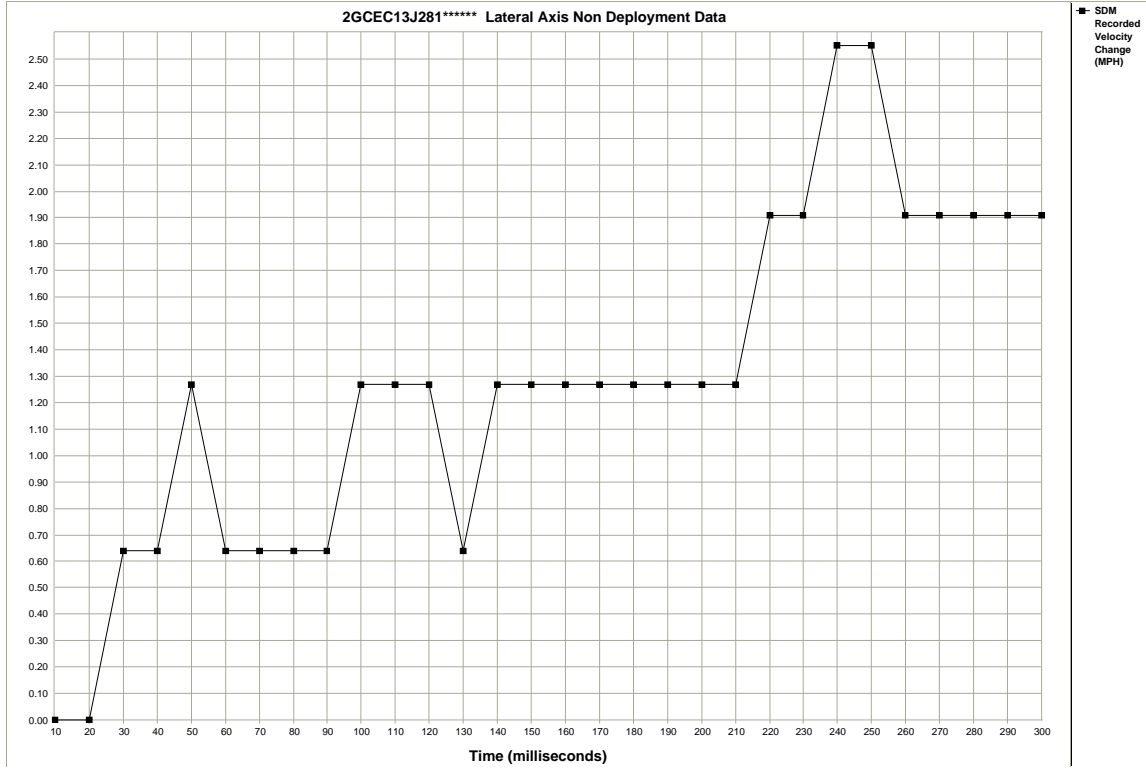
Time (milliseconds)	10	20	30	40	50	60	70	80	90	100	110	120	130	140	150
SDM Lateral Axis Recorded Velocity Change (MPH)	0.00	0.00	0.64	0.64	1.27	0.64	0.64	0.64	0.64	1.27	1.27	1.27	0.64	1.27	1.27
Time (milliseconds)	160	170	180	190	200	210	220	230	240	250	260	270	280	290	300
SDM Lateral Axis Recorded Velocity Change (MPH)	1.27	1.27	1.27	1.27	1.27	1.27	1.91	1.91	2.55	2.55	1.91	1.91	1.91	1.91	1.91
