SCI/NASS COMBINATION CASE REPORT

CASE NUMBER - NASS-1997-72-103A

VEHICLE - 1996 Ford Taurus

CRASH DATE - August 1997

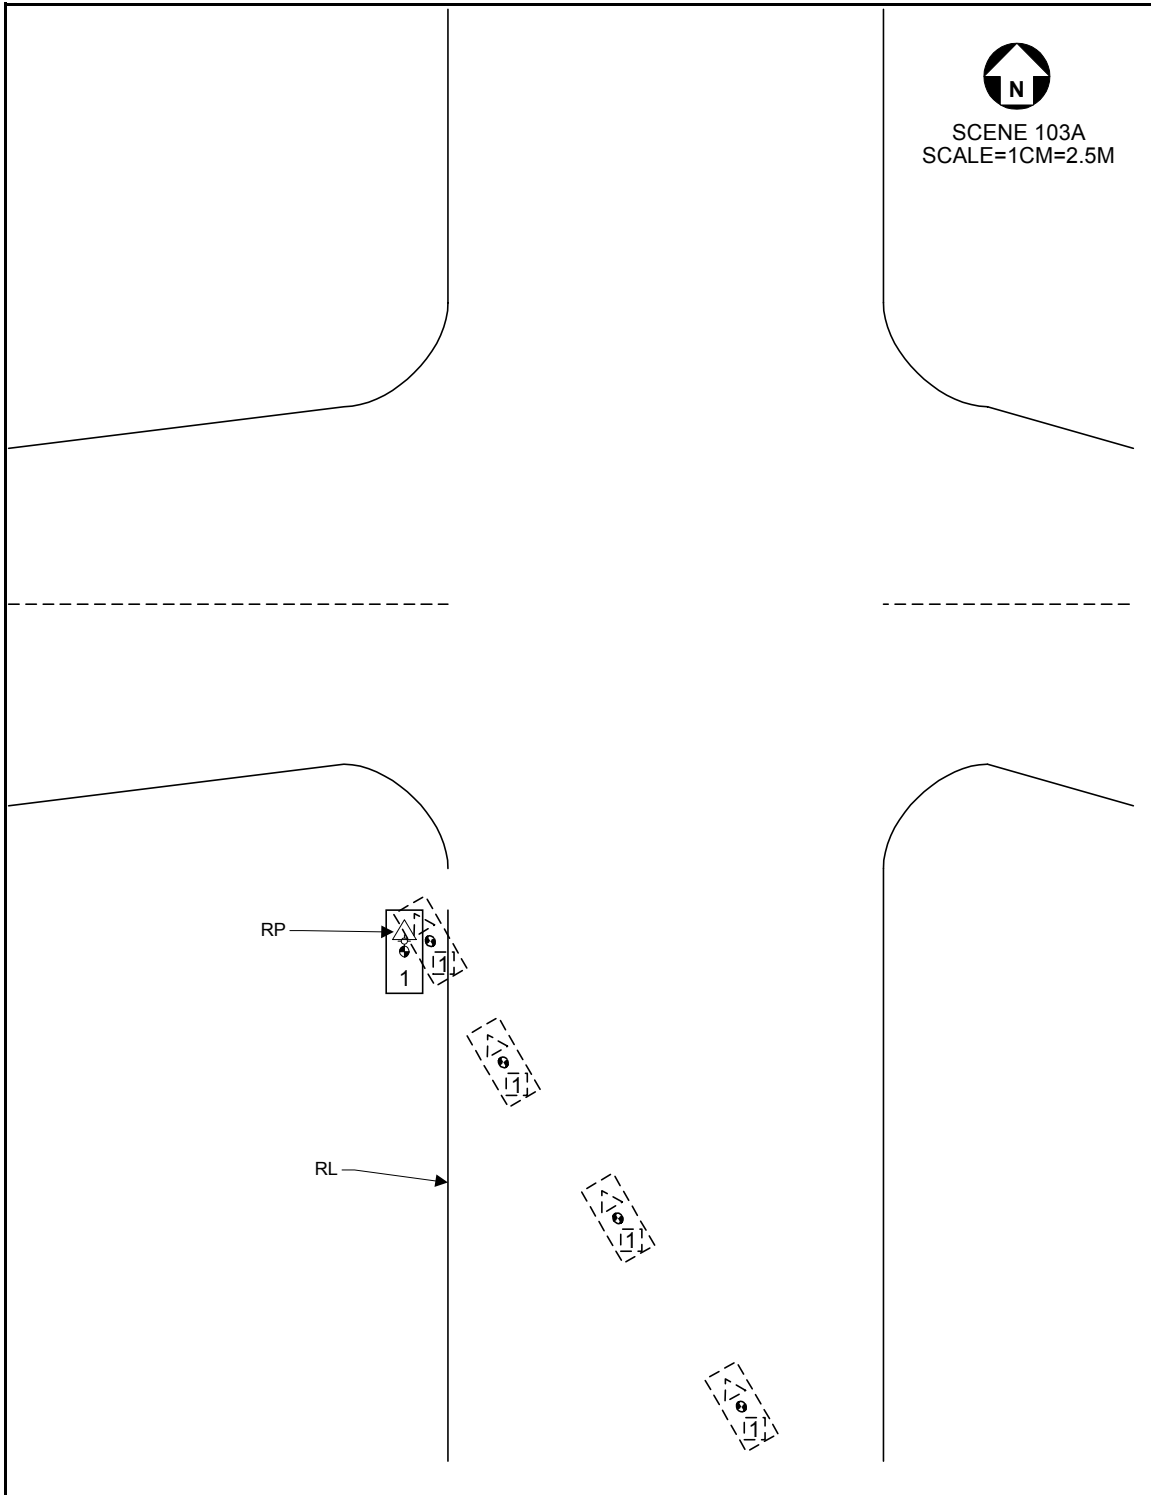
CRASH DIAGRAM

1. There is only one event (left departure into a pole) encoded in the NASS version of this case, but there is damage on the right side of the vehicle that is suggestive of a sideswipe-type event. The roadway is a two-lane, two-way residential street with parallel parking on both sides. A scenario where V1 swipes a parked car, causing V1's driver to over-correct, lose control and run off the road to the left is consistent with the evidence and explains why V1 made the left departure. Under this scenario, the right side swiping-type impact (to a “parked car” or an “unknown object”?) would be event #1 and the pole impact would be event #2.
