Remote, Redesigned Air Bag Special Study

Dynamic Science, Inc., Case Number (1998-048-802E)

1998 Toyota Tacoma

October, 1998

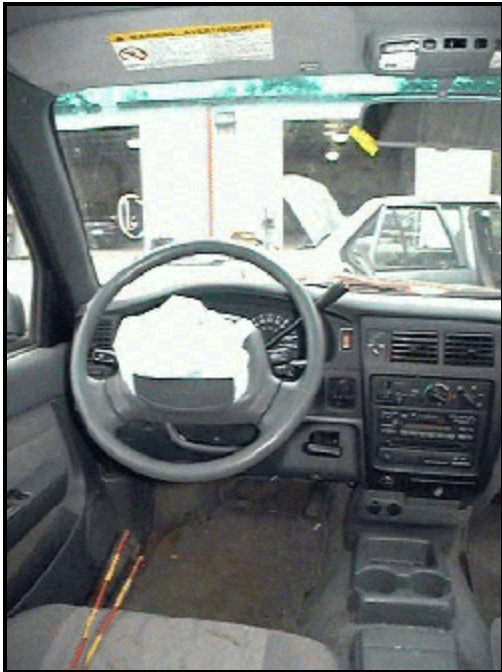
Figure 9. Interior, case vehicle.

The interior of the Toyota Tacoma sustained minor damage from occupant contact. There were no areas of intrusion into the passenger compartment. There was occupant contact evidence to the left instrument panel and rear view mirror.

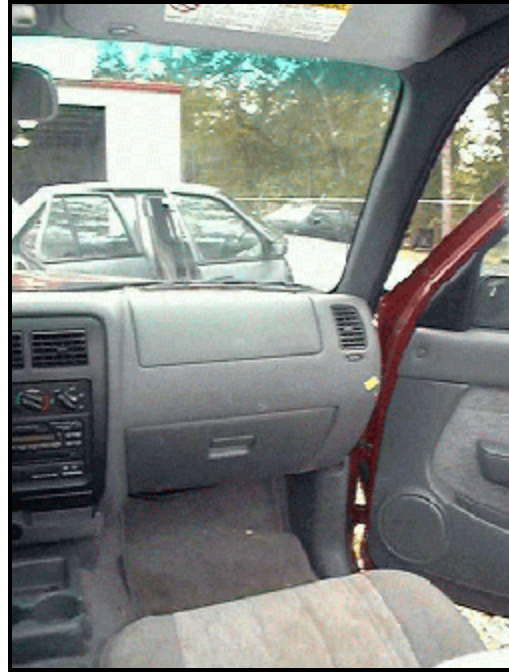
Figure 10. Interior, case vehicle.

At impact, the occupants reacted to the 360 degree principle direction of force by moving forward and loading the lap/shoulder restraints. As the restraints locked, further forward movement of the occupants was prevented. The driver had moved far enough forward to impact the left instrument panel with his left knee. A scuff mark was found on the panel. It also appeared that the driver may have impacted the rearview mirror with his right hand. The mirror had been pushed out of place. No evidence of occupant contact was found on the air bag but it is presumed that he contacted the bag somewhat with his chest in this moderate frontal collision. No evidence was found in the vehicle of contact from the passenger. Case occupant 02 sustained a chest contusion from contact with the seat belt webbing. It appears that the cervical spine strain suffered by case occupant 02 was caused by the force of the impact, rather than contact with any component of the vehicle's interior.
